# CSM - Whiteley Hall

Design and Access Statement  
October 2022

Project name: CSM – Whiteley Hall

Project number: 9357

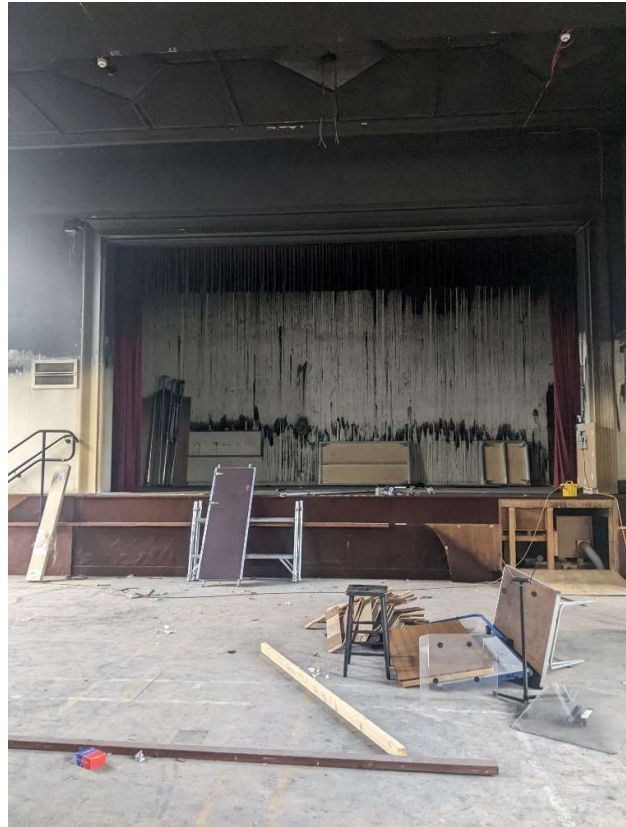
Whiteley Hall - Damage to the Stage
