# London Road Fire Station

Manchester

Internal Repairs – Ground Floor

## London Road Fire Station, Manchester – Schedule of Enabling Works for Internal Repairs – Ground Floor

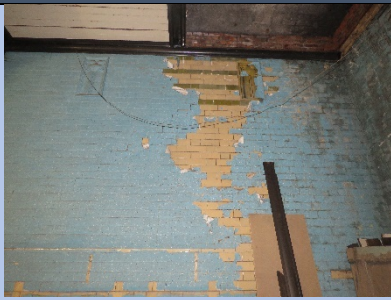
| Room Ref. | Element | Description / Item | Condition | Action | Photographs | | |
|---|---|---|---|---|---|---|--|
| Unit A | Walls | Glazed brick painted. | Good / fair | <ul style="list-style-type: none"> <li>Remove flaking paint with hand tools.</li> <li>Remove remaining blue paint using peel away.</li> <li>Paint is to be removed from both all existing walls and all columns</li> <li>Glazed bricks to then be cleaned and protected. Any holes to be infilled using reclaimed glazed bricks. Small holes to be reviewed by design team on-site to decide on which scars are acceptable and which scars require replacement brick insertion. Please state prov. number of brick replacements allowed for within contractor price.</li> <li>Final TC5 works to bi-folding doors to be completed.</li> </ul> | | | |

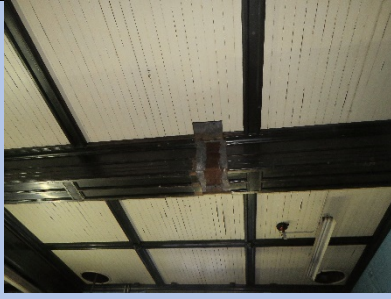
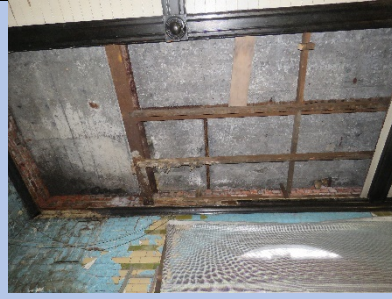
| Room Ref. | Element | Description / Item | Condition | Action | Photographs | | |
|---|---|---|---|---|---|---|--|
| | Ceiling | Painted timber board or exposed concrete and steel beams. | Fair | <ul style="list-style-type: none"> <li>Assess condition of all timber boards.</li> <li>Remove all flaking paint.</li> <li>De-rust corroded steel beam.</li> <li>Exposed steel to be treated with intumescent treatment per NBS:M61/120.</li> <li>All existing Timber boarding and steel encasement repaired and painted with intumescent paint NBS:Z12/213. All holes infilled and redundant services removed.</li> <li>All missing areas of timber boarding to be replaced with like for like boarding and painted with intumescent paint NBS:Z12/213.</li> </ul> | | | |

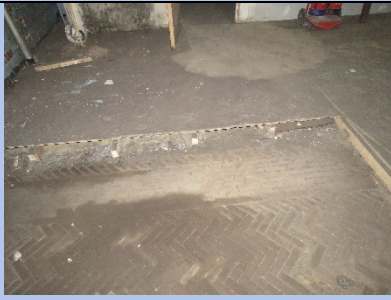
| Room Ref. | Element | Description / Item | Condition | Action | Photographs | | |
|---|---|---|---|---|---|---|--|
| | Floor | Herringbone brick | Fair | <ul style="list-style-type: none"> <li>Existing tile floor cleaned, and loose material removed</li> <li>Remove all debris.</li> <li>Clean bricks surface and infill any areas of missing brickwork.</li> <li>Install protection.</li> </ul> | | | |

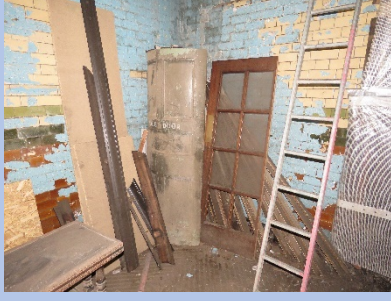
| Room Ref. | Element | Description / Item | Condition | Action | Photographs | | |
|---|---|---|---|---|---|---|--|
| | Joinery | Pile of timber from staircase S06.<br>2no. doors, 1no is a fire pole door.<br>Skirting | | <ul style="list-style-type: none"> <li>Staircase timber and doors to be set aside for reuse elsewhere, fire pole cupboard door to be returned to its original location.</li> <li>Skirting reused elsewhere for repairs, if possible, otherwise scrapped.</li> </ul> | | | |

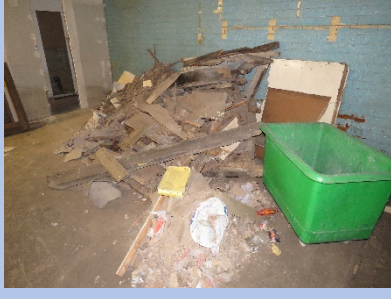
| Room Ref. | Element | Description / Item | Condition | Action | Photographs | | |
|---|---|---|---|---|---|---|--|
| | Misc. | Demolition waste from S06. | | <ul style="list-style-type: none"> <li>Remove all demolition waste (non-timber).</li> </ul> | | | |

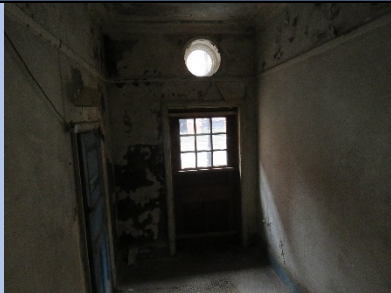
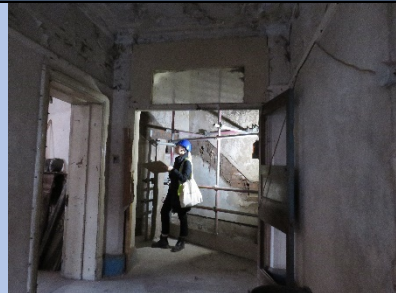
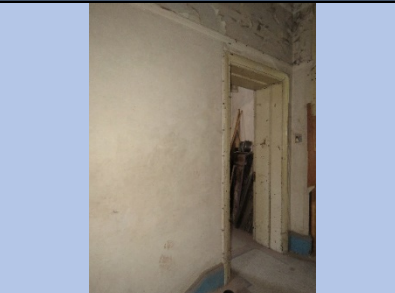
| Room Ref. | Element | Description / Item | Condition | Action | Photographs | | |
|---|---|---|---|---|---|---|---|
| SO6 | Walls | Plaster to brick with paint finish.<br>Timber stud partition with chipboard.<br>Crack above door. | Fair | <ul style="list-style-type: none"> <li>• Hammer test remaining plaster and remove any bossed plaster.</li> <li>• Remove flaking paint.</li> <li>• Remove stud partition and chipboard including all nails.</li> <li>• CURTINS COMMENT: Helifix crack stitching – standard detail CS05 (both sides of wall). Repoint (crack above door).</li> <li>• Lime plaster to be repaired/reinstated where missing to specification NBS:M20/210.</li> </ul> | | | |

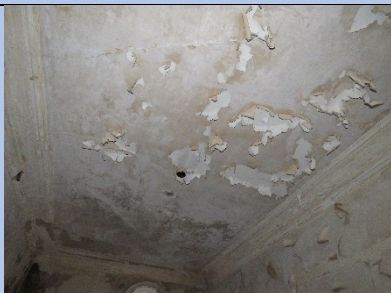
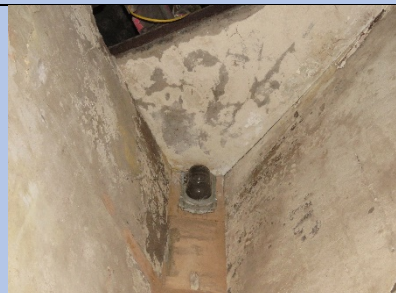
| Room Ref. | Element | Description / Item | Condition | Action | Photographs | | |
|---|---|---|---|---|---|---|---|
| | Ceiling | Plaster to lath with paint finish.<br>Cornice survives. | Fair | <ul style="list-style-type: none"> <li>• Hammer test remaining plaster and remove any bossed plaster.</li> <li>• Remove flaking paint.</li> <li>• Lime plaster ceiling to be repaired as NBS:M20/587 and treated with intumescent paint as NBS:Z12/212.</li> <li>• Cornice repaired and reinstated where missing.</li> </ul> | | | |

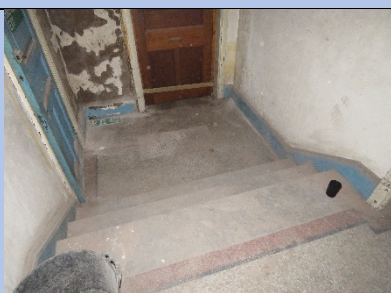
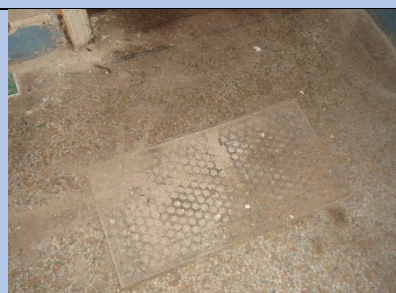
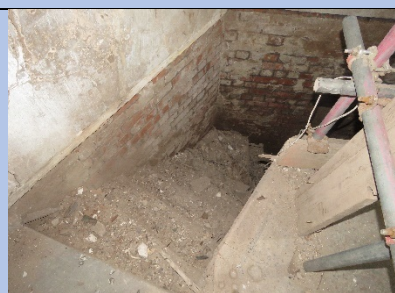
| Room Ref. | Element | Description / Item | Condition | Action | Photographs | | |
|---|---|---|---|---|---|---|---|
| | Floor | Terrazzo.<br>Rubber entrance matt.<br>Stone stairs. | Fair | <ul style="list-style-type: none"> <li>• Remove all debris.</li> <li>• Remove rubber entrance mat and infill temporarily with plyboard.</li> <li>• Clean and protect terrazzo.</li> <li>• Install protection.</li> <li>• Existing terrazzo flooring cleaned and protected.</li> </ul> | | | |

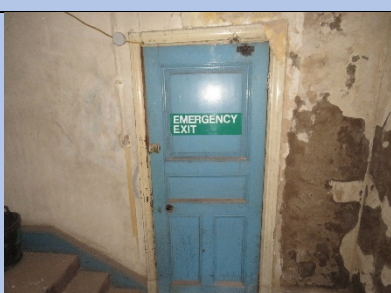
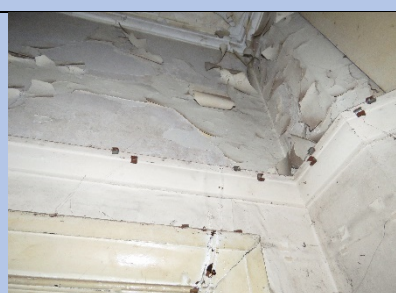
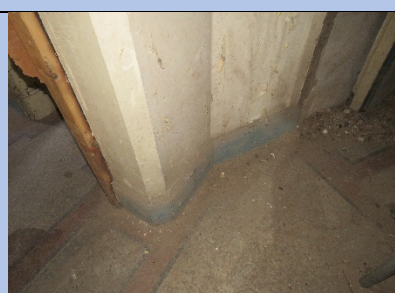
| Room Ref. | Element | Description / Item | Condition | Action | Photographs | | |
|---|---|---|---|---|---|---|---|
| | Joinery | 1no. original door<br>Skirting<br>Picture rail<br>Door architrave<br>Timber board to wall of stair. | | <ul style="list-style-type: none"> <li>• Existing door and architrave removed and set aside for re-use. New fire doors installed as per door schedule.</li> <li>• Skirting and picture rail repaired/reinstated to plaster walls.</li> <li>• Timber boarding to walls removed.</li> </ul> | | | |

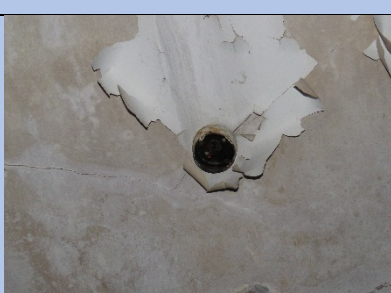
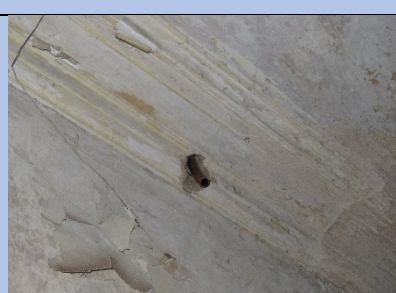
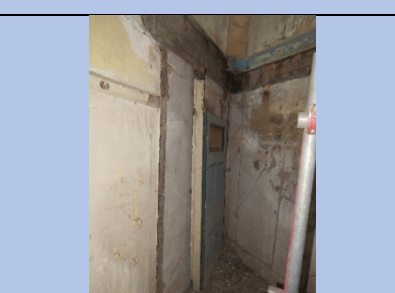
| Room Ref. | Element | Description / Item | Condition | Action | Photographs | | |
|---|---|---|---|---|---|---|---|
| | Misc. | Redundant door and frame to staircase.<br>Doorstop.<br>Redundant M&E including pipe and stair light.<br>Modern pendant. | | <ul style="list-style-type: none"> <li>• Remove redundant door and frame. Door to be stored in heritage store.</li> <li>• Remove door stop.</li> <li>• Remove redundant M&amp;E &amp; fill holes in walls.</li> <li>• Remove pendant to ceiling.</li> </ul> | | | |

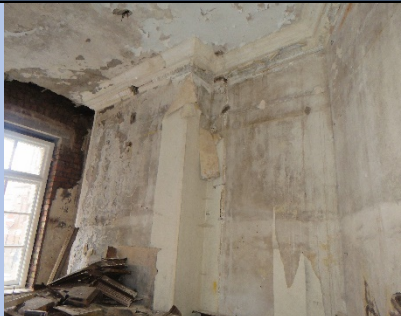
| Room Ref. | Element | Description / Item | Condition | Action | Photographs | | |
|---|---|---|---|---|---|---|---|
| 0.46 Switch Room | Walls | Plaster to brick with wallpaper finish. | Fair | <ul style="list-style-type: none"> <li>Hammer test remaining plaster and remove any bossed plaster.</li> <li>Remove flaking paint.</li> <li>Lime plaster to be repaired/reinstated as per M20/210.</li> </ul> | | | |

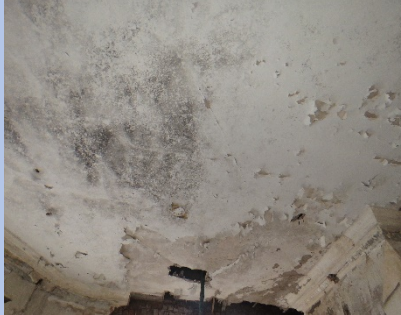
| Room Ref. | Element | Description / Item | Condition | Action | Photographs | | |
|---|---|---|---|---|---|---|---|
| | Ceiling | Plaster to lath with paint finish. Cornice survives. | Fair | <ul style="list-style-type: none"> <li>Hammer test remaining plaster and remove any bossed plaster.</li> <li>Remove flaking paint.</li> <li>Plaster ceiling to be repaired as M20/587 and treated with intumescent paint as per Z12/212</li> </ul> | | | |

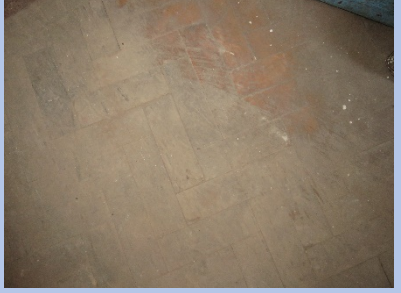
| Room Ref. | Element | Description / Item | Condition | Action | Photographs | | |
|---|---|---|---|---|---|---|---|
| | Floor | Wood block with presumed glazed tile hearth. | Fair | <ul style="list-style-type: none"> <li>Record quantity of wood block, lift and store on pallet in room.</li> <li>Existing woodblock floor reinstated (Purcell to advise if resilient layer is required).</li> </ul> | | | |

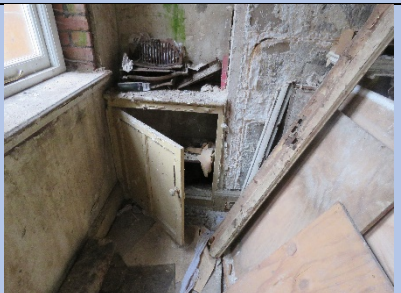
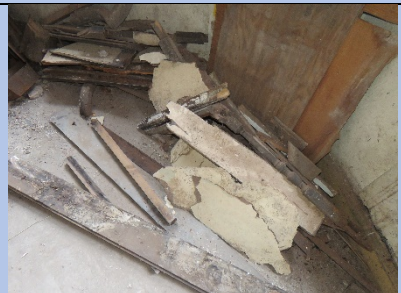
| Room Ref. | Element | Description / Item | Condition | Action | Photographs | | |
|---|---|---|---|---|---|---|---|
| | Joinery | 1no. original door<br>Skirting<br>Window surround partly survives.<br>Misc. pile of timber.<br>Timber cupboard. | | <ul style="list-style-type: none"> <li>Existing doors to be removed and set aside for reuse elsewhere.</li> <li>Skirting, picture rails and window surrounds to be reinstated/replaced to repaired plaster</li> <li>Misc. joinery to be used for repairs where possible, otherwise scrapped.</li> </ul> | | | |

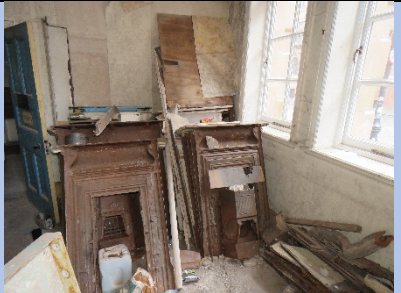
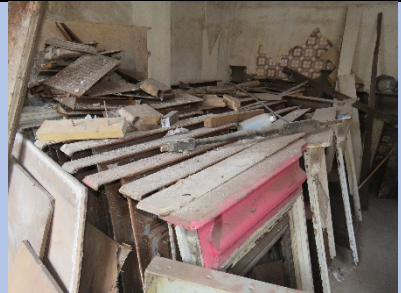
| Room Ref. | Element | Description / Item | Condition | Action | Photographs | | |
|---|---|---|---|---|---|---|---|
| | Misc. | Fireplaces.<br>Cast steel stair balusters. | | <ul style="list-style-type: none"> <li>Clean, catalogue and record all fireplaces. Allowance for the cleaning of all fireplaces and redistribution across the building and fixing to relevant rooms (to be dictated by Architect – Room locations TBC).</li> <li>Record all other metalwork and items stored in the room.</li> <li>Relocate all items to the heritage store.</li> </ul> | | | |

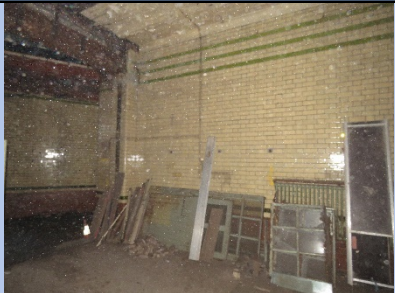
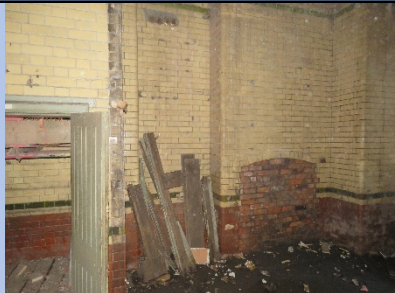
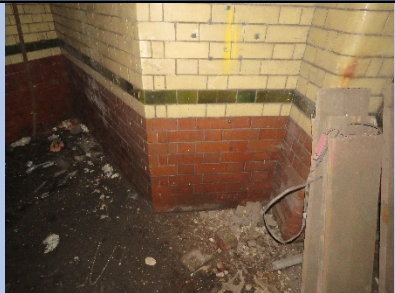
| Room Ref. | Element | Description / Item | Condition | Action | Photographs | | |
|---|---|---|---|---|---|---|---|
| 0.47 + 0.47a | Walls | Glazed brick.<br>Red brick. | Good / fair | <ul style="list-style-type: none"> <li>Existing glazed bricks cleaned and protected, any holes to be infilled with matching reclaimed bricks. Small holes to be reviewed by design team on-site to decide on which scars are acceptable and which scars require replacement brick insertion. Please state prov. number of brick replacements allowed for within contractor price.</li> </ul> | | | |

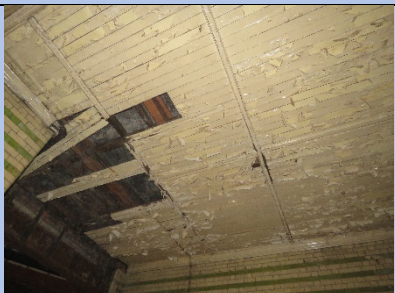
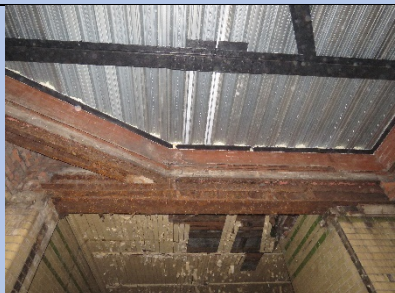
| Room Ref. | Element | Description / Item | Condition | Action | Photographs | | |
|---|---|---|---|---|---|---|---|
| | Ceiling | Painted timber board or exposed concrete and steel beams.<br>Timber cornice. | Fair | <ul style="list-style-type: none"> <li>Assess condition of all timber boards.</li> <li>Remove all flaking paint.</li> <li>De-rust corroded steel beam.</li> <li>Steel beams to be treated with intumescent paint per NBS:M61/120.</li> <li>Existing timber boarding to be repaired/ reinstated where missing and to received intumescent treatment per NBS:Z12/213</li> </ul> | | | |

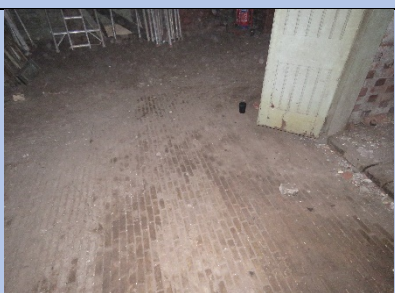
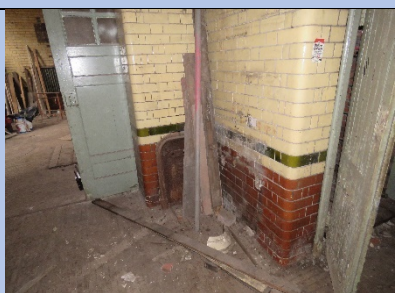
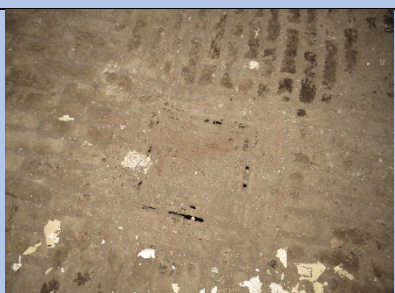
| Room Ref. | Element | Description / Item | Condition | Action | Photographs | | |
|---|---|---|---|---|---|---|---|
| | Floor | Brick.<br>Cast steel drainage grille. | Fair | <ul style="list-style-type: none"> <li>Remove all debris.</li> <li>Clean bricks.</li> <li>Install protection.</li> <li>Brick floor to be cleaned and protected, any holes to be infilled with reclaimed brick to match.</li> </ul> | | | |

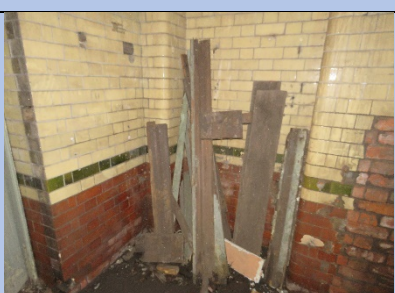
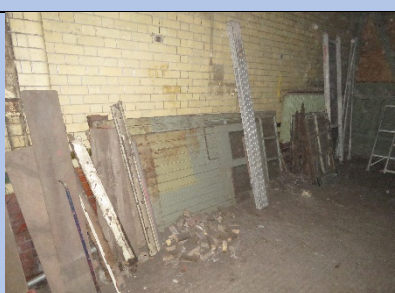
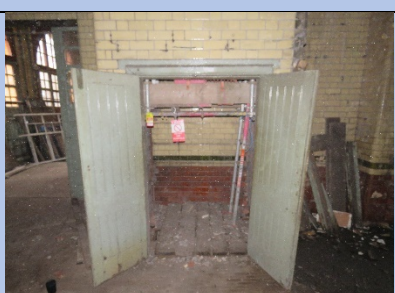
| Room Ref. | Element | Description / Item | Condition | Action | Photographs | | |
|---|---|---|---|---|---|---|---|
| | Joinery | Large timber doors.<br>Misc. joinery.<br>Timber doors and architrave to cupboard. | | <ul style="list-style-type: none"> <li>Large timber doors to be removed and relocated within the building (architect to advise).</li> <li>Misc. joinery to be reused where possible for repairs, otherwise scrapped.</li> <li>Timber doors to be removed and set aside for reuse.</li> <li>Cupboard to be removed.</li> </ul> | | | |

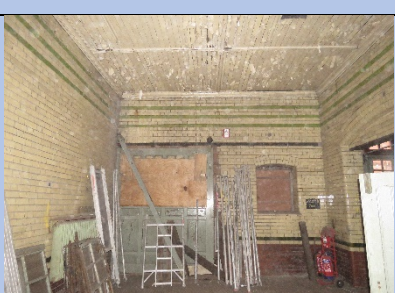
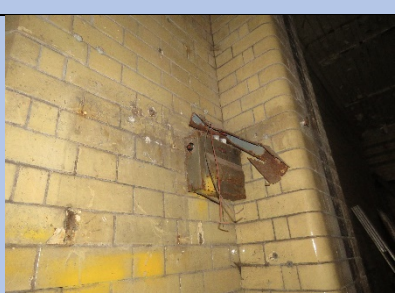
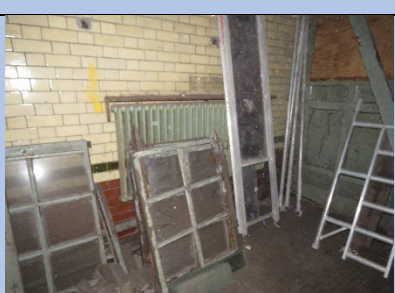
| Room Ref. | Element | Description / Item | Condition | Action | Photographs | | |
|---|---|---|---|---|---|---|---|
| | Misc. | Windows.<br>Radiator.<br>Misc. M&E.<br>Builders waste. | | <ul style="list-style-type: none"> <li>Record windows and relocate to heritage store.</li> <li>Remove radiator and bracket and relocate to heritage store.</li> <li>Remove all redundant M&amp;E (and fill holes).</li> <li>Remove all debris and building waste.</li> </ul> | | | |
