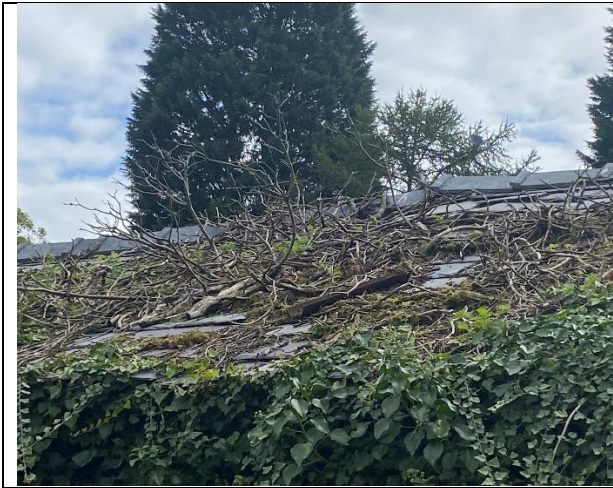
Roof repairs necessary to the rose garden elevation

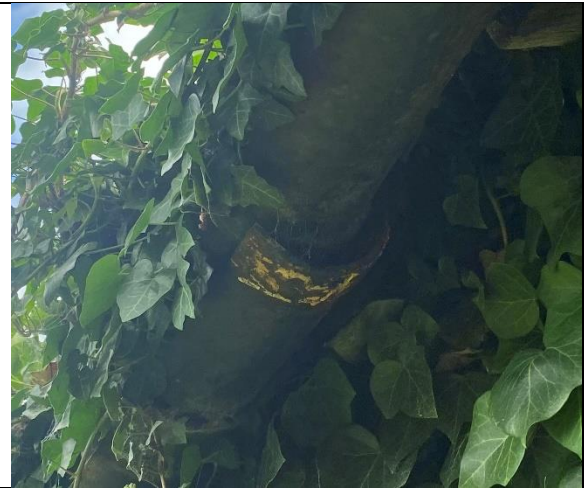
Displaced guttering requires repair

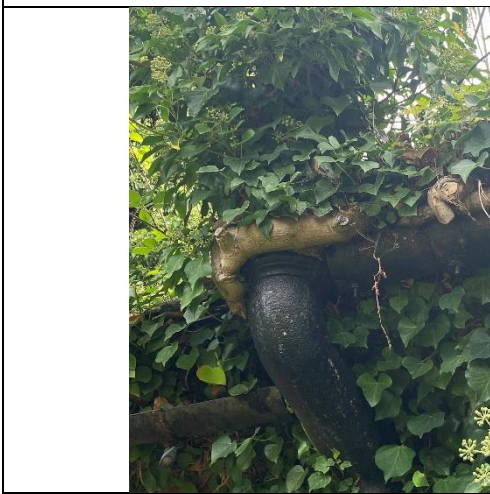
Rainwater goods blocked by Ivy

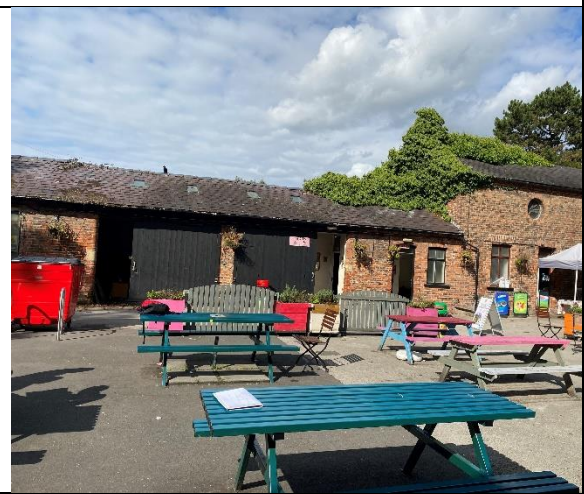
Location of new facility (behind door on the left)

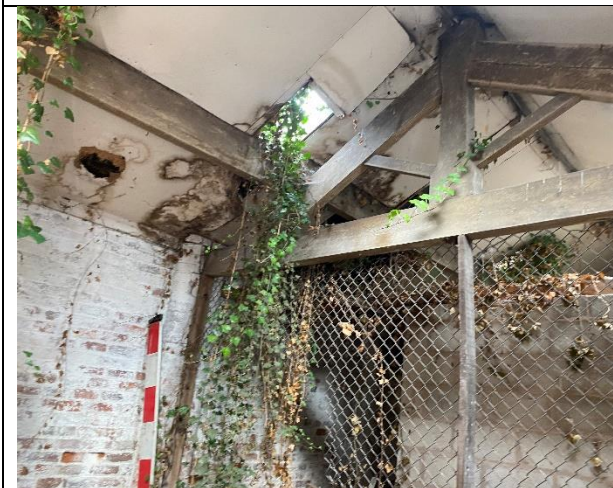
Inside the new facility looking North.

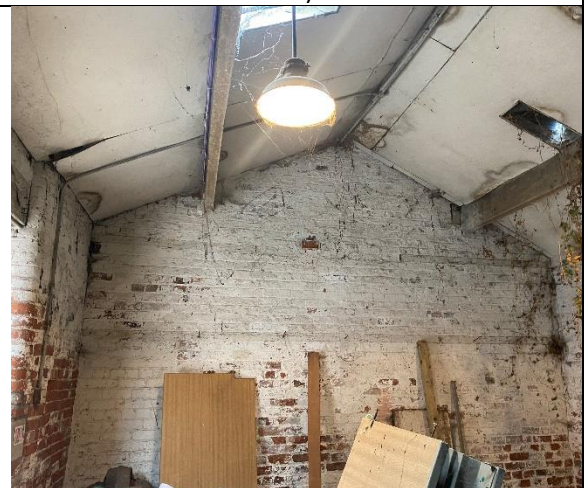
Inside the new facility looking south.

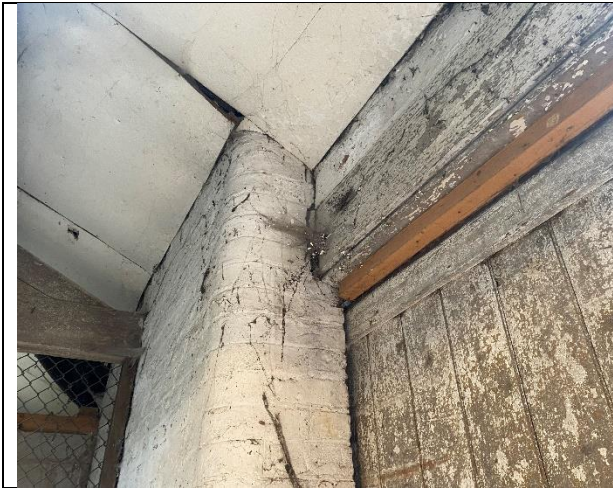
Existing doors to rear

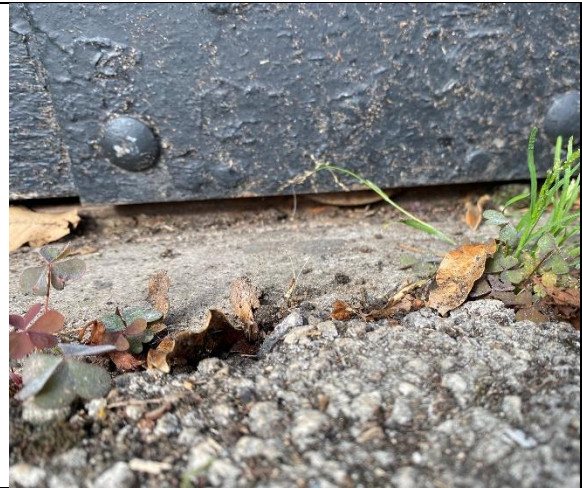
Existing sliding door wheel

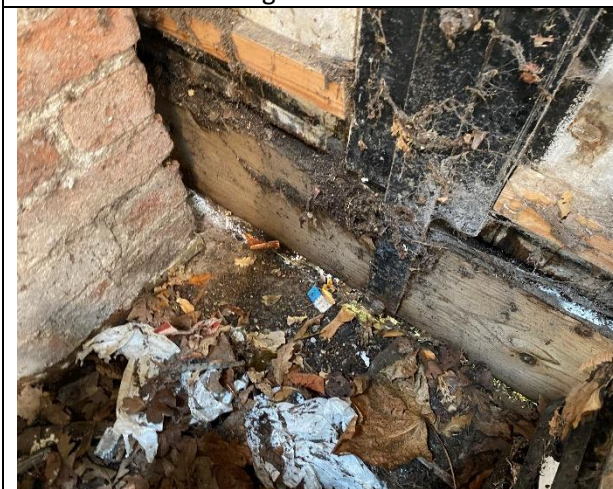
Existing sliding door wheel bracket

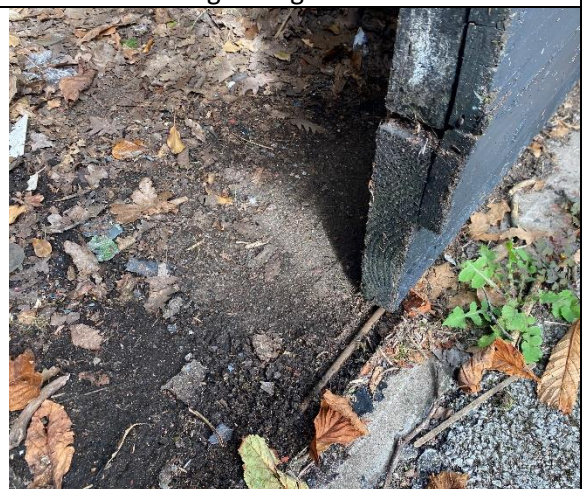
Existing door runner

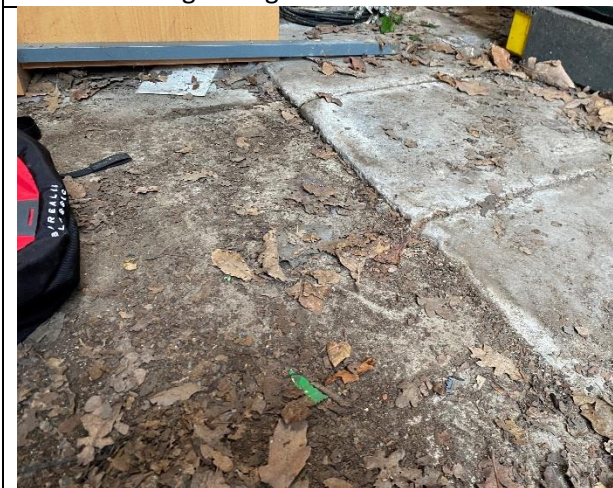
Existing stone flag floor
