ING Design Limited. Railway House, Railway Road, Chorley.

# Structural Report on Existing Building.

33, Thomas Street, Manchester.

Job No: 22119

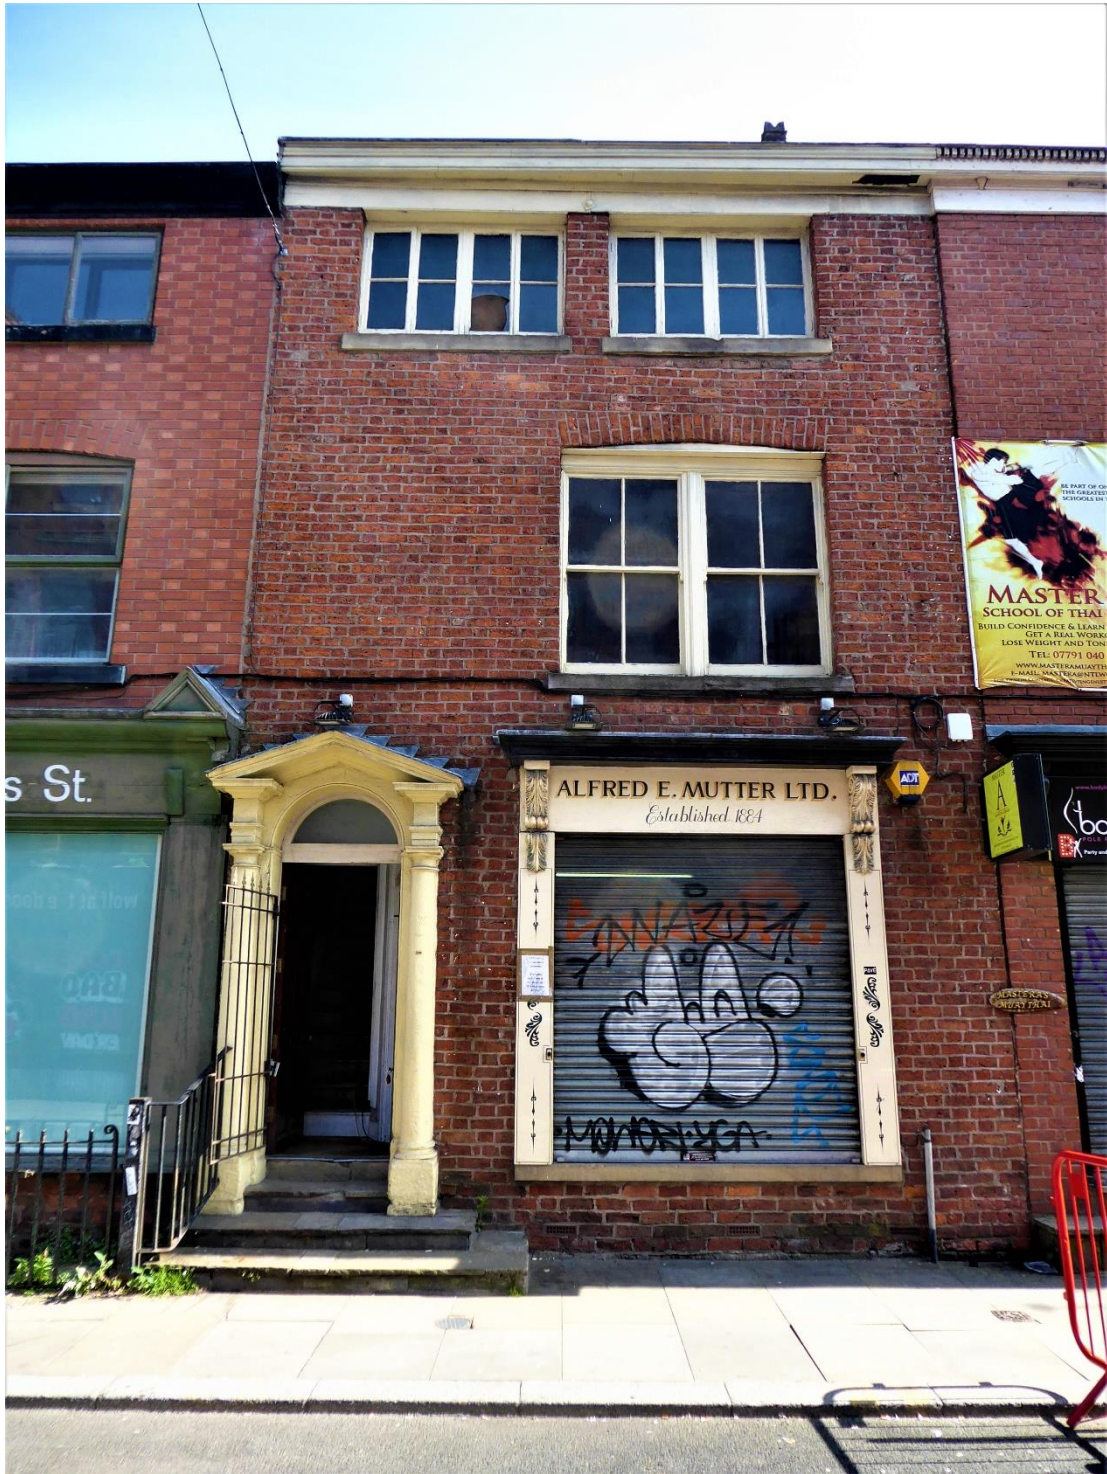
2.1 Photographs 1, & 2 show general views of the external front and rear elevations. From the photographs the general external condition of the property appears to be in good order.

Photograph 1 – Front elevation of property.

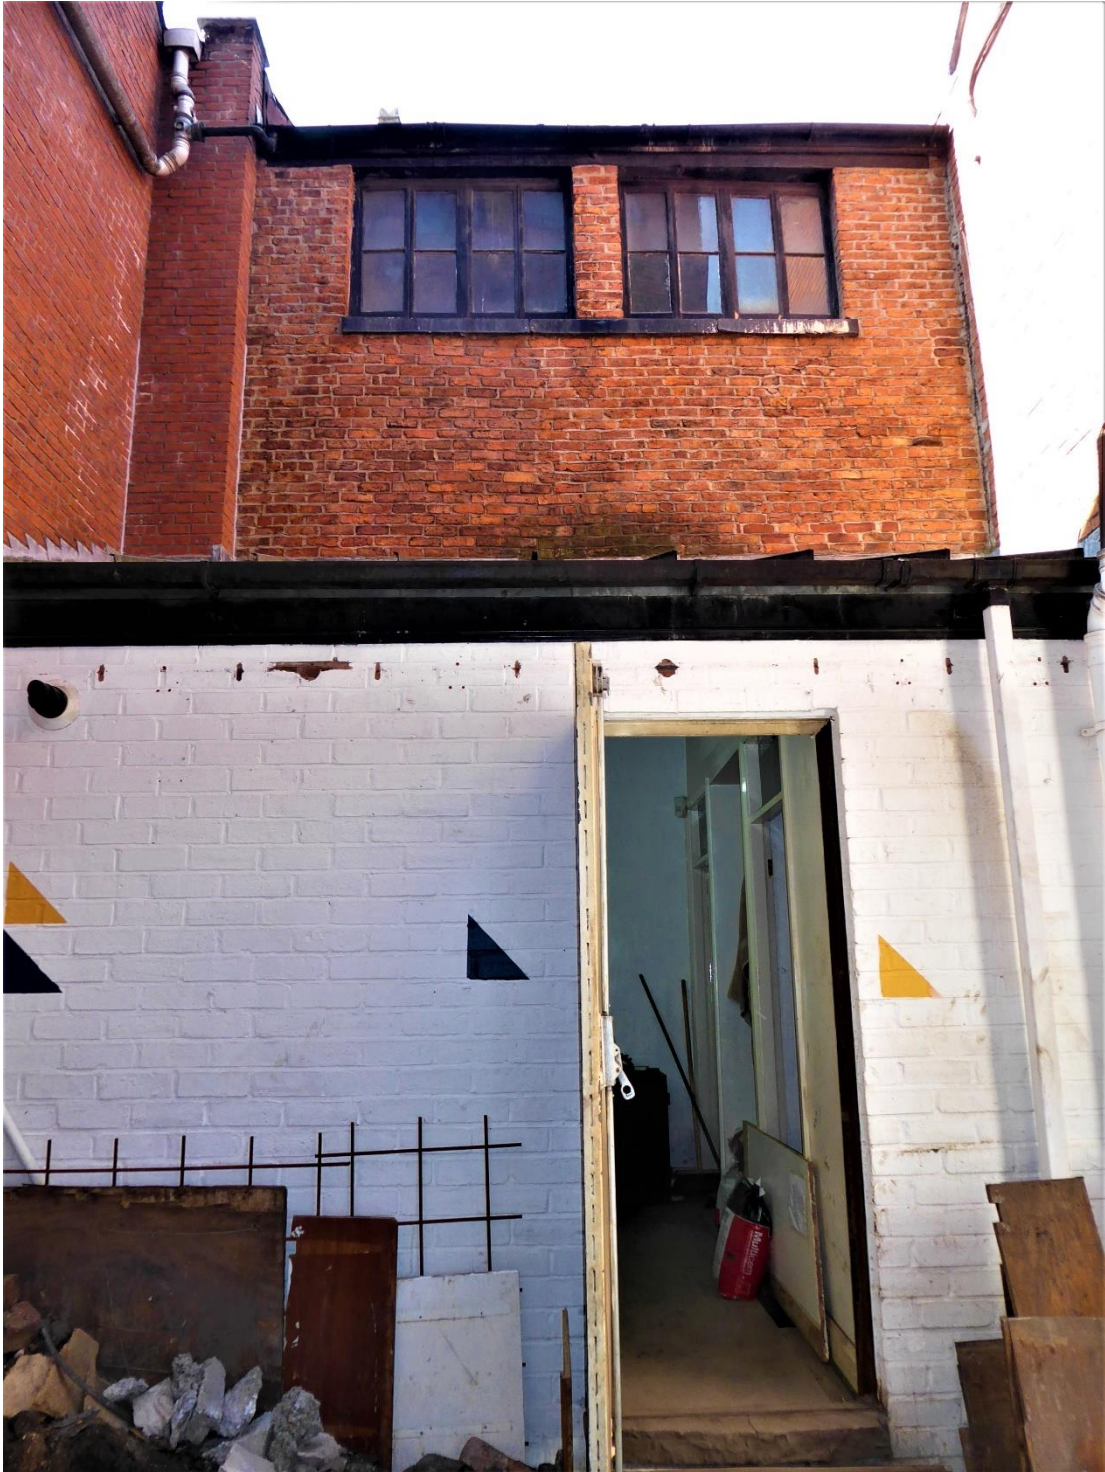
Photograph 2 – Rear elevation of property.

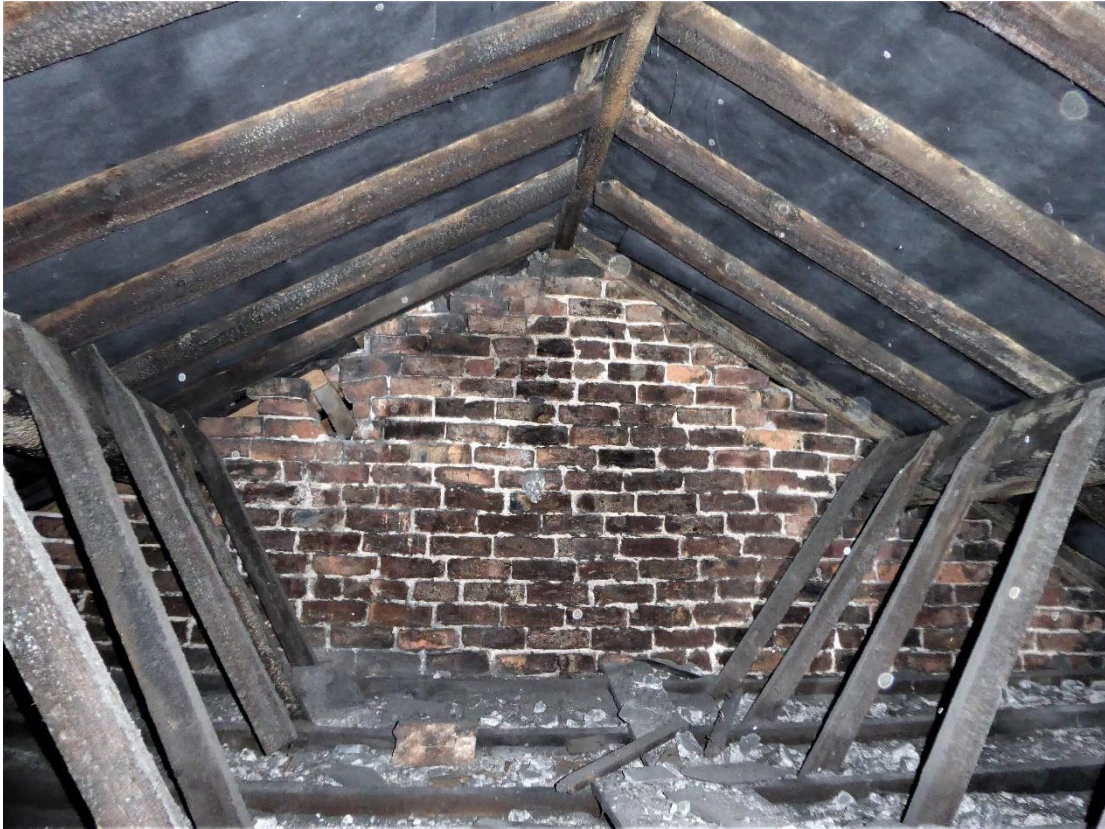
3.1 Photograph 3 shows a general view of the internal roof structure. The second-floor ceiling which encloses the existing roof space is damaged and badly sagging. Photograph 4 shows some of the damaged roof timbers which have led to the deterioration of the ceiling. Photograph 5 gives an indication of the sag in the second-floor ceiling.

Photograph 3 – General view of internal roof structure.

5.2 The second-floor ceiling should be removed, and the roof timbers repaired or replaced before a new ceiling is installed. The repairs can take the form of replacing damaged timbers with new or possibly reclaimed timbers, or the repairs can be made obvious by installing steel splints and bolts if this approach is more acceptable to the conservation officers.

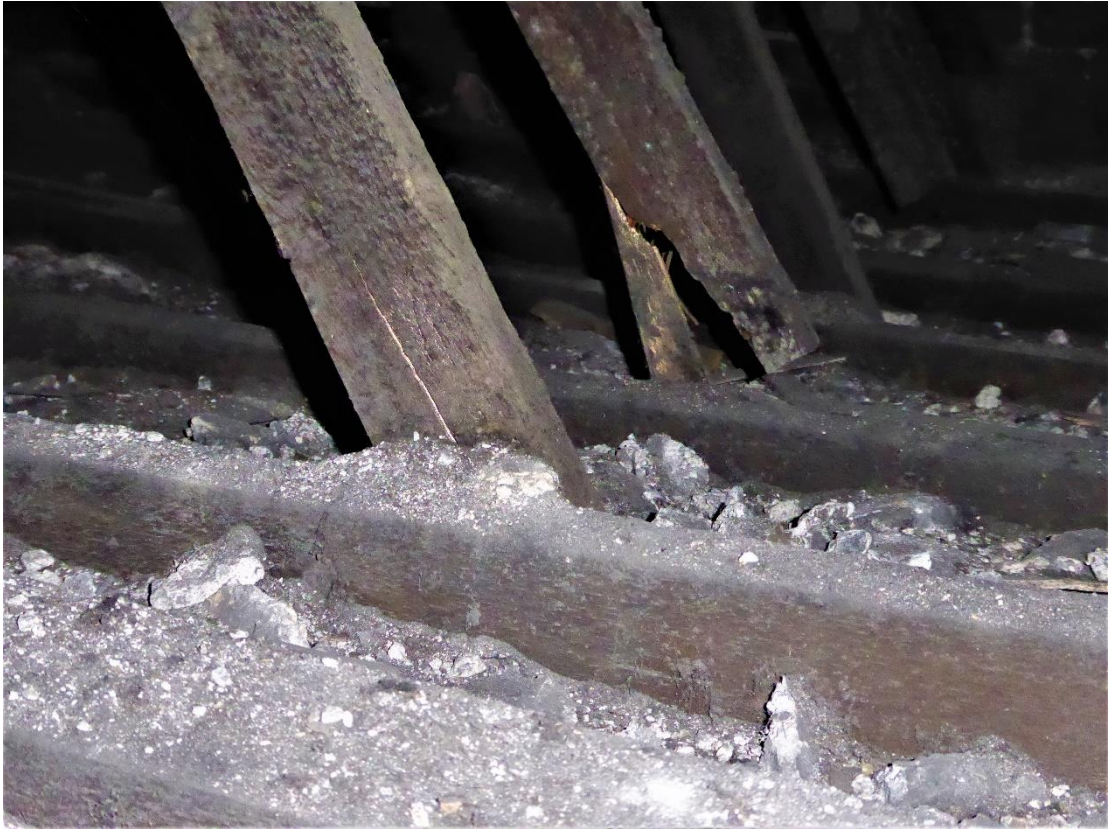
4.4 The roof timbers appear to be in a reasonable state of repair with obvious exceptions where timbers have broken leading to the sagging second floor ceiling.

Photograph 4 – View of broken roof timbers.

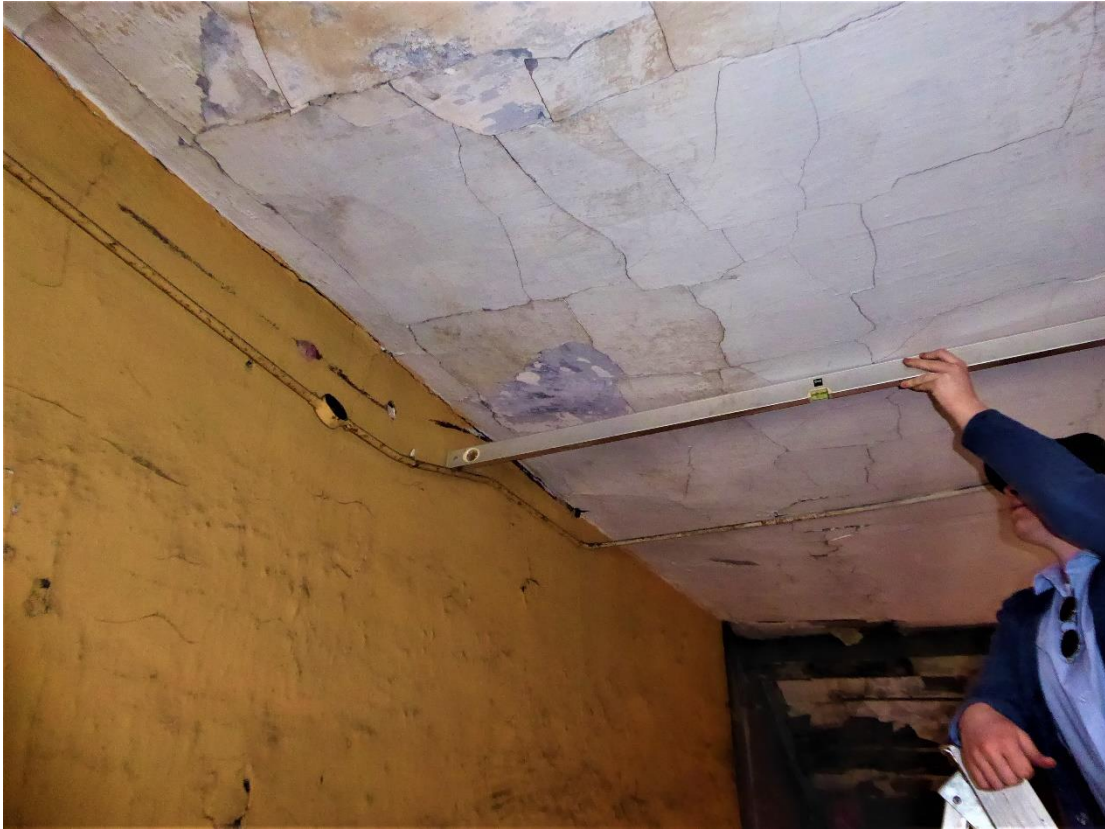
Photograph 5 – View showing sag in existing second floor ceiling.

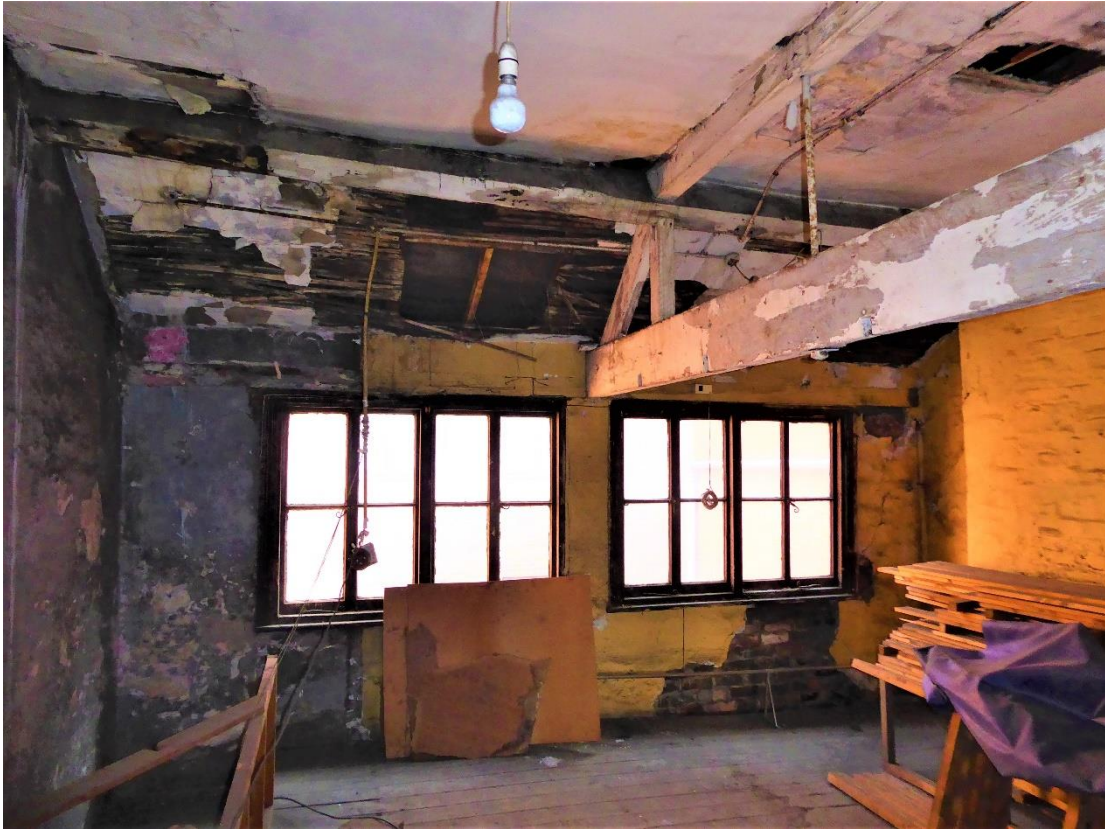
3.2 Photographs 6, & 7 show the inside face of the front and rear elevations at second floor level. These photographs show the main roof beam system which is supporting the 4 timber purlins. Photographs 6, & 7 also indicate the deteriorating and missing inner face of the masonry below each window at second floor level.

4.6 Sections of the external walls inner face masonry have collapsed, probably due to the floors sagging and thus removing the lateral support or due to the window lintels sagging allowing the masonry to settle and become loose, or a combination of the above.

Photograph 6 – Internal view of rear elevation at second floor level.

5.6 All the areas of damaged masonry are to be repaired and made good. It is anticipated that lime mortars will be required by the conservation officer. Reclaimed bricks should be used throughout.

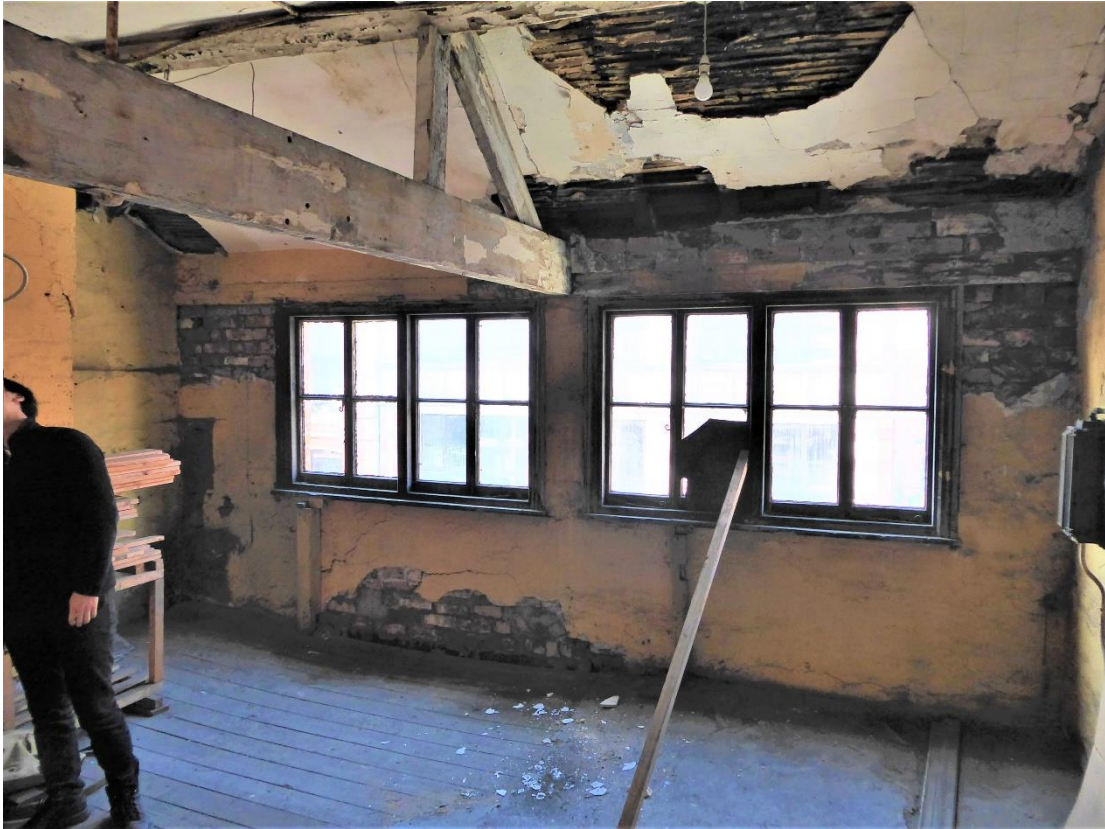
Photograph 7 – Internal view of front elevation at second floor level.

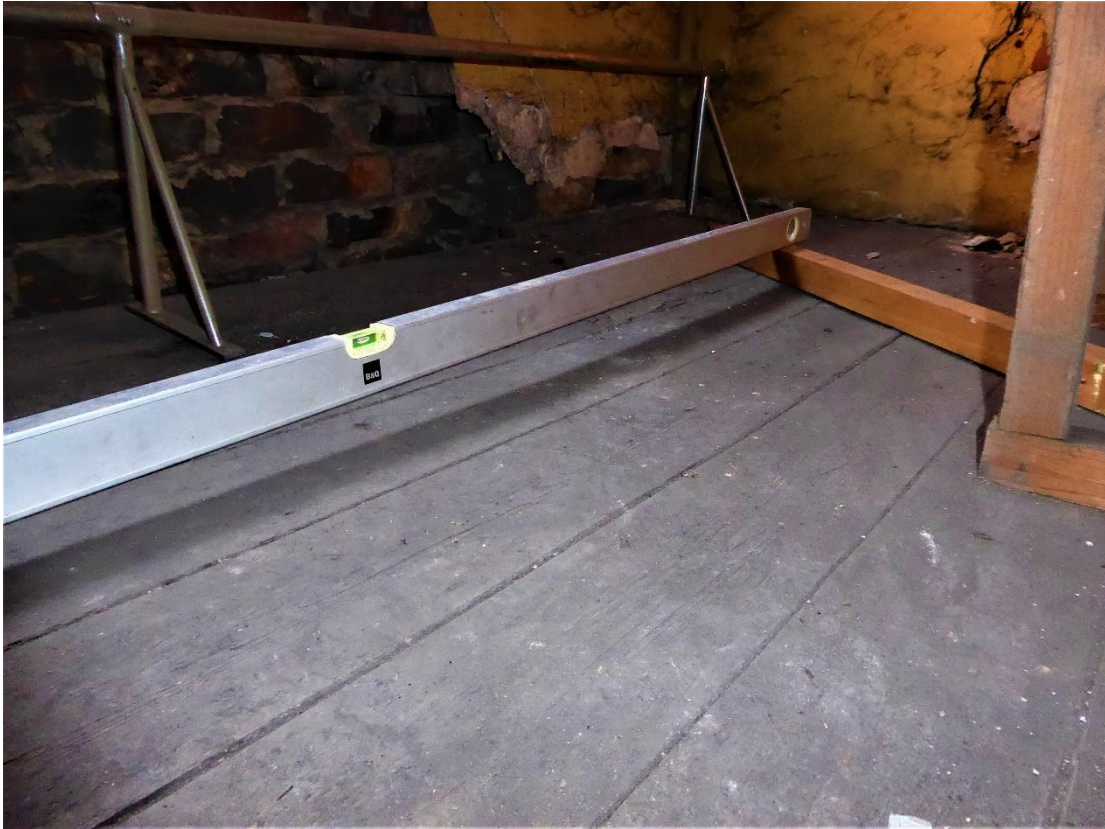
3.3 Photographs 8, & 9 show the displacement of the second-floor structure adjacent to the rear and front elevations respectively.

4.2 The timber suspended floors are sagging beyond an acceptable, useable, and safe limit. This is most likely due to ongoing and historical deterioration of the timber and in some part due to inadequately supervised alterations.

Photograph 8 – Showing displacement of second floor at the rear elevation

5.3 All the timber suspended floors, and supporting beams are to be refurbished and repaired where necessary to make the property safe and fit for purpose. As the property is a listed building, we would suggest the use of reclaimed timbers and possibly second-hand historic steel sections where available and suitable. The existing timber floor joists could be retained if additional support is provided. The additional support would need to be in the form of new beams. These could be either reclaimed timber or historical steel sections.

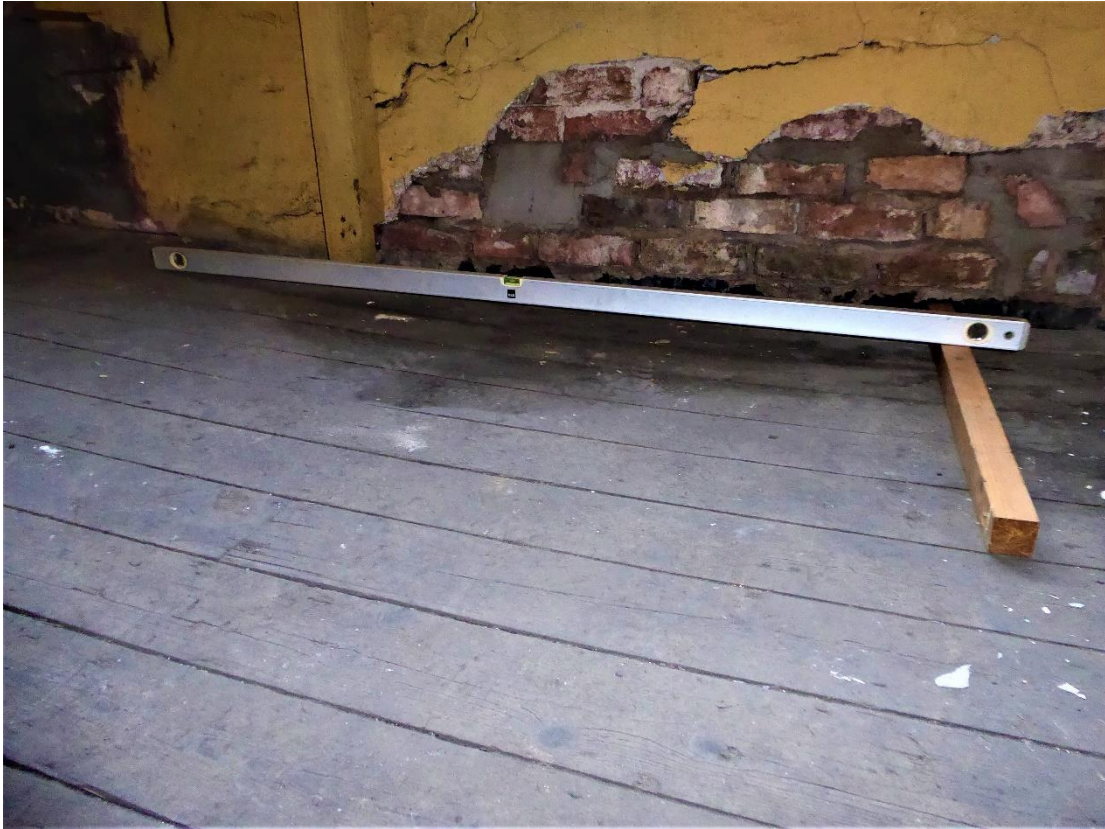
Photograph 9 – Showing displacement of second floor at the front elevation.

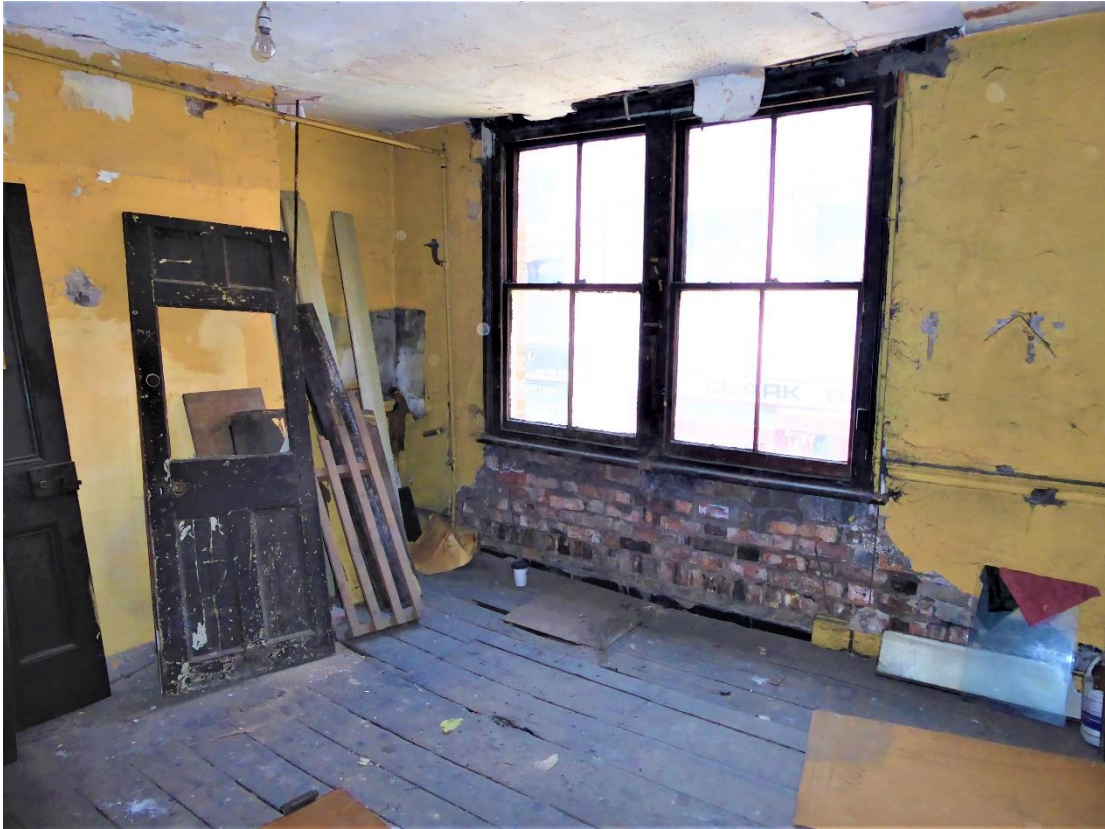
3.4 Photograph 10 shows the inside view of the front elevation at first floor level. Photograph 11 shows the deflection of the first-floor structure and photograph 12 shows the displacement cracking in the internal dividing wall at first floor level.

Photograph 10 – Inside view of front elevation at first floor level.

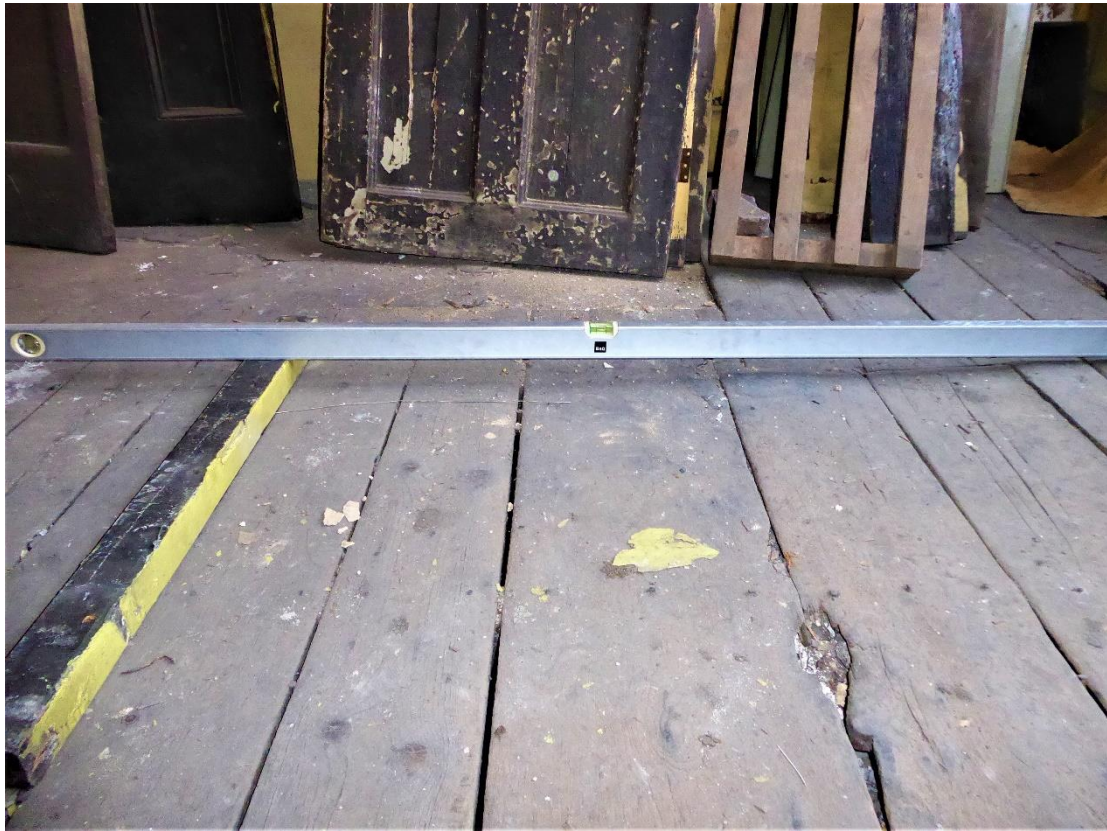
Photograph 11 – Showing the displacement of first floor at front of property.

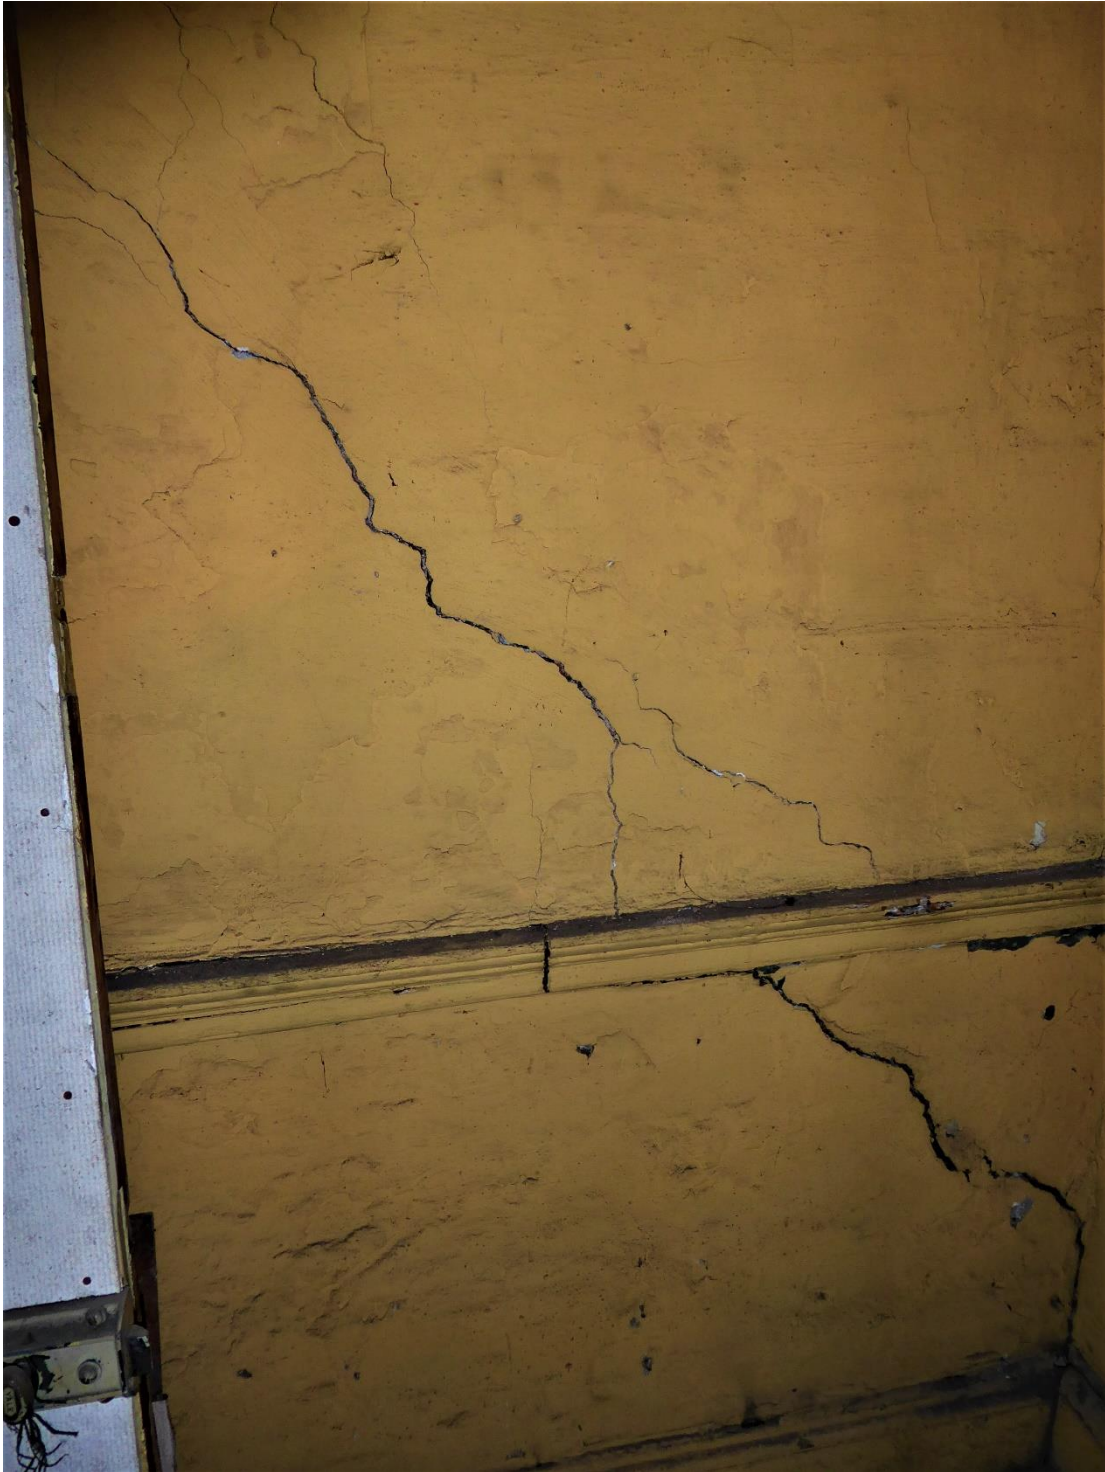
4.3 At first floor level there is an internal dividing wall which is unstable due to the deterioration of the floor and the supporting beam below. The wall has cracked, and areas of the masonry are loose.

Photograph 12 – Showing movement cracks on internal wall at first floor level.

5.4 The cracked and unsafe internal dividing wall at first floor level should be carefully taken down to facilitate the repair of the first floor and supporting structure. The supporting beams cannot be safely repaired or replaced if the first-floor wall remains unstable. The wall should be rebuilt using all the bricks recovered during its dismantling and new lime based mortar.

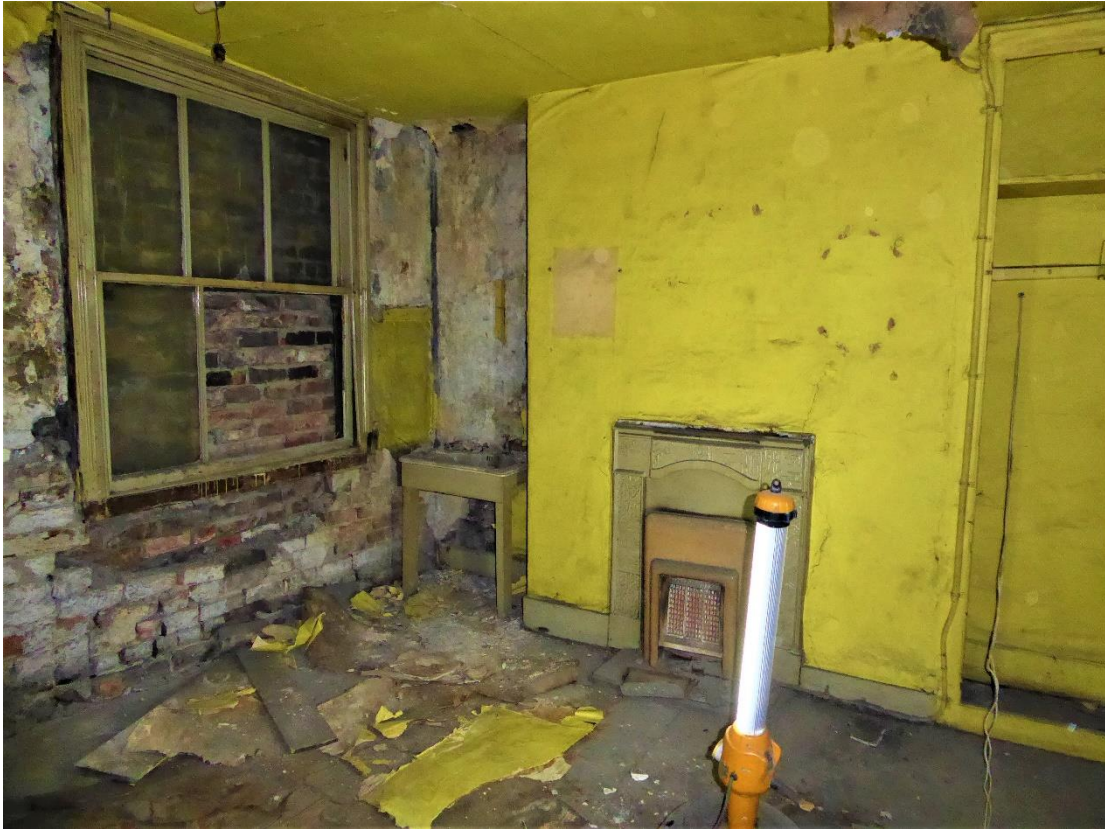
3.5 Photograph 13 shows a general view of the first-floor room at the rear of the property. The deterioration of the inner masonry on the rear elevation below the bricked-up window can be seen. Photograph 14 shows the deflection of the first floor at the rear of the property.

Photograph 13 – Showing internal view of rear room at first floor level.

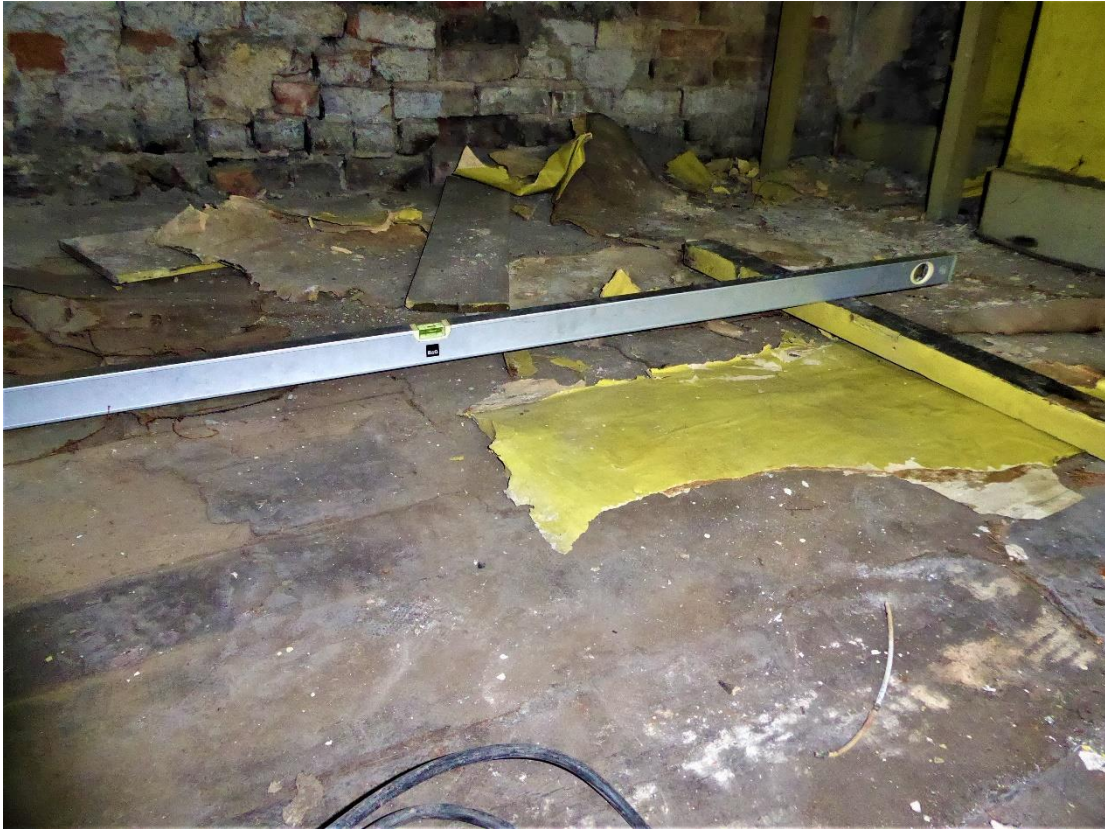
Photograph 14 – Showing displacement of first floor at rear elevation.

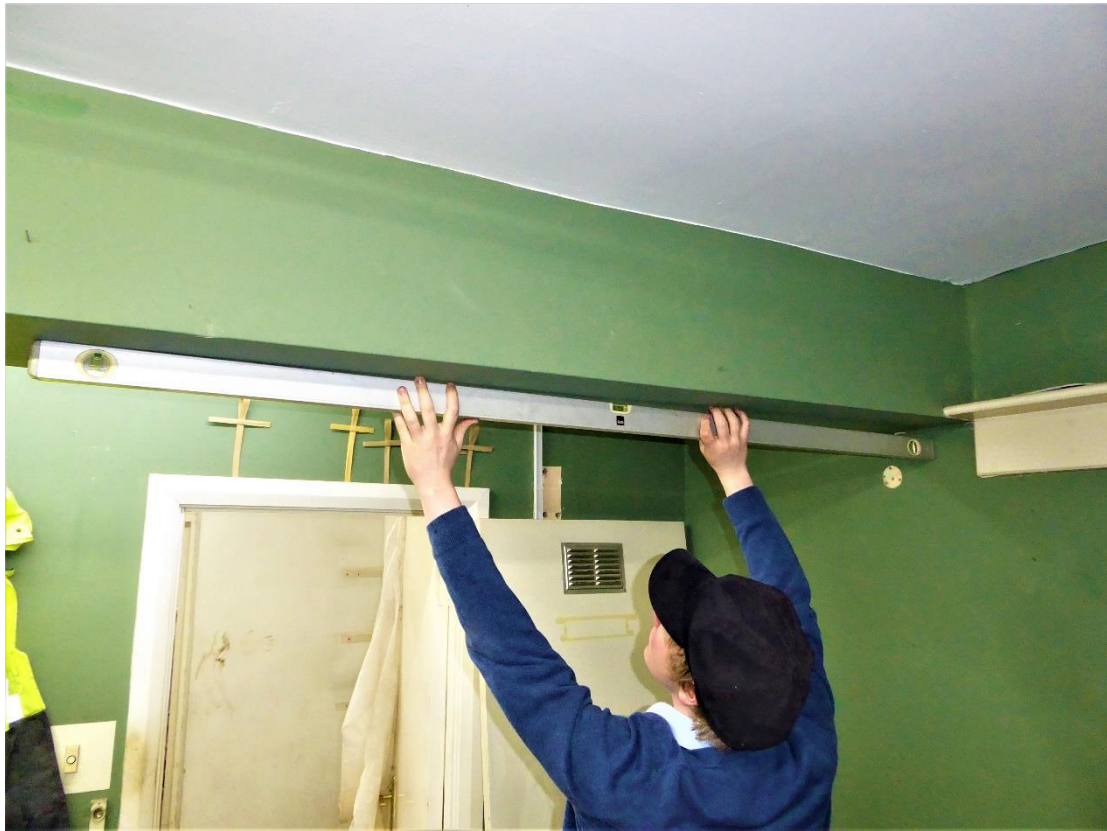
3.6 Photographs 15, & 16 indicate the deflection of the ground floor ceiling beam which is carrying the internal dividing wall at first floor which features in photograph 12.

Photograph 15 – Showing deflection of supporting beam at ground floor ceiling level.

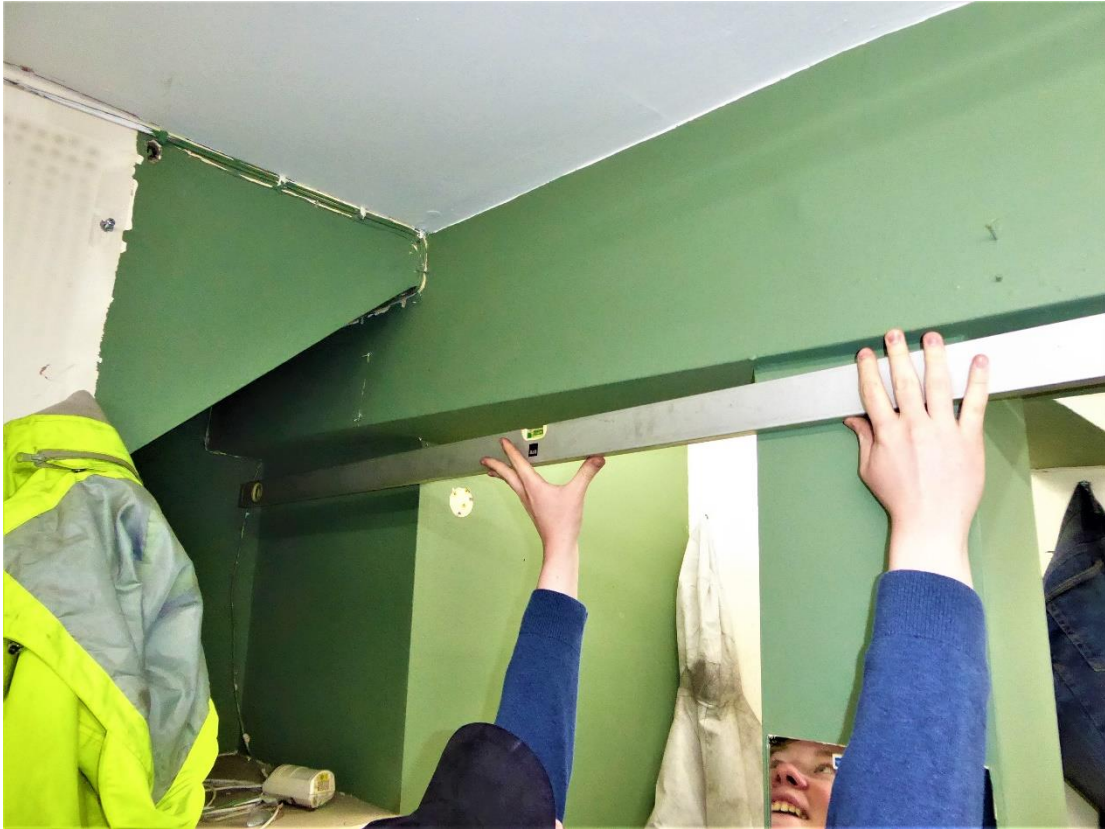
Photograph 16 – Showing deflection of supporting beam at ground floor ceiling level.

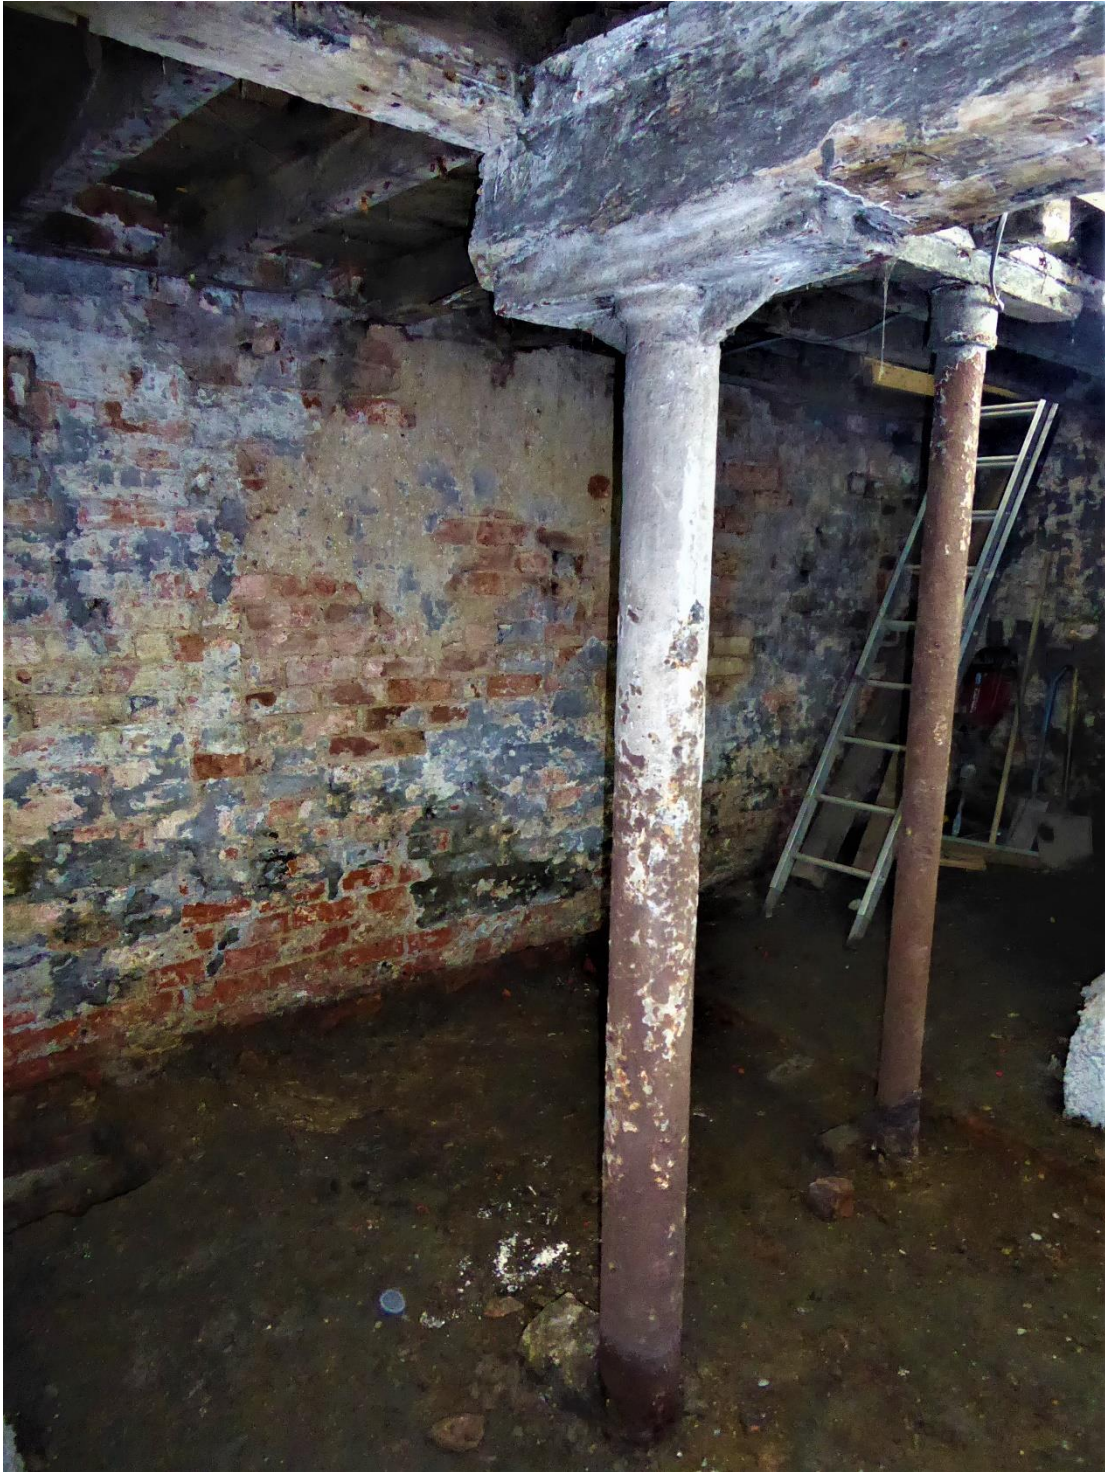
3.7 Photographs 17, 18, 19, & 20 show various aspects of structure in the basement of the property. Numerous items of attempted structural remedial strengthening which all appear to be inadequately constructed. On the left side of photograph 18 can be seen the front edge of the existing fireplace, masonry oven. The masonry structure of the 'oven' is practically falling apart.

4.5 The remedial strengthening attempts in the basement are dangerous and should be replaced with adequate alternatives.

Photograph 17 – Showing original cast iron columns in basement.

5.5 The attempted remedial strengthening works in the basement are to be removed and new suitably designed alternative remedial strengthening is to be installed. This will take the form of installing new beams to support the existing suspended timber ground floor. The new beams could be historical steel sections obtained from architectural salvage yards or other sources of second-hand steelwork. The existing concrete foundations are too high and

obstruct the effective use of the basement. These need to be broken out and replaced with more suitable foundations as required by the strengthening works.

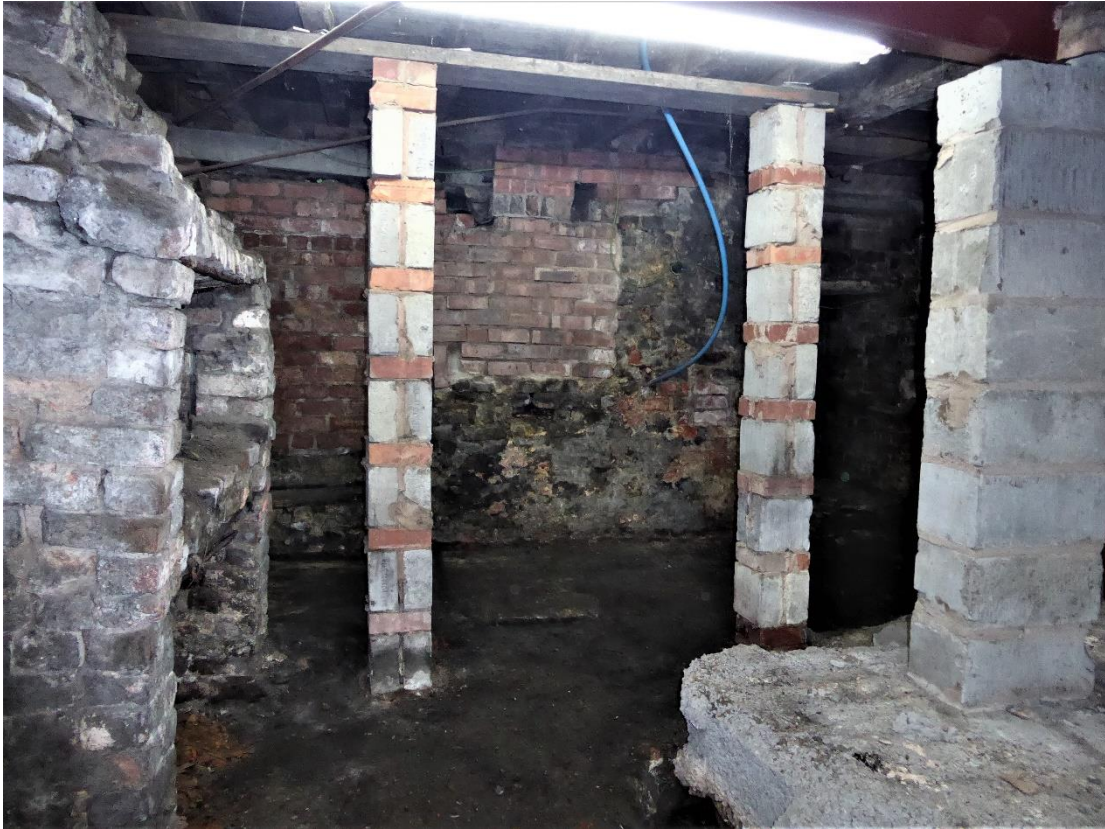
Photograph 18 – Showing modern masonry piers in basement.

5.7 The existing 'oven' in the basement must either be rebuilt or enclosed. The condition of the masonry structure of the 'oven' is in such a poor condition that it will present a hazard to any construction operatives working in the confined space of the basement.

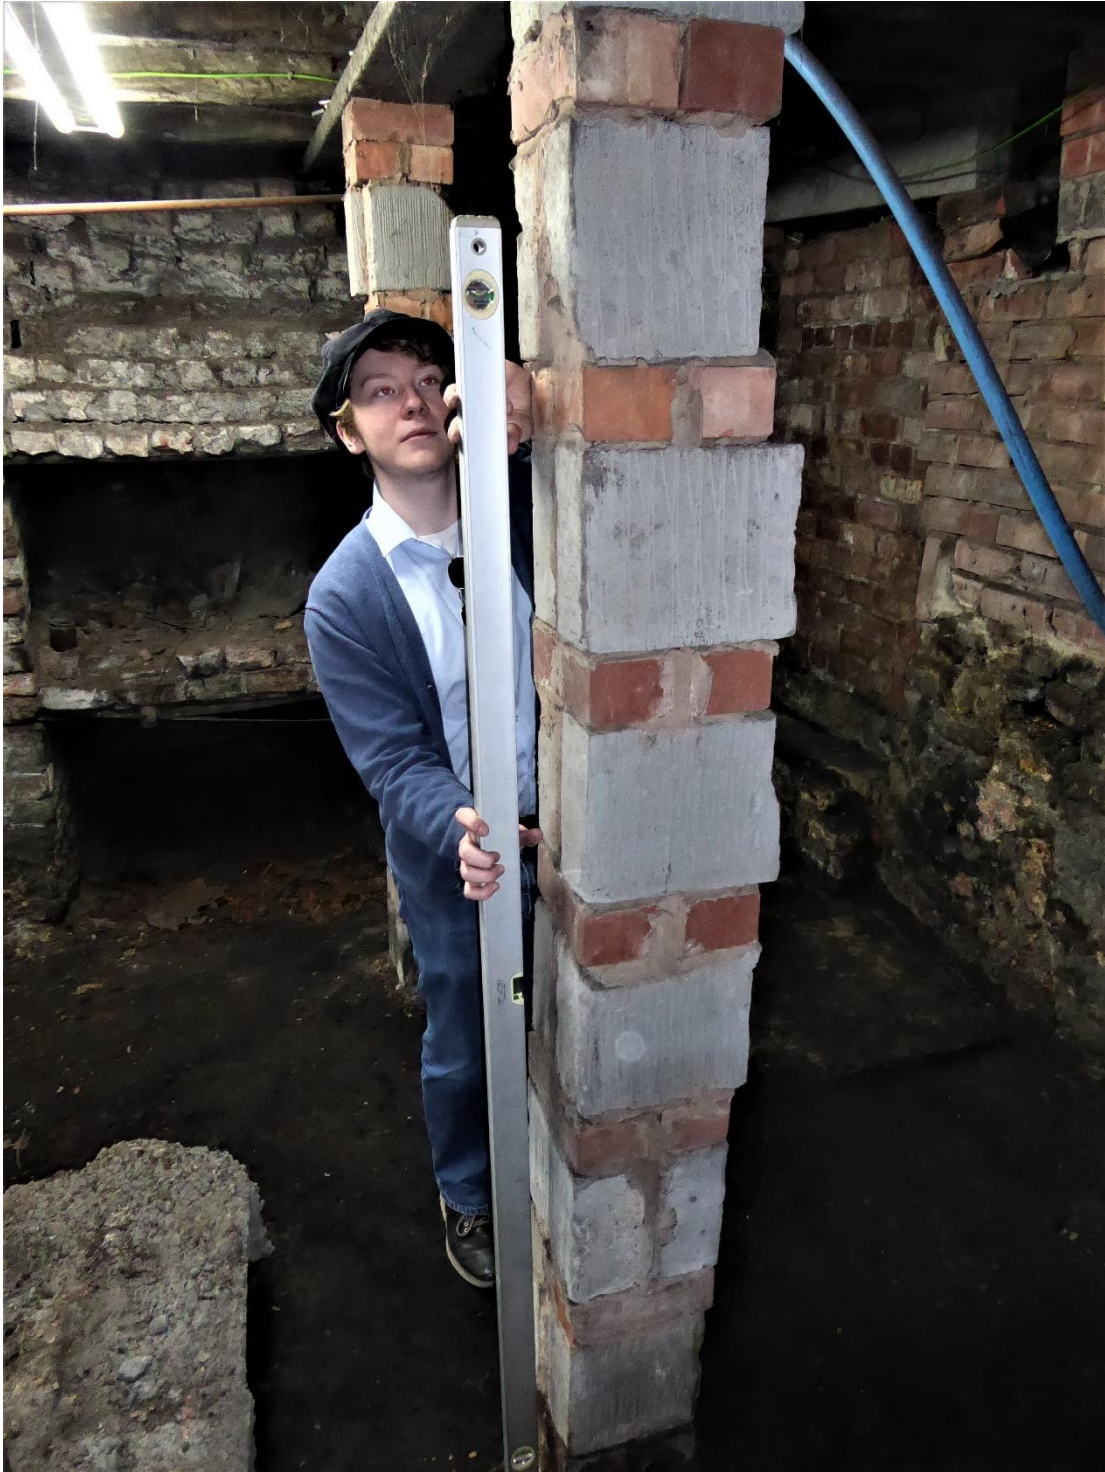
Photograph 19 – Showing poor construction of masonry piers in basement.
