ING Design Limited. Railway House, Railway Road, Chorley.

# Structural Report on Existing Building.

33, Thomas Street, Manchester.

Job No: 22119

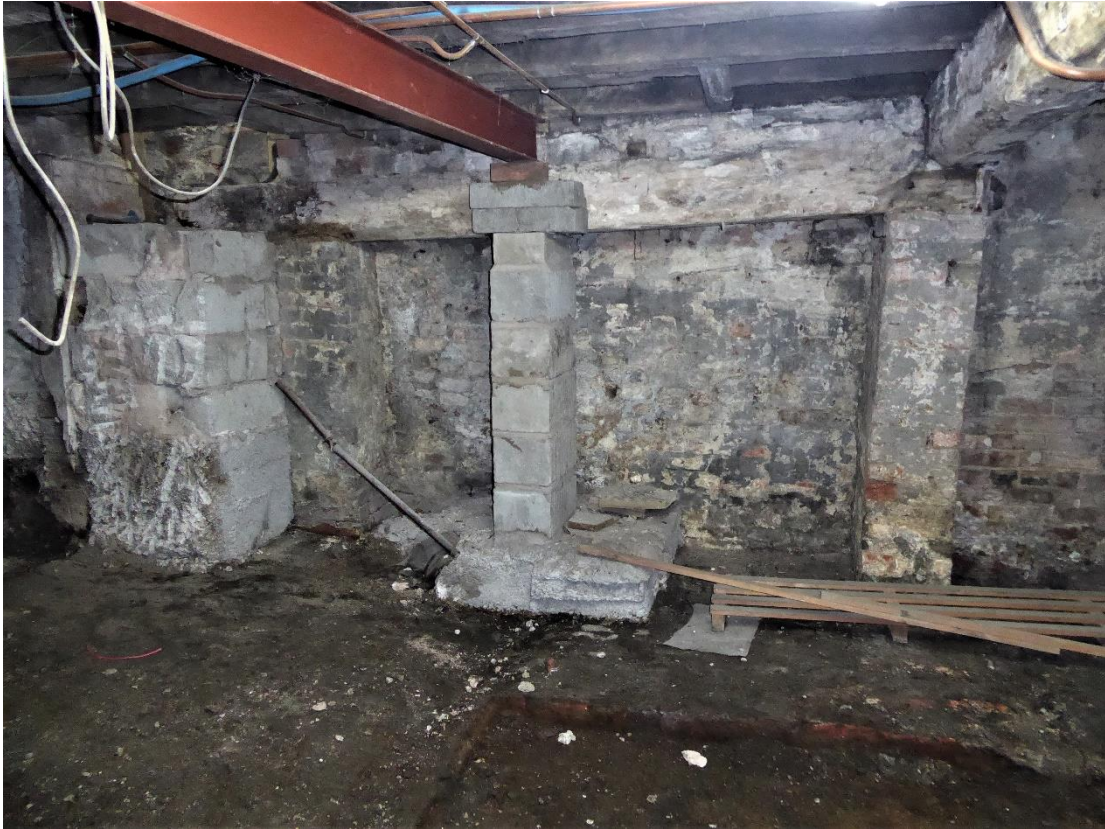
3.7 Photographs 17, 18, 19, & 20 show various aspects of structure in the basement of the property. Numerous items of attempted structural remedial strengthening which all appear to be inadequately constructed. On the left side of photograph 18 can be seen the front edge of the existing fireplace, masonry oven. The masonry structure of the 'oven' is practically falling apart.

4.5 The remedial strengthening attempts in the basement are dangerous and should be replaced with adequate alternatives.

Photograph 20 – Showing more remedial strengthening to ground floor.

5.5 The attempted remedial strengthening works in the basement are to be removed and new suitably designed alternative remedial strengthening is to be installed. This will take the form of installing new beams to support the existing suspended timber ground floor. The new beams could be historical steel sections obtained from architectural salvage yards or other sources of second-hand steelwork. The existing concrete foundations are too high and

obstruct the effective use of the basement. These need to be broken out and replaced with more suitable foundations as required by the strengthening works.
