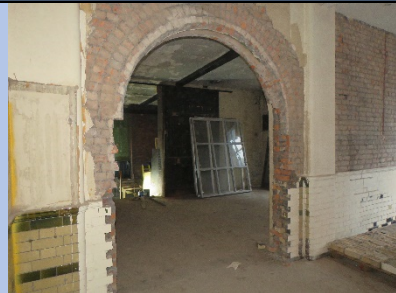
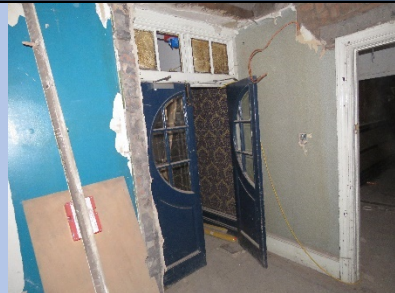
| Room Ref. | Element | Description / Item | Condition | Action | Photographs | | |
|---|---|---|---|---|---|---|---|
| 0.29 | Walls | Plaster on brick with paint or wallpaper finish. Some glazed brick with paint or plaster over. | Fair | <ul style="list-style-type: none"> <li>Existing walls stripped back to masonry (level of stripping back to be agreed) and glazed brickwork (use of peelaway required).</li> <li>New black metal crittal style external entrance screen to courtyard and street entrance.</li> <li>Reclaimed masonry wall to form working fireplace recess.</li> <li>New fire rated black metal crittal style door to lift lobby.</li> <li>Existing timber sliding doors refurbished, cleaned and rehung.</li> </ul> | | | |

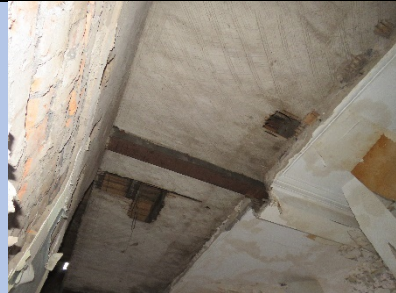
| Room Ref. | Element | Description / Item | Condition | Action | Photographs | | |
|---|---|---|---|---|---|---|---|
| | Ceiling | Plaster on lath with paint finish. | Fair | <ul style="list-style-type: none"> <li>Hammer test remaining plaster and remove any bossed plaster.</li> <li>Remove flaking paint.</li> <li>Existing lath and plaster ceiling repaired to non-visual grade to achieve required fire separation.</li> <li>Existing ceiling to receive coating of intumescent paint. Architect to confirm specification.</li> </ul> | | | |

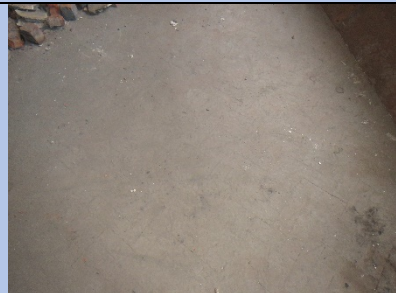
| Room Ref. | Element | Description / Item | Condition | Action | Photographs | | |
|---|---|---|---|---|---|---|---|
| | Floor | Terrazzo. Woodblock | Fair | <ul style="list-style-type: none"> <li>Remove all debris, clean and install protection to terrazzo.</li> <li>Quantify wood block, lift and store on pallet.</li> <li>Reclaimed timber block parquet laid on resilient layer</li> <li>Inset timber block border detail to reception desk location. Architect to confirm reception desk dimensions and location.</li> </ul> | | | |

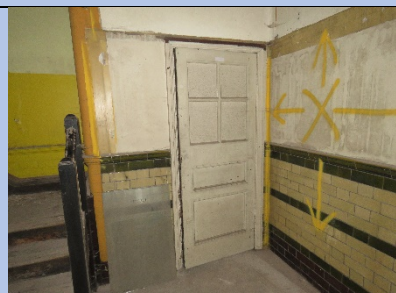
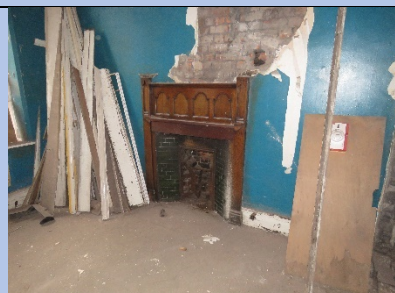
| Room Ref. | Element | Description / Item | Condition | Action | Photographs | | |
|---|---|---|---|---|---|---|---|
| | Joinery | Misc. joinery.<br>Fire surround.<br>Cornice<br>Skirting<br>Picture rail<br>Timber and glazed screens<br>Original double door. | | <ul style="list-style-type: none"> <li>Misc joinery to be reused where possible, otherwise scrapped.</li> <li>Skirting &amp; picture rails to be removed.</li> <li>Glazed screening to be set aside for reuse.</li> </ul> | | | |

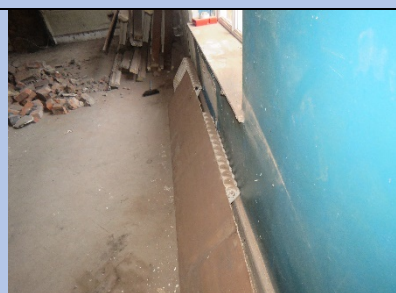
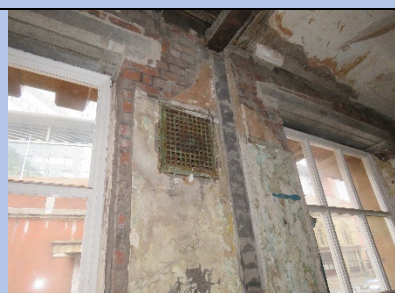
| Room Ref. | Element | Description / Item | Condition | Action | Photographs | | |
|---|---|---|---|---|---|---|---|
| | Misc. | Piles of brick from demolition.<br>Misc. construction materials<br>Fireplace.<br>1no. vent. | | <ul style="list-style-type: none"> <li>Remove loose debris and brickwork and discard or store on pallets.</li> </ul> | | | |

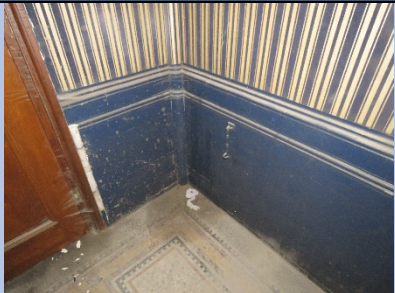
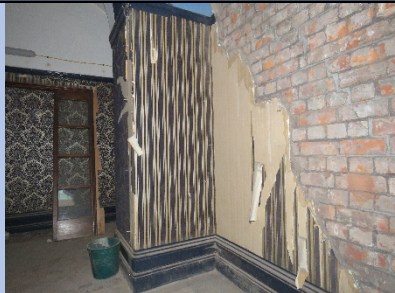
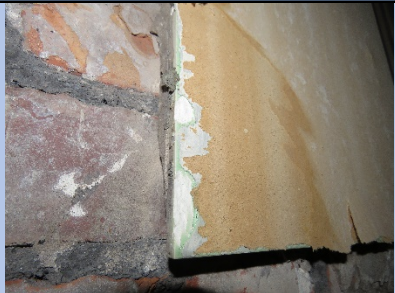
| Room Ref. | Element | Description / Item | Condition | Action | Photographs | | |
|---|---|---|---|---|---|---|---|
| 0.32b | Walls | Plaster on brick with wallpaper or paint finish. Also wallpaper and plaster over glazed tile. | Poor | <ul style="list-style-type: none"> <li>Carefully remove wallpaper and plaster over glazed tile.</li> <li>Remove all wallpaper and flaking paint from plaster.</li> <li>Existing walls stripped back to masonry (level of stripping back to be agreed)</li> </ul> | | | |

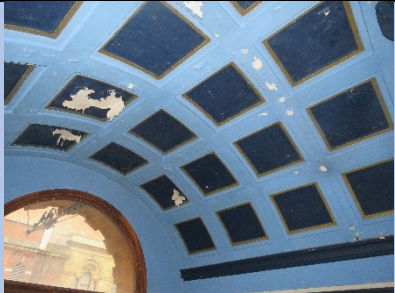
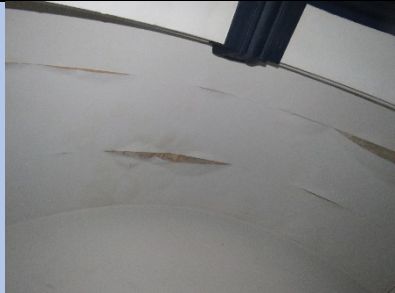
| Room Ref. | Element | Description / Item | Condition | Action | Photographs | | |
|---|---|---|---|---|---|---|---|
| | Ceiling | Plaster barrel vaulted coffered ceiling with paint finish. | Fair | <ul style="list-style-type: none"> <li>Hammer test remaining plaster and remove any bossed plaster.</li> <li>Remove flaking paint.</li> <li>Existing lath and plaster decorative ceiling repaired</li> <li>Existing ceiling to receive coating of intumescent paint. Architect to confirm specification.</li> </ul> | | | |

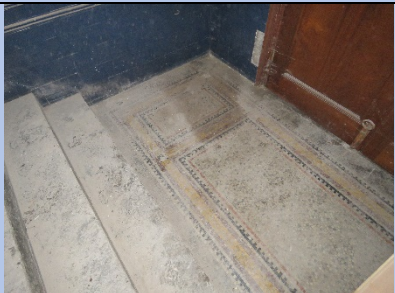
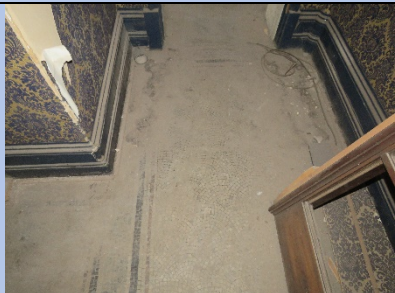
| Room Ref. | Element | Description / Item | Condition | Action | Photographs | | |
|---|---|---|---|---|---|---|---|
| | Floor | Terrazzo with mosaic tile border. | Fair | <ul style="list-style-type: none"> <li>Remove all debris, clean and install protection.</li> <li>Existing terrazzo floor cleaned, polished and protected.</li> </ul> | | | |

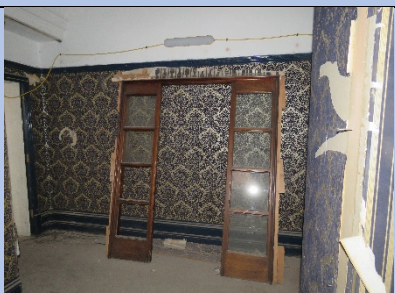
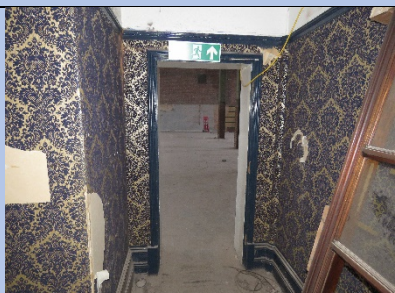
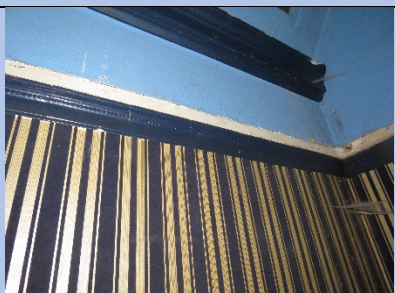
| Room Ref. | Element | Description / Item | Condition | Action | Photographs | | |
|---|---|---|---|---|---|---|---|
| | Joinery | Picture rail<br>Door architrave<br>Remove timber and glazed partition. | | Remove all joinery. | | | |

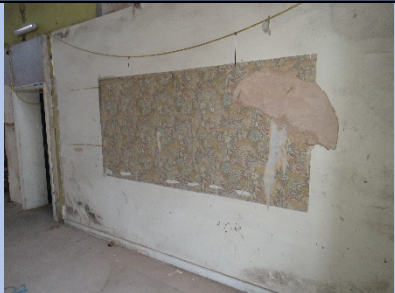
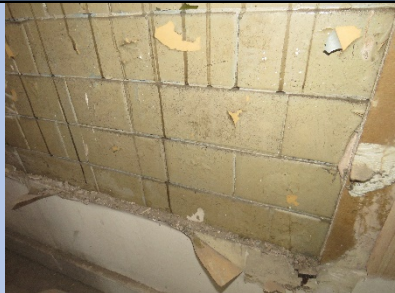
| Room Ref. | Element | Description / Item | Condition | Action | Photographs | | |
|---|---|---|---|---|---|---|---|
| 0.32 (Unit D) | Walls | Plaster on brick or over glazed brick. Paint or wallpaper finish. | Fair | <ul style="list-style-type: none"> <li>Existing walls stripped back to masonry/glazed bricks - missing bricks replaced / repaired.</li> <li>Existing glazed wall tiles to be cleaned.</li> <li>Existing steel columns to be intumescent painted. Architect to confirm specification.</li> <li>New plasterboard partition to form North Wall to be installed. Refer to Purcell GA drawings. Architect to confirm specification.</li> </ul> | | | |

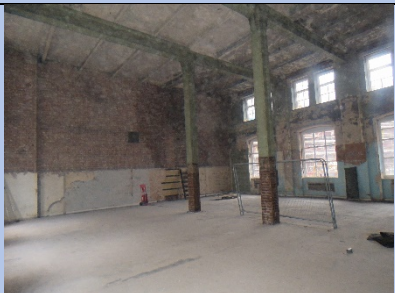
| Room Ref. | Element | Description / Item | Condition | Action | Photographs | | |
|---|---|---|---|---|---|---|---|
| | Ceiling | Plaster on concrete with paint finish. | Fair | <ul style="list-style-type: none"> <li>Hammer test remaining plaster and remove any bossed plaster.</li> <li>Remove flaking paint.</li> <li>Existing exposed concrete soffit retained and repaired.</li> <li>Soffit and steel beams to receive intumescent paint coating. Architect to confirm specification.</li> </ul> | | | |

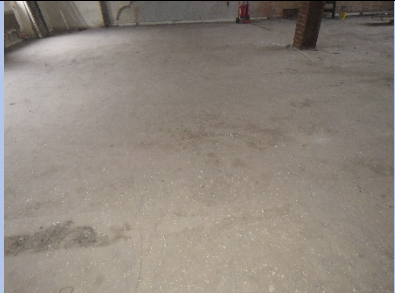
| Room Ref. | Element | Description / Item | Condition | Action | Photographs | | |
|---|---|---|---|---|---|---|---|
| | Floor | Exposed concrete with screed. | Fair | <ul style="list-style-type: none"> <li>Remove all screed.</li> <li>Reclaimed timber block parquet to be installed. Architect to confirm if resilient layer is to be installed.</li> </ul> | | | |

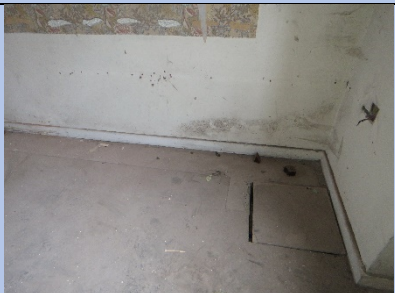
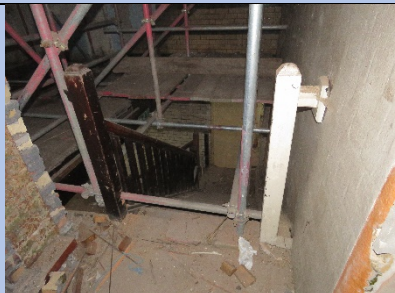
| Room Ref. | Element | Description / Item | Condition | Action | Photographs | | |
|---|---|---|---|---|---|---|---|
| | Joinery | Skirting<br>Timber staircase and handrail. | | <ul style="list-style-type: none"> <li>Staircase removed</li> <li>Remove skirting</li> </ul> | | | |

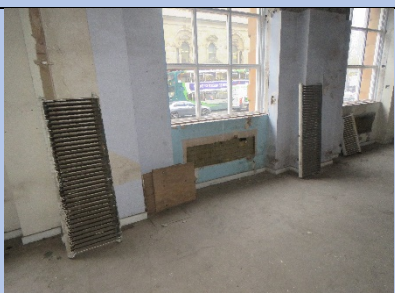
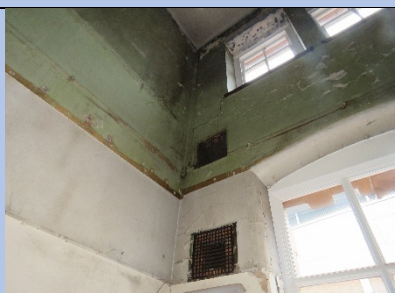
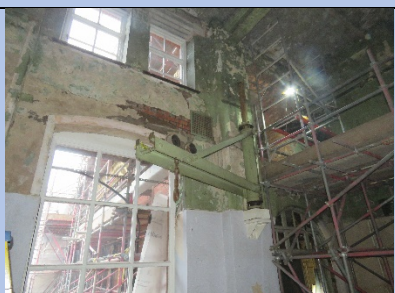
| Room Ref. | Element | Description / Item | Condition | Action | Photographs | | |
|---|---|---|---|---|---|---|---|
| | Misc. | 10no. ventilation grilles.<br>Hoist machinery.<br>Radiators | | <ul style="list-style-type: none"> <li>Record and relocate radiators to heritage store.</li> </ul> | | | |

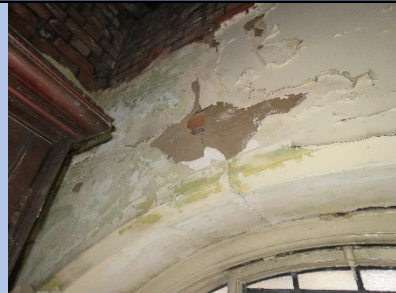
| Room Ref. | Element | Description / Item | Condition | Action | Photographs | | |
|---|---|---|---|---|---|---|--|
| 033 | Walls | Plaster on brick with paint finish. | Poor | <ul style="list-style-type: none"> <li>Hammer test remaining plaster and remove any bossed plaster.</li> <li>Remove flaking paint.</li> <li>Fill any holes with salvaged red brick and mortar.</li> <li>Replace missing lime plaster to specification M20/210.</li> </ul> | | | |

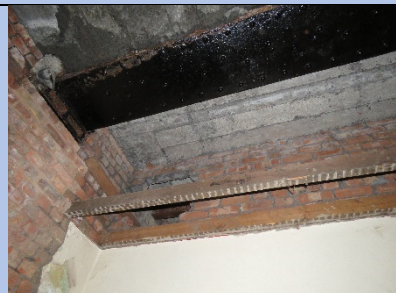
| Room Ref. | Element | Description / Item | Condition | Action | Photographs | | |
|---|---|---|---|---|---|---|--|
| | Ceiling | Exposed concrete and steel beam. Timber ceiling joist. | Fair | <ul style="list-style-type: none"> <li>Remove 2no. timber ceiling joists.</li> <li>Existing exposed concrete soffit to be retained, repaired to SE details.</li> <li>Steel beams to receive intumescent paint NBS:M61/120.</li> <li>Install new suspended ceiling on MF grid consisting of 2 layers 15mm fireboard and skim in preparation for decoration (NBS tbc).</li> </ul> | | | |

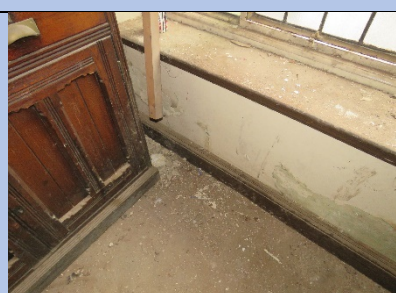
| Room Ref. | Element | Description / Item | Condition | Action | Photographs | | |
|---|---|---|---|---|---|---|--|
| | Joinery | Skirting<br>Door architrave<br>Door<br>Window and frame. | | <ul style="list-style-type: none"> <li>Skirtings to be reinstated complete around perimeter.</li> <li>Doors and architraves to be removed and replaced with new fire doors.</li> </ul> | | | |

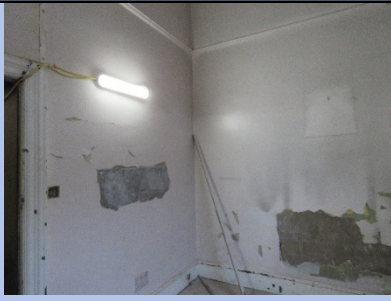
| Room Ref. | Element | Description / Item | Condition | Action | Photographs | | |
|---|---|---|---|---|---|---|---|
| 0.34 + 0.34a | Walls | Plaster on brick with paint finish. Timber panelling to entrance vestibule. | Poor | <ul style="list-style-type: none"> <li>• Hammer test remaining plaster and remove any bossed plaster.</li> <li>• Remove flaking paint.</li> <li>• Remove screws and protect timber vestibule.</li> <li>• Panelling to be retained and refurbished by a specialist carpenter / joiner.</li> <li>• Lime plaster to be repaired and reinstated to specification M20/210</li> </ul> | | | |

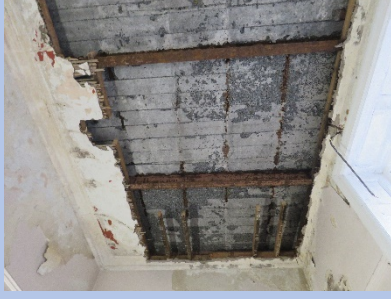
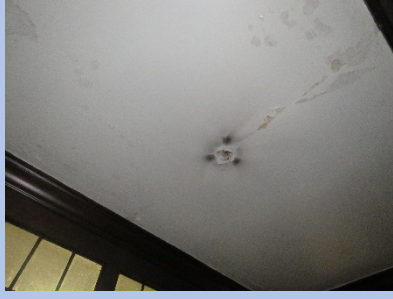
| Room Ref. | Element | Description / Item | Condition | Action | Photographs | | |
|---|---|---|---|---|---|---|---|
| | Ceiling | Exposed concrete and steel beams. Plaster on lath with paint finish. Cornice survives. | Fair | <ul style="list-style-type: none"> <li>• De-rust corroded steel beams.</li> <li>• Hammer test remaining plaster and remove any bossed plaster.</li> <li>• Remove flaking paint.</li> <li>• Existing exposed concrete soffit to be retained, repaired to SE details.</li> <li>• Steel beams to receive intumescent paint NBS:M61/120.</li> <li>• Install new suspended ceiling on MF grid consisting of 2 layers 15mm fireboard and skim in preparation for decoration (NBS tbc).</li> </ul> | | | |

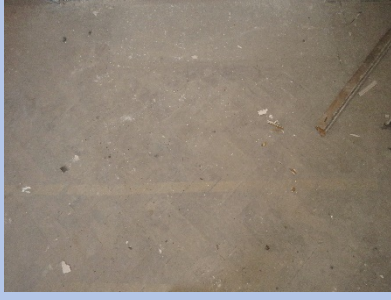
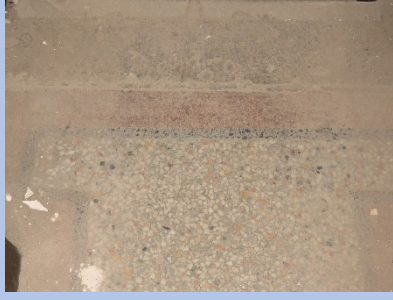
| Room Ref. | Element | Description / Item | Condition | Action | Photographs | | |
|---|---|---|---|---|---|---|---|
| | Floor | Woodblock. Terrazzo. | | <ul style="list-style-type: none"> <li>• Remove all debris.</li> <li>• Remove underlay from steps.</li> <li>• Clean terrazzo and protect.</li> <li>• Quantify wood block, lift and store on pallet.</li> <li>• Existing timber block (parquet) to be refurbished, re-laid and re-sealed.</li> <li>• Terrazzo to be polished.</li> </ul> | | | |

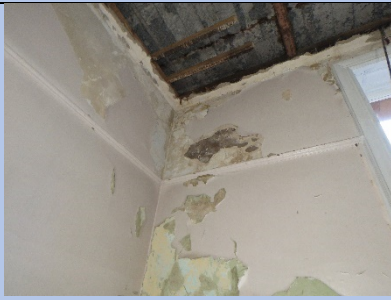
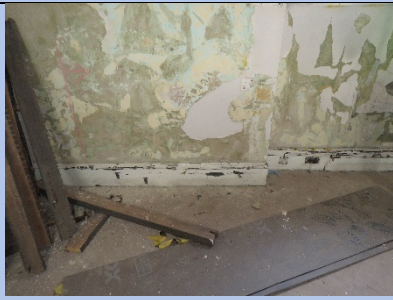
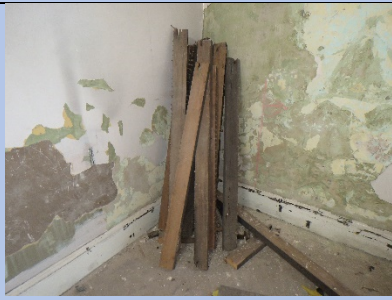
| Room Ref. | Element | Description / Item | Condition | Action | Photographs | | |
|---|---|---|---|---|---|---|---|
| | Joinery | Skirting<br>3no. door architraves.<br>3no. door<br>Pile of ceiling joists.<br>Picture rail<br>Timber window cill and reveal. | | <ul style="list-style-type: none"> <li>• Skirting and picture rail to be reinstated in full.</li> <li>• Doors and architraves to be retained and refurbished.</li> <li>• Loose timber to be used for repairs where possible, otherwise scrapped.</li> </ul> | | | |

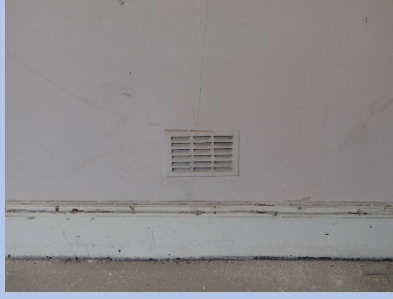
| Room Ref. | Element | Description / Item | Condition | Action | Photographs | | |
|---|---|---|---|---|---|---|---|
| | Misc. | Vent to blocked up chimney. Redundant M&E conduit. | | <ul style="list-style-type: none"> <li>• Remove ventilation grille and clear all debris and fill holes.</li> <li>• Remove conduit and fill holes.</li> </ul> | | | |

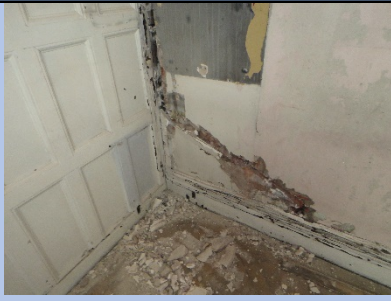
| Room Ref. | Element | Description / Item | Condition | Action | Photographs | | |
|---|---|---|---|---|---|---|---|
| 0.35 | Walls | Plaster on brick with paint finish. Timber panelling to entrance vestibule, painted. Timber and coloured glass partition. White tile to | Poor | <ul style="list-style-type: none"> <li>• Hammer test remaining plaster and remove any bossed plaster.</li> <li>• Remove flaking paint.</li> <li>• Remove screws and protect timber vestibule.</li> <li>• Protect all timber and glazed partitioning.</li> <li>• Panelling to be retained and refurbished by a specialist carpenter / joiner.</li> <li>• Lime plaster to be repaired/reinstated to walls to specification M20/210.</li> </ul> | | | |

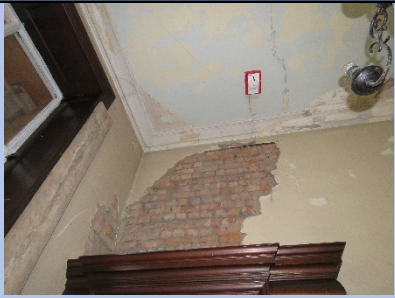
| Room Ref. | Element | Description / Item | Condition | Action | Photographs | | |
|---|---|---|---|---|---|---|---|
| 0.35a | Walls | Plaster on brick with paint finish. Timber and coloured glass partition. | Poor | <ul style="list-style-type: none"> <li>• Hammer test remaining plaster and remove any bossed plaster.</li> <li>• Remove flaking paint.</li> <li>• Protect all timber and glazed partitioning.</li> <li>• Panelling to be retained and refurbished by a specialist carpenter / joiner.</li> <li>• Lime plaster to be reinstated where missing to specification M20/210.</li> </ul> | | | |

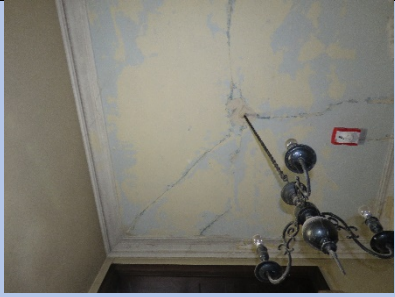
| Room Ref. | Element | Description / Item | Condition | Action | Photographs | | |
|---|---|---|---|---|---|---|---|
| | Ceiling | Plaster on lath with paint finish. Cornice survives. | Fair | <ul style="list-style-type: none"> <li>• Hammer test remaining plaster and remove any bossed plaster.</li> <li>• Remove flaking paint.</li> <li>• Existing lath and plaster ceiling to be repaired and to receive intumescent paint coatings to Architect specification. Cornice to be repaired and reinstated where missing.</li> </ul> | | | |

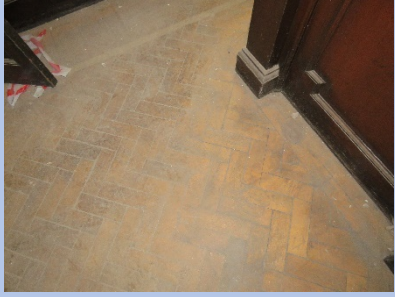
| Room Ref. | Element | Description / Item | Condition | Action | Photographs | | |
|---|---|---|---|---|---|---|---|
| | Floor | Woodblock. | Fair | <ul style="list-style-type: none"> <li>• Remove all debris.</li> <li>• Remove tape and residue of adhesive.</li> <li>• Quantify wood block, lift and store on pallet.</li> <li>• Existing timber boards and existing timber block (parquet) to be refurbished, re-laid and re-sealed.</li> </ul> | | | |

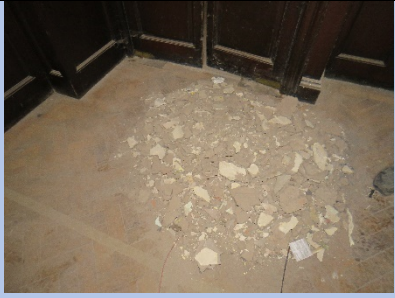
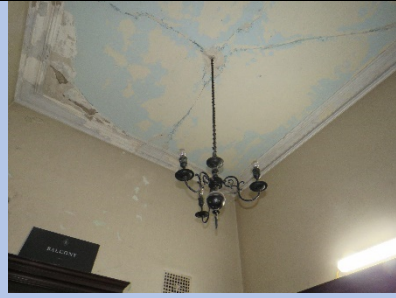
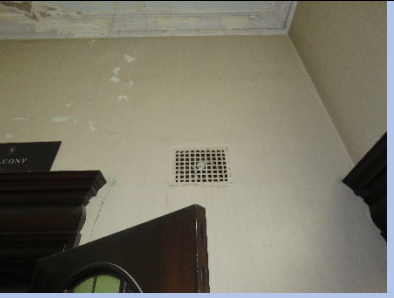
| Room Ref. | Element | Description / Item | Condition | Action | Photographs | | |
|---|---|---|---|---|---|---|---|
| | Misc. | Misc. pile of debris.<br>Light fitting.<br>Ventilation grille. | | <ul style="list-style-type: none"> <li>• Remove all debris.</li> <li>• Protect light fitting in-situ (check fixing for adequacy).</li> </ul> | | | |

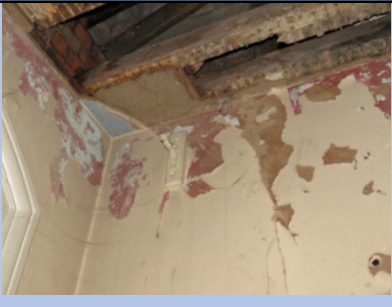
| Room Ref. | Element | Description / Item | Condition | Action | Photographs | | |
|---|---|---|---|---|---|---|---|
| 0.36 | Walls | Plaster on brick with paint finish. Timber panelling. | Poor | <ul style="list-style-type: none"> <li>• Hammer test remaining plaster and remove any bossed plaster.</li> <li>• Remove flaking paint.</li> <li>• Protect all timber panelling.</li> <li>• Panelling to be retained and refurbished by a specialist carpenter / joiner.</li> <li>• Lime plaster reinstated to masonry walls M20/210</li> </ul> | | | |

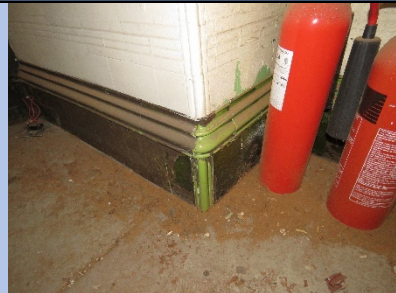
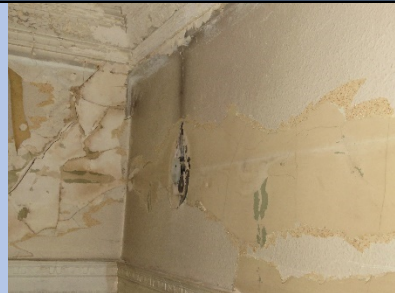
| Room Ref. | Element | Description / Item | Condition | Action | Photographs | | |
|---|---|---|---|---|---|---|---|
| S04 | Walls | Glazed tile, painted over. Plaster on brick with paint finish. Tiled skirting. Crack to wall. | Fair | <ul style="list-style-type: none"> <li>Remove all paint from glazed tiles with peelaway.</li> <li>Hammer test remaining plaster and remove any bossed plaster.</li> <li>Remove flaking paint.</li> <li>Protect all glazed tiles.</li> <li>CURTINS COMMENT: Quadriga to locally remove patch of plaster to enable review of crack please. (crack to wall).</li> <li>Repair lime plaster to plaster walls to specification NBS:M20/210</li> </ul> | | | |

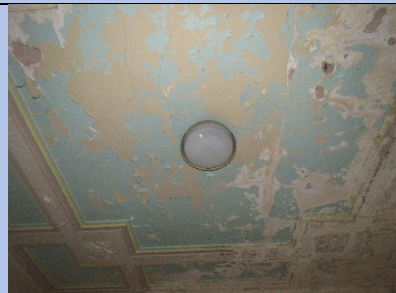
| Room Ref. | Element | Description / Item | Condition | Action | Photographs | | |
|---|---|---|---|---|---|---|---|
| | Ceiling | Plaster on lath with paint finish. Cornice and decorative relief of ceiling survives. | Fair | <ul style="list-style-type: none"> <li>Hammer test remaining plaster and remove any bossed plaster.</li> <li>Remove flaking paint.</li> <li>Existing lath and plaster ceiling to be repaired and to receive intumescent paint coatings to Architect specification. Cornice to be repaired and reinstated where missing.</li> </ul> | | | |

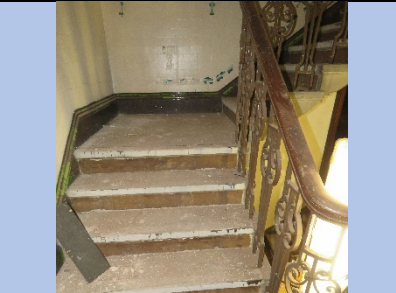
| Room Ref. | Element | Description / Item | Condition | Action | Photographs | | |
|---|---|---|---|---|---|---|---|
| | Floor | Stone slabs and steps. | Fair | <ul style="list-style-type: none"> <li>Remove all adhesive and protect flooring.</li> <li>Stone treads to be repaired &amp; infilled where damaged.</li> </ul> | | | |

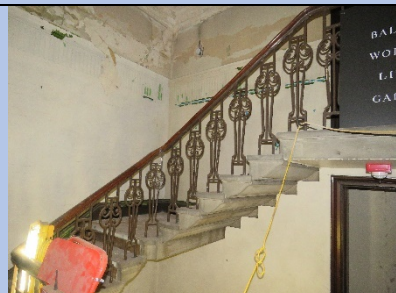
| Room Ref. | Element | Description / Item | Condition | Action | Photographs | | |
|---|---|---|---|---|---|---|---|
| | Misc. | Misc. waste. Cast steel balusters and timber handrail. Light switch. Light fitting & faceplate to ceiling. | | <ul style="list-style-type: none"> <li>Remove all waste.</li> <li>Remove flaking paint from balusters, record condition and install protection.</li> <li>Retain light switch.</li> <li>Remove signage to laylight.</li> <li>Remove light fitting and faceplate to ceiling.</li> <li>Fill any holes in walls / ceilings following removals.</li> </ul> | | | |

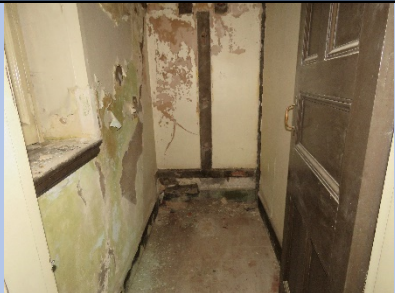
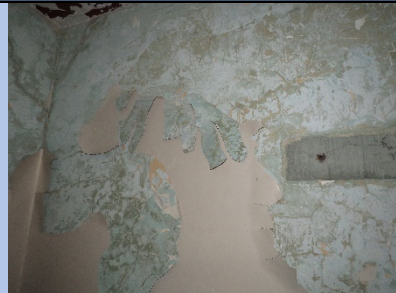
| Room Ref. | Element | Description / Item | Condition | Action | Photographs | | |
|---|---|---|---|---|---|---|---|
| 0.35b + 48 | Walls | Plaster on brick with paint finish.<br>Concrete skirting. | Poor | <ul style="list-style-type: none"> <li>Hammer test remaining plaster and remove any bossed plaster.</li> <li>Remove flaking paint.</li> <li>Remove nails.</li> <li>Paneling to be retained and refurbished by a specialist carpenter / joiner.</li> <li>Repair lime plaster to plaster walls to specification NBS:M20/210.</li> </ul> | | | |

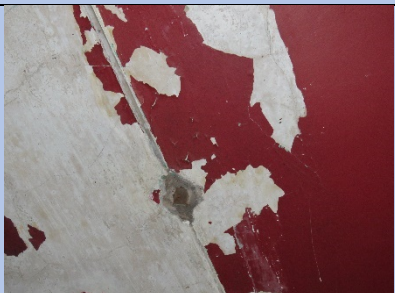
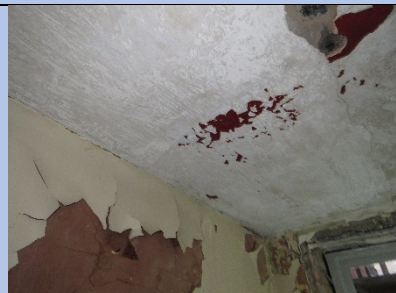
| Room Ref. | Element | Description / Item | Condition | Action | Photographs | | |
|---|---|---|---|---|---|---|---|
| | Ceiling | Plaster on brick with paint finish. | Poor | <ul style="list-style-type: none"> <li>Hammer test remaining plaster and remove any bossed plaster.</li> <li>Existing lath and plaster ceiling to be repaired and to receive intumescent paint coatings to Architect specification. Cornice to be repaired and reinstated where missing.</li> </ul> | | | |

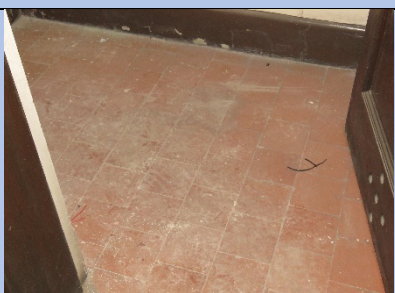
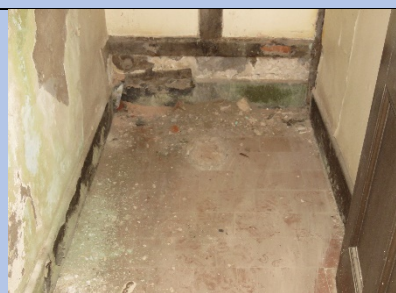
| Room Ref. | Element | Description / Item | Condition | Action | Photographs | | |
|---|---|---|---|---|---|---|---|
| | Floor | Red quarry tile.<br>Toilet base. | | <ul style="list-style-type: none"> <li>Remove toilet base &amp; fill hole remaining in floor.</li> <li>Remove all debris.</li> <li>Clean and protect tiled floor areas.</li> <li>Existing timber boards and existing timber block (parquet) to be taken up, refurbished, re-laid and re-sealed.</li> </ul> | | | |

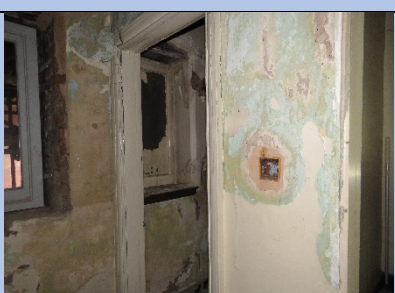
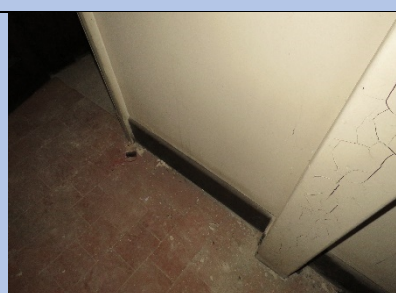
| Room Ref. | Element | Description / Item | Condition | Action | Photographs | | |
|---|---|---|---|---|---|---|---|
| | Joinery | Cubicle doors and architraves. | | <ul style="list-style-type: none"> <li>To be retained and refurbished</li> </ul> | | | |

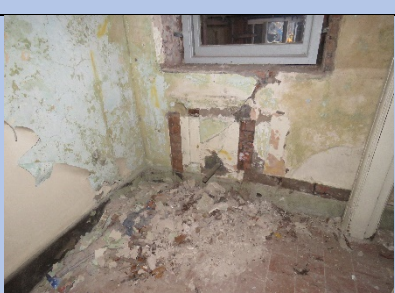
| Room Ref. | Element | Description / Item | Condition | Action | Photographs | | |
|---|---|---|---|---|---|---|---|
| | Misc. | Sink waste pipe<br>General demolition waste.<br>Redundant clip to ceiling.<br>Mirror Chain. | | <ul style="list-style-type: none"> <li>Remove waste pipe and fill hole with red brick / mortar.</li> <li>Remove all waste.</li> <li>Remove clip to ceiling &amp; make good.</li> <li>Remove mirror and chain &amp; make good wall.</li> </ul> | | | |

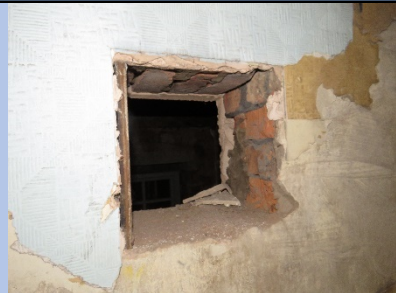
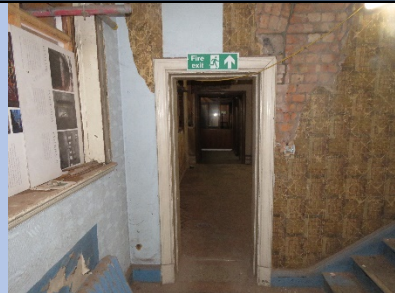
| Room Ref. | Element | Description / Item | Condition | Action | Photographs | | |
|---|---|---|---|---|---|---|---|
| S12 | Walls | Plaster on brick with wallpaper or paint finish.<br>Timber boarding to entrance. | Fair | <ul style="list-style-type: none"> <li>Hammer test remaining plaster and remove any bossed plaster.</li> <li>Remove flaking paint.</li> <li>Remove wallpaper.</li> <li>Large and structural holes to be infilled with reclaimed brickwork.</li> <li>Repair lime plaster as per specification NBS:M21/210.</li> </ul> | | | |

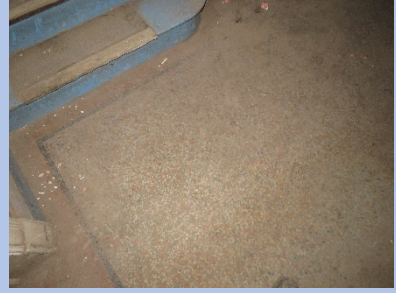
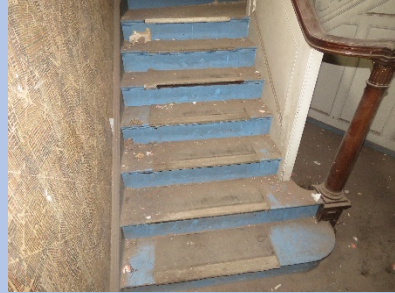
| Room Ref. | Element | Description / Item | Condition | Action | Photographs | | |
|---|---|---|---|---|---|---|---|
| | Floor | Terrazzo.<br>Timber stairs. | Fair | <ul style="list-style-type: none"> <li>Install plyboard to entrance mat recess.</li> <li>Remove all debris, clean, polish and install protection to terrazzo.</li> <li>Remove vinyl tread and nosings to stairs &amp; remove all adhesives.</li> <li>Remove all debris to stairs and install protection.</li> <li>Make cost allowance for floor to be levelled and prepared throughout with latex levelling screed and finished with polished screed as FIN04 2212. Item to be instructed by Architect if required.</li> </ul> | | | |

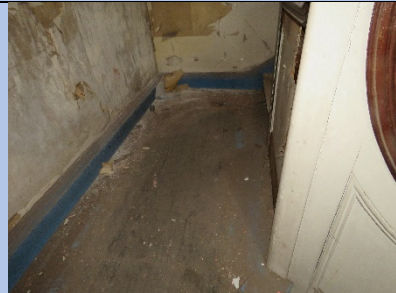
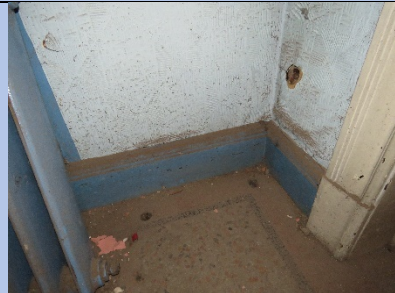
| Room Ref. | Element | Description / Item | Condition | Action | Photographs | | |
|---|---|---|---|---|---|---|---|
| | Joinery | Skirting<br>Timber stair and panelling.<br>Entrance vestibule.<br>Door architraves. | Fair | <ul style="list-style-type: none"> <li>Entrance vestibule and door to be removed.</li> <li>Stair and panelling removed.</li> <li>Skirtings to be reinstated/replaced to walls.</li> </ul> | | | |

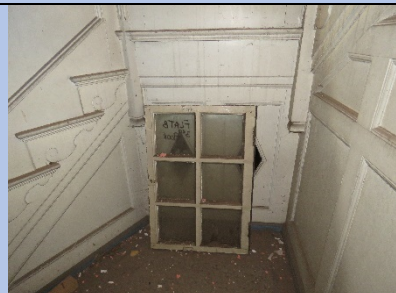
| Room Ref. | Element | Description / Item | Condition | Action | Photographs | | |
|---|---|---|---|---|---|---|---|
| | Misc. | 1no. radiator.<br>1no. window. | | <ul style="list-style-type: none"> <li>Record radiator and window before relocating to Heritage store.</li> </ul> | | | |
