# ARBORICULTURAL IMPACT ASSESSMENT AND TREE SURVEY

466-472 Moss Lane East, Manchester.  
M14 4PJ.

Steven Calderbank BSc (Hons)

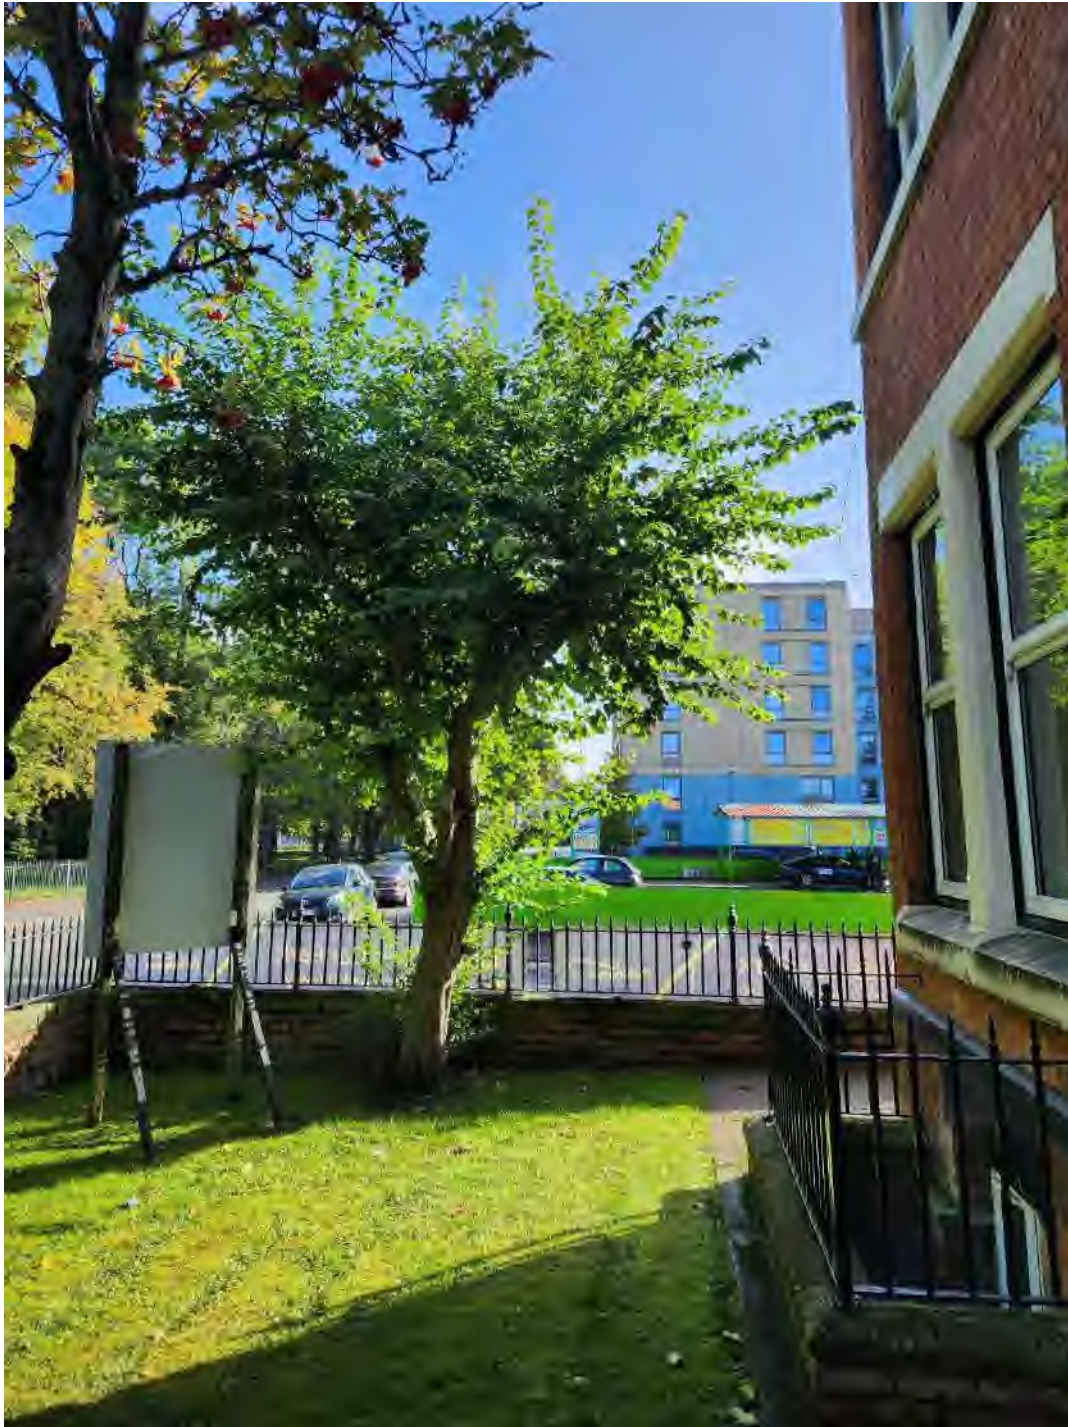
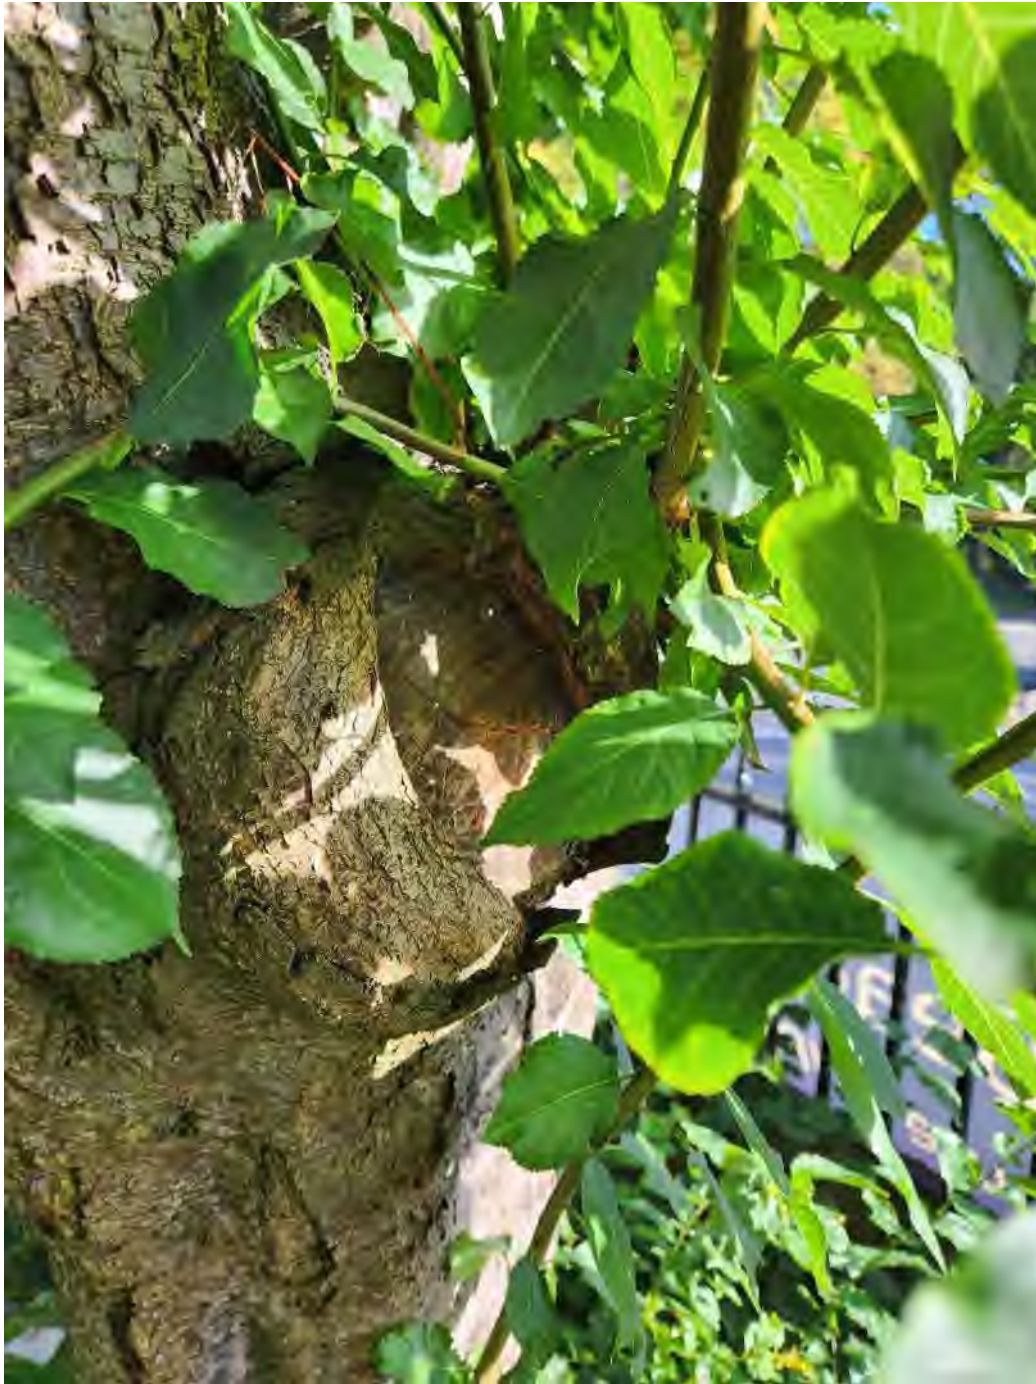
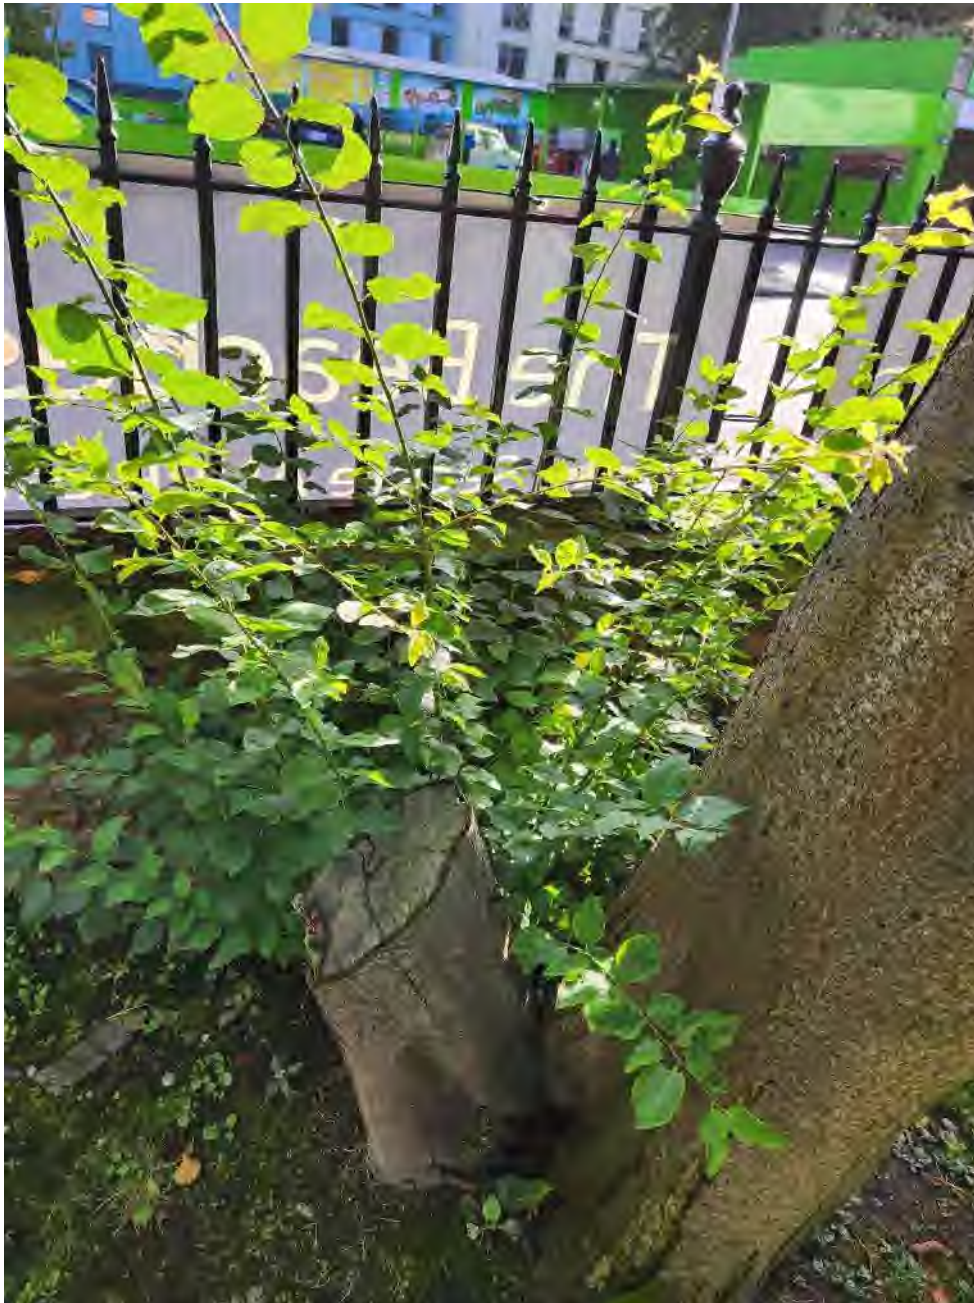
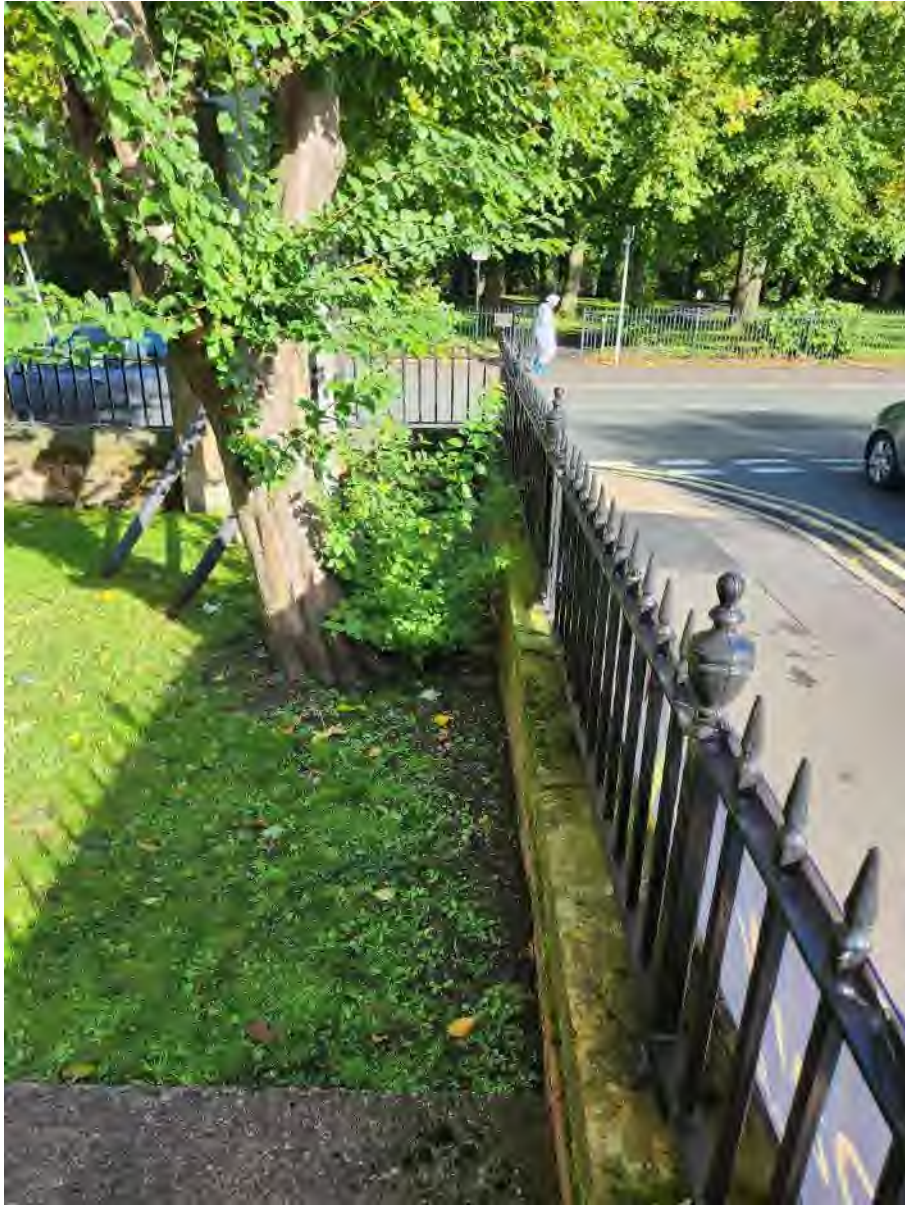
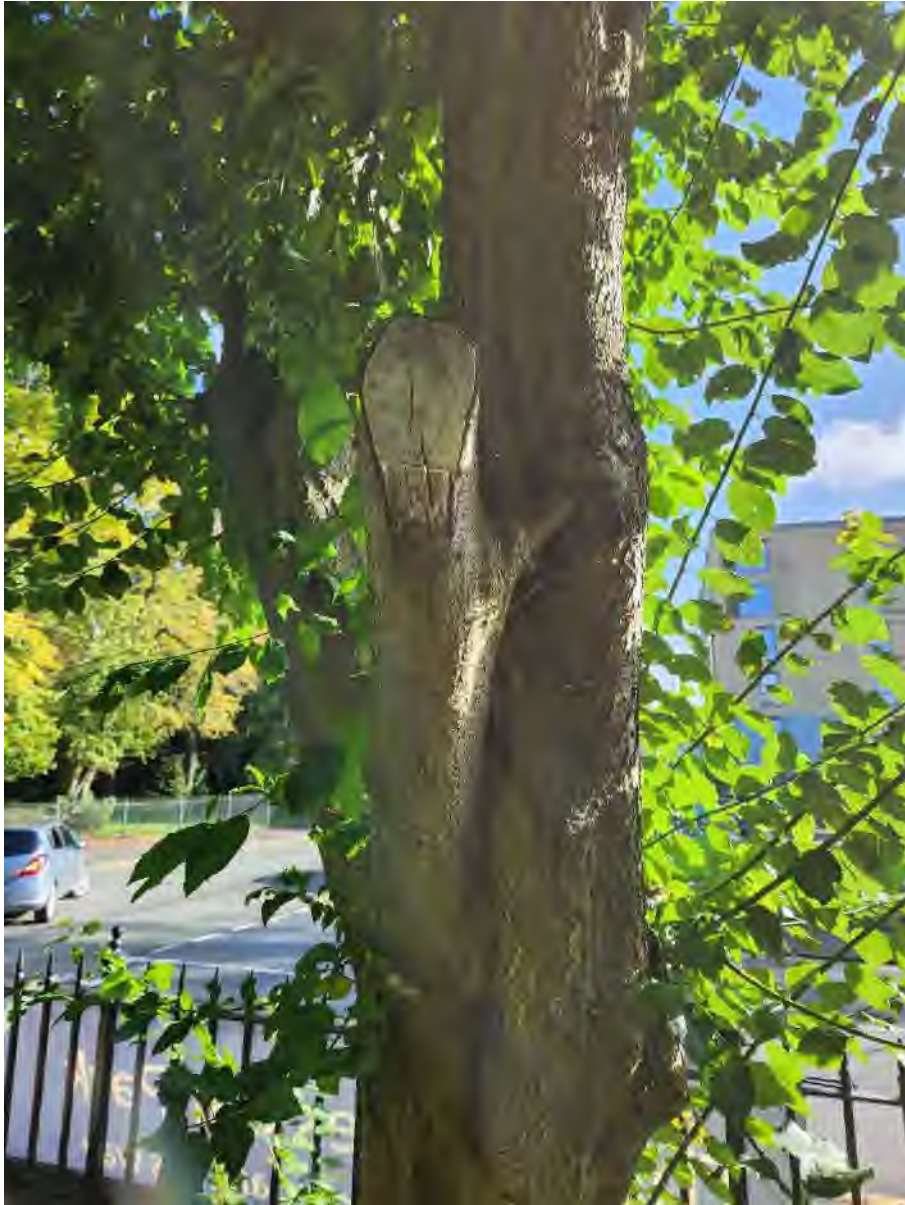
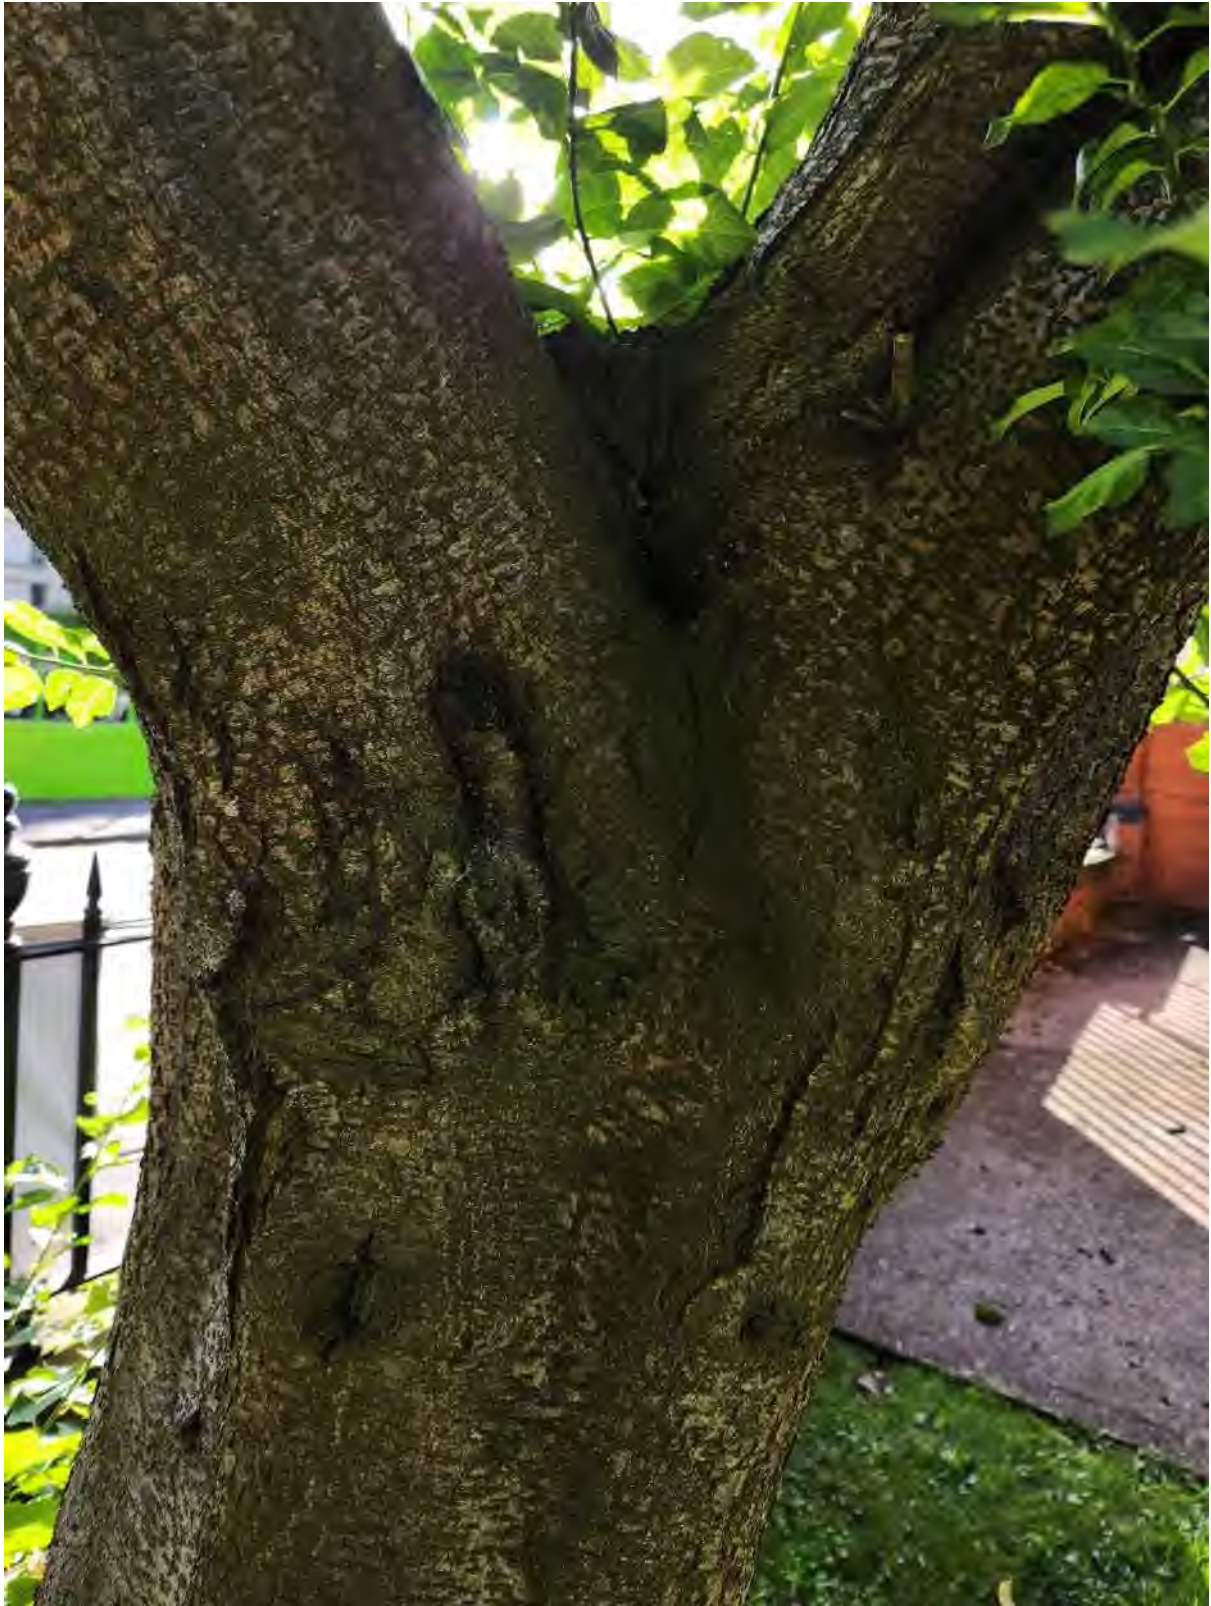
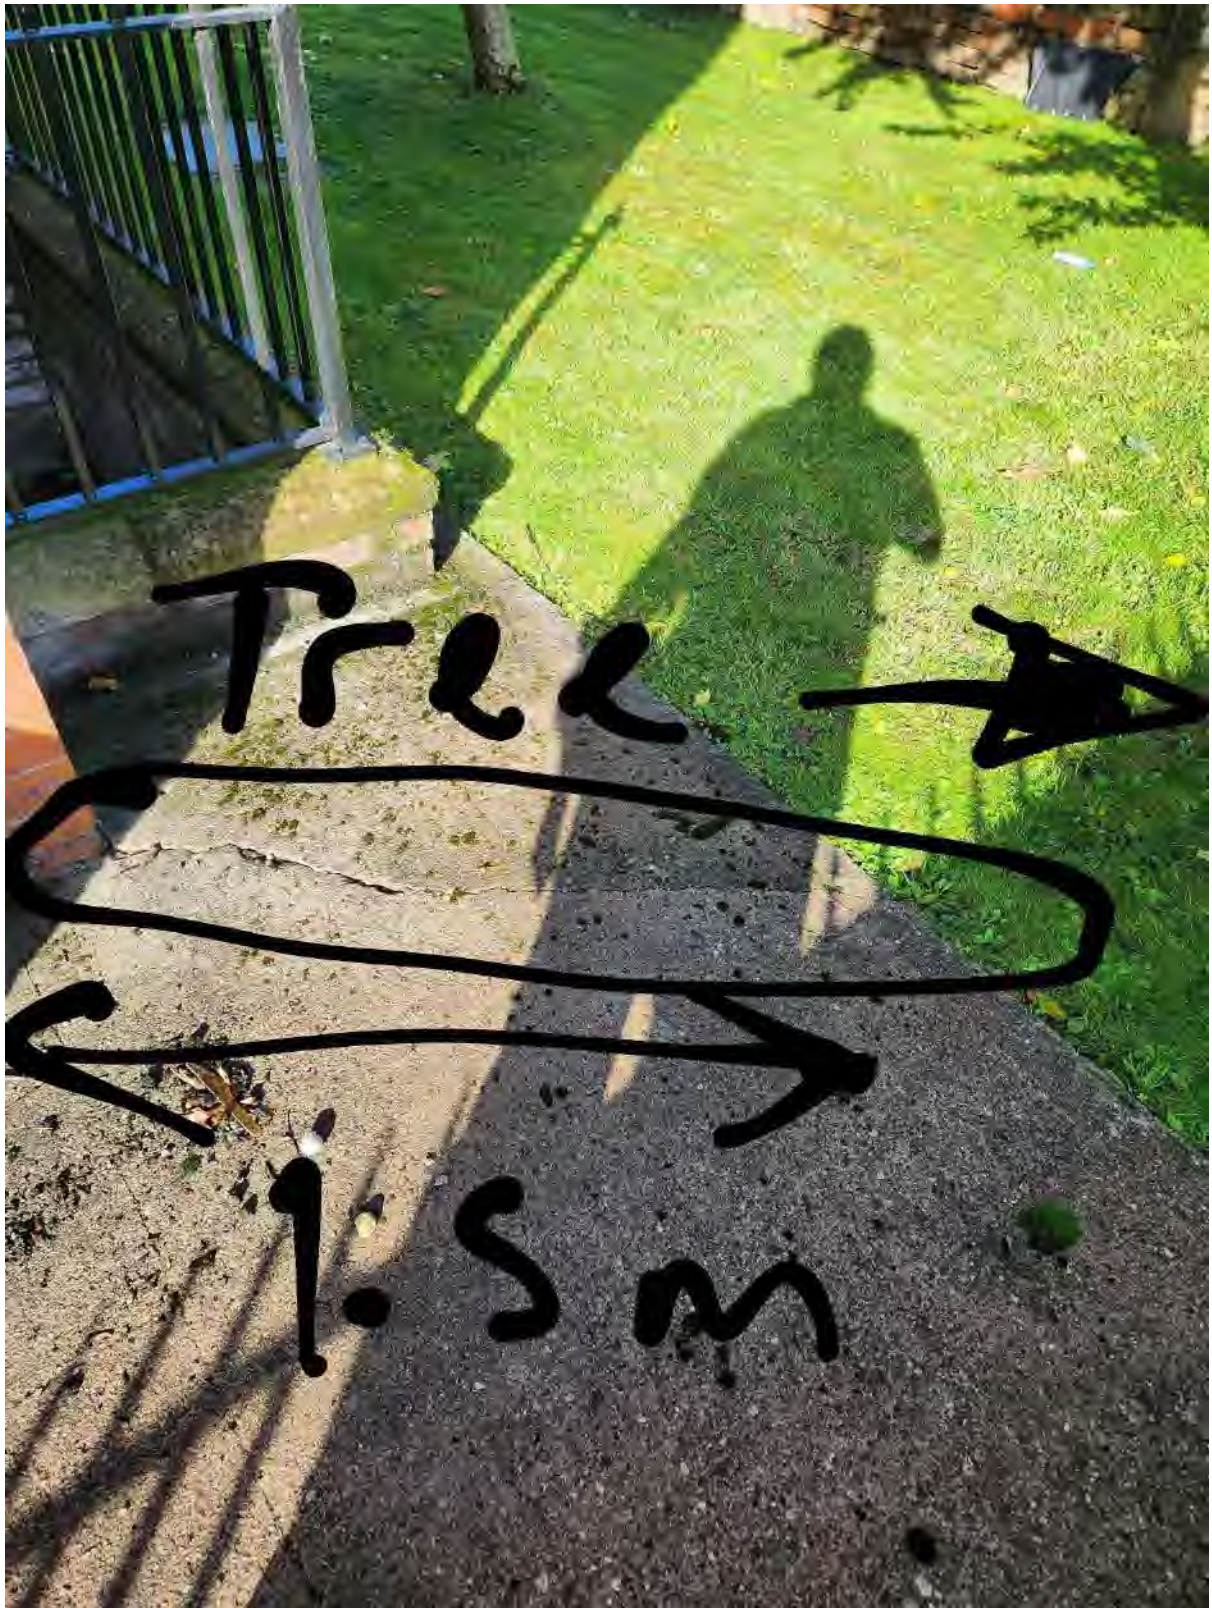
| Condition survey:<br><br>-Surface crack in concrete pad to the south of the surface root direction 1.5m long<br>-Fluted buttress on the (N) (E) (S) Side<br>-Dominant lean and weighted (S)<br>-Evidence of stem removed (N) at ground level with epicormic protruding from cut face. See photos<br>-Pruning wound at 1.5m (S) 15cm dia. No evidence of sealing.<br>-Pruning wound and fusing limb at 1.5m (W). Cut is made 0.5m from branch bark union. Remaining limb is fused to the main stem. See photos<br>-All tops had previous works and showing signs of epicormic growth at the point of cut.<br>-Tree tips (S) touching building | | | |
| Offsite notes-<br><br>Tree is showing signs of stress with epicormic growth. The exposed cuts are discoloring and showing signs of decline. The previous works suggest pollarding in the past. The previous works goes against BS:3998 recommendations. This tree will suffer ill effects during and after construction. As it is not a good specimen and not a notable tree, recommendation, are to remove and replace with better specimen choices | | | |
| QTRA Rating:<br><br>Whole tree failure<br>1/1mil | Physiological<br>condition: Fair | Structural condition:<br>Poor | BS:5837 category:<br>C1 |

| Works required and time scales:<br>Fell and remove trees. Works prior to construction | | | |
