# ARBORICULTURAL IMPACT ASSESSMENT AND TREE SURVEY

466-472 Moss Lane East, Manchester.  
M14 4PJ.

Steven Calderbank BSc (Hons)

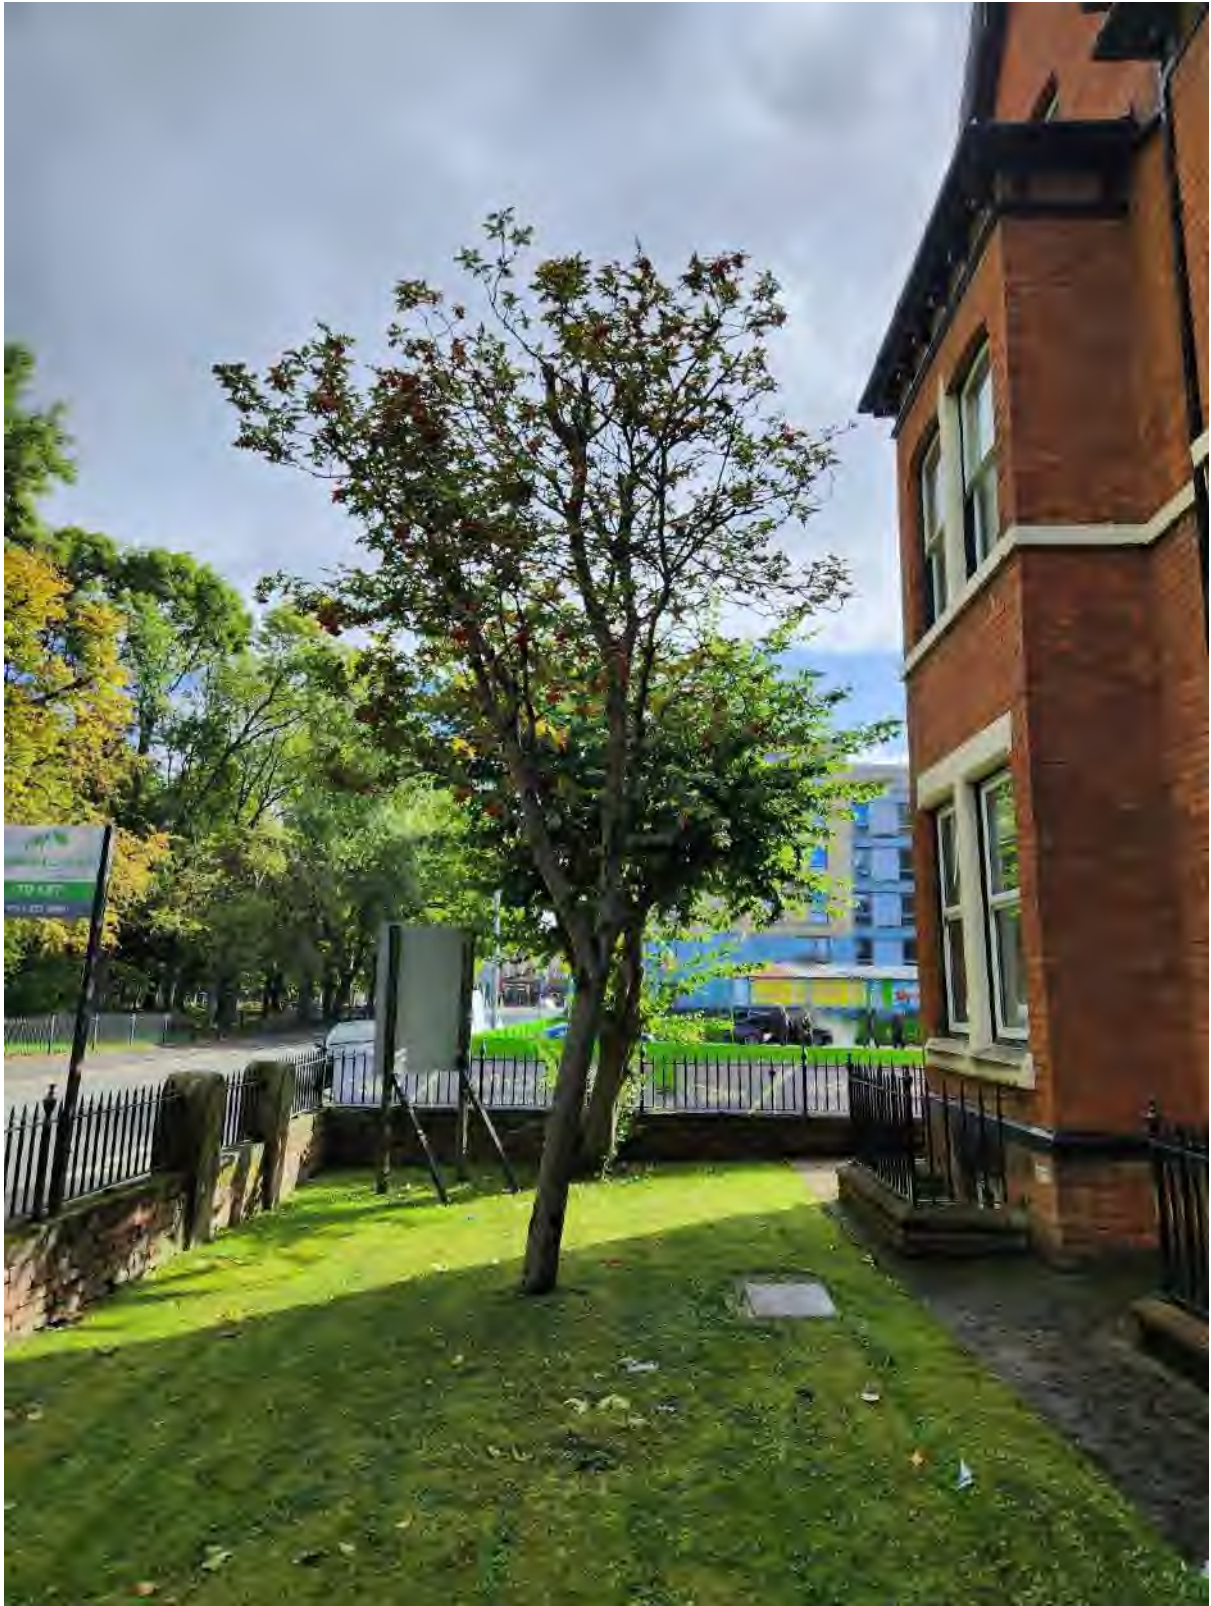
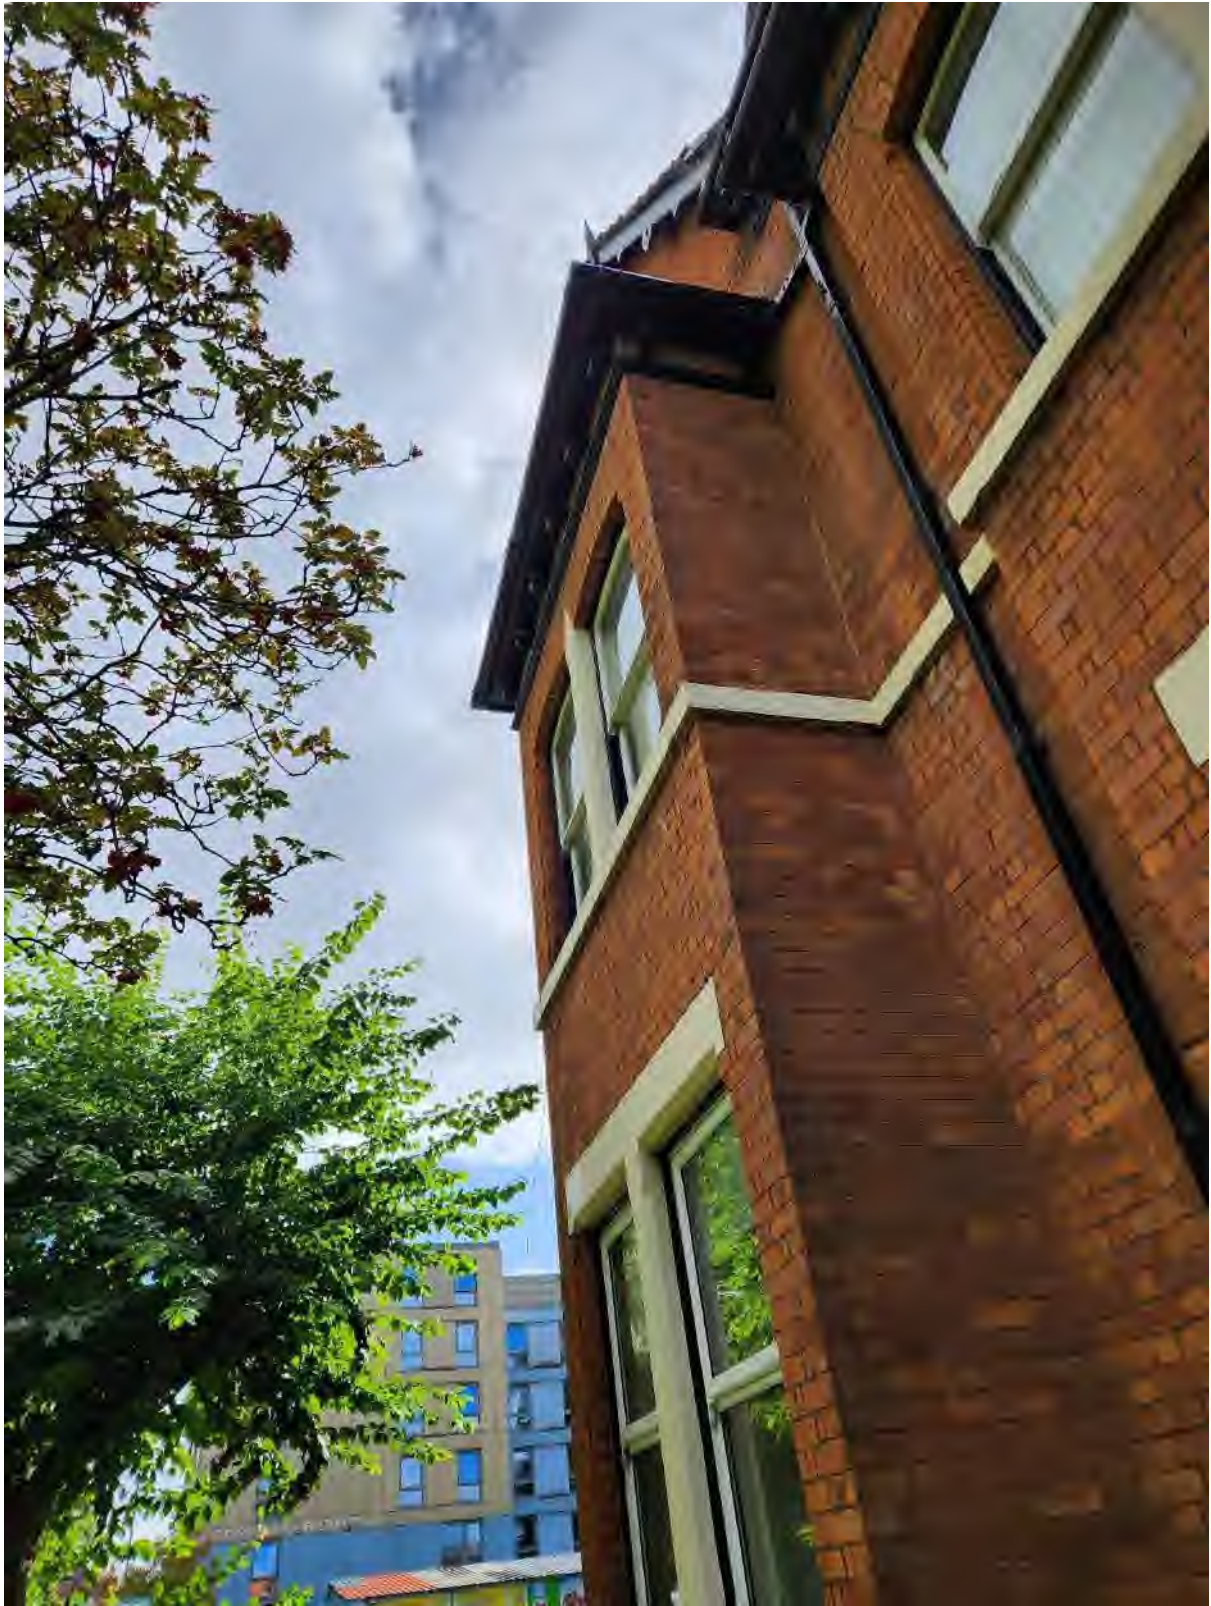
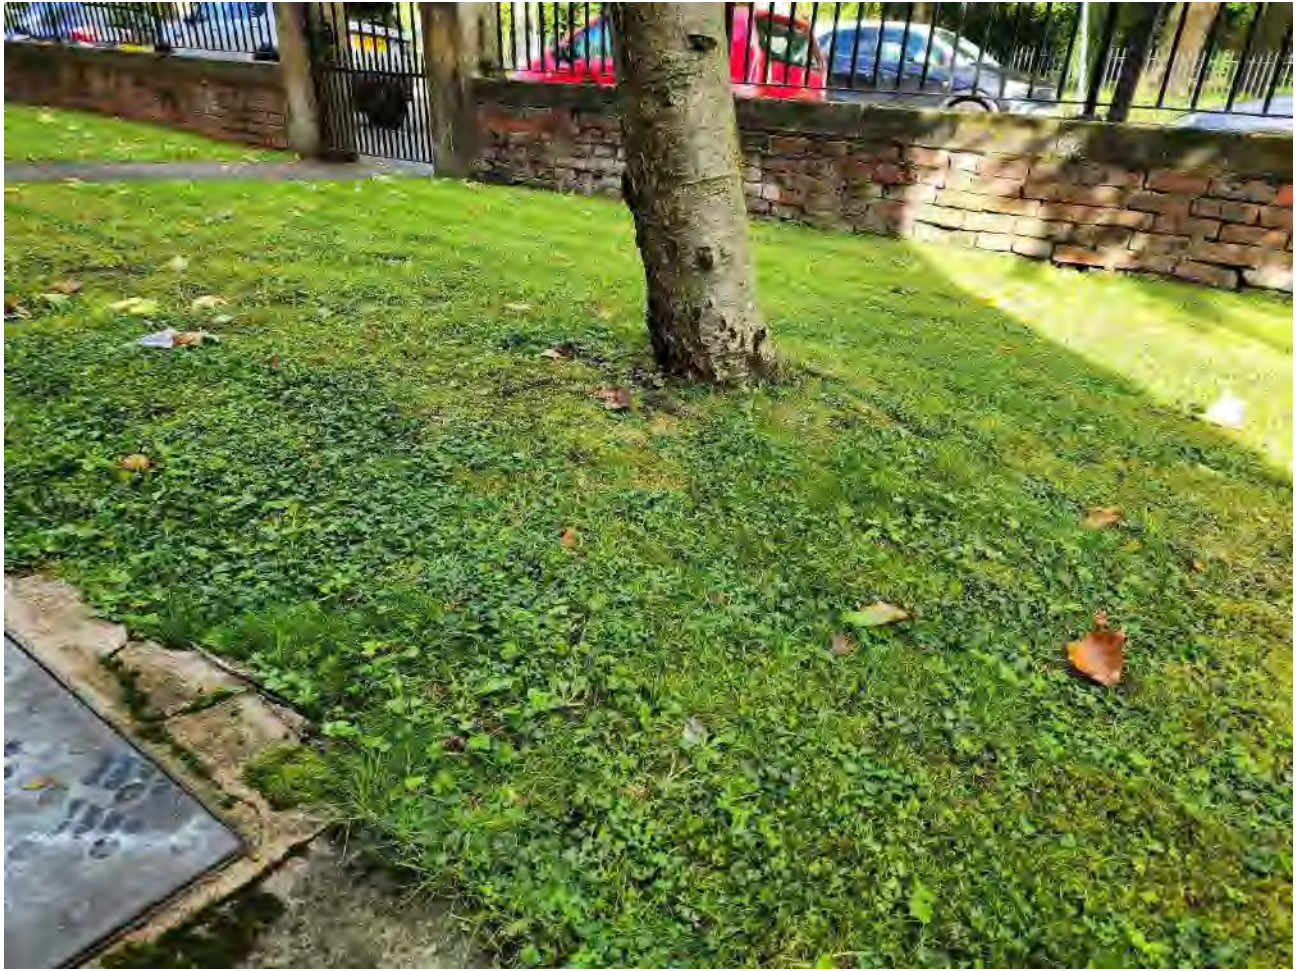
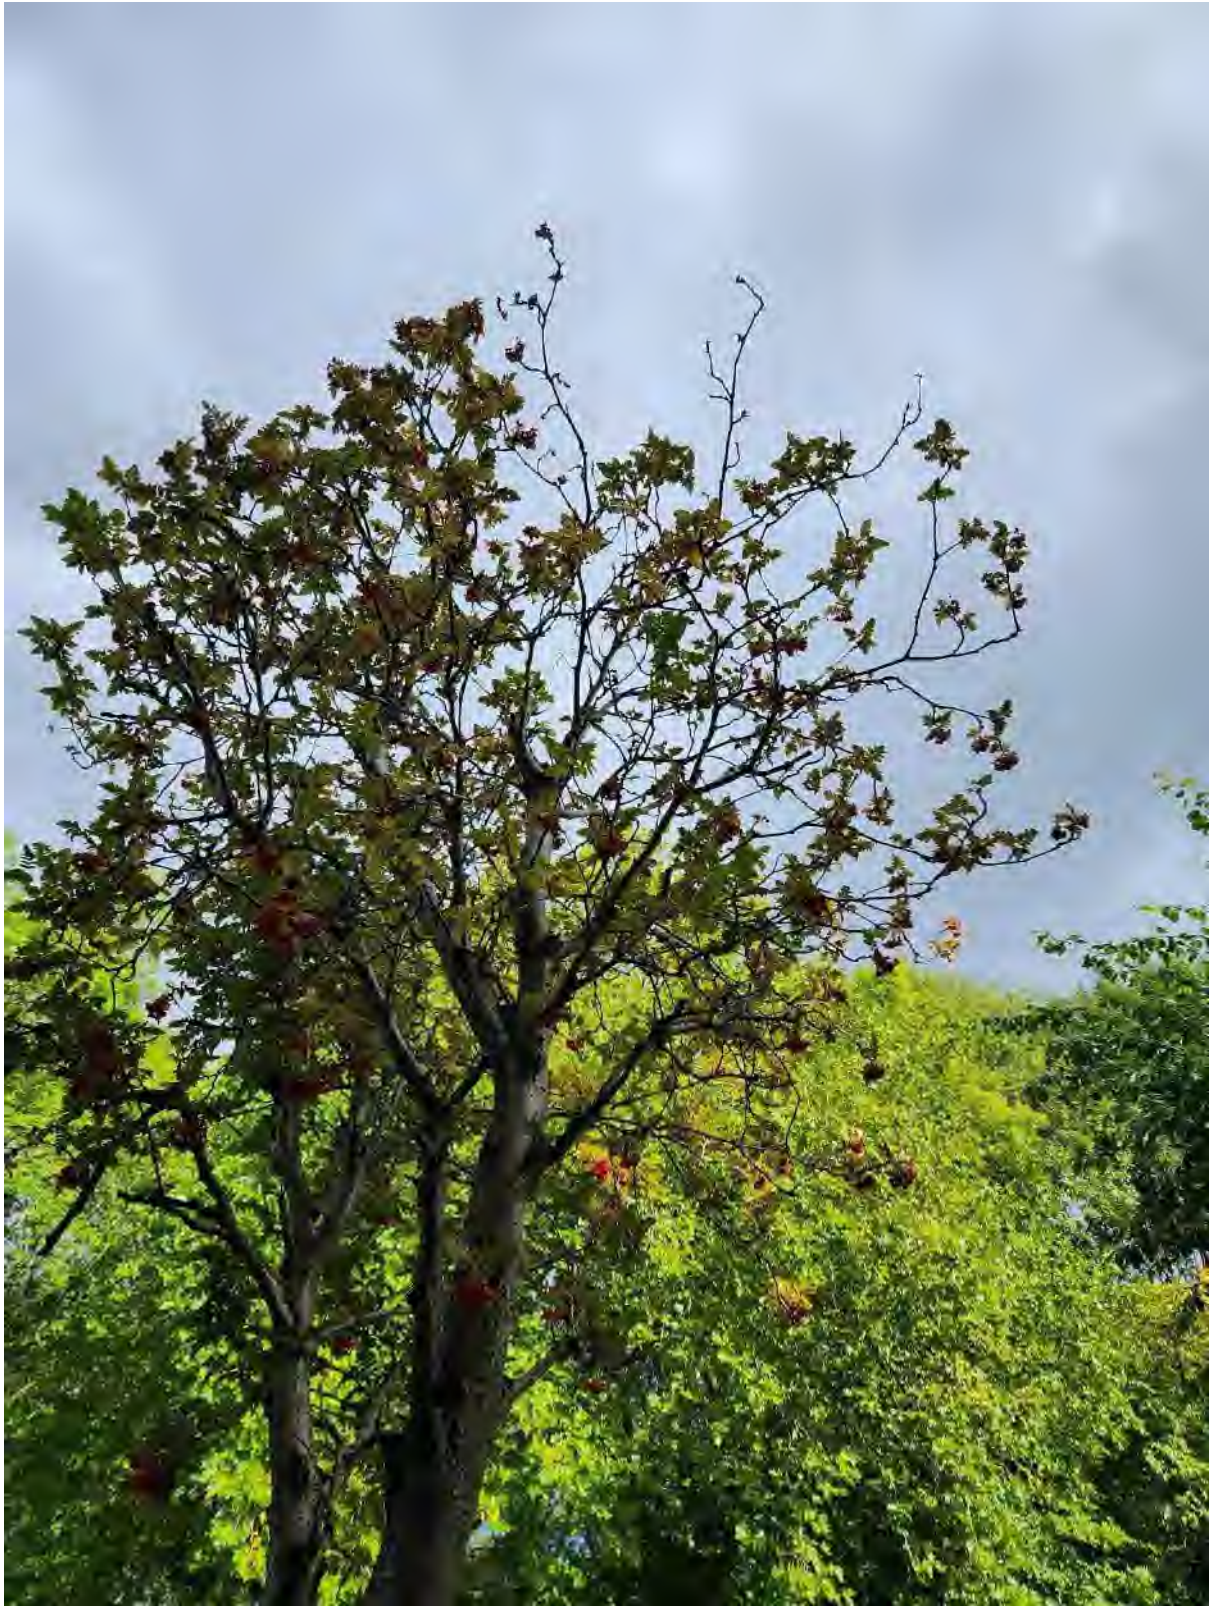
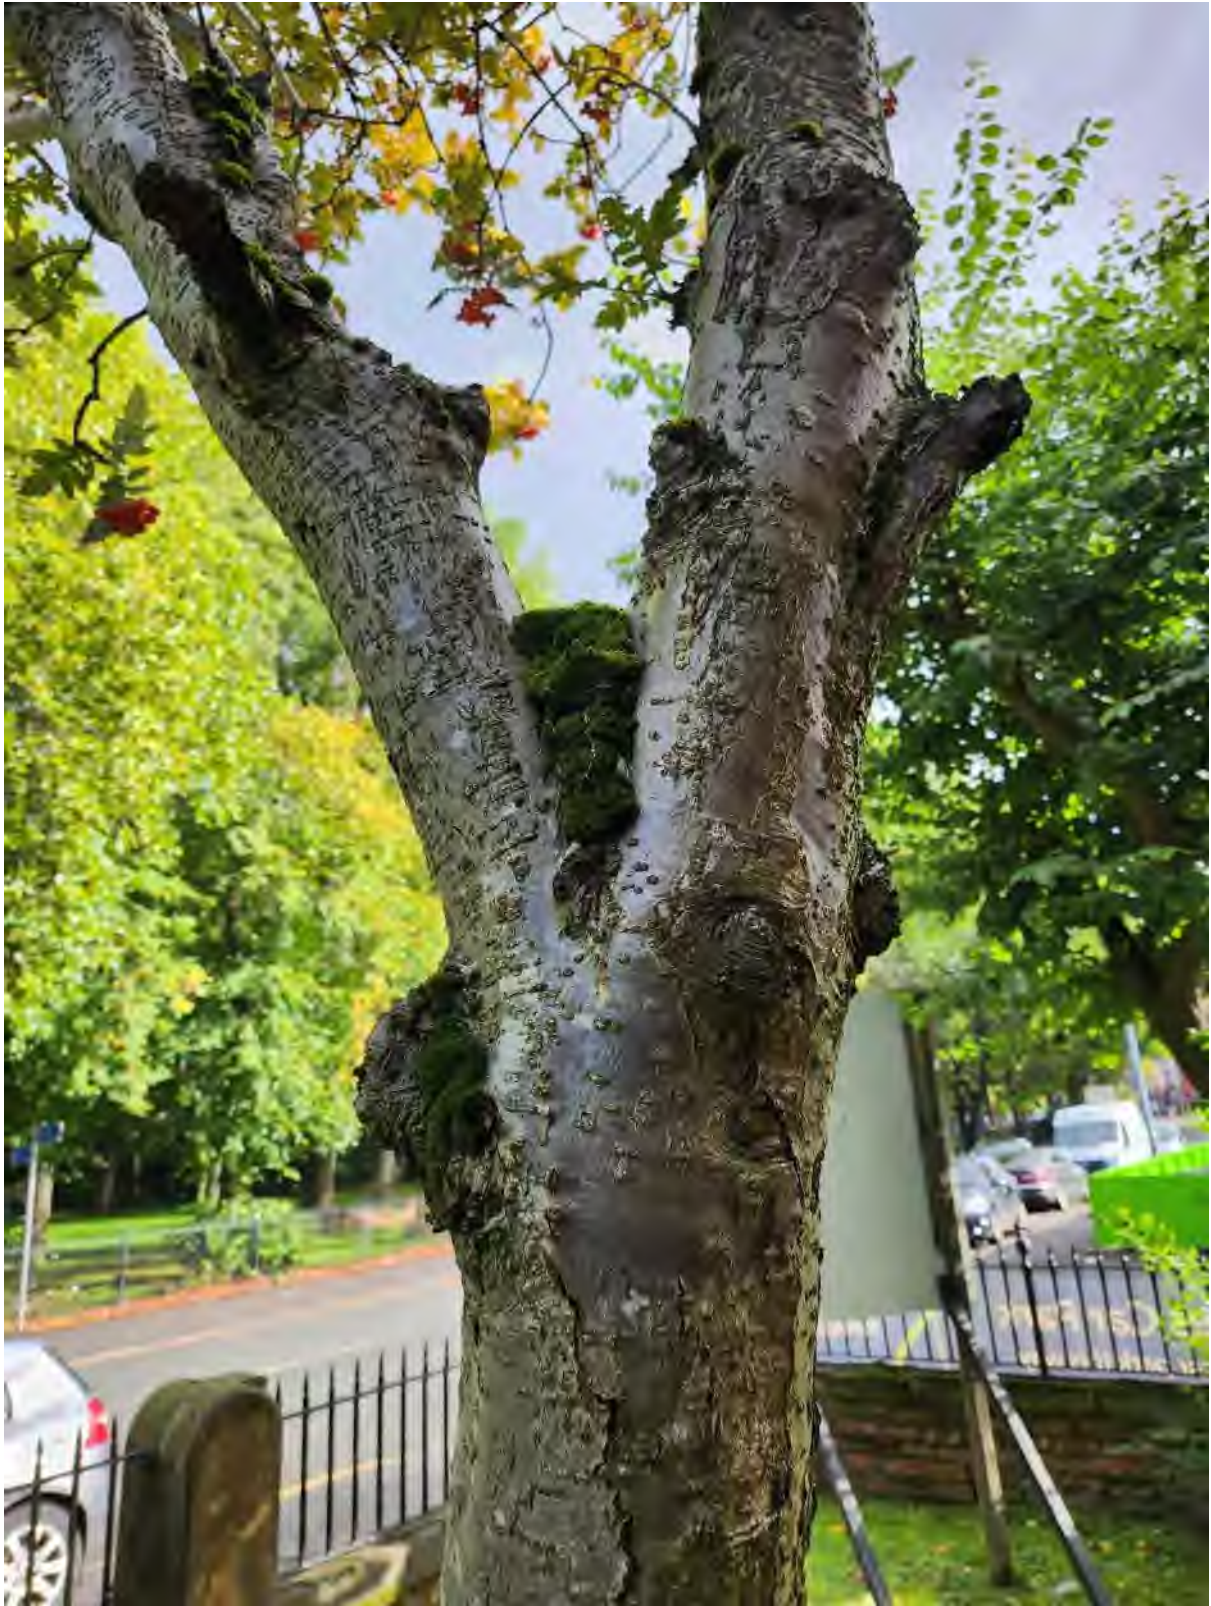
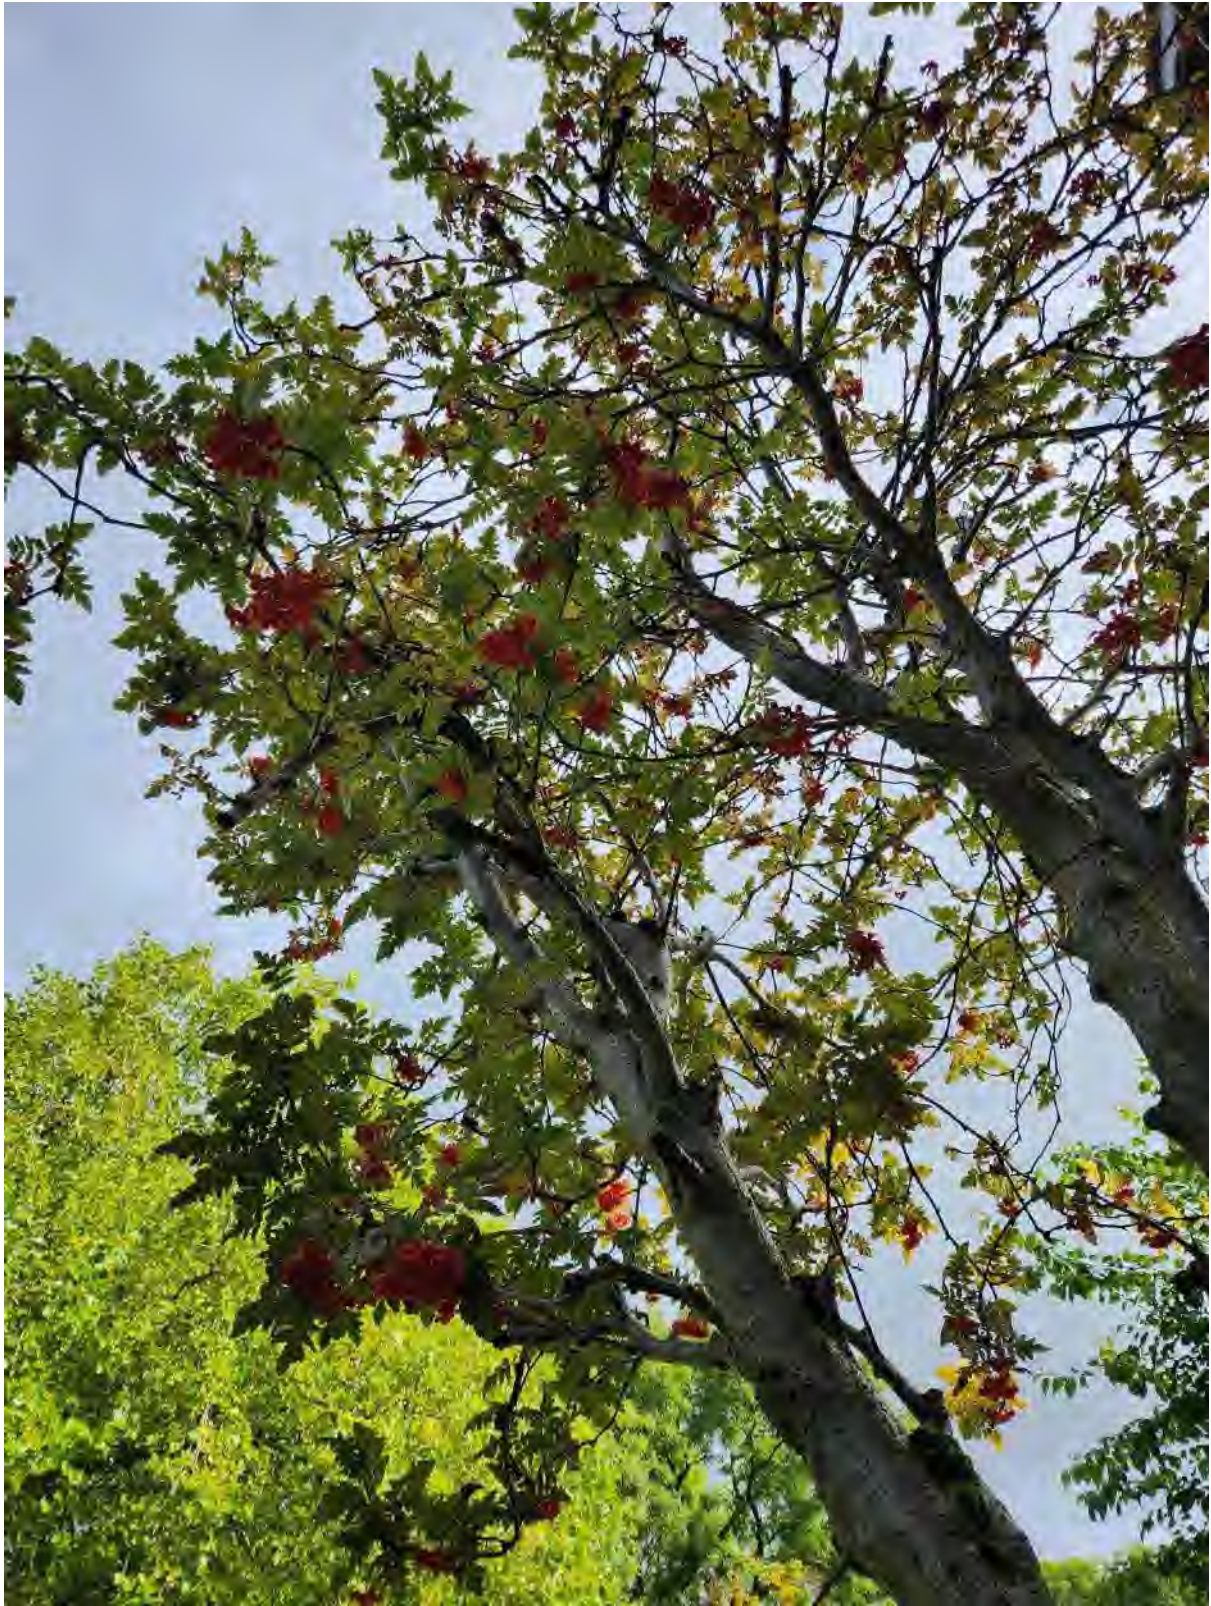
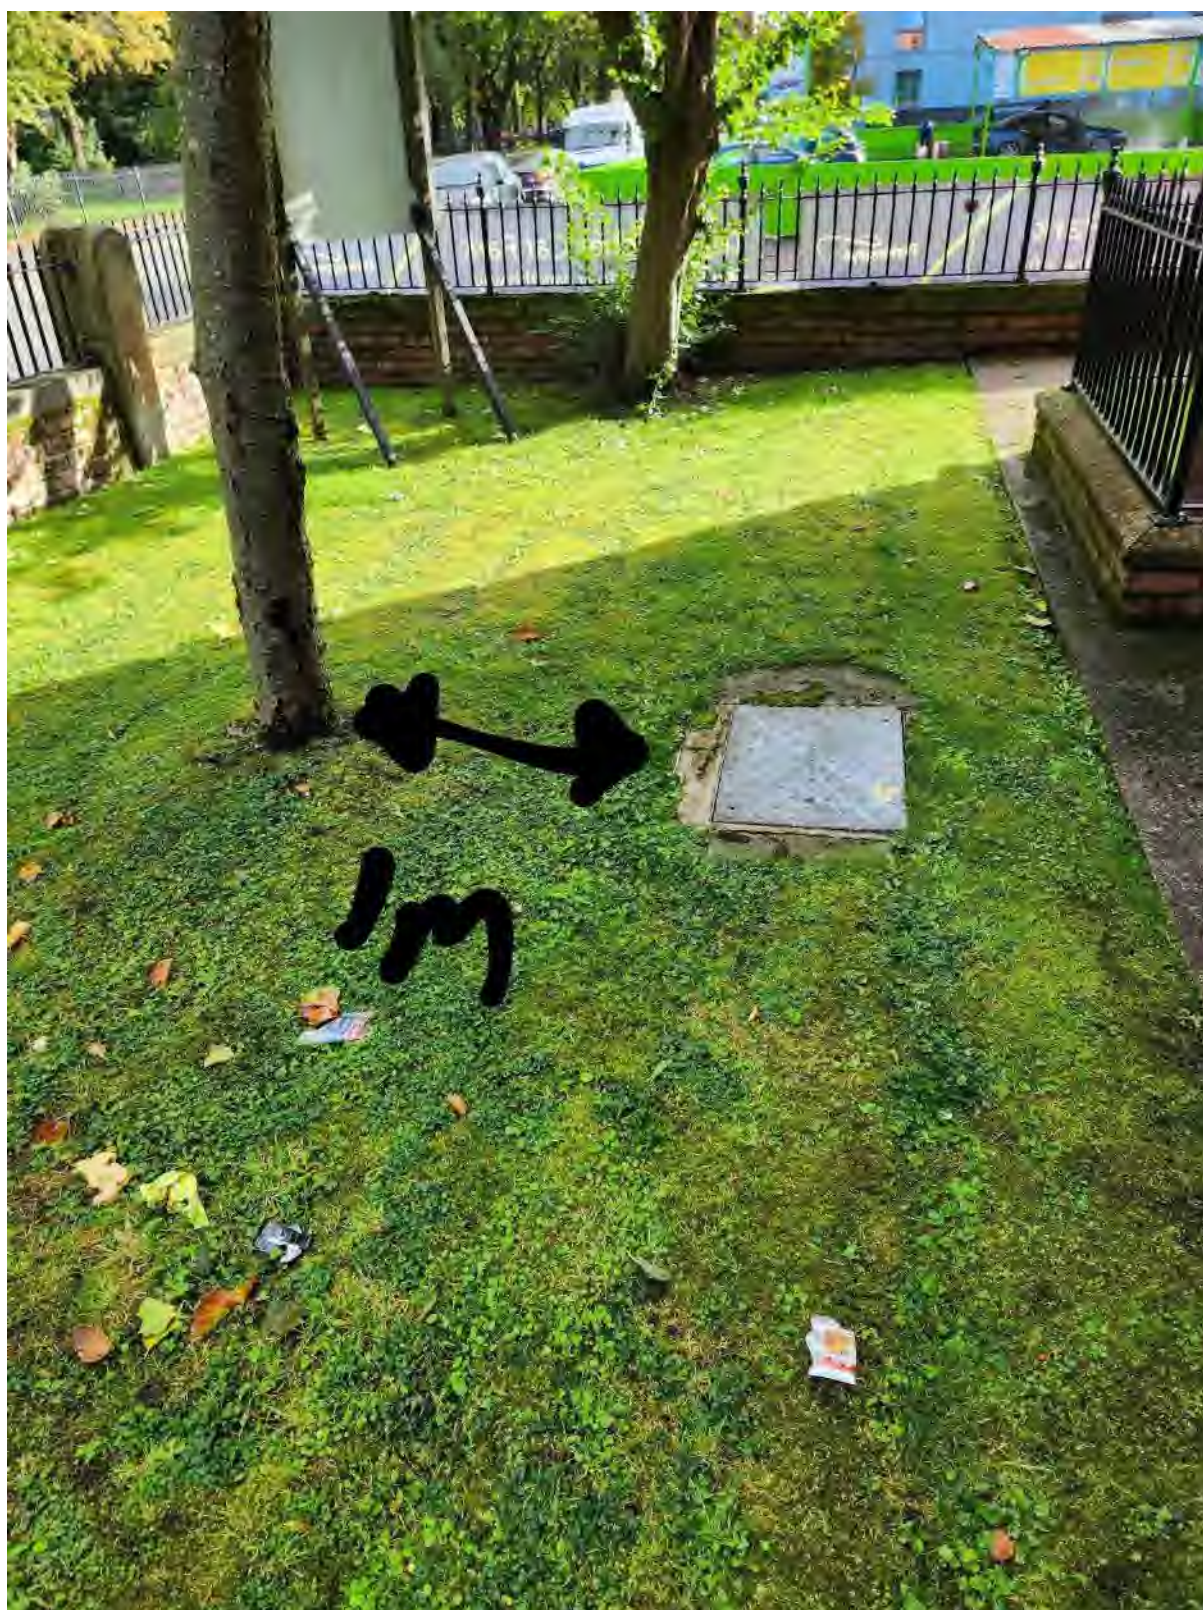
| <p>Condition survey:</p> <ul style="list-style-type: none"> <li>-scaring on main stem to 2m</li> <li>-Change in resonance when hit with resi hammer from ground level to 2m.</li> <li>-Peeling bark at ground level to 2m (S) on the stem. Exposed timber is discolored</li> <li>-Die back on tips at 5m on the (SE)</li> <li>-Dead wood throughout the crown moderate. 20% coverage</li> <li>-Moss and lichen growth on key growth points i.e. unions and branch bark collars</li> <li>-All tops have previously been worked on. Epicormic growth from cut points. Cuts showing no signs of sealing</li> </ul> | | | |
| <p>Offsite notes-</p> <p>Tree is showing signs of stress with epicormic growth. The exposed cuts are discoloring and showing signs of decline. The previous works suggest pollarding in the past. The previous works goes against BS:3998 recommendations. This tree will suffer ill effects during and after construction. As it is not a good specimen and not a notable tree, recommendation, are to remove and replace with better specimen choices</p> | | | |
| QTRA Rating:<br><br>Whole tree failure<br>1/3k | Physiological<br>condition: Poor | Structural condition:<br>Poor | BS:5837 category:<br>U |

| <p>Monitor frequency:</p> <p>Fell and remove within 6 months</p> | | | |

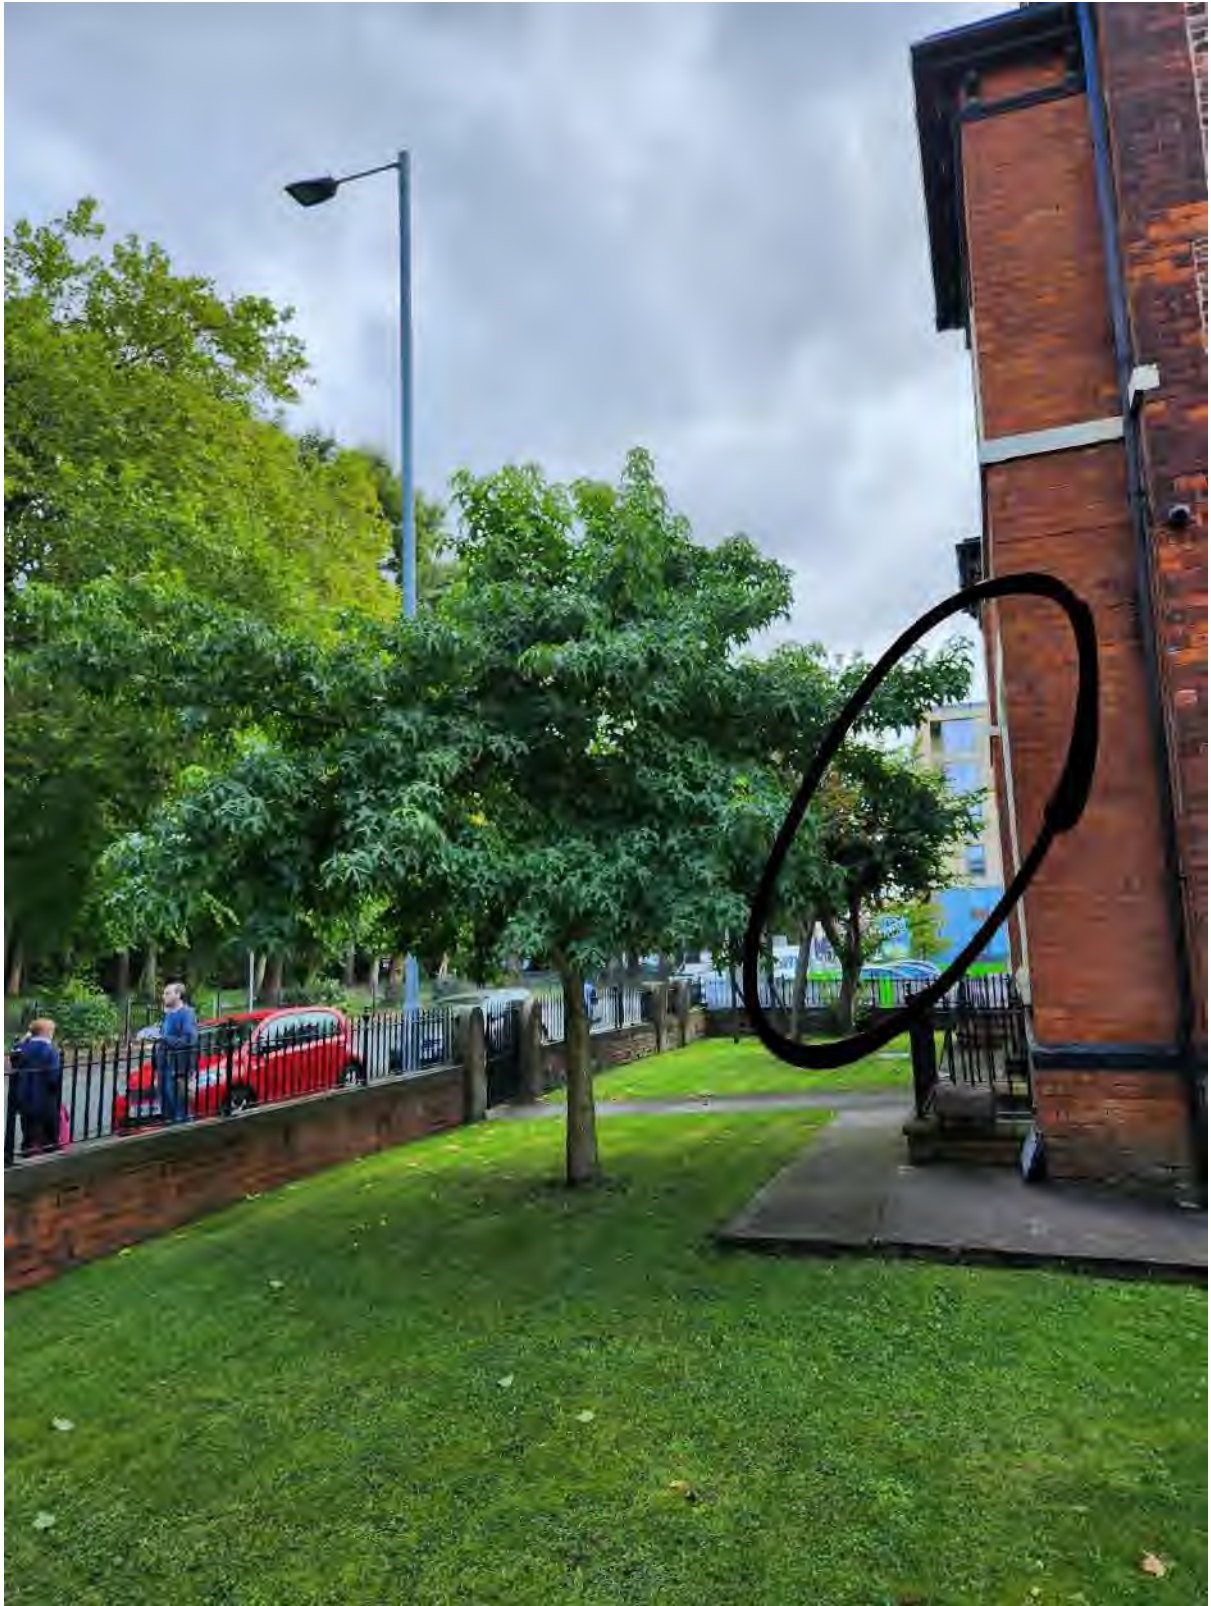
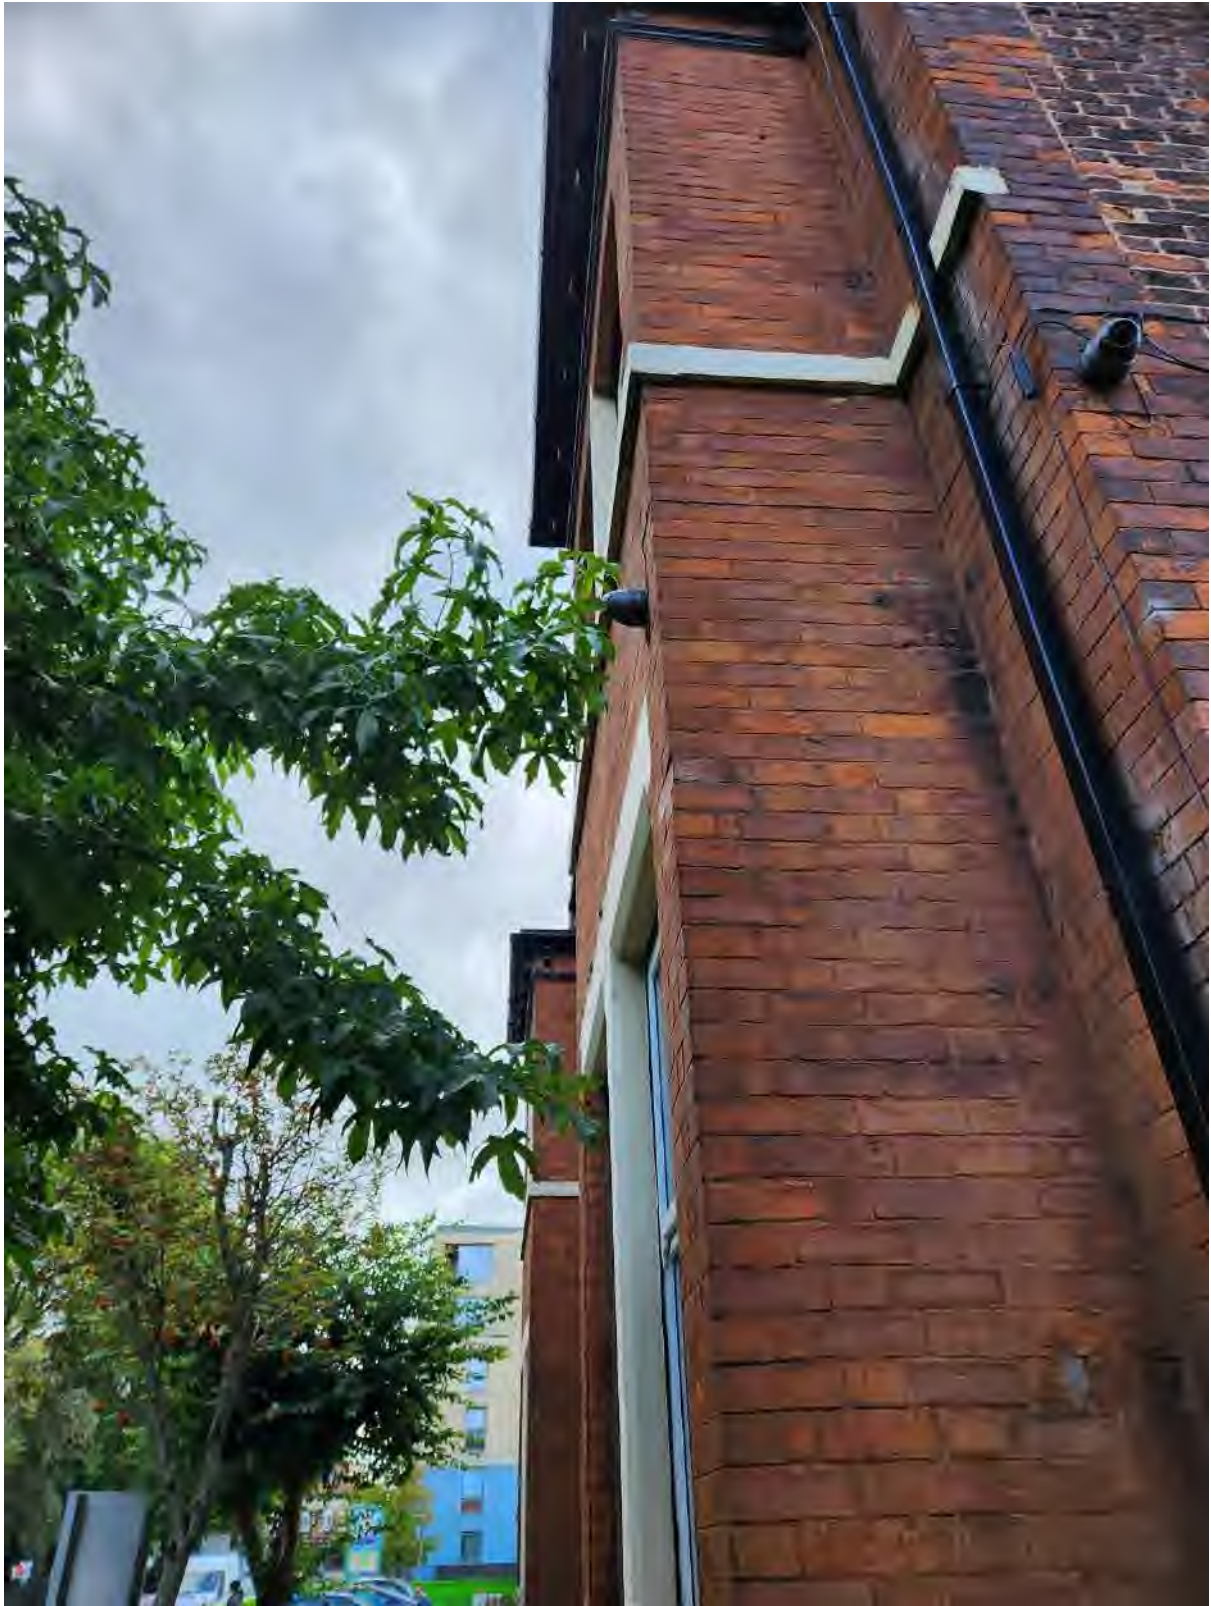
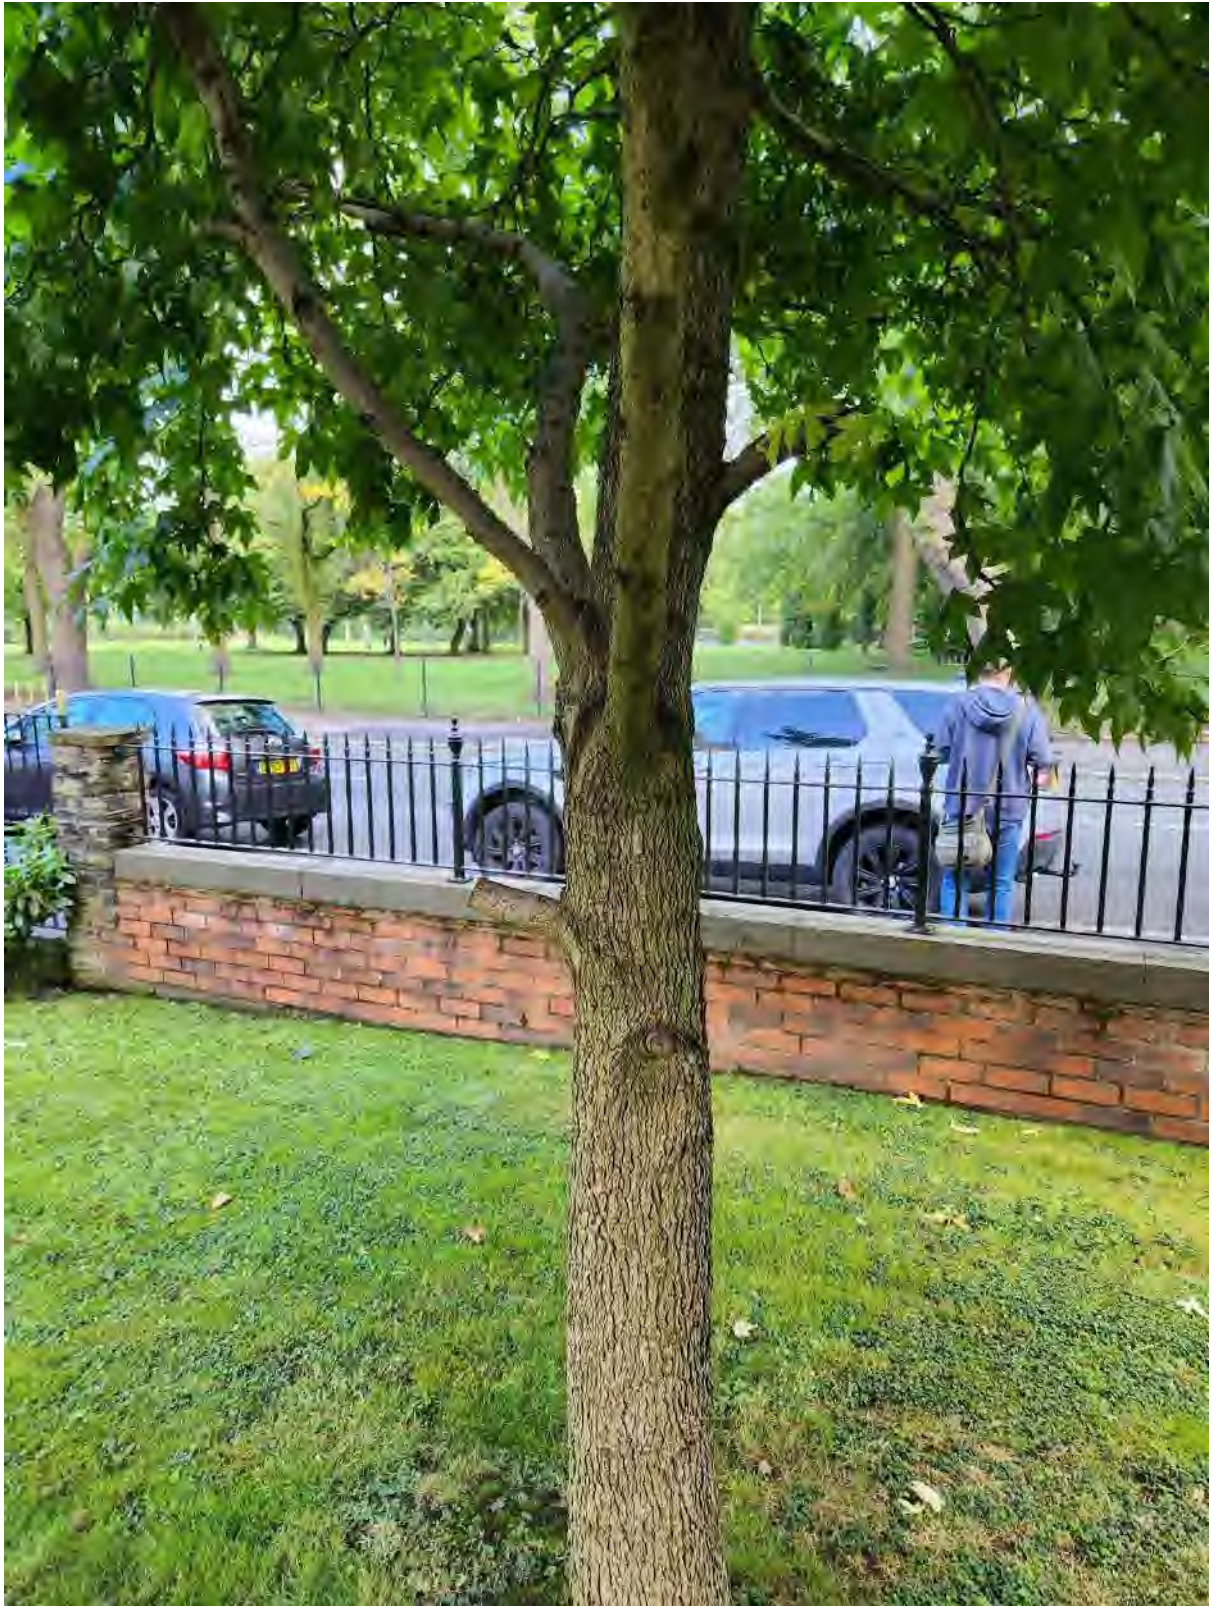
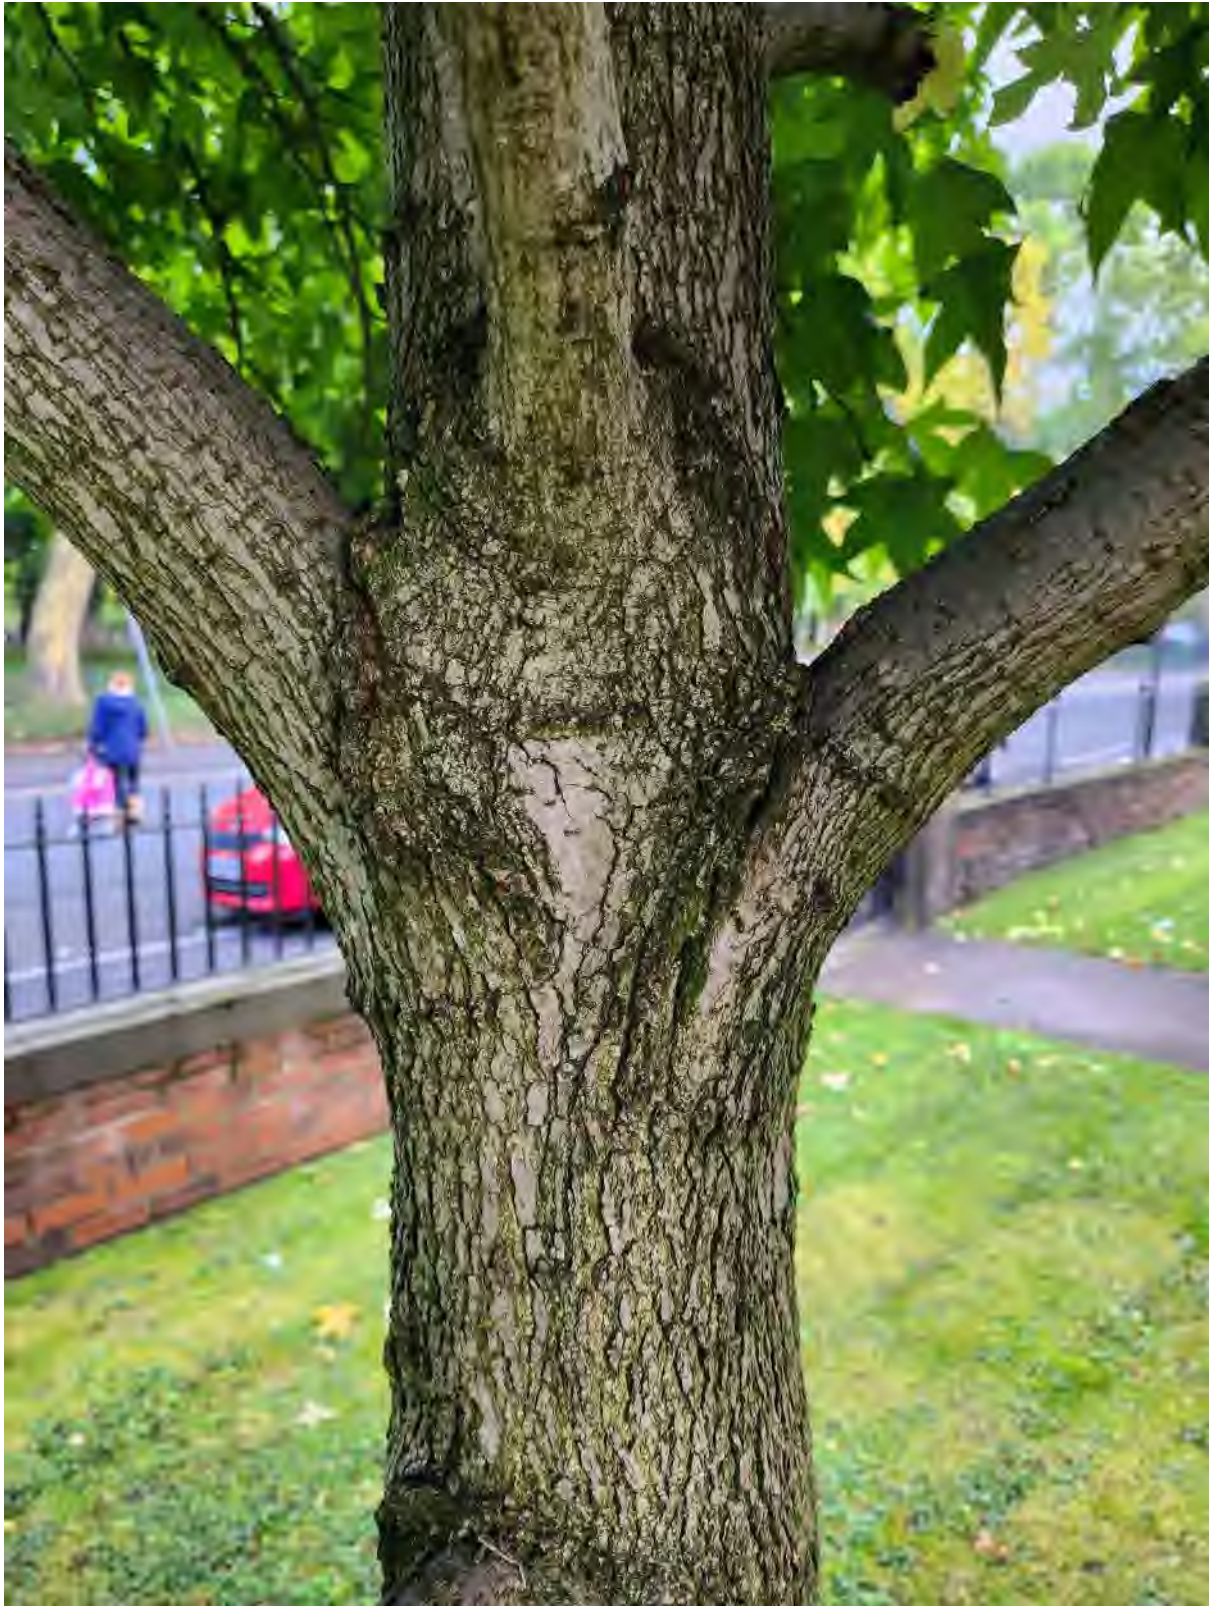
| Tree number:<br>T3 | Botanical name:<br><i>Liquidambar<br/>styraciflua</i> | Height (m): 4 | DBH (cm): 17 |

| Condition survey:<br><br>-1x exposed root (S) damaged.<br><br>-3x stubs on the stem (S) (W) (E) at 1-2m 30cm in length<br><br>-1 <sup>st</sup> 2 opposite limbs at 1.5m (NW) (SE) are included<br><br>-No change in resonance throughout the stem<br><br>-(S) crown 0.2m from building | | | |
| Offsite notes-<br><br>Tress is to be retained throughout the construction process. Tree needs RPA of 1.02m and a reduction on the south side to prevent any damages during the demolition process | | | |
| QTRA Rating:<br><br>Whole tree failure<br>1/1mil+ | Physiological<br>condition: Good | Structural condition:<br>Good | BS:5837 category:<br>B1 |

| Works required and time scales:<br><br>Reduce the southern canopy by 1.5m to reduce likelihood of damaged caused by falling debris from demolition process. Prior to start of work | | | |
