# ARBORICULTURAL IMPACT ASSESSMENT AND TREE SURVEY

466-472 Moss Lane East, Manchester.  
M14 4PJ.

Steven Calderbank BSc (Hons)

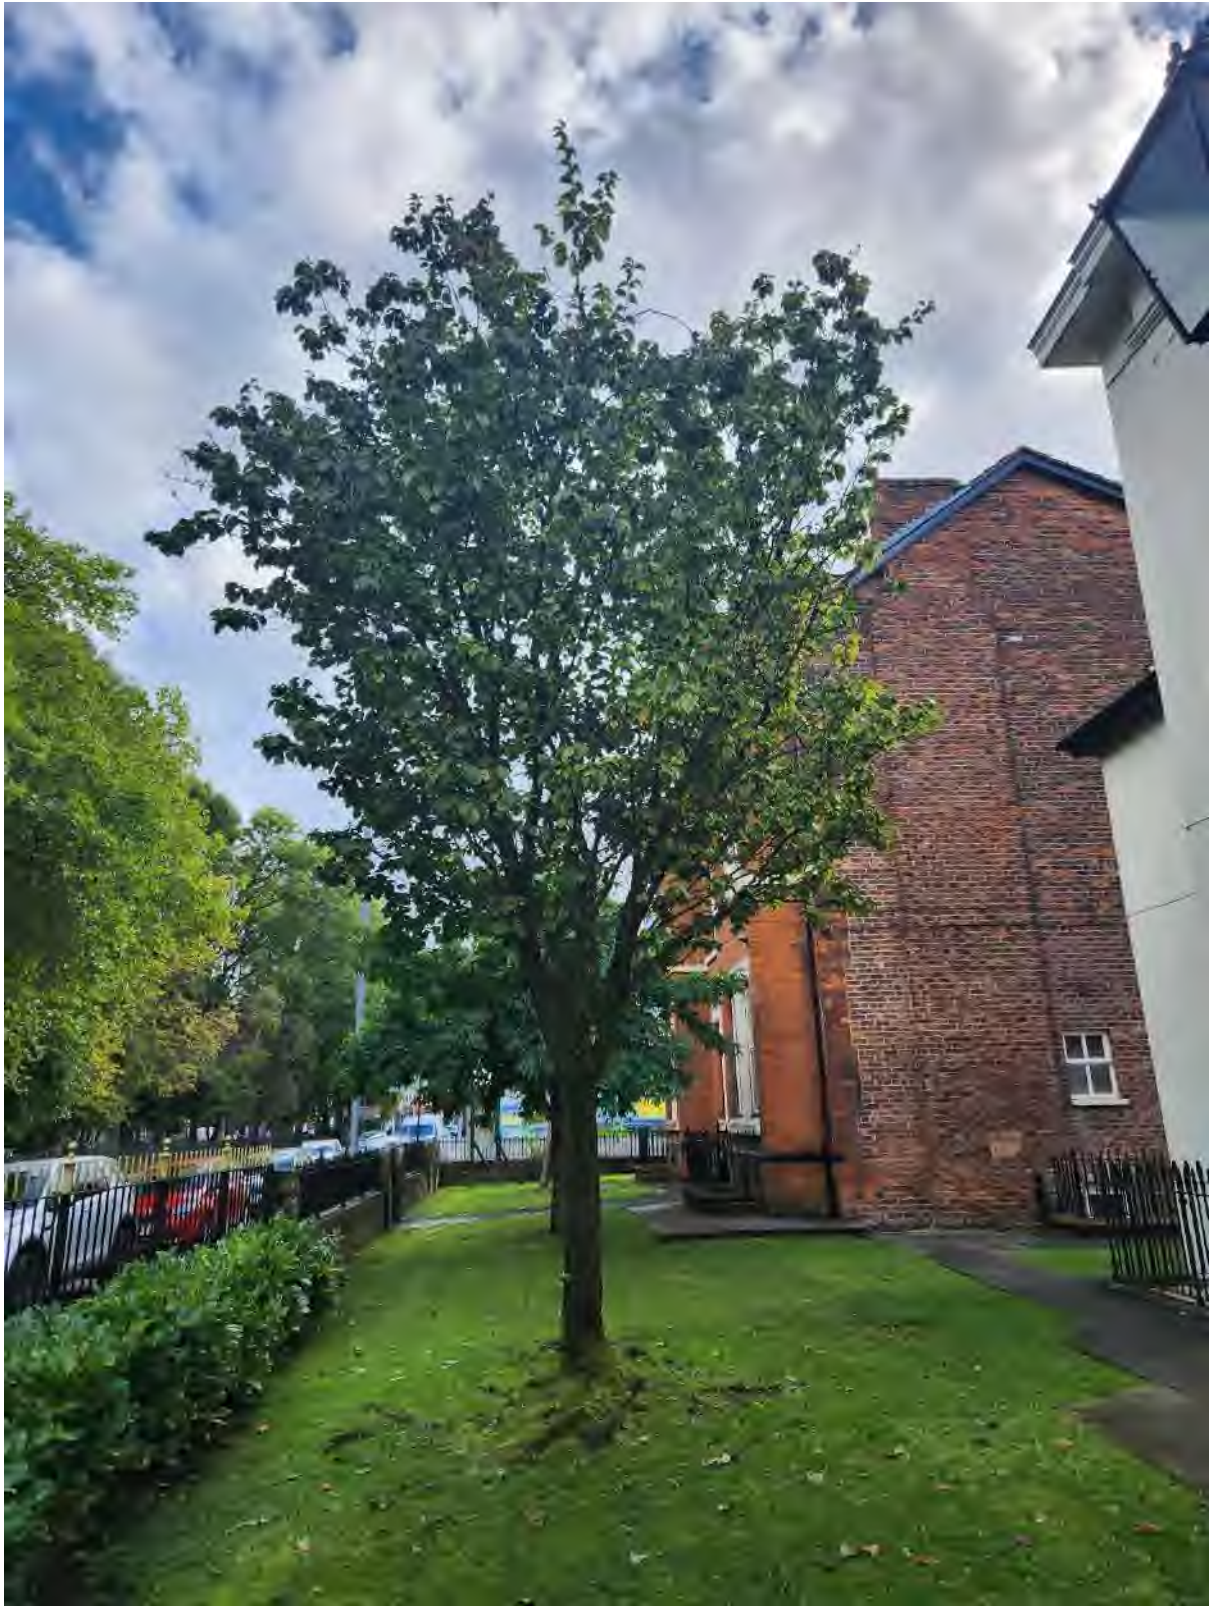
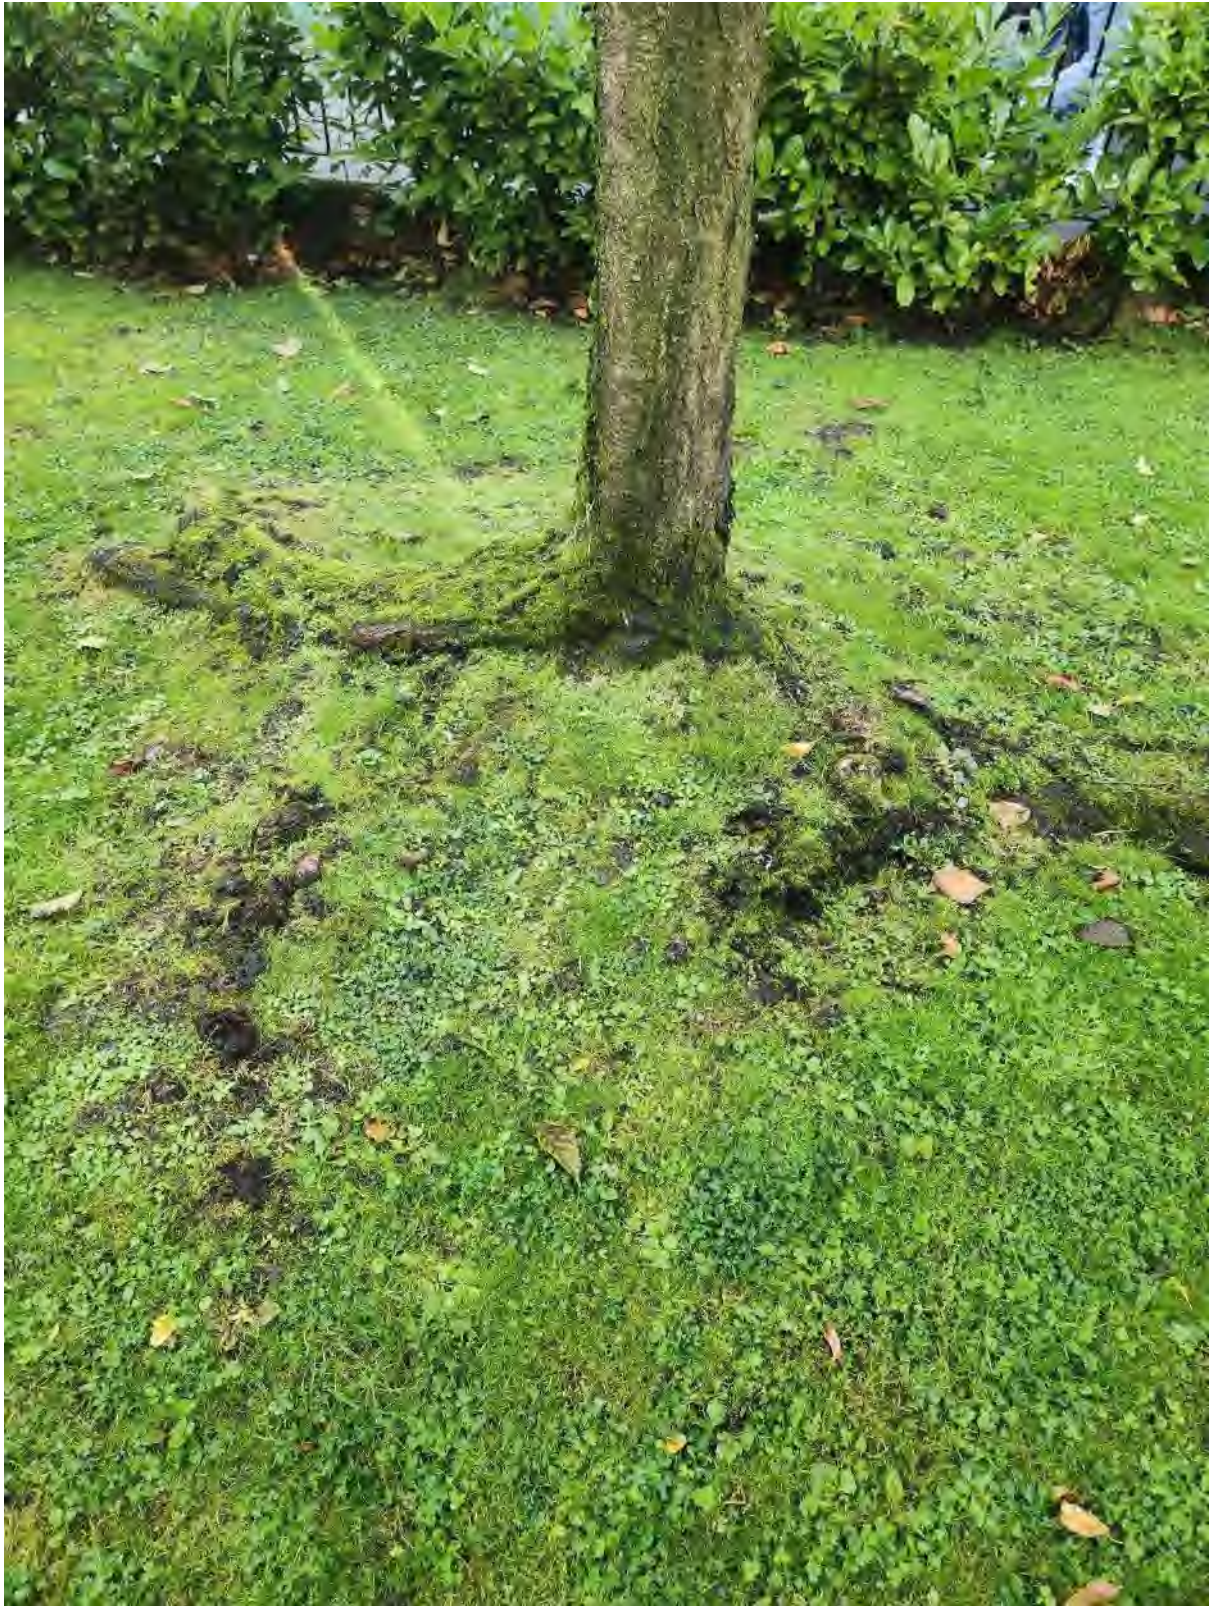
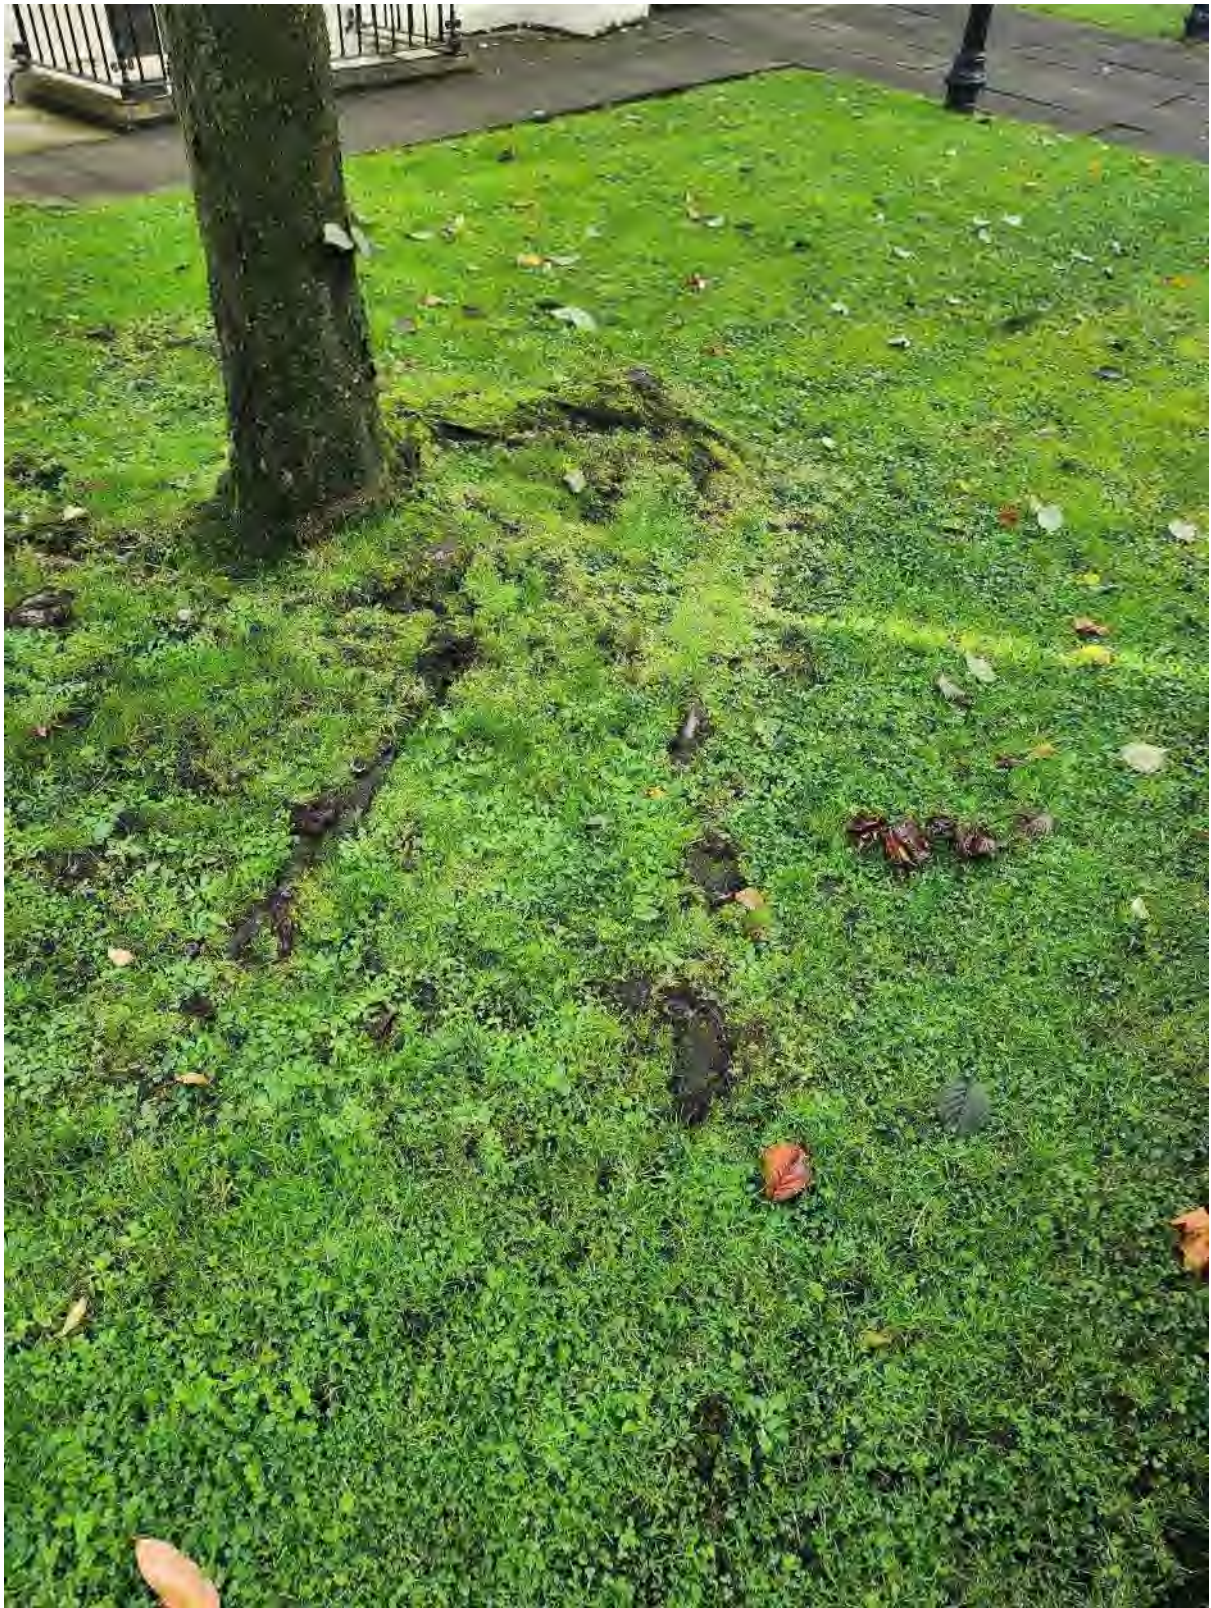
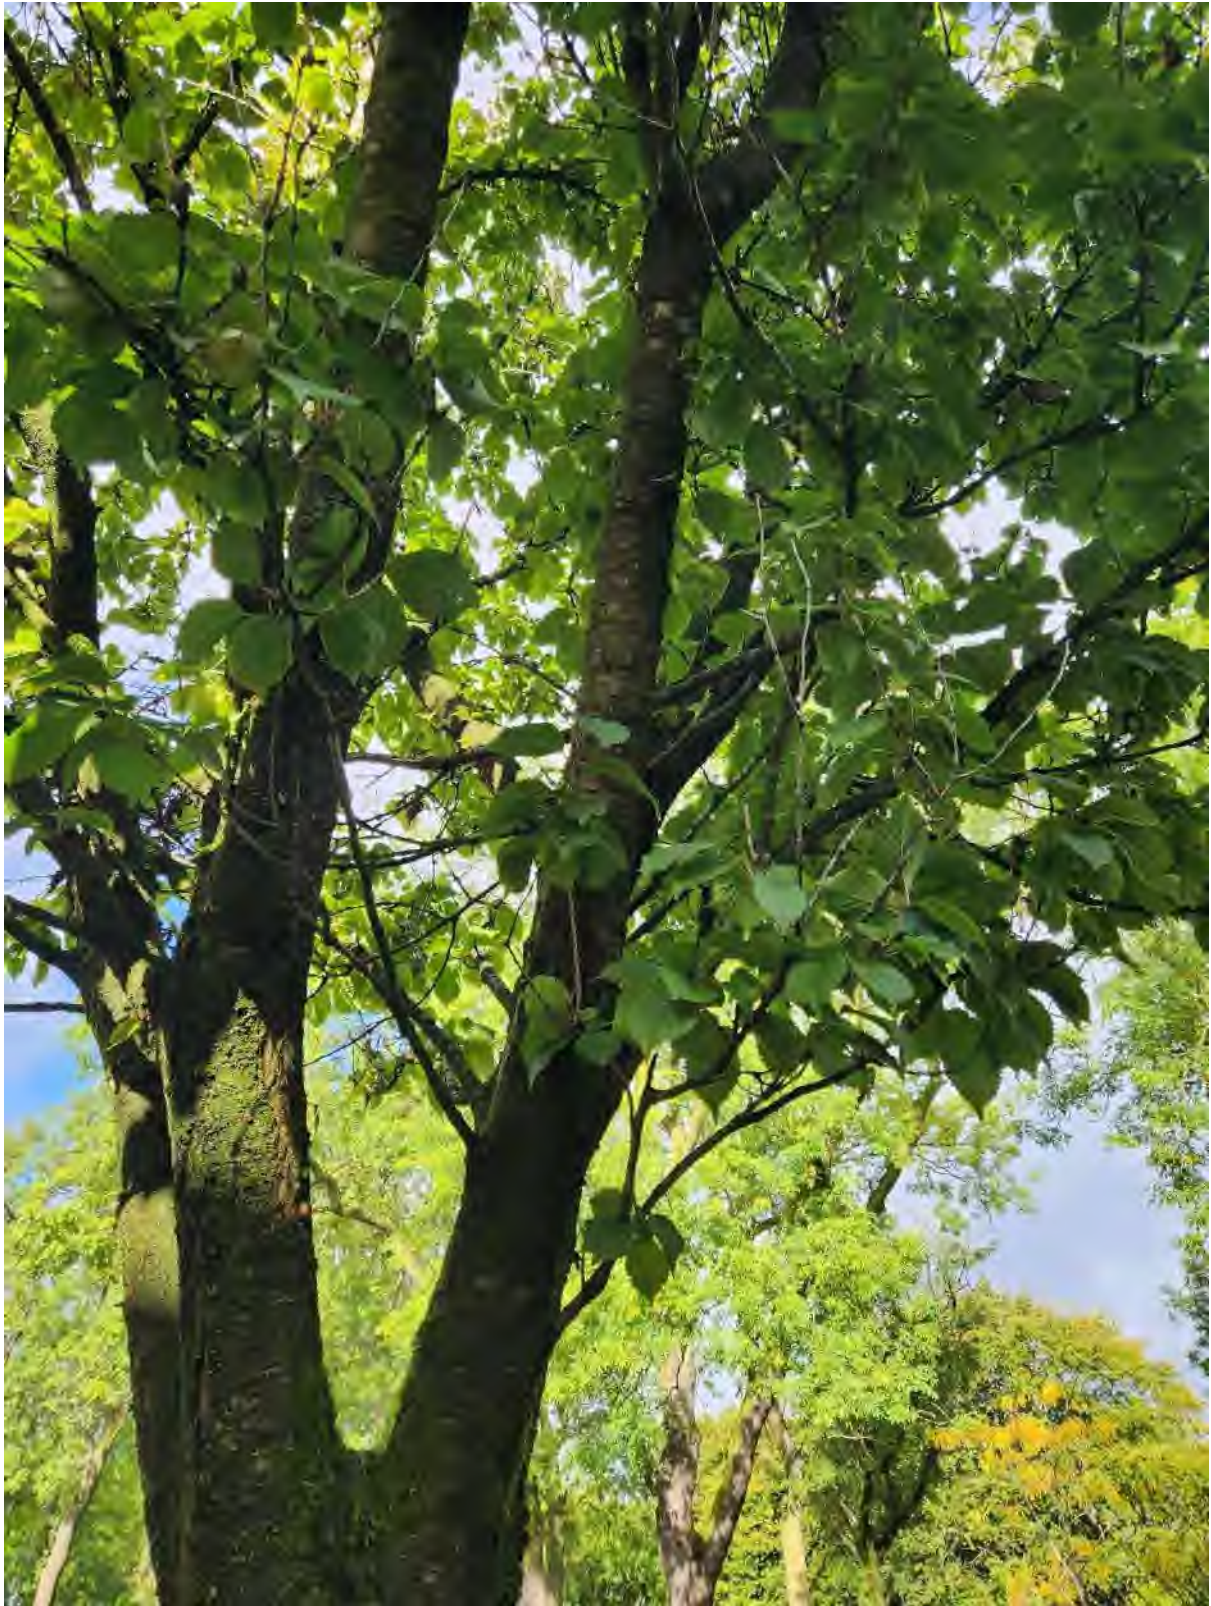
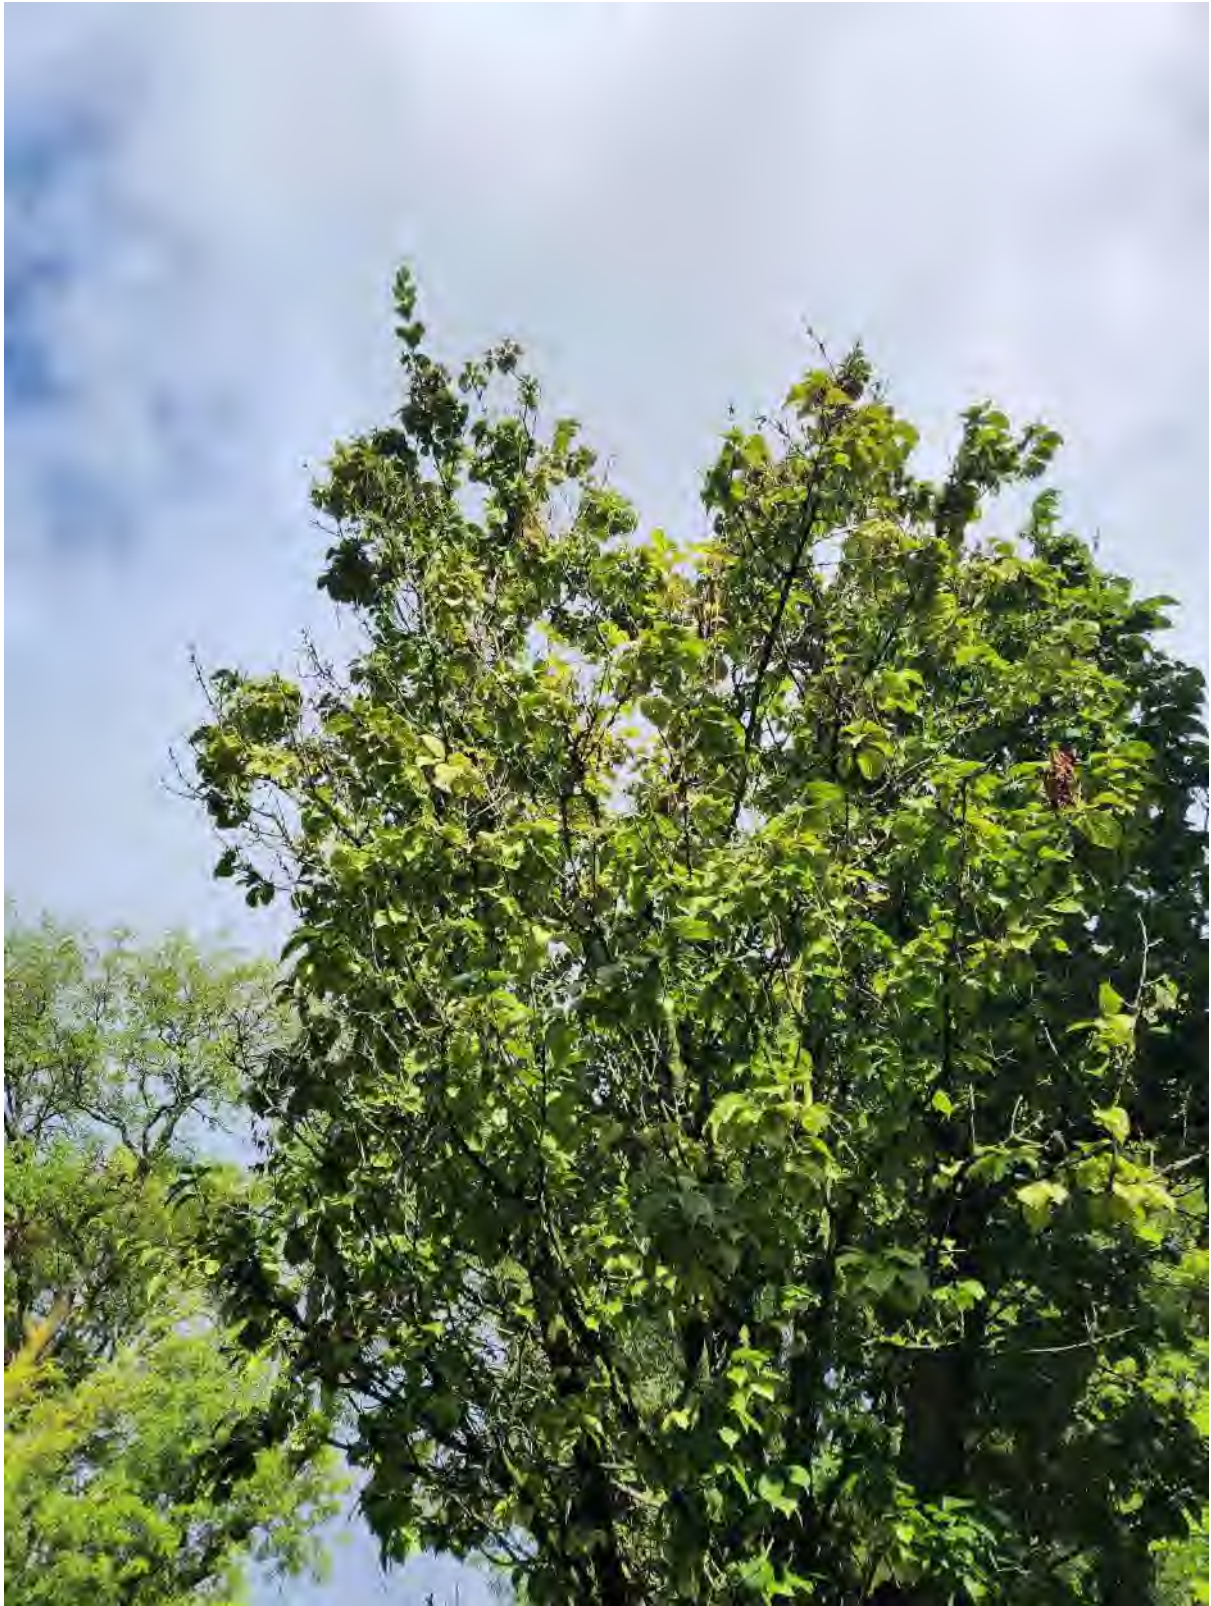
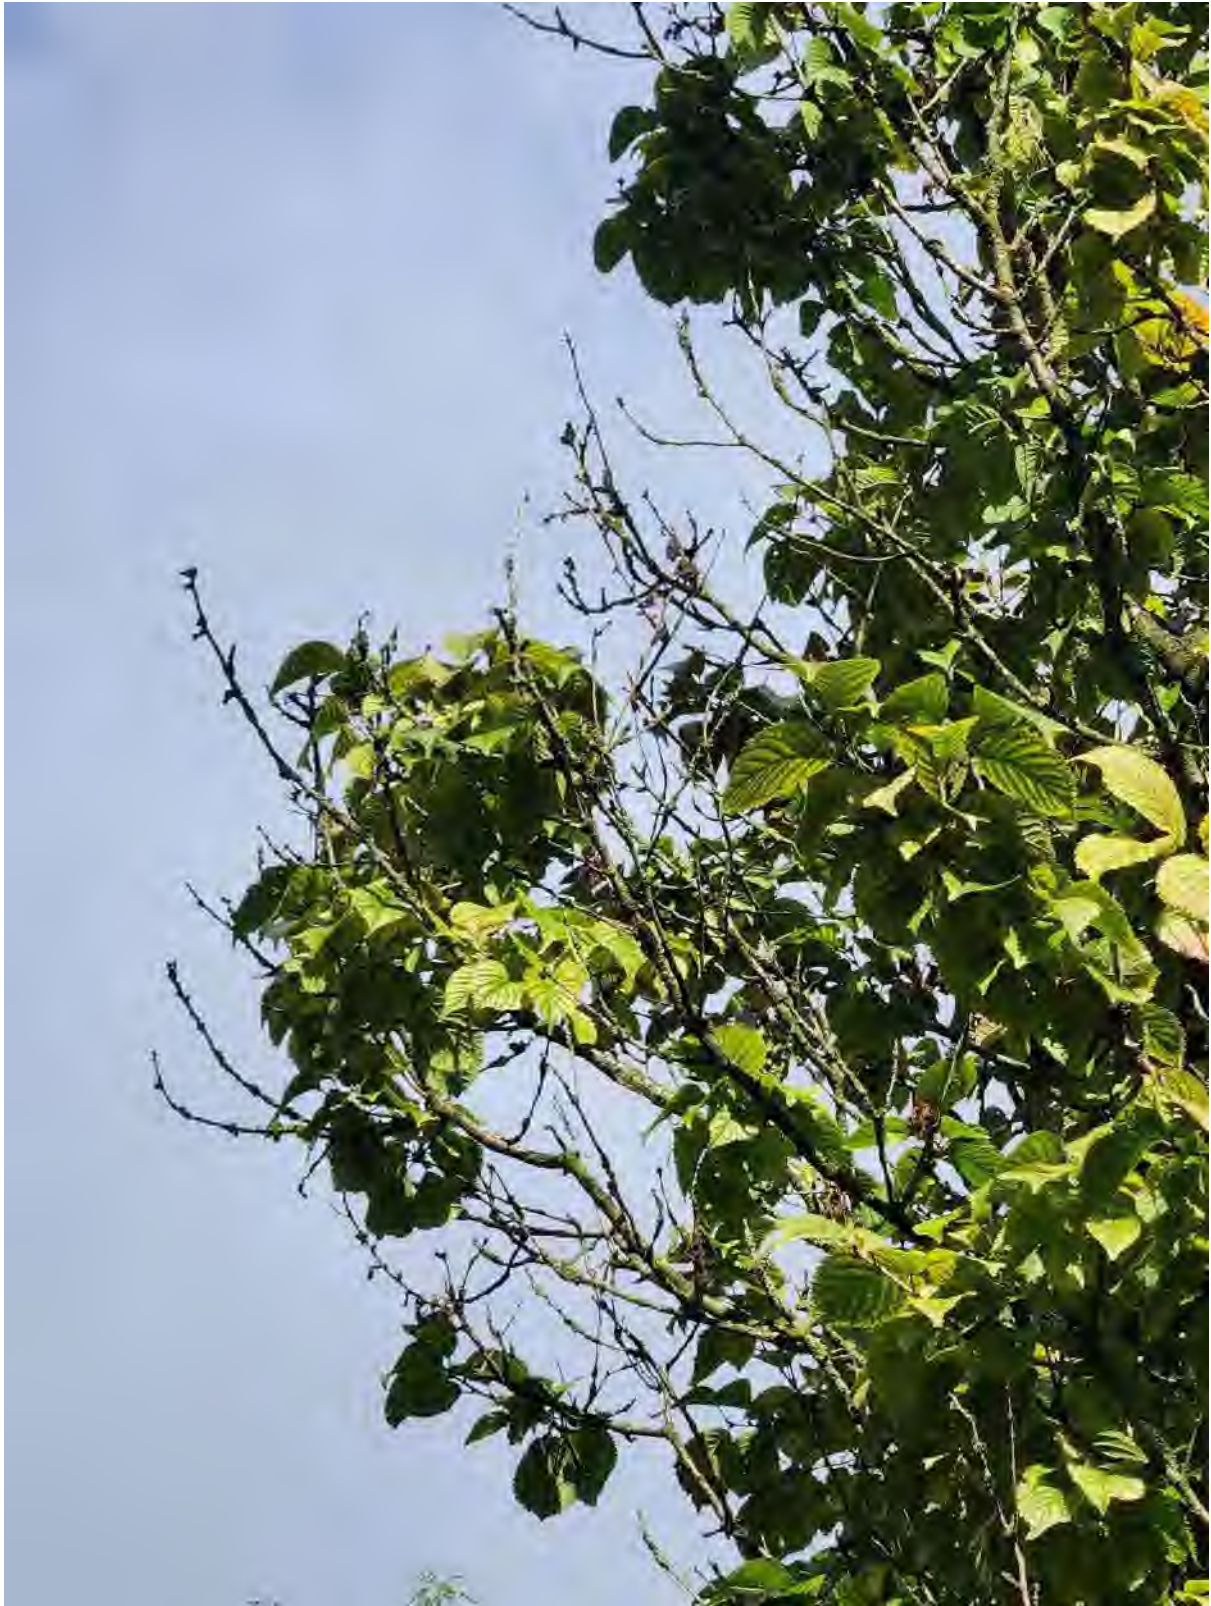
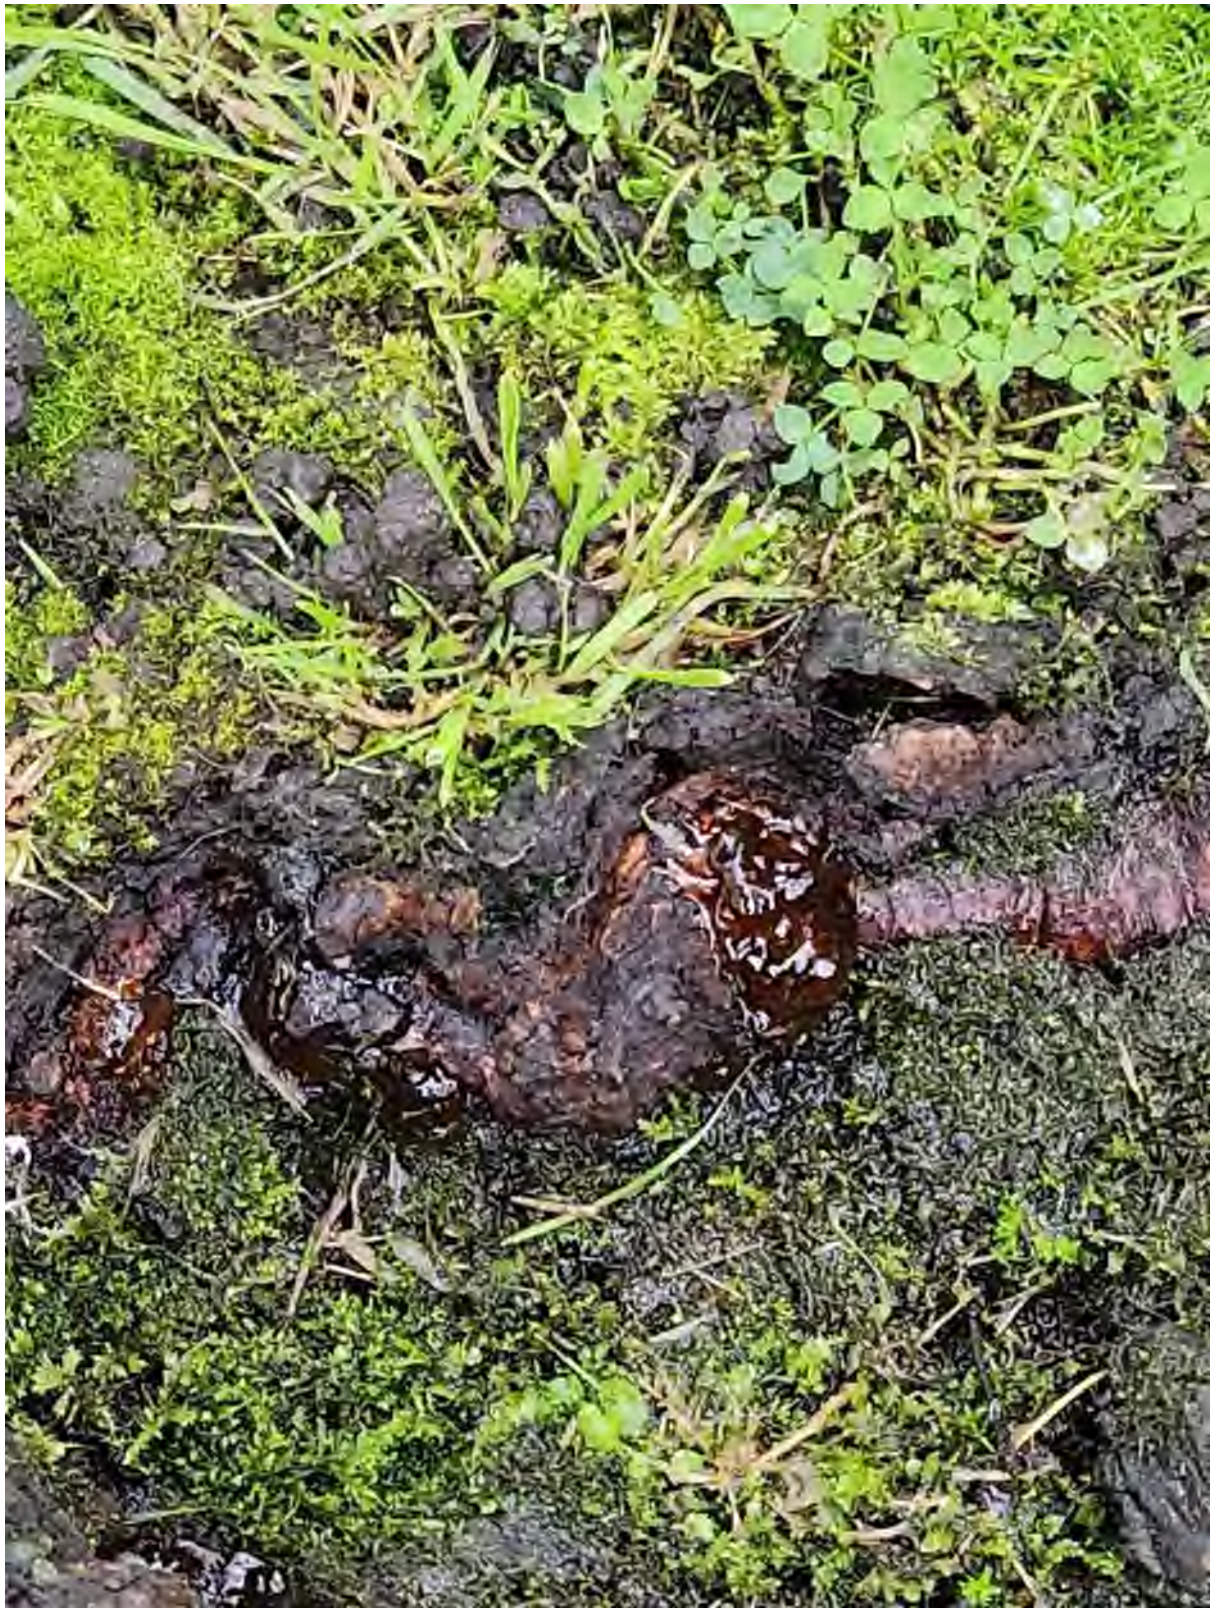
| Condition survey:<br><br>-Exposed roots 360 degrees from the base of the tree to 2m. roots show evidence of damage<br><br>-Evidence of oozing from damaged roots (E) 2m from stem<br><br>-Hanging branches at 3m (S), 2.5m (Central), 5m (N). branches are <50mm in dia and well lodged<br><br>-Die back at the tips throughout the crown 10% | | | | | | | |
| Offsite notes-<br><br>Tress is to be retained throughout the construction process. Tree needs RPA of 1.02m and a reduction on the south side to prevent any damages during the demolition process | | | | | | | |
| QTRA Rating:<br><br>Whole tree failure<br>1/1mill yellow | Physiological<br>condition: poor | Structural condition:<br>fair | BS:5837 category:<br>C1 | | | | |

| Monitor frequency:<br><br>Reinspect every 18months. Monitor for further decline by professional Arboriculturalist | | | | | | | |
