# ARBORICULTURAL IMPACT ASSESSMENT AND TREE SURVEY

466-472 Moss Lane East, Manchester.  
M14 4PJ.

Steven Calderbank BSc (Hons)

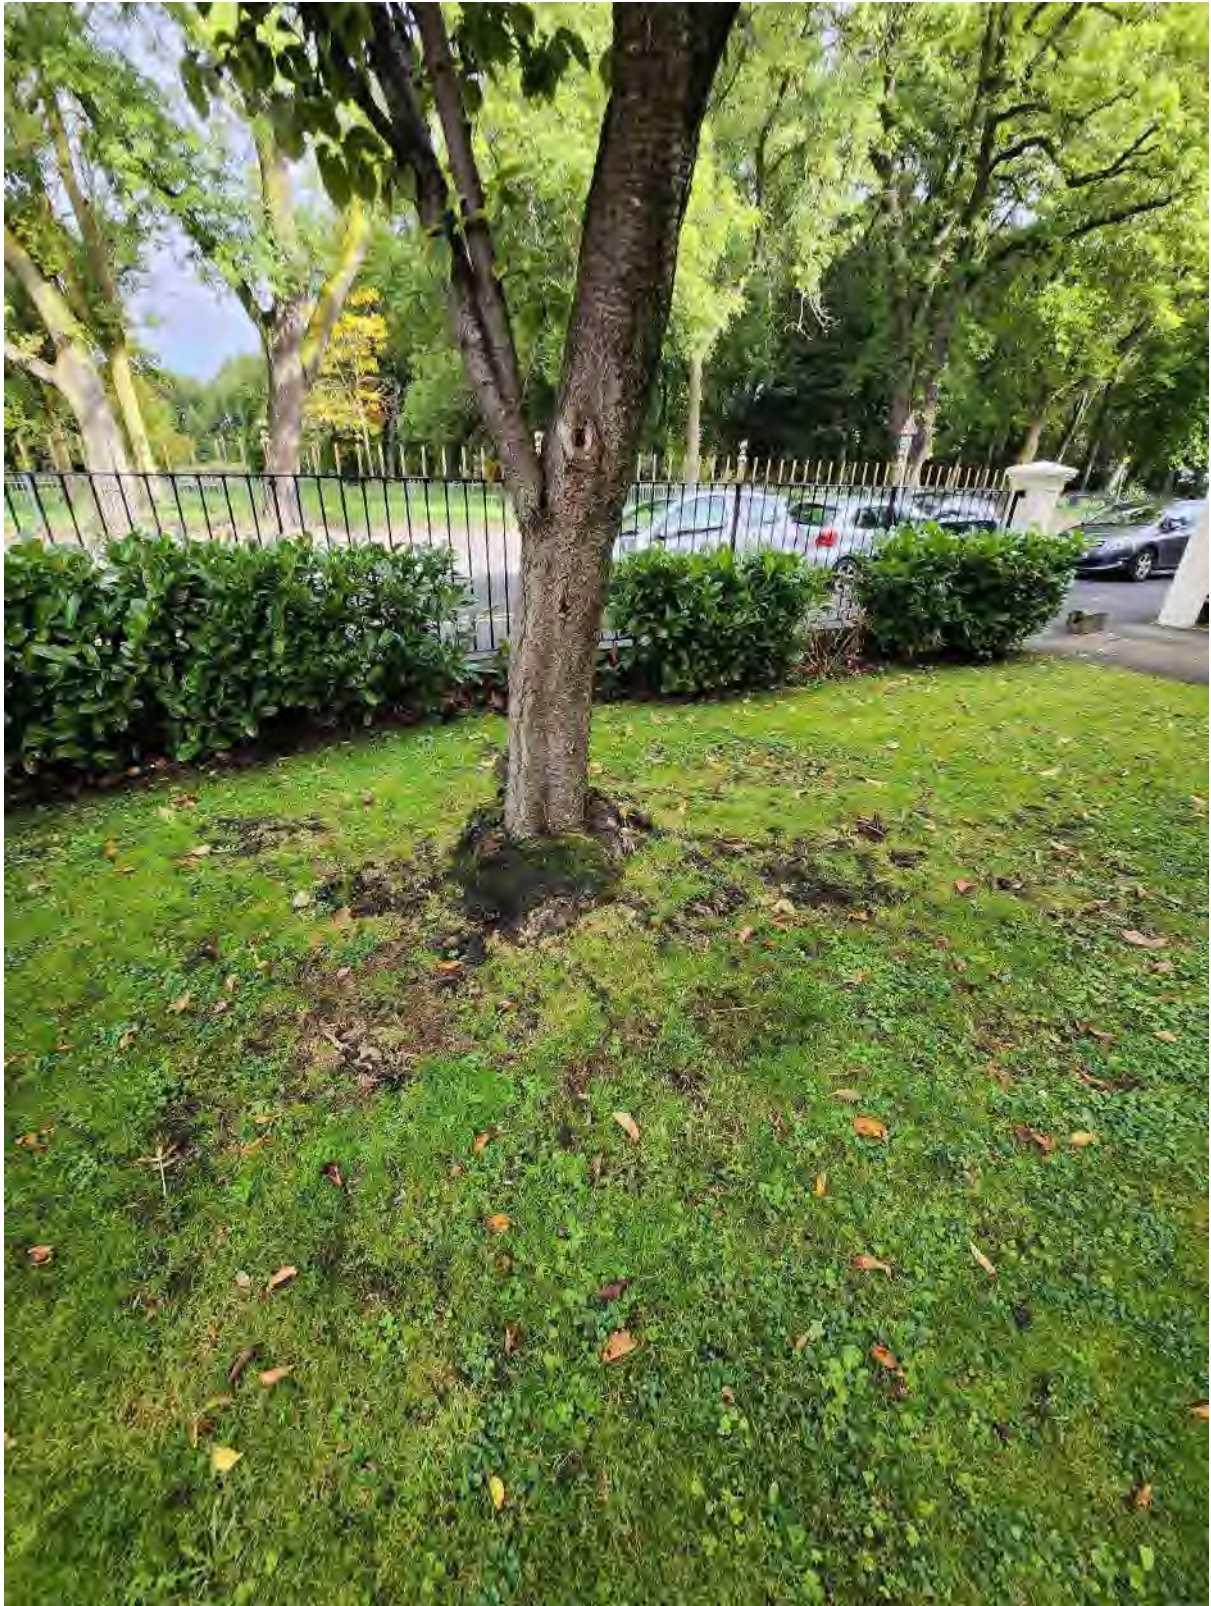
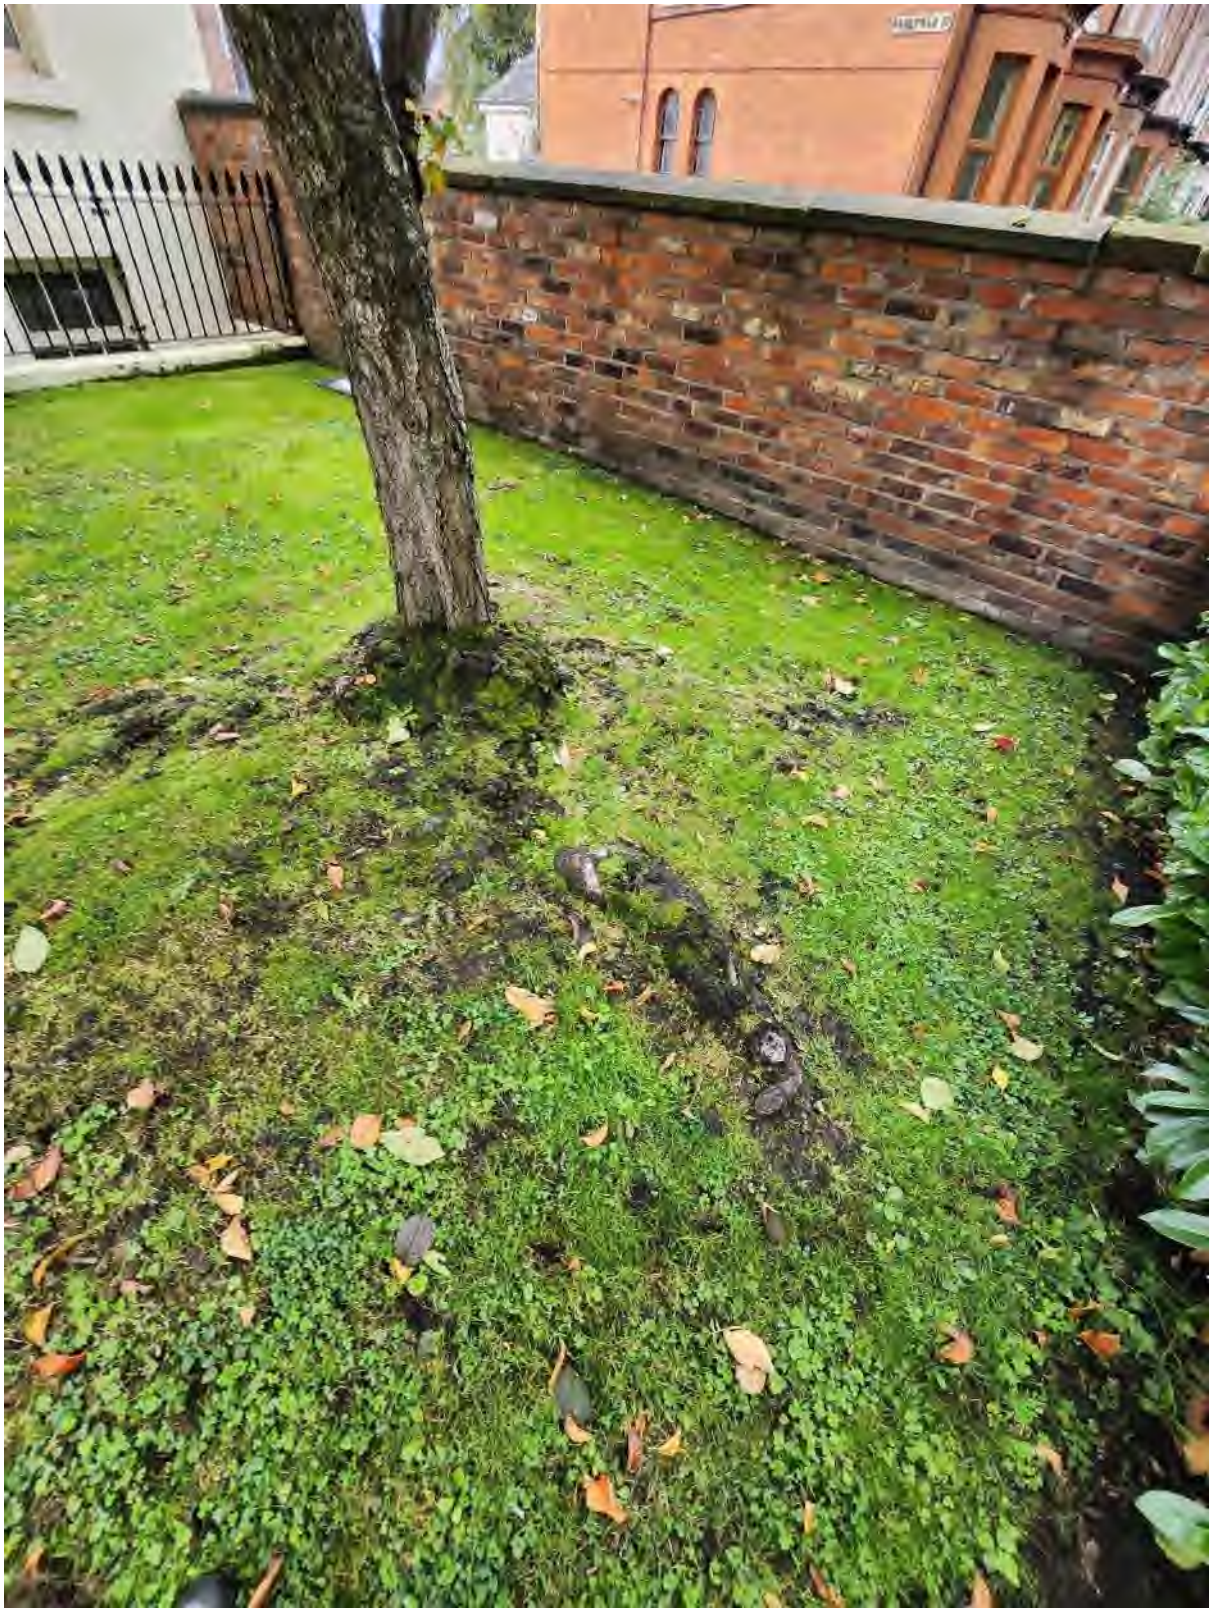
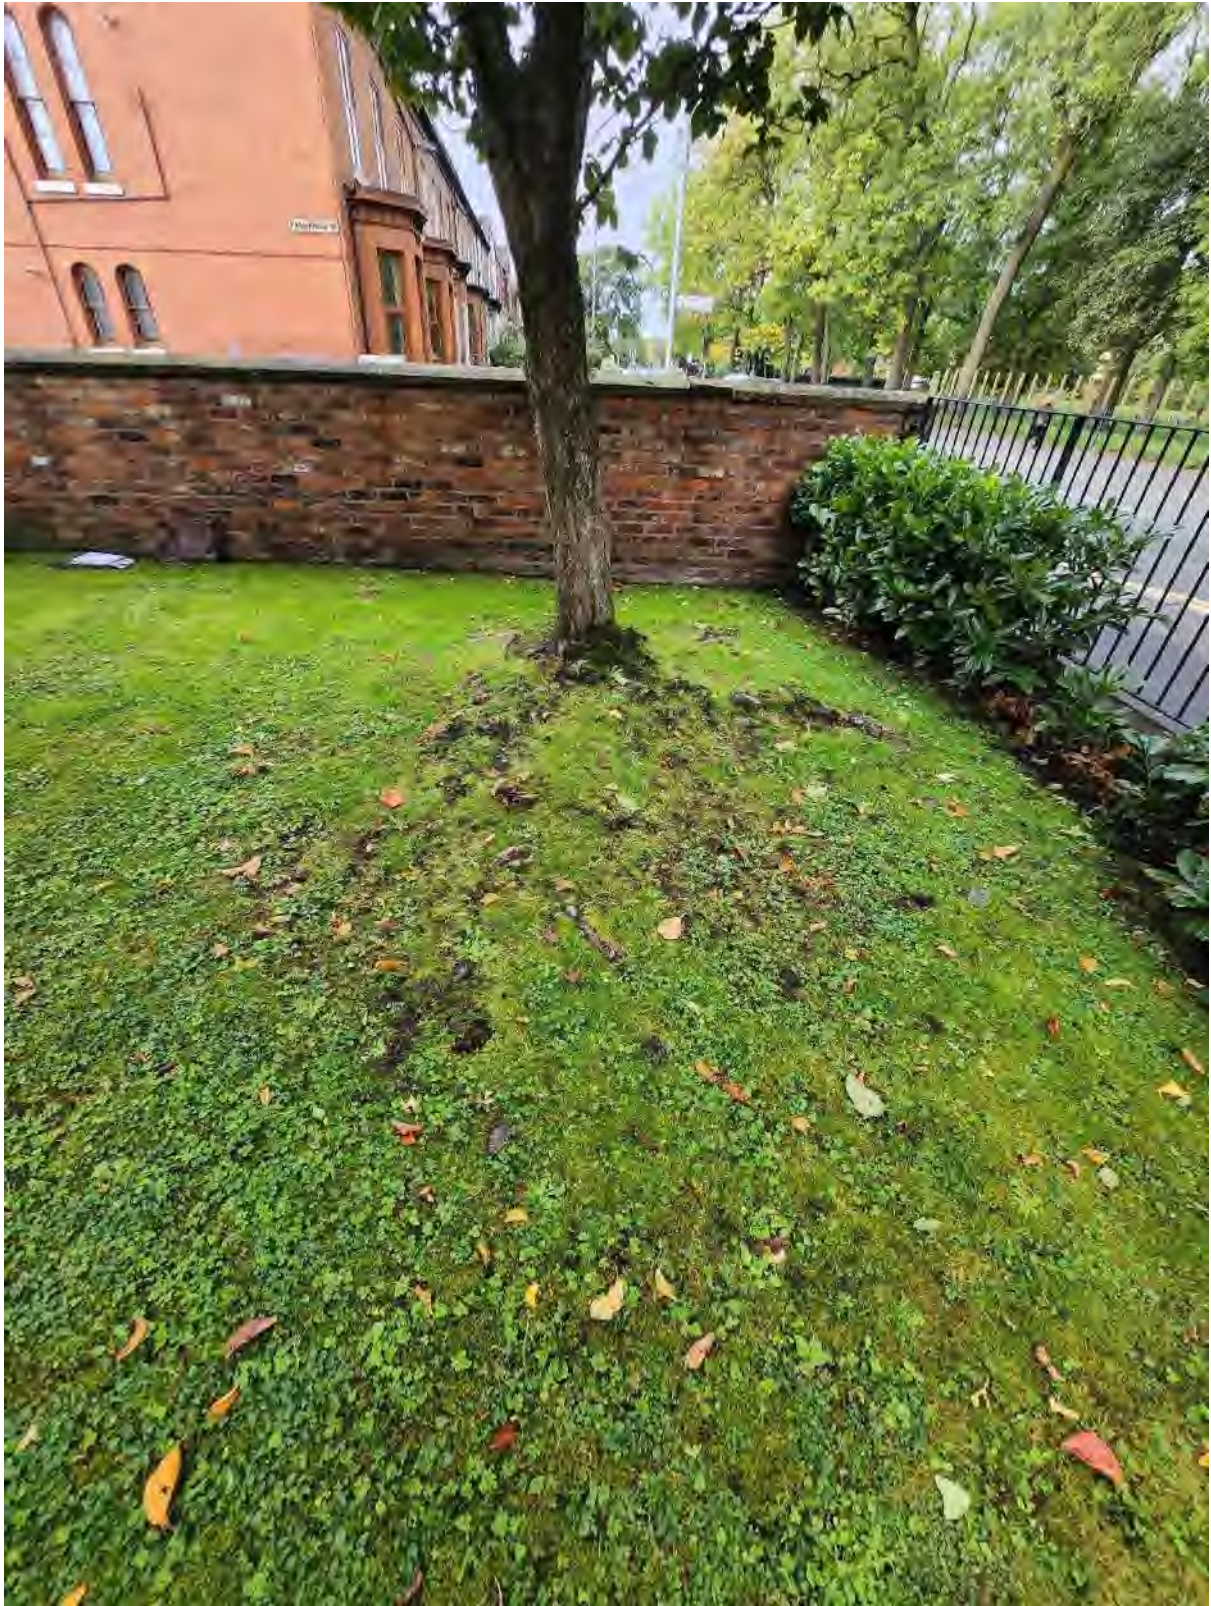
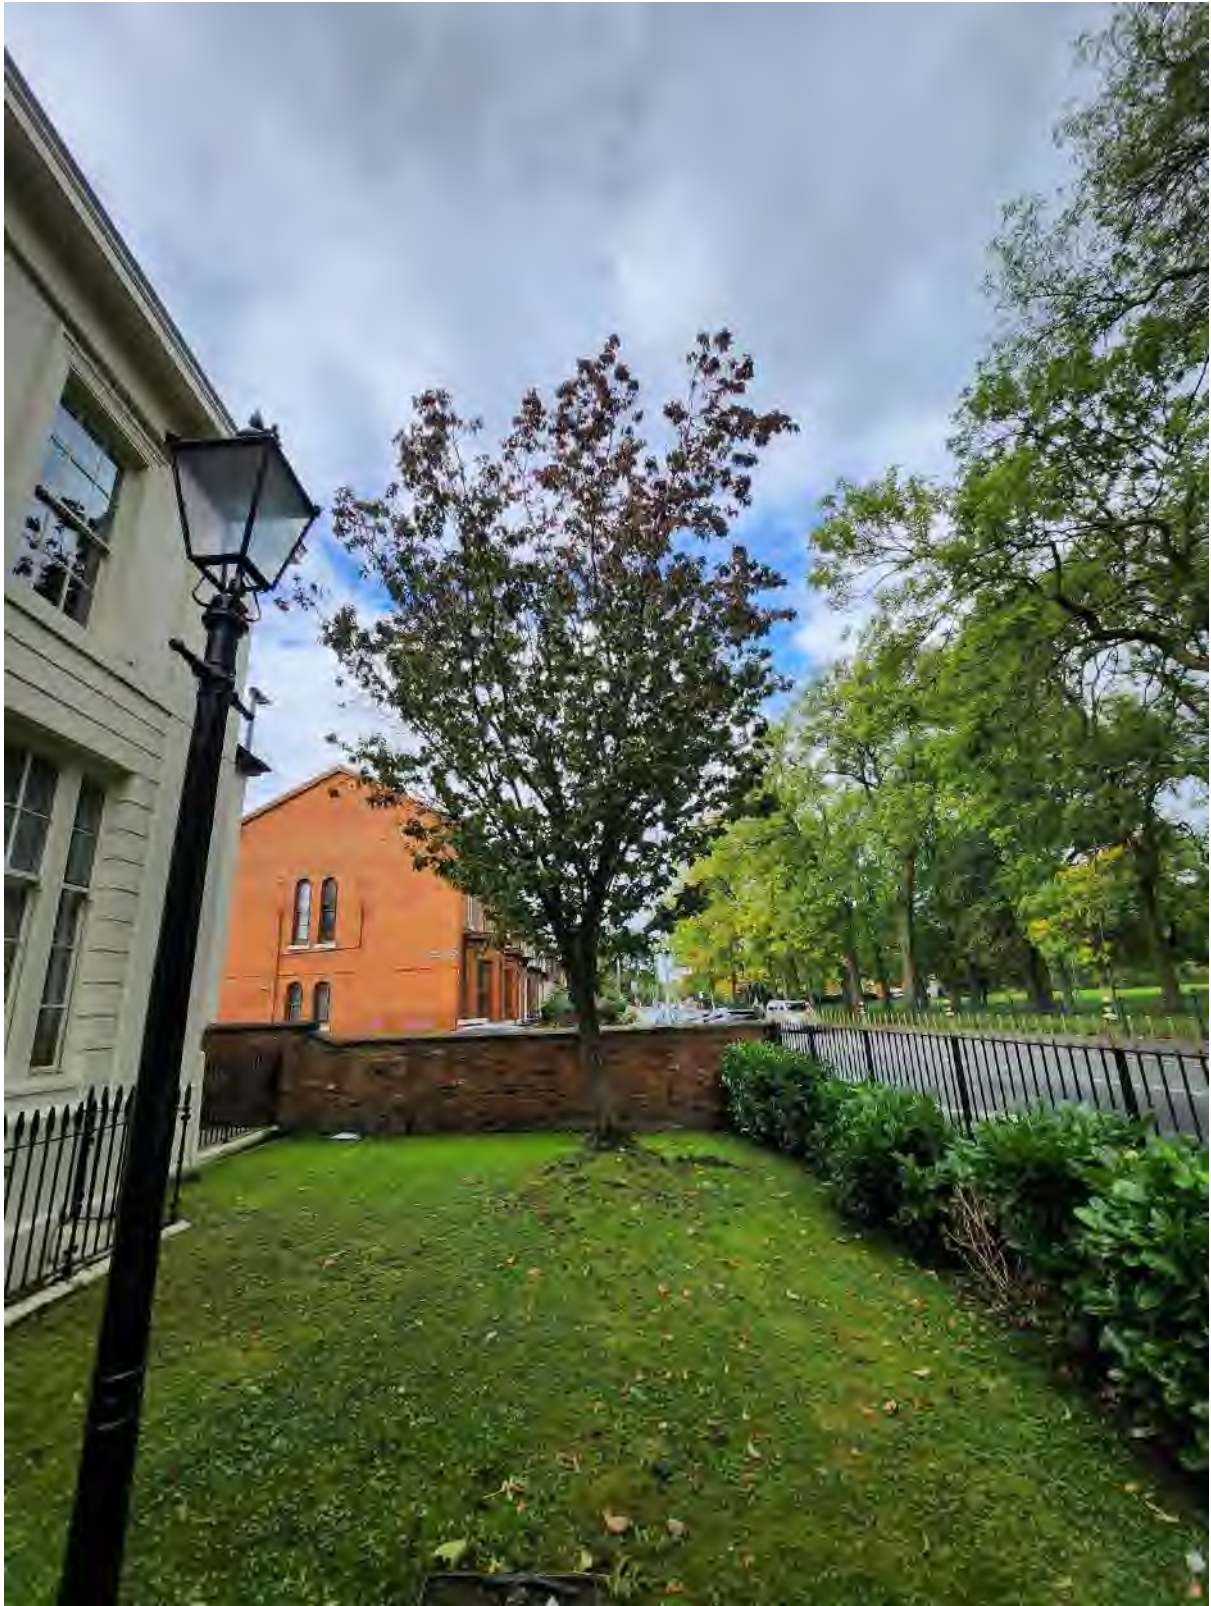
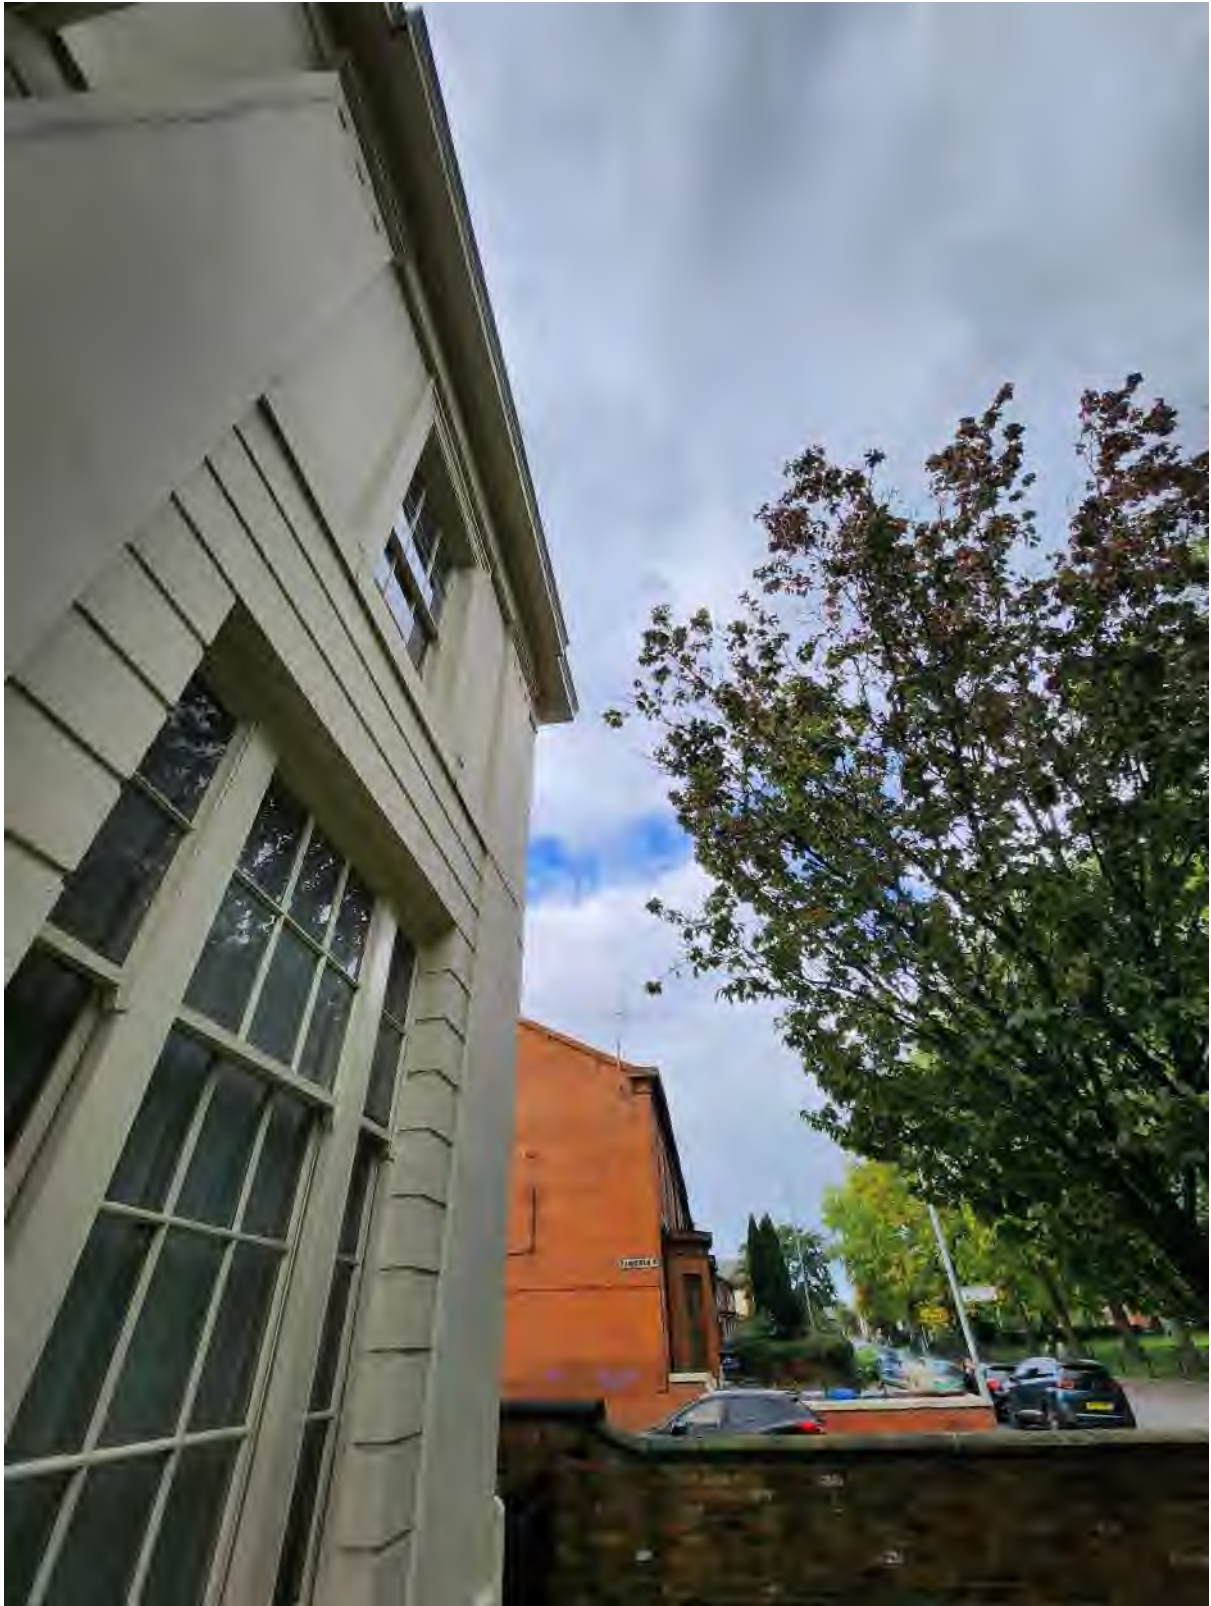
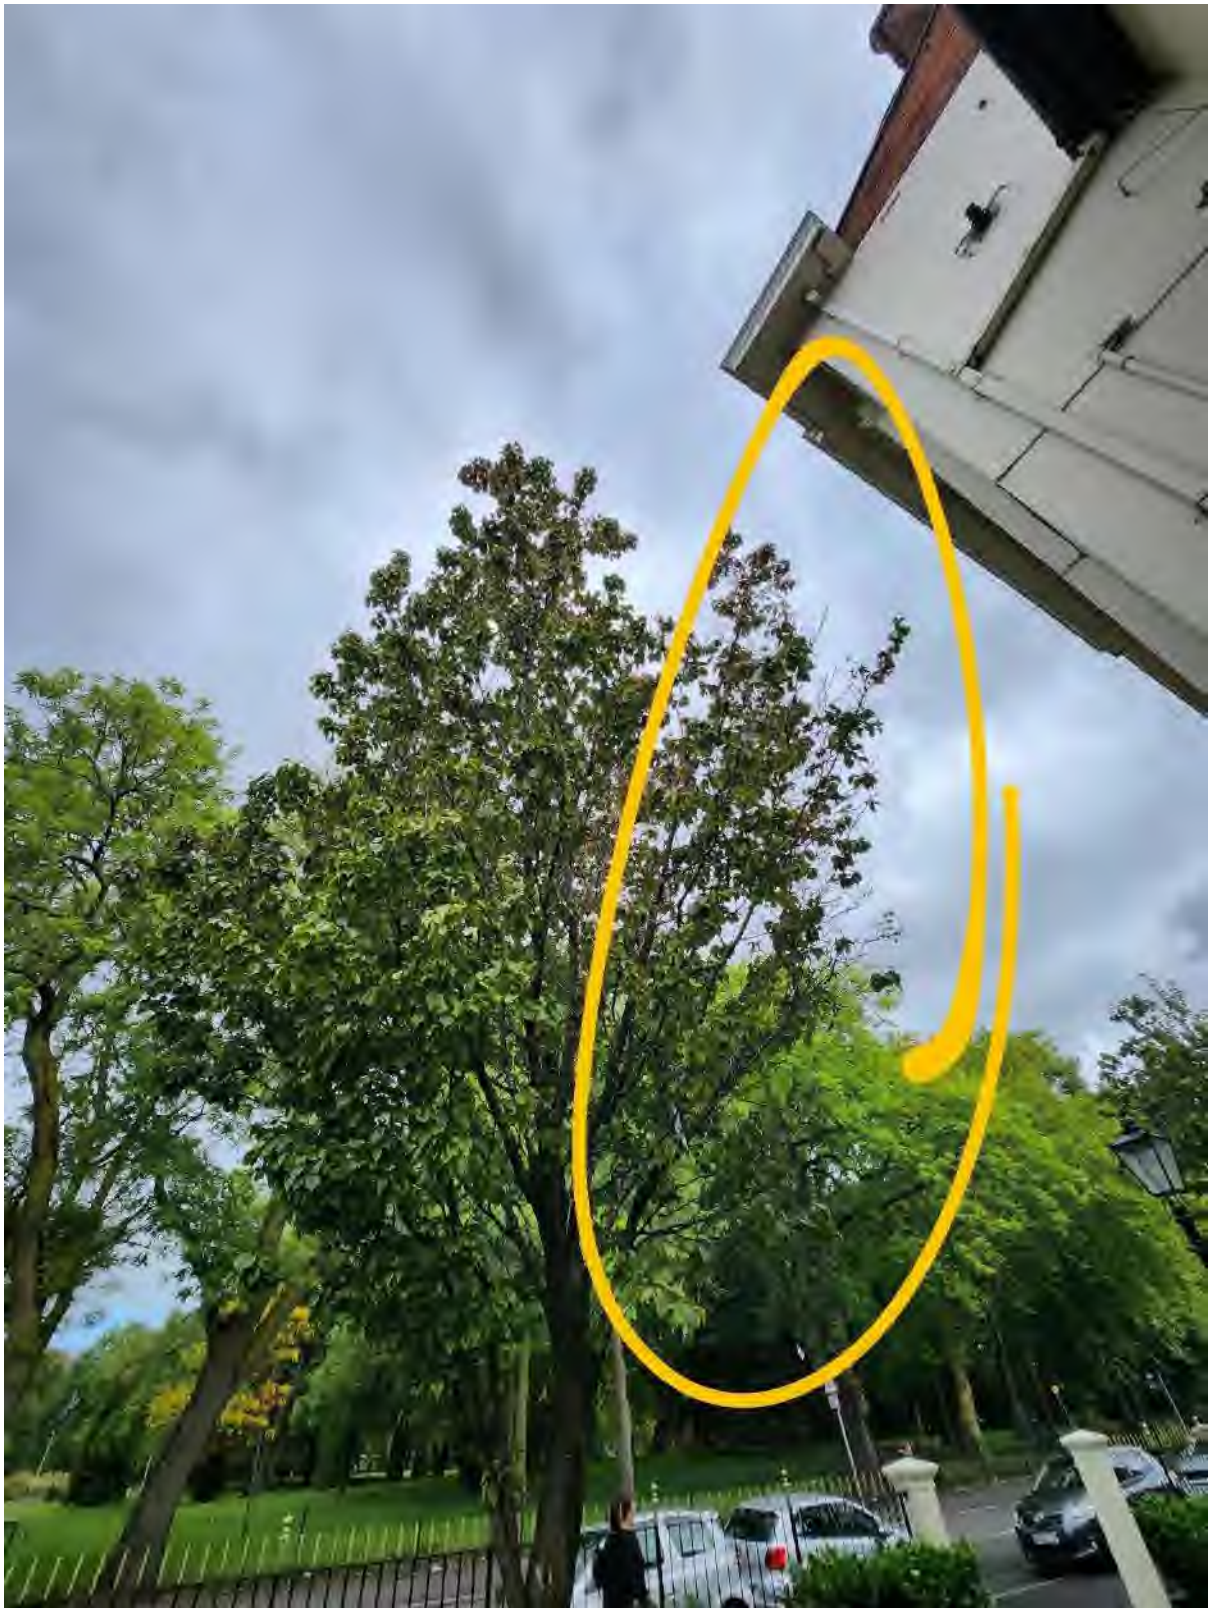
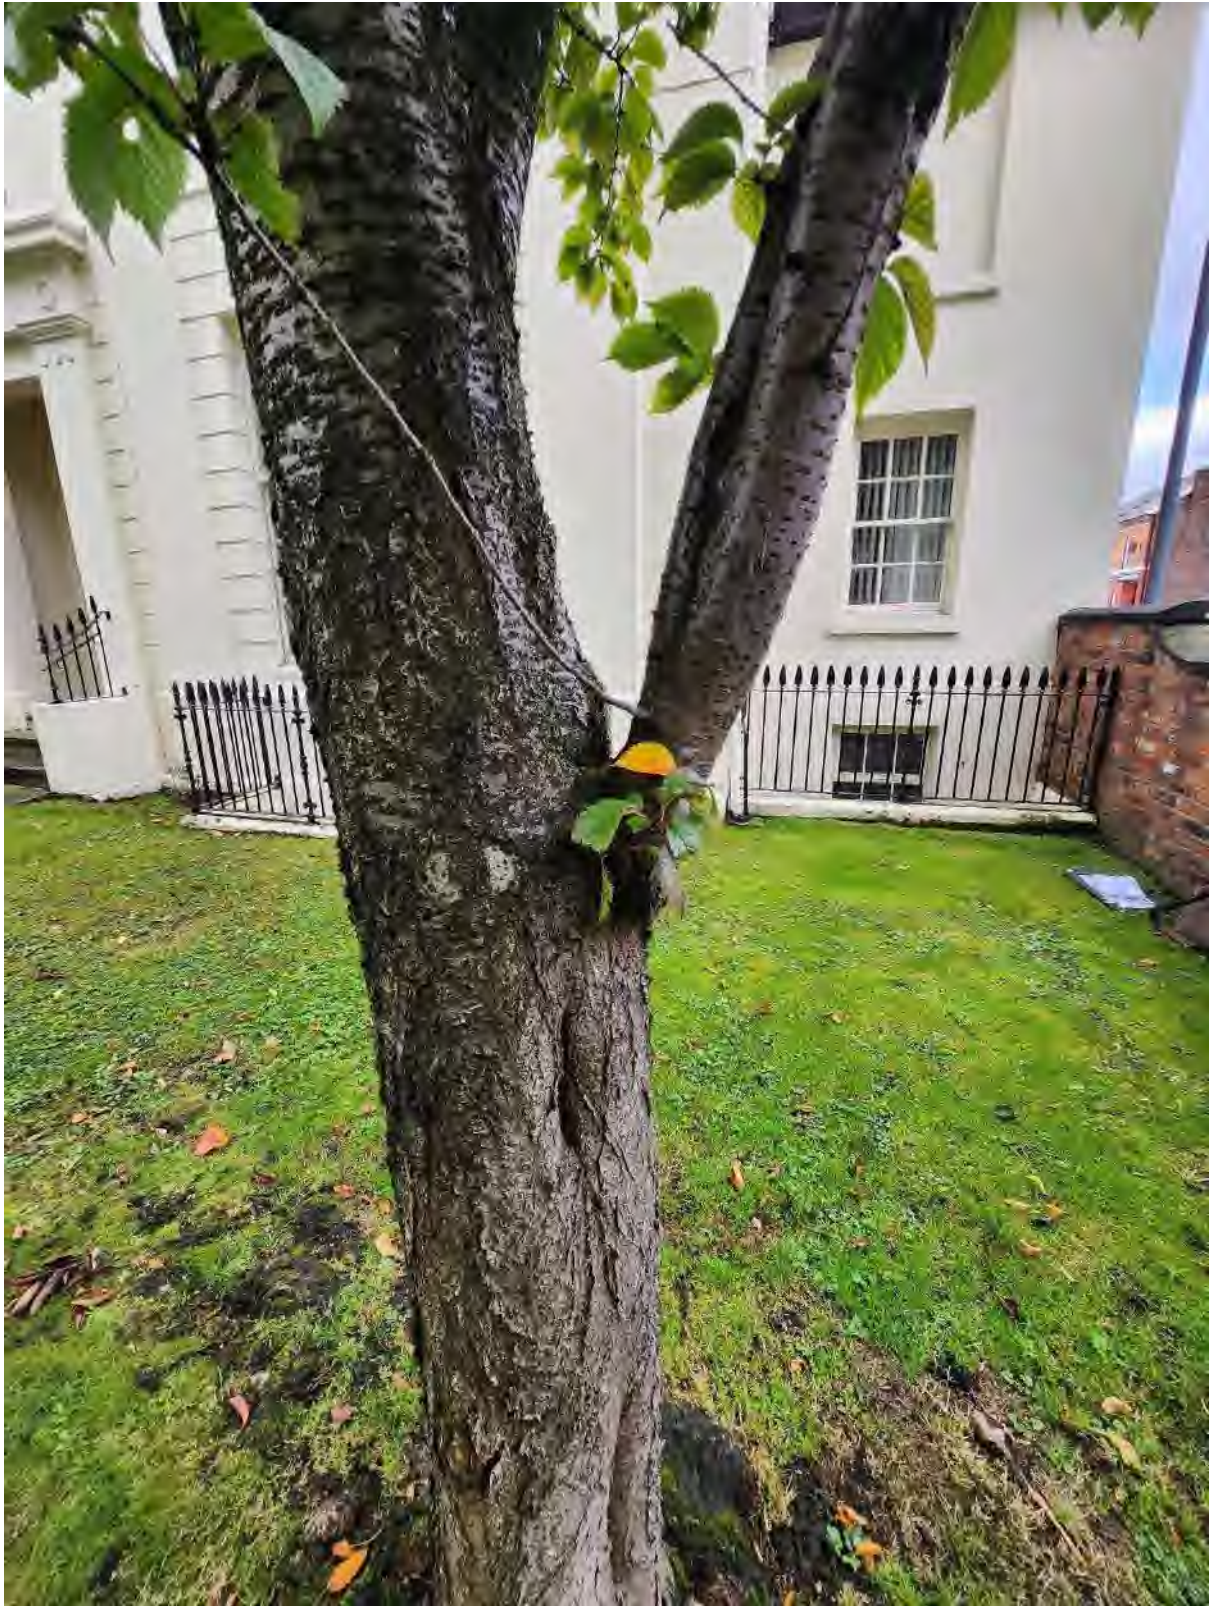
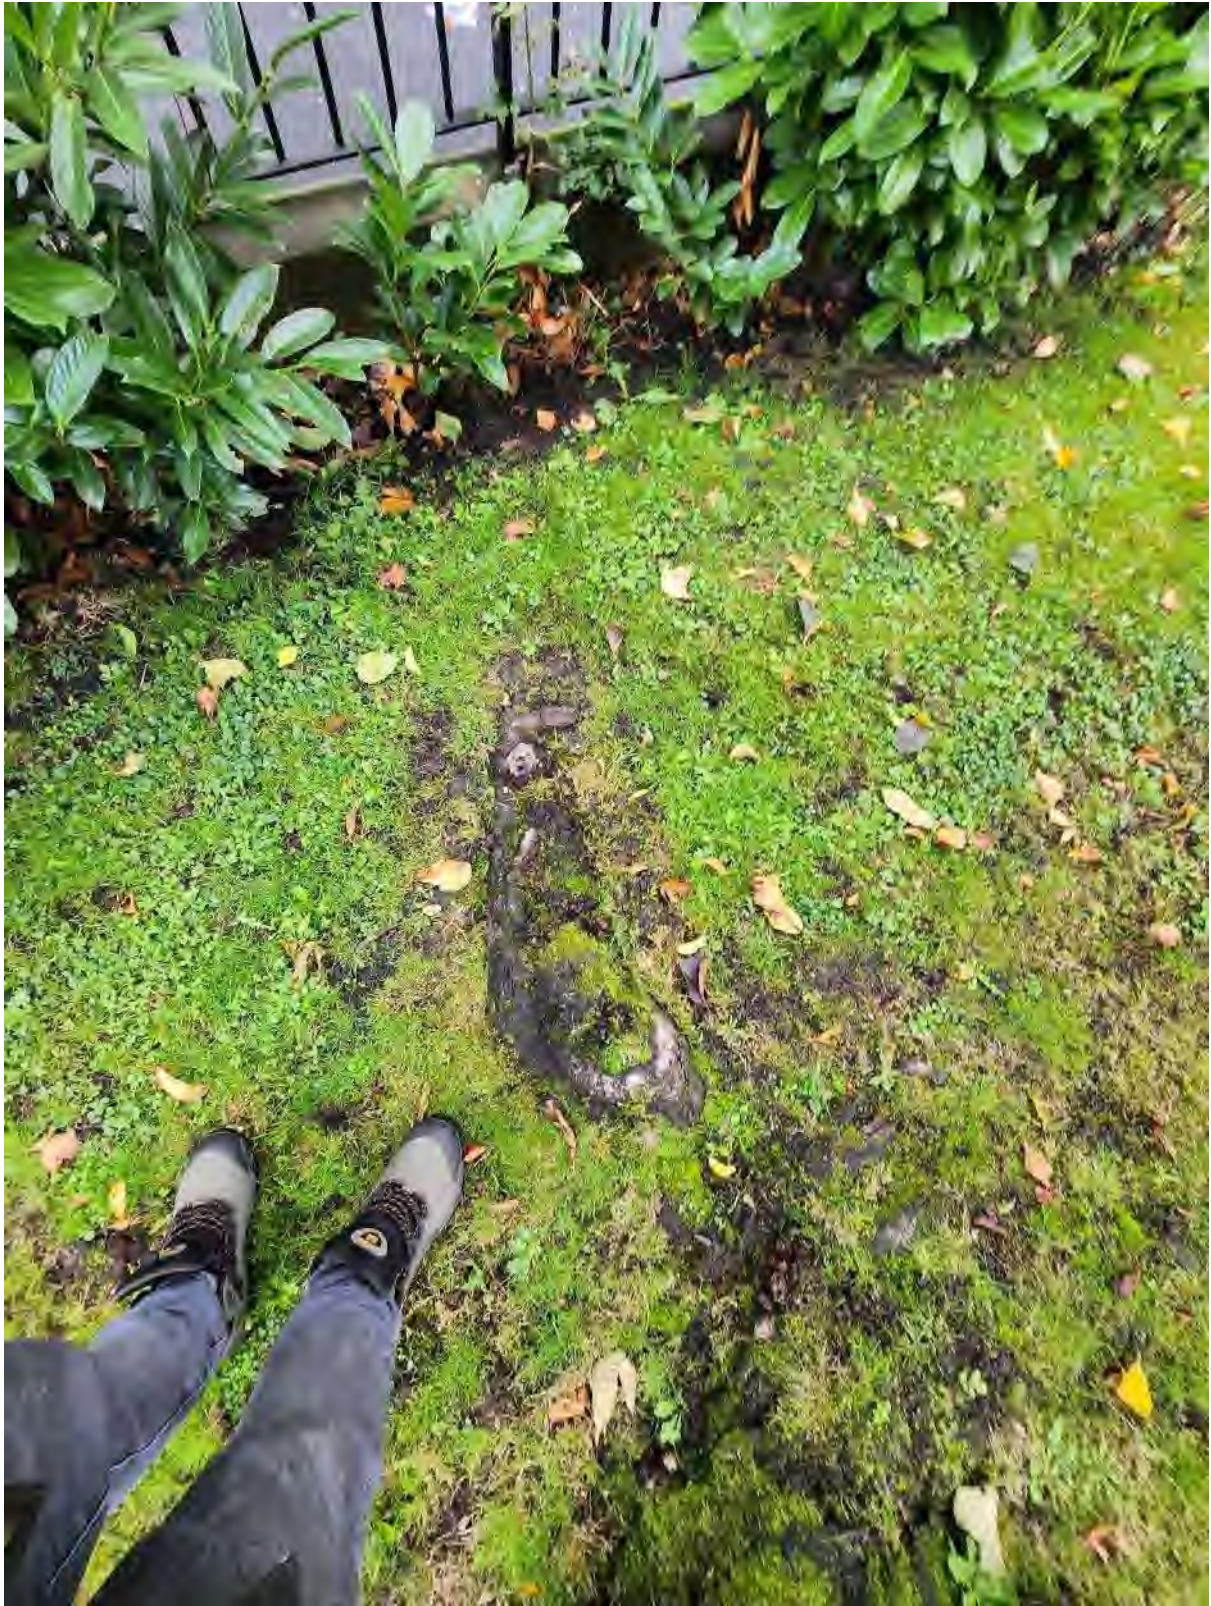
| <p>Condition survey:</p> <ul style="list-style-type: none"> <li>-Exposed roots 360 degrees from the base of the tree to 2m. Roots show evidence of damage</li> <li>-Indented growth at 0.5m (W) 30cm long 1cm wide. No change in resonance</li> <li>-Central stem included at 2m</li> <li>-Small cavity at 1.5m (S). 3cm diameter 2cm deep. Good sealing wood around the wound and no change in resonance.</li> <li>-1<sup>st</sup> limb at 1.5m (W) included. No cracking</li> <li>-Die back throughout the crown.</li> <li>-Crown sparser on the (N) (E) (SE) side</li> <li>-Tips of the crown on the (S) 0.5m from building</li> </ul> | | | |
| <p>Offsite notes-</p> <p>Tress is to be retained throughout the construction process. Tree is visually suffering with die back and suspected mechanical damage to the roots</p> | | | |
| QTRA Rating: | Physiological condition: Poor | Structural condition: fair | BS:5837 category: C1 |
