# ARBORICULTURAL IMPACT ASSESSMENT AND TREE SURVEY

466-472 Moss Lane East, Manchester.  
M14 4PJ.

Steven Calderbank BSc (Hons)

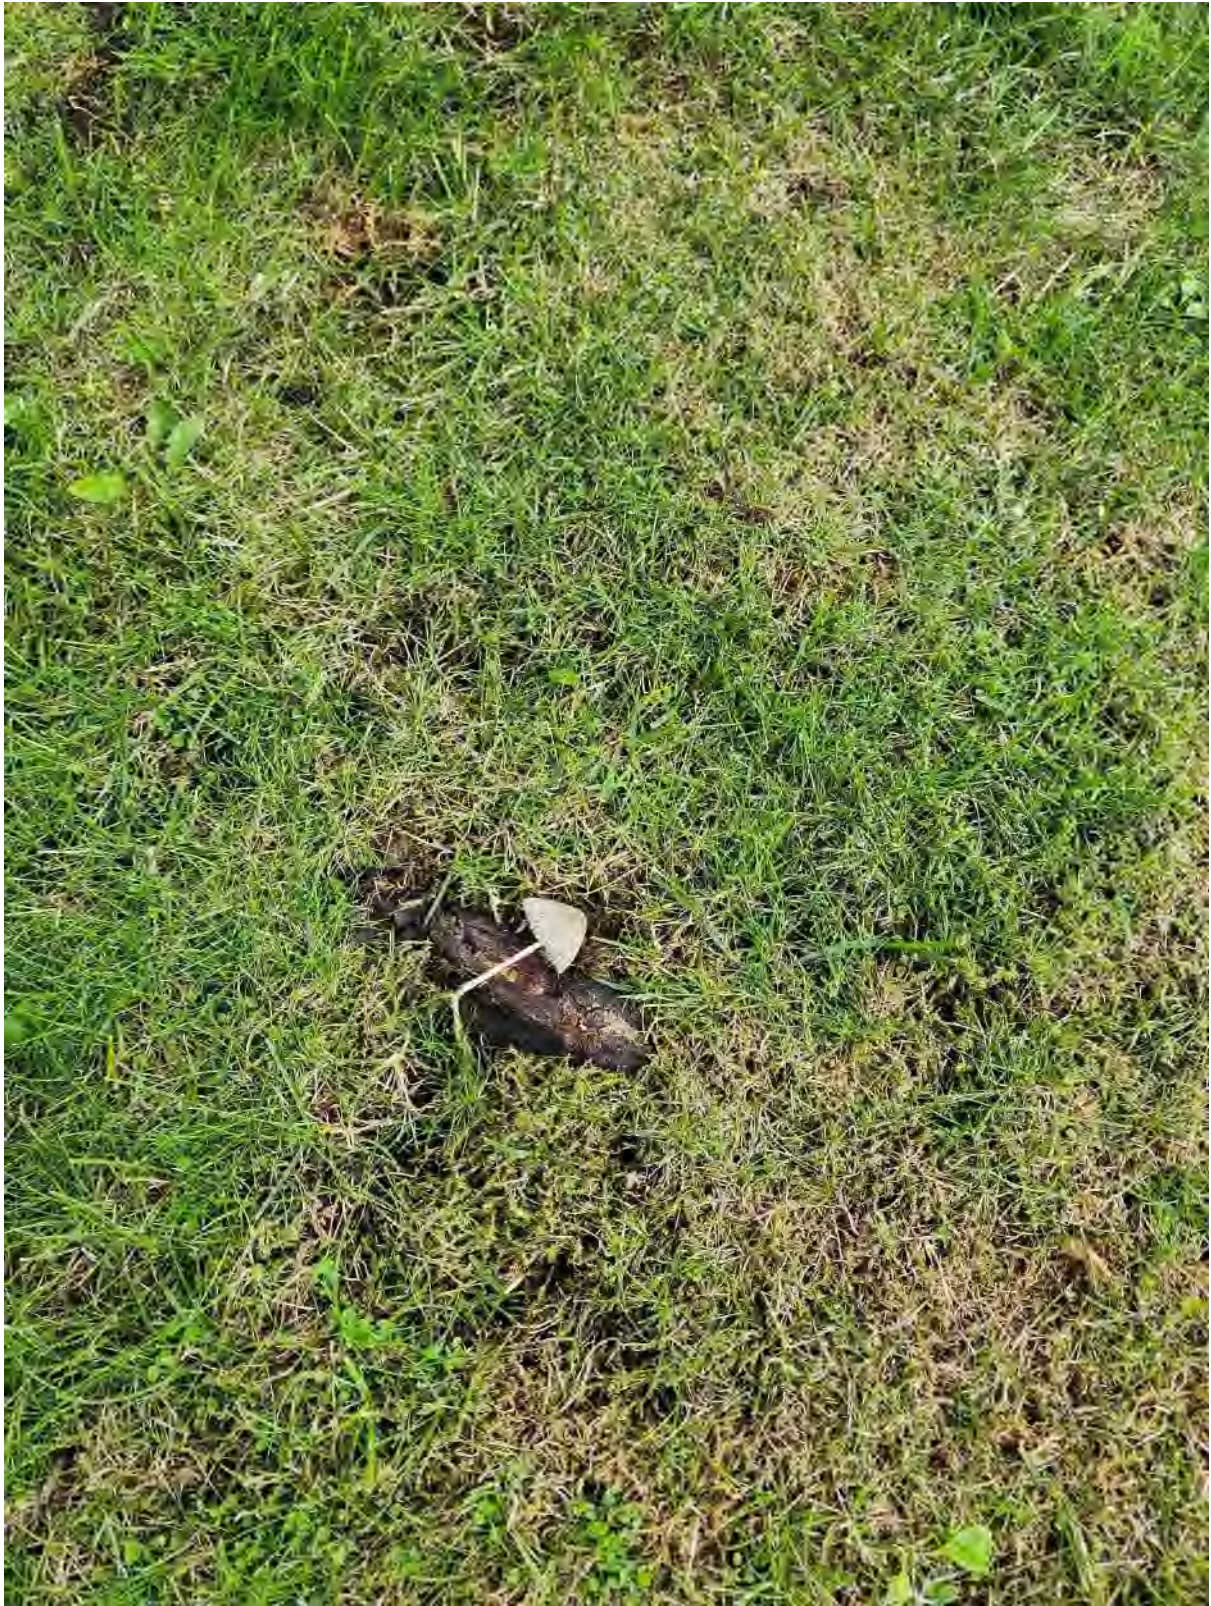
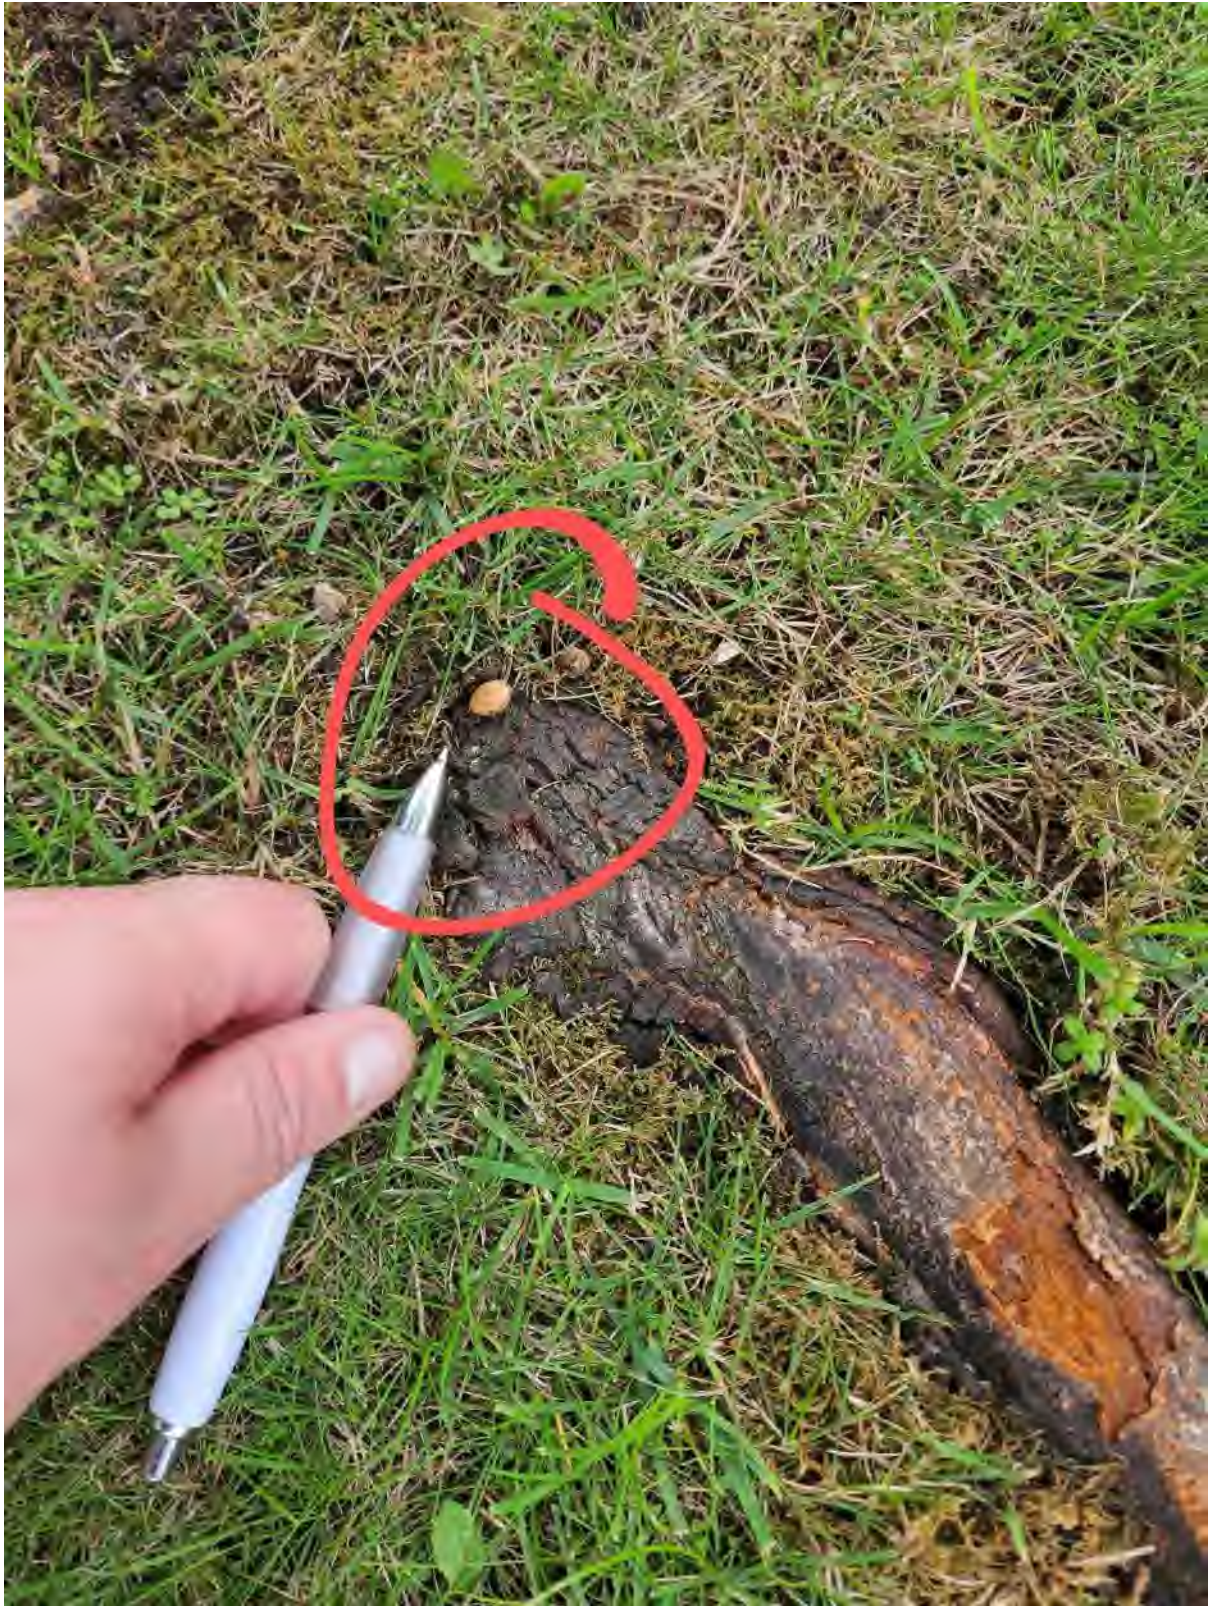
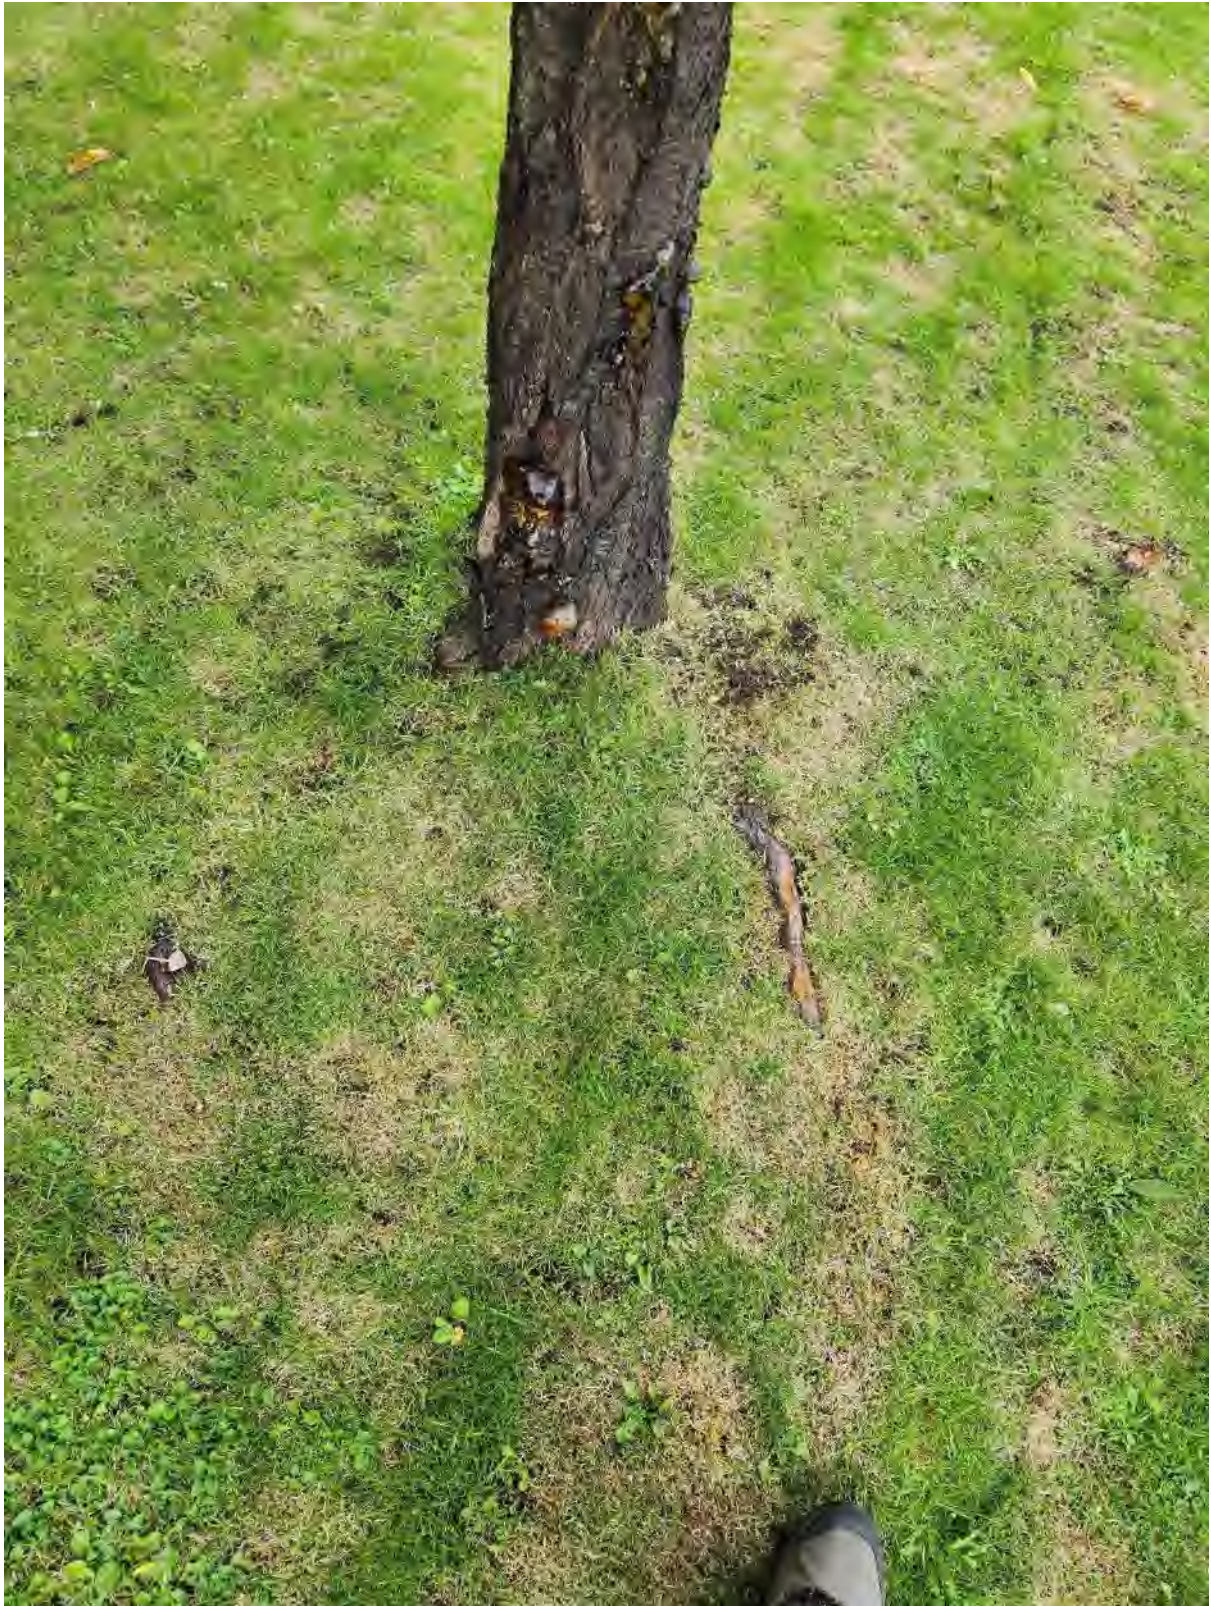
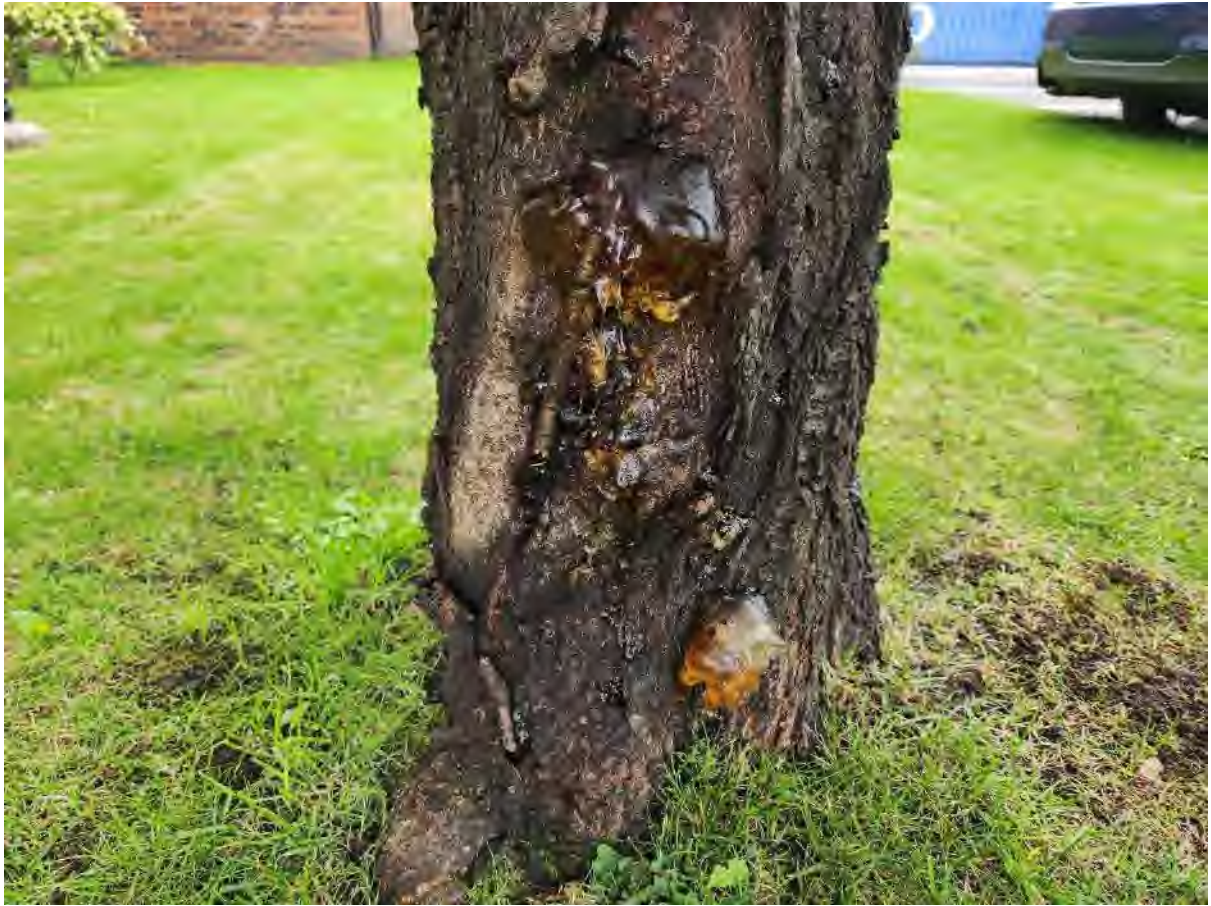
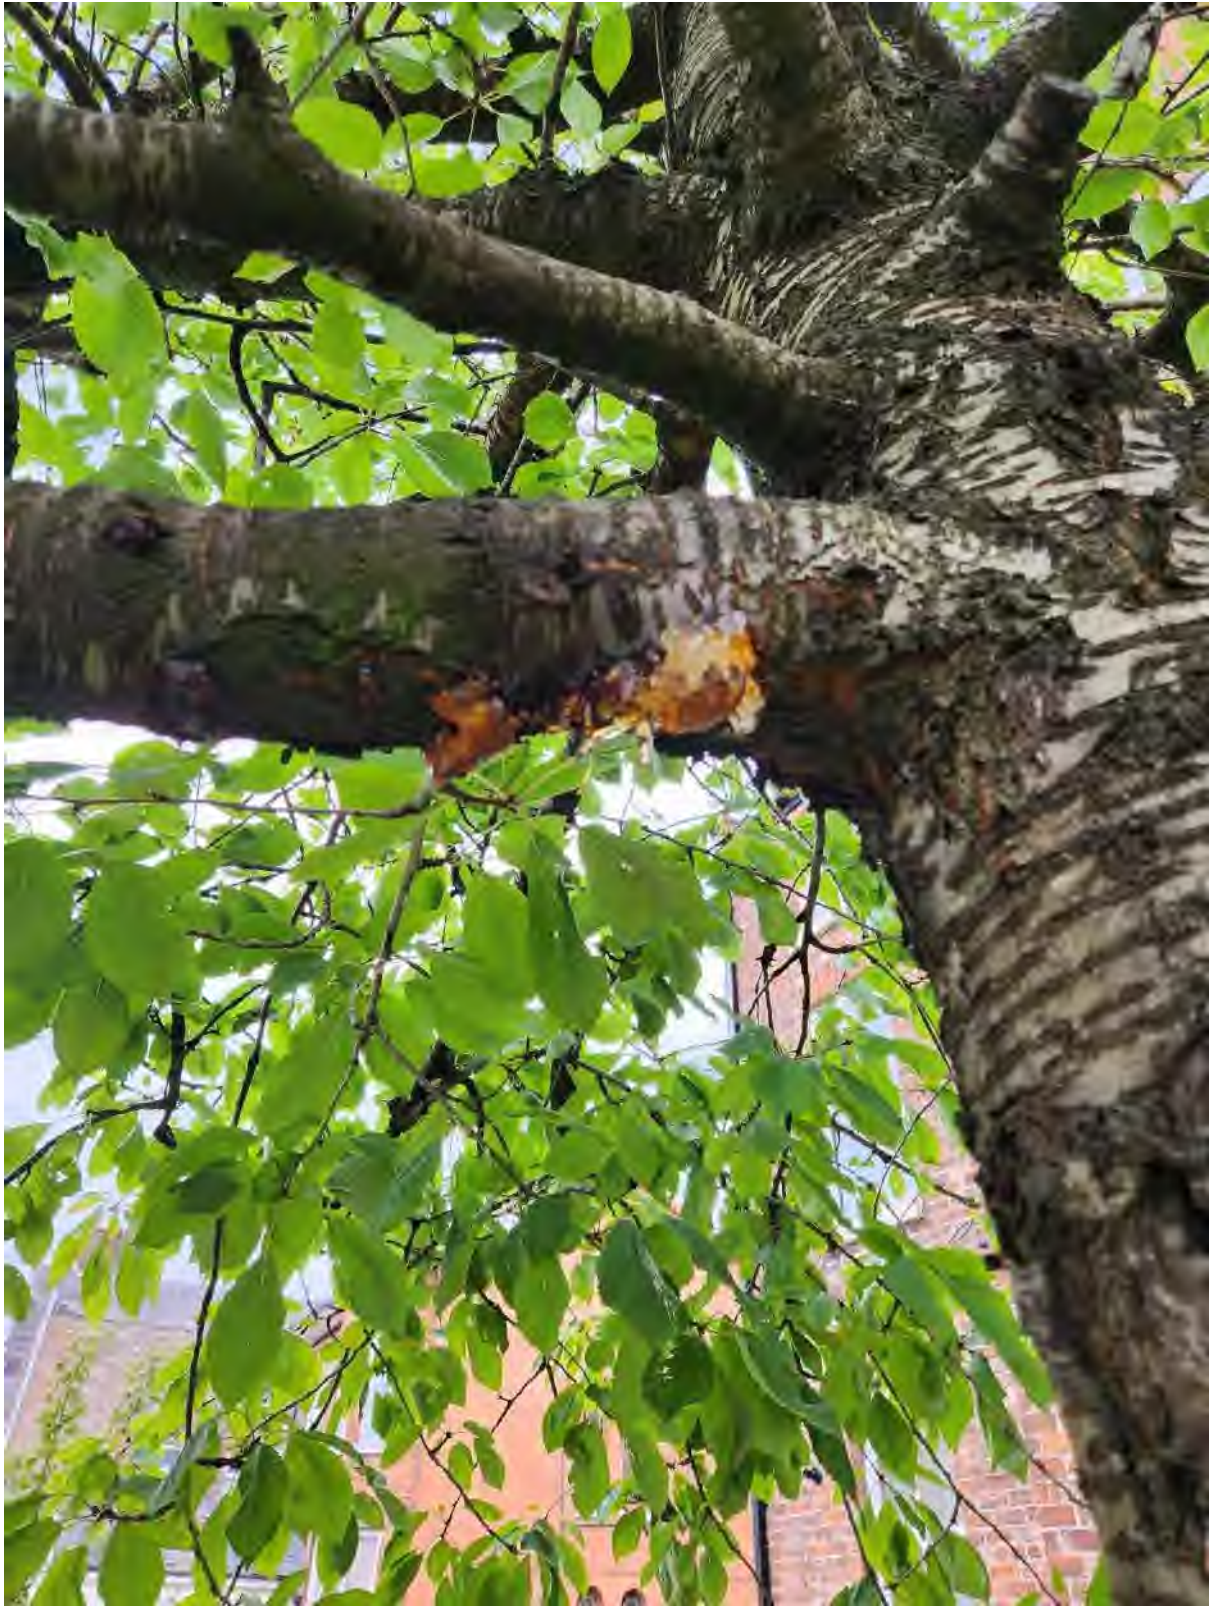
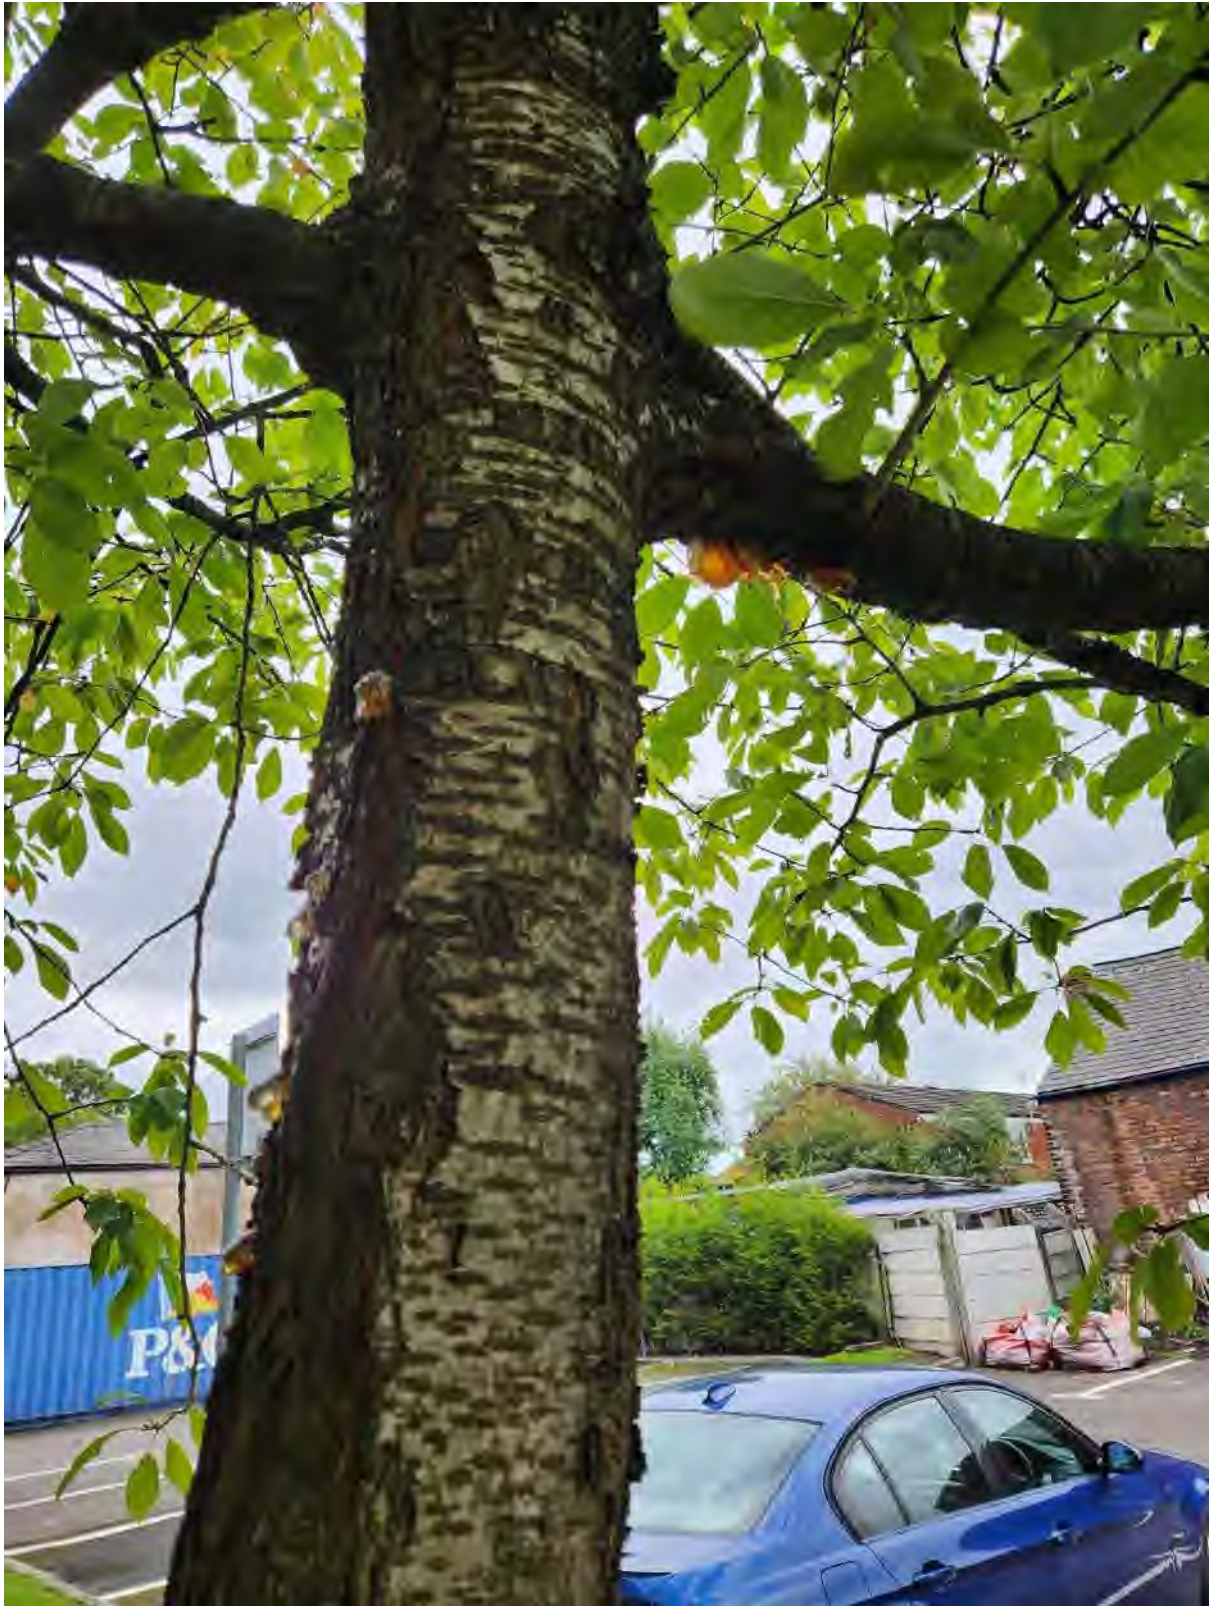
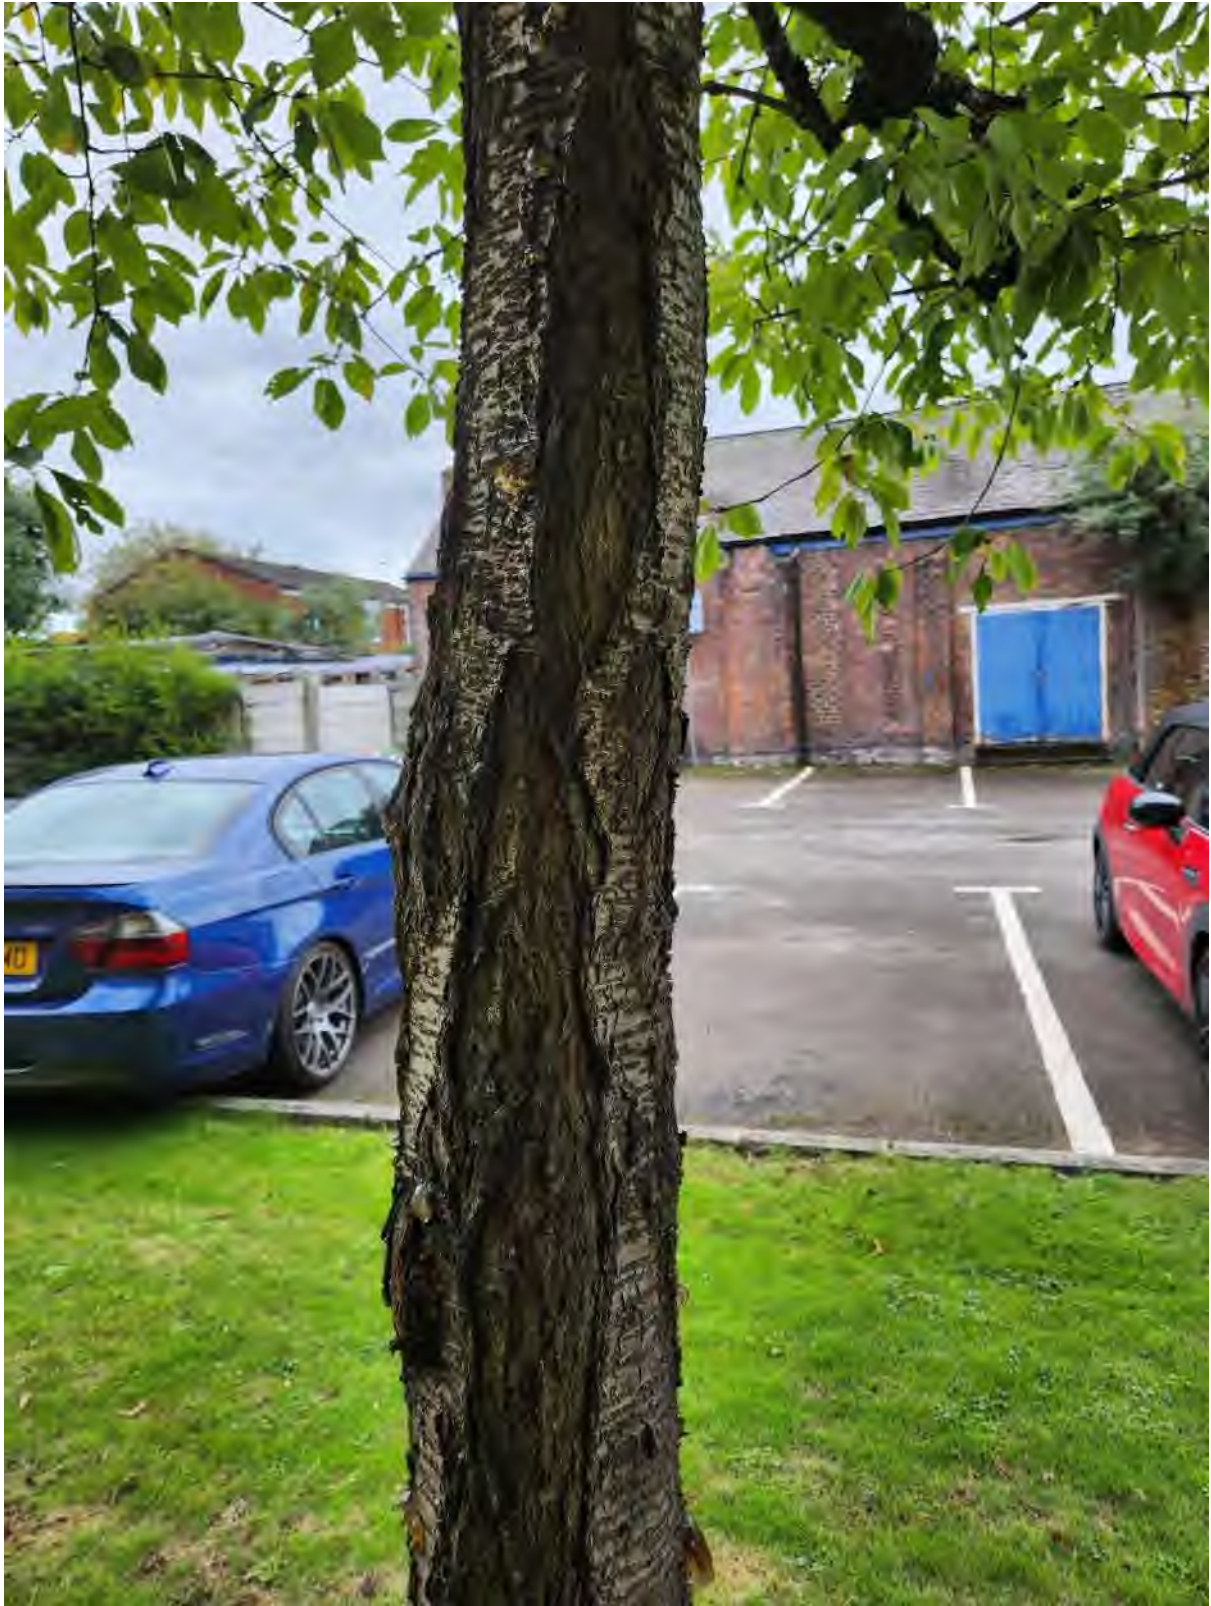
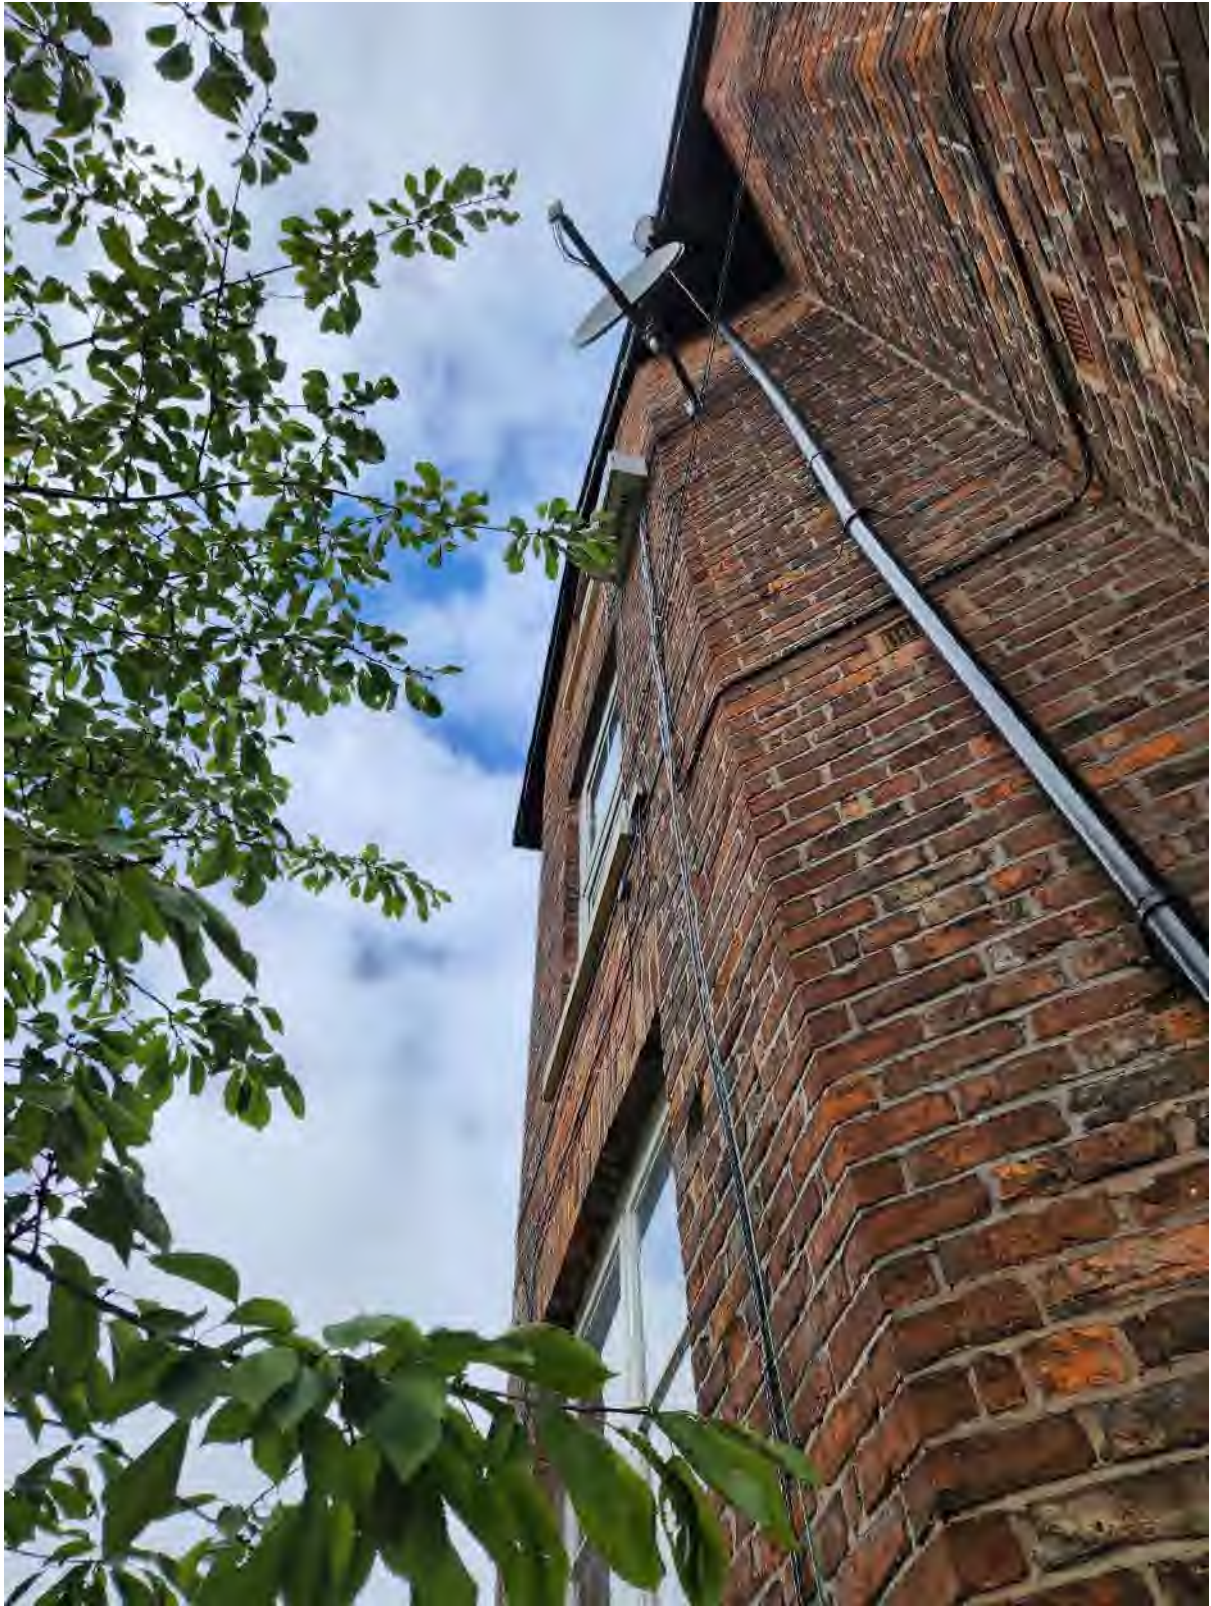
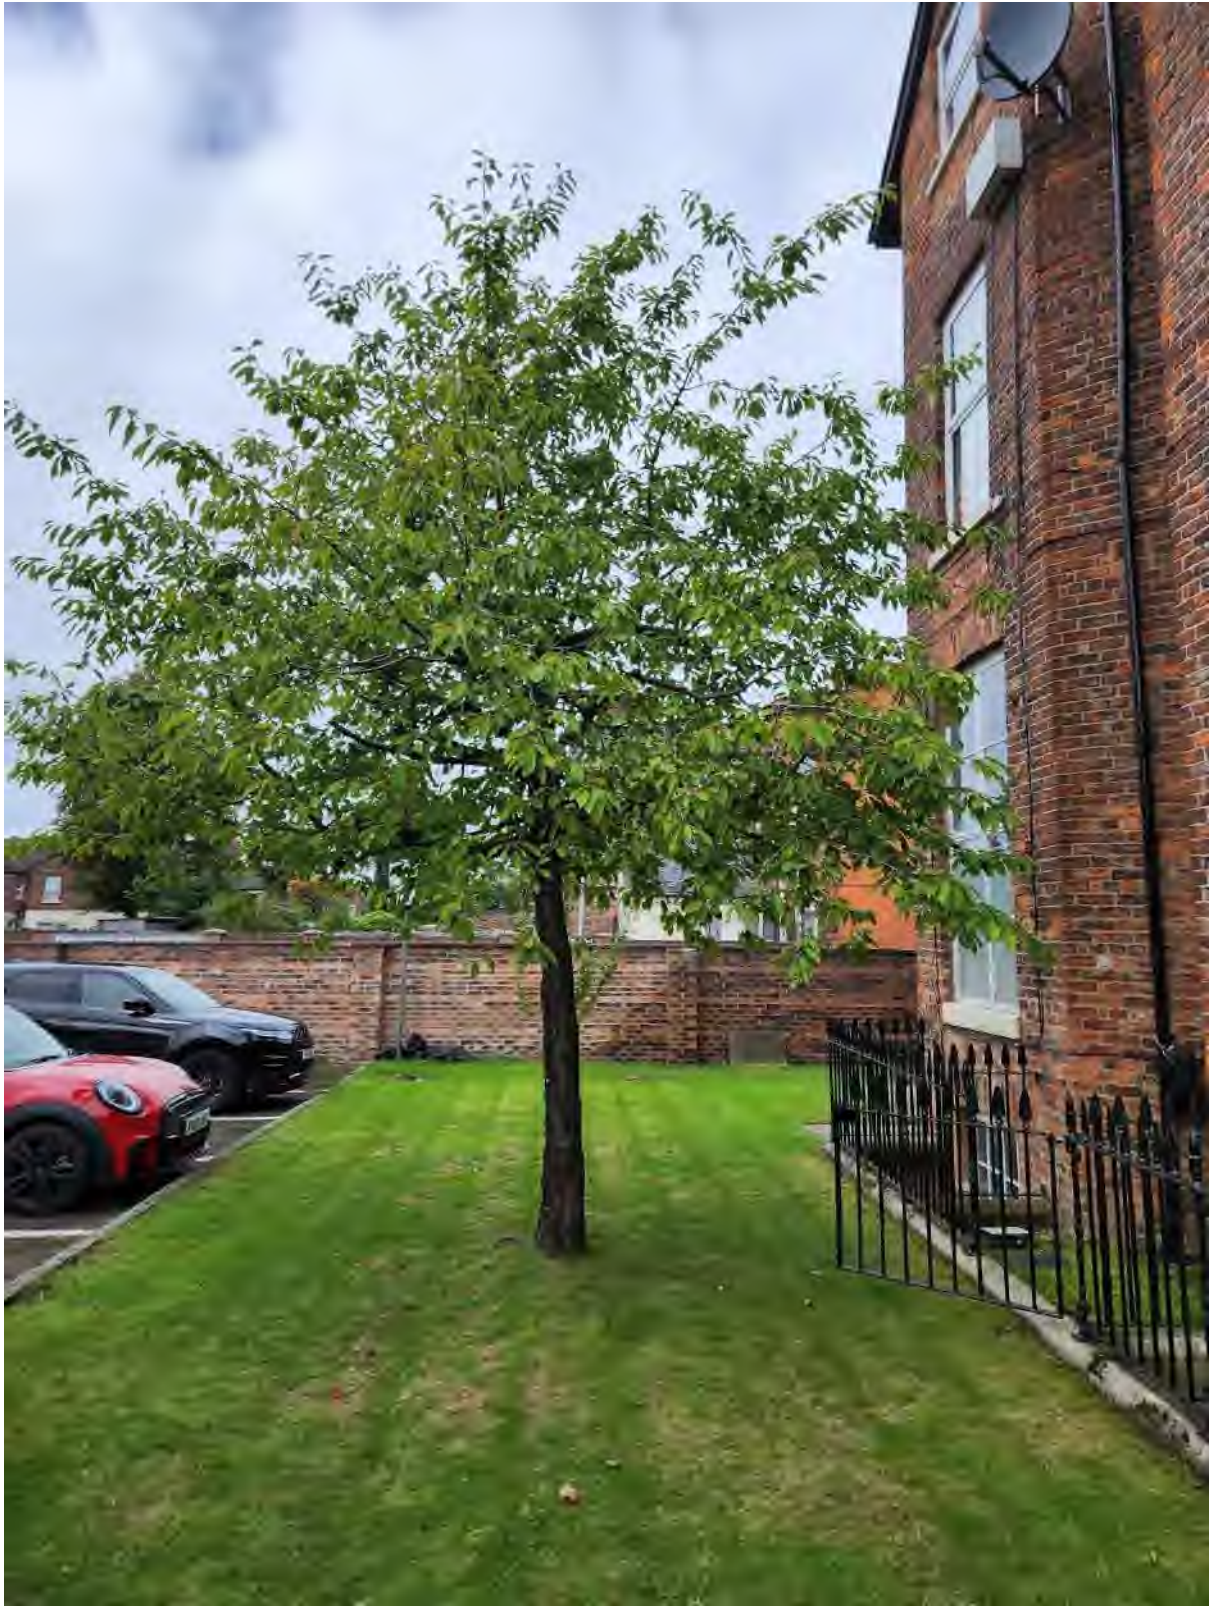
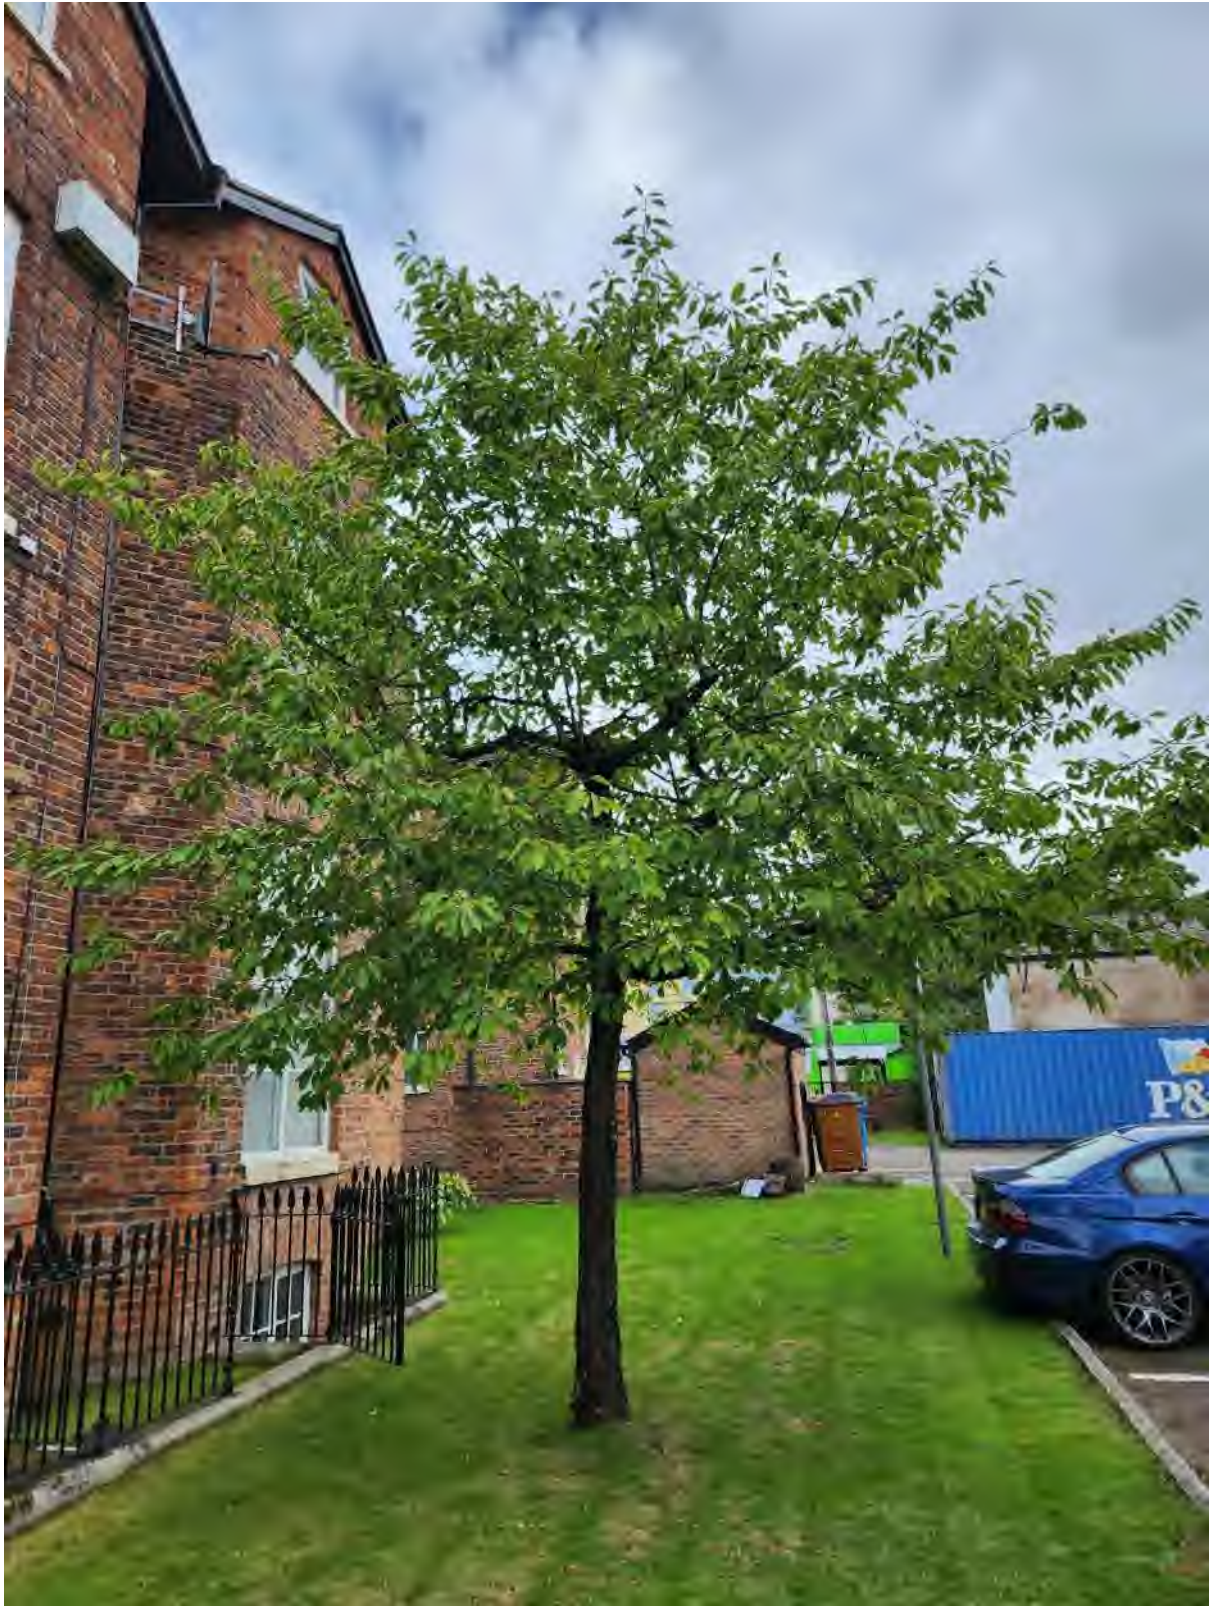
| Condition survey:<br><br>-Exposed roots (SW) 0.5m from stem, small fungi present<br><br>-Exposed roots 0.5m from stem (W). fungi present but loosely on grass next to wound<br><br>-Excessive bleeding throughout the stem and limbs.<br><br>-Excessive scaring on the stem. Change in resonance throughout the stem from ground level to 3m<br><br>-0.2m from building and touching phone lines | | | |
| Offsite notes-<br><br>Tree is showing signs of bleeding canker (Phytophthora). This can lead to tree failure in cherries. Coupled with the other fungi present this tree need immediate removal | | | |
| QTRA Rating:<br><br>Whole tree failure<br>1/3k unacceptable | Physiological<br>condition: fair | Structural condition:<br>poor | BS:5837 category:<br>U |

| Monitor frequency:<br>Fell and remove within 1 month | | | |
