# ARBORICULTURAL IMPACT ASSESSMENT AND TREE SURVEY

466-472 Moss Lane East, Manchester.  
M14 4PJ.

Steven Calderbank BSc (Hons)

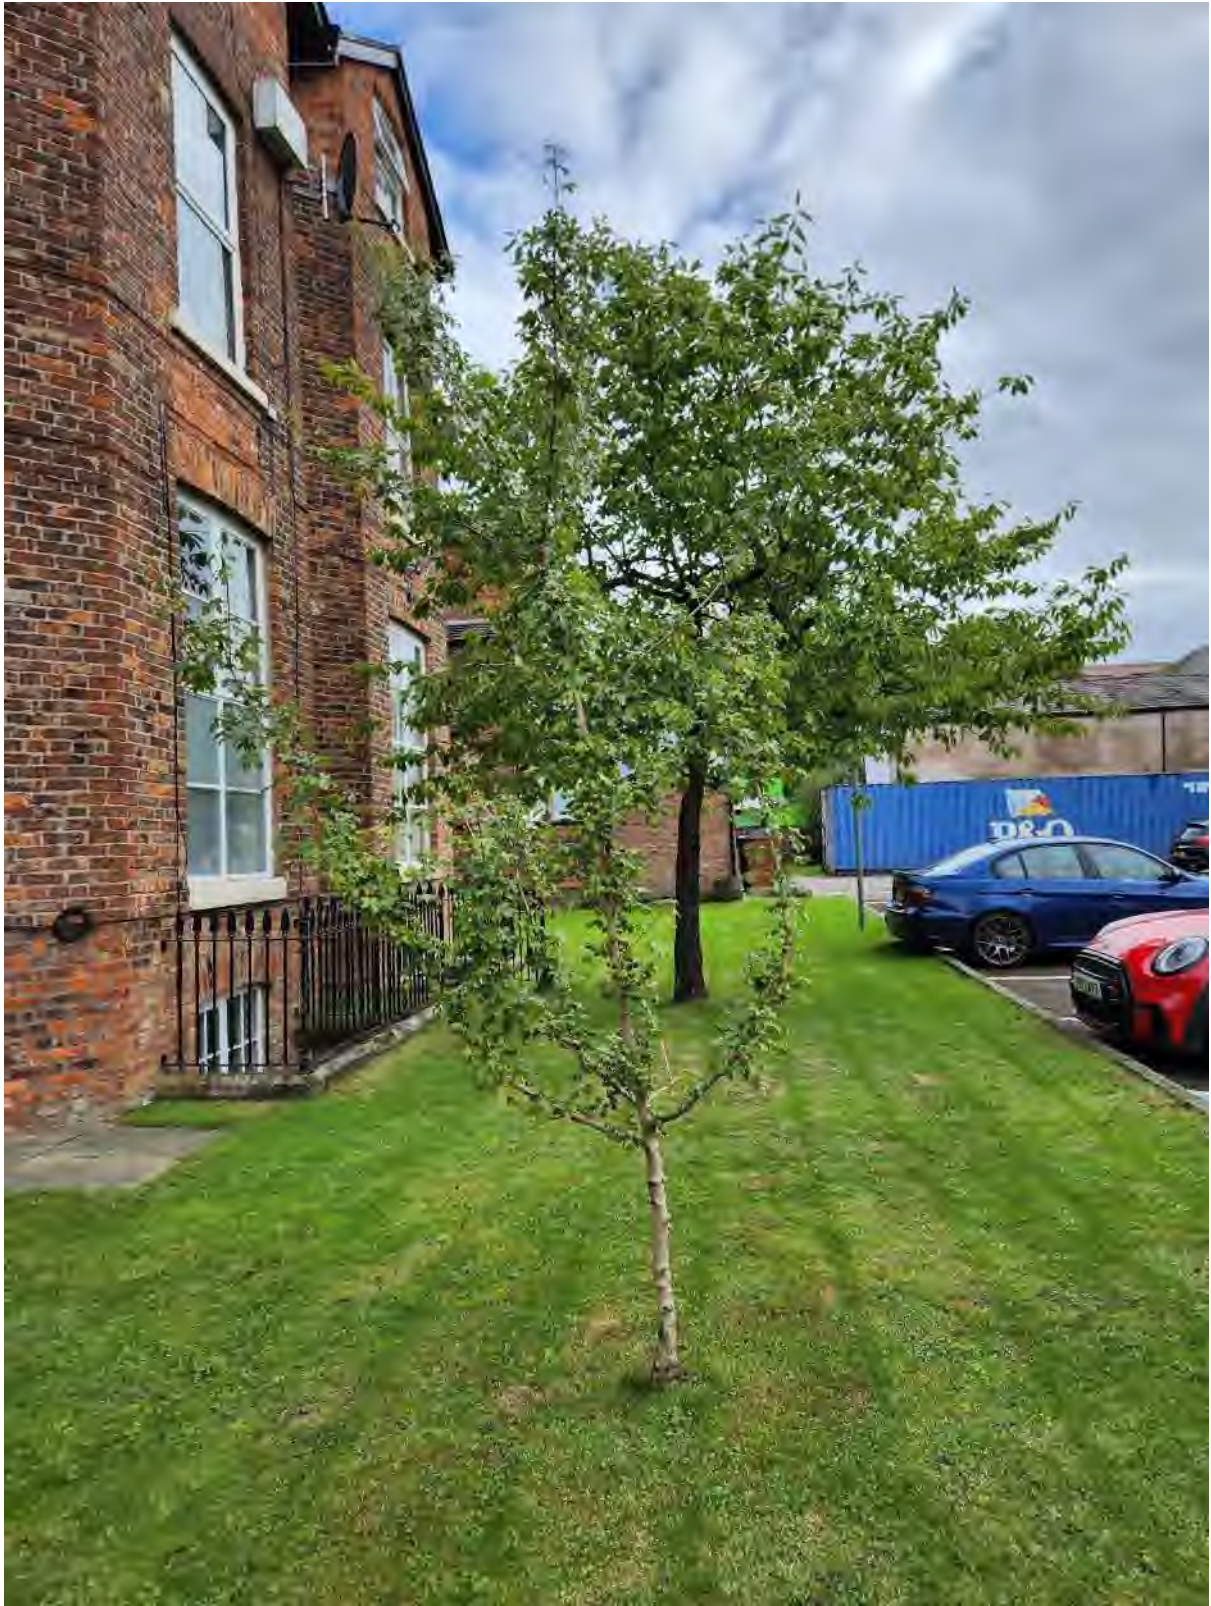
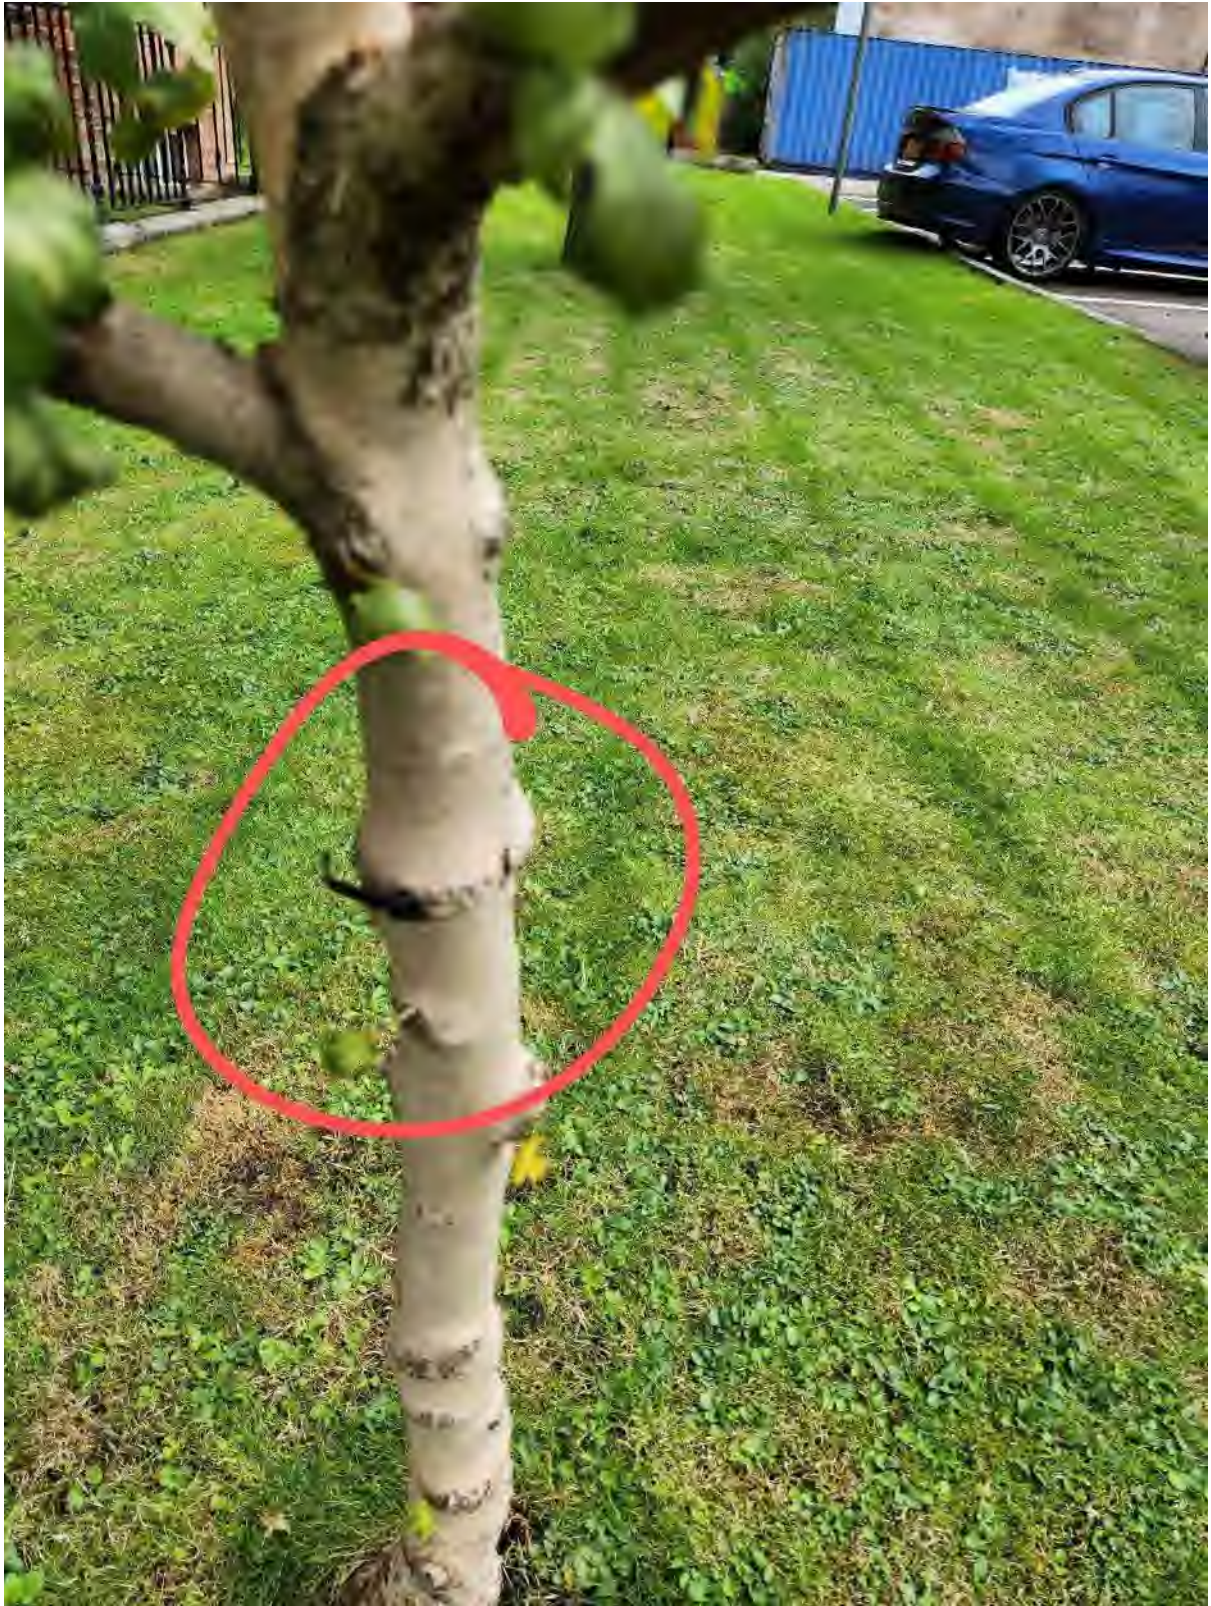
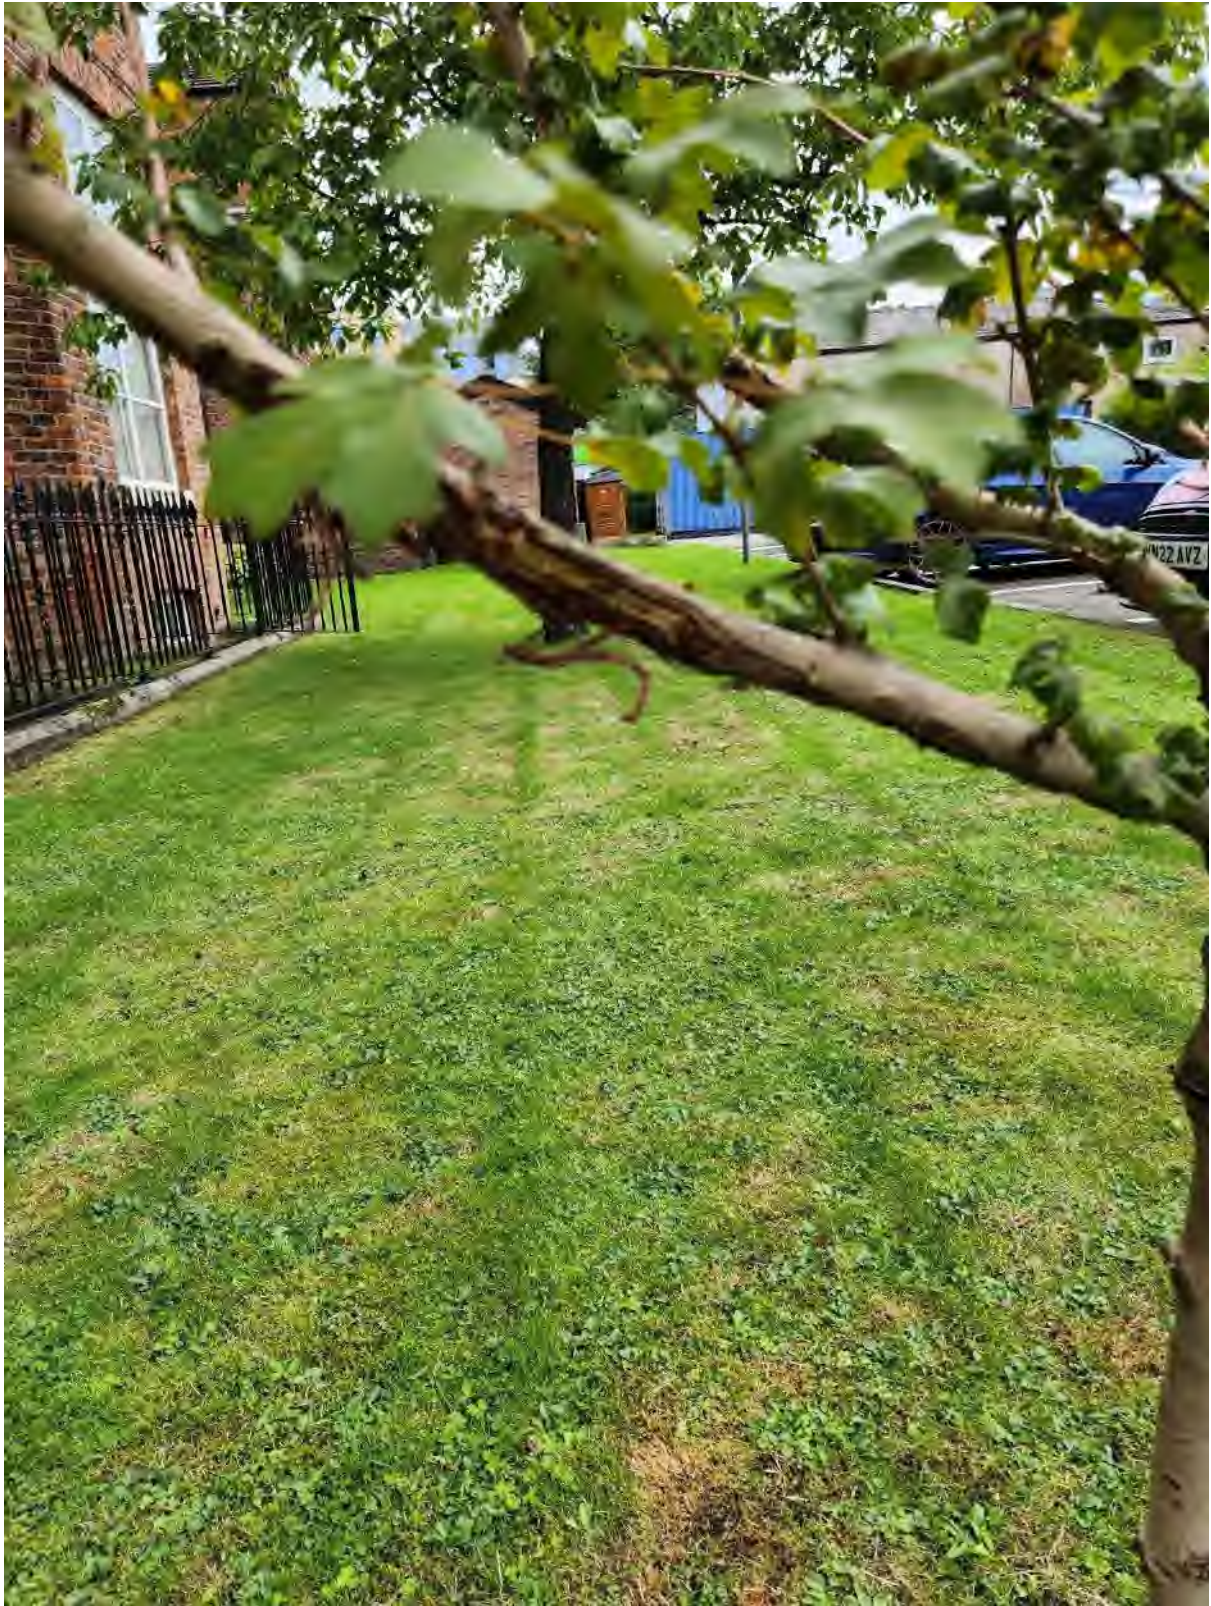
| | Condition survey:<br><br>-Multiple damage to stem and branches.<br><br>-Tie wrap enveloped by stem | | | |
| | Offsite notes-<br><br>Tree is very juvenile. It appears to been planted too deep, not staked, no evidence of tree pit and has many defects for such a young tree. In such this will lead to bad physiological growth in future and not be sustainable | | | |
| QTRA Rating:<br><br>1/1mil | | Physiological<br>condition: poor | Structural<br>condition:<br>good | BS:5837<br>category:<br>U |

| | Works required and time scales:<br><br>Fell and remove prior to works and replace in more suitable location once works have finished | | | |

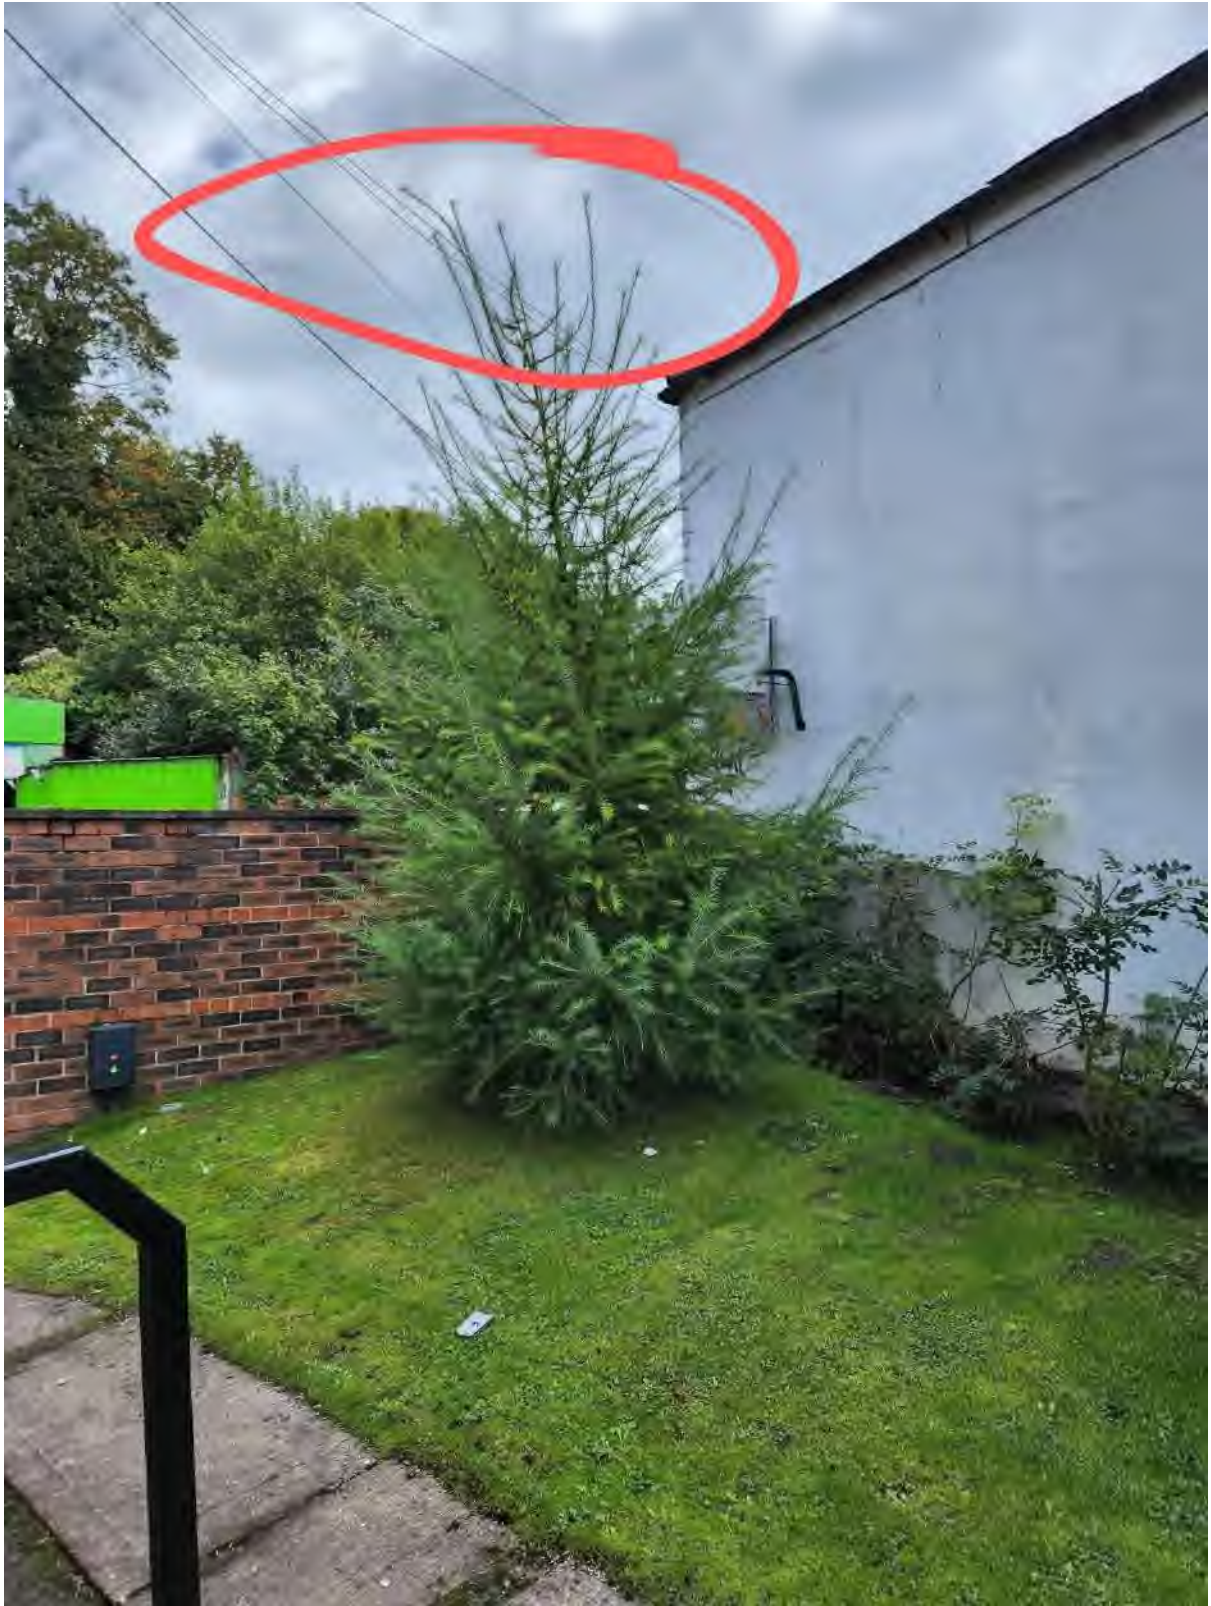
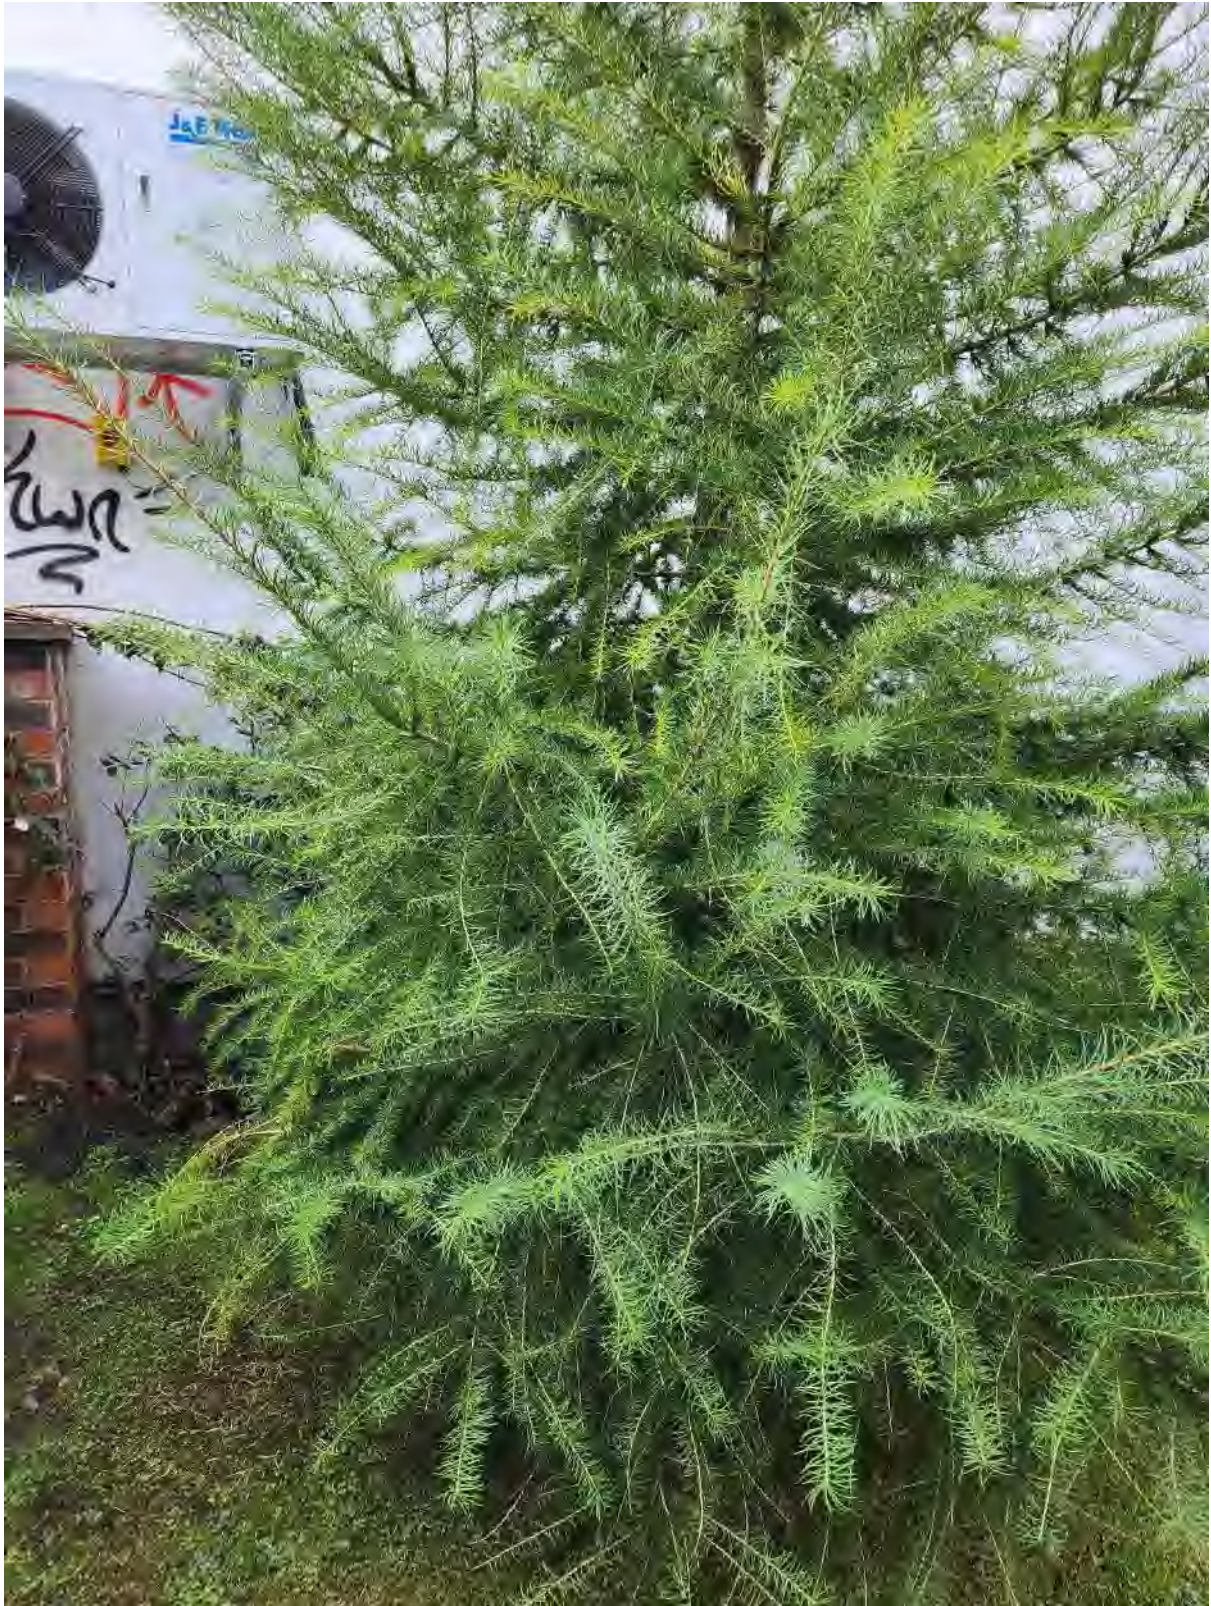
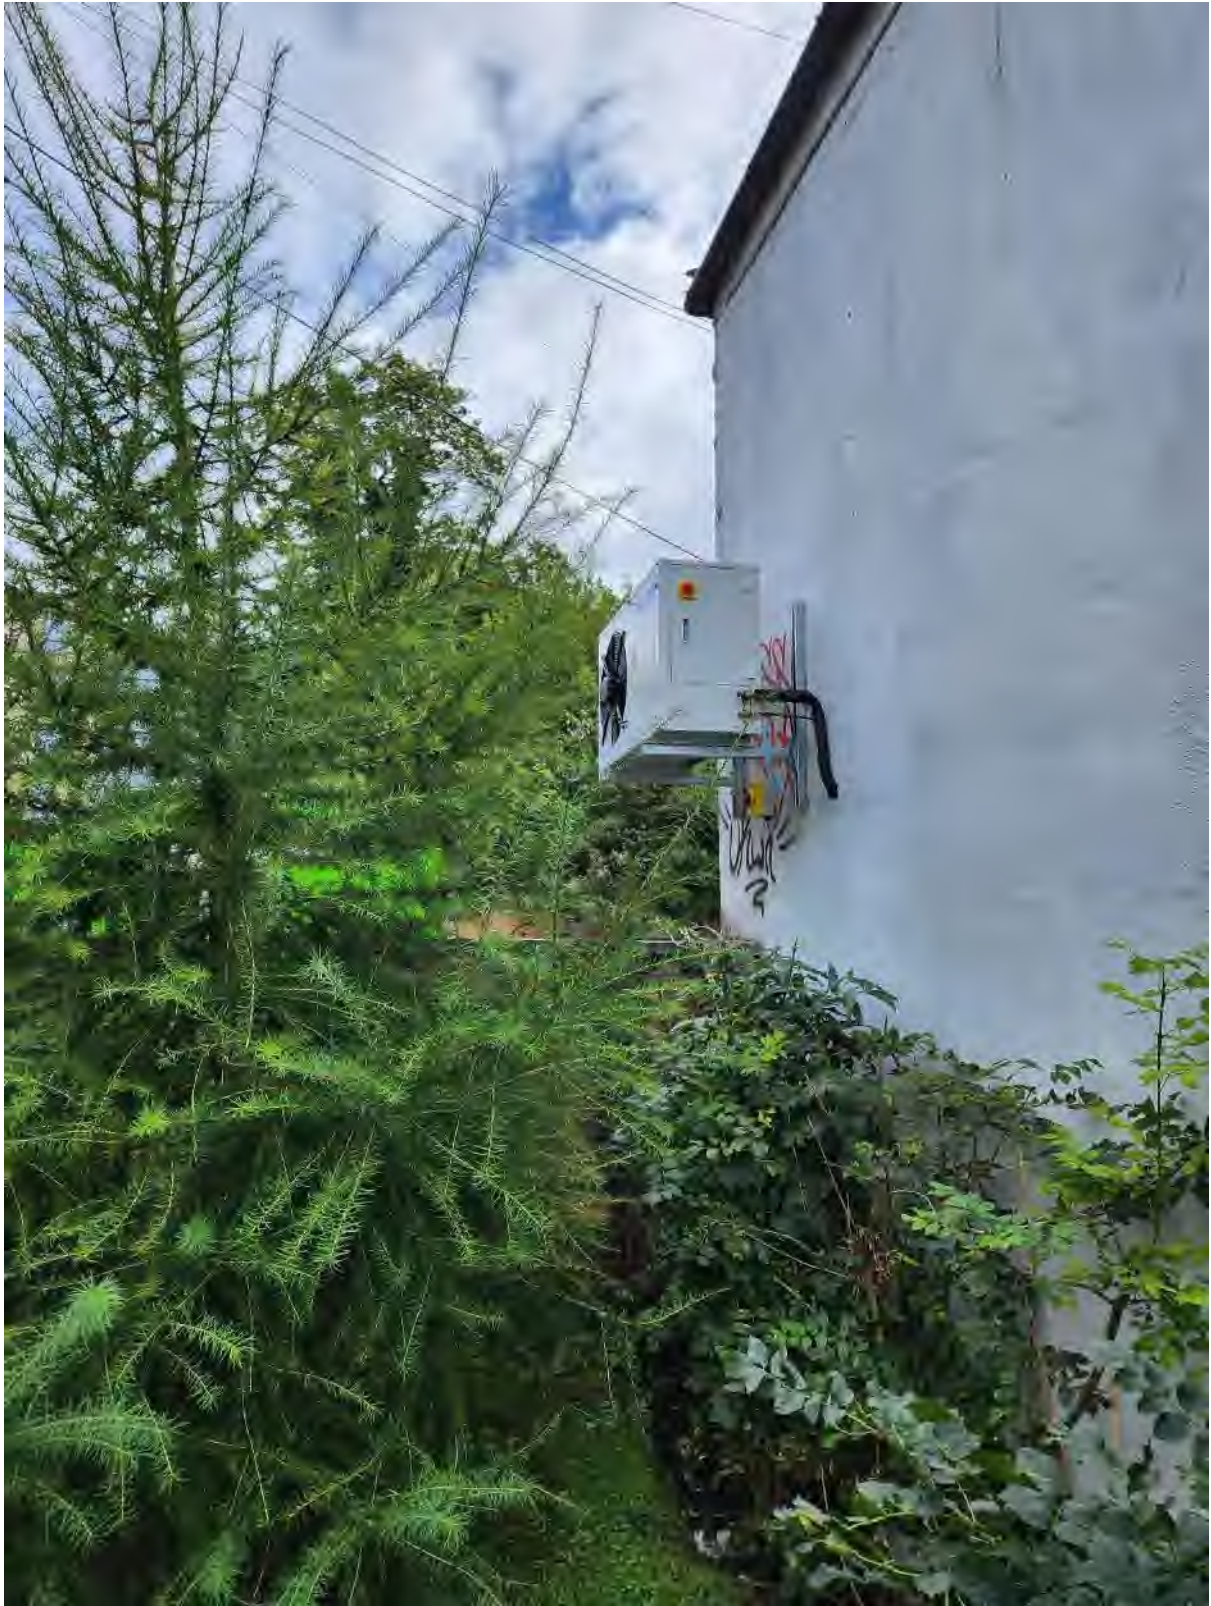
| Condition survey:<br><br>No major or visual defects to the tree | | | |
| Offsite notes-<br><br>Tree is the wrong specimen in the wrong place. To retain the tree would require remedial works that are impracticable and lead to poor future form and potential damage to the surrounding infrastructure. As such before the tree requires remedial works to reduce from the phone lines and reduce from damaging property it would be recommended to remove and replace with a more suitable specimen in another location. | | | |
| QTRA Rating:<br>1/1mil+ | Physiological<br>condition: good | Structural condition:<br>good | BS:5837 category:<br>B1 |

| Monitor frequency:<br>Fell and remove within 1 month | | | |

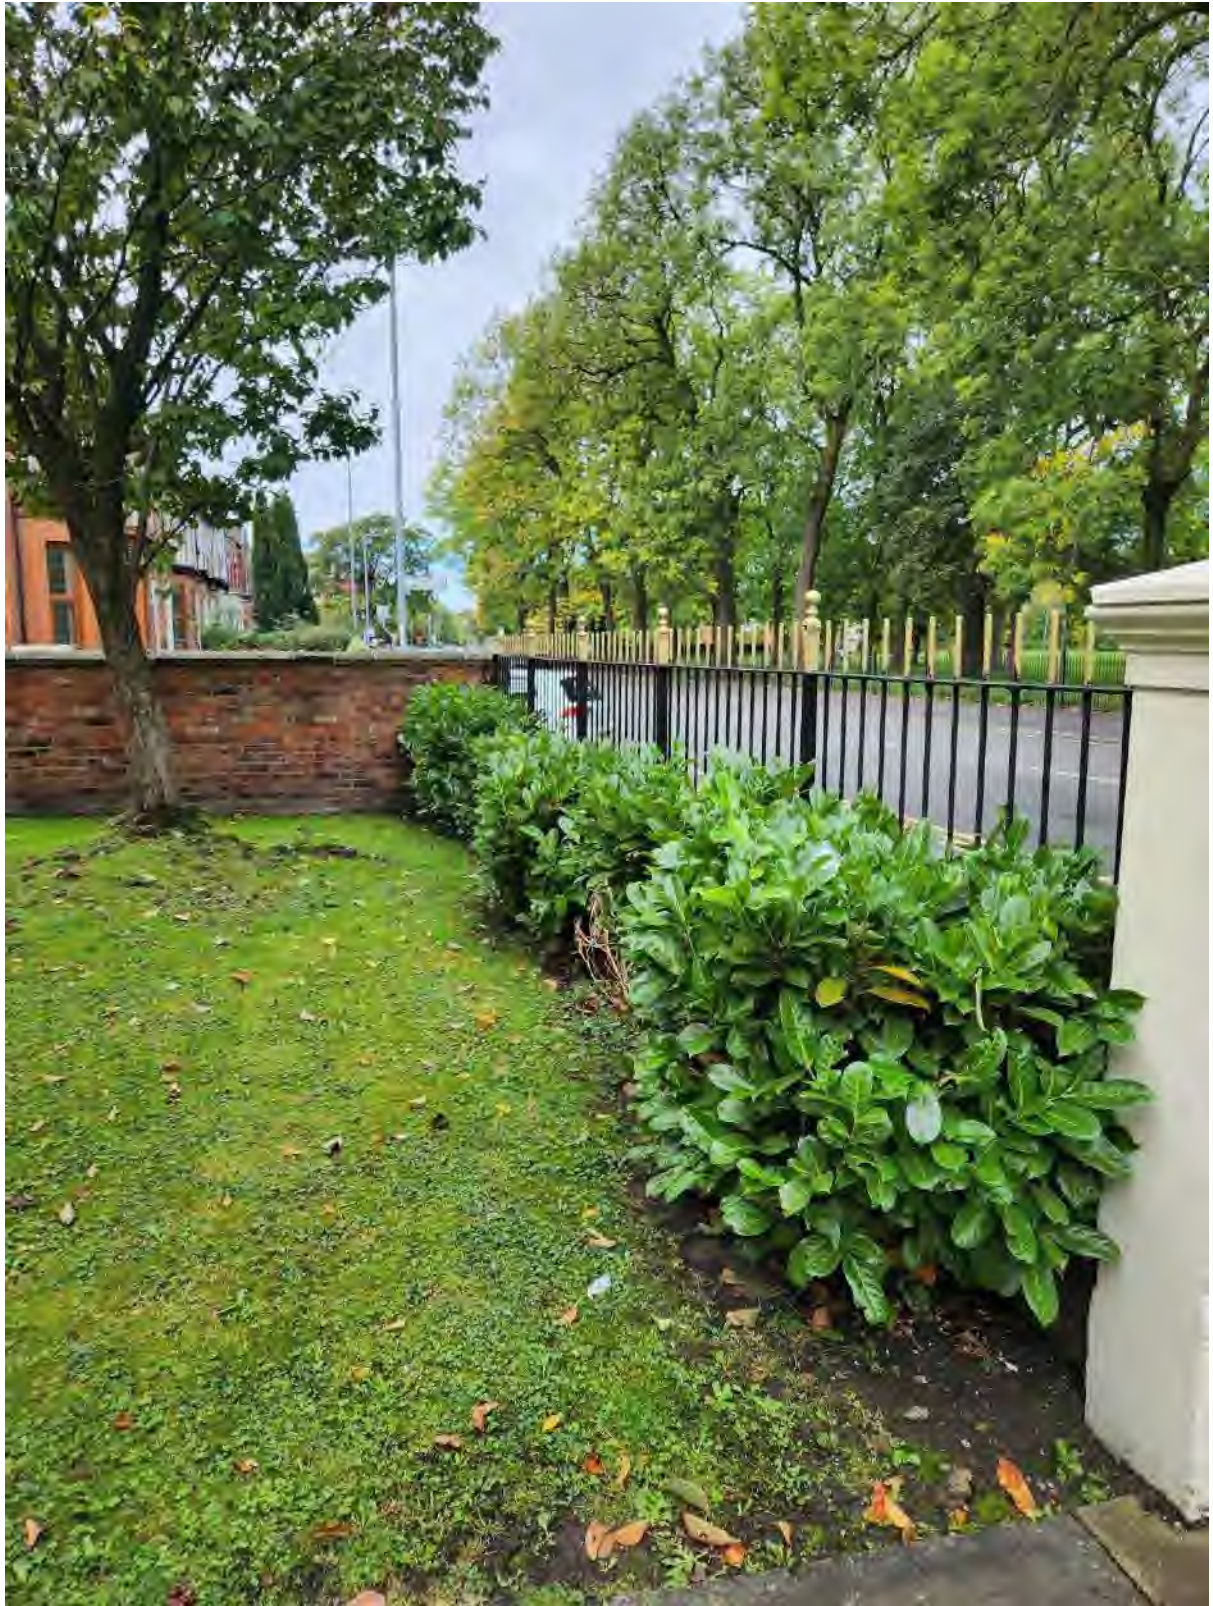
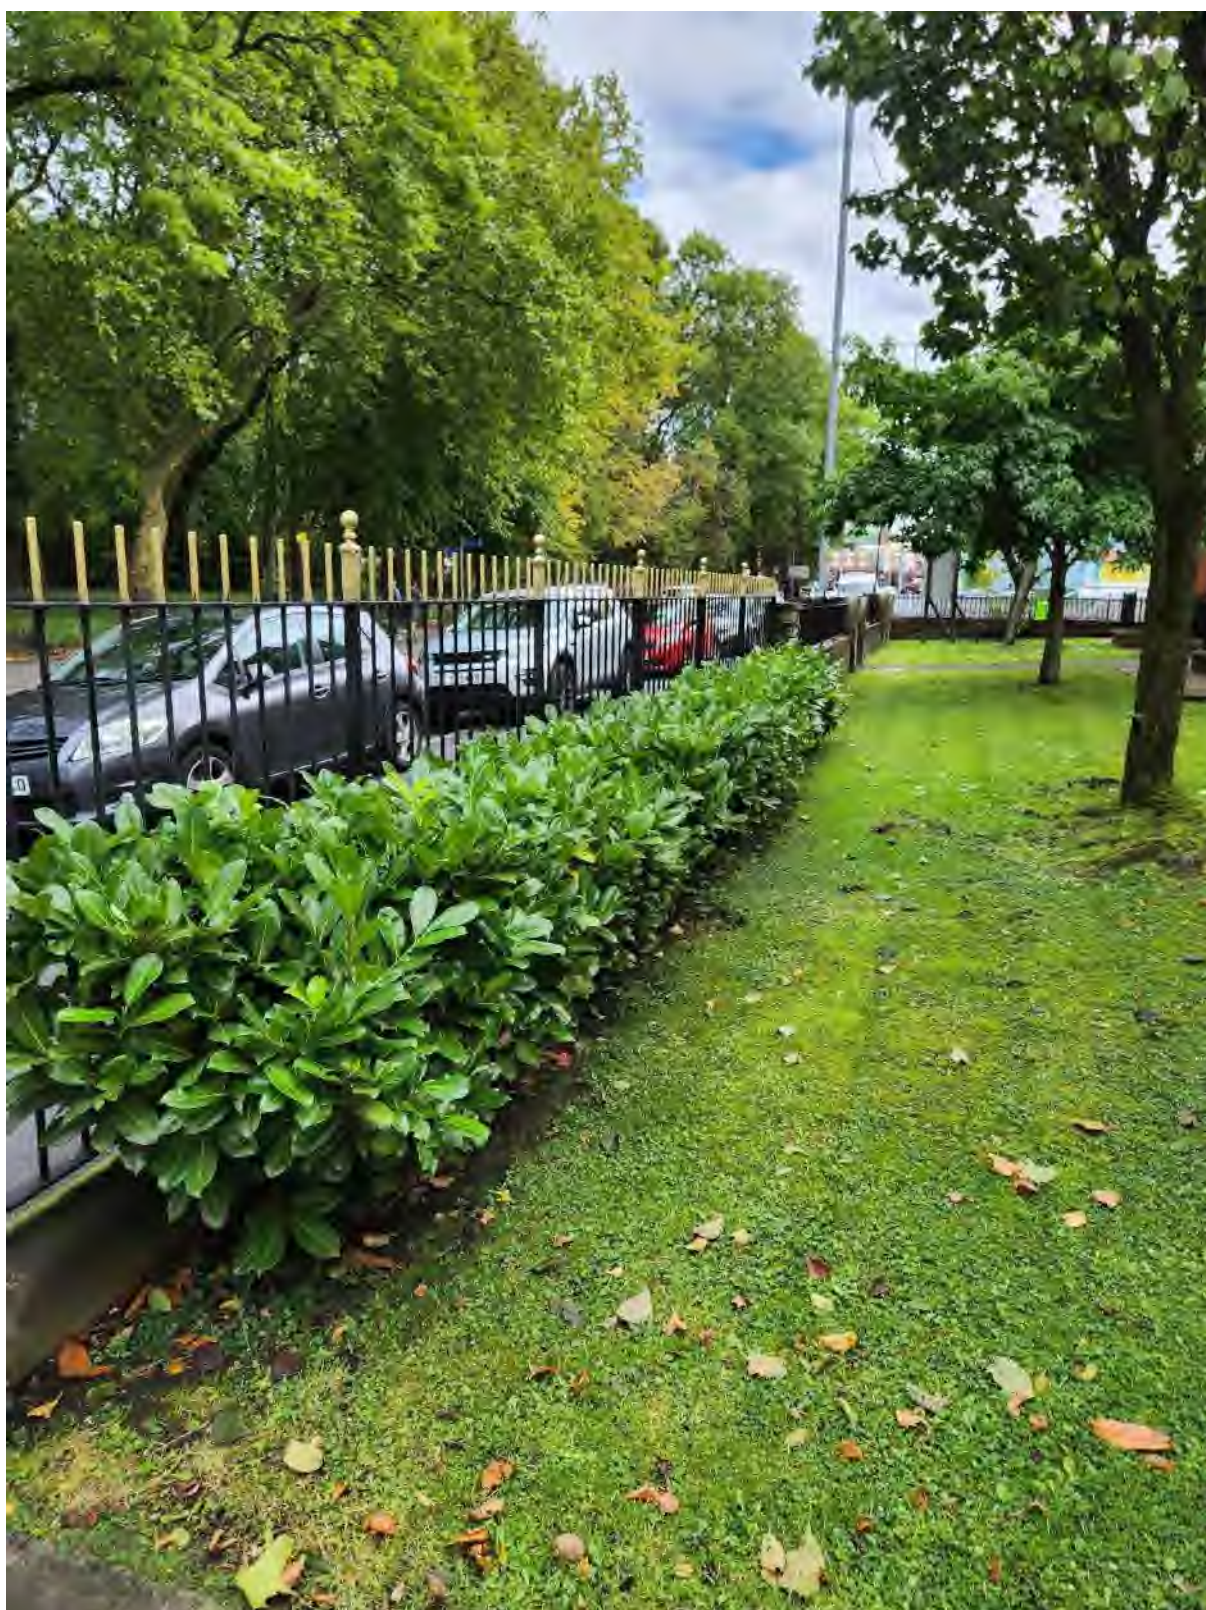
| Tree number:<br>H1 | Botanical name:<br>Prunus ssp | Height (m): 1.5 | DBH (cm): unknown<br>due to dense<br>foliage |

| Condition survey:<br><br>No major or visual defects to the hedge | | | |
| QTRA Rating:<br>1/1mil+ | Physiological<br>condition: good | Structural condition:<br>good | BS:5837 category:<br>B3 |

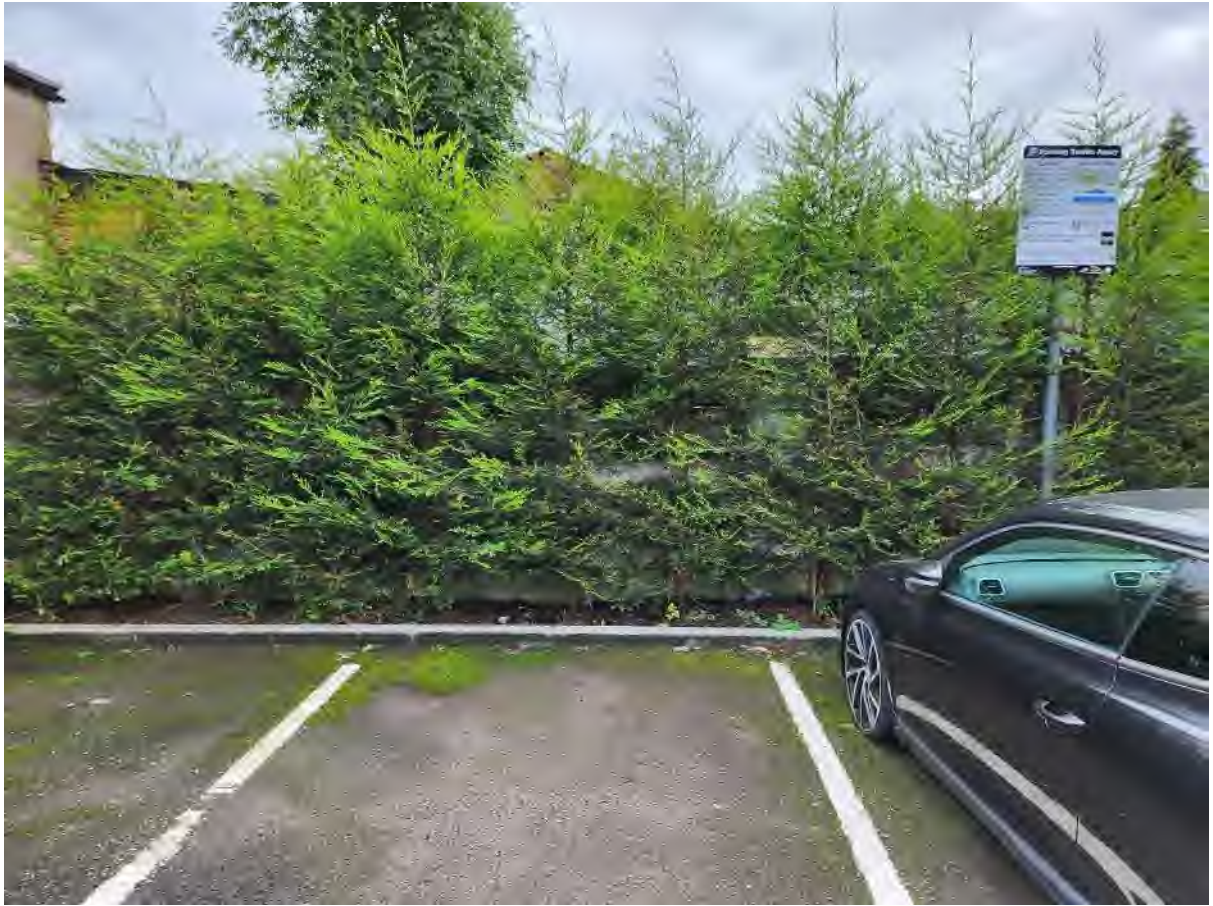
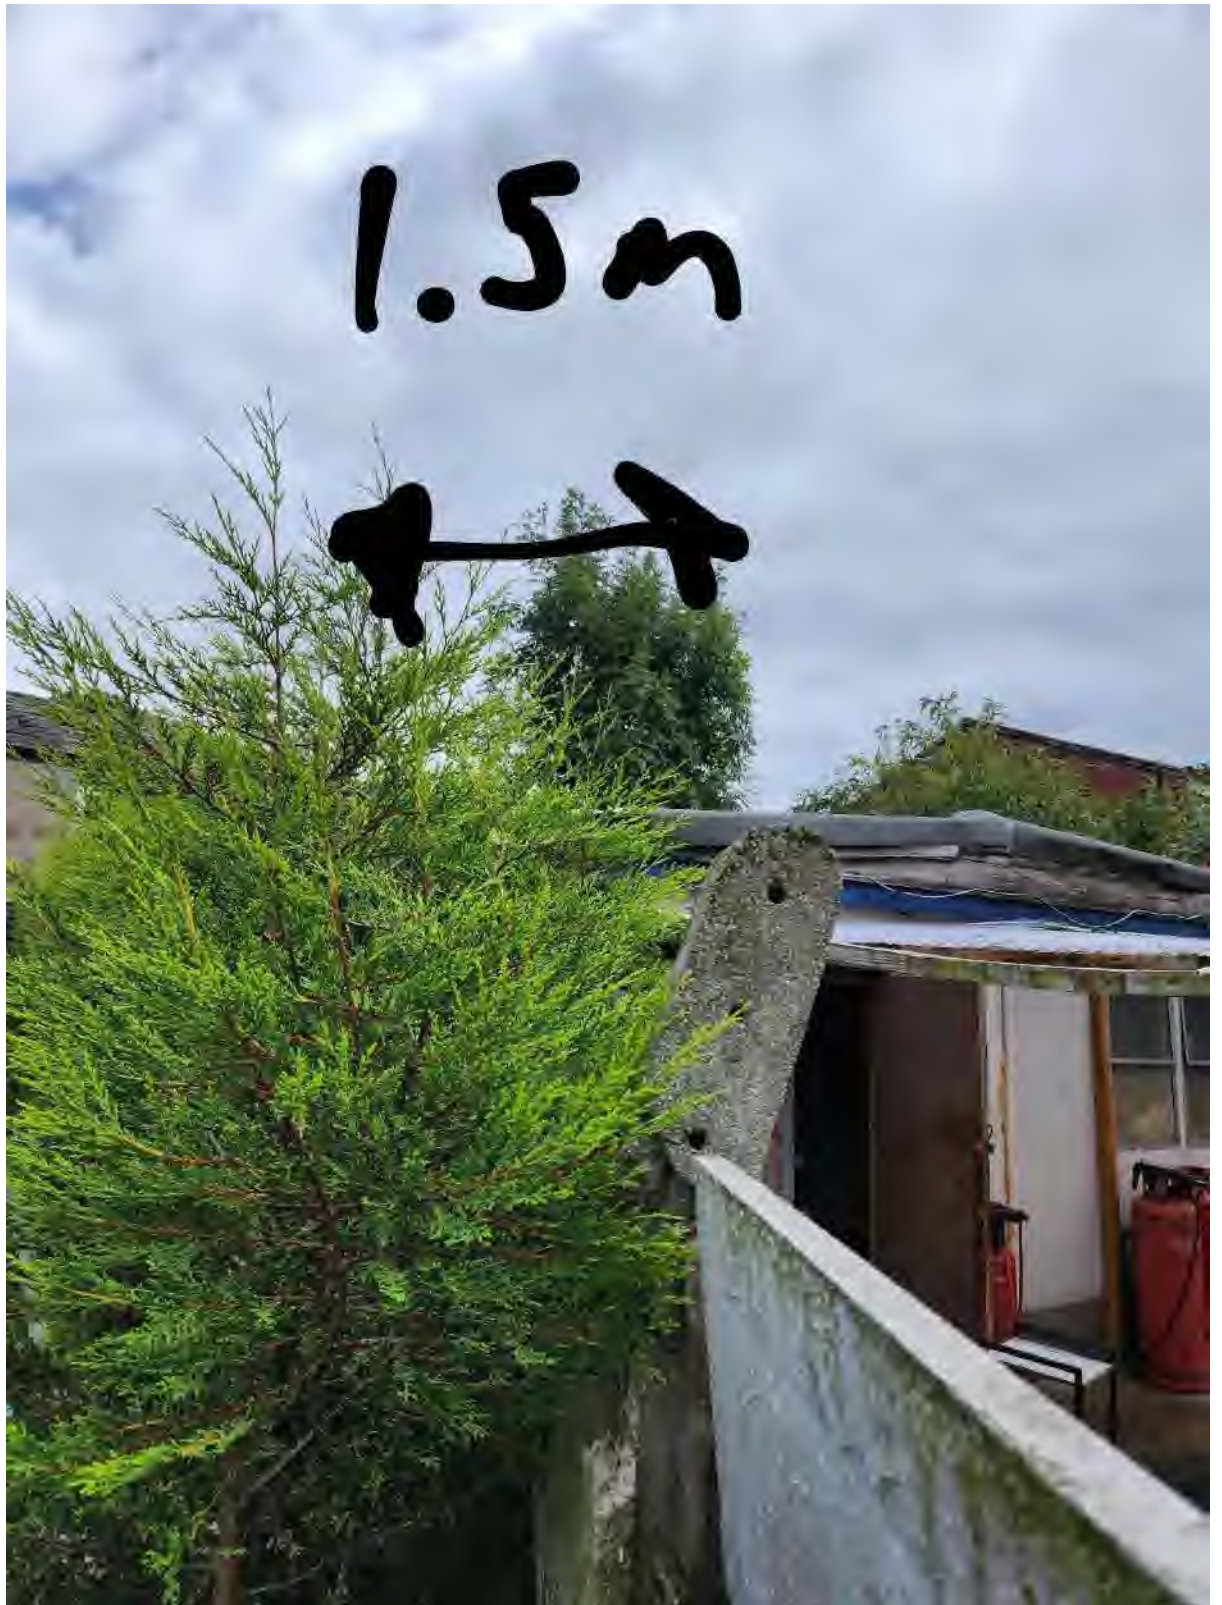
| Condition survey:<br><br>No major or visual defects to the hedge<br><br>Tree is located 1.5m to the property to the rear top to property | | | |
| Offsite notes-<br><br>With eh growth potential of the species it is unfeasible and impracticable to expect correct management for long term sustainability. It is recommended this hedge to be removed and replaced once construction is finished in a more suitable location with suitable specimens | | | |
| QTRA Rating:<br>1/1mil+ | Physiological<br>condition: good | Structural condition:<br>good | BS:5837 category:<br>C3 |
