PORTLAND STREET ELEVATION. (Image taken prior to current repair works.)

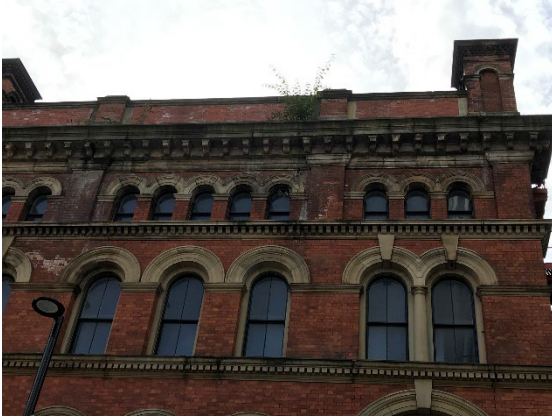
Vegetation to be removed and masonry repointed to cornice. See spec for outline description of new lead cladding to cornice.

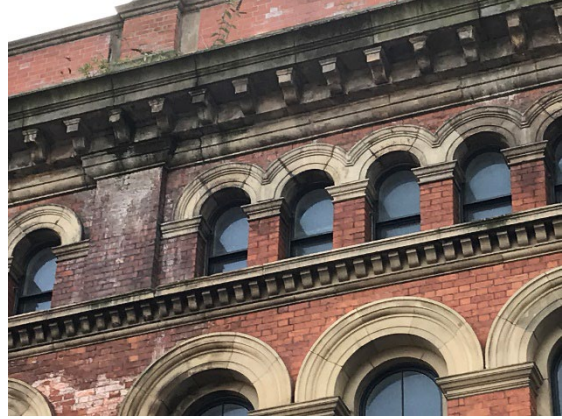
Water staining on the masonry at high level is to be investigated further.

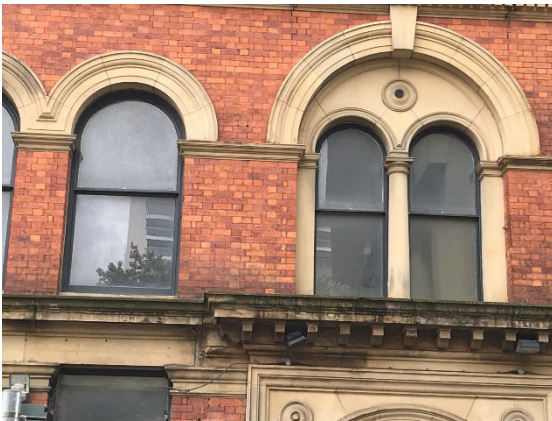
Typical sash windows for redecoration.

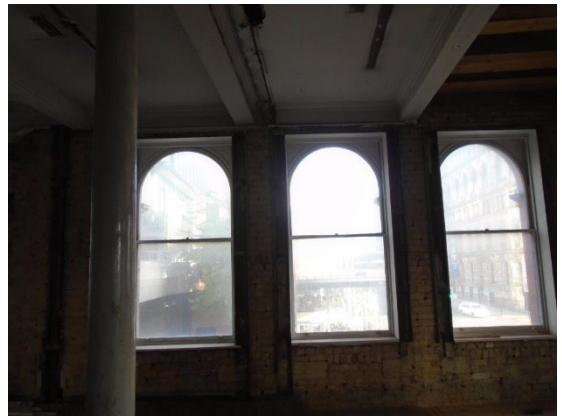
Typical sash windows (previously repaired). Include allowance for easing works.

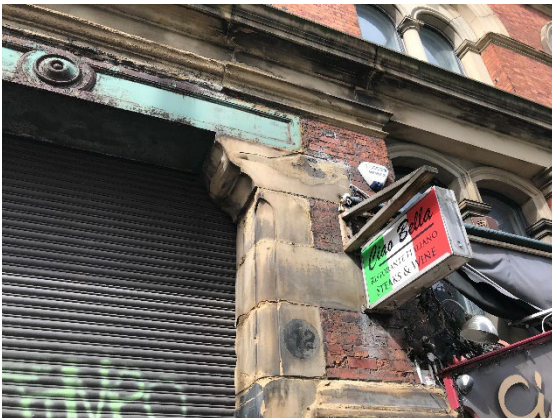
Spalled stone and masonry. (image taken prior to current works)

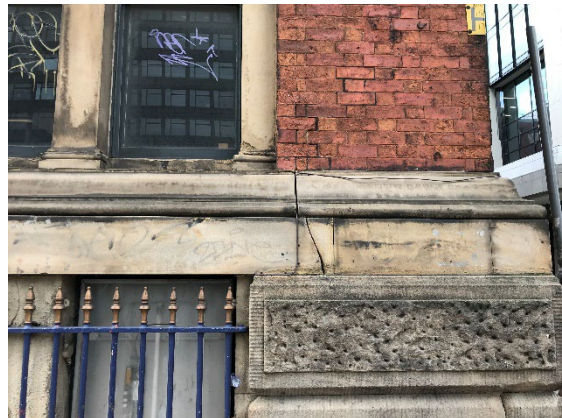
Typical indent repair to stone coursing.

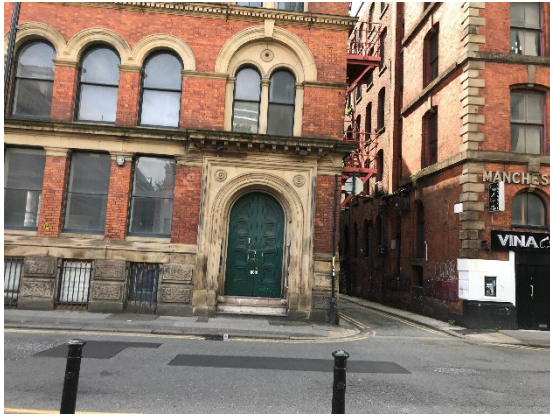
Front door to be overhauled and redecorated.

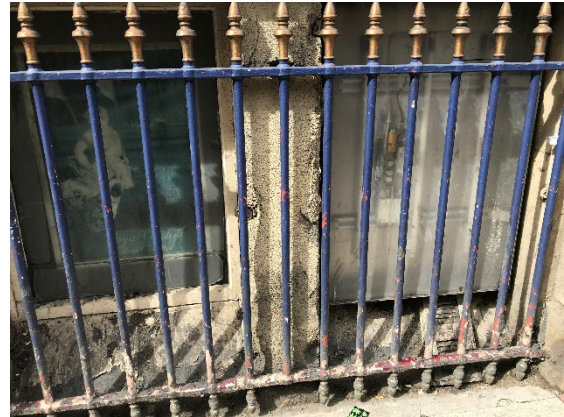
Typical cast iron railing to be redecorated and indent repairs to mullions behind.
