# **BAA.2210 Victoria North HIF Infrastructure Main Works**

## **Emerging Water Technical Note**

Prepared by BAM Nuttall

25/11/22

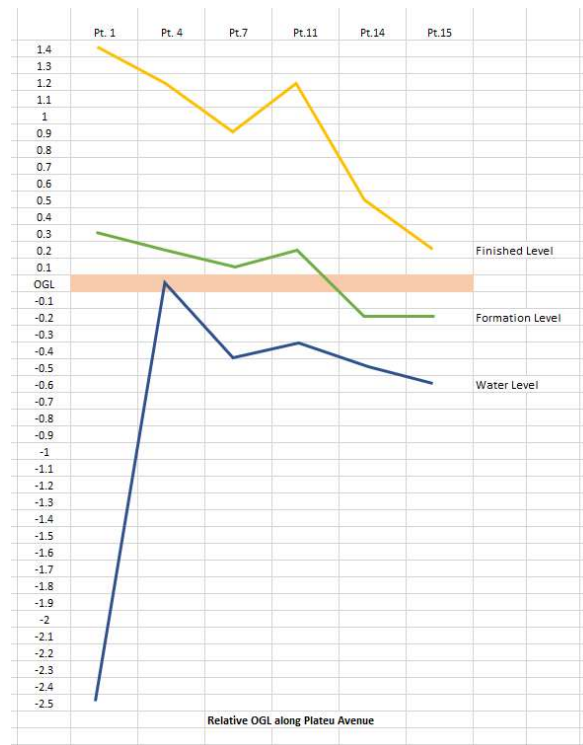
Figure 1 - Ground Water Levels Against OGL

Plotting the difference relative to OGL gives the next graph, Figure 1, shows we are only encountering ground water within 200mm of levels around Pt4 CH330 (Plateau Av), and not in areas where the plots are being developed .

The above ground water measurements suggest that the emerging water is not draining through the ground at a level which will be encountered during proposed earthworks on the plots. Additionally, the presence of dry wells in the context of a constant 0.216l/s flow rate into the area of emerging water suggests that water is not infiltrating through the ground freely at a level which will be interfaced with during wider earthworks across the site. Due to the made ground in the area it may be that it is freely infiltrating vertically to lower levels outside of the remediation levels.

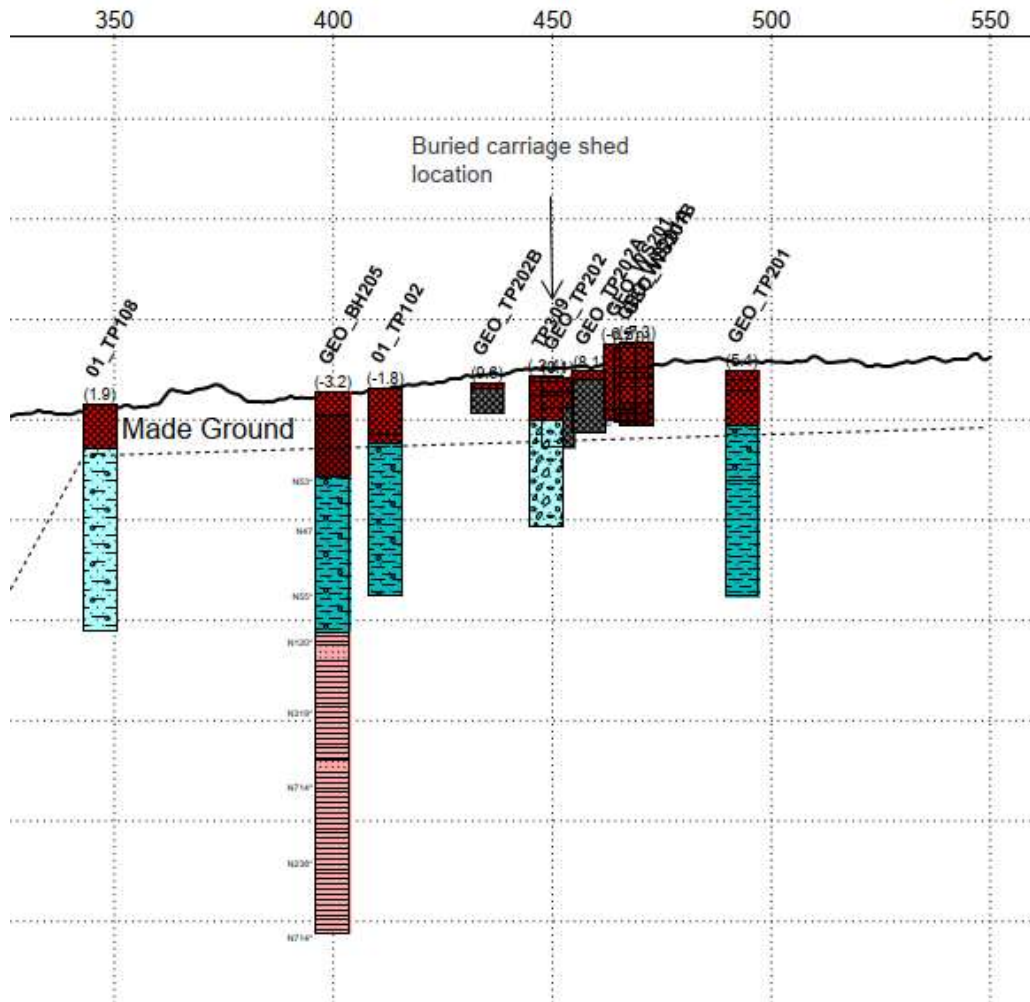
Figure 2- Geotechnical Boreholes from GIR (pdf pg 1188)

Reviewing the geotechnical boreholes around the emerging water, Figure 2 and Appendix 7 – Geological Long section – Red Bank Plateau, provides evidence to support the change in water level between Pt.7 and Pt.9, -450mm to -2300mm (OGL), is prevented from infiltrating by a localised lens of cohesive material. Which runs along between Plateau Avenue and the development plots of RB05, between TP108 and BH205.

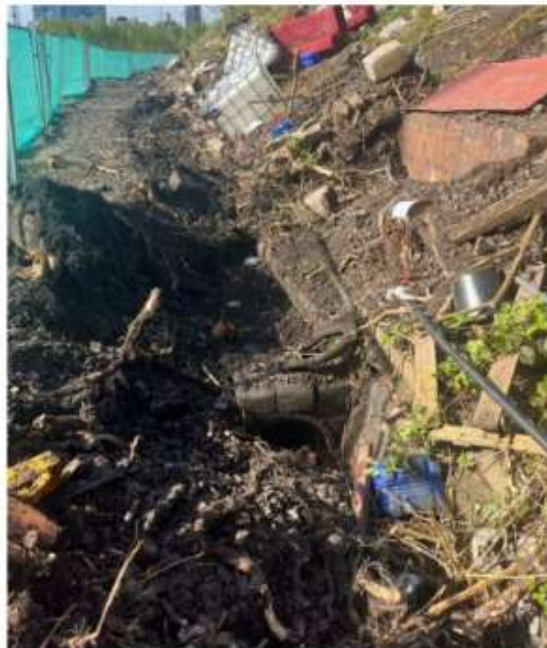
A. Headwall uncovered

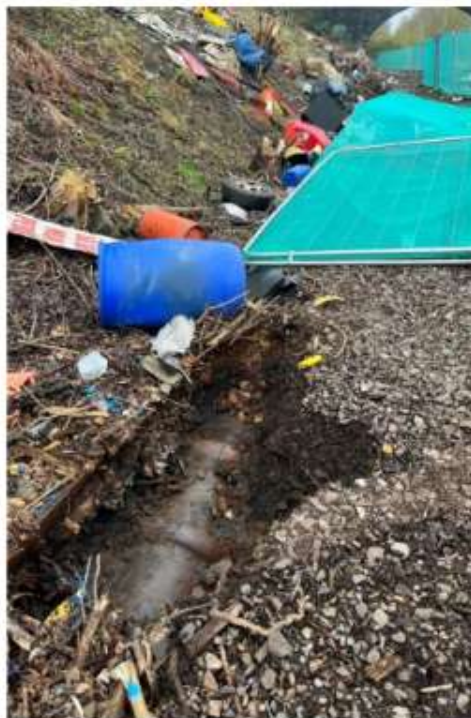
B. Clay pipe work of culverted section of drain

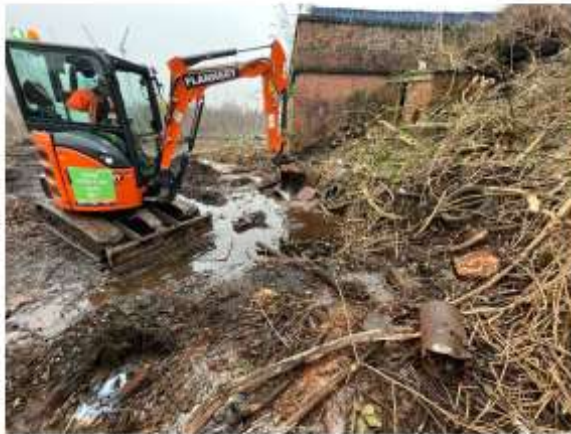
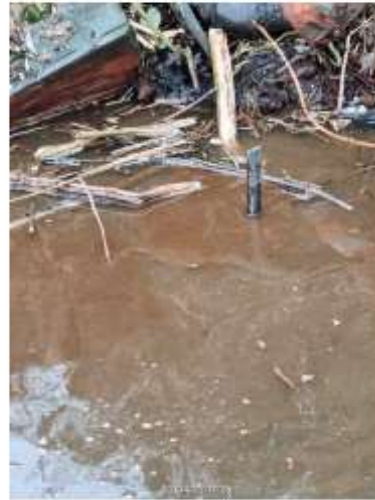
C. Area where water emerges from existing ground

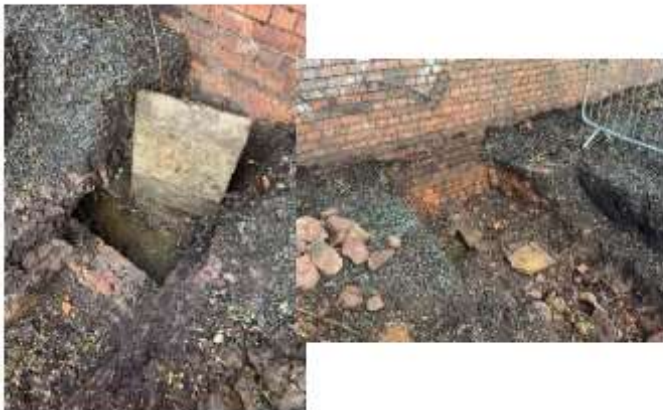
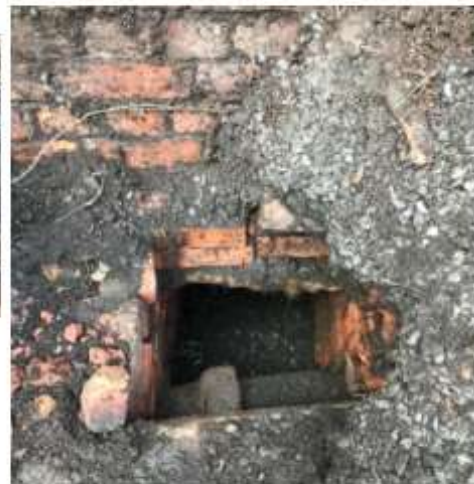
D. Identified areas of culvert/drain construction

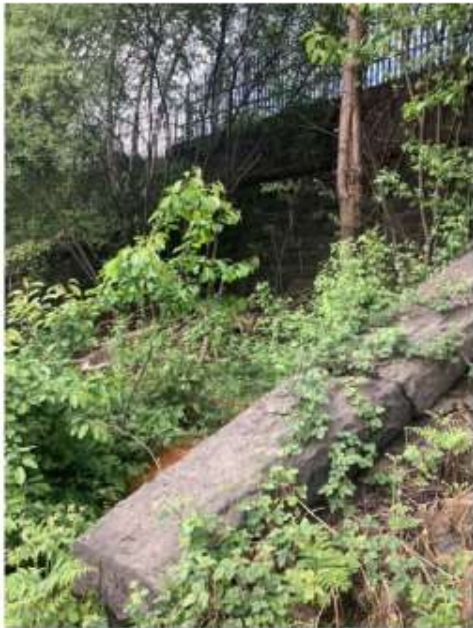
Outfall present day overgrown

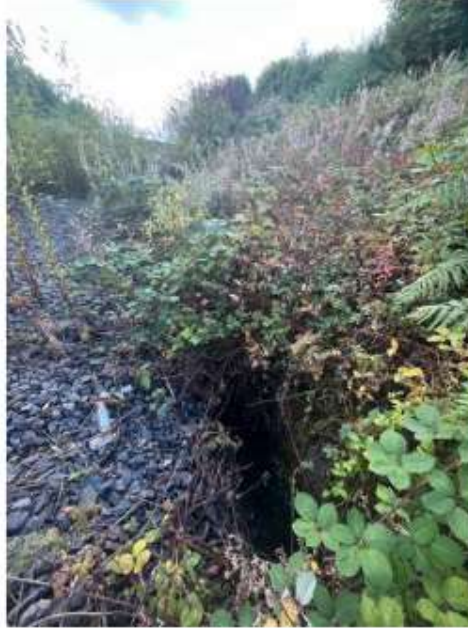
Fig 1: Open channel off site towards Queens Road tram depot.

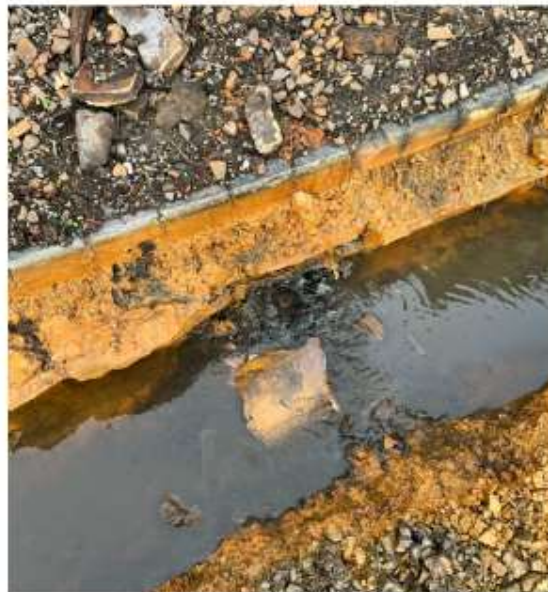
Fig. 2: Incoming pipe from the Showman's Guild direction @ CH430, with a significant flow of water. This water appears clear compared to the water in the channel.

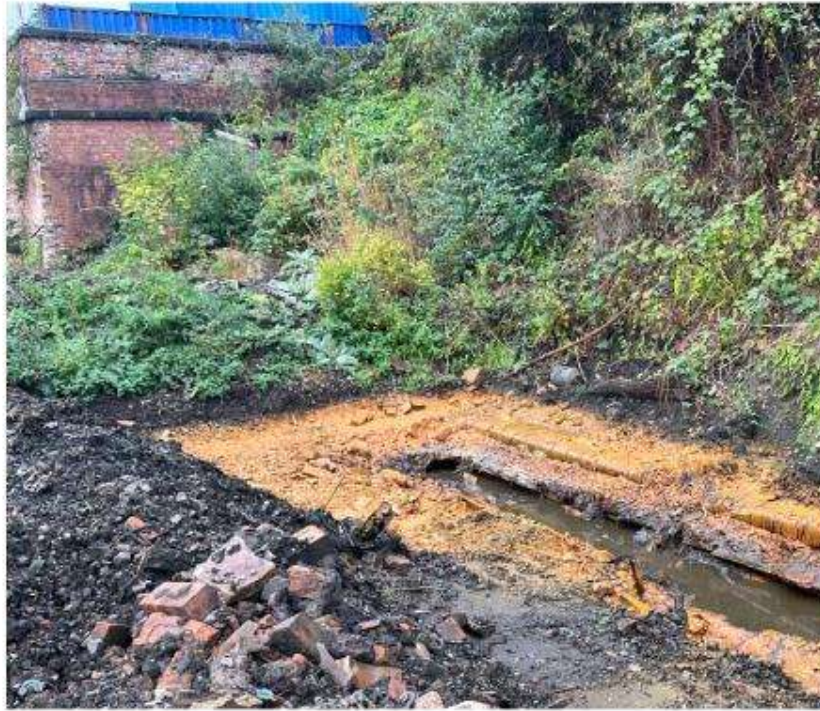
Fig. 3: Approx. 450mm pipe going from the channel to the spring location under the bund.

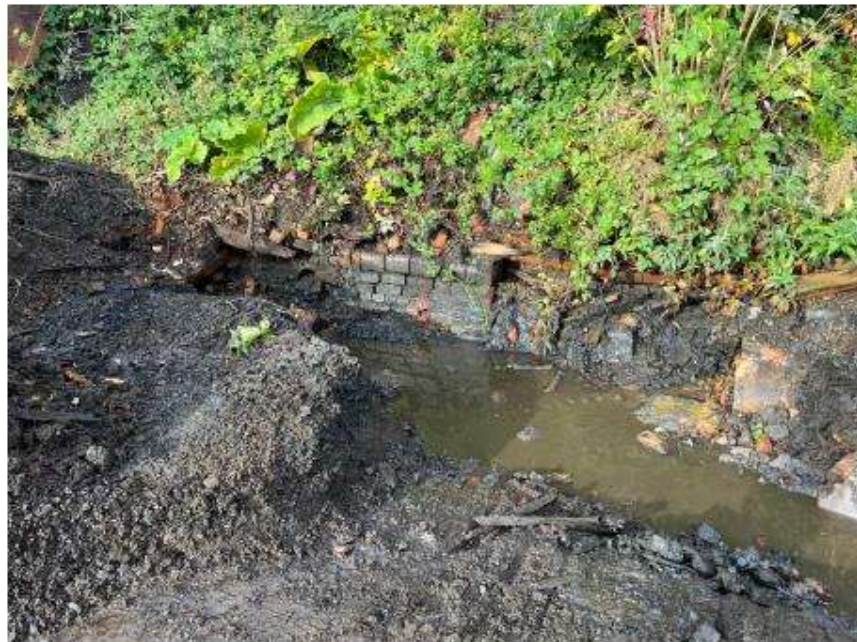
The investigation the emerging water to be discharging from a broken pipe (Appendix 1b – Onsite Drainage Investigation fig 4) which historically drained to the public sewer across site via a now derelict drainage network, at the point of the emerging water. The ultimate source of the incoming flows is still unknown, but there is potential for it to be emanating from a historic landfill to the north of the site. Tracing the pipe below the Showman's Guild embankment has found that 14.5m from the break it changes direction which has prevented the camera team getting further. This information is being used to determine possibilities of where this pipe goes, but the length before the turn suggests the turn is either before or at the crest of the embankment, which makes any intrusive survey impractical.

Fig 4: Emerging water location, after pumping.

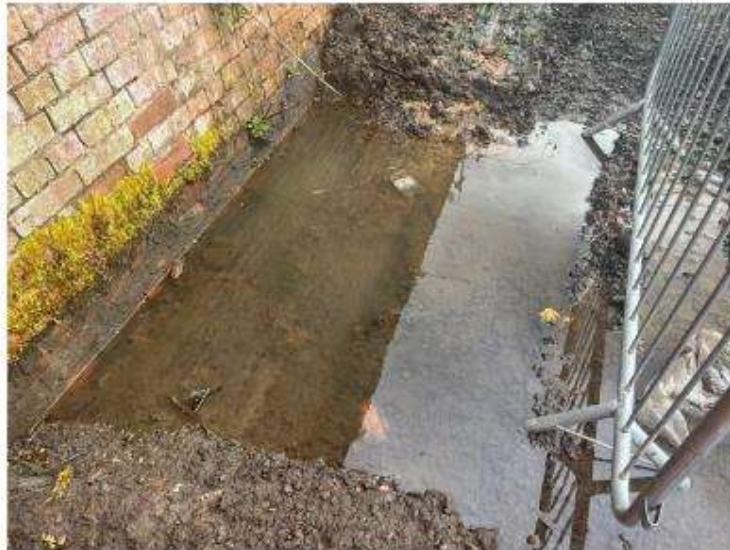
Fig 5: Attempted trail hole to locate the culvert run @ CH290. This hole had to be abandoned due to high ground water, however the culvert was seen.

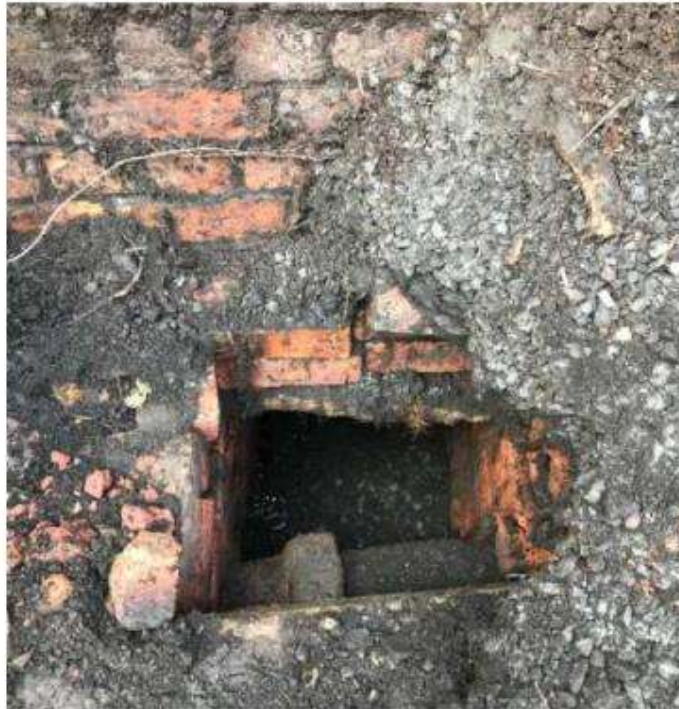
Fig. 6: In this location we observed the culvert running parallel to Honey Street retaining wall passing over a second culvert of similar construction, coming from under Honey Street Wall. The first culvert continues along the wall and the second one continues to a nearby chamber. Water has been observed to be running through this second run. These two runs eventually converge in the manhole that was found with a Kelly block in it.

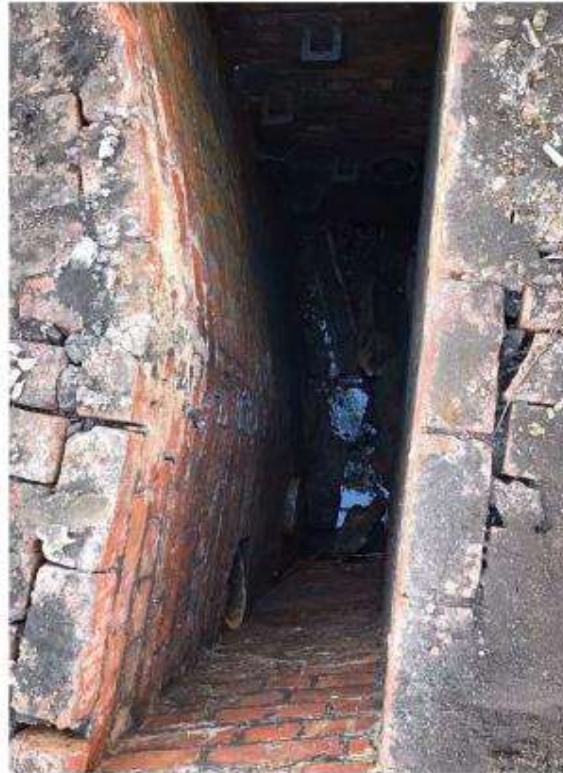
Fig. 7: This chamber is the destination of the run coming from under the wall in figure 6.

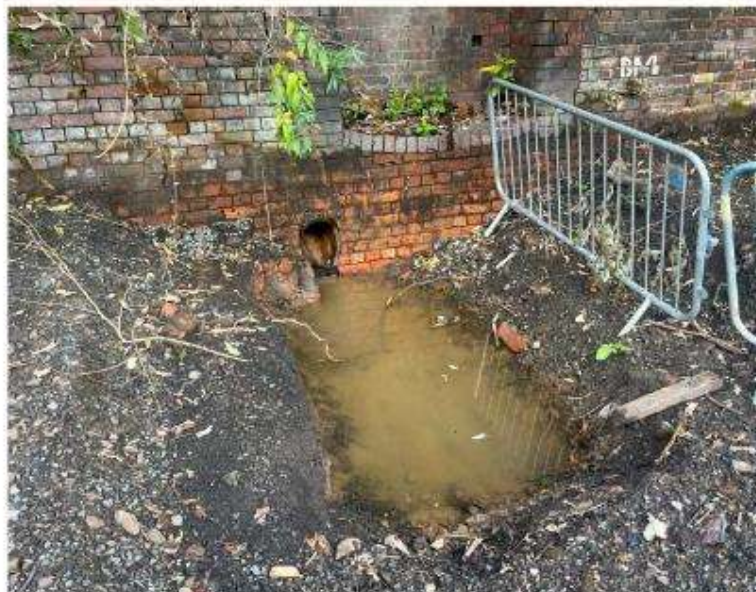
Fig. 8: A 200mm ceramic pipe coming from behind Honey Street wall @CH100. This pipe has had a constant trickle of water coming out since it was discovered.

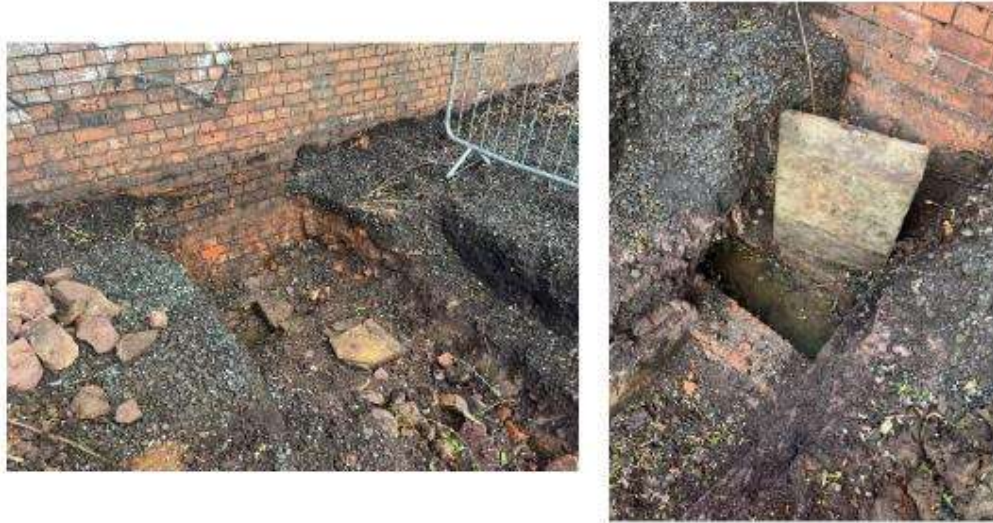
Fig. 9: a pair of trial holes completed to locate the culvert.

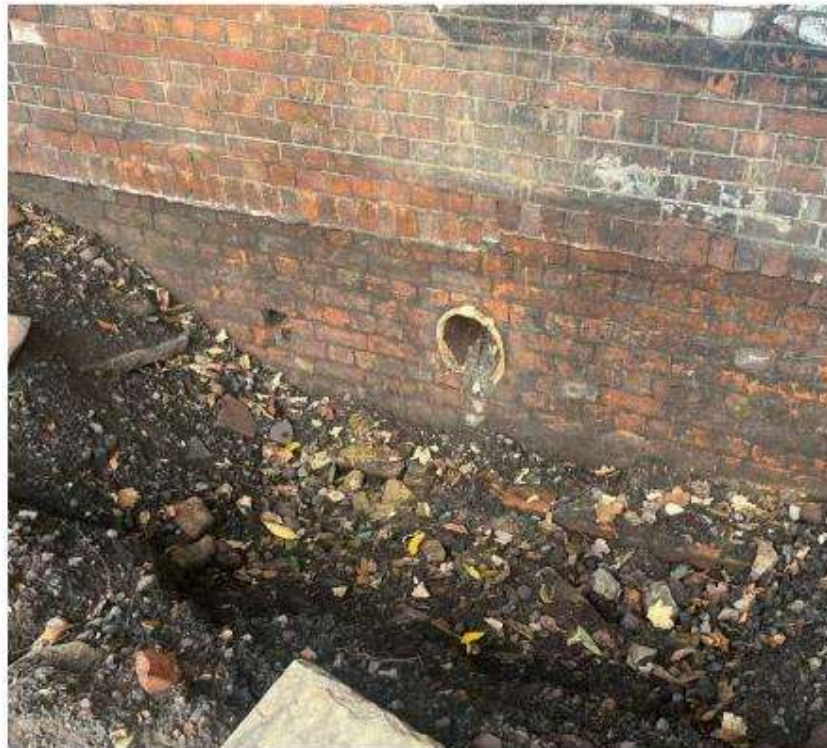
Fig. 10: A second 200mm pipe coming in from behind the wall, this one is dry.

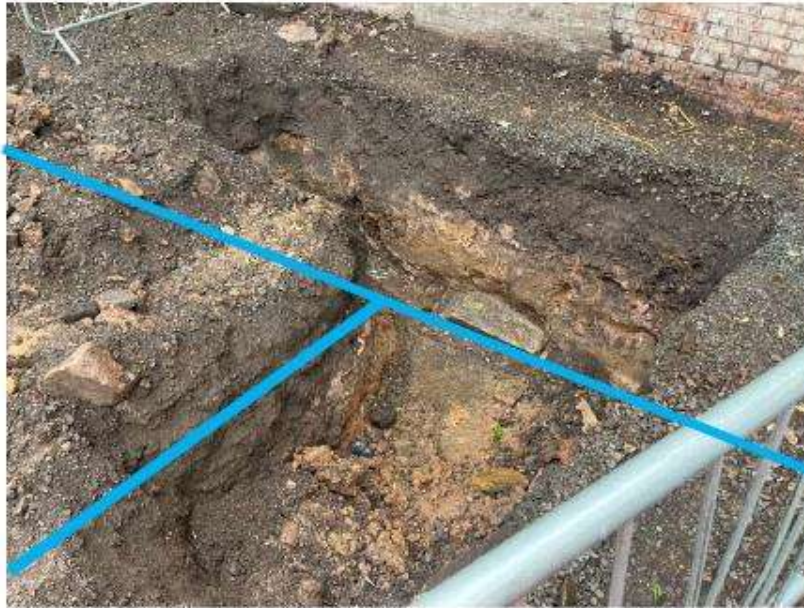
Fig. 11: 'T' junction in the culvert which, in operational condition, would collect water from in front of the retaining wall from both directions. This water is channelled South-East to another chamber.

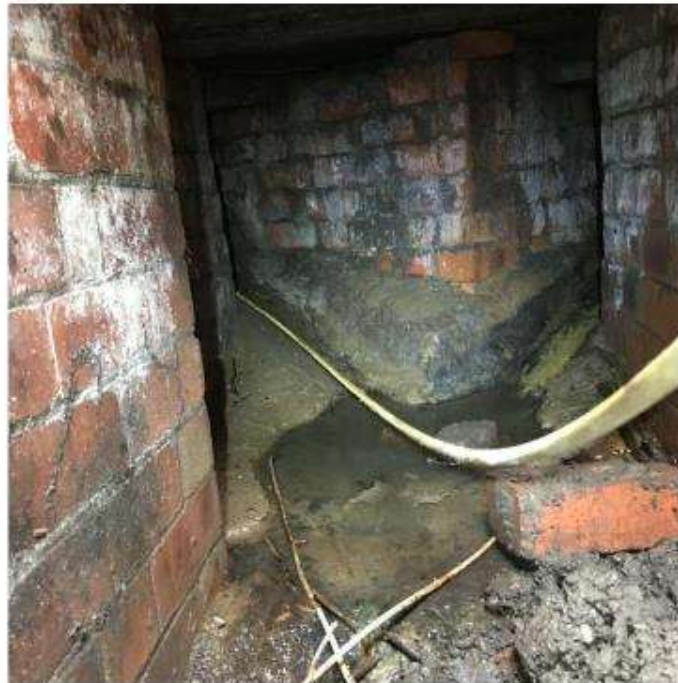
Fig. 12: Chamber at the bottom of the haul road. Picture taken on the inside, with the concrete 'V' shapes coming from the 'T' in figure 11 and a derelict and dry pipe running along the plateau.

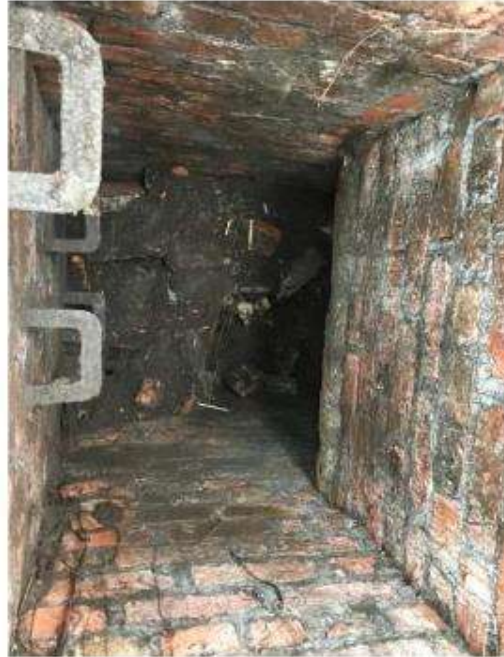
Fig. 13: This manhole was discovered by sending a sonde down from the manhole in figure 7. When it was located, a large concrete block had been wedged in it for an unknown reason. When the block was removed, the chamber was full of debris which was also subsequently removed. This chamber is the point at which both main runs we have discovered on site converge.

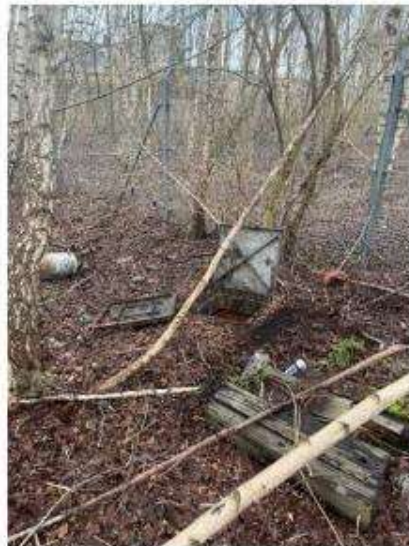
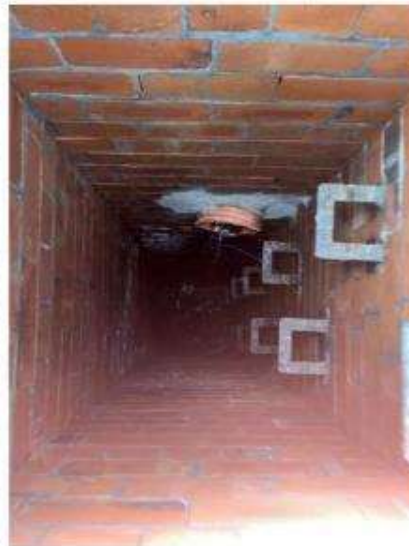
Fig. 14: 6m deep manhole which has water running through it. This manhole looks much more modern than the rest. Dye was put into the water in this chamber which was then seen on Hargreaves Street. We tried to sonde from this chamber but hit an obstruction. We suspect due to no water build up and the level difference between this chamber and Hargreaves Street that there is a drop shaft on this section.
