*Notes to be read in conjunction with Preliminary Drawing MCC\_B01\_R1\_DR\_B\_011\_S3.*

## 1.0 Roof

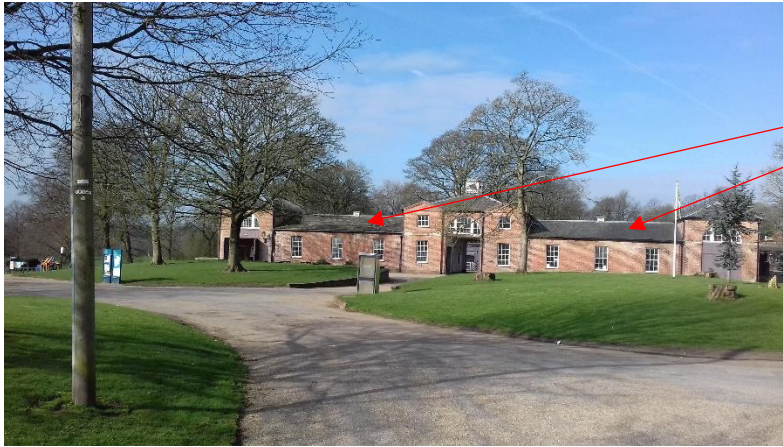
**Photo 1**

- c) The following issues have been noted:
  - o Investigation has calculated the pitches of the roofs over the café and workshop as approx. 13° - *minimum pitch for slate roof coverings is typically 20°.*

- o The slates have a maximum headlap of 75mm – *typically 130-150mm for a minimum roof pitch of 20°.*
  - o The slates/ underlay have a minimal overhang into the eaves gutters - *typically 45-55mm overhang in accordance with BS5534.*

- d) Site have reported correlation between water ingress and with wind driven rain, with the likely cause water tracking underneath the slates due to the low pitch and limited headlap.

Pitched roofs with  
slate coverings  
approx. 12°.

Limited slate/  
underlay overhang  
into gutter.

- g) Increase slate and underlay overhang into gutter to between 45-55mm in line with BS Standards.
- h) Lead detailing (stepped flashing, soakers, rolled lead ridge) to be replaced with new leadwork in accordance with Lead Sheet Association details – ***can lead alternatives be considered due to high incidences of theft (e.g. zinc)?***

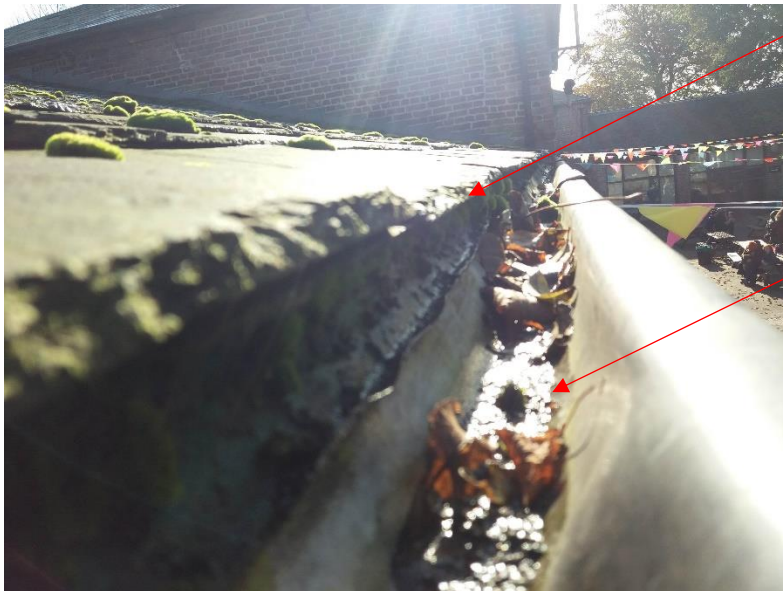
**Photo 2**

- o Existing box gutters which are lead lined cannot cope with the amount of rain and overflow; capacity is restricted by the lead lining which has reduced the depth and width of the gutters.

Lead lining reduces  
gutter capacity.

- a) Supply and install new treated timber gutter to existing profile and dimensions; coated internally with a bitumen or similar.
- b) Increase height of lip to outer edge of gutter to eliminate any potential overshoot of rainwater discharge.
- c) Omit lead lining in any replacement to increase internal gutter capacity.

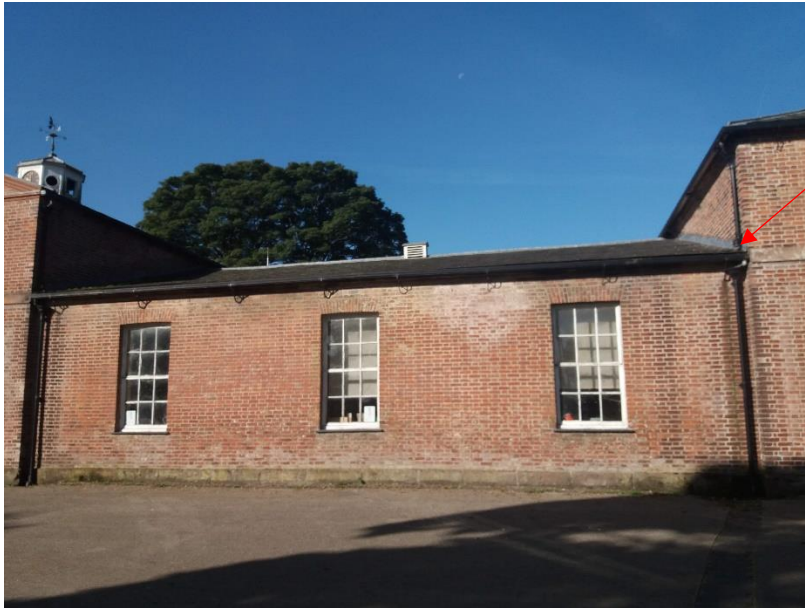
**Photo 3**

- o Rainwater from upper roofs drain onto lower roof slopes is compounding the above.
  - o The lead linings to the gutters to the low-level roofs do not lap under the slates as it was retrofitted following earlier theft without the eaves slates being removed.

Upper roofs drain  
onto lower roofs;  
rainwater goods  
over capacity.

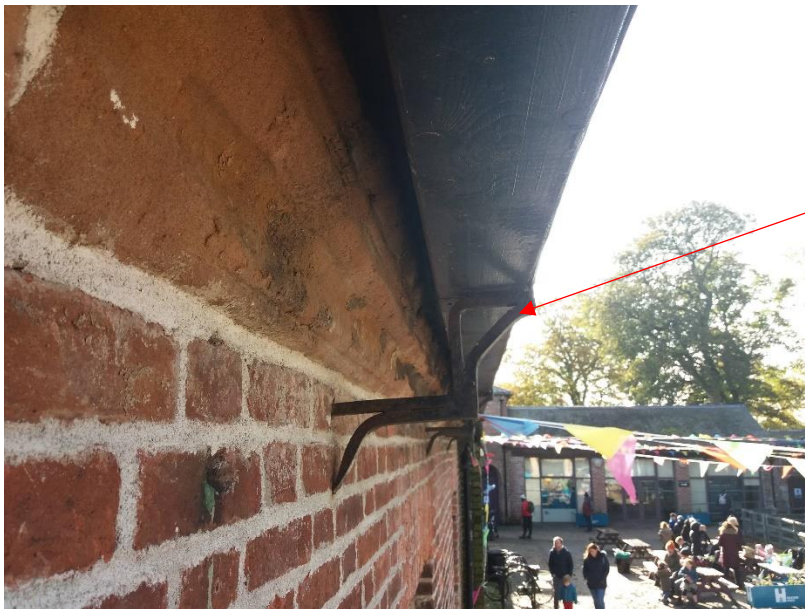
**Photo 4**

Existing gutter  
brackets restrict  
changes to gutter  
design/ capacity.

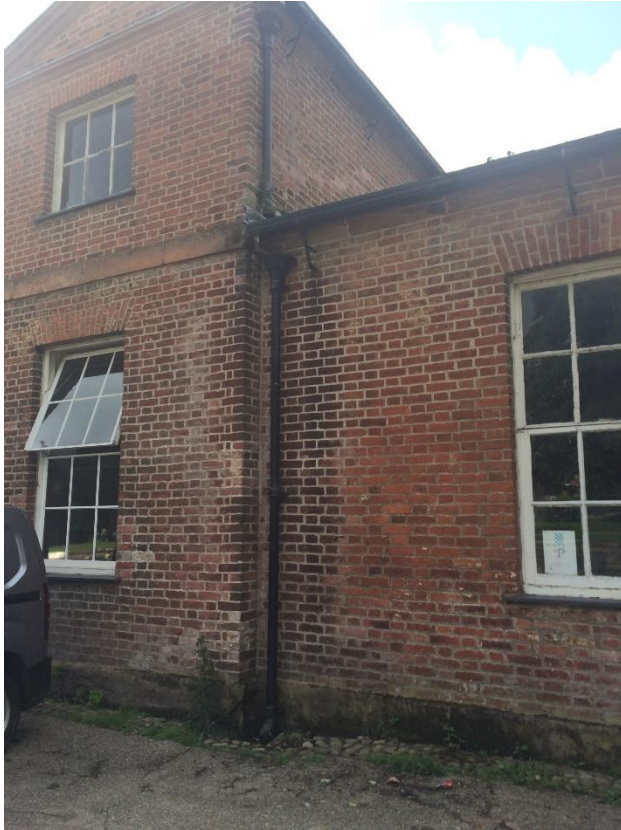
**Photo 5** – Existing hopper arrangement.

- d) **OPTION A** – Remove existing hoppers in locations marked on Drawing *MCC\_B01\_R1\_DR\_B\_011\_S3*. Replace with new purpose made timber hoppers as the indicative detail below to increase discharge capacity; as below.

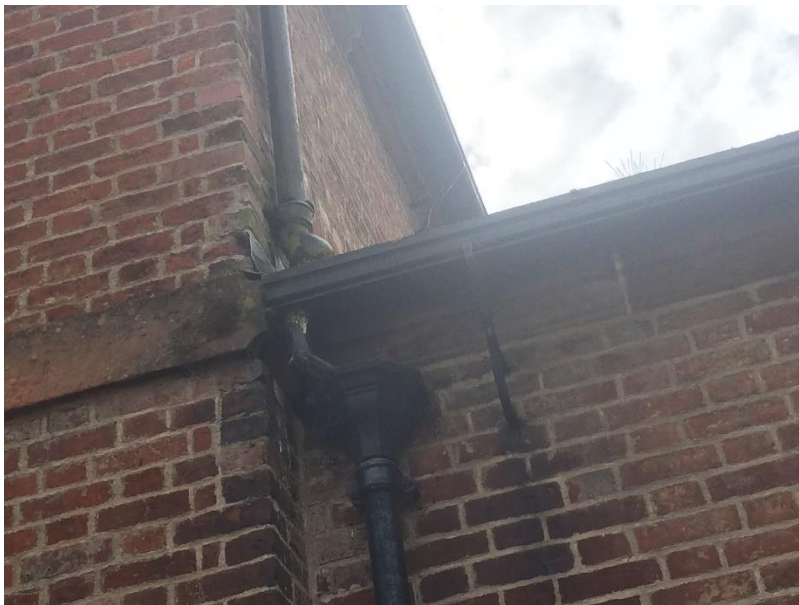
**Photo 6** – Existing hopper arrangement.

- e) **OPTION B** – Form additional lead outlet from gutter into existing hopper increase discharge capacity; as below.
