**Re: Application Number: 124265/FO/2019 – Vacant Land Bounded By Ashton Old Road, Lees Street And Stanley Street , Manchester- Condition 18**

I am writing to seek discharge of Condition 18 related to the installation of the drainage on the scheme.

# Drainage Report

**RETURNFLOW LTD**  
**Surveyor: D Scallan**  
**info@returnflow.co.uk**  
**07547648371**

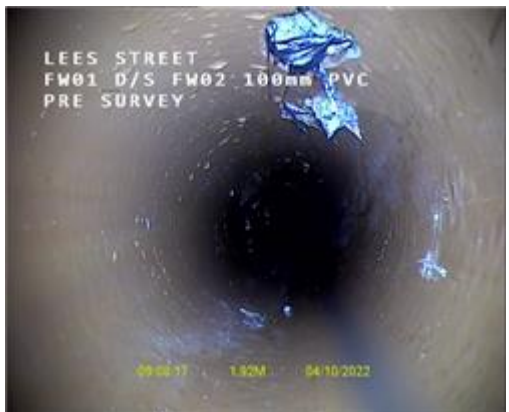
| Pos | Video Ref | Code | Description | Image |
|---|---|---|---|---|
| 01.90m | 0:00:15 | H | Hole in drain/sewer at 02 o'clock - Severity 4 | Image Provided - Ref: 0_3<br> |

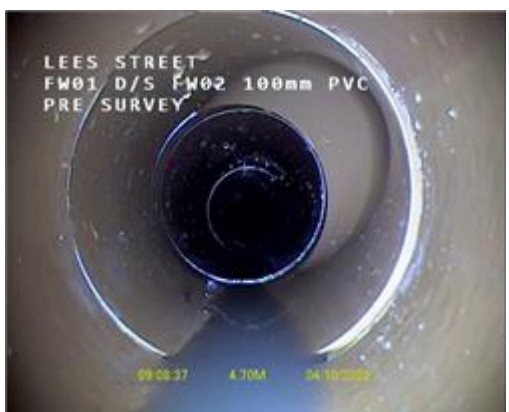
| Pos | Video Ref | Code | Description | Image |
|---|---|---|---|---|
| 04.70m | 0:00:36 | JN | Junction at 03 o'clock: 100mm Diameter | Image Provided - Ref: 0_4<br> |

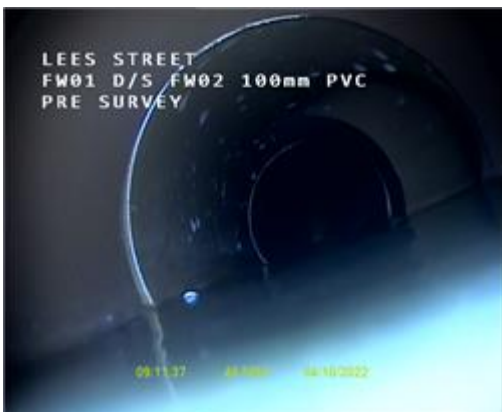
| Pos | Video Ref | Code | Description | Image |
|---|---|---|---|---|
| 45.50m | 0:03:37 | JN | Junction at 03 o'clock: 100mm Diameter | <p>Image Provided - Ref: 0_12</p> |

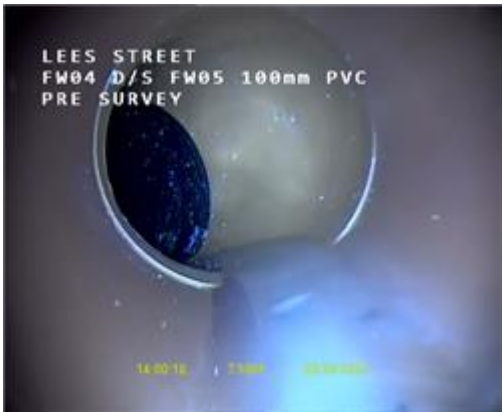
| Pos | Video Ref | Code | Description | Image |
|---|---|---|---|---|
| 07.58m | 0:00:22 | LLQ | Line of drain/sewer deviates left [quarter] | <p>Image Provided - Ref: 2_2</p> |

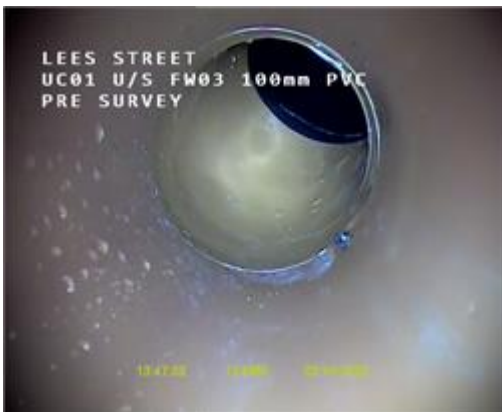
| Pos | Video Ref | Code | Description | Image |
|---|---|---|---|---|
| 12.69m | 0:00:59 | LRQ | Line of drain/sewer deviates right [quarter] | Image Provided - Ref: 4_3<br> |

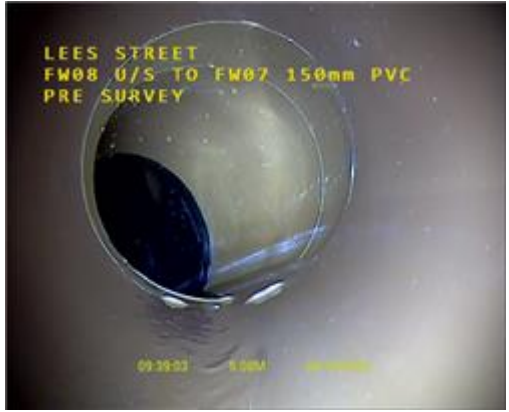
| Pos | Video Ref | Code | Description | Image |
|---|---|---|---|---|
| 05.08m | 0:00:21 | LLQ | Line of drain/sewer deviates left [quarter] | <p>Image Provided - Ref: 7_2</p> |

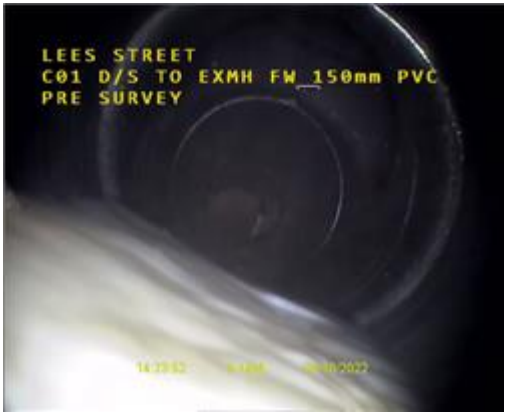
| Pos | Video Ref | Code | Description | Image |
|---|---|---|---|---|
| 06.14m | 0:00:41 | JN | Junction at 12 o'clock: 100mm Diameter | <p>Image Provided - Ref: 9_3</p> |

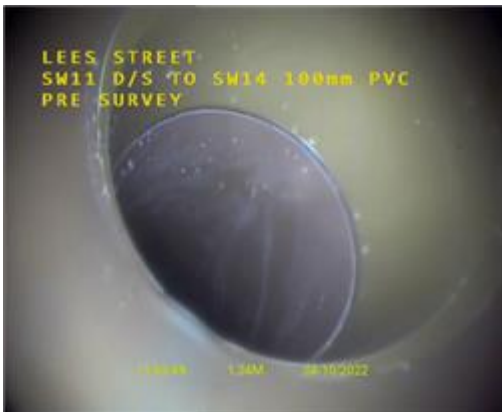
| Pos | Video Ref | Code | Description | Image |
|---|---|---|---|---|
| 01.34m | 0:00:10 | LDH | Line of drain/sewer deviates down [half] | Image Provided - Ref: 9_2<br> |

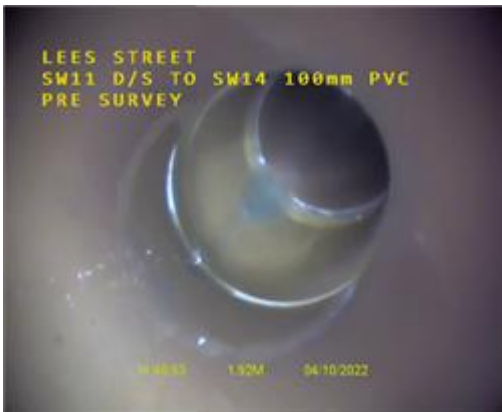
| Pos | Video Ref | Code | Description | Image |
|---|---|---|---|---|
| 01.92m | 0:00:14 | LUH | Line of drain/sewer deviates up [half] | Image Provided - Ref: 9_3<br> |

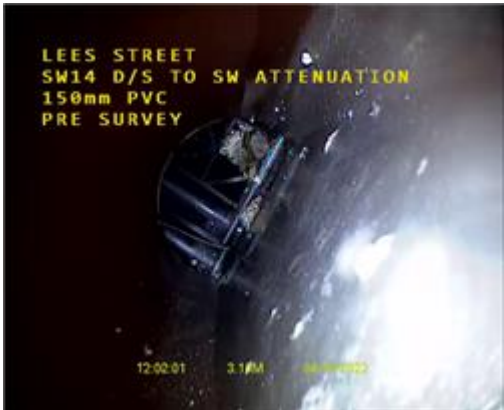
| Pos | Video Ref | Code | Description | Image |
|---|---|---|---|---|
| 03.18m | | SKF | Finish node type, soakaway SW ATTENTION | Image Provided - Ref: 14_9999<br> |
