## GAS MEMBRANE VALIDATION

| <b>Site: Brunswick- Manchester</b> | |
| Date: 09-06-2020 | Project Number: 14-207 |
| Ground Gas Risk Assessment: <b>Characteristic Situation 2 / Amber 1</b> | |

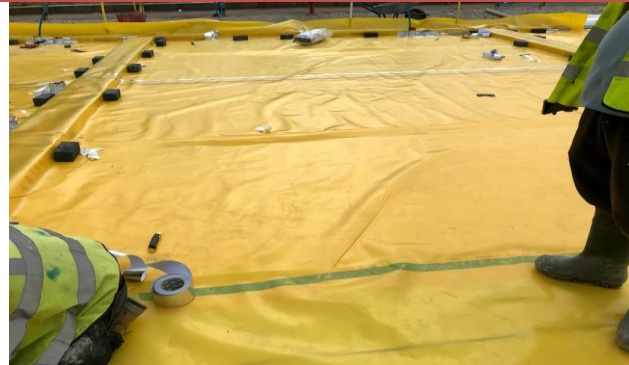
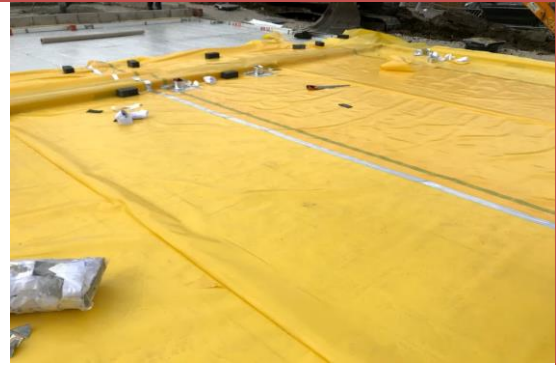
**Plot - 268**

**General Condition of Membrane-Good Condition**

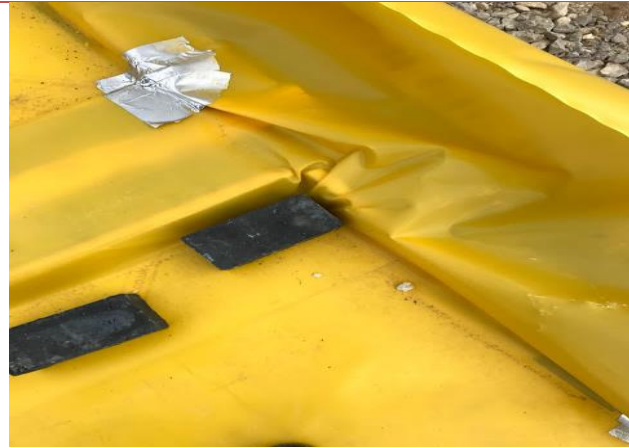
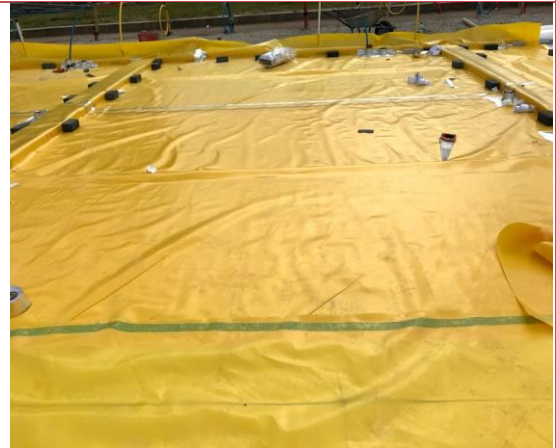
**Verification of Joints and Seals-Good Condition**

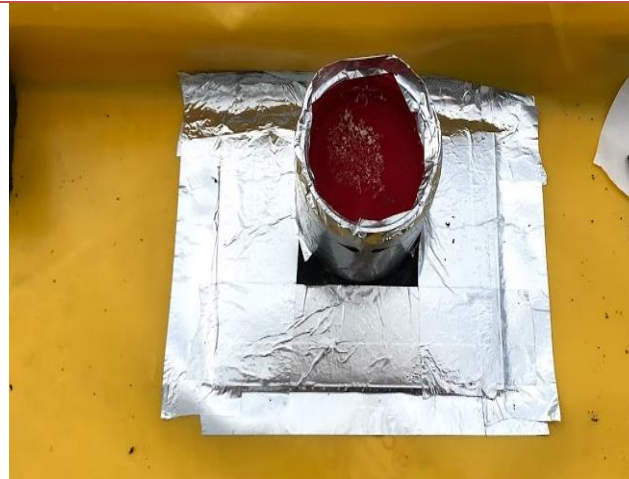
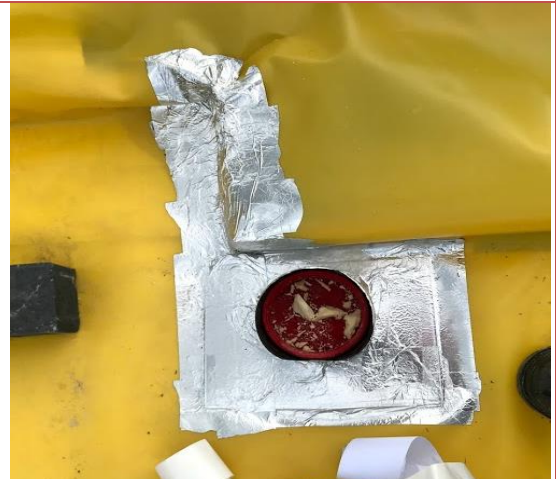
**Verification of Service Penetrations-Good Condition**

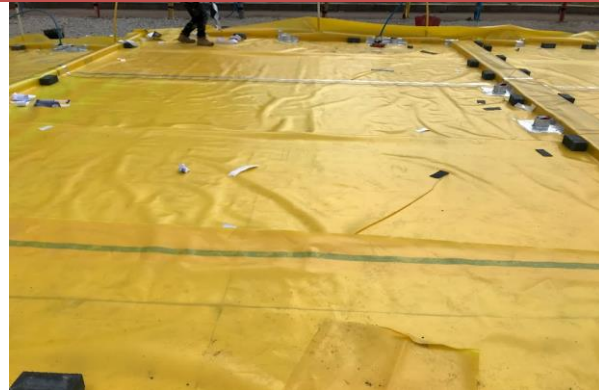
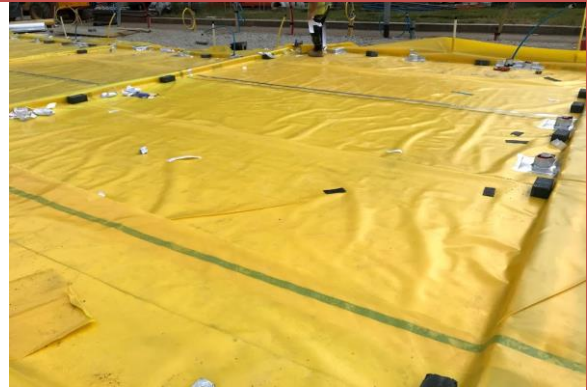
**Plot - 269**

**General Condition of Membrane-Good Condition**

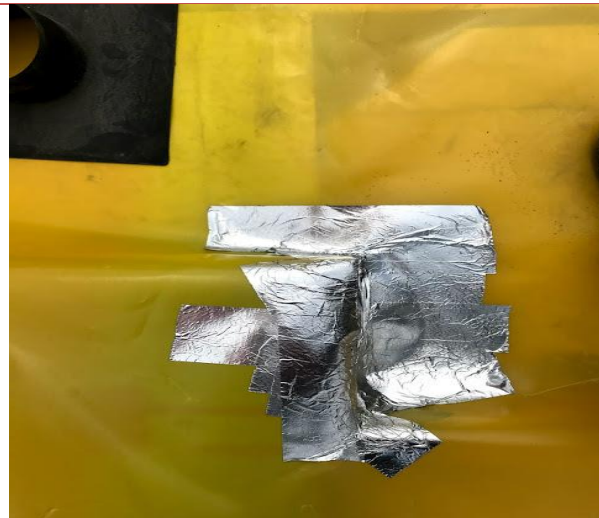
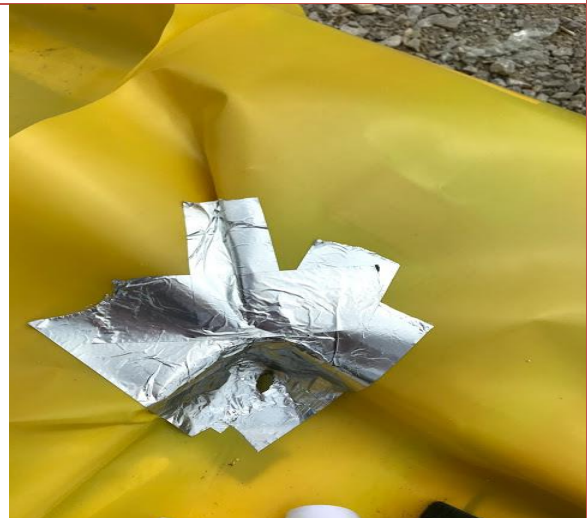
**Verification of Joints and Seals-Good Condition**

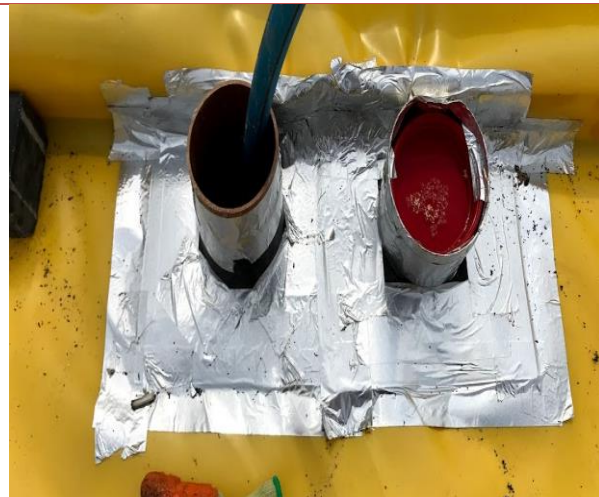
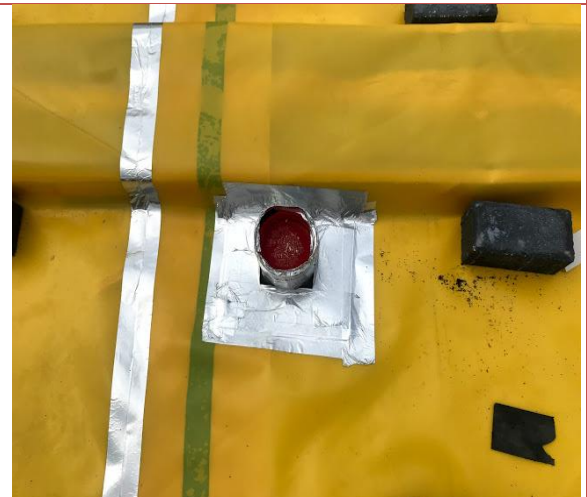
**Verification of Service Penetrations-Good Condition**

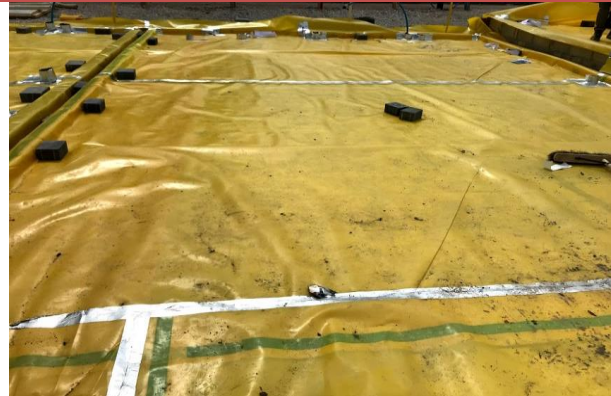
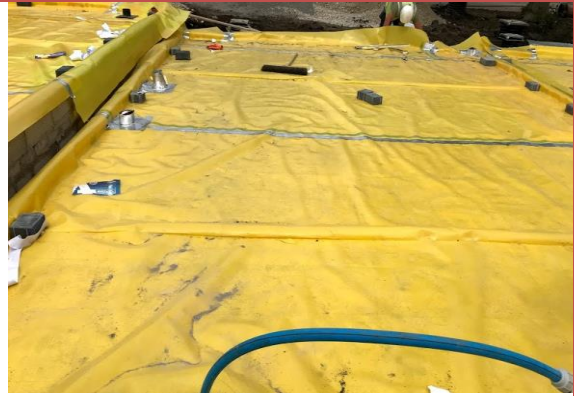
**Plot - 270**

**General Condition of Membrane-Good Condition**

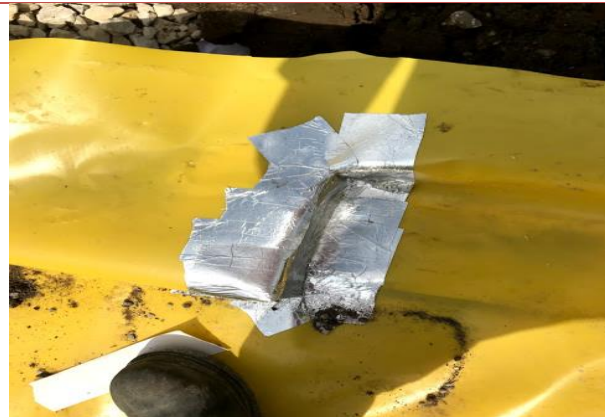
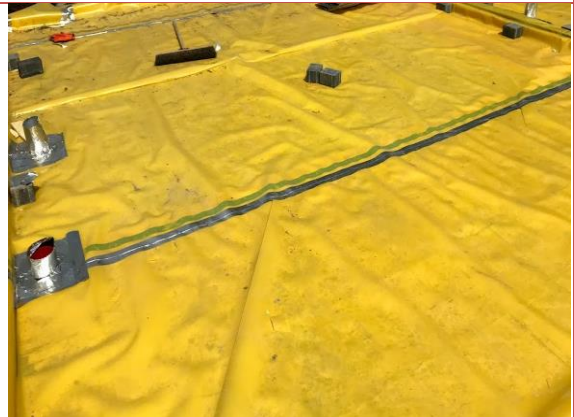
**Verification of Joints and Seals-Good Condition**

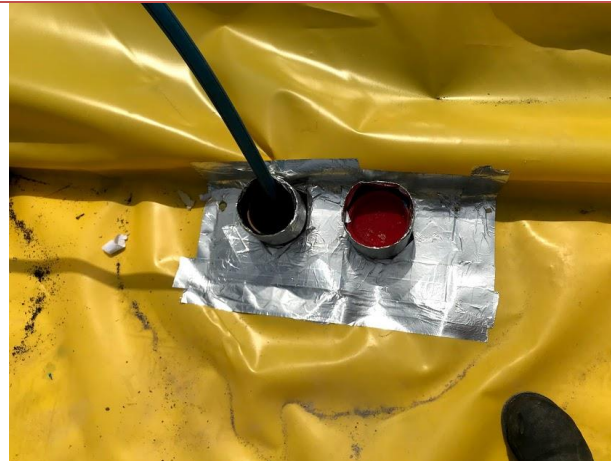
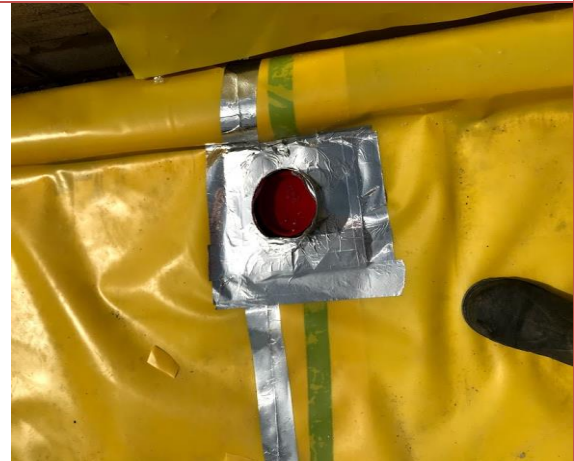
**Verification of Service Penetrations-Good Condition**

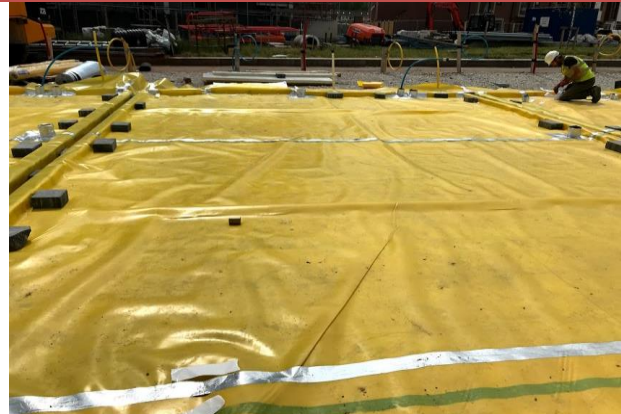
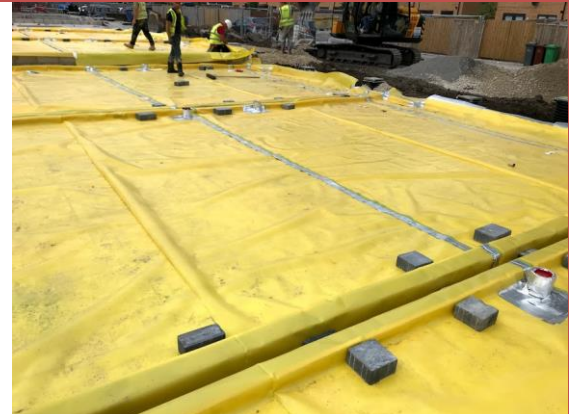
**Plot - 271**

**General Condition of Membrane-Good Condition**

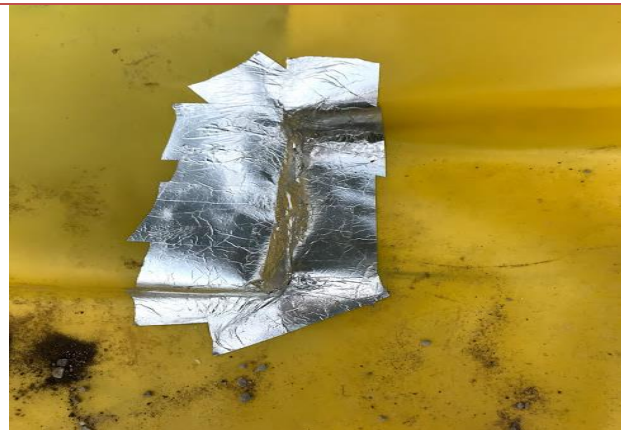
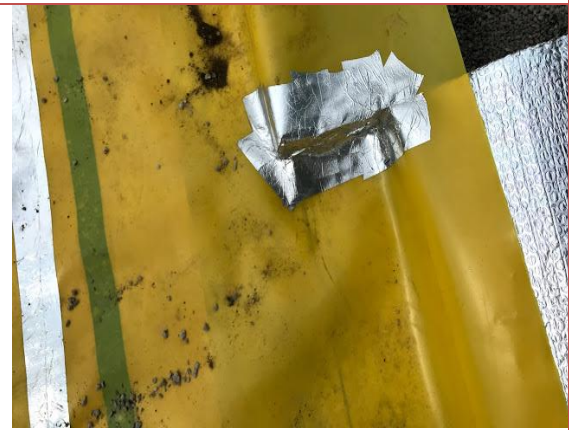
**Verification of Joints and Seals-Good Condition**

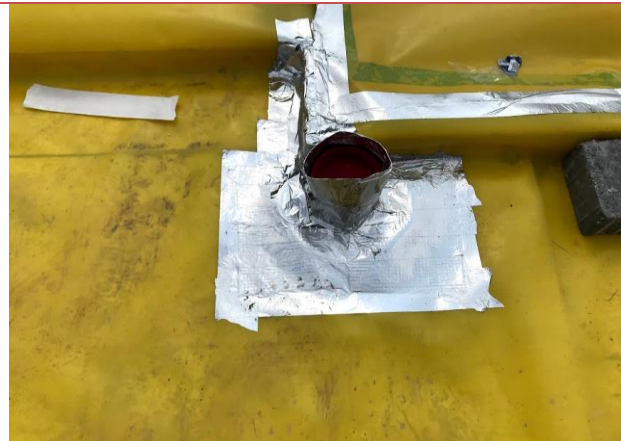
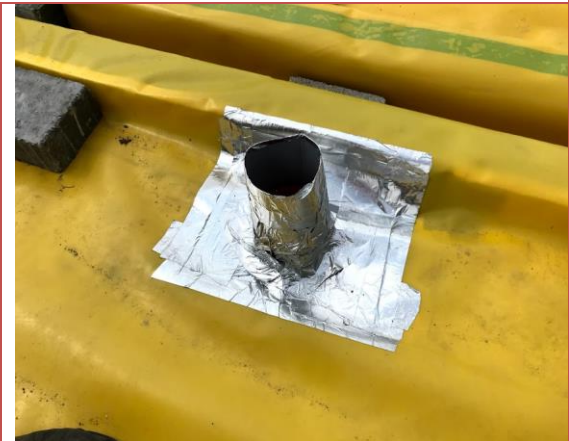
**Verification of Service Penetrations-Good Condition**

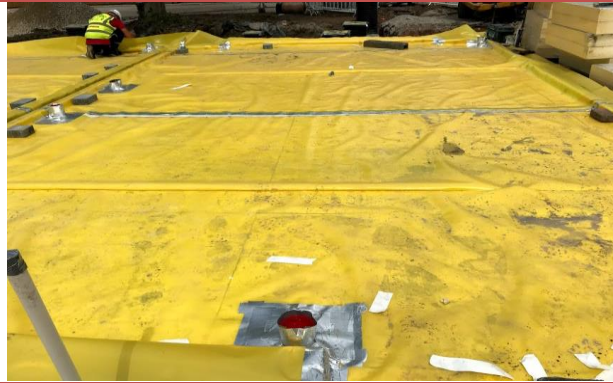
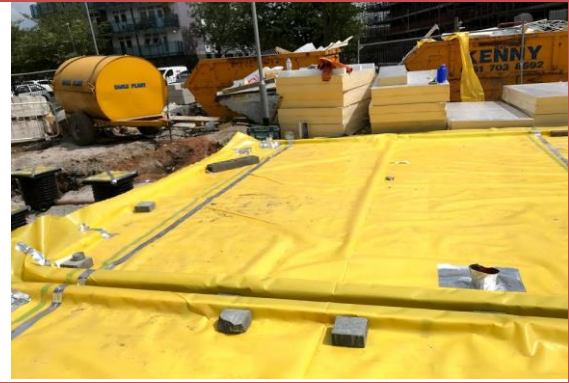
**Plot - 272**

**General Condition of Membrane-Good Condition**

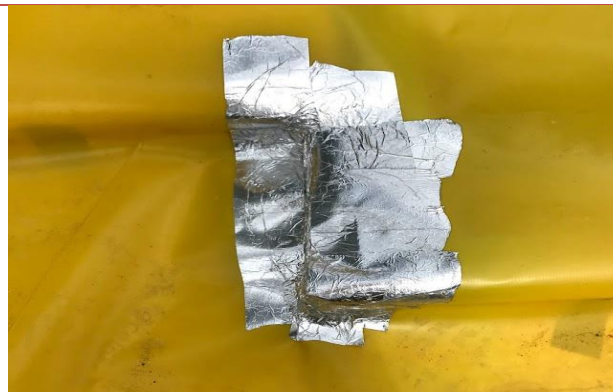
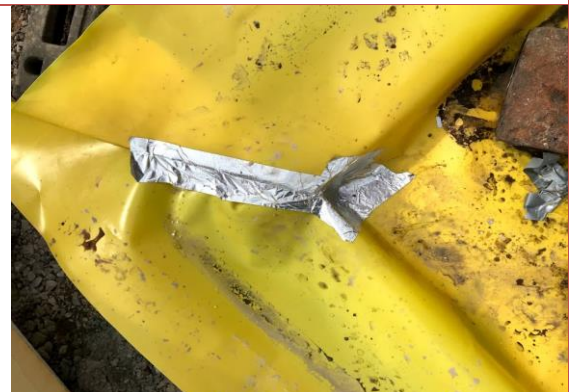
**Verification of Joints and Seals-Good Condition**

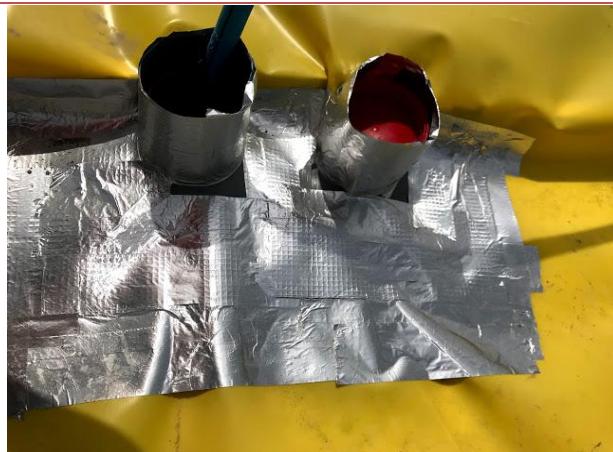
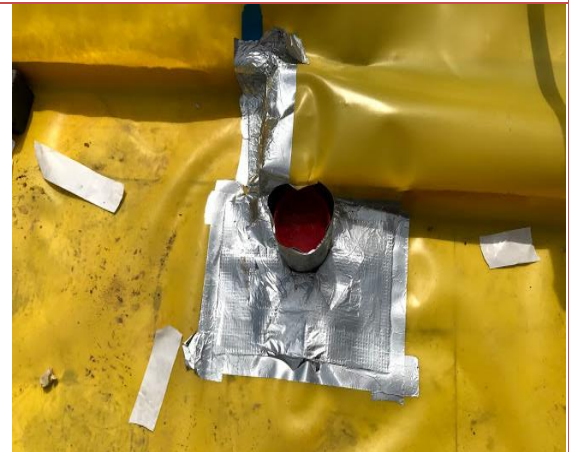
**Verification of Service Penetrations-Good Condition**

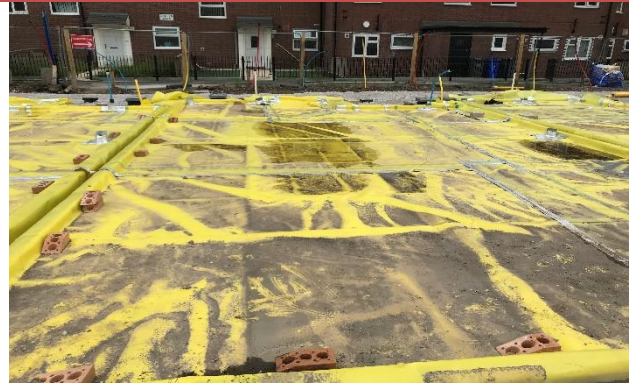
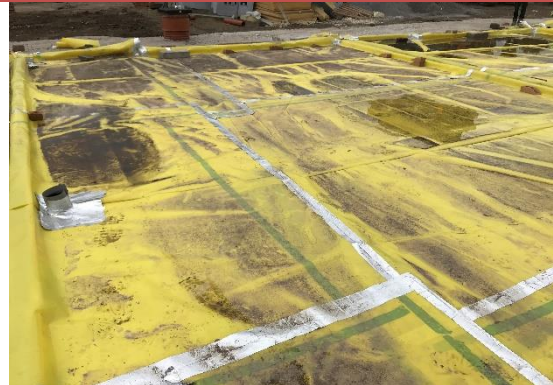
**Plot - 310**

**General Condition of Membrane-Good Condition**

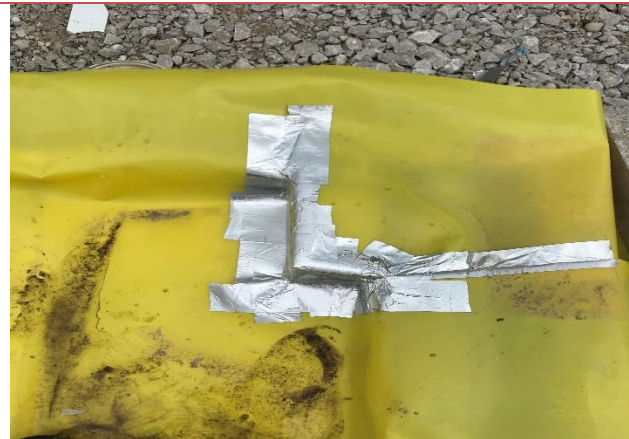
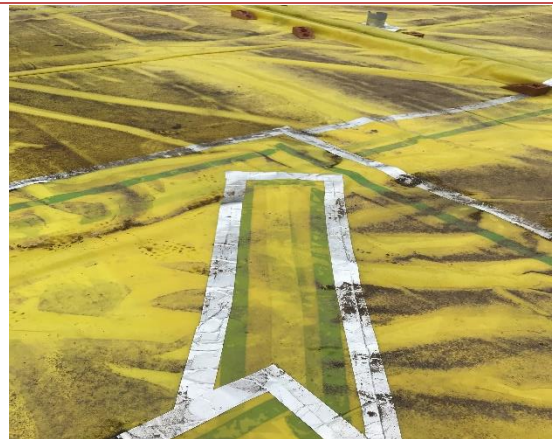
**Verification of Joints and Seals-Good Condition**

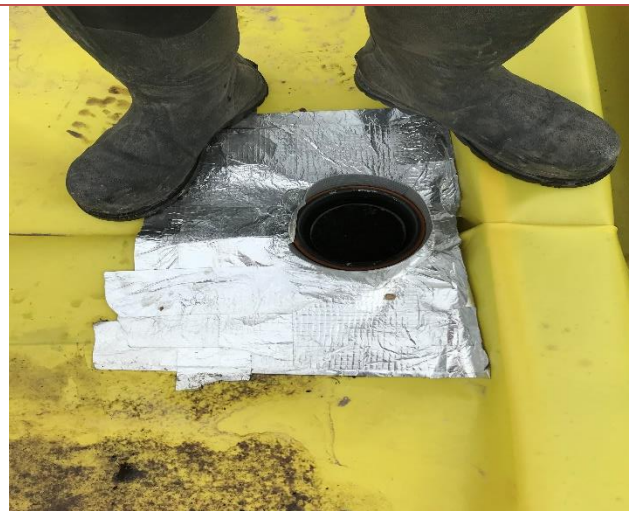
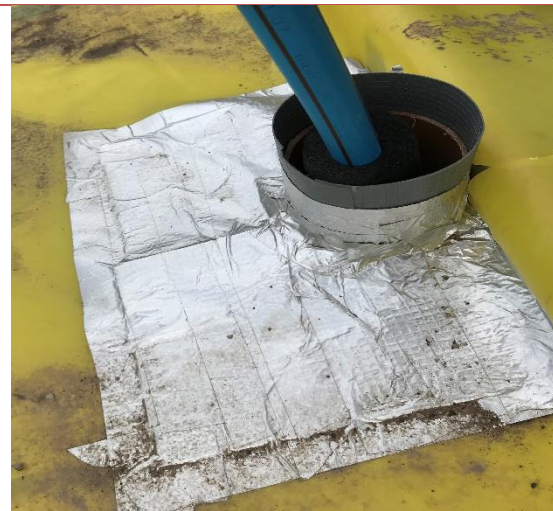
**Verification of Service Penetrations-Good Condition**

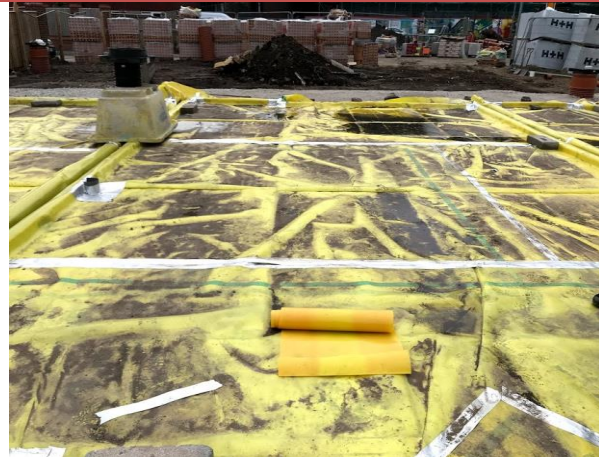
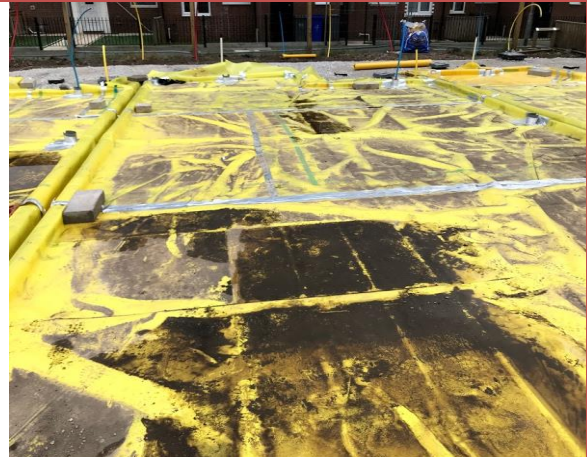
**Plot - 311**

**General Condition of Membrane-Good Condition**

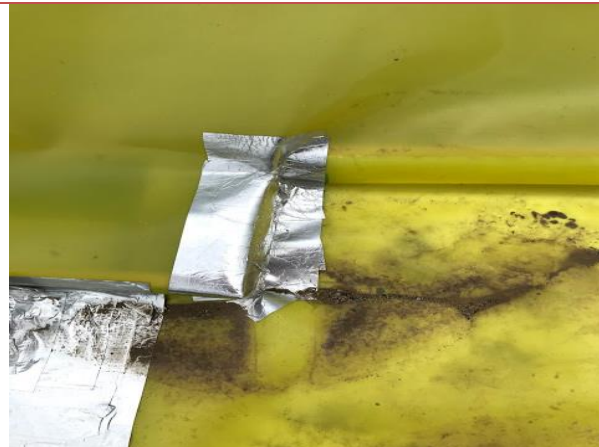
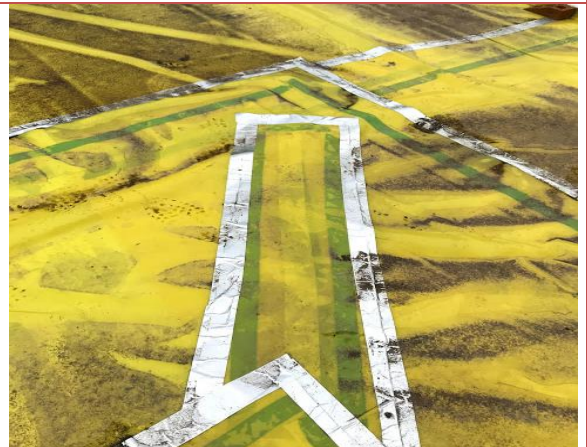
**Verification of Joints and Seals-Good Condition**

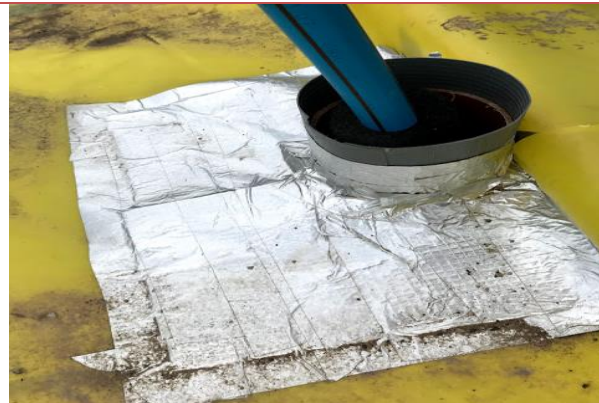
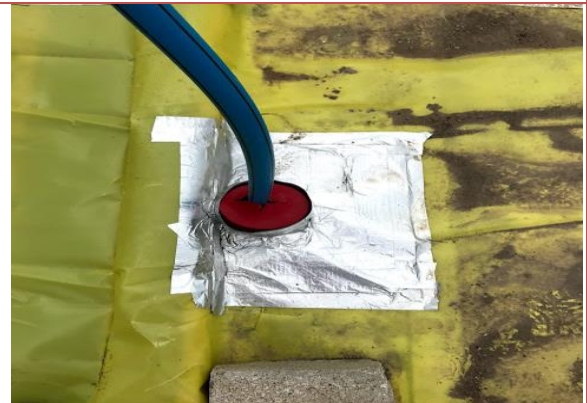
**Verification of Service Penetrations-Good Condition**

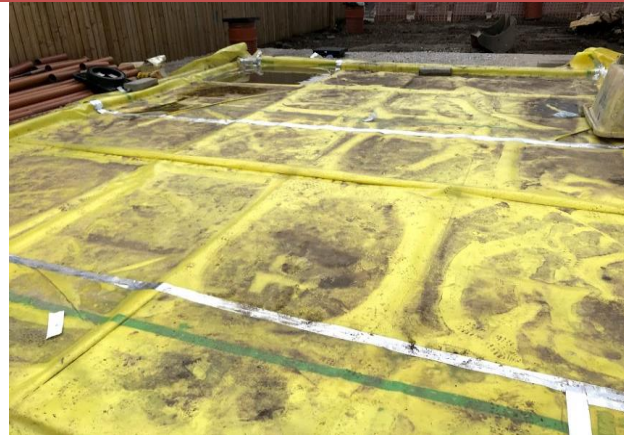
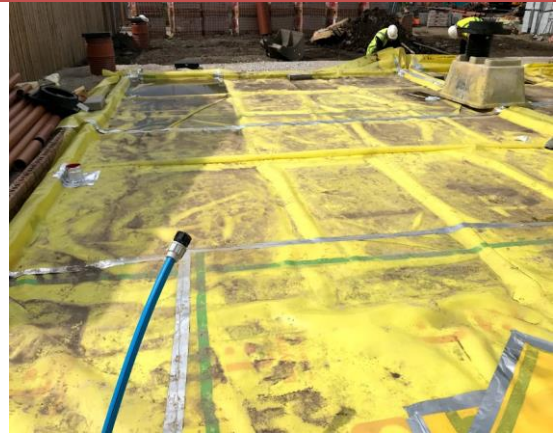
**Plot - 312**

**General Condition of Membrane-Good Condition**

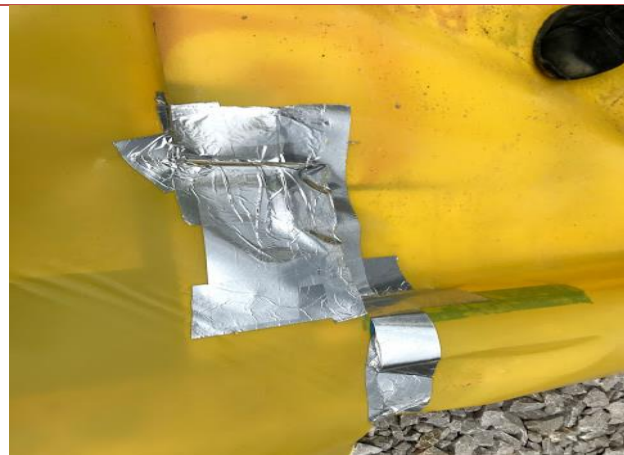
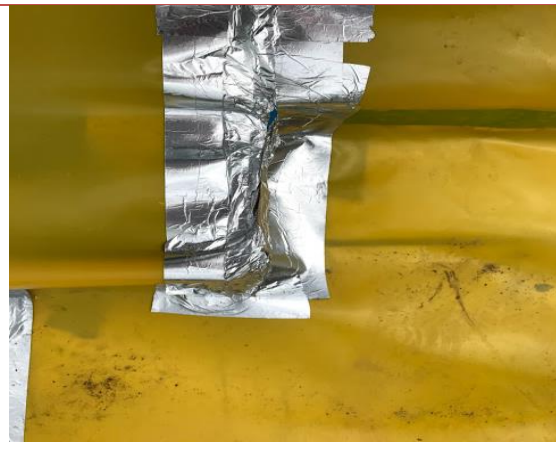
**Verification of Joints and Seals-Good Condition**

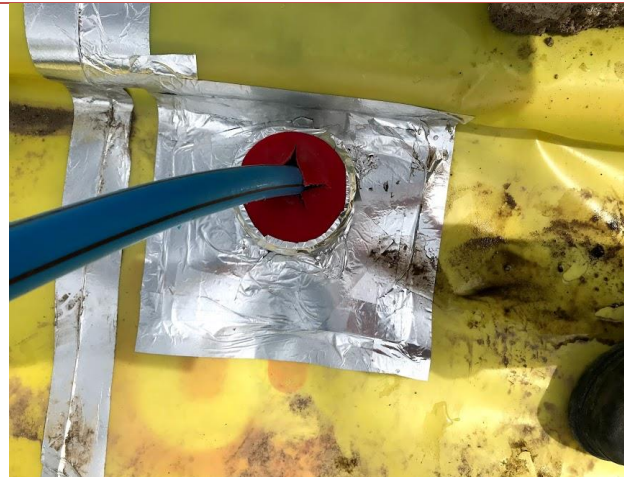
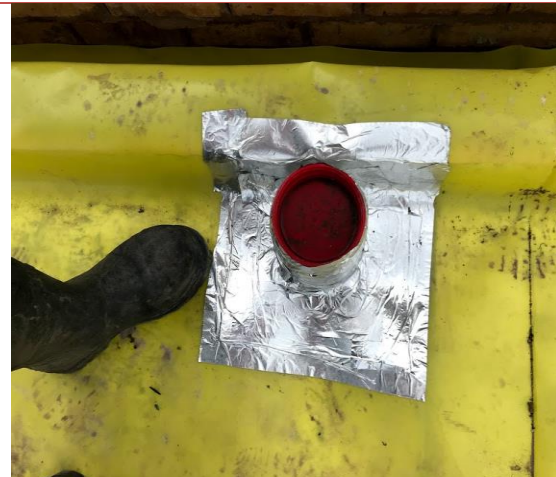
**Verification of Service Penetrations-Good Condition**
