## ROOF CONDITION ASSESSMENT

GREAT NORTHERN & DEANSGATE TERRACES

MANCHESTER M3

Report Ref. 22029/1

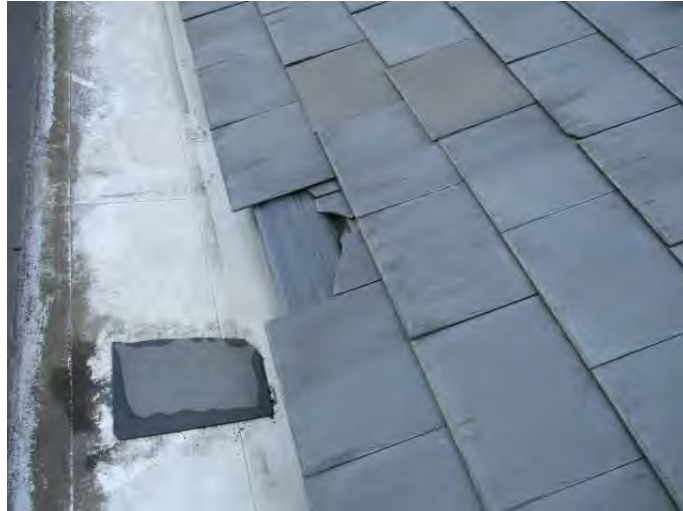
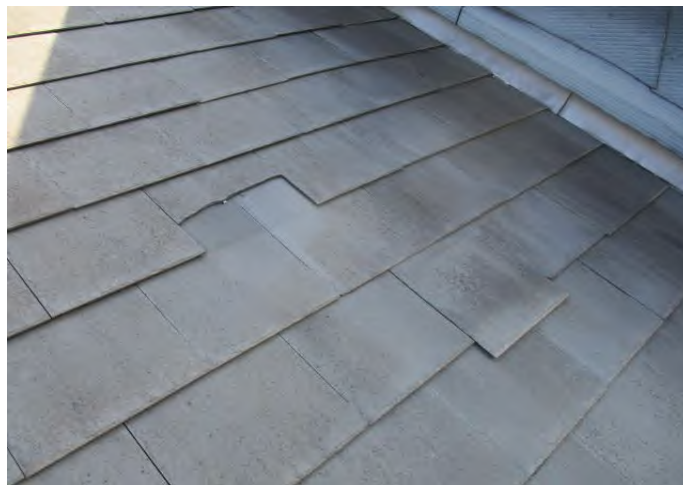
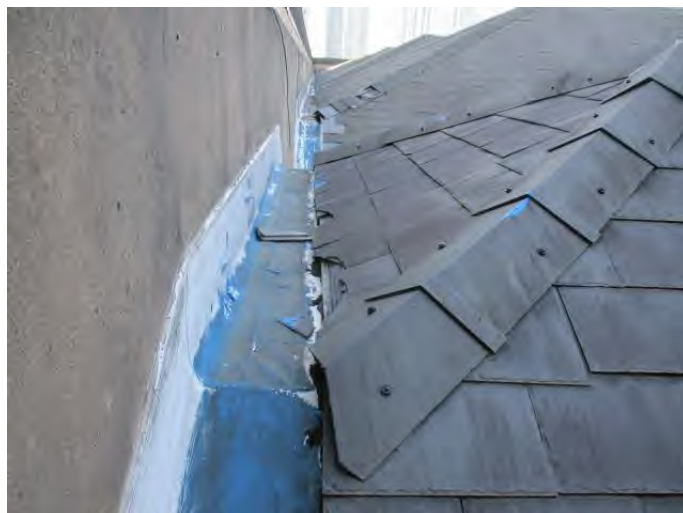
1. There were numerous cracked, loose or missing slates.

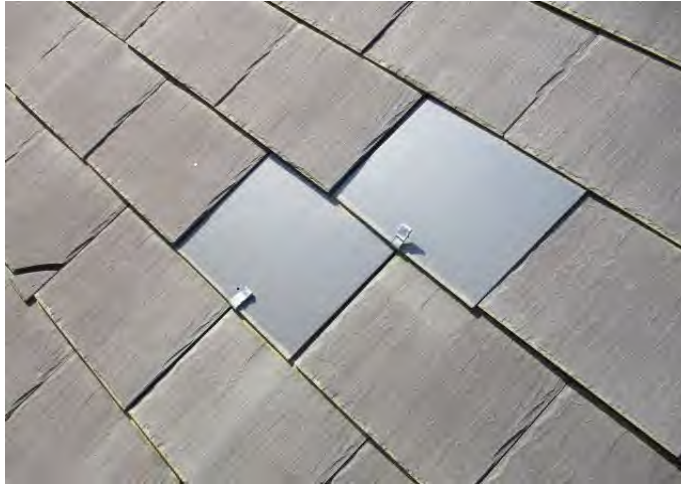
2. Numerous slates had been replaced and remedial slate clips had been installed.

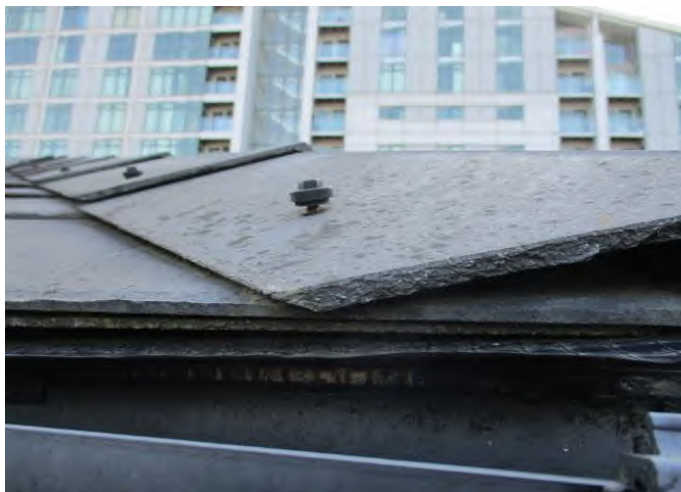
3. A number of ridge capping fixings were loose.

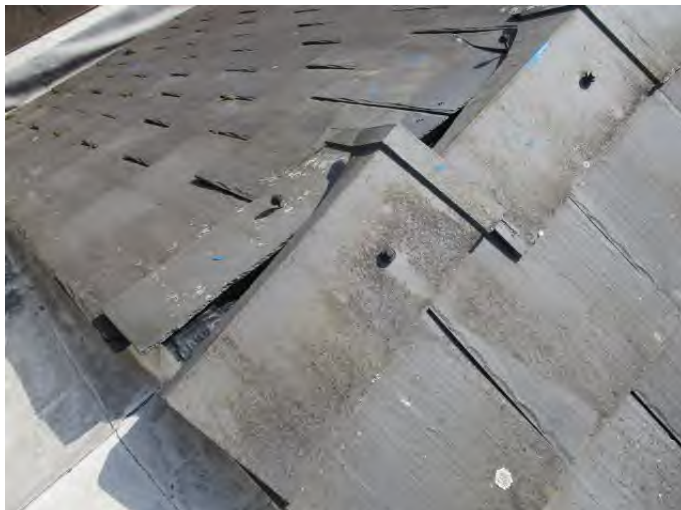
4. A ridge capping section had failed.

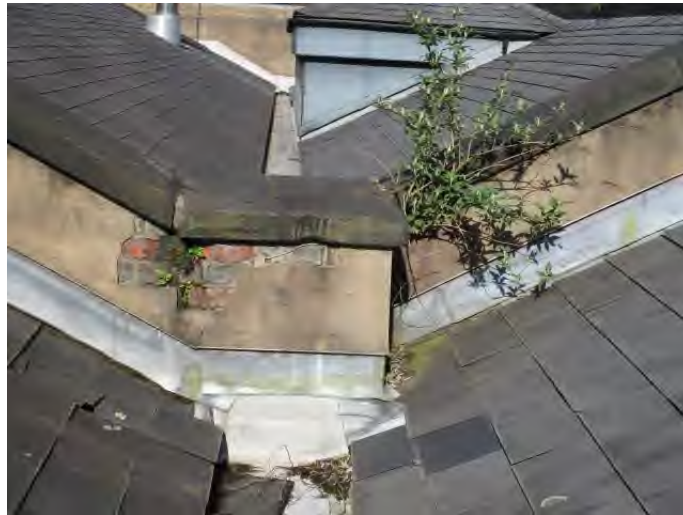
- 5. Vegetation growth was present.
- 6. The render to the central parapet wall had failed.

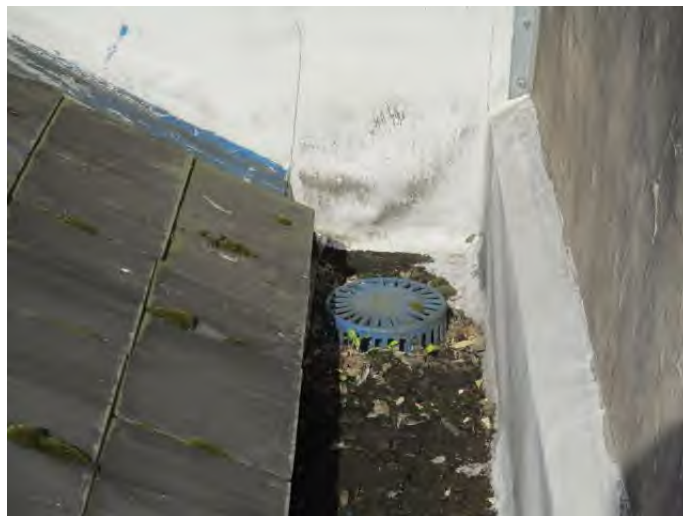
- 7. There was debris within the valley gutter.

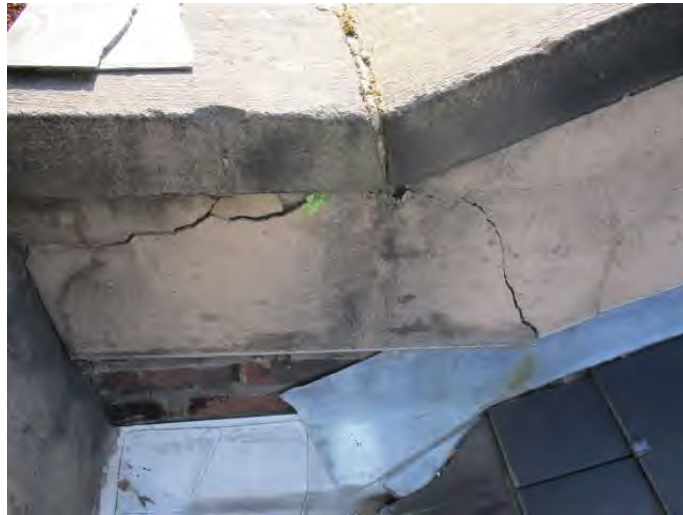
8. The lead to the central parapet wall was loose and the render had cracked.

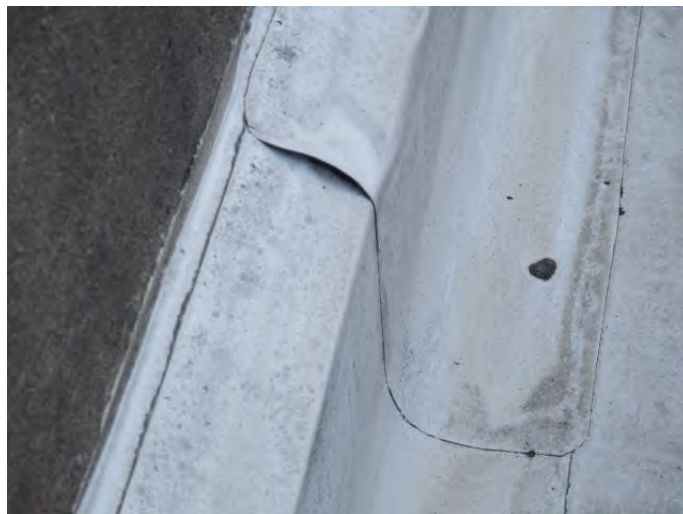
9. At least one joint in the PVC single ply membrane (SPM) was open.

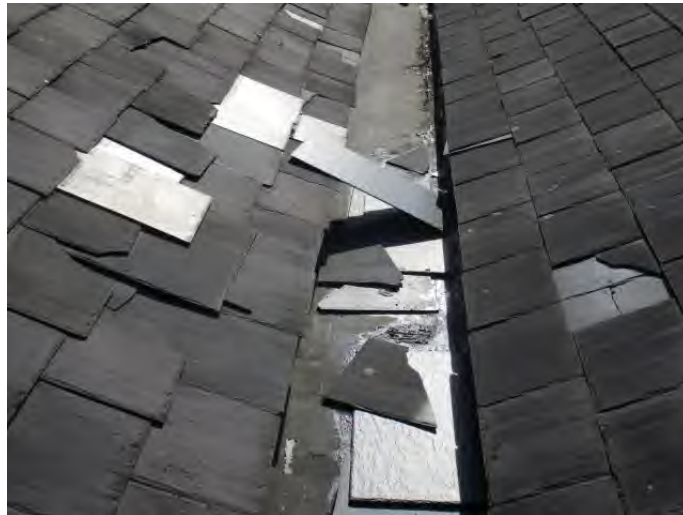
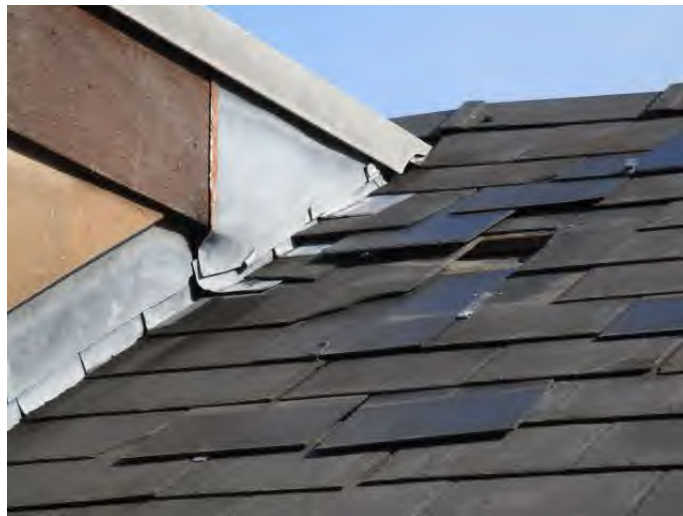
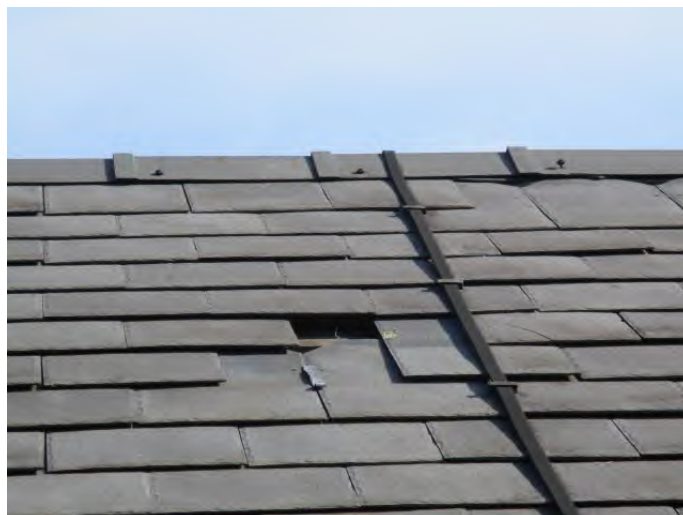
1. There were numerous cracked, loose or missing slates. There were holes in the roof, exposing the sarking and battens in places.

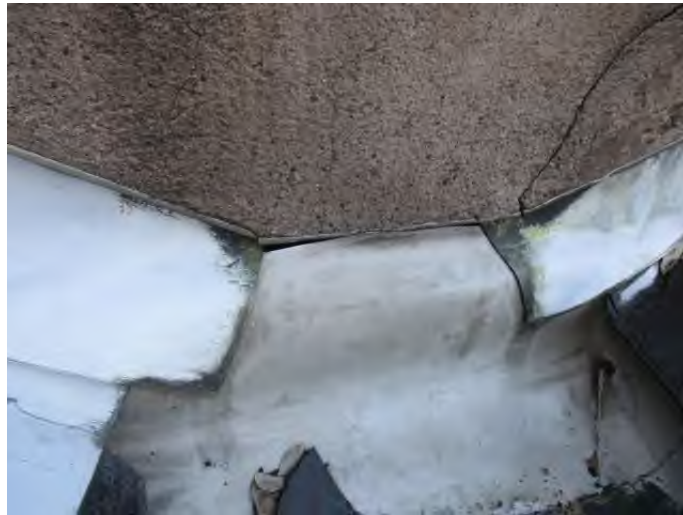
2. The SPM to the valley gutter was not weathered adequately into the central parapet wall.

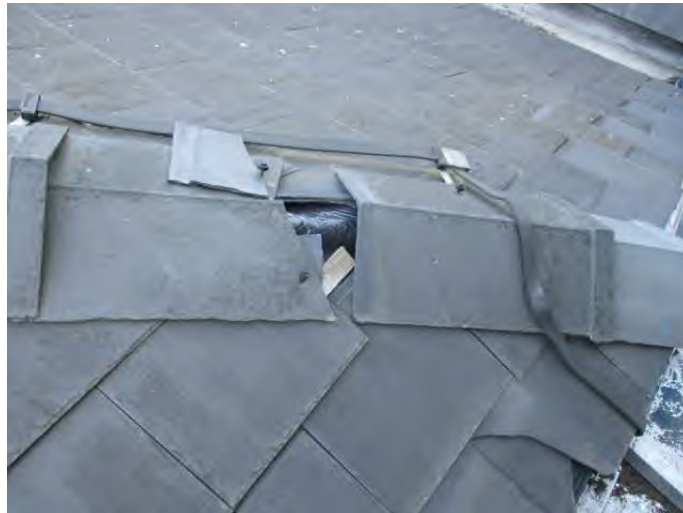
3. Numerous slates had been replaced and remedial slate clips had been installed.
4. There was debris within the gutters.
5. Hip cappings were damaged in at least one area.

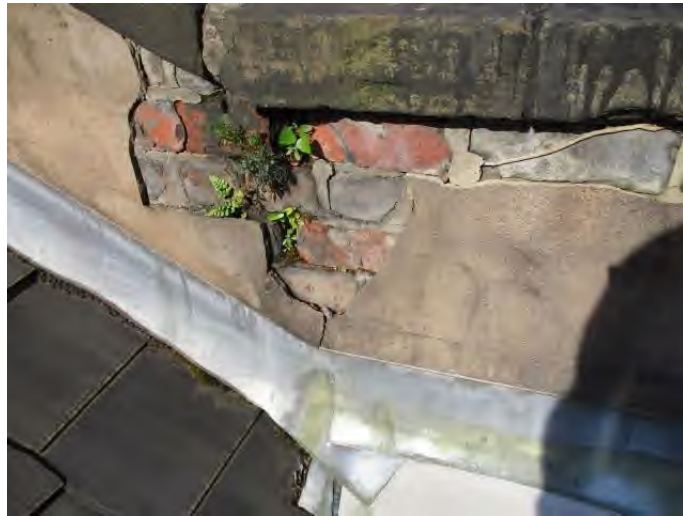
6. The render to the central parapet wall had failed.

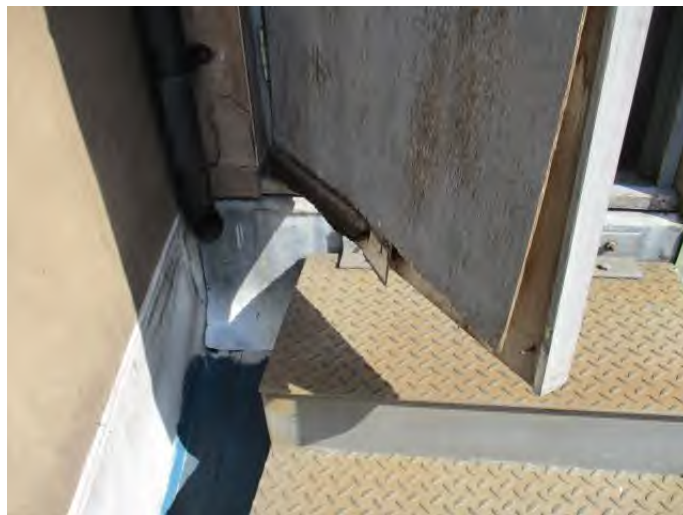
7. The roof access door and frame were in a poor condition.

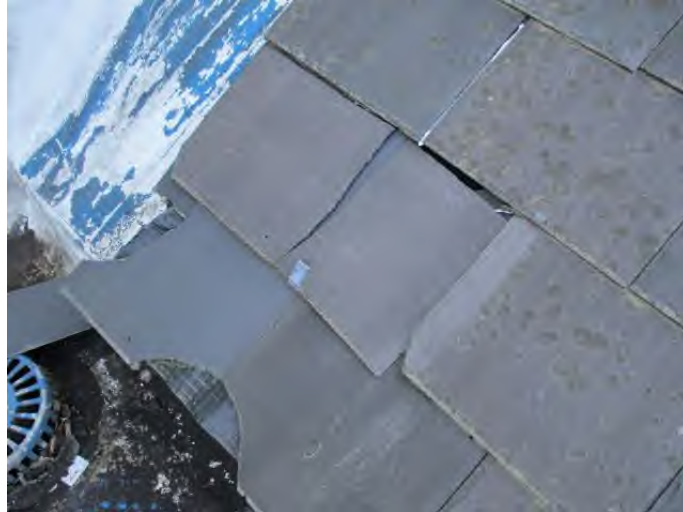
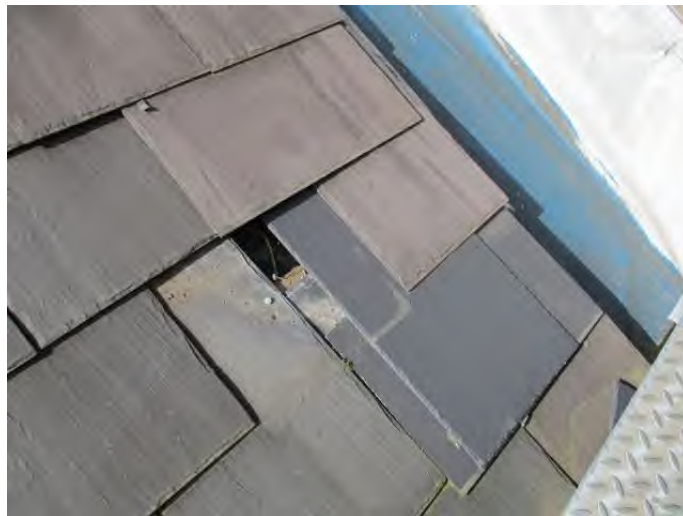
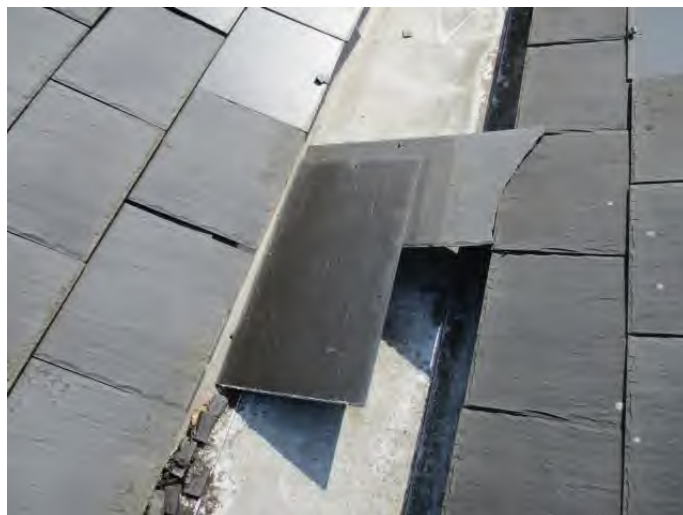
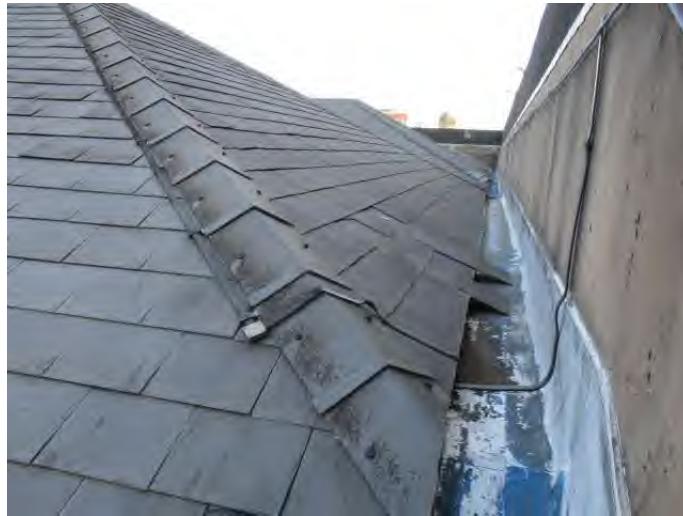
1. There were numerous cracked, loose or missing slates. There were holes in the roof.

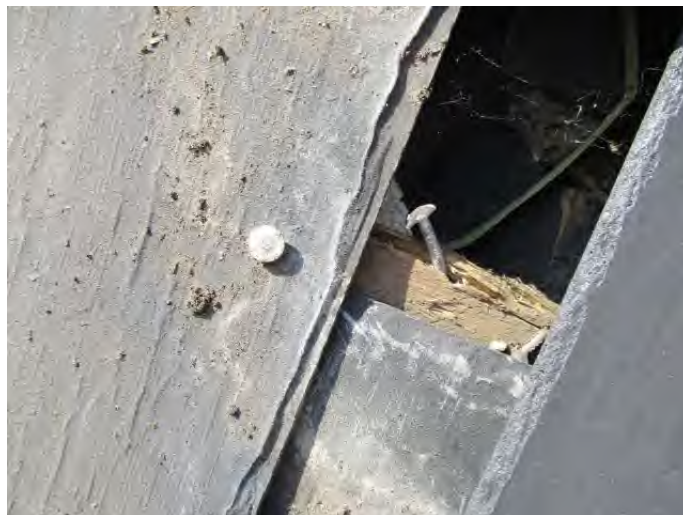
2. Where exposed the nails were not visibly corroded.

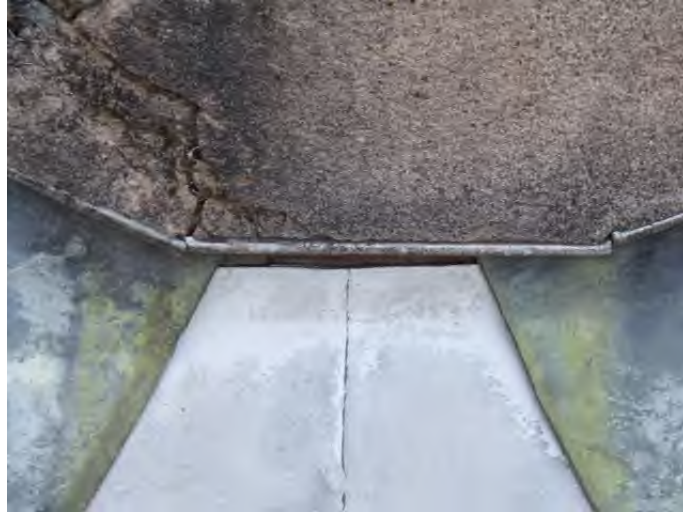
3. Numerous slates had been replaced and remedial slate clips had been installed.
4. There was debris within the gutters.

5. The SPM to the valley gutter was not weathered adequately into the central parapet wall.

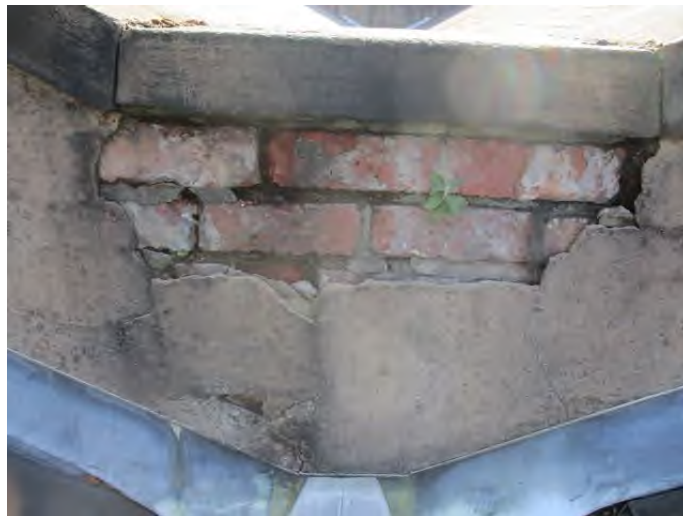
6. The render had also failed.

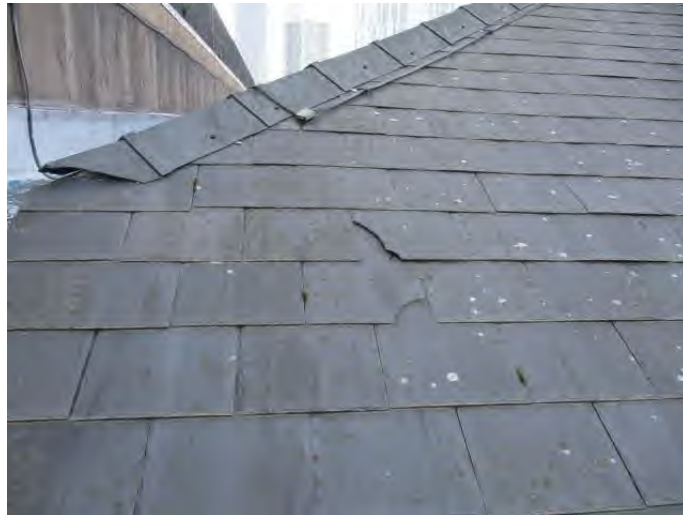
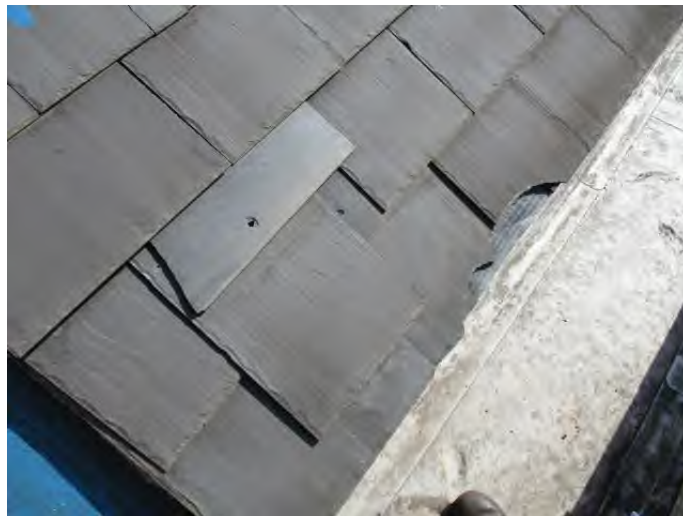
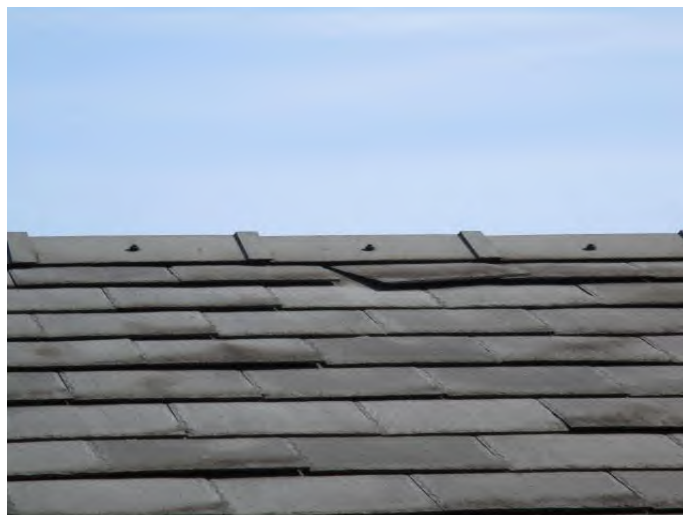
1. There were numerous cracked, loose or missing slates. There were holes in the roof.

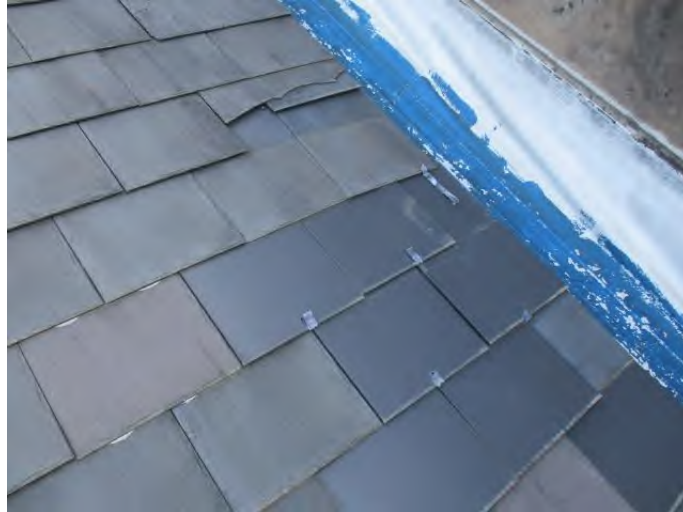
2. Numerous slates had been replaced and remedial slate clips had been installed.

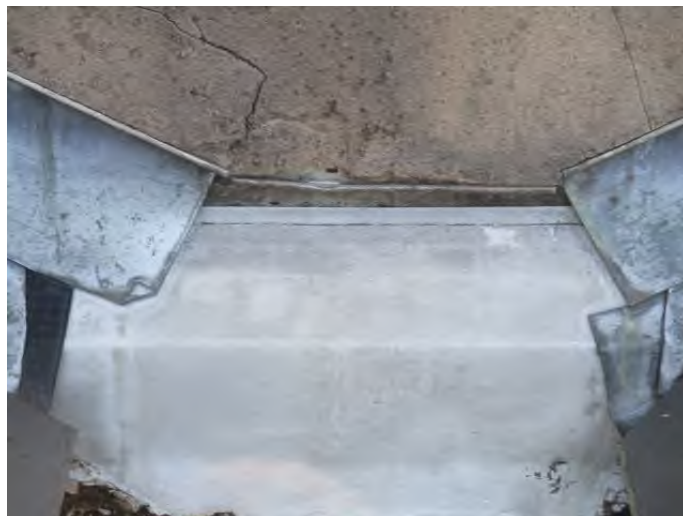
3. There was debris within the gutters.
4. The SPM to the valley gutter was not weathered adequately into the central parapet wall. The render was also cracked.

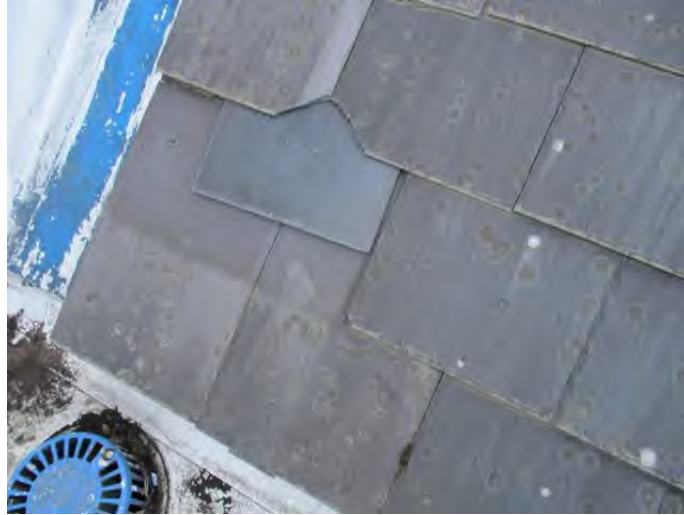
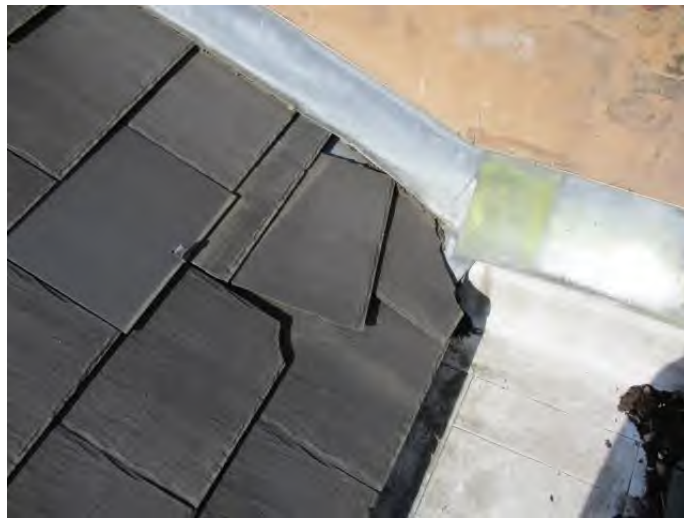
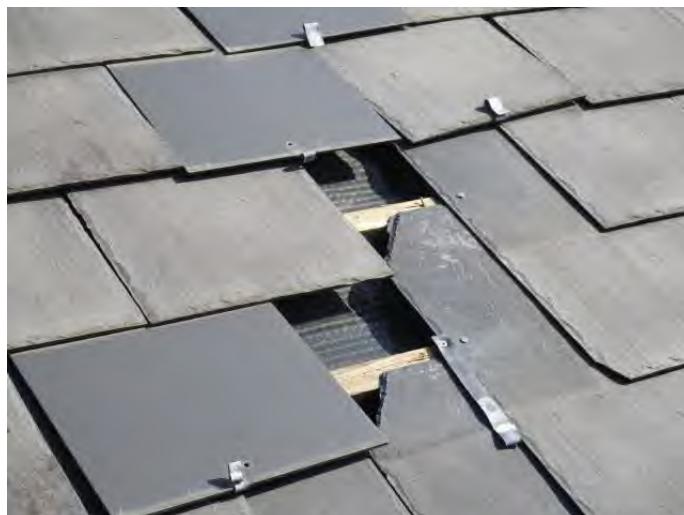
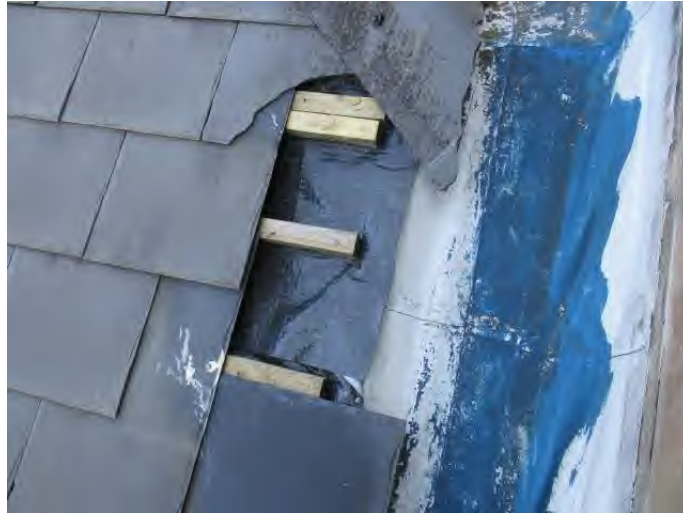
1. There were numerous cracked, loose or missing slates. There were holes in the roof.

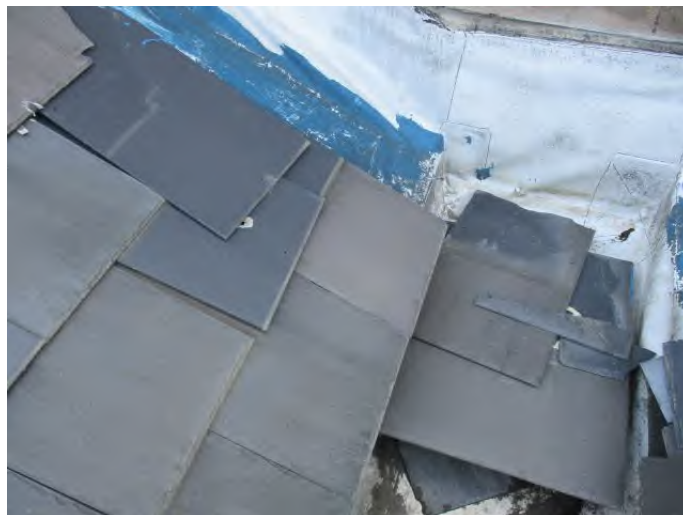
2. Numerous slates had been replaced and remedial slate clips had been installed.

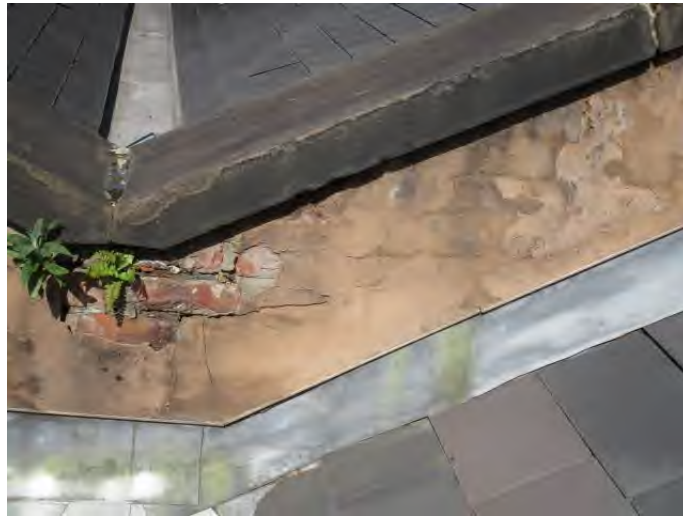
3. There was debris within the gutters.

4. The render to the central parapet wall had cracked.

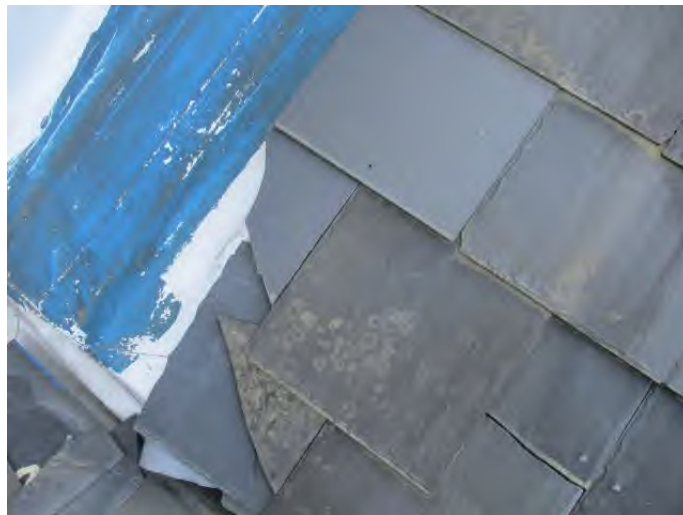
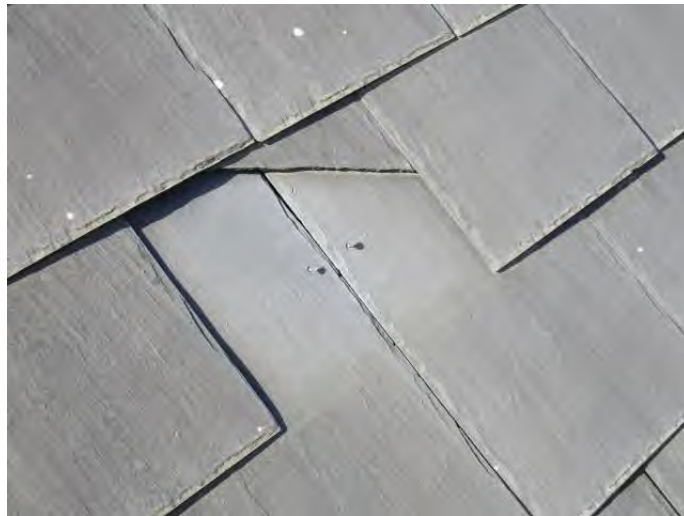
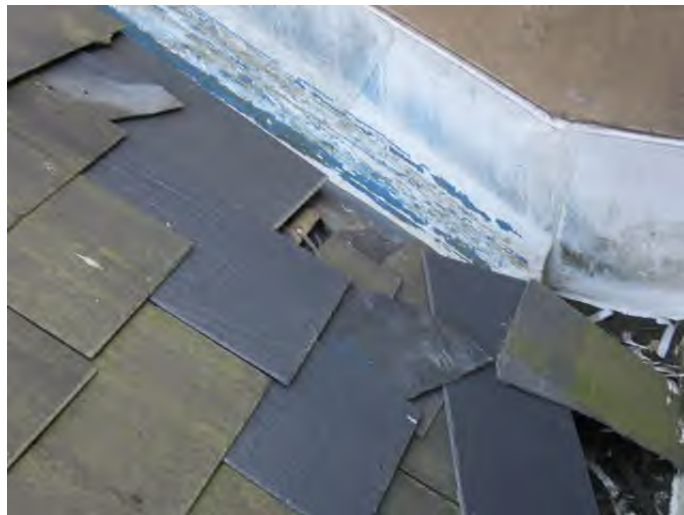
1. There were numerous cracked, loose or missing slates. There were holes in the roof.

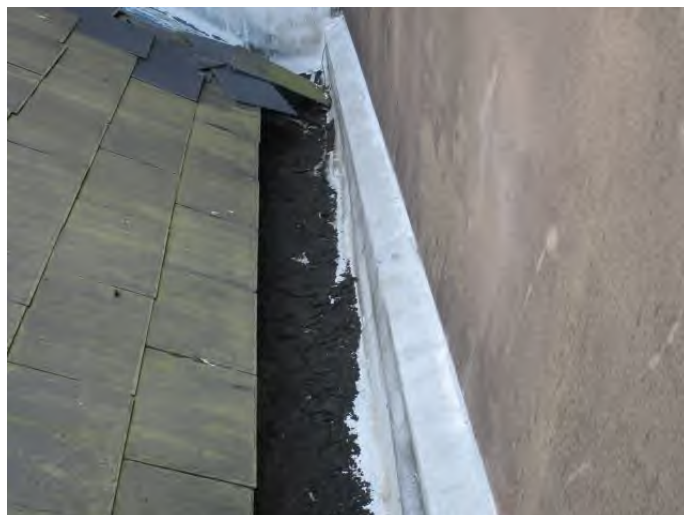
2. Numerous slates had been replaced and remedial slate clips had been installed.
3. There was debris within the gutters.

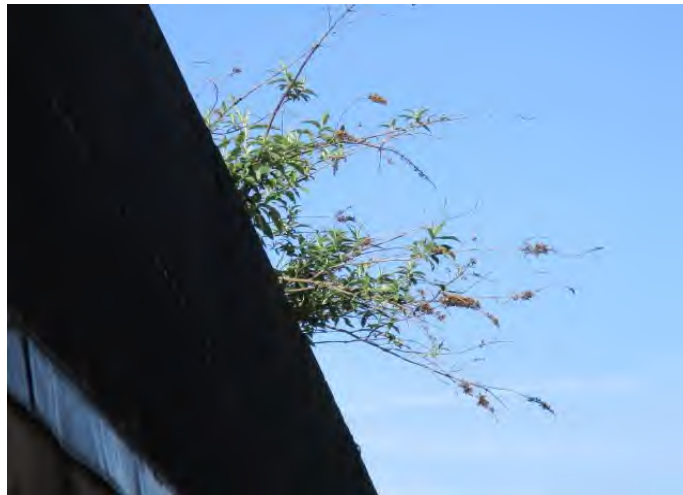
5. Vegetation growth was noted to the parapet.

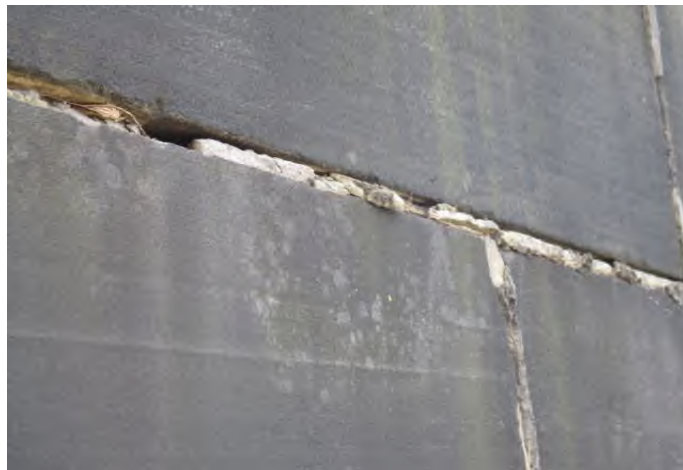
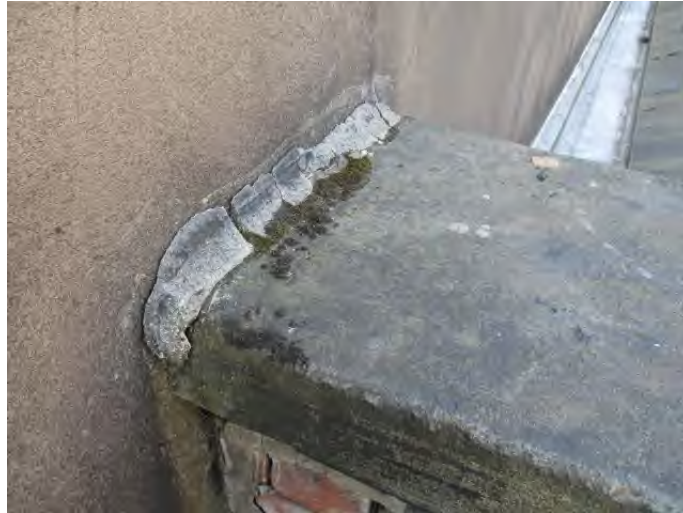
6. Pointing to the parapets had failed in places.

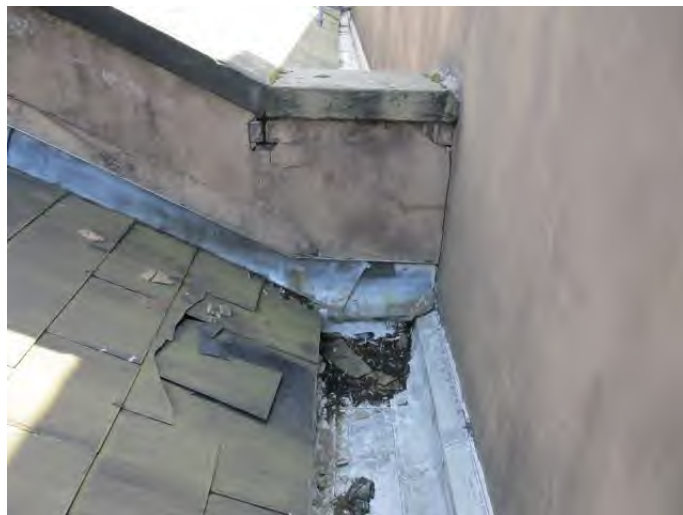
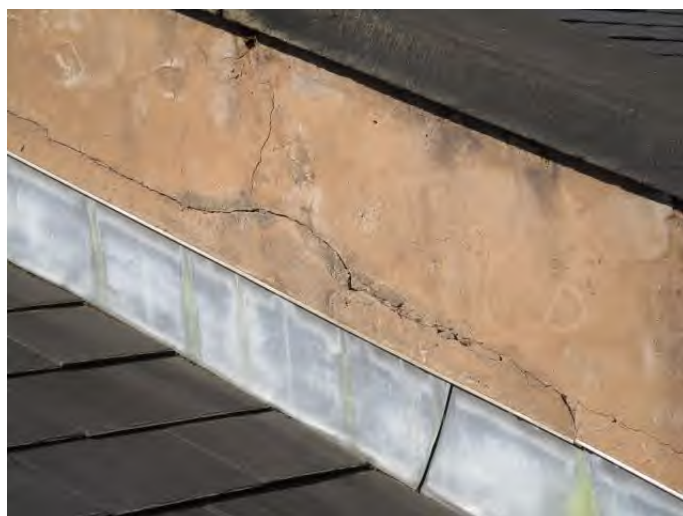
7. The render to the central parapet had cracked.

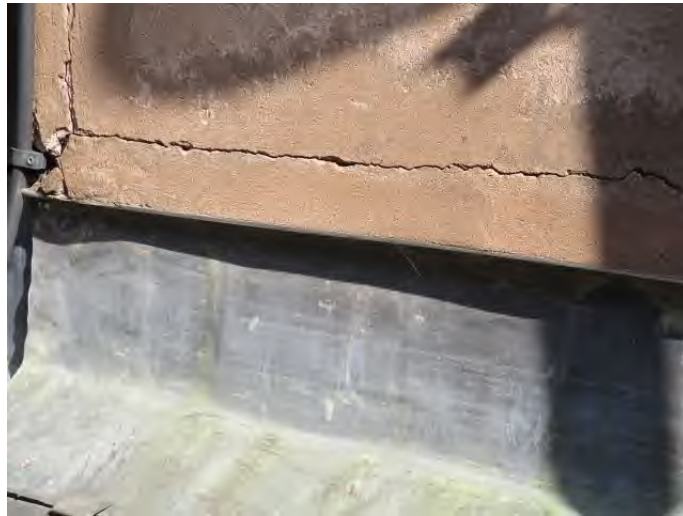
8. The render to the access door enclosure had cracked.

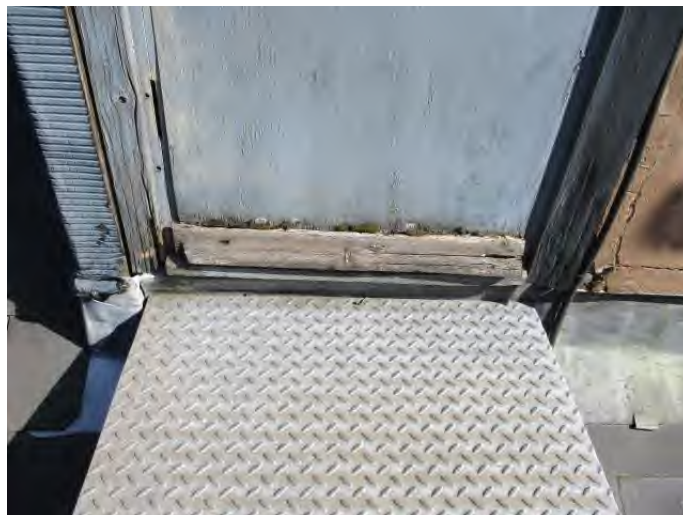
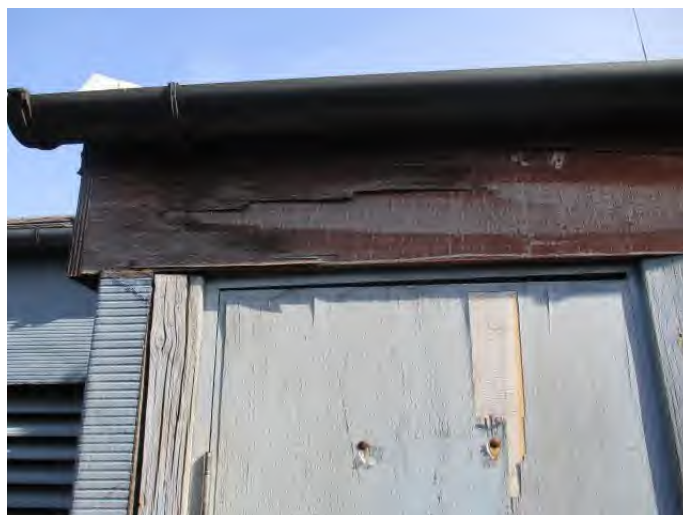
9. The roof access door and frame were in a poor condition.

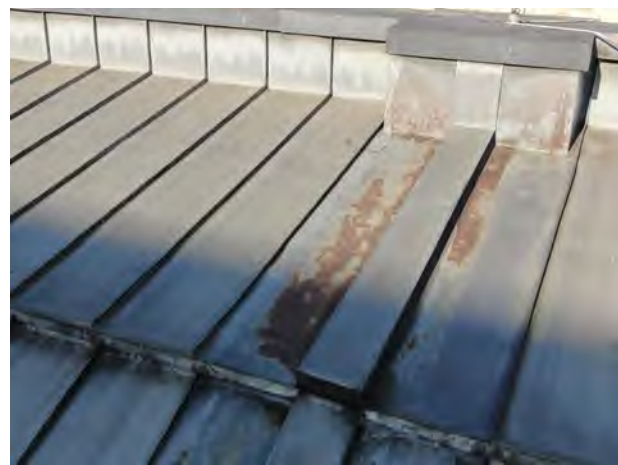
Zinc roof panels have signs of oxidization which requires treatment.

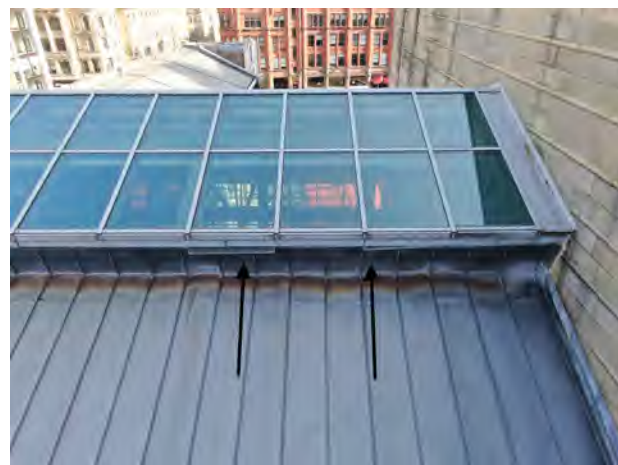
The lead flashing to the aluminium window frame appears to be cracking allowing potential for water ingress. This should be checked and repaired or replaced as necessary.

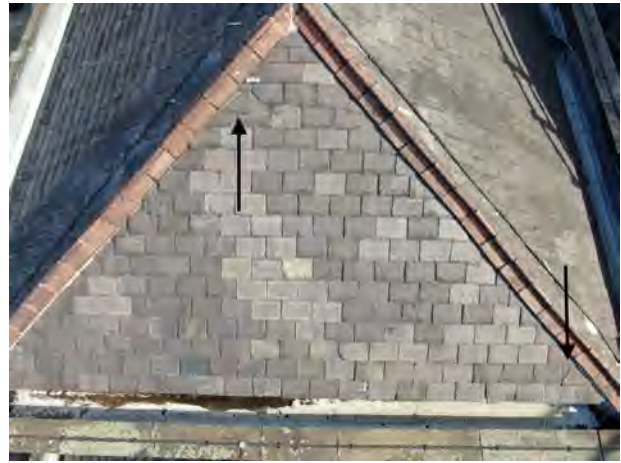
A slate has slipped and three slates are cracked.

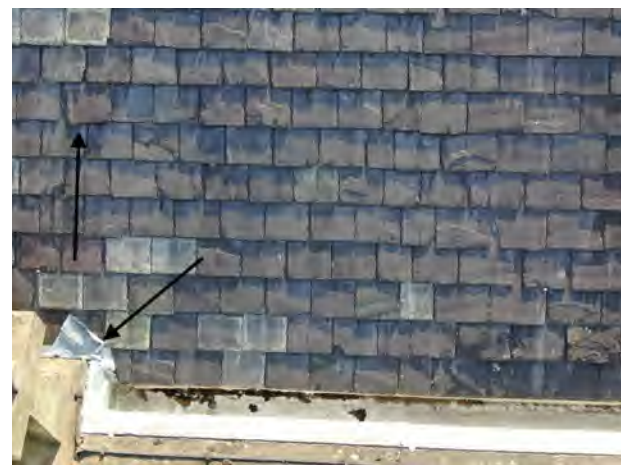
Three slates are missing and need replacing, A broken slate is noted in the gutter and should be removed.

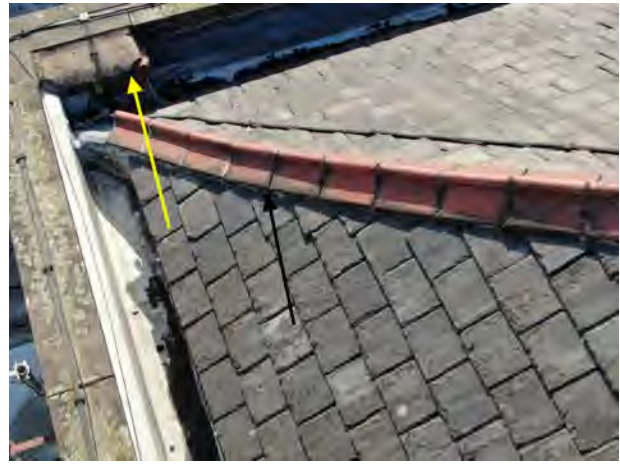
Detritus material should be removed from the gutter. Flashband has been used around the corner of the parapet gutter. This should be replaced with a more durable lead flashing.

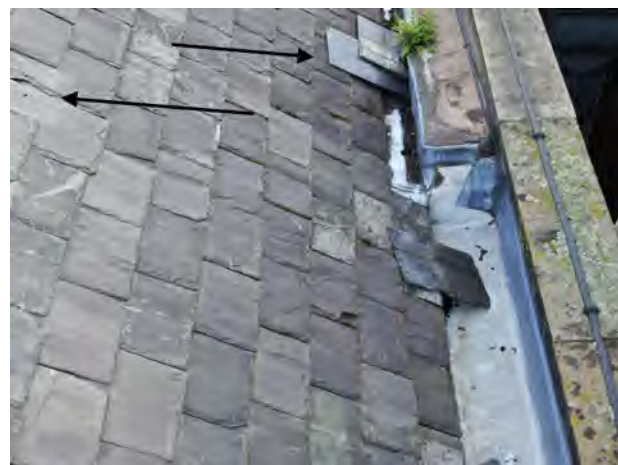
Three slates have broken and slipped into the gutter. These need to be replaced.

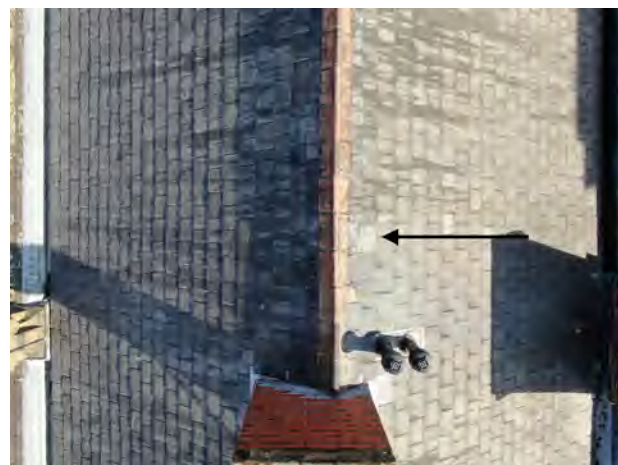
A slate is broken at ridge level, another is broken above gutter level and a further slate is missing. These all require replacing. Some vegetation is noted in the gutter and should be removed.

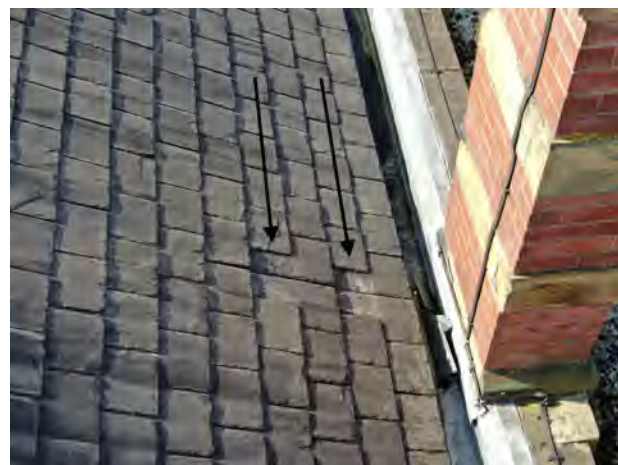
Bedding to the ridge tiles is in poor condition. Ridge tiles should be rebbed and pointed. The highlighted slate has a large crack and is close to failing.

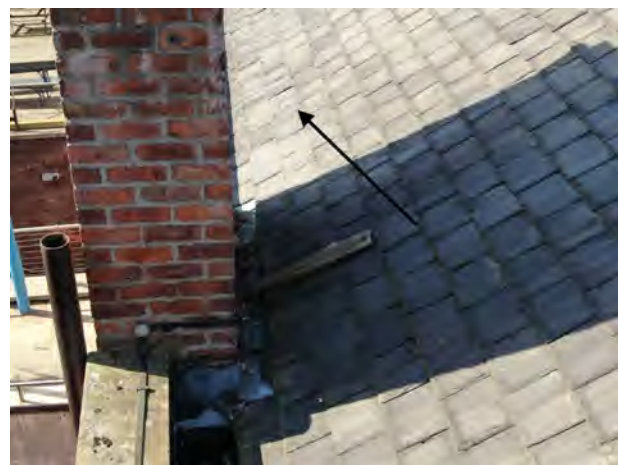
A slate at ridge level is cracked and one is missing lower down.

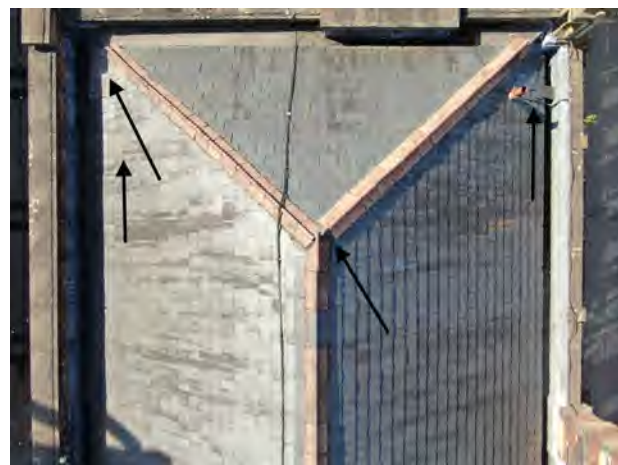
Mortar joints and bedding to hip tiles is missing. Hip tiles need rebedding and pointing.

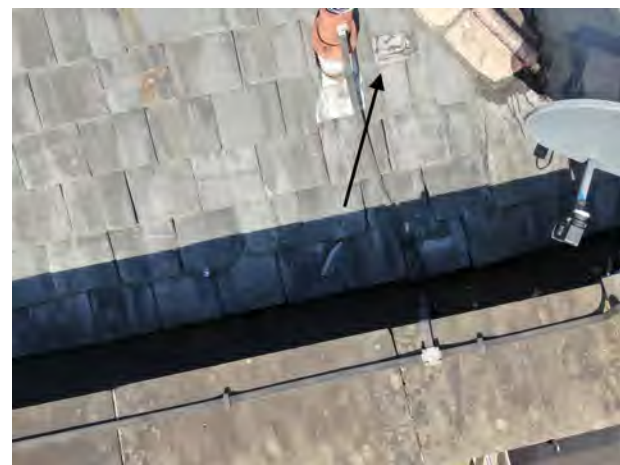
Bedding to the hip tiles is missing and mortar joints are in a poor condition. These need rebedding and pointing. There is a build up of lichen to the ridge/hip area which should be removed.

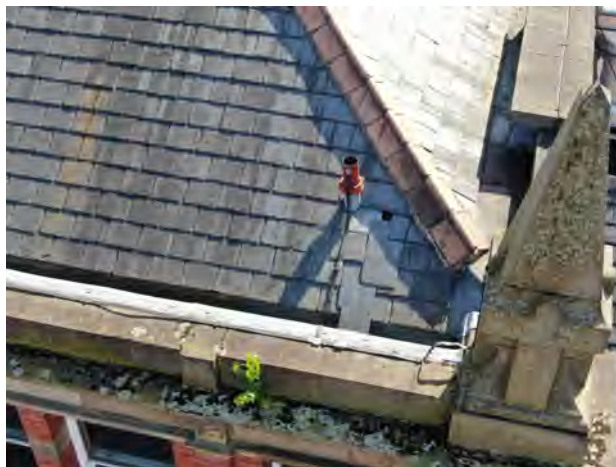
Two slates have slipped. Bedding to the hip tiles is in poor condition and needs replacing.
