Our Ref: DH/31106/01

**Re: Cavendish House, Manchester - Timber Inspection**

## REPORT TIMBER INSPECTION

CAVENDISH HOUSE  
MANCHESTER

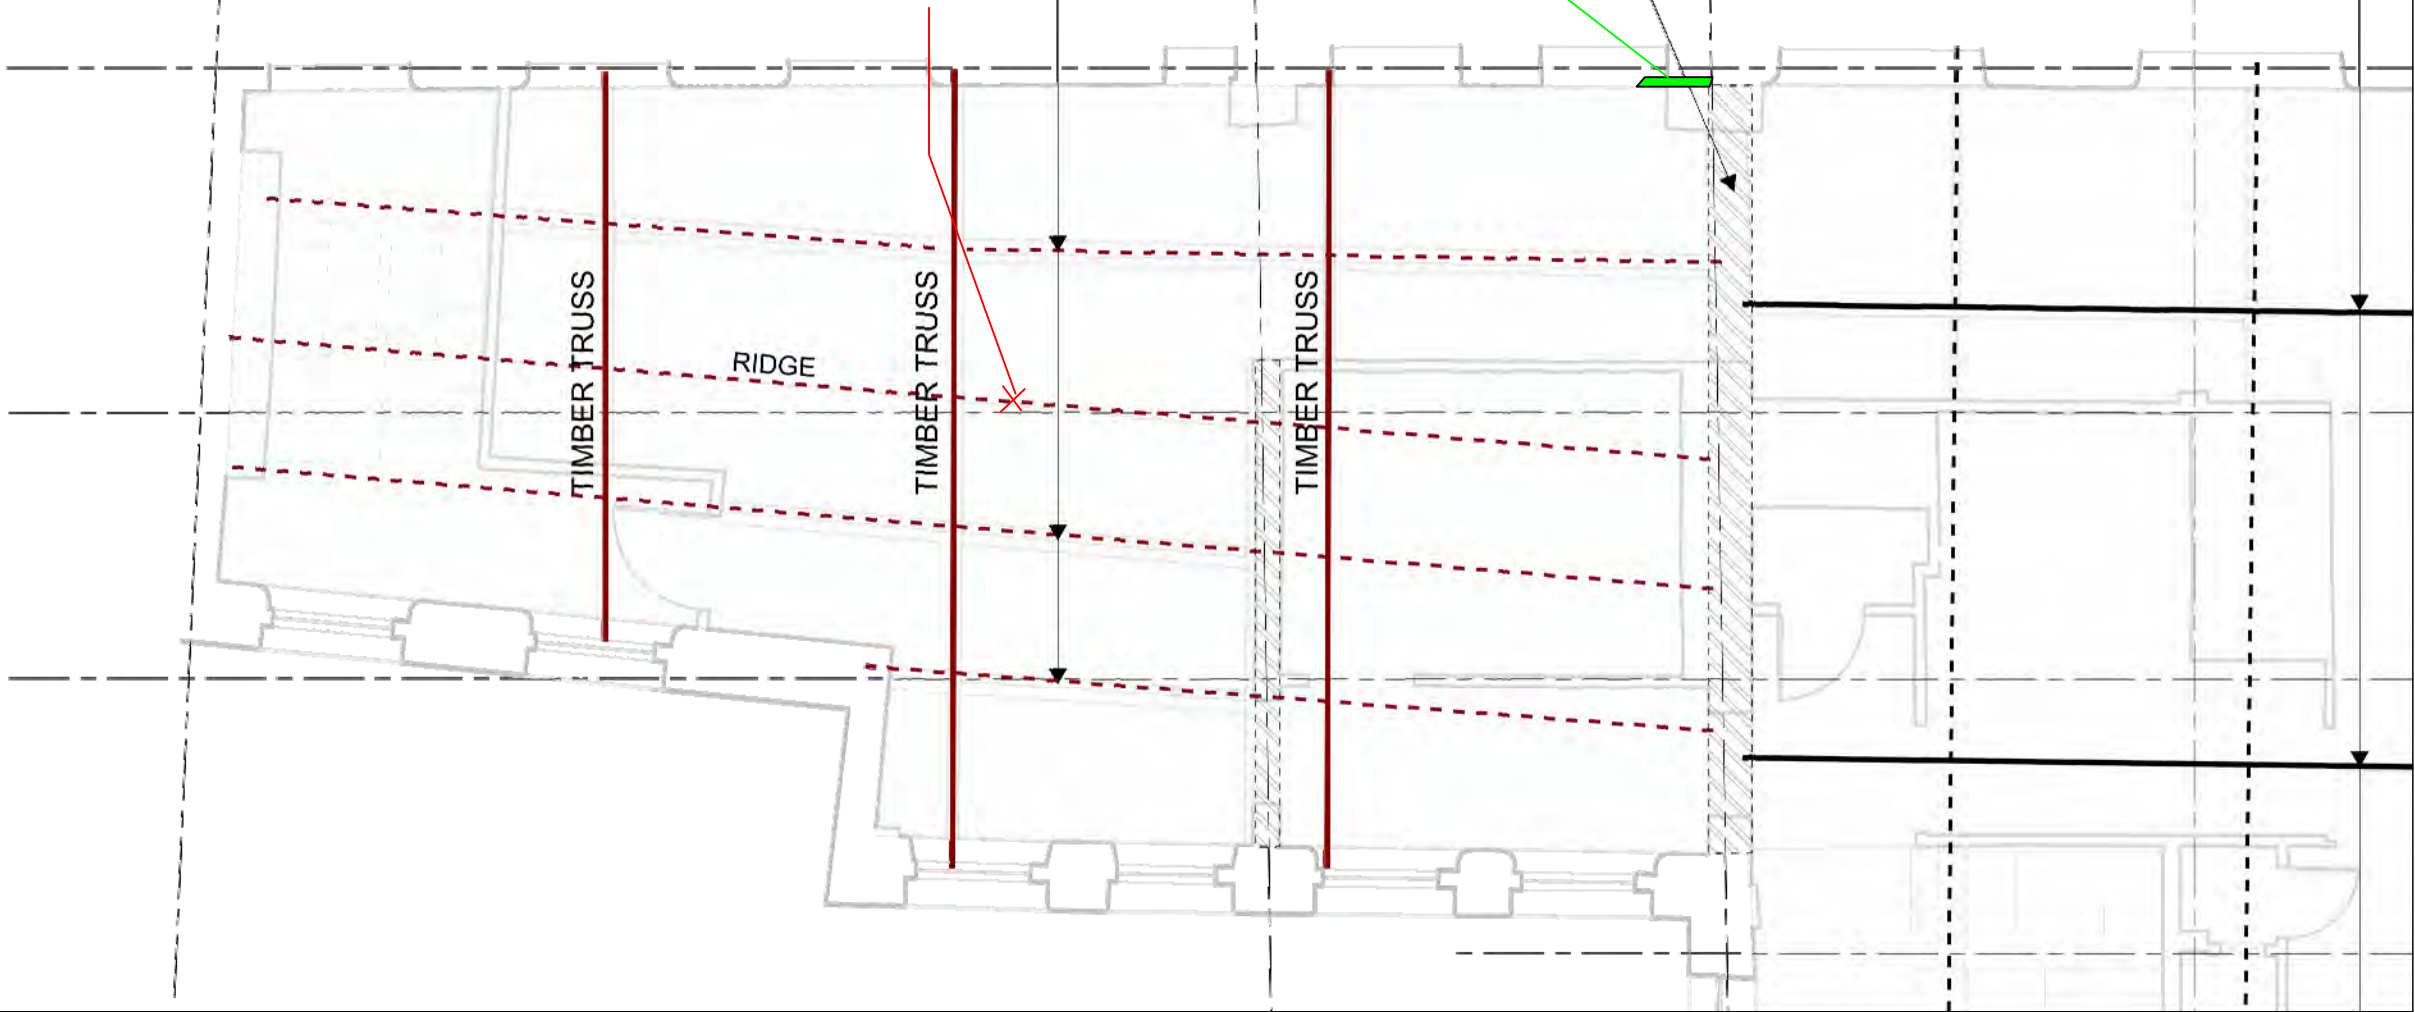
ROOF

- 3.0.4 The Roof trusses and wall plate have been tested and the bearing ends are free from decay at timber members (1no. area of wall plate decayed only). A foil backed membrane and breather membrane is visible behind the soffit board, so we suspect the timber roof structure has been re-roofed previously.

RIDGE TIMBER HAS  
SPLIT NOTED

WALLPLATE DECAY;  
125MM X 75MM X  
500MM LONG

Ridge position seems to  
vary between being  
recessed into king post and  
sat over king post

We did not identify decay to  
bearing end of Truss  
members in all x3no.  
Trusses

| ITEM NO | DESCRIPTION | UNIT | QTY | RATE | Sum | |
|---|---|---|---|---|---|--|
| | WALL PLATE DECAYED; CUT OUT AND REPLACE TO MATCH EXISTING: | | | | | |

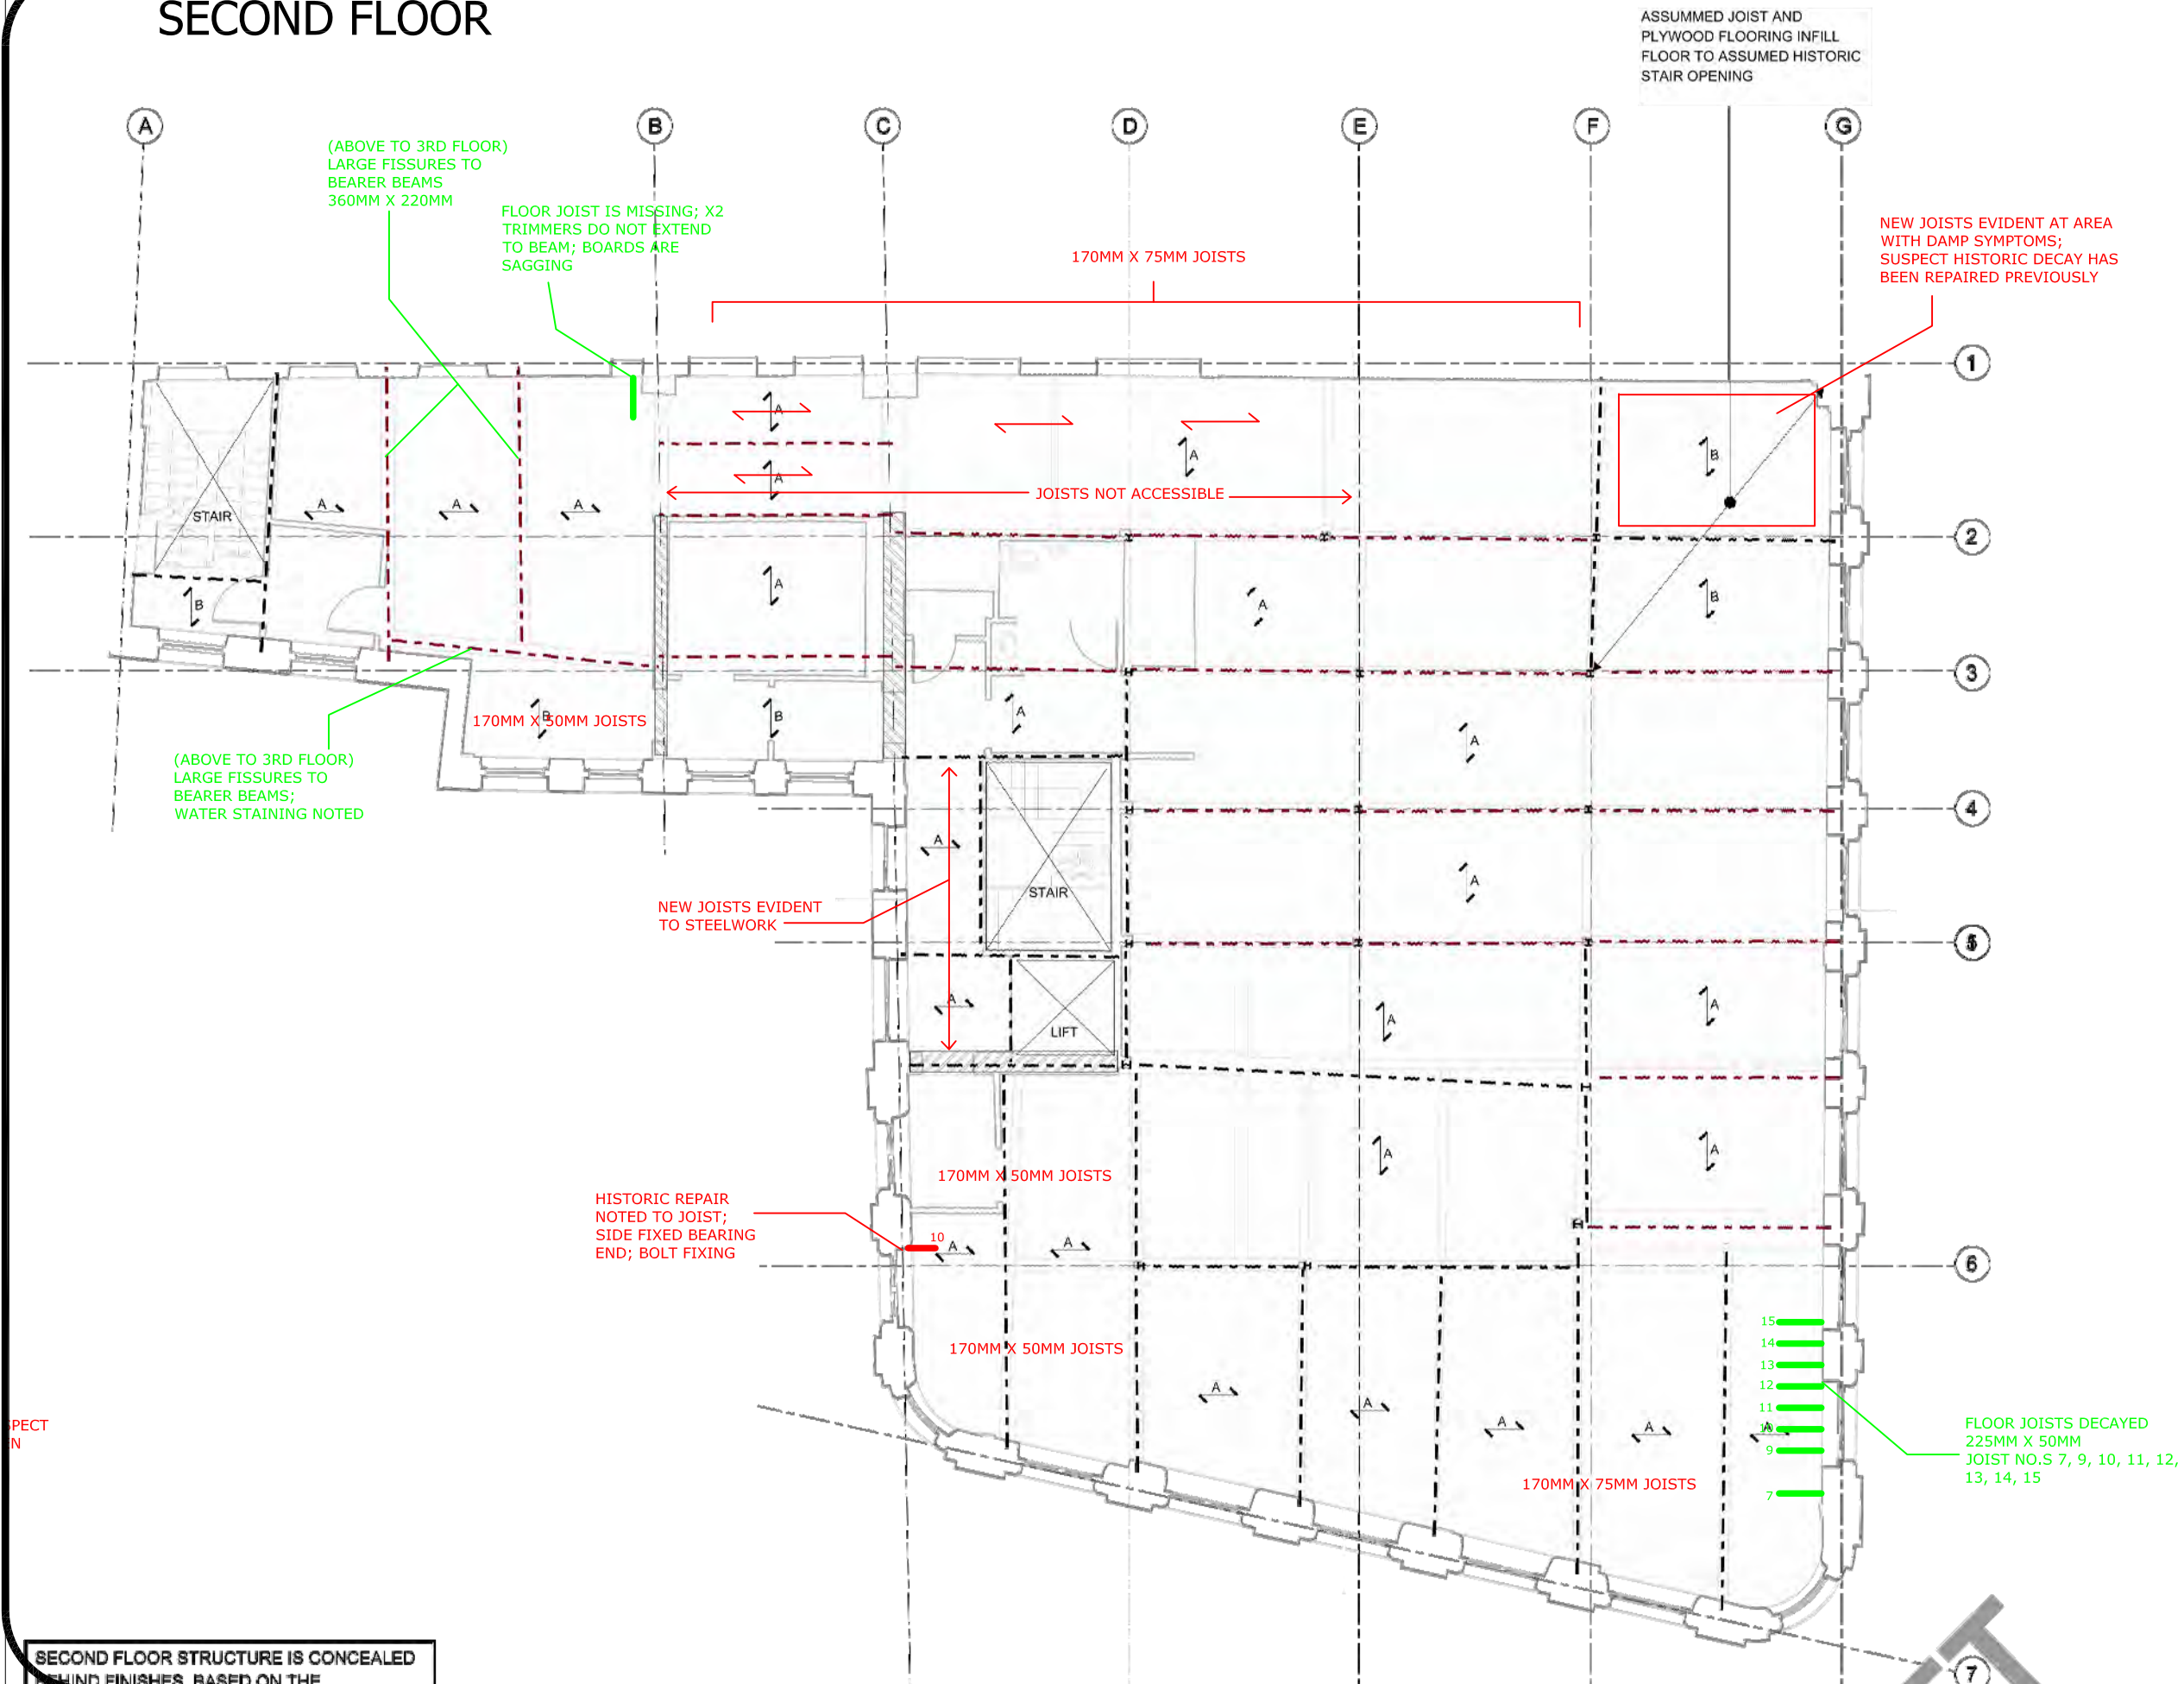
# SECOND FLOOR

- 3.0.6 Second floor joists at the front corner are decayed, this location following the historic pattern of ingress from the upper roof. Beyond this, we noted some large fissures to second floor beams in the off-shot structure, the length of which are beyond grading standards (if assessing for visual strength grading) and therefore the fissures justify resin filling in this area. First floor also has a trimmer joist and lintel decay in the stairwell, but these members are very localised.

The most significant area with remaining decay is located to 2nd floor joists (front corner) and more minor issues in terms of timber repair around the internal downpipes.

| ITEM NO | DESCRIPTION | UNIT | QTY | RATE | Sum | |
|---|---|---|---|---|---|--|
| 5.0 | <b>REPAIR NO. 5</b><br>X8NO. FLOOR JOISTS DECAYED AT BEARING ENDS; ALLOW TO CUT BACK AND SPLICE ON NEW WITH TIMBER JOISTS EITHER SIDE BOLTED THROUGH WITH THREADED BAR AND OVERSIZED WASHERS | | | | | |

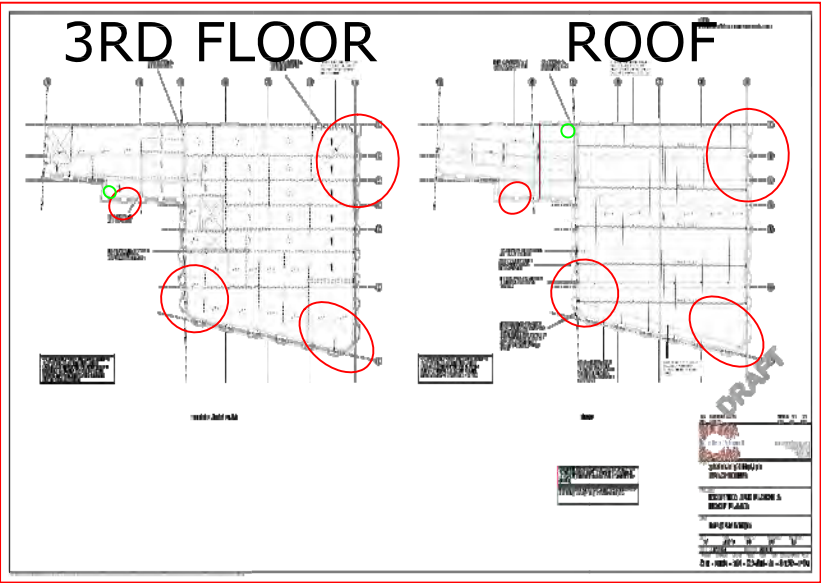
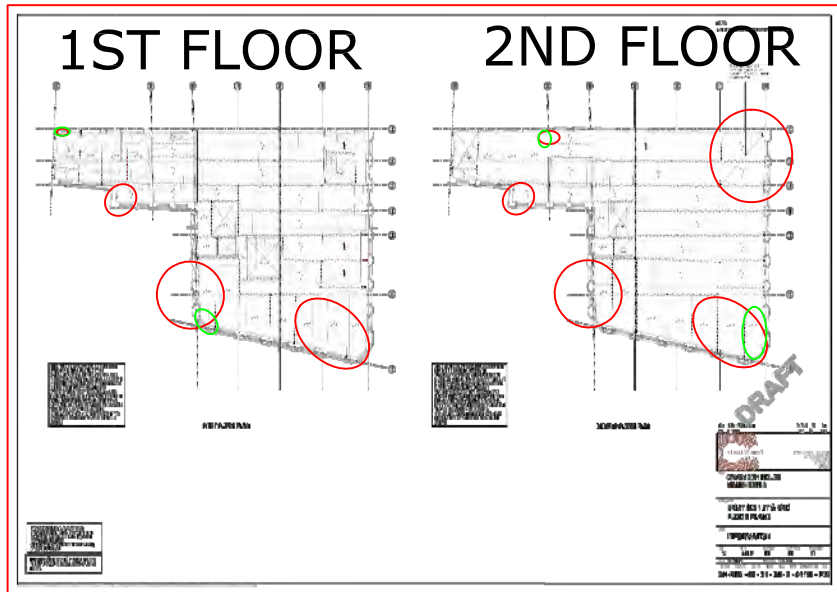
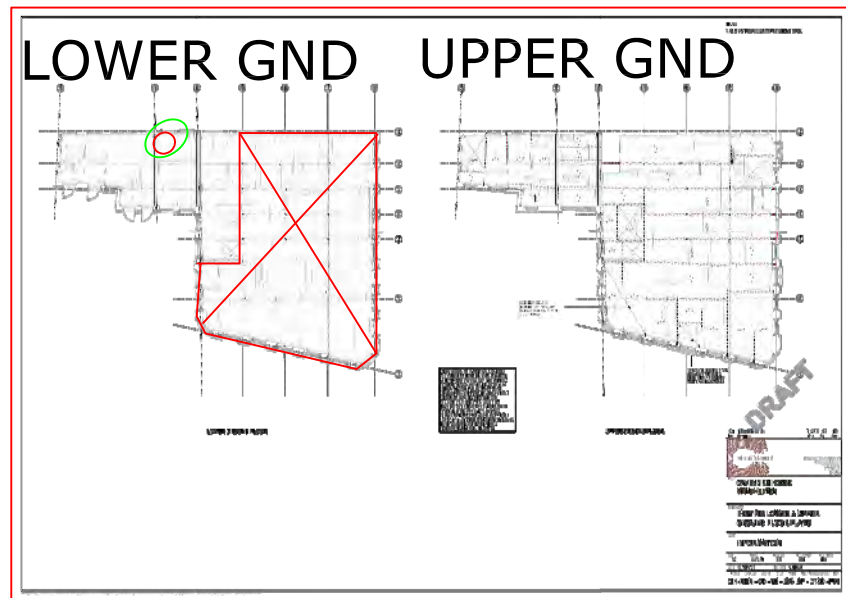
The areas in red generally highlight the areas that have had obvious damp/ingress issues that have migrated down through the building. These seem to have manifested from the Roof and rainwatergoods, including the internal downpipes in areas.

The areas highlighted in green show areas that still have decay/timber repairs, but generally these are localised repairs and more significant areas of replacement have been completed historically, which follow the pattern of damp/ingress down the building.

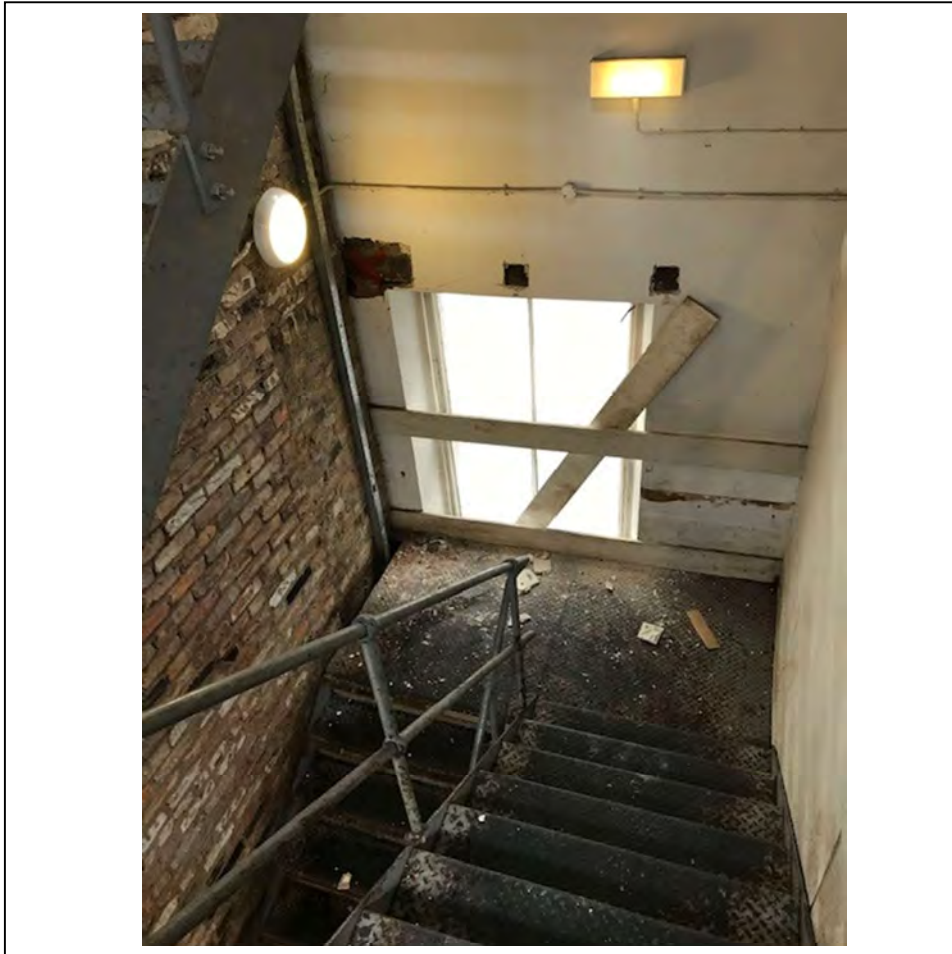
Lintel decayed at Stairwell

| ITEM NO | DESCRIPTION | UNIT | QTY | RATE | Sum | |
|---|---|---|---|---|---|--|
| 7.0 | <b>REPAIR NO. 7</b><br>LINTEL END IS DECAYED; ALLOW TO CUT OUT AND REPLACE TO MATCH EXISTING:<br>- PROP LINTEL; STRONGBOY<br>- CUT OUT EXISTING LINTEL<br>- NEW SOFTWOOD C24; 150MM X 160MM X 2000MM<br>- CUT TO SIZE<br>- INSTALL NEW LINTEL; TREAT CUT ENDS; ISOLATE BACK FACE ON DPC | <b>SUM</b><br><b>HRS</b><br><b>SUM</b><br><b>HRS</b><br><b>HRS</b> | <b>1.00</b><br><b>4.00</b><br><b>1.00</b><br><b>2.00</b><br><b>4.00</b> | 100.00<br>30.00<br>95.00<br>30.00<br>30.00 | 100.00<br>120.00<br>95.00<br>60.00<br>120.00<br>495.00 | |

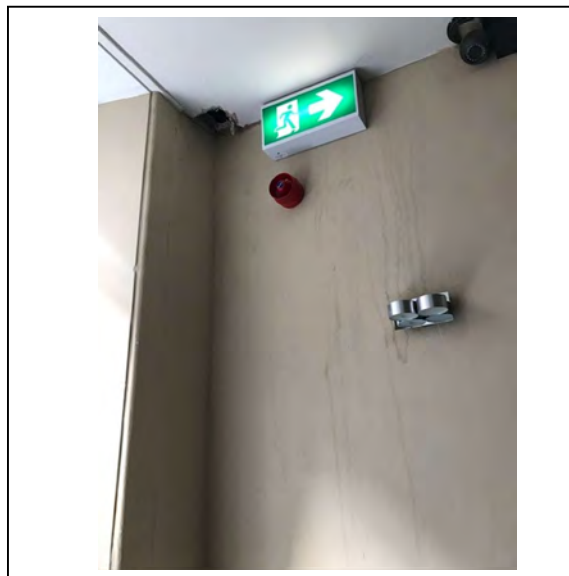
Visible moisture stains to wall upper Gnd floor - ceiling void above 450mm deep

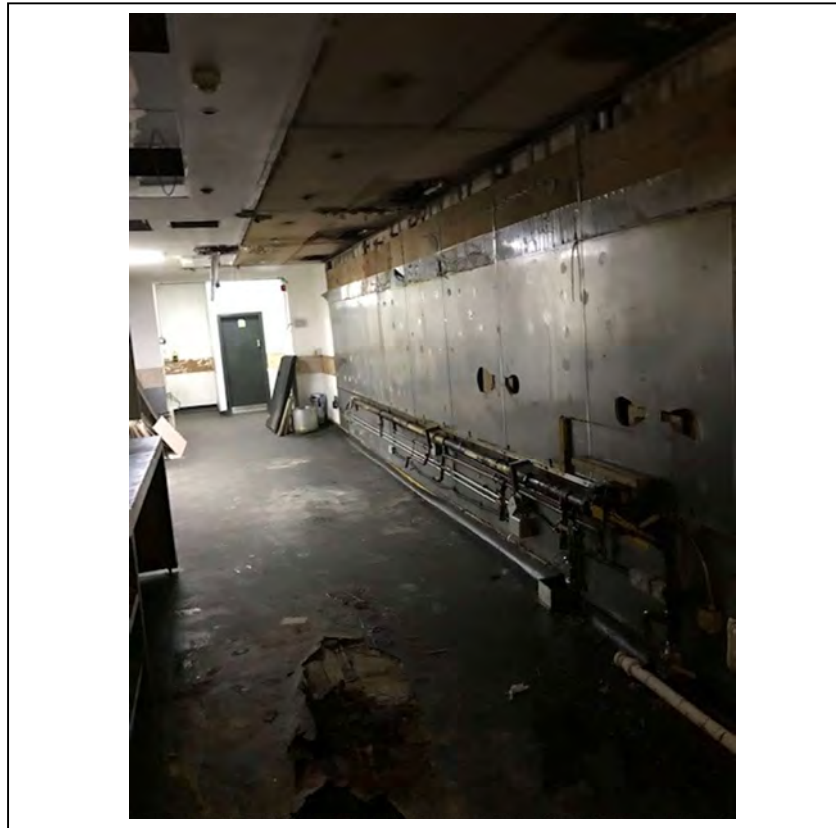
### Restricted access at upper Gnd Floor

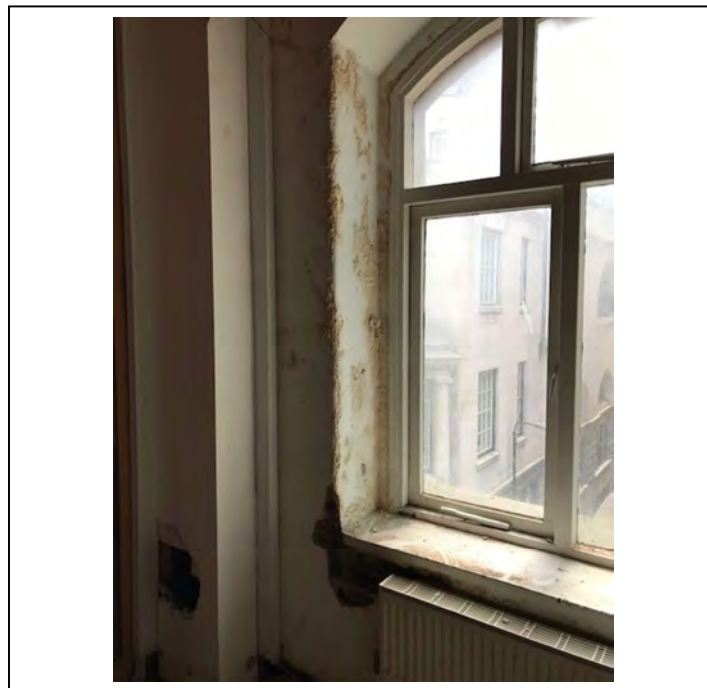
### Example of moisture penetration; salts to plaster substrates

- 4.3.1 To all walls where damp symptoms or high meter readings are noted, we would typically advise that the plaster is removed to reduce the risk of residual moisture and salts spoiling new finishes. The walls should be wire-brushed to remove surface contaminants prior to remedial measures.

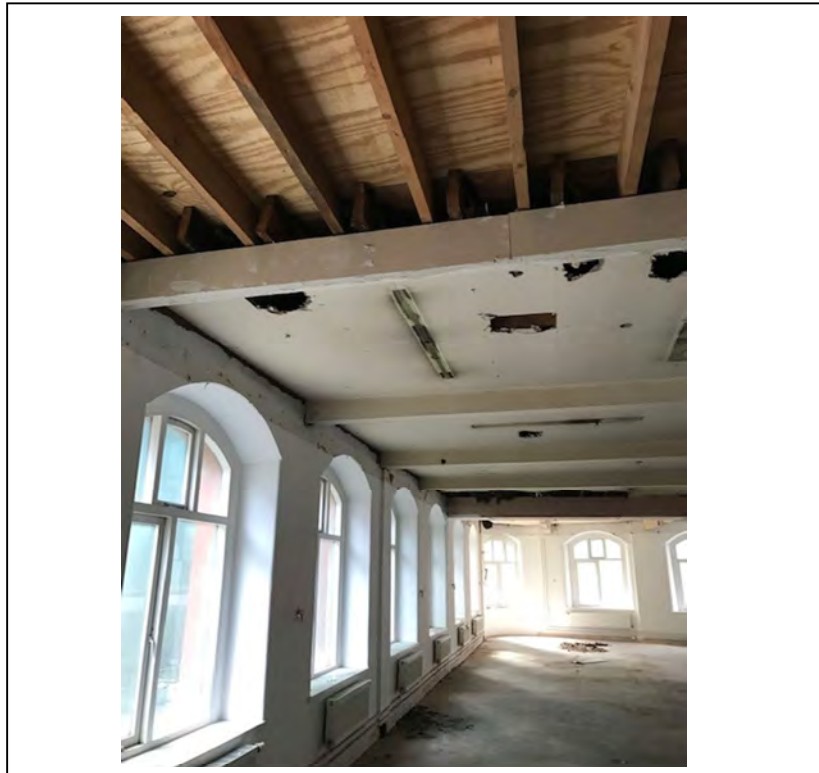
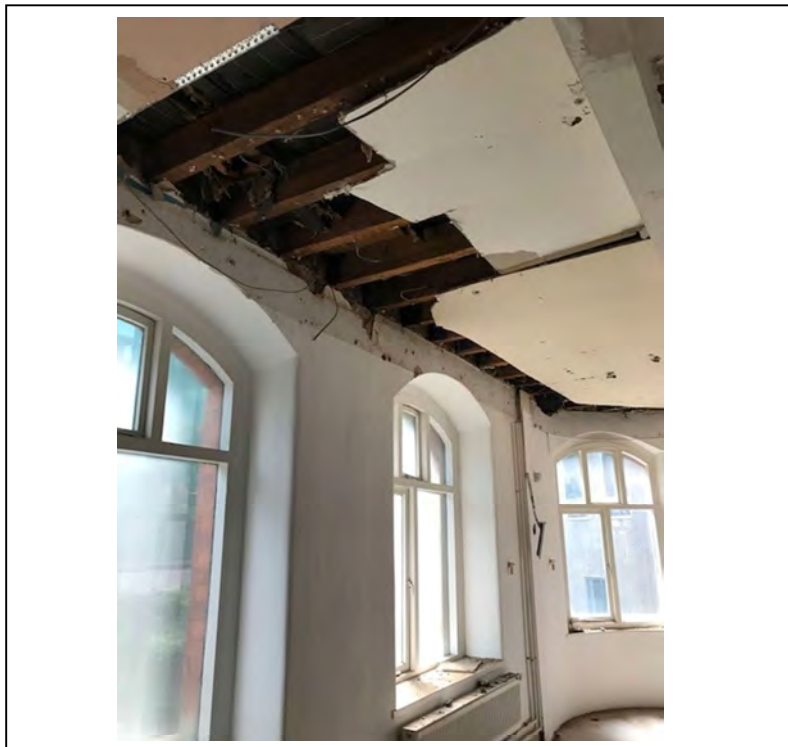
### Example of new floor joist infill

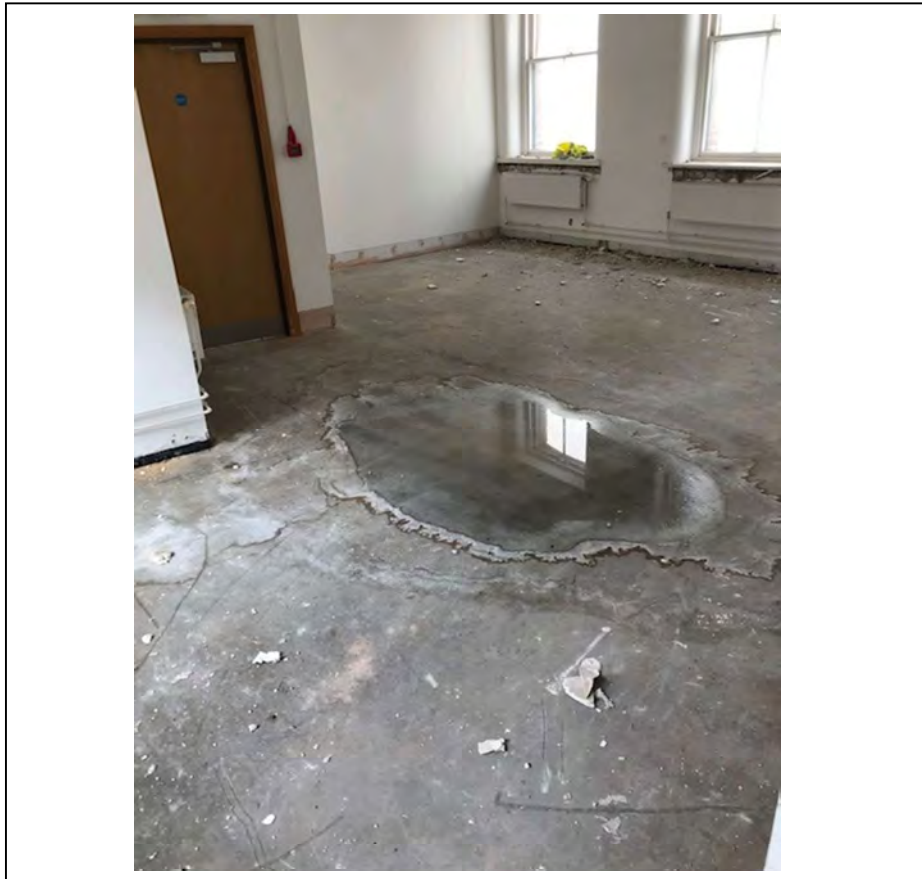
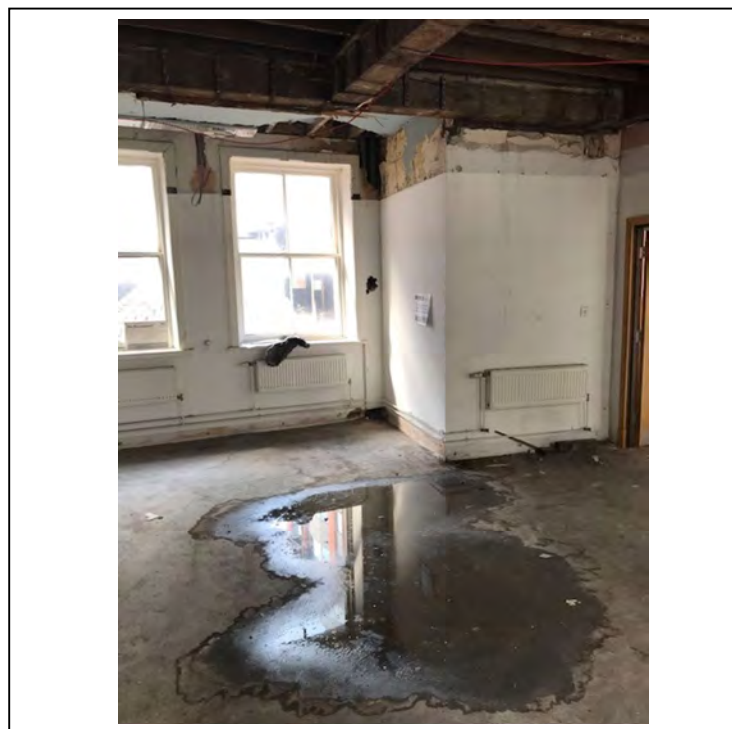
Ingress is ongoing with standing water to upper floors and this is through to be via the internal downpipes as we did not see any moisture staining to the pitched roof soffits in the locality.

### Standing Water to floor

4.2.2 The off-shot structure has areas of standing water and whilst many joists/boards bear between steelwork, the floor areas that have been replaced to the main building can justify localised treatment as wall areas are still damp and we cannot verify if pre-treated timber was used or whether the cut ends were treated during install, so we will propose to eliminate risk in these areas.

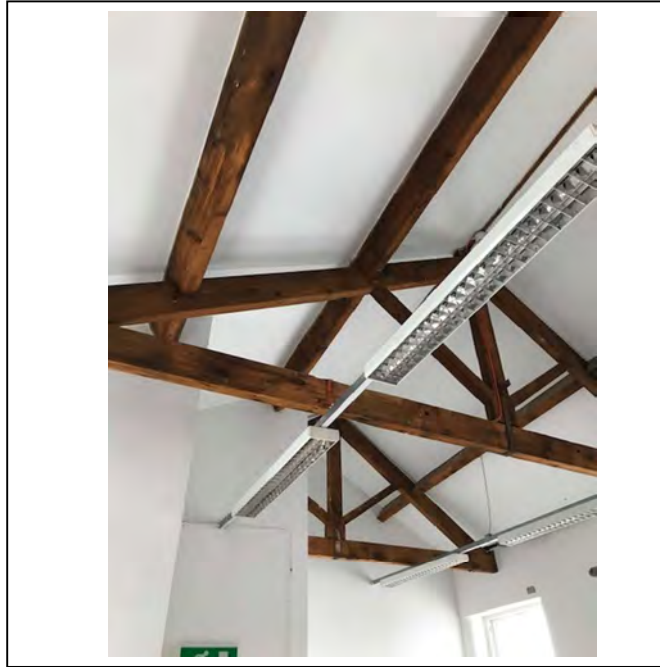
Example of king Post Truss

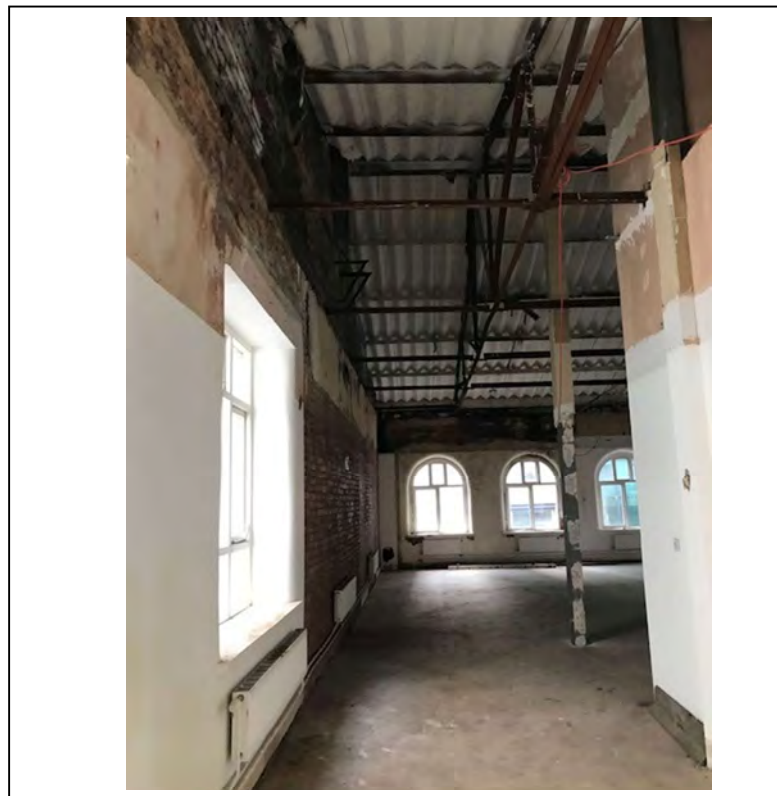
Profiled sheet roof
