GROUND FLOOR | WINDOWS

| snookarchitects | | project: | rev. | date | description |
|---|---|---|---|---|---|
| 89 Wood Street | Liverpool | bridgewater house | | | |
| t: 0151 707 0100 | | dwg title: | | window survey [1 of 16] | |

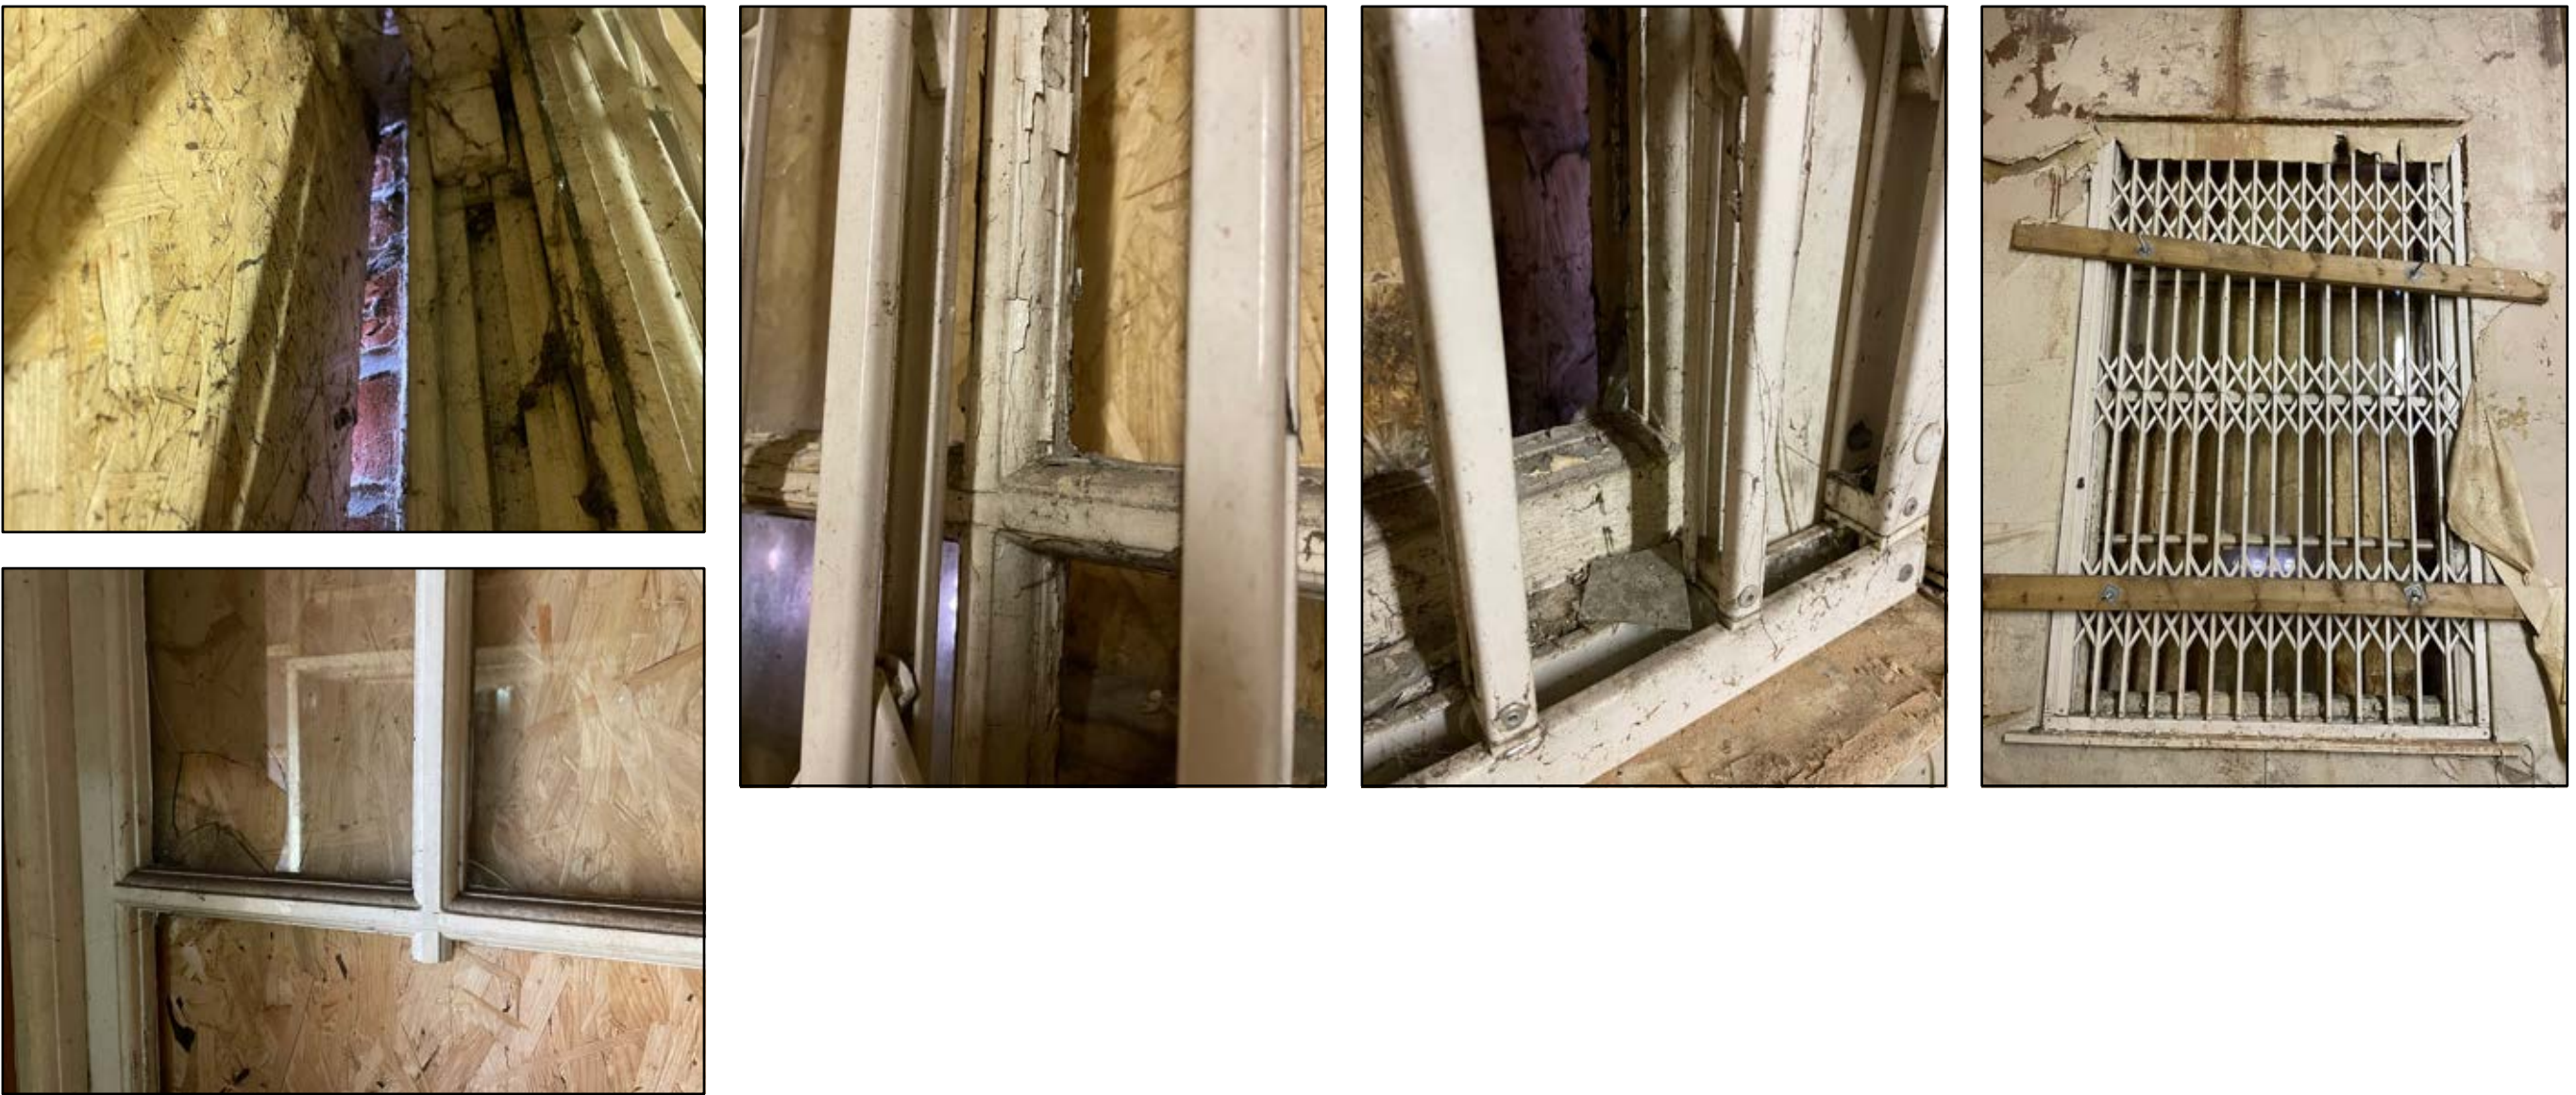
WINDOW WG.04

- Unable to open
- No glass
- Non original frame (probably)
- Damaged frame

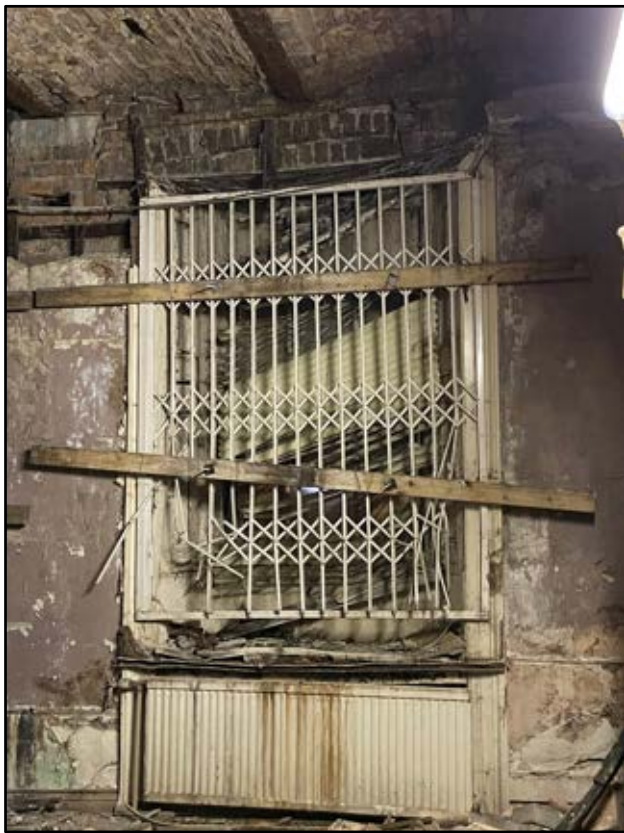
WINDOW **WG.09**

- Restricted access - Window is inaccessible due to collapsed ceiling and/or unsafe floor structure
- Photo taken from a distance
- Frame looks damaged
- Glass looks broken

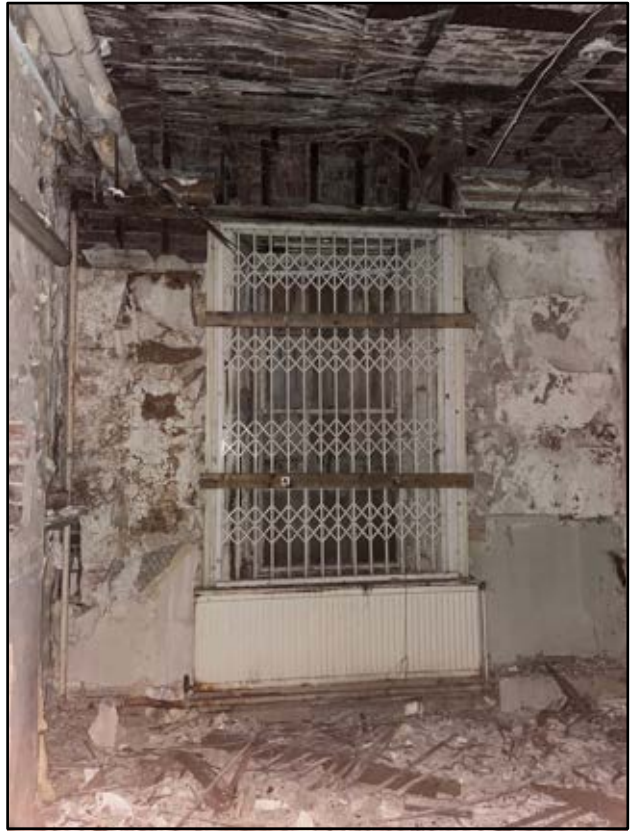
WINDOW **WG.15**

- Restricted access - Window is inaccessible due to collapsed ceiling and/or unsafe floor structure
- Photo taken from a distance
- Frame looks damaged
- Glass looks broken

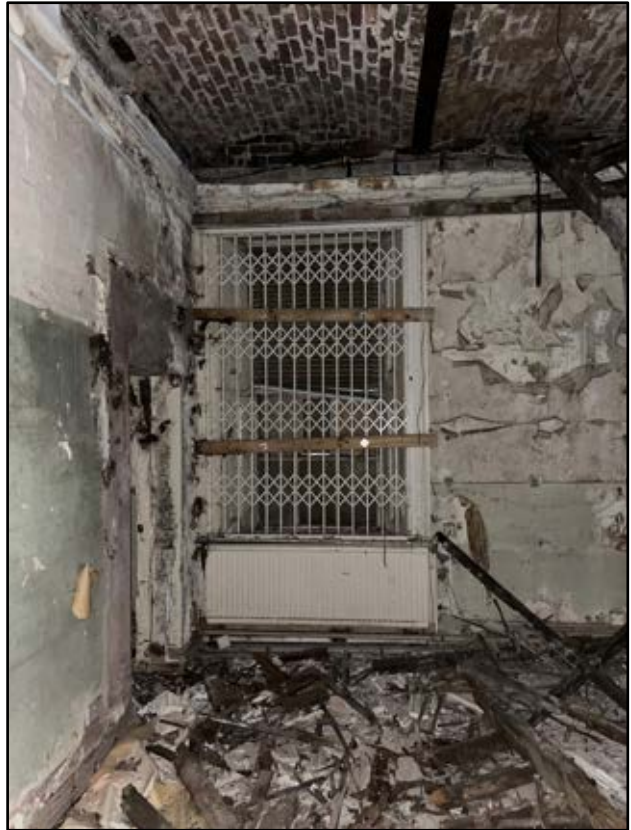
WINDOW **WG.16**

- Restricted access - Window is inaccessible due to collapsed ceiling and/or unsafe floor structure
- Photo taken from a distance
- Frame looks damaged
- Glass looks broken

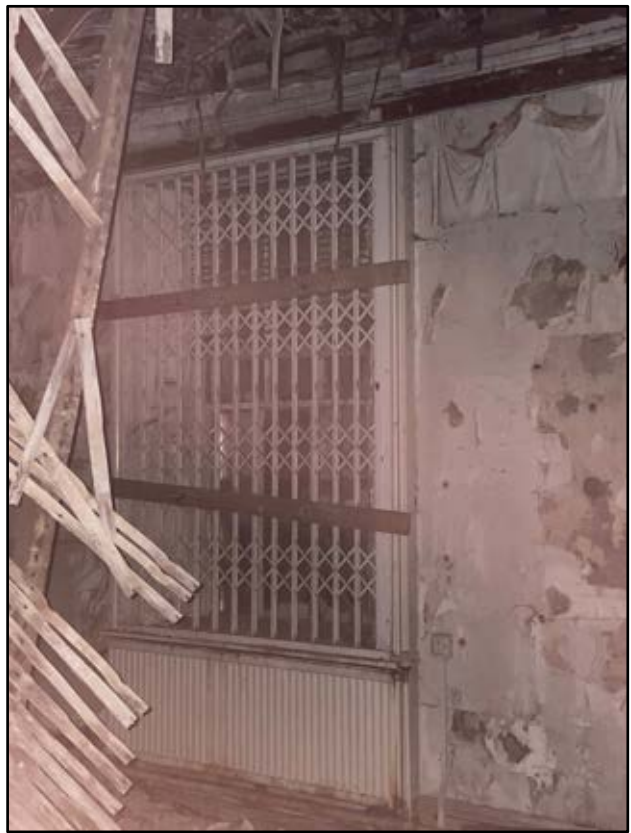
WINDOW **WG.17**

- Restricted access - Window is inaccessible due to collapsed ceiling and/or unsafe floor structure
- Photo taken from a distance
- Frame looks damaged
- Glass looks broken

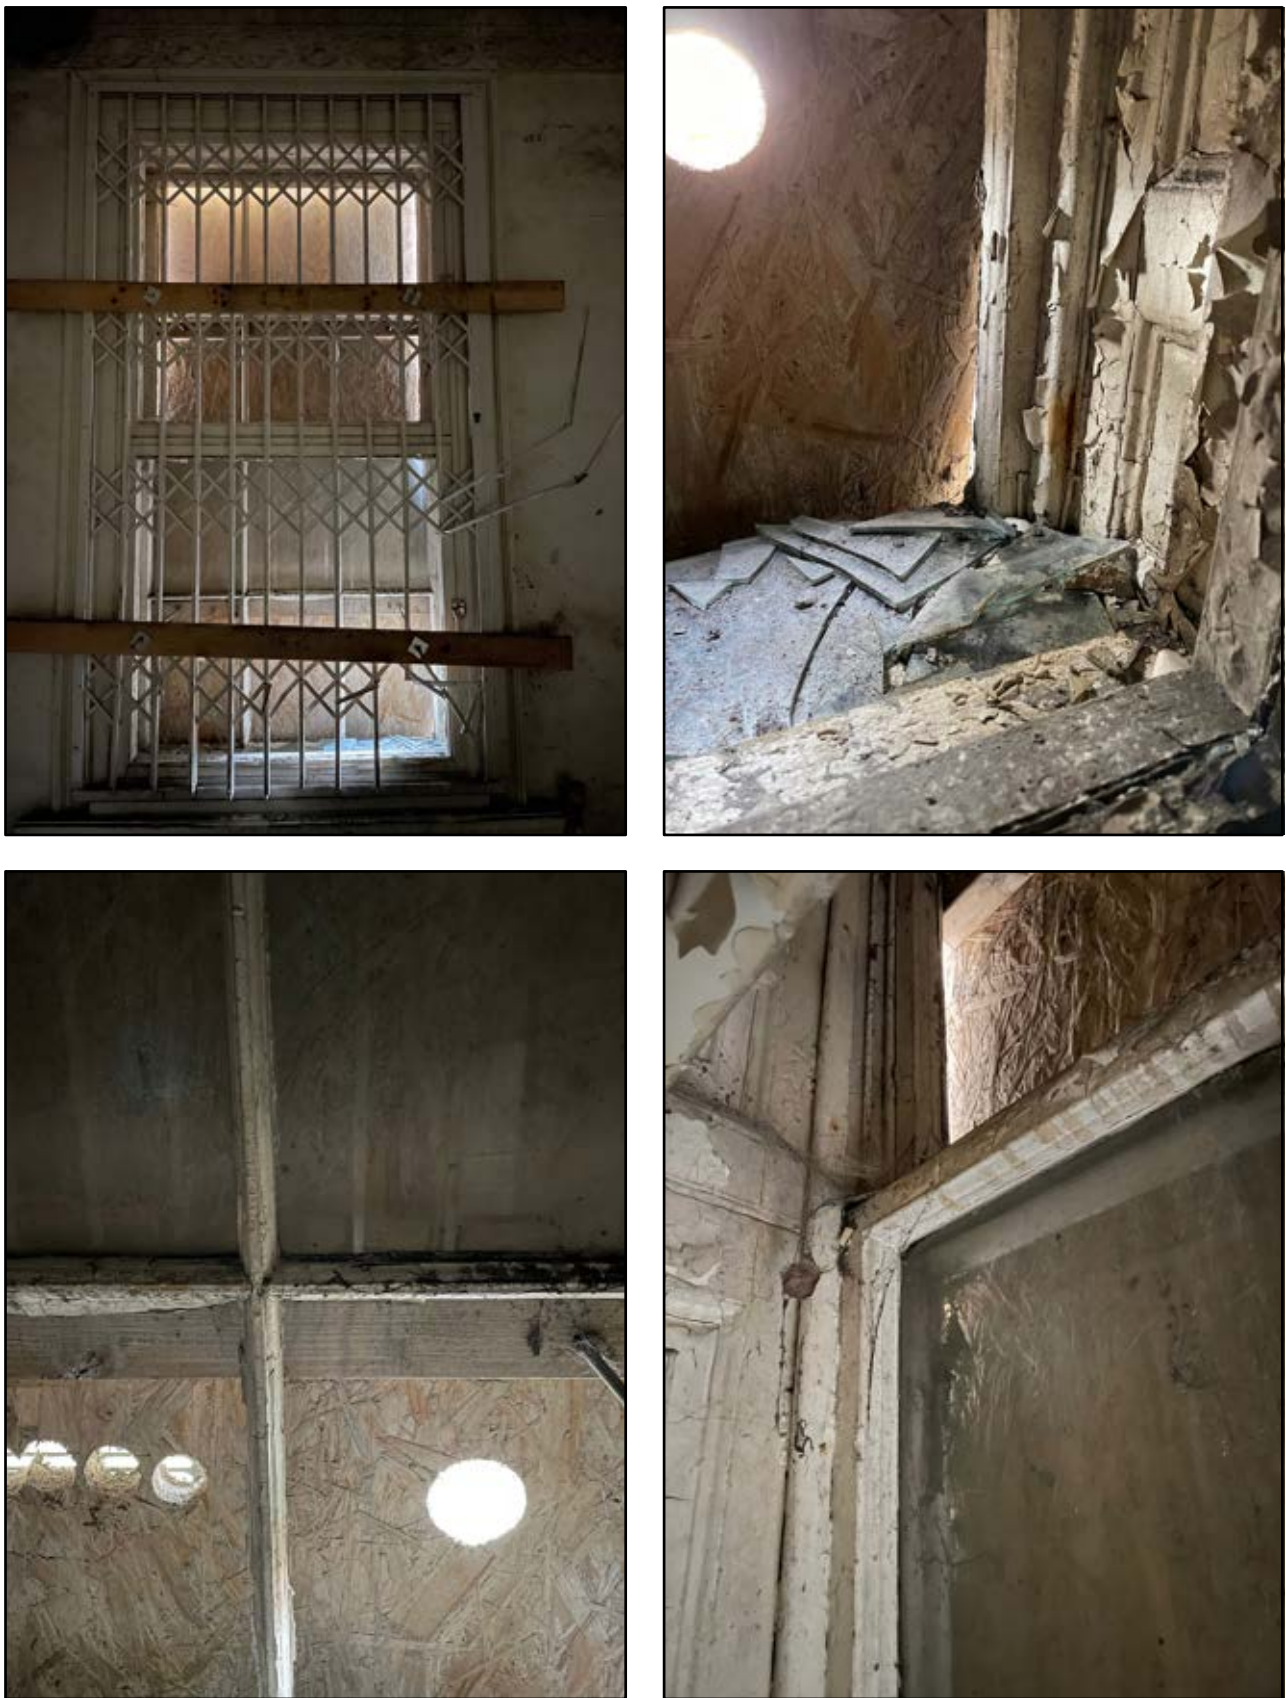
WINDOW WG.24

- Unable to open
- Original frame
- Damaged frame
- No glass (mostly broken)
- Non original glass

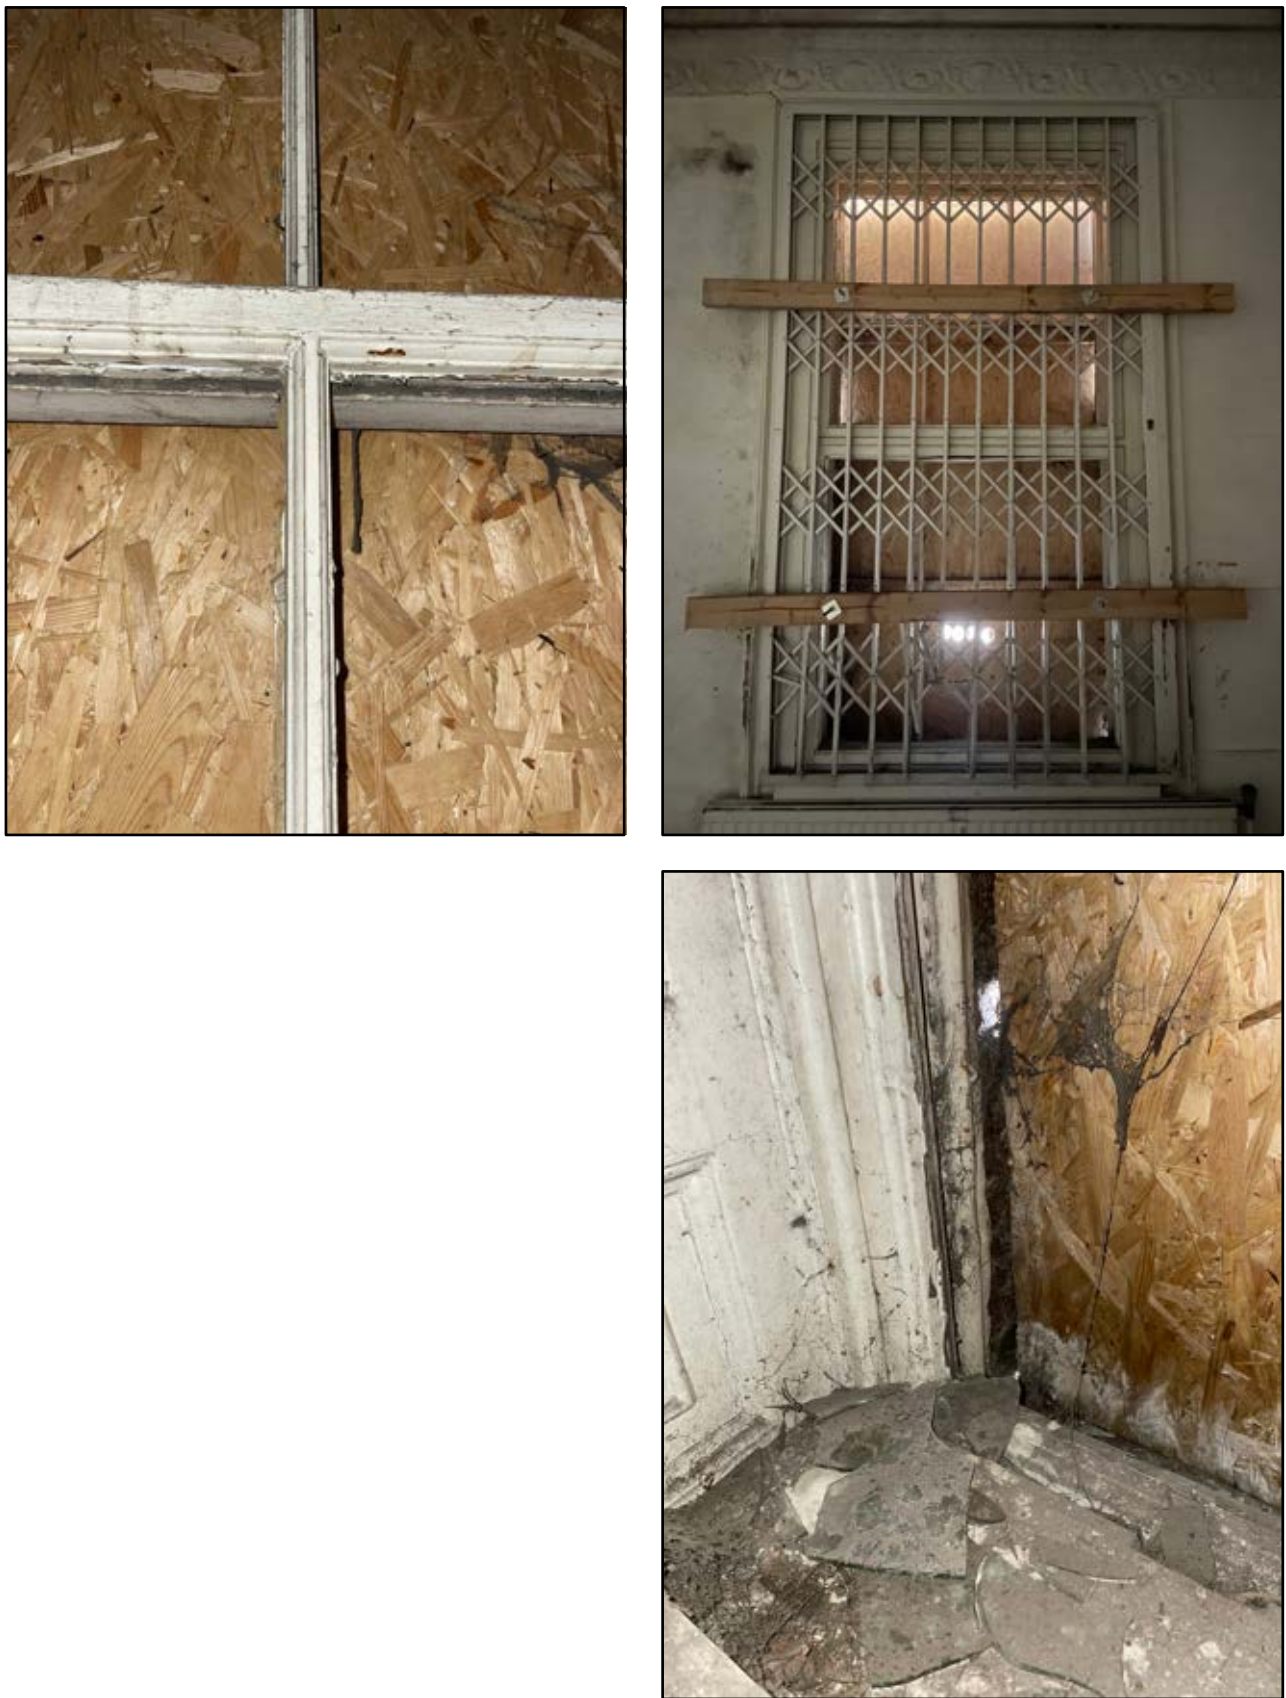
WINDOW WG.25

- Unable to open
- Original frame
- Damaged frame
- No glass (mostly broken)
- Non original glass

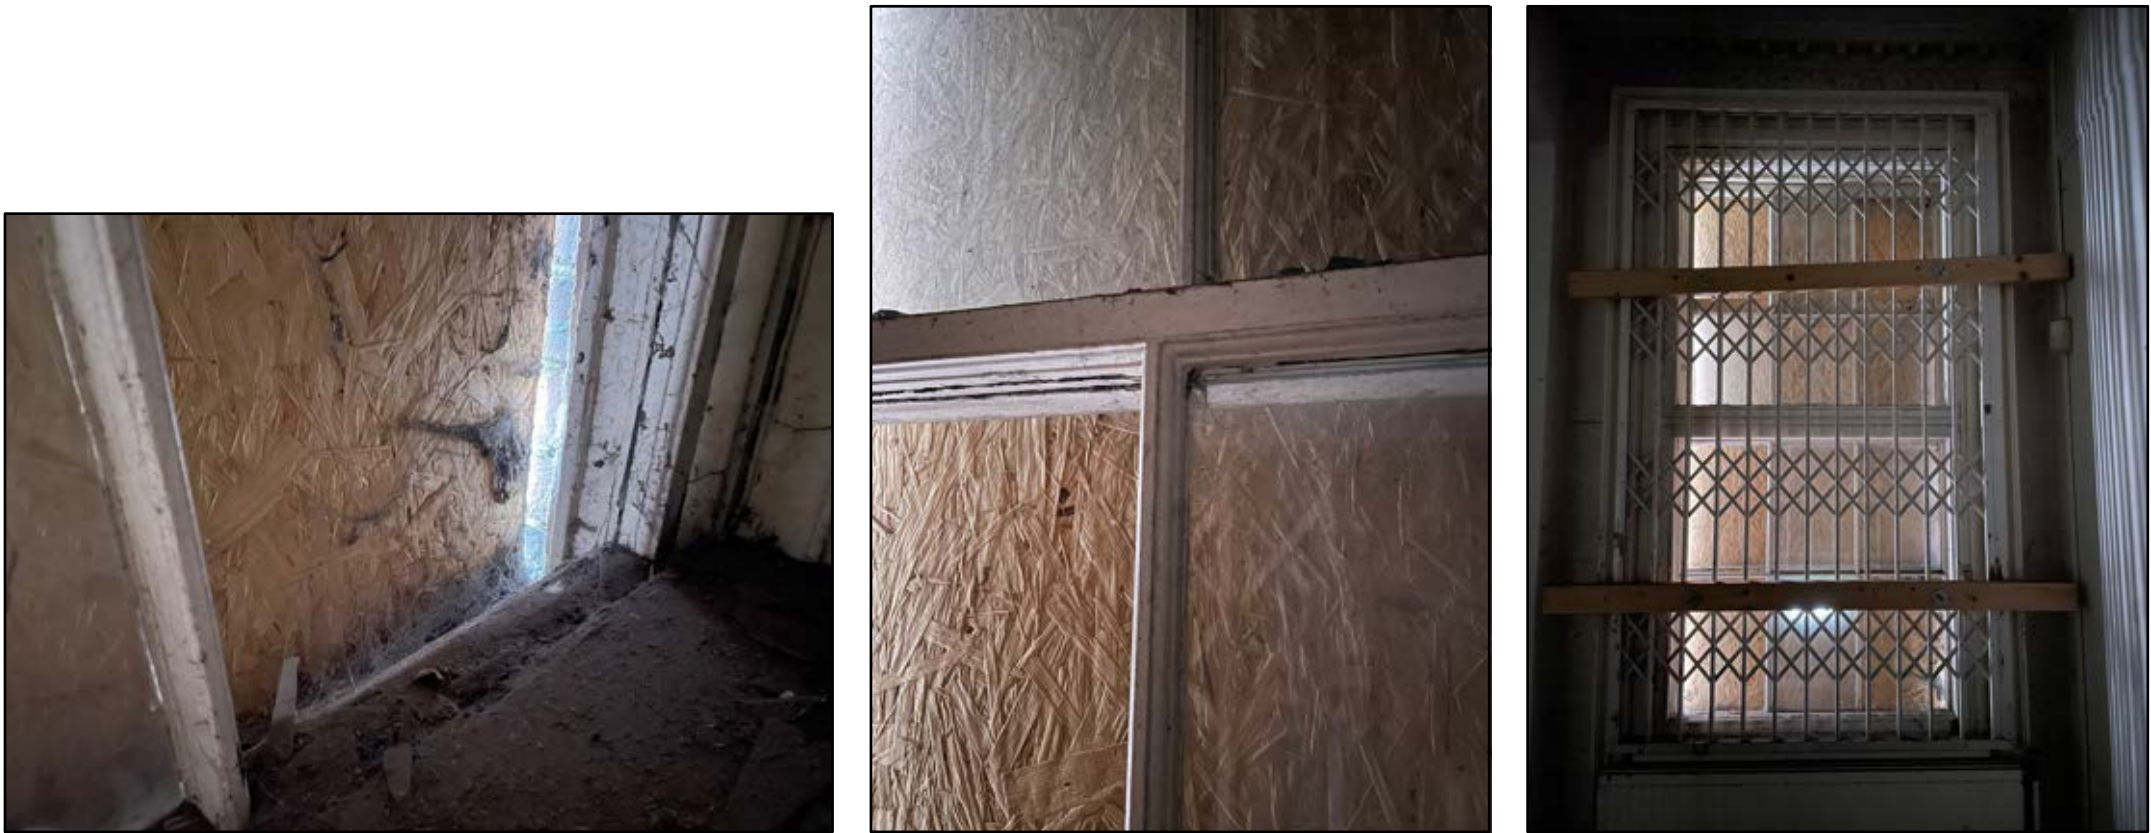
WINDOW WG.26

- Unable to open
- Original frame
- Damaged frame
- No glass (mostly broken)
- Non original glass

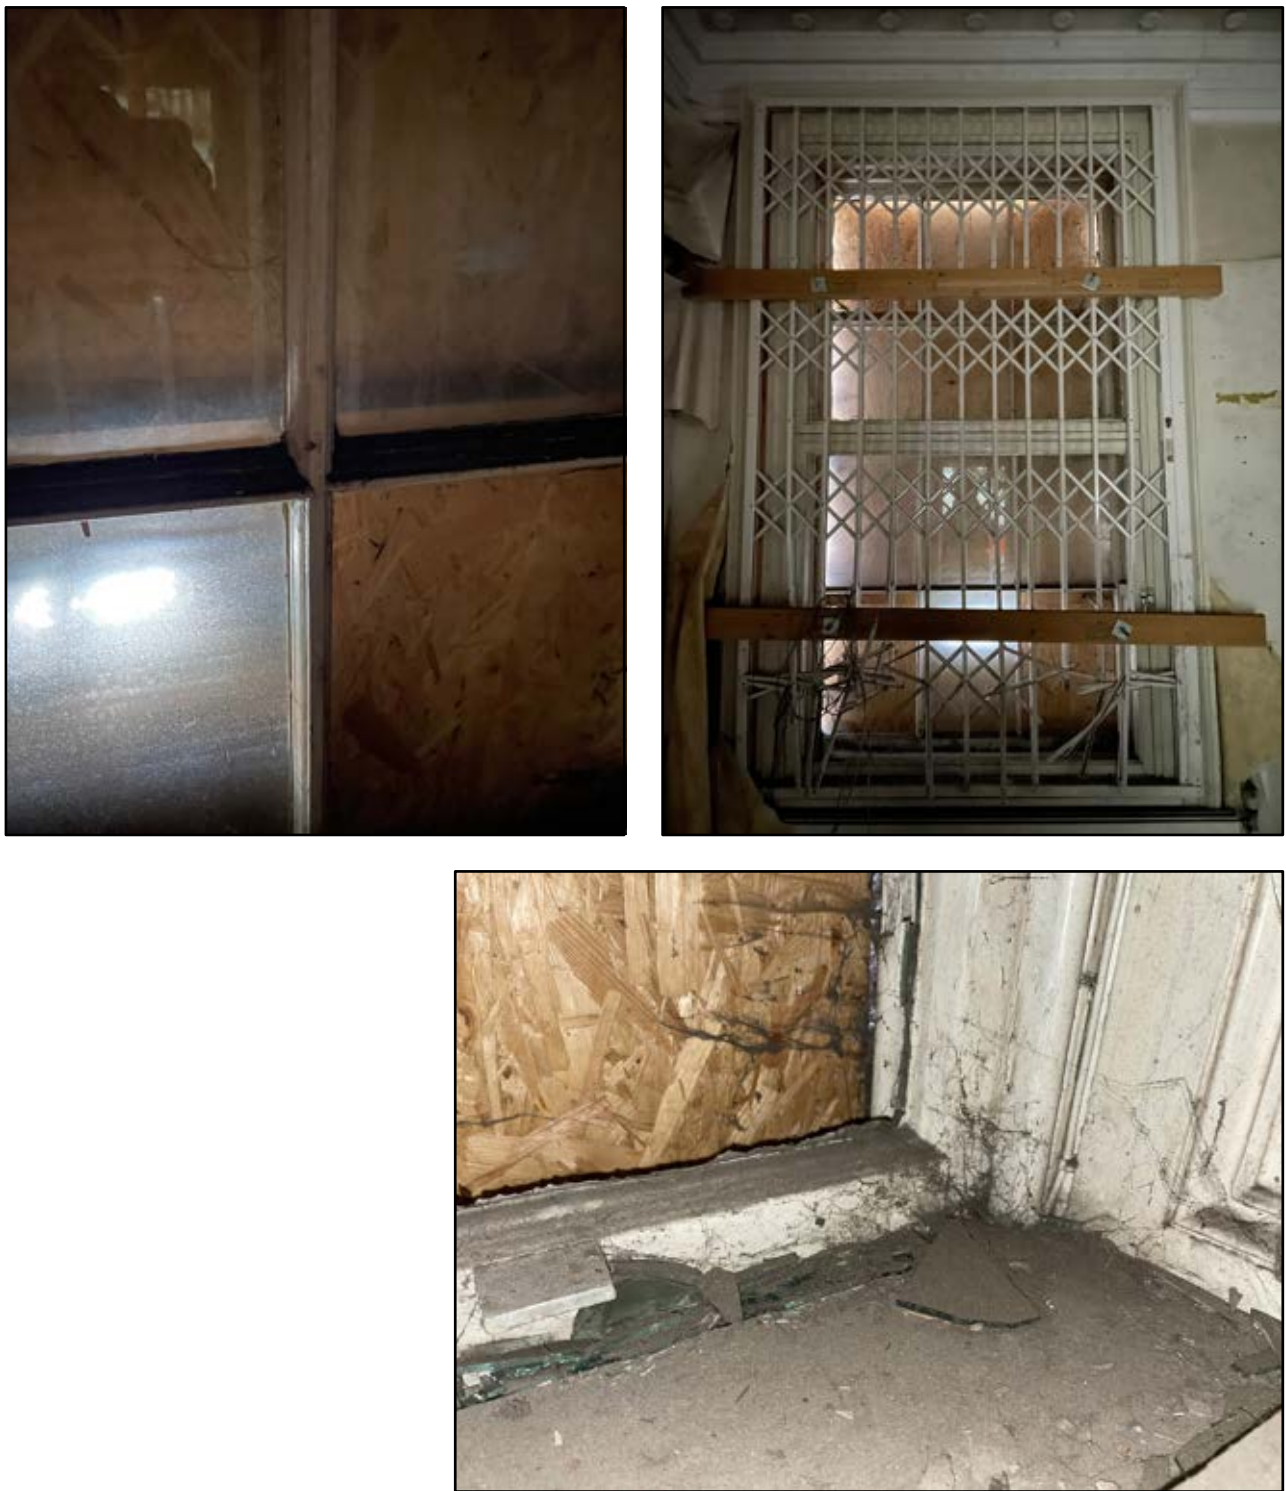
WINDOW WG.31

- Unable to open
- Original frame
- Damaged frame
- No glass (mostly broken)
- Non original glass

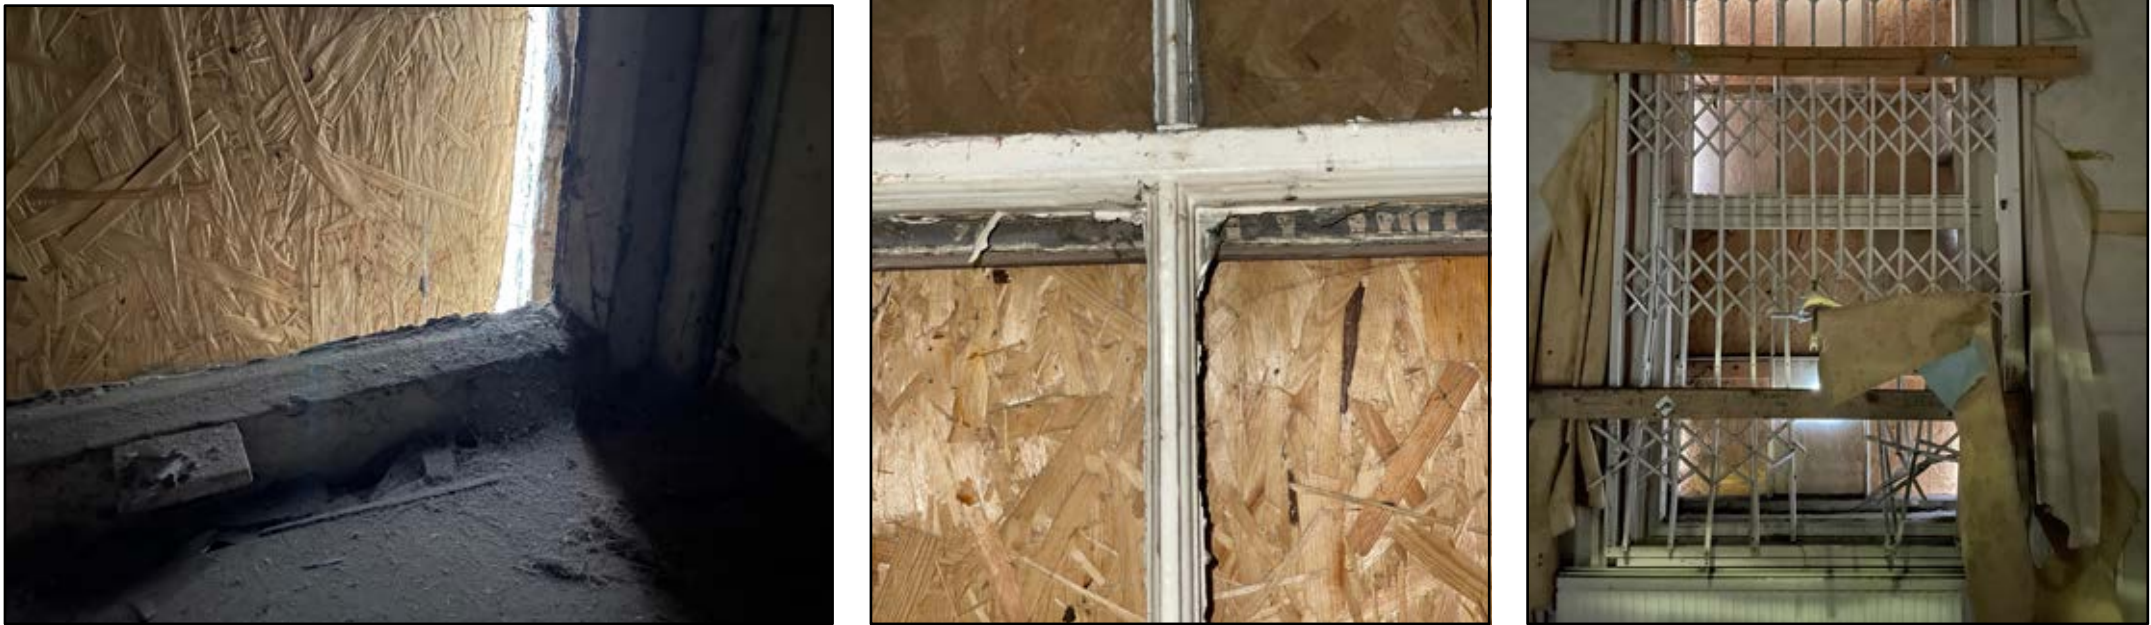
WINDOW WG.32

- Unable to open
- Original frame
- Damaged frame
- No glass (mostly broken)
- Non original glass

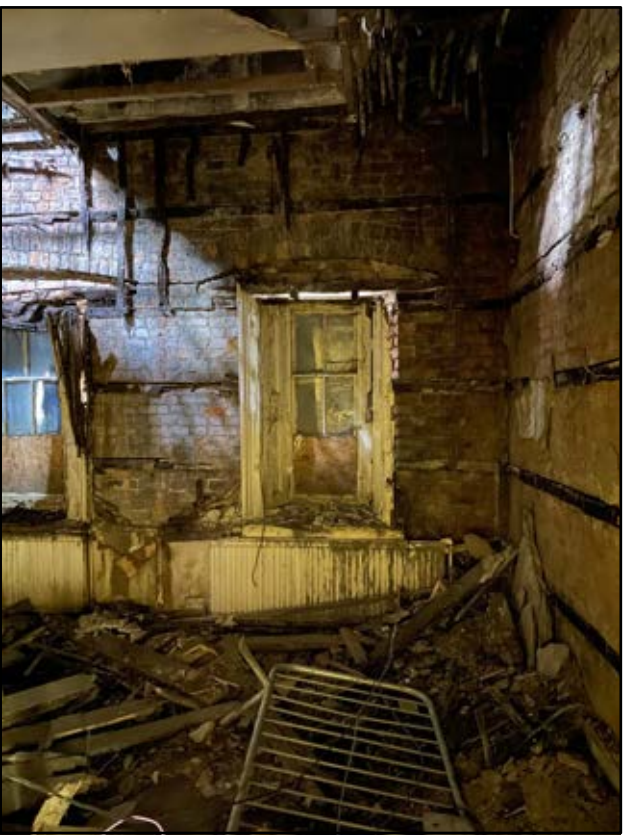
WINDOW **W1.17**

- Restricted access - Window is inaccessible due to collapsed ceiling and/or unsafe floor structure
- Photo taken from a distance
- Frame looks badly damaged
- Window is partially boarded up

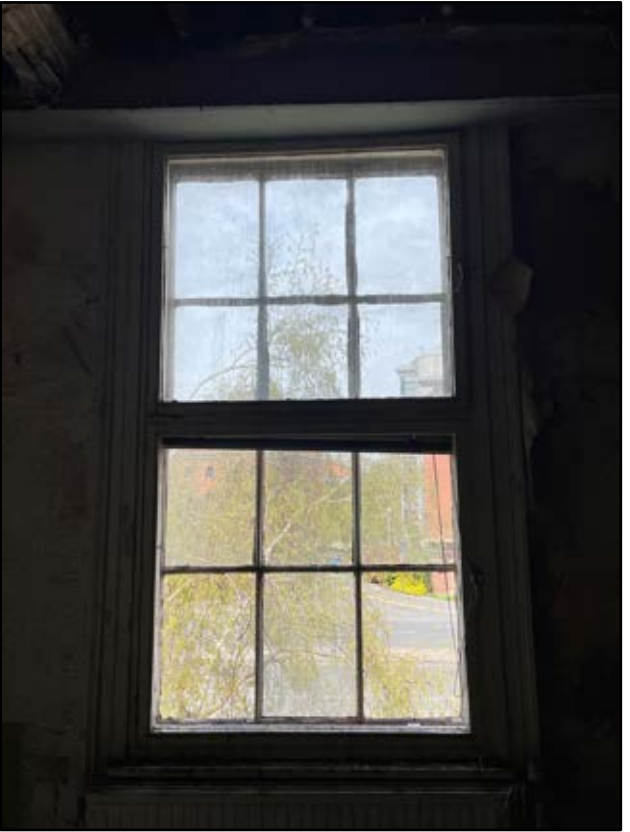
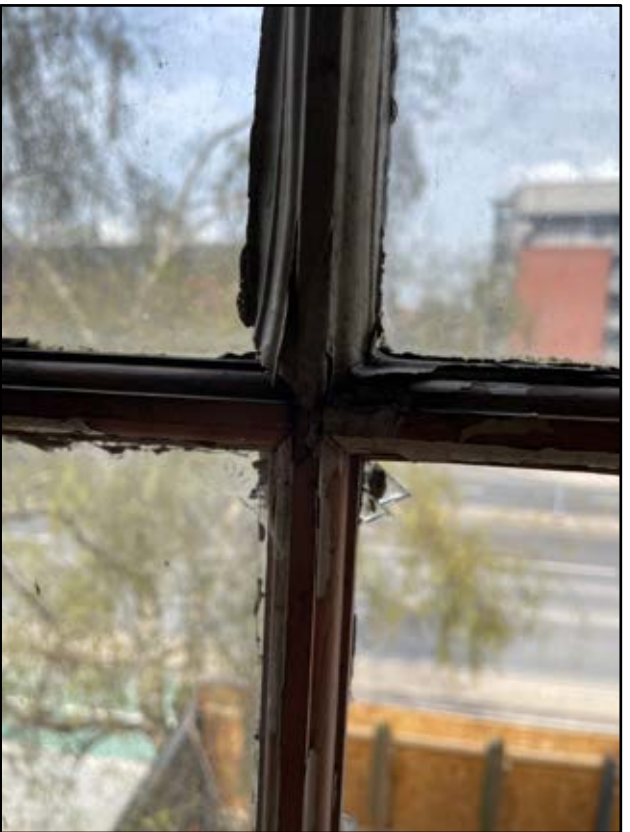
WINDOW **W1.22**

- Unable to open
- Original frame
- Frame is rotten
- Glass is missing and/or broken
- No chords

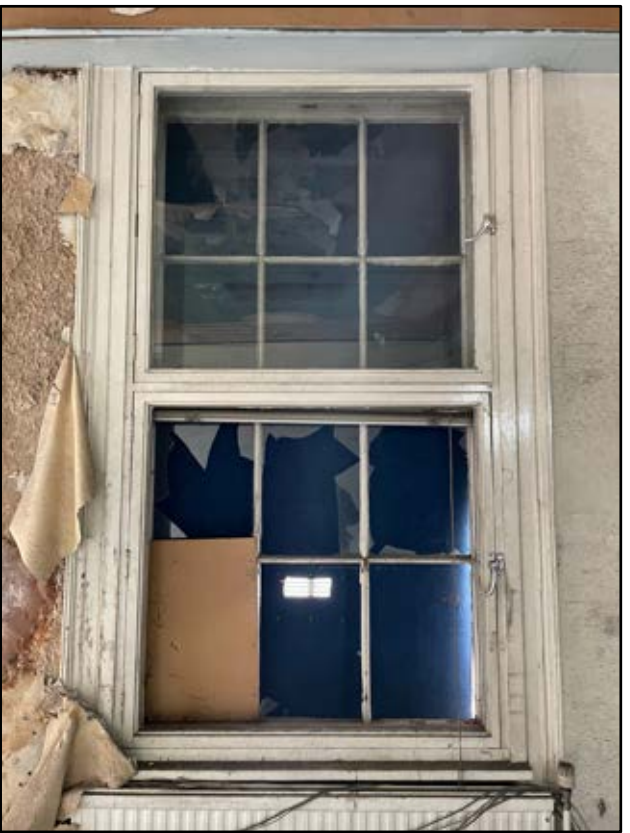
WINDOW **W1.23**

- Unable to open
- Original frame
- Frame is rotten
- Glass is missing and/or broken
- No chords

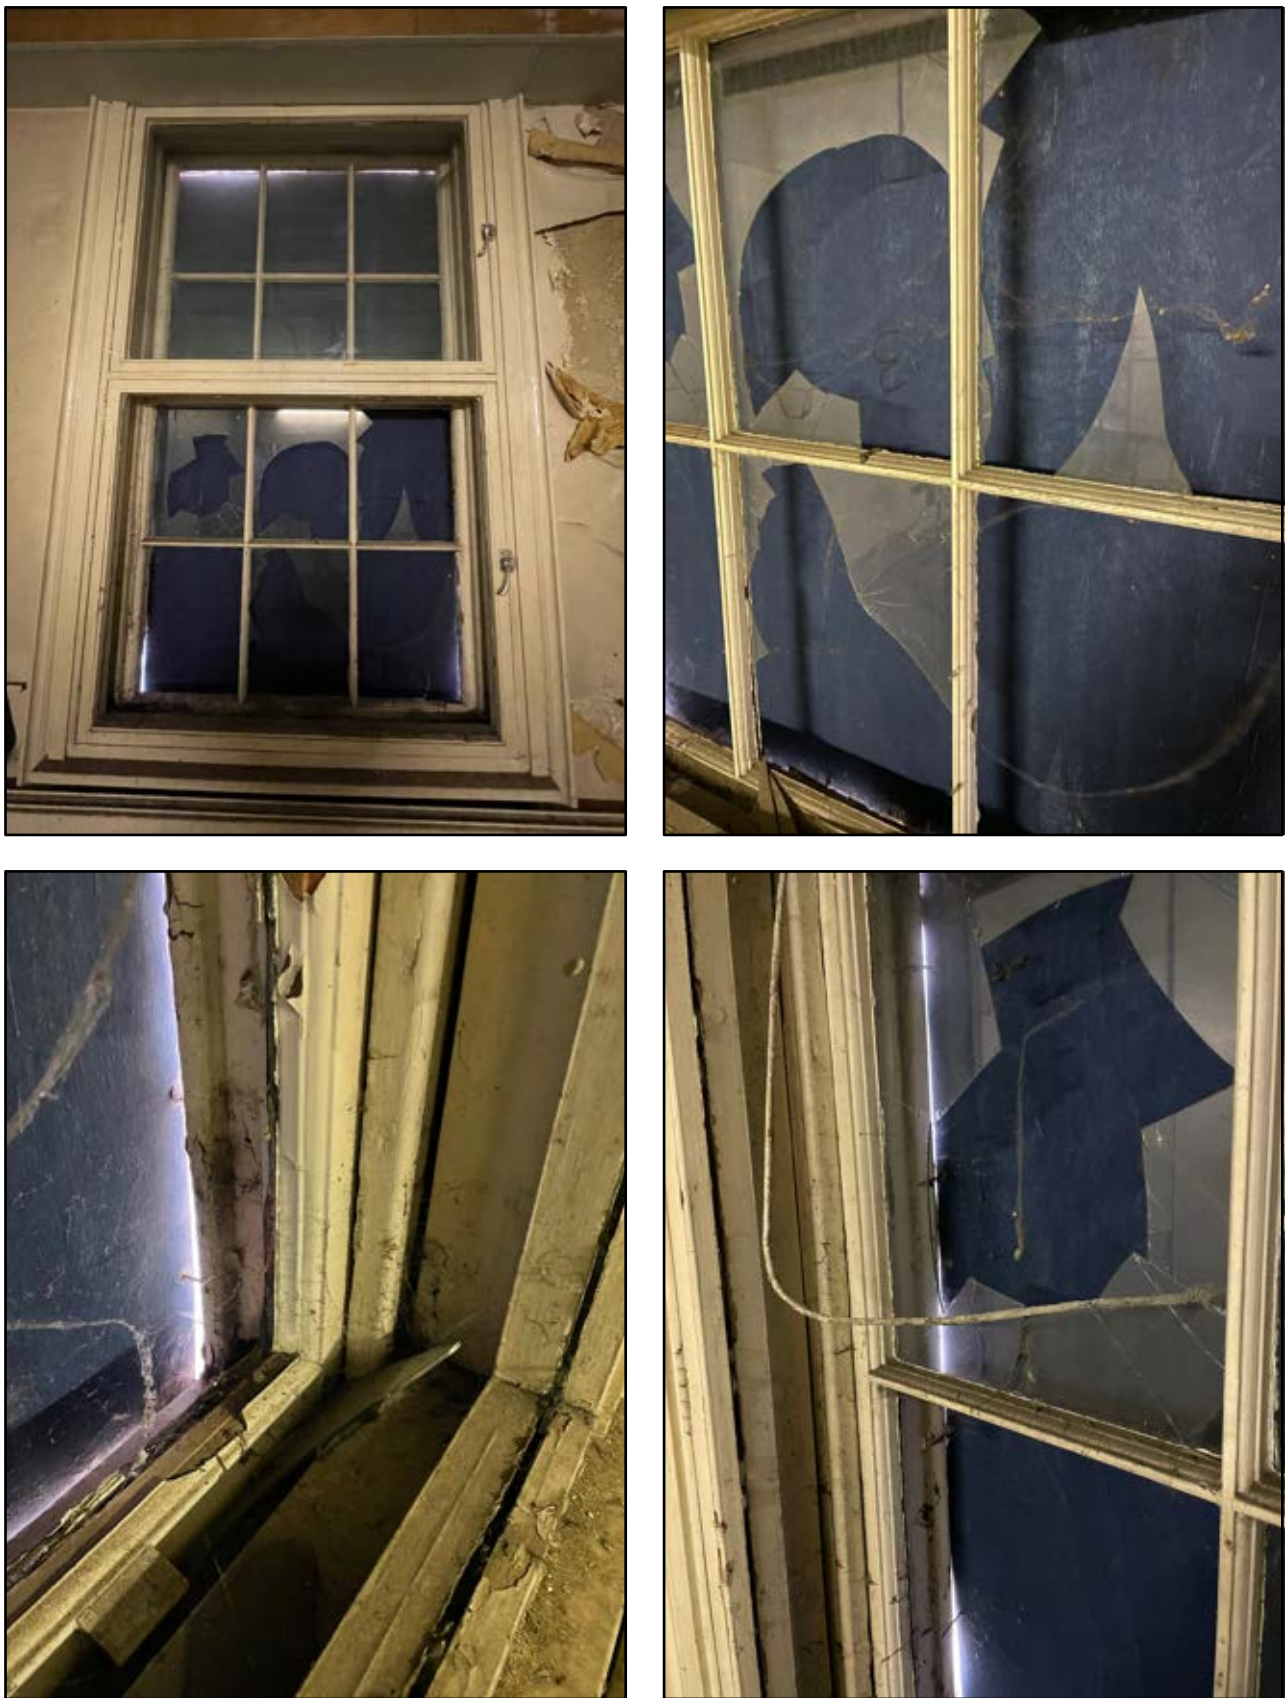
WINDOW W1.30

- Unable to open
- Original frame
- Non original glass
- Glass is smashed
- Chords are missing

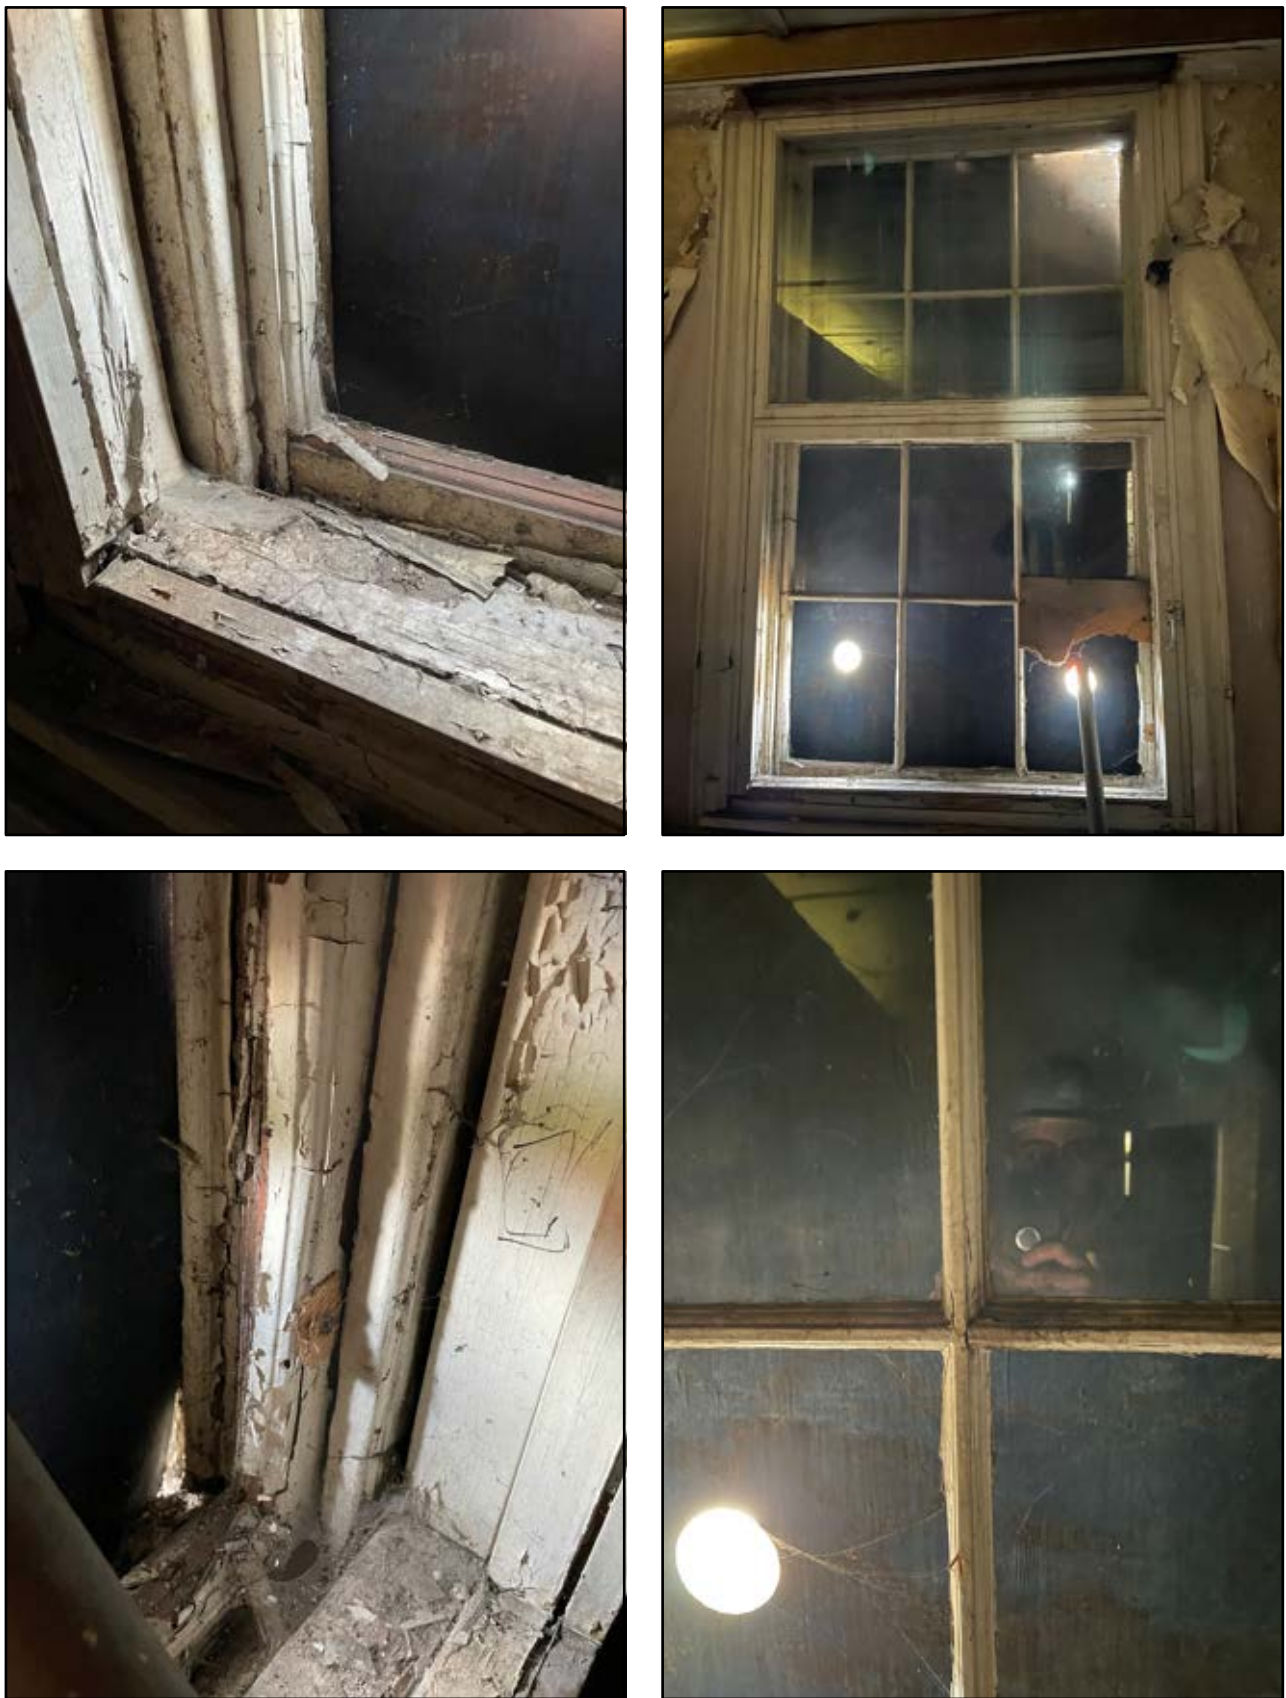
WINDOW W1.31

- Unable to open
- Original frame
- Non original glass
- Glass is smashed
- Chords are missing

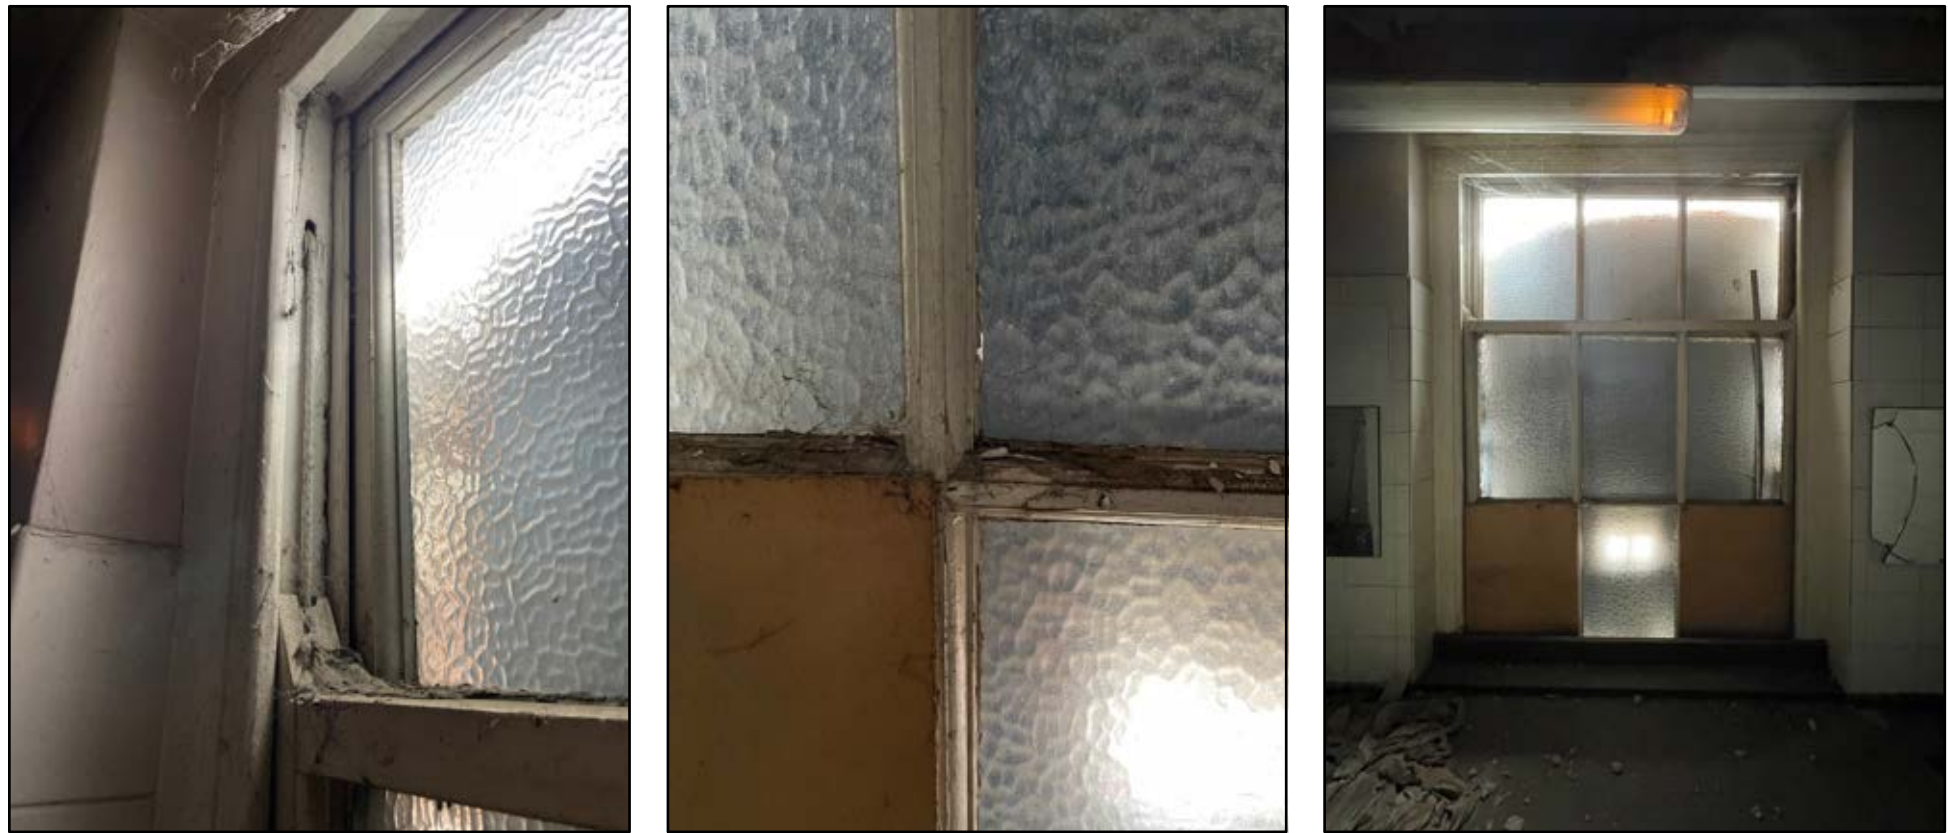
WINDOW W1.34

- Unable to open
- Window is partially boarded up
- Non original frame
- Frame is skewed
- Glass looks modern
