**GAS MEMBRANE VALIDATION**

| <b>Site: Bowes Street – Happi Block</b> | |
| Date: 20-07-2021 | Project Number: 11-813 |
| <b>Ground Gas Risk Assessment: Hydrocarbon Resistant Membrane (VOC Blok and Visqueen GX)</b> | |

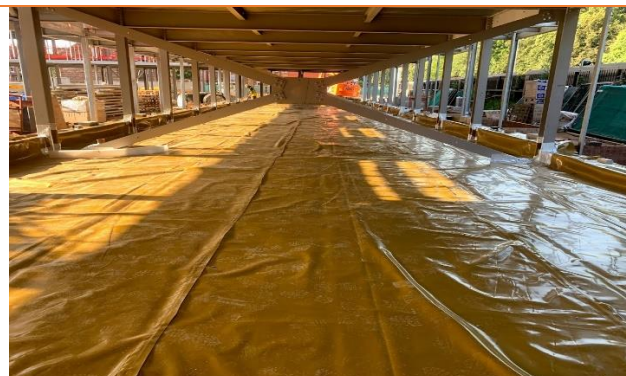
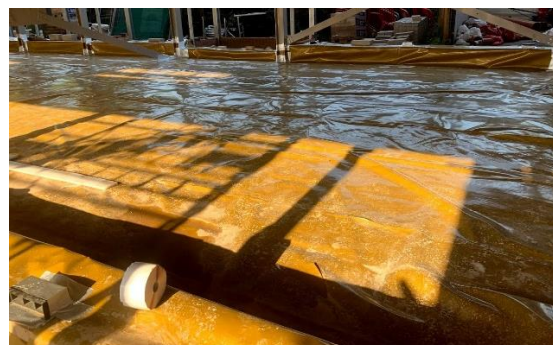
### General Condition of Membrane-Good Condition

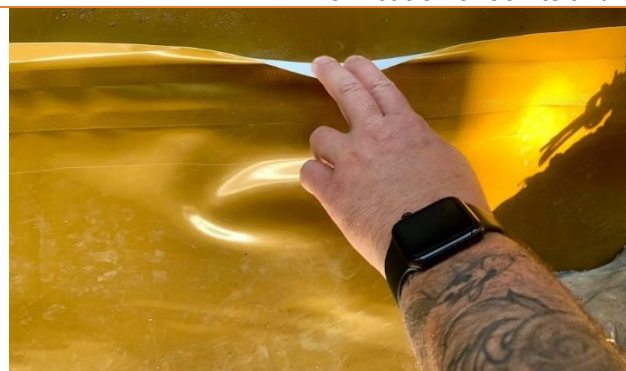
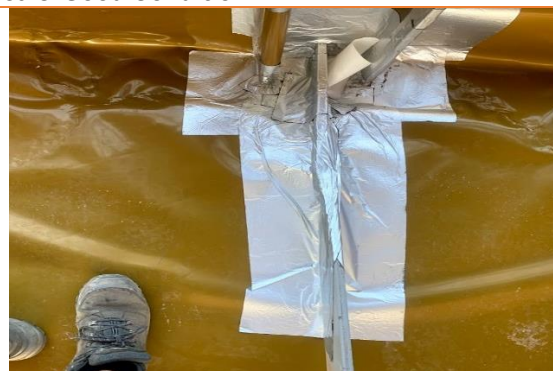
### Verification of Joints and Seals-Good Condition

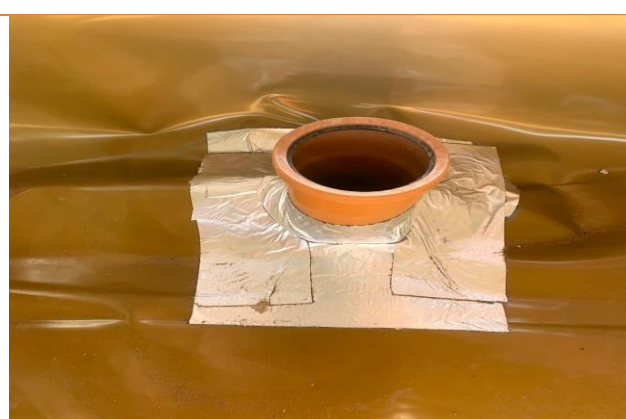
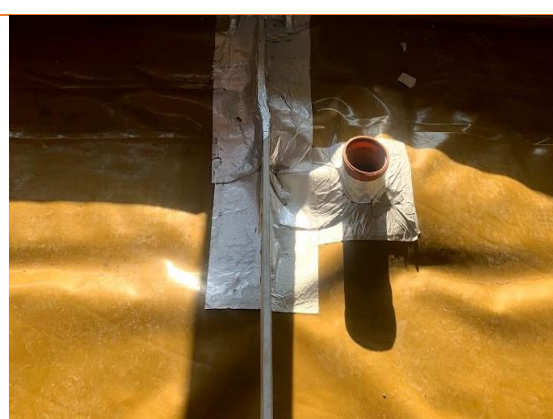
### Verification of Service Penetrations-Good Condition

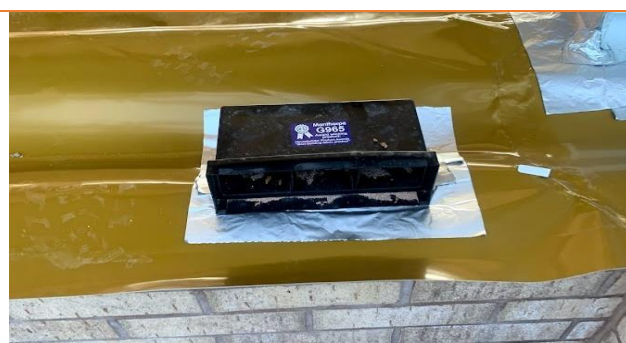
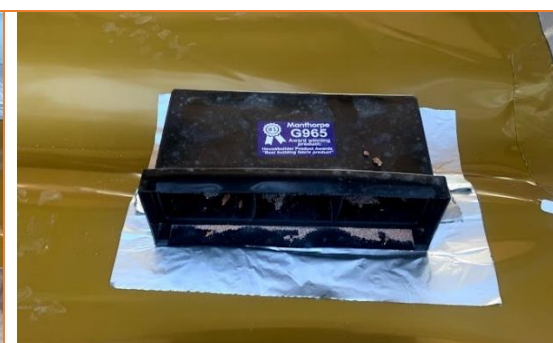
### Verification of ventilation – Good Condition
