# Historic Fabric Inventory, 32-34 Laystall Street Manchester (Former John Armitage & Sons Works)

14/7/22 Draft

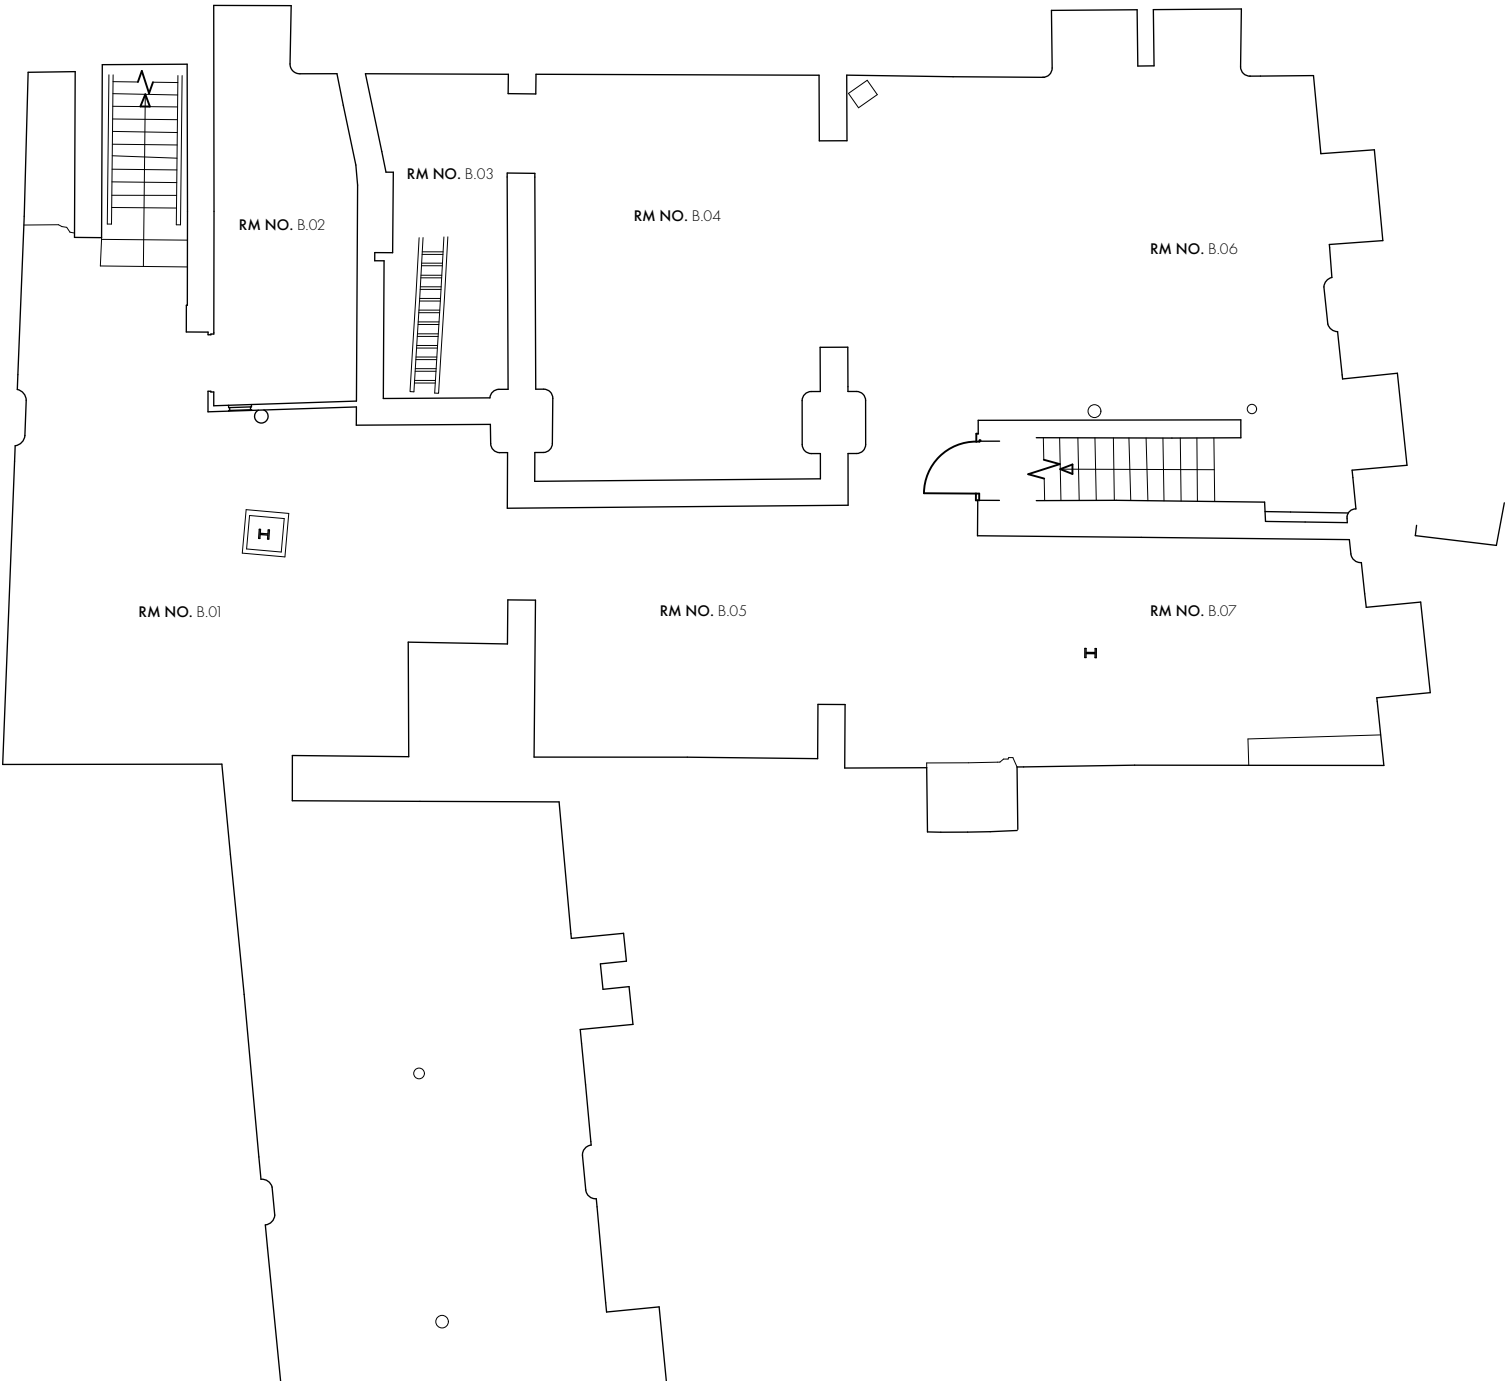
LEVEL -01 - EXISTING PLAN  
1:100@A3

| Ref | Location (REF) | Element | Description & Condition. | Proposal/Action | Mitigation/Approach/<br>Comments. |
|---|---|---|---|---|---|
| 001 | B01 | Iron (riveted) beam and column. | Iron column with capital, supporting riveted beam (found throughout building in same pattern) Limited corrosion, sound. | Retained and decorated. | N/A |
| 002 | B01 | Remnants of flagstone floor. | Limited flagstones remain, some under later brickwork wall. Generally missing to central area. 2 no. flags leant against wall, several in debris to corner of room. | Retain existing flags in situ. Relay flags leant against wall. | N/A |
| 003 | B01, 02, 07 | Corrugated lining to soffit of ground floor. | Modern (mid C20) lining. Assumed installed as part of use as air-raid shelter. Heavily corroded and failing. | Removed to allow repair of timber floor structure above. | Retain small section in area to be agreed and record with photographs prior to removal. |
| 004 | B01 | Remaining debris to north-western corner. | There is a stack of (mainly modern) debris. | Sift and remove debris. | Confirm if any asbestos present. Sift debris and record any elements of built fabric survive underneath. Agree action for conservation with CA. |
| 005 | B01 | Modern staircase (E) | Poor quality modern staircase. | Carefully remove | N/A |
| 006 | B02 | Debris covering floor. | The floor is currently covered in modern debris. This needs to be removed to enable inspection of floor (floor to remain undisturbed). | Sift and remove debris. | Confirm if any asbestos present. Sift debris and record any elements of built fabric survive underneath. Agree action for conservation with CA. Floor beneath to be assessed and conserved in situ. |
| 007 | B04 & 05 | Remnants of Flags | Generally floor has been removed, some small elements of flags remain stacked to south-western corner. Generally broken/damaged. | Sift and retain in space. Stack. | |
| 008 | B06 | Tie plate | Iron tie plate to pier on south wall. Good condition, light corrosion. | Retain and decorate in situ. | N/A |

| 009 | B06 | Iron columns | Iron columns with capital (found throughout building in same pattern) supporting later beam. Limited corrosion, sound. | Retained and decorated. | N/A |
| 010 | B06 | Stone Stairs (now redundant). | Stone treads on brickwork now covered at ground floor level. | Retain in situ. | N/A |
| 011 | B06 | Elements of glazed brickwork | Glazed brickwork with radiused corner (to pier) and adjacent to incoming valve. | Retain in situ (exposed). | N/A |
| 012 | B06 | Beam (string for earlier stair?) laid on floor. | Purpose not entirely clear, but of C19 origin, probably associated with staircase. | Photograph in current location. | Label and store in basement, raised off floor. (assumes basement for storage only). |
| 013 | B06 | Mather & Platt incoming supply pipework and valve. | Incoming main (assumed water) from the street via an early C20 valve inscribed 'Mather and Platt, Manchester', linking to modern pipework. | Modern pipework to be removed (ceiling level). Retain M&P valve in situ. | N/A |
| 014 | B07 | Remnants of flagstone floor. | Limited flagstones remain, some under later brickwork plinth. Again largely missing to central area. | Retain existing flags in situ. | N/A |
| 015 | B07 | Recess to west with cap. | Assumed former hearth/stack. Now capped. | Retain in situ (exposed). | N/A |

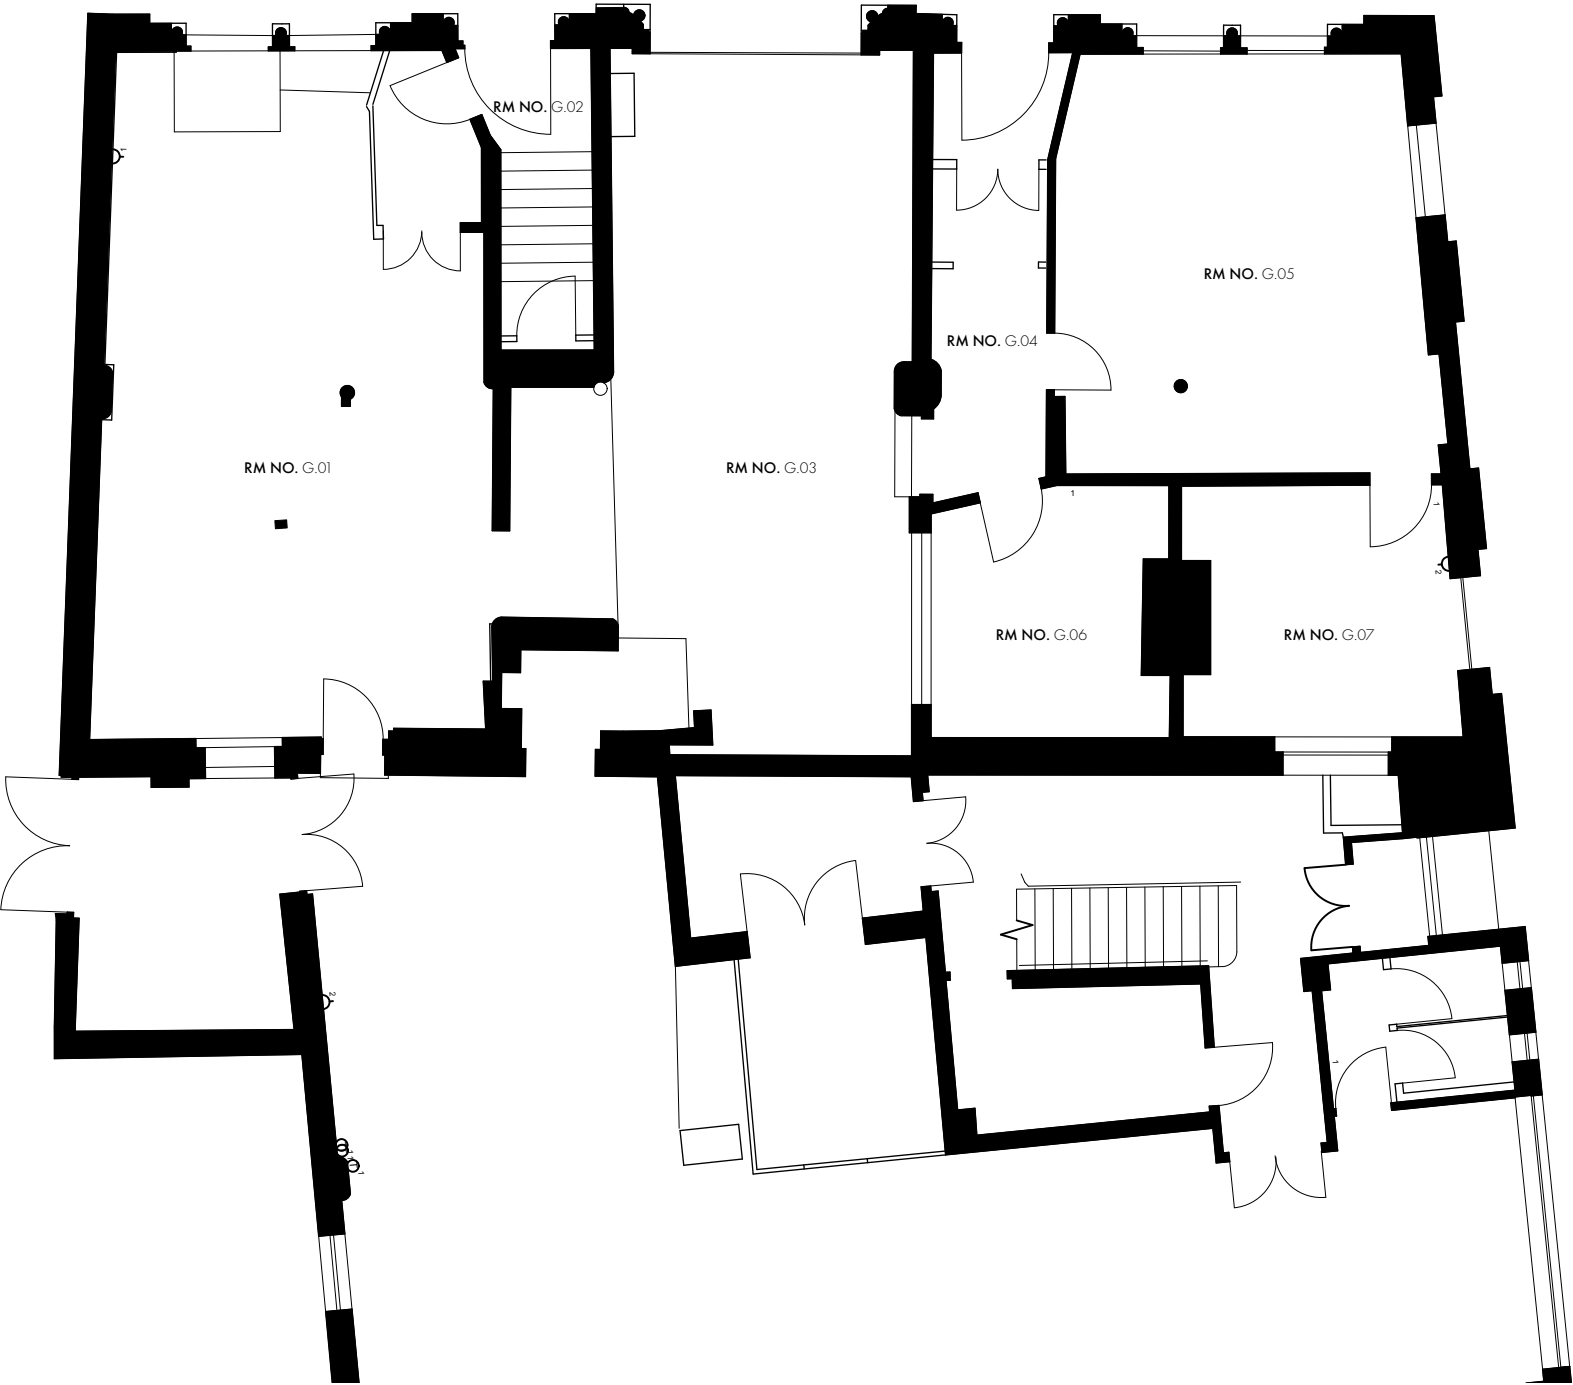
LEVEL 00 - EXISTING PLAN  
1:100@A3

| 016 | G01 | Partial boarded lining to brick walls. Assumed early C20. | Basic tongue and groove boarded lining (beaded) to part of north wall to dado height and to east wall below window. Some decay, especially in timber grounds disrupted by later change around window. | Removal in part, retention under window. | N/A |
| 017 | G01 | Vestibule into G02 (added after C1950). | Modern partitioning and vestibule into G02 | Removal | N/A |
| 018 | G01 | Mezzanine & staircase inserted c.1927 | Mezzanine recorded as being inserted c.1927, including part boarded and glazed screen. | Removal | Photograph prior to removal. |
| 019 | G01 | Iron (riveted) beam and column. | Iron column with capital, supporting riveted beam (found throughout building in same pattern) Limited corrosion, sound. | Retained and decorated. | N/A |
| 020 | G01 | Terracotta blocks to south wall. | Terracotta blocks used to create dividing wall with exposed 'frogs' visible. | Retained and Cleaned. | N/A |

| 021 | G01 | Boarding to Ceiling | Tongue & groove lining to ceiling. Pre-dates mezzanine. | Retained and decorated. | N/A |
| 022 | G02 | Fireplace and iron grate (western wall) | Only remaining hearth and grate. | Retained and repaired in situ. | N/A |
| 023 | G02 | Staircase inserted c1927 | Staircase recorded as being inserted c.1927. | Removal | Photograph prior to removal. |
| 024 | G03 | Iron (riveted) beam and column. | Iron column with capital, supporting riveted beam (found throughout building in same pattern) Limited corrosion, sound. | Retained and decorated. | N/A |
| 025 | G03 | Projecting timber brackets N wall. | Projecting timber brackets, assumed to be associated with original opening gates (prior to installation of shutter). | Retained and decorated. | N/A |
| 026 | G03 | Internal window into office. | Window into former private office (as noted on 1952 plan). | Retained, repaired and decorated. | N/A |
| 027 | G04 | Encaustic tiles to lobby. | Encaustic tiles (Minton or similar) on timber suspended floor, now badly affected by dry rot and partially collapsed. | Lifted, floor repaired, repair and reinstatement. | Carefully photograph in situ prior to lifting, repair and reinstatement. |
| 028 | G04 (and G05) | Internal glazed screen between G04 and 05 (Vestibule and General Office). | Partially glazed screen between vestibule and former general office. Lath & plaster with dado below glazing. Glazing part replaced and several panes broken. Plaster extensively damaged below dado. | Repaired and conserved in situ. | N/A |
| 029 | G04 | Cornice | Moulded (run in situ) plaster cornice remains. | Retained, repaired and decorated. | N/A |
| 030 | G04 | Door into former cellar stair | Partly covered, C19 panelled door, broken upper panels. | Repaired retained in situ. | N/A |
| 031 | G05 | Iron column. | Iron column with capital, supporting riveted beam (assumed, concealed by modern ceiling lining) Limited corrosion, sound. | Retained and decorated. | N/A |
| 032 | G05 | Remains of original staircase (visible above door) | Upper section of pre 1927 staircase remains. Some decay. | Retained in situ. | N/A |
| 033 | G06 | Shelving to former window opening | Window infilled with shelving and surround following erection of extension | Removed and window reinstated. | Record, photograph. Retain and label section of moulded surround. |
| 034 | G06 | Cornice | Moulded (run in situ) plaster cornice remains. | Retained, repaired and decorated. | N/A |
| 035 | G07 | Cornice | Moulded (run in situ) plaster cornice remains. | Retained, repaired and decorated. | N/A |

| 036 | G06 & 07 | Skirtings | C19 timber skirtings remain in situ. | Retained, repaired and decorated. | N/A |

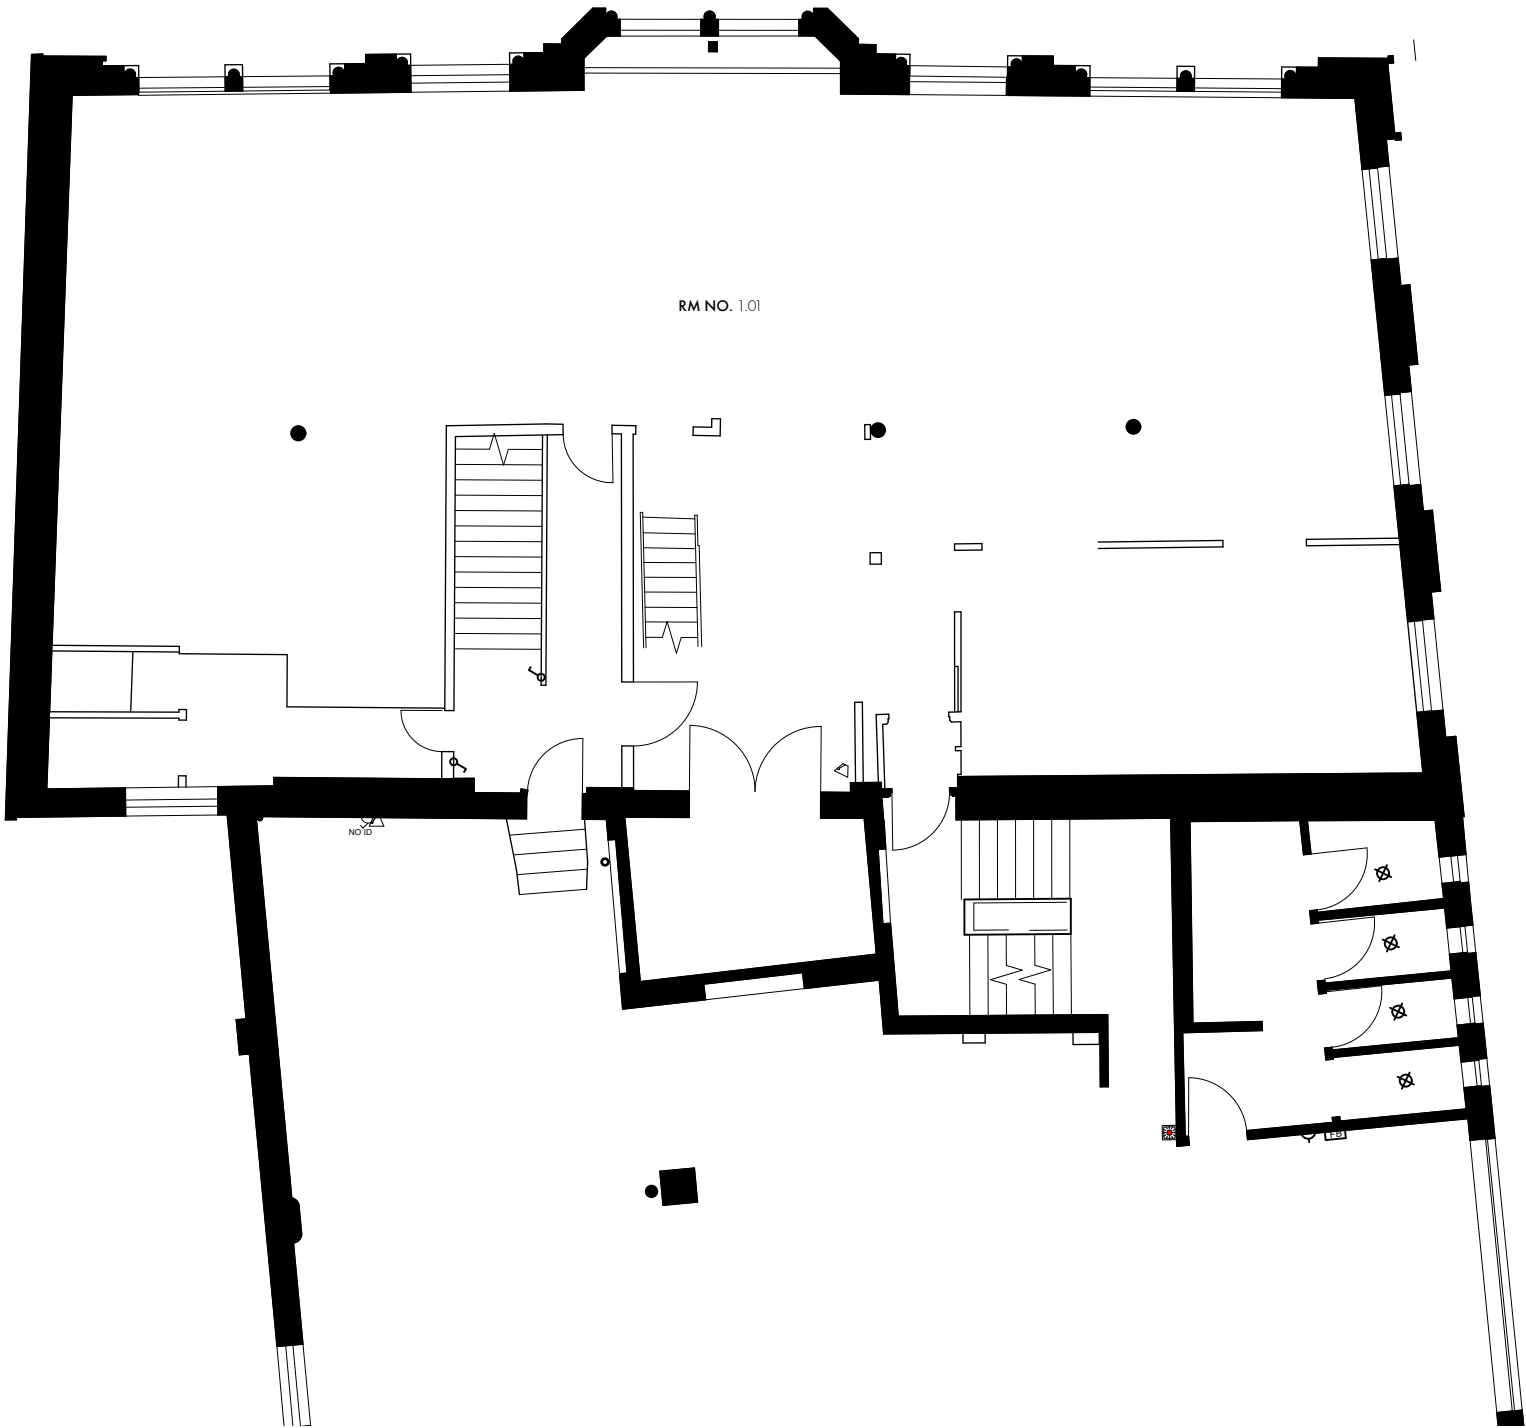
LEVEL 01 - EXISTING PLAN  
1:100@A3

| 037 | 1.01 | Boxings and wooden roller shutters. | External roller shutter boxes (with extant shutters) protrude through the floor into room 1.01. Some limited damage to housings, south eastern has facing panel missing. | Retained, repaired in situ. | Allow to expose and photograph shutters, record dimensions and profiles. |
| 038 | 1.01 | Iron columns. | Iron column with capital, supporting riveted beam (assumed, concealed by modern ceiling lining) Limited corrosion, sound. | Retained and decorated. | N/A |
| 039 | 1.01 | Iron Support brackets (SE) corner. | Support brackets for display of terracotta. | Retained and decorated. | N/A |
| 040 | 1.01 | Cornice | Moulded (run in situ) plaster cornice remains. Sections are damaged and missing. | Retained, repaired (reinstated) and decorated. | N/A |
| 041 | 1.01 | Skirtings | C19 timber skirtings (generally) remain in situ. | Retained, repaired and decorated. | N/A |
| 042 | 1.01 | Exposed terracotta to oriel window | Numbered terracotta blocks exposed to base of oriel window. | Retained exposed. | N/A |
| 043 | 1.01 | Mezzanine & staircase inserted in part after 1952. | Mezzanine recorded as being inserted part c.1927 part after 1952, including stair. | Removal | Photograph prior to removal. |

| 044 | 1.01 | Flooring/screed. | Floor over-screeded and finished in linoleum, possibly c.1927. Timber floor below potentially decayed and needs to be inspected. | Removal. | Carefully remove and record build-up prior to removal. |
| 045 | 1.01 | C20 (possibly 1927) sliding doors to rear vertical loading area. | Part glazed, part boarded doors heavily decayed with corroded runners over. | Removal. | Photograph prior to removal. |

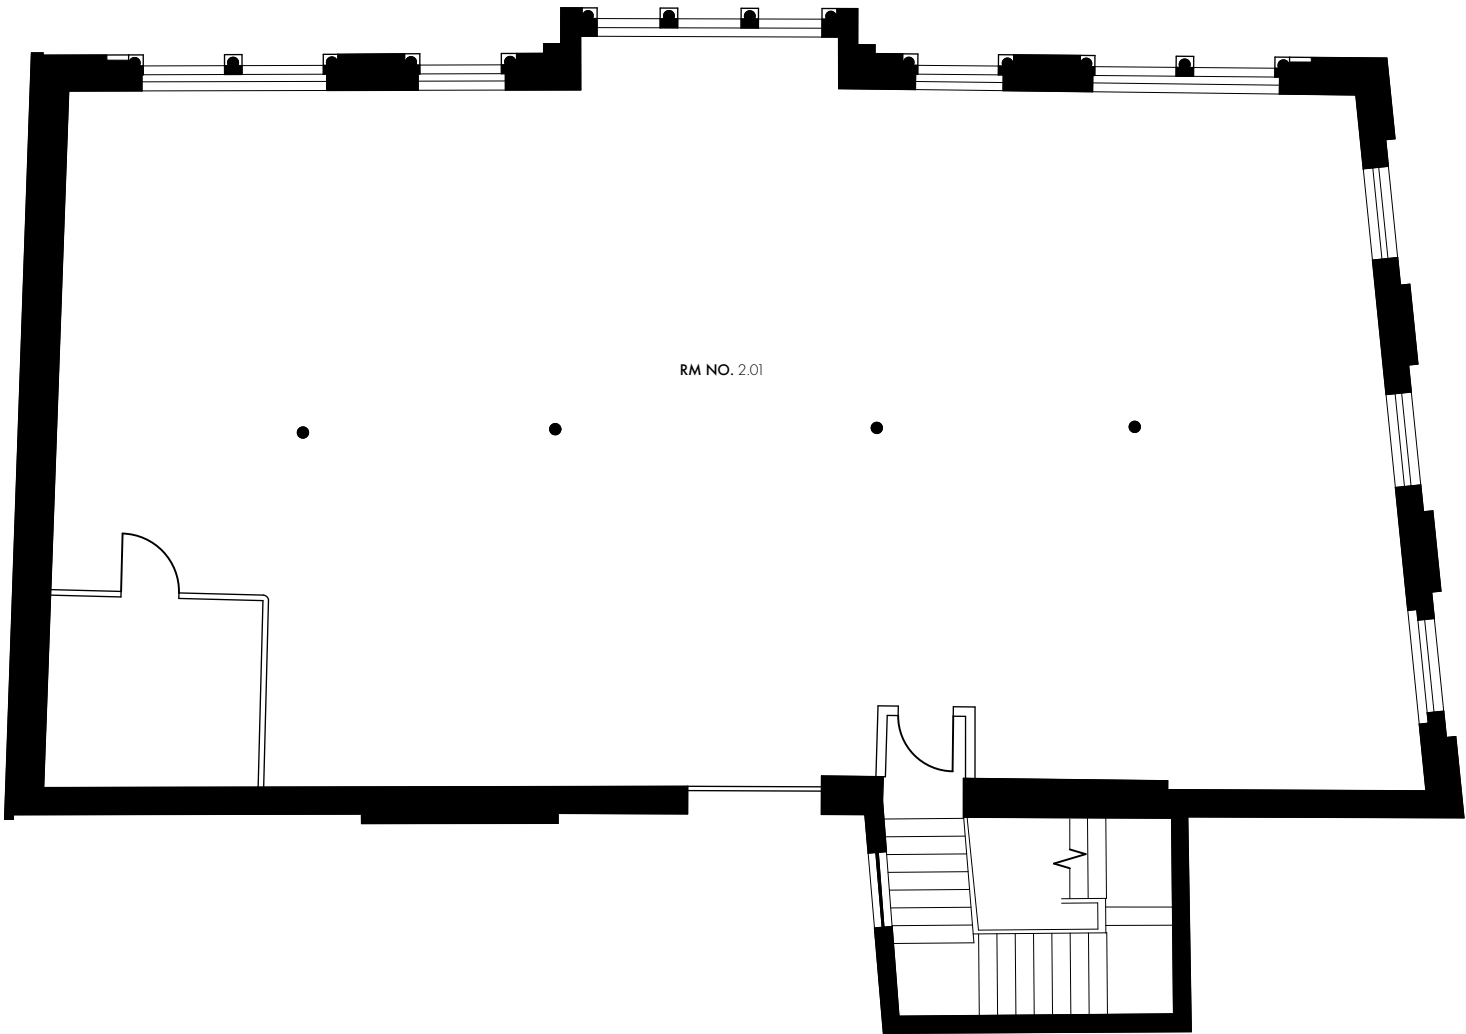
LEVEL 02 - EXISTING PLAN  
1:100@A3

| 046 | 2.01 | Iron (riveted) beam and columns. | Iron column with capital (simpler than lower floors), supporting riveted beam (found throughout building in same pattern) Limited corrosion, sound. | Retained and decorated. | N/A |
| 047 | 2.01 | Flooring/screed. | Floor over-screeded and finished in linoleum, possibly c.1927. Timber floor below potentially decayed and needs to be inspected. | Removal. | Carefully remove and record build-up prior to removal. |
| 048 | 2.01 | Bracket/Arm | Bracket and arm with floor pin, adjacent to vertical access from loading area. Presumably for bringing goods in. | Retained and decorated. | N/A |
| 049 | 2.01 | Fireplace | Bricked-up former fire place, adjacent to later escape stair (corresponds to basement hearth). | Retained and exposed. | N/A |
