**McDonald's Restaurant  
Oldham Road, Failsworth, Manchester**

**Road Safety Audit Stage 1**

**TMS reference no: 17395**

**Date: 10<sup>th</sup> November 2022**

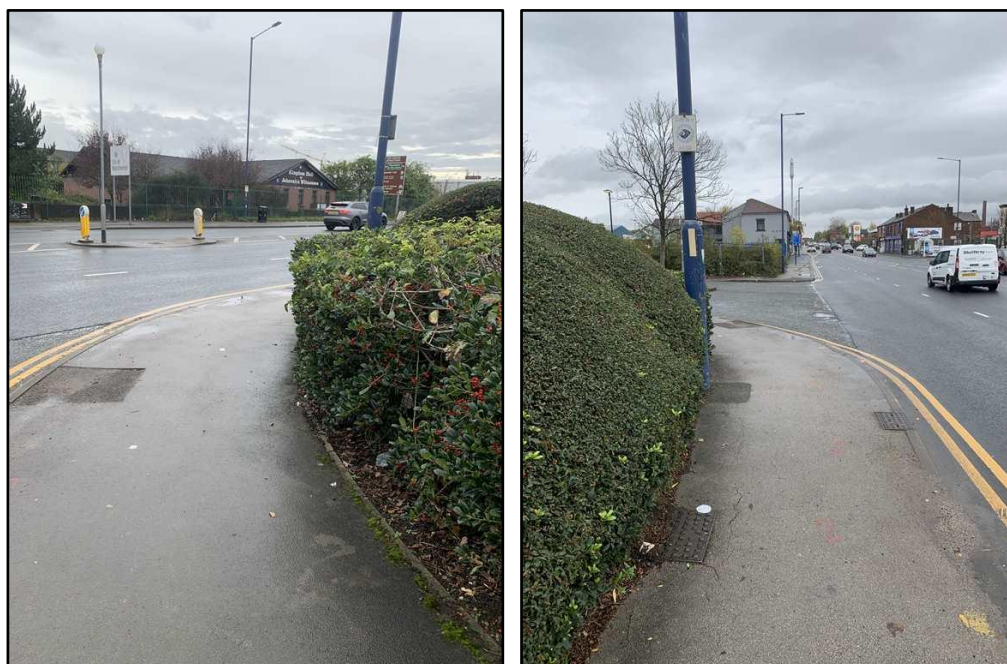
Location – Intervisibility at uncontrolled pedestrian crossing point on western side of entrance

Summary: Risk of pedestrians and vulnerable road users being struck by vehicles whilst crossing

The inter-visibility splay to the right of the crossing is restricted by a mature hedgerow planted in the verge. This vegetation has grown above 600mm in height and thus effects the inter-visibility of the crossing point. Poor inter-visibility may lead to pedestrians and, in particular, vulnerable road users being struck by vehicles whilst crossing. The problem could be exacerbated by the proposals to allow two entrance lanes.

Hedgerow restricting intervisibility at uncontrolled junction crossing

The vegetation within the verge should be cut down and maintained at a height no greater than 600mm so that the inter-visibility splay is unaffected.

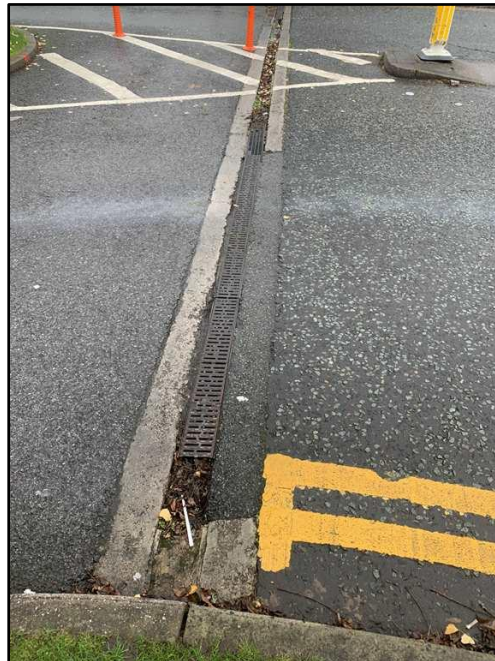
Location – Drainage system within restaurant access

Summary: Increased risk of loss of control type collisions

The channel drainage system at the restaurant access is damaged and blocked with detritus which could result in ponding. The grids are also broken and missing in places. This could result in loss of control type collisions, particularly involving two-wheeled vehicles.

Damaged and blocked drainage system

The drainage should be replaced with an improved more robust system.
