## Schedule of Condition For

Wellington House,  
39 — 41 Piccadilly,  
Manchester  
M1 4AJ

Dated: 22<sup>nd</sup> March 2022

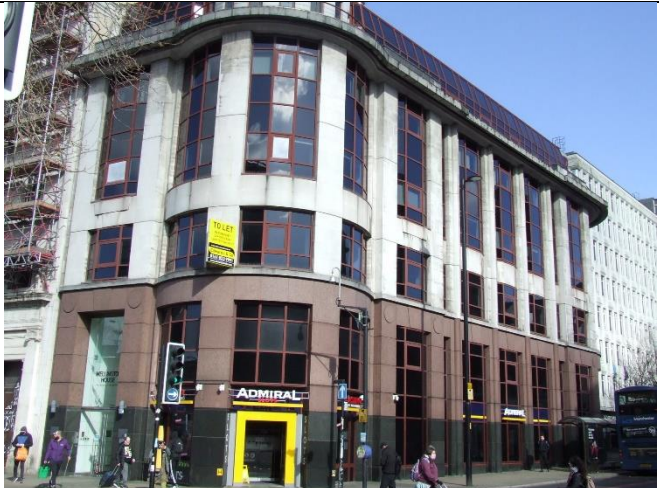
| <i>comments</i> | <i>photograph</i> | <i>comments</i> | <i>photograph</i> |
|---|---|---|---|
| <b>PICCADILLY PLAZA<br/>FRONT ELEVATION</b><br><br>Front elevation corner.<br><br>Steel frame building with stone or concrete block façade infills to curtain wall and rainscreen aluminium cladding systems. | | Marble block feature facades.<br><br>Washed out and aged pointing between blocks. | |

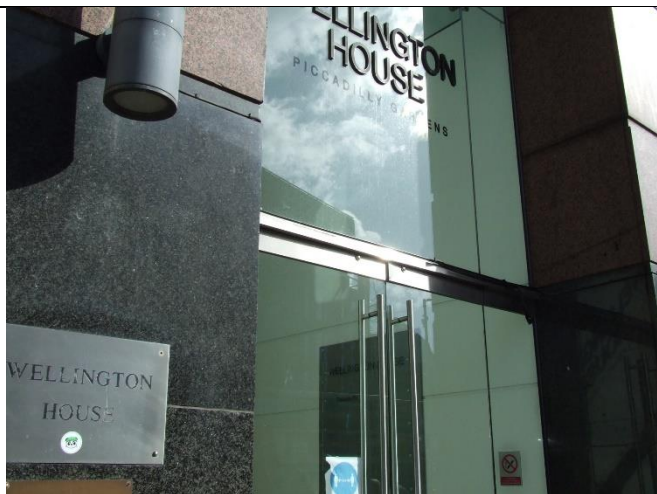
Main entrance doors in structural glass.

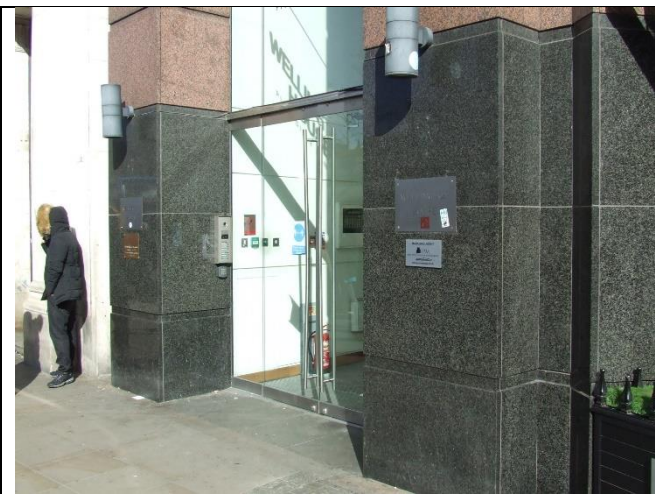
Main entrance doors in structural glass.

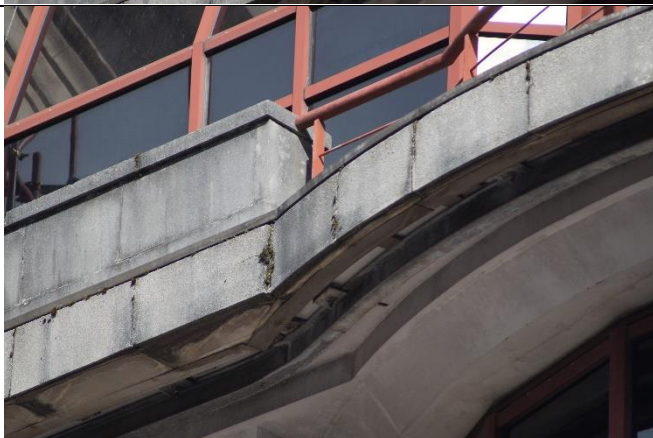
Aluminium double glazed rainscreen claddings and curtain walling windows systems.

Soiled frame and leaking rubber sealed to the windows generally.

Concrete stone block infills soiled with washed out and eroded jointing.

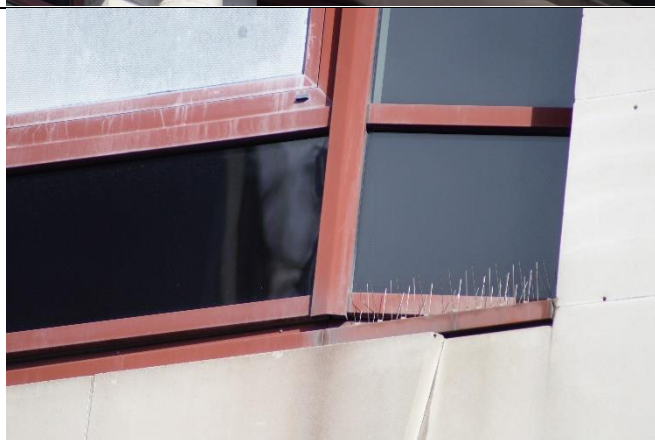
Aluminium double glazed rainscreen claddings and curtain walling windows systems.

Soiled frame and leaking rubber sealed to the windows generally.

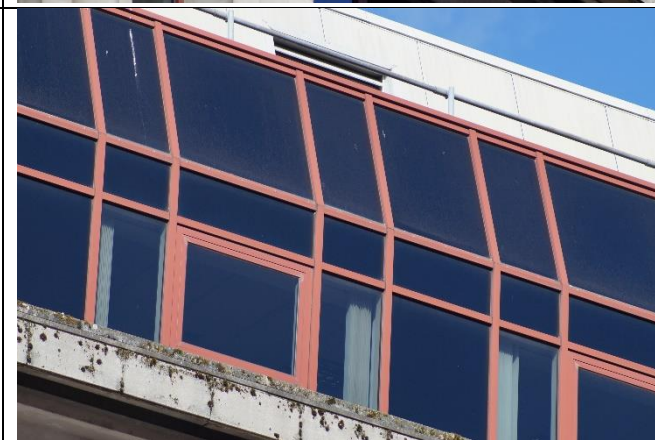
Aluminium double glazed rainscreen claddings and curtain walling windows systems.

Soiled frame and leaking rubber sealed to the windows generally.

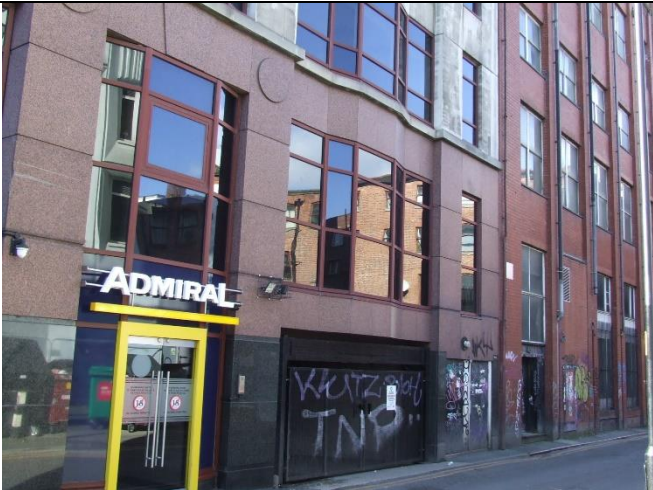
| <p>Rear elevation.</p> <p>Steel frame building with stone or concrete block façade infills to curtain wall and rainscreen aluminium cladding systems.</p> | | <p>Aluminium double glazed rainscreen claddings and curtain walling windows systems.</p> <p>Soiled frame and leaking rubber sealed to the windows generally.</p> | |

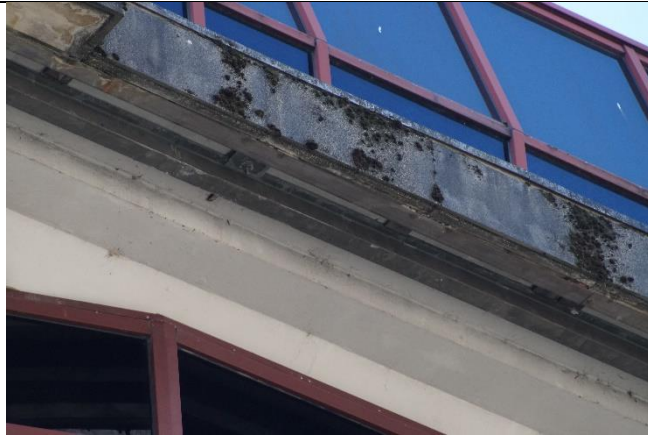
| <p>Generally.</p> | | <p>Concrete stone block infills soiled with washed out and eroded jointing.</p> | |

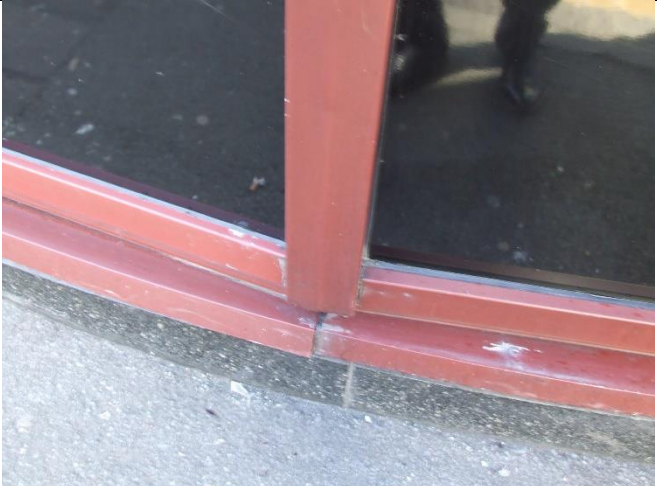
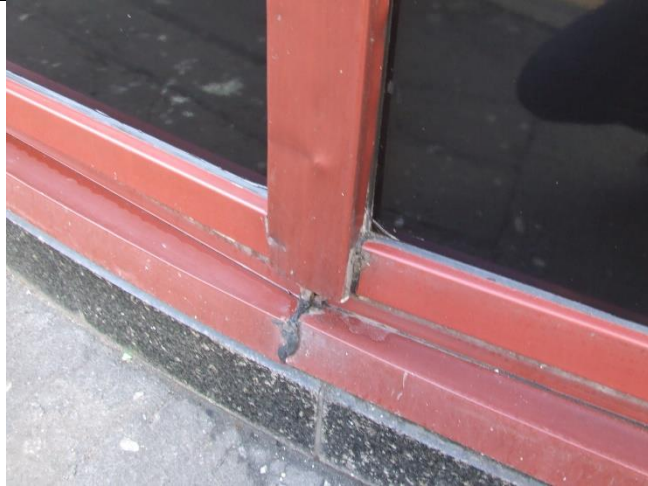
| <p>Aluminium double glazed rainscreen claddings and curtain walling windows systems.</p> <p>Soiled frame and leaking rubber sealed to the windows generally.</p> | | <p>Aluminium double glazed rainscreen claddings and curtain walling windows systems.</p> <p>Soiled frame and leaking rubber sealed to the windows generally.</p> | |

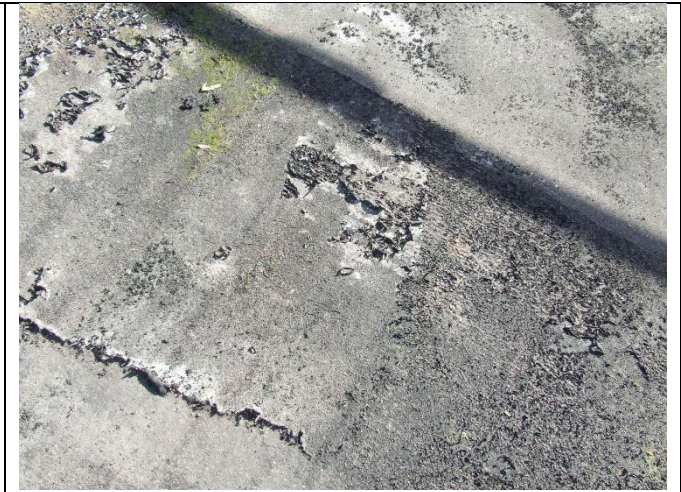
Asphalt roof deck coated with solar reflective treatments.

Some distress in the finish with crazed surfaces and peeling back of solar reflective treatments.

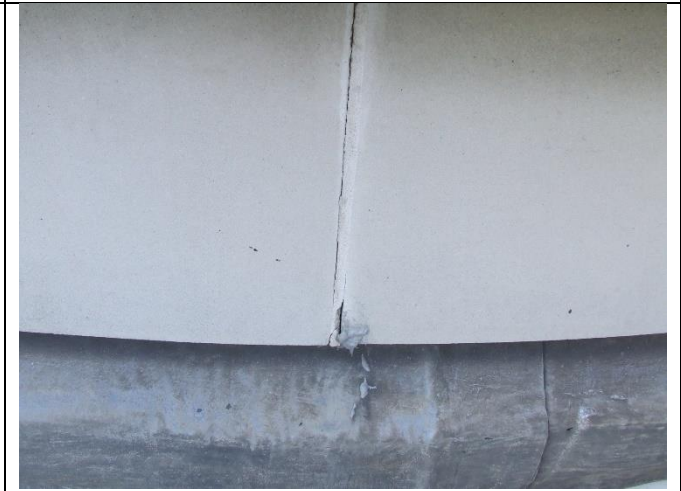
Eroded and washed out pointing to the masonry joints.

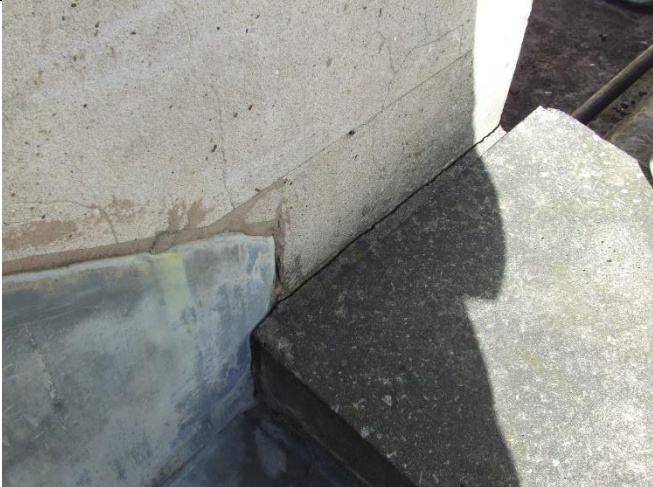
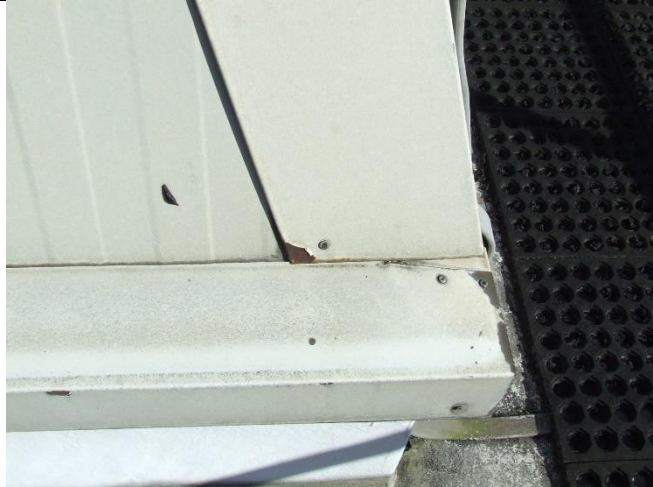
| <p>Eroded and washed out pointing to the concrete coping joints.</p> | | <p>Light corrosion to the plant room colour coated cladding panels.</p> <p>Heavy soiling.</p> | |
