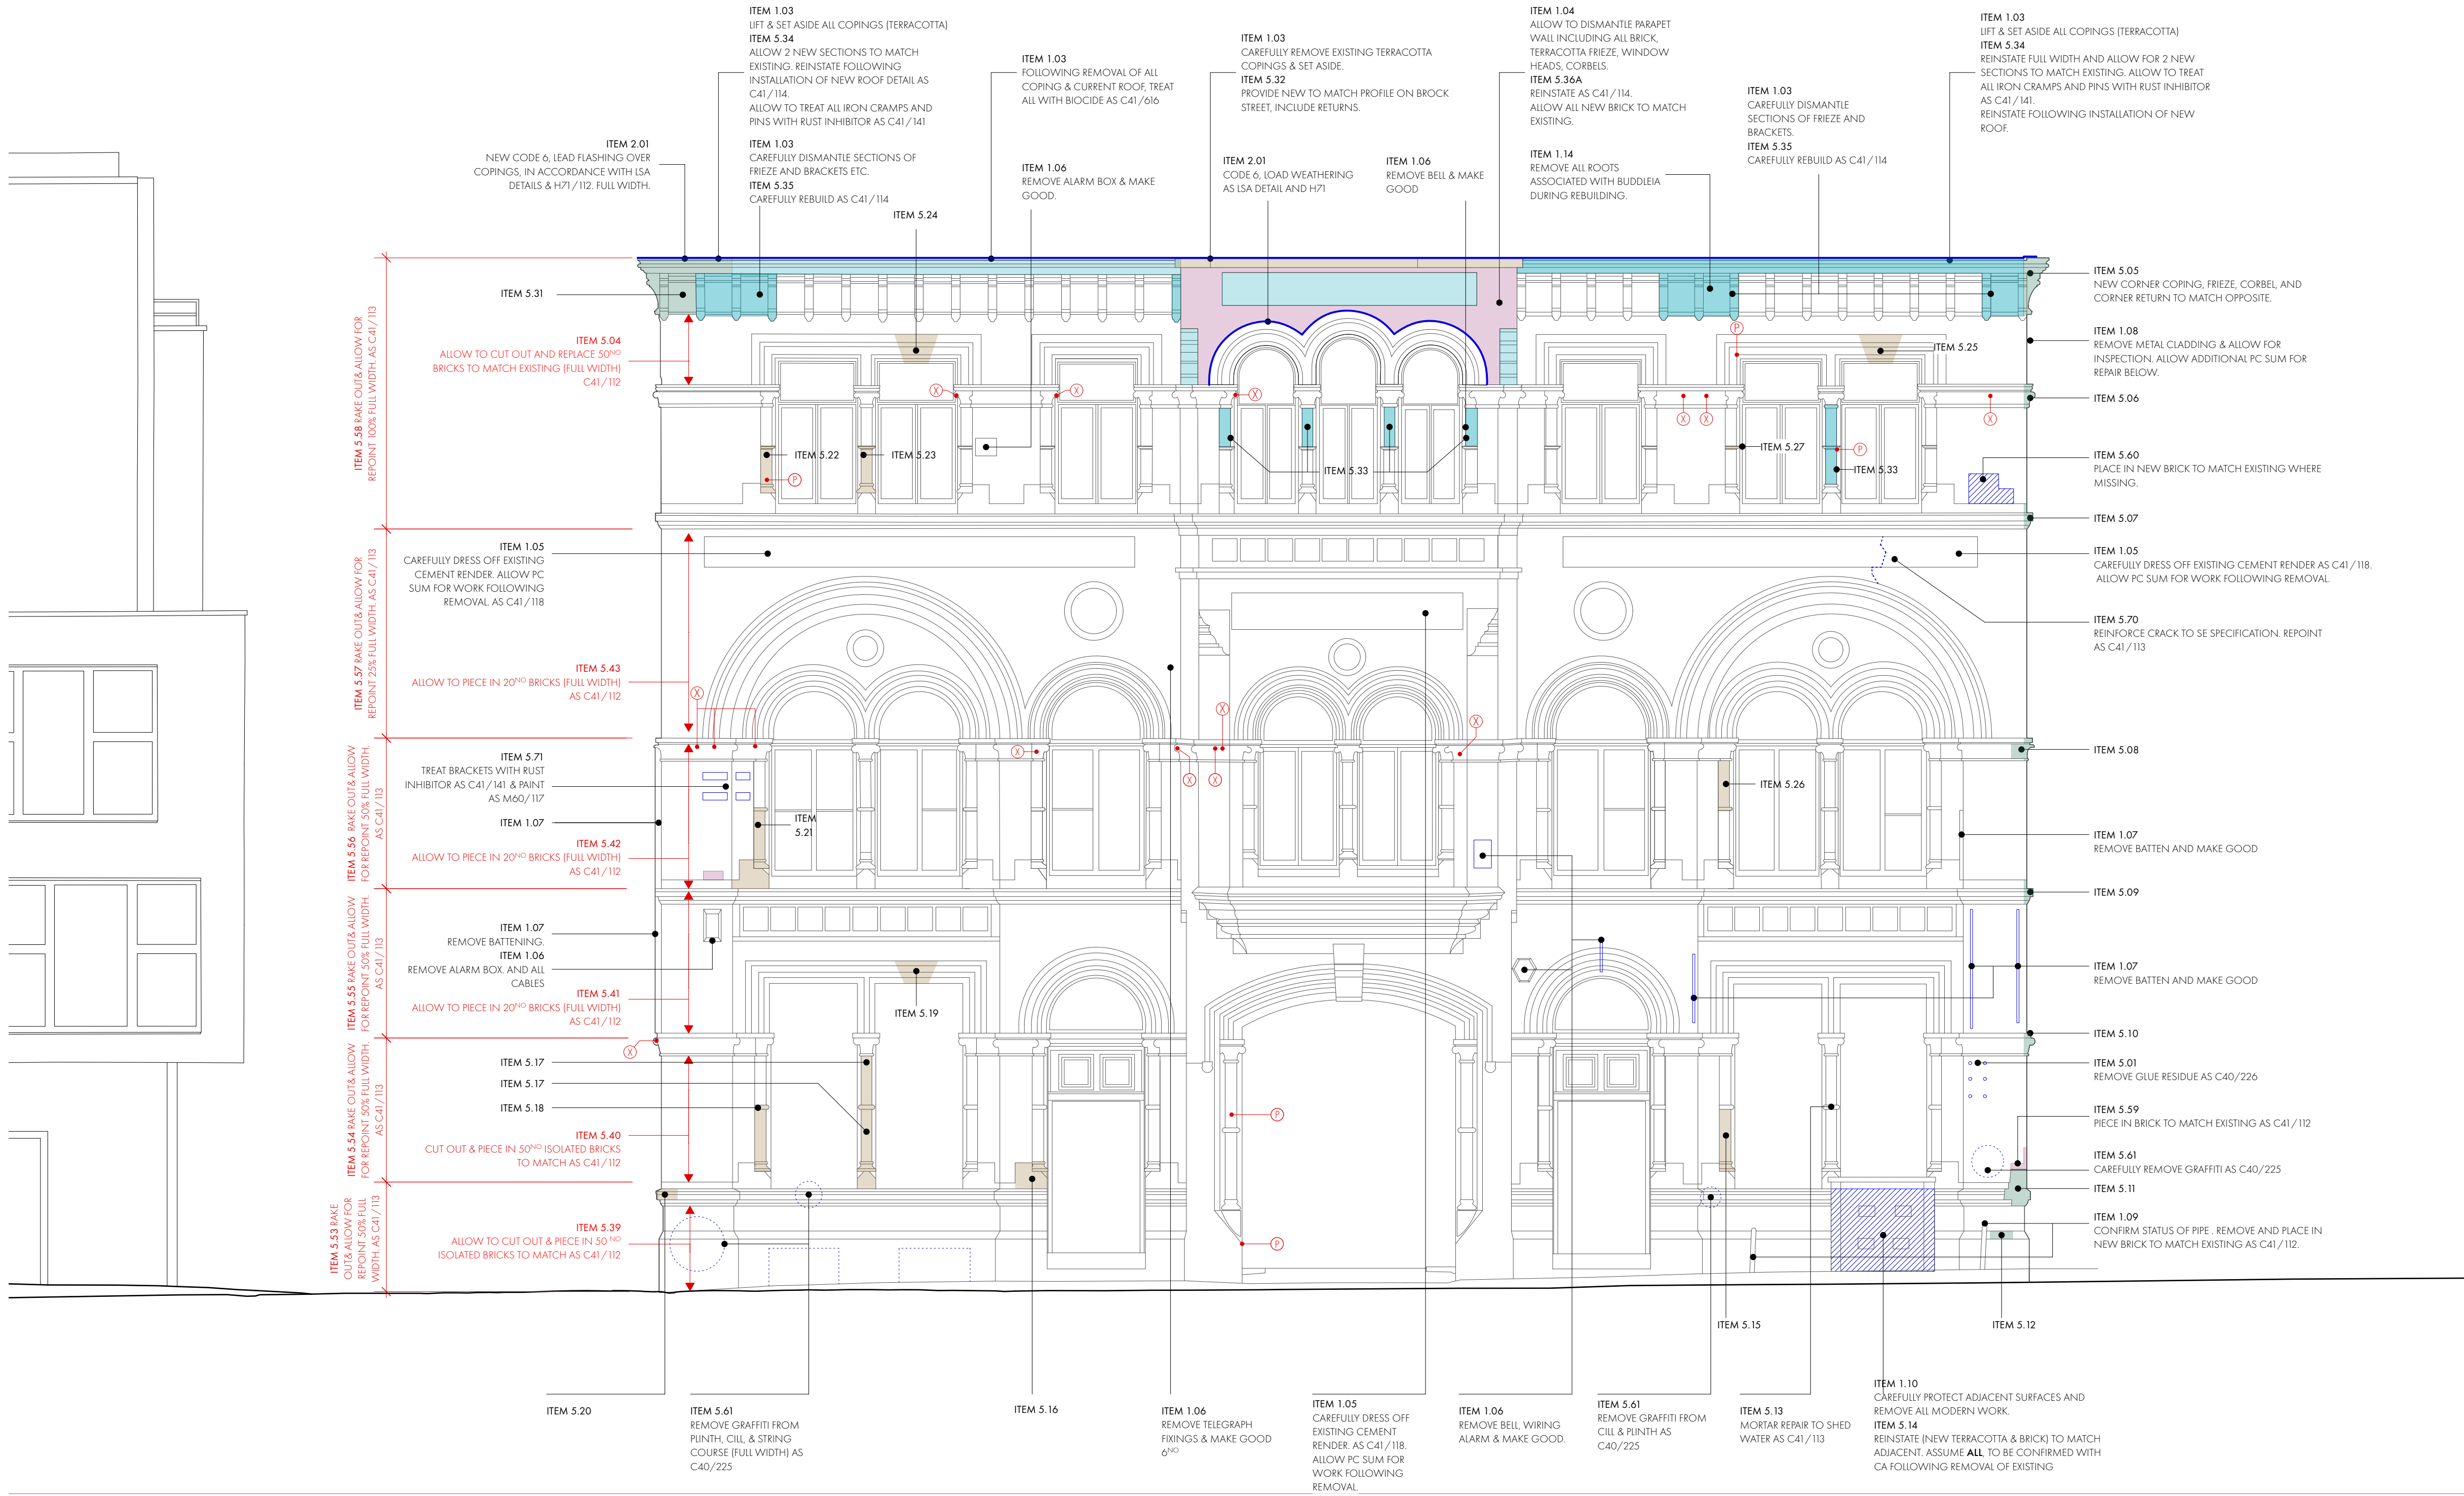
- CAREFULLY DISMANTLE, ALLOW TO REBUILD BRICKWORK/ ALLOW FOR RENEWAL AS STATED C41 /112.
- TERRACOTTA MISSING. PREPARE AND PROVIDE NEW SECTION AS C41 /121 ( I WILL REQUIRE PATTERN)

- ITEM 2.01  
NEW CODE 6 LEAD FLASHING/ WEATHERING AS H71 /112
- ITEM 5.02  
CAREFULLY REMOVE PIN CRACKED TERRACOTTA (SUBJECT TO SITE TRIAL) AS C41 /119 & REINSTATE.

- ITEM 5.03  
MISSING ACANTHUS LEAF DETAIL (SINGLE) REMOVE EXISTING PIN (IRON). PROVIDE NEW TERRACOTTA DETAIL AND RE ADD USING STAINLESS DOWEL AS C41 /120.

- ITEM 1.15  
REMOVE **ALL** METAL GRILLES & METAL ROLLER SHUTTER, & MAKE GOOD. ALLOW ADDITIONAL PC SUM FOR REPAIR FOLLOWING REMOVAL.
- ITEM 5.04  
CAREFULLY REMOVE PIN CRACKED TERRACOTTA (SUBJECT TO SITE TRIAL) AS C41 /119 & REINSTATE.

- CAREFULLY DISMANTLE TERRACOTTA COPING TO CORNICE, INSPECT & ALLOW TO REBUILD, ALLOW PC SUM FOR RENEWAL AND REPAIRS AS STATED. AS C41 /114.
- CAREFULLY DISMANTLE/ REMOVE EXISTING TERRACOTTA. (WHERE APPLICABLE) PROVIDE NEW TO MATCH EXISTING. (OR AS STATED) AS C41 /115
