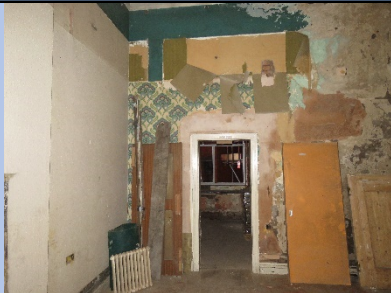
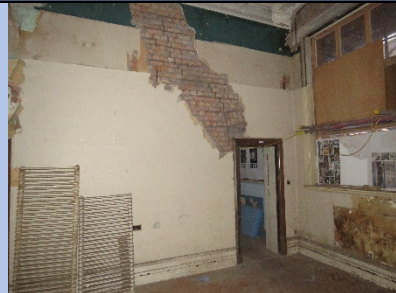
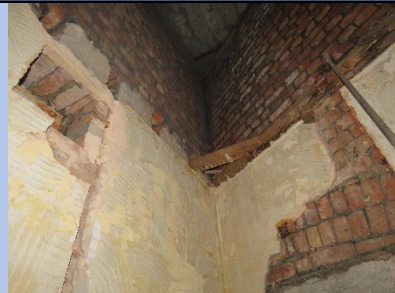
| Room Ref. | Element | Description / Item | Condition | Action | Photographs | | |
|---|---|---|---|---|---|---|---|
| 0.38 + R15 | Walls | Plaster on brick with wallpaper finish. | Poor | <ul style="list-style-type: none"> <li>Hammer test remaining plaster and remove any bossed plaster.</li> <li>Remove peeling paper.</li> <li>Loose material removed from existing walls, large and structural holes infilled with reclaimed brickwork.</li> <li>Repair lime plaster walls as per specification NBS:M21/210.</li> </ul> | | | |

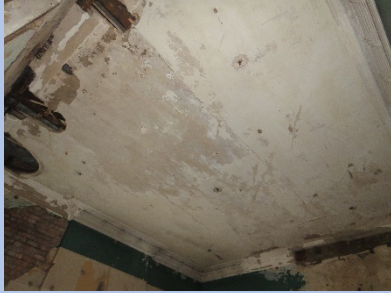
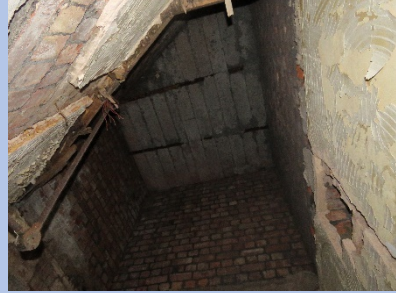
| Room Ref. | Element | Description / Item | Condition | Action | Photographs | | |
|---|---|---|---|---|---|---|---|
| | Ceiling | Plaster on lath with paint finish. Cornice partially survives. Remnant of timber ceiling joists to R15. | Fair | <ul style="list-style-type: none"> <li>Hammer test remaining plaster and remove any bossed plaster.</li> <li>Remove flaking paint.</li> <li>Remove ceiling joists to R15.</li> <li>Existing Lath and plaster ceiling to be repaired (NBS:M20/587) and cornice restored. Ceiling to receive intumescent coat finish (NBS:Z12/212).</li> </ul> | | | |

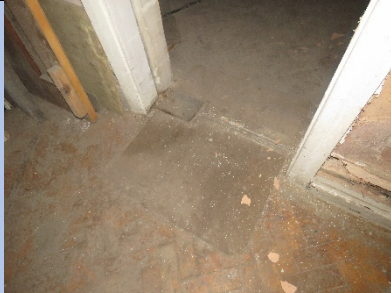
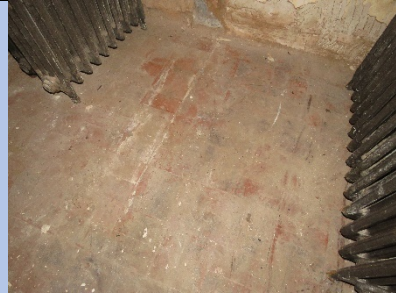
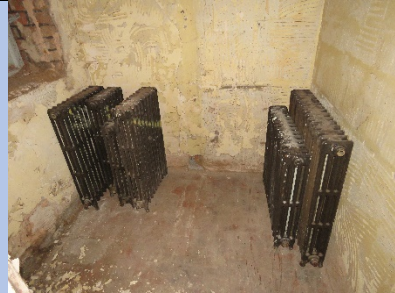
| Room Ref. | Element | Description / Item | Condition | Action | Photographs | | |
|---|---|---|---|---|---|---|---|
| | Floor | Woodblock. Glazed tiles to hearth. Red quarry tile to R15 | Fair | <ul style="list-style-type: none"> <li>Remove all debris.</li> <li>Remove minor area of carpet.</li> <li>Quantify wood block, lift and store on pallet.</li> <li>Remove small glazed tile area and store in box in room.</li> <li>Clean tile and install protection.</li> <li>Allow for floor to be levelled and prepared throughout with latex levelling screed or similar (M10/120).</li> </ul> | | | |

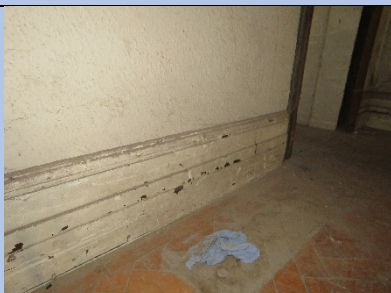
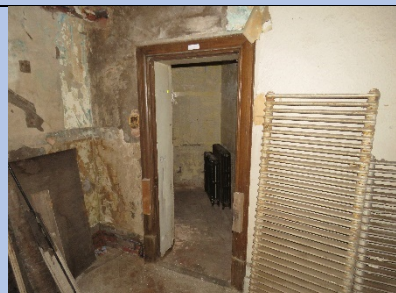
| Room Ref. | Element | Description / Item | Condition | Action | Photographs | | |
|---|---|---|---|---|---|---|---|
| | Joinery | Skirting Architrave Pile of misc. joinery. | Fair | <ul style="list-style-type: none"> <li>Skirtings to be repaired and reinstated to lime plastered walls.</li> <li>Architrave leading between 0.38/0.39 to be retained and refurbished, others removed and scrapped.</li> </ul> | | | |

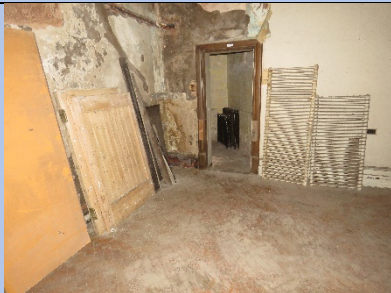
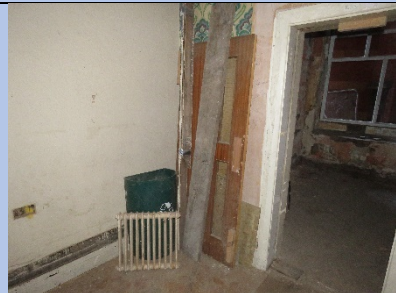
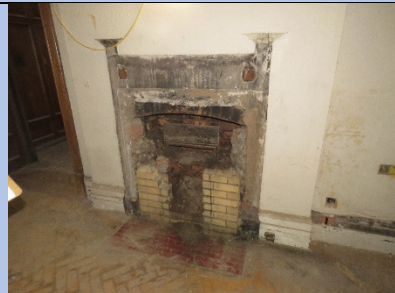
| Room Ref. | Element | Description / Item | Condition | Action | Photographs | | |
|---|---|---|---|---|---|---|---|
| | Misc. | 8no. radiators. Fireplace insert. Redundant M&E pipes / conduit. | | <ul style="list-style-type: none"> <li>Record radiators and relocate to Heritage store.</li> <li>Remove insert to fireplace &amp; make good area.</li> <li>Remove redundant M&amp;E and fill holes remaining in walls.</li> </ul> | | | |

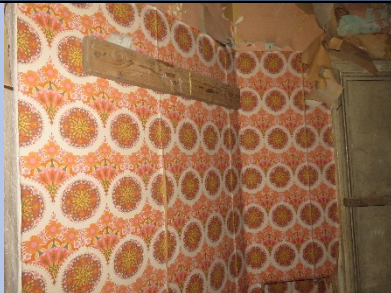
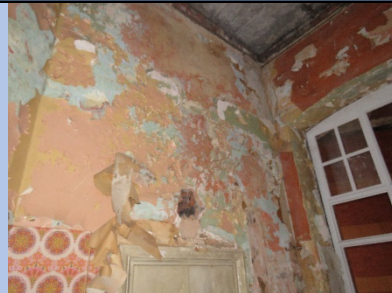
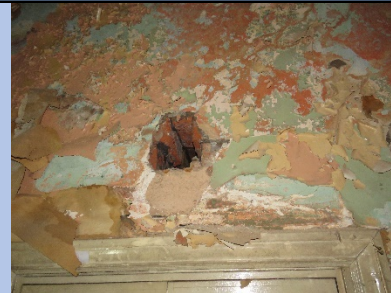
| Room Ref. | Element | Description / Item | Condition | Action | Photographs | | |
|---|---|---|---|---|---|---|---|
| 0.39 + R15 | Walls | Plaster on brick with wallpaper finish. | Poor | <ul style="list-style-type: none"> <li>Hammer test remaining plaster and remove any bossed plaster.</li> <li>Remove peeling paper.</li> <li>Loose material removed from existing walls, large and structural holes infilled with reclaimed brickwork.</li> <li>Repair lime plaster walls as per specification NBS:M21/210.</li> </ul> | | | |

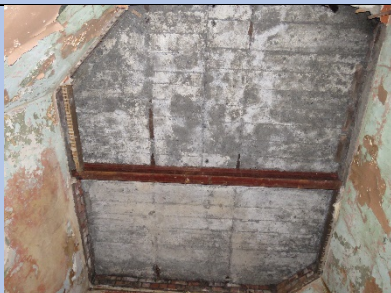
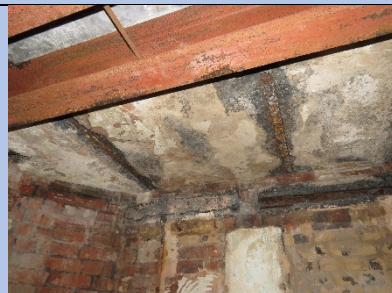
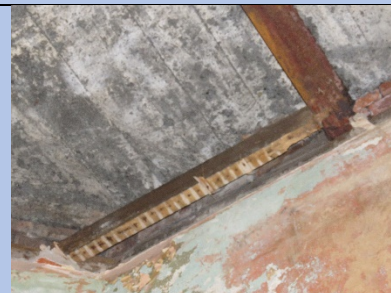
| Room Ref. | Element | Description / Item | Condition | Action | Photographs | | |
|---|---|---|---|---|---|---|---|
| | Ceiling | Exposed concrete with steel beams. 1no. ceiling joist. | Fair | <ul style="list-style-type: none"> <li>Remove ceiling joist.</li> <li>De-rust steel beam.</li> </ul> <p>Proposed works</p> <ul style="list-style-type: none"> <li>Existing exposed concrete soffit to be repaired to SE details.</li> <li>Steel beams to receive intumescent paint NBS:M61/120.</li> <li>Install new suspended ceiling on MF grid consisting of 2 layers 15mm fireboard and skim in preparation for decoration (NBS tbc).</li> </ul> | | | |

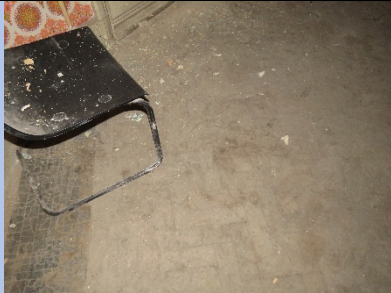
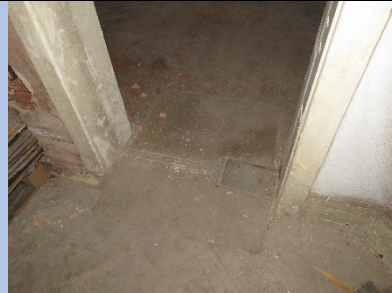
| Room Ref. | Element | Description / Item | Condition | Action | Photographs | | |
|---|---|---|---|---|---|---|---|
| | Floor | Woodblock. Glazed tiles to hearth. Threshold strip to doorway to Unit E 0.38. | Fair | <ul style="list-style-type: none"> <li>Remove all debris.</li> <li>Remove threshold strip.</li> <li>Quantify wood block, lift and store on pallet.</li> <li>Remove small area of glazed tile and store in box in room.</li> <li>Allow for floor to be levelled and prepared throughout with latex levelling screed or similar (M10/120).</li> </ul> | | | |

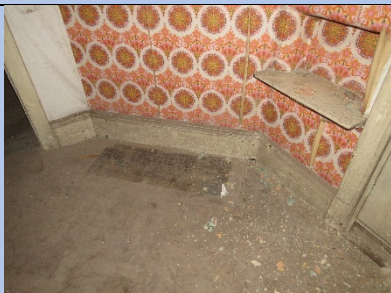
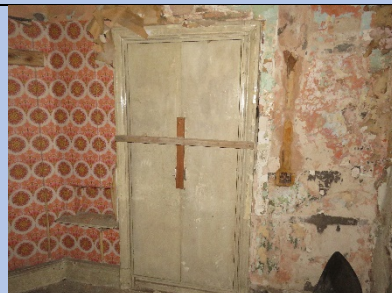
| Room Ref. | Element | Description / Item | Condition | Action | Photographs | | |
|---|---|---|---|---|---|---|---|
| | Joinery | Skirting Shelves Small cupboard. | | <ul style="list-style-type: none"> <li>Skirtings to be repaired and reinstated to lime plastered walls.</li> <li>Architrave leading between 0.38/0.39 to be retained, others removed and scrapped.</li> <li>Cupboard retained &amp; refurbished.</li> </ul> | | | |

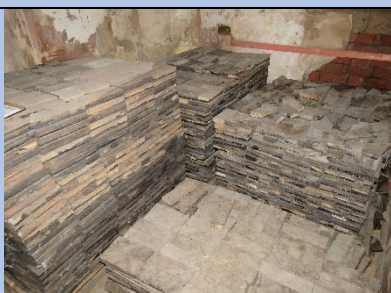
| Room Ref. | Element | Description / Item | Condition | Action | Photographs | | |
|---|---|---|---|---|---|---|---|
| | Misc. | Large quantity of woodblock store in room. | | <ul style="list-style-type: none"> <li>Identify where this wood block is from (Unit E 0.37?) and relocate.</li> </ul> | | | |

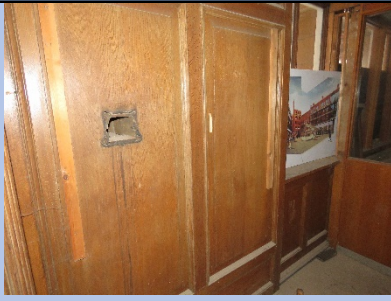
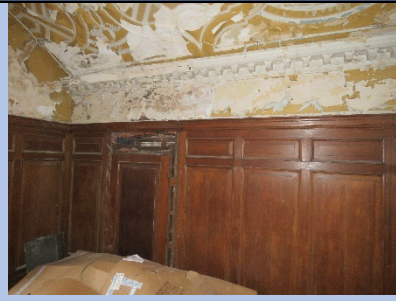
| Room Ref. | Element | Description / Item | Condition | Action | Photographs | | |
|---|---|---|---|---|---|---|---|
| Unit H 0.4 | Walls | Predominantly wood panelling up to picture rail height. Plaster on brick above with paint finish. | | <ul style="list-style-type: none"> <li>Survey joinery and protect.</li> <li>Hammer test remaining plaster and remove any bossed plaster.</li> <li>Remove flaking paint.</li> <li>Existing Timber wall panelling and glazed partitions to be retained and restored by specialist.</li> <li>Replace any sections of missing joinery.</li> </ul> | | | |

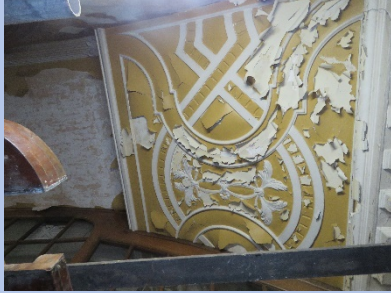
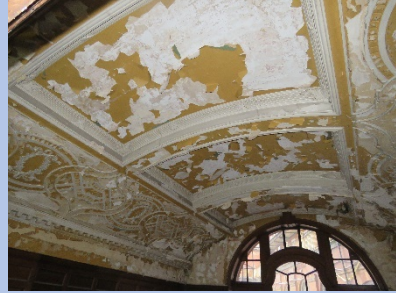
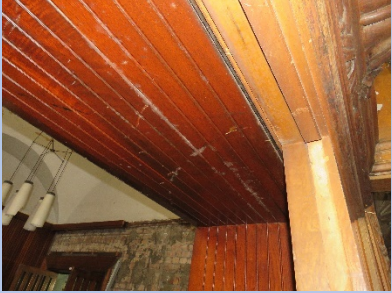
| Room Ref. | Element | Description / Item | Condition | Action | Photographs | | |
|---|---|---|---|---|---|---|---|
| | Ceiling | Ornate barrel vaulted ceiling. Plaster on lath with paint finish. Timber boards to vestibule. | Fair | <ul style="list-style-type: none"> <li>Hammer test remaining plaster and remove any bossed plaster, recording decorative features and retaining plaster that has been removed. Store on pallet in room.</li> <li>Remove flaking paint.</li> <li>Existing lath and plaster decorative ceiling to be repaired (M20/587) and to receive intumescent paint coating (Z12/212). Architect to advise on paint colours required to plasterwork.</li> </ul> | | | |

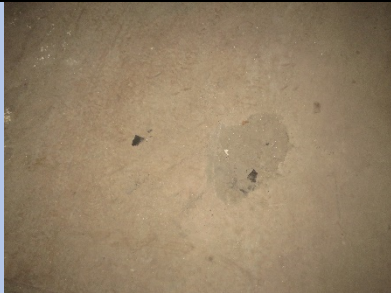
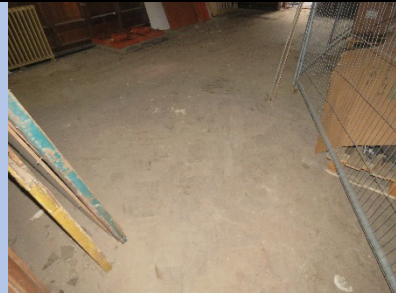
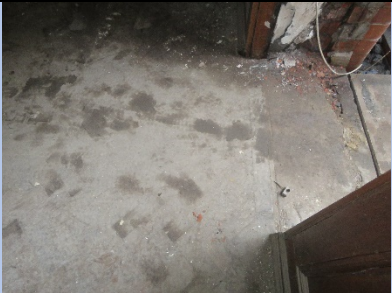
| Room Ref. | Element | Description / Item | Condition | Action | Photographs | | |
|---|---|---|---|---|---|---|---|
| | Floor | Underlay and adhesive over wood block. | Fair | <ul style="list-style-type: none"> <li>Remove underlay and all adhesive.</li> <li>Quantify and lift wood block, store on pallets in room.</li> <li>Allow for floor to be levelled and prepared throughout with latex levelling screed or similar (M10/120).</li> </ul> | | | |

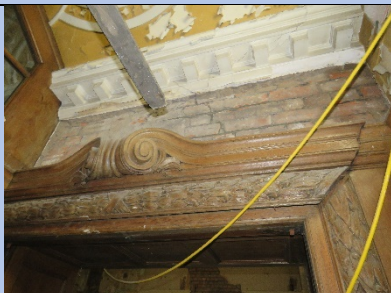
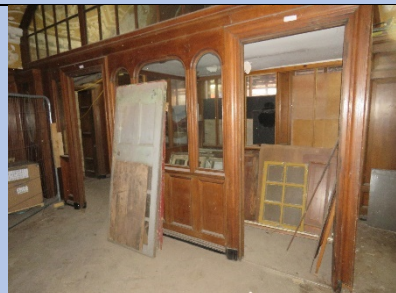
| Room Ref. | Element | Description / Item | Condition | Action | Photographs | | |
|---|---|---|---|---|---|---|---|
| | Joinery | Wall panelling. Ornate door surrounds. Skirting. Timber and glazed partition. Misc. pile of doors / panelling. | | <ul style="list-style-type: none"> <li>Wall panelling to be restored along with skirting and glazed partitions.</li> <li>Misc doors to be recorded and set aside for reuse.</li> <li>Misc joinery used for repairs where possible otherwise scrapped.</li> </ul> | | | |

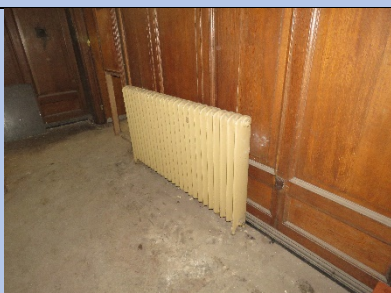
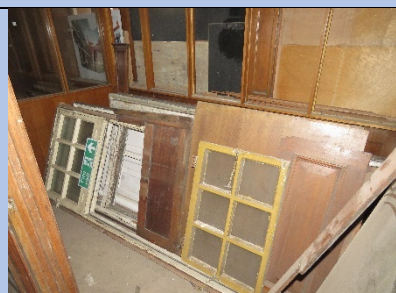
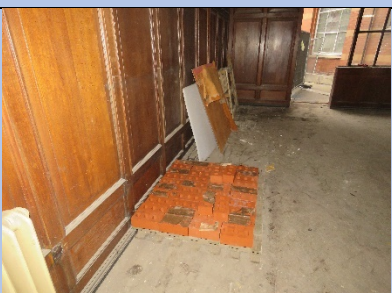
| Room Ref. | Element | Description / Item | Condition | Action | Photographs | | |
|---|---|---|---|---|---|---|---|
| | Misc. | Pile of windows. 2no. radiators. Salvaged red brick. | | <ul style="list-style-type: none"> <li>Record windows / loose historic items and relocate to Heritage store.</li> <li>Record radiators, remove and store in Heritage Store &amp; fill holes following removals.</li> <li>Relocate salvaged red brick to site store.</li> </ul> | | | |

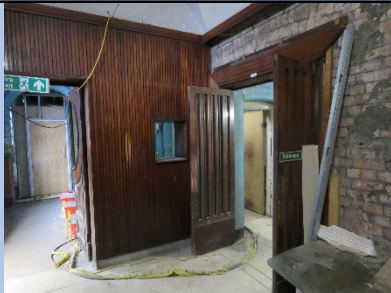
| Room Ref. | Element | Description / Item | Condition | Action | Photographs | | |
|---|---|---|---|---|---|---|---|
| Lobby 0.41 | Walls | Timber boarding.<br>Exposed brick. | Fair | <ul style="list-style-type: none"> <li>Existing Timber wall panelling and glazed partitions to be cleaned, retained, and restored by specialist. Protect following restoration.</li> </ul> | | | |

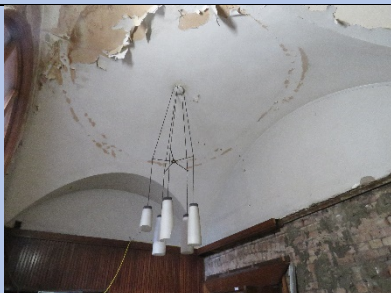
| Room Ref. | Element | Description / Item | Condition | Action | Photographs | | |
|---|---|---|---|---|---|---|---|
| | Ceiling | Vaulted plaster ceiling.<br>Plaster on lath with paint finish. | Good | <ul style="list-style-type: none"> <li>Hammer test remaining plaster and remove any bossed plaster.</li> <li>Remove flaking paint.</li> <li>Existing lath and plaster decorative ceiling to be repaired (M20/587) and to receive intumescent paint coating (Z12/212).</li> </ul> | | | |

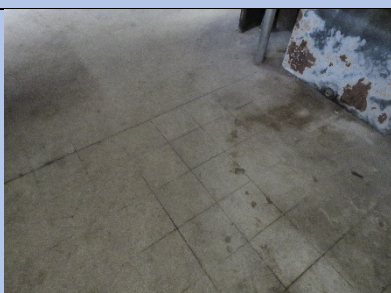
| Room Ref. | Element | Description / Item | Condition | Action | Photographs | | |
|---|---|---|---|---|---|---|---|
| | Floor | Terrazzo tile. | Fair | <ul style="list-style-type: none"> <li>Remove debris, clean and protect.</li> <li>Loose floor covering to be removed.</li> <li>Allow for floor to be levelled and prepared throughout with latex levelling screed or similar (M10/120).</li> </ul> | | | |

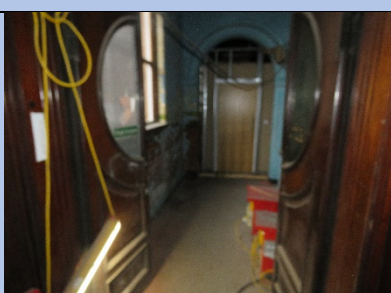
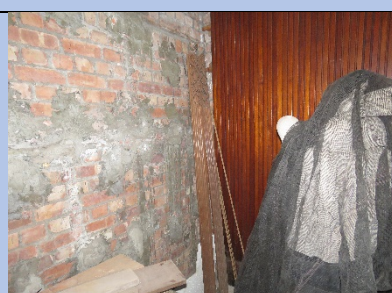
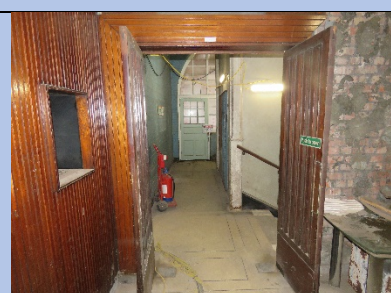
| Room Ref. | Element | Description / Item | Condition | Action | Photographs | | |
|---|---|---|---|---|---|---|---|
| | Joinery | Decorative joinery stored from 0.4.<br>Double timber door. | | <ul style="list-style-type: none"> <li>Wall panelling to be restored along with skirting and glazed partitions (allow for replacement of sections where required).</li> <li>Misc doors to be set aside for reuse</li> <li>Misc joinery to be used for repairs where possible otherwise scrapped.</li> </ul> | | | |

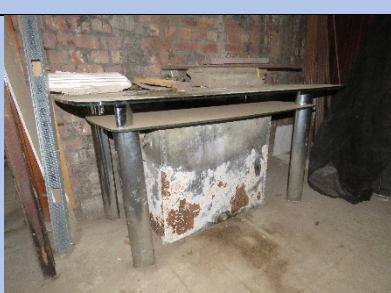
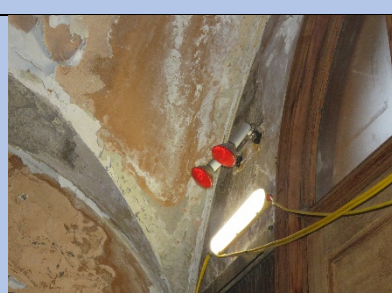
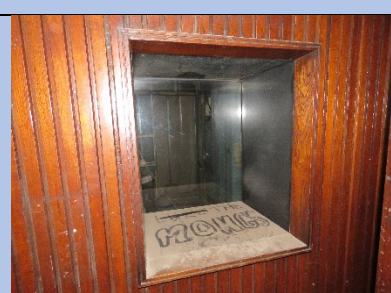
| Room Ref. | Element | Description / Item | Condition | Action | Photographs | | |
|---|---|---|---|---|---|---|---|
| | Misc. | Metal table.<br>Lead water tank.<br>Modern light fitting to ceiling.<br>Light fitting to wall.<br>Wall hatch. | | <ul style="list-style-type: none"> <li>Remove table from site if not heritage significant.</li> <li>Relocate water tank to Heritage store.</li> <li>Record ceiling light and remove to heritage store room.</li> <li>Remove wall lights.</li> </ul> | | | |

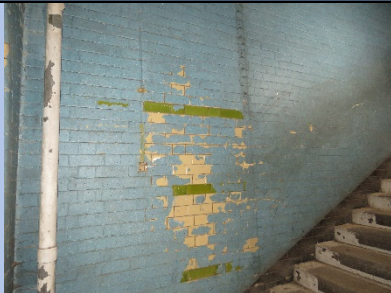
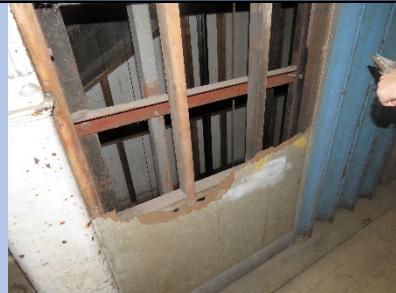
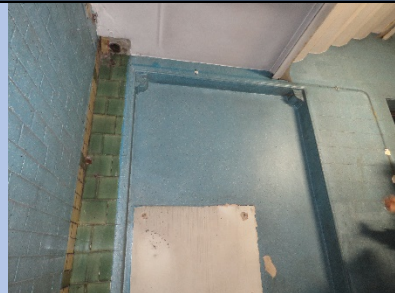
| Room Ref. | Element | Description / Item | Condition | Action | Photographs | | |
|---|---|---|---|---|---|---|---|
| S07 | Walls | Glazed brick painted.<br>Modern timber / MDF type board to lift with timber stud.<br>Unknown finish below paint of opening to wall towards Lobby 0.41. | Good / poor | <ul style="list-style-type: none"> <li>Remove flaking paint with hand tools.</li> <li>Remove remaining paint using peelaway.</li> <li>Remove timber boards, timber stud and install temporary protection.</li> <li>Strip paint from infill to investigate earlier finishes.</li> </ul> | | | |

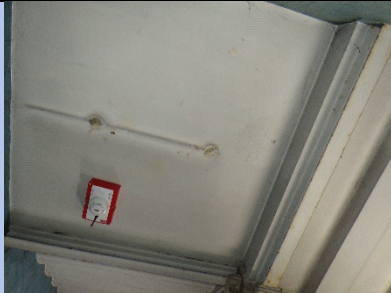
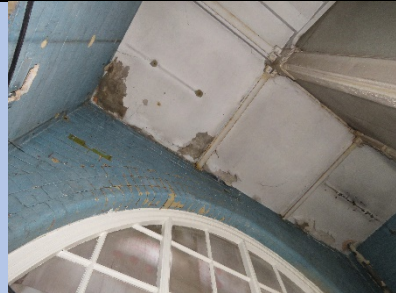
| Room Ref. | Element | Description / Item | Condition | Action | Photographs | | |
|---|---|---|---|---|---|---|---|
| | Ceiling | Paint on concrete. | N/A | <ul style="list-style-type: none"> <li>Remove peeling paint.</li> </ul> Proposed works <ul style="list-style-type: none"> <li>Existing exposed concrete soffit retained, repaired to SE details and decorated in intumescent paint NBS:Z12/211 applied to manufacturers recommendations.</li> <li>Steel beams to receive intumescent paint NBS:M61/120.</li> </ul> | | | |

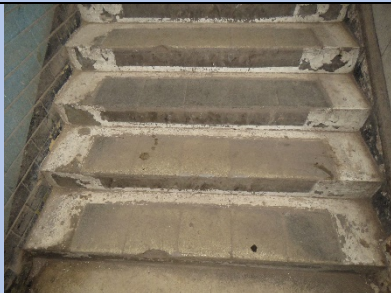
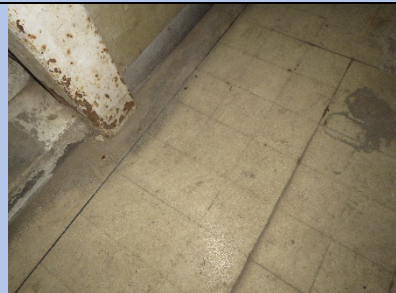
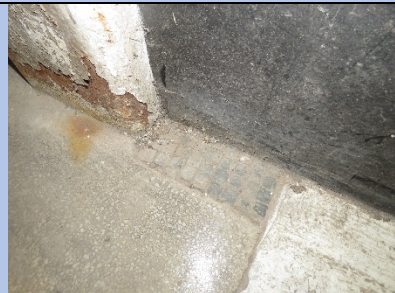
| Room Ref. | Element | Description / Item | Condition | Action | Photographs | | |
|---|---|---|---|---|---|---|---|
| | Floor | Paint over terrazzo tile.<br>Small section of mosaic. | N/A | <ul style="list-style-type: none"> <li>Remove paint, clean and protect.</li> </ul> Proposed works <ul style="list-style-type: none"> <li>Undertake repair to any holes in floor to specification NBS:M10/121.</li> </ul> | | | |

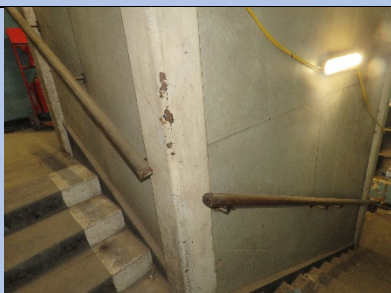
| Room Ref. | Element | Description / Item | Condition | Action | Photographs | | |
|---|---|---|---|---|---|---|---|
| | Joinery | Timber handrail. | | <ul style="list-style-type: none"> <li>Protect handrail in-situ.</li> <li>Sand and treat timber handrail. Architect to confirm treatment specification.</li> <li>Ironmongery to handrail to be painted. Architect to confirm paint specification.</li> </ul> | | | |

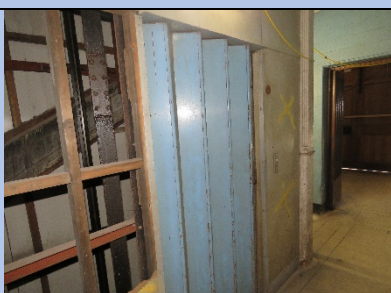
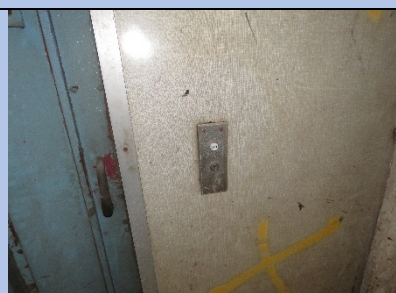
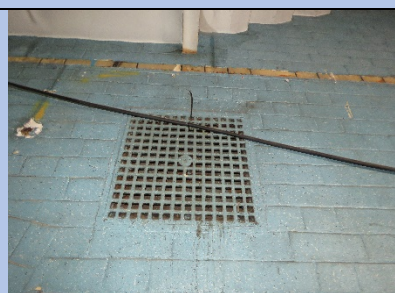
| Room Ref. | Element | Description / Item | Condition | Action | Photographs | | |
|---|---|---|---|---|---|---|---|
| | Misc. | Water pipe of original firefighting hose pipes.<br>Lift door and call button with faceplate.<br>Cast steel stair posts. | | <ul style="list-style-type: none"> <li>Remove flaking paint, clean and protect pipe.</li> <li>Remove lift door, button and faceplate, record and store on site.</li> <li>Remove flaking paint and corrosion to steel posts and protect in situ.</li> <li>Remove any redundant fixtures and fittings.</li> </ul> | | | |

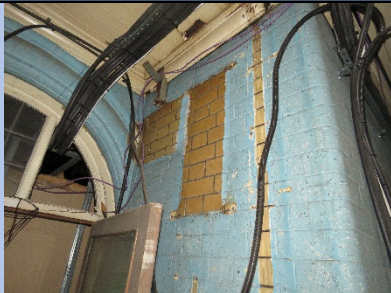
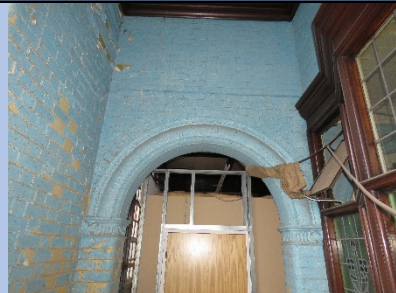
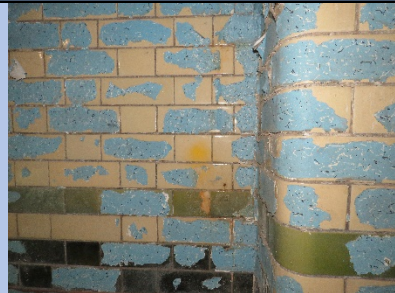
| Room Ref. | Element | Description / Item | Condition | Action | Photographs | | |
|---|---|---|---|---|---|---|---|
| 0.43 + Lobby | Walls | Glazed brick painted.<br>Timber and leaded glazing partition.<br>Timber and glazed partition to Unit A 0.45<br>Decorative arch to door opening | Fair | <ul style="list-style-type: none"> <li>Remove flaking paint with hand tools.</li> <li>Remove remaining paint using peelaway (walls &amp; columns)</li> <li>Record condition of glazed panels, timber and protect.</li> <li>Any holes to be infilled using reclaimed glazed bricks.</li> </ul> | | | |

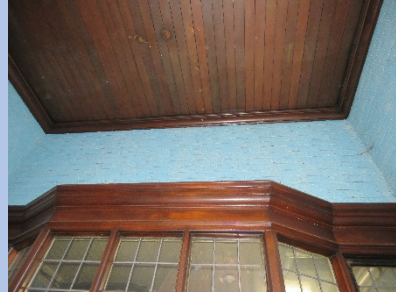
| Room Ref. | Element | Description / Item | Condition | Action | Photographs | | |
|---|---|---|---|---|---|---|---|
| | Ceiling | Timber boards, painted and not painted. | Fair | <ul style="list-style-type: none"> <li>Remove flaking paint.</li> <li>Existing Timber boarding and steel encasement repaired and painted with intumescent paint NBS:Z12/213. All holes to be infilled and redundant services removed. Infill all holes following removals.</li> </ul> | | | |

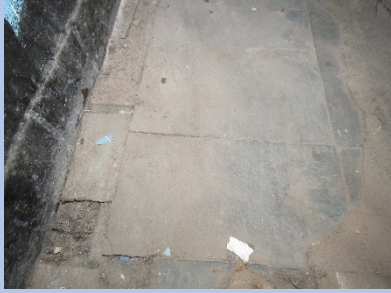
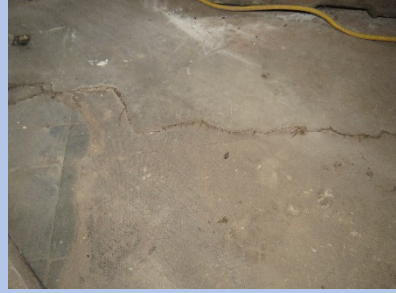
| Room Ref. | Element | Description / Item | Condition | Action | Photographs | | |
|---|---|---|---|---|---|---|---|
| | Floor | Chipboard over original floor, unknown but presumed terrazzo tile.<br>Red terrazzo tile. | Fair | <ul style="list-style-type: none"> <li>Remove all debris.</li> <li>Remove chipboard and later floor coverings.</li> <li>Existing tile floor cleaned.</li> <li>Protect original floor finish.</li> </ul> | | | |

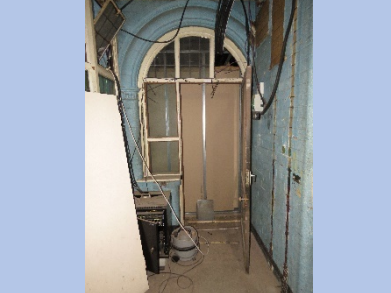
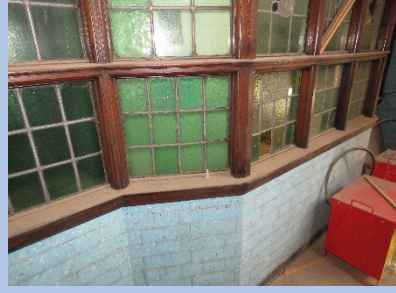
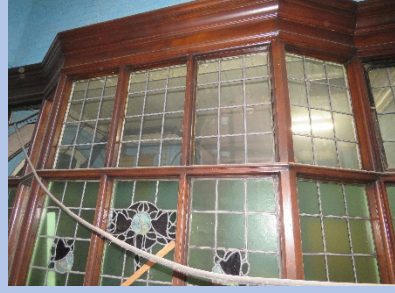
| Room Ref. | Element | Description / Item | Condition | Action | Photographs | | |
|---|---|---|---|---|---|---|---|
| | Joinery | Timber cornice.<br>Double door<br>Timber hatch to ceiling.<br>Hatch to wall.<br>Glazed partitions. | | <ul style="list-style-type: none"> <li>Timber cornice repaired in situ by specialist.</li> <li>Double doors retained and refurbished.</li> <li>Hatches retained and repaired.</li> <li>Clean windows to glazed partition &amp; treat to match existing finish.</li> </ul> | | | |

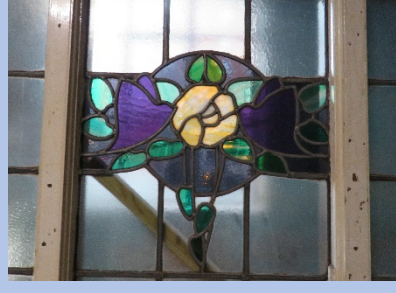
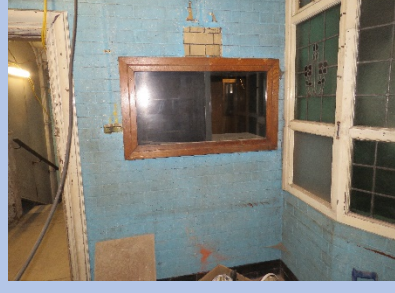
| Room Ref. | Element | Description / Item | Condition | Action | Photographs | | |
|---|---|---|---|---|---|---|---|
| | Misc. | Glazed hatch.<br>Redundant M&E.<br>Incoming site electrical supply and distribution boards. | | <ul style="list-style-type: none"> <li>Remove all redundant electrical items &amp; fill holes.</li> </ul> | | | |
