**PROPOSED DEMOLITION OF WORKSHOP AND OFFICE SPACE**  
**EGERTONS RECOVERY GROUP, PASTON ROAD, WYTHENSHAW**

JULY 2022

This document has been prepared by Davenport Architecture to accompany a full planning application for the demolition of a derelict single storey workshop building and 3 storey office building on the Egertons Recovery Group site in Shartson.

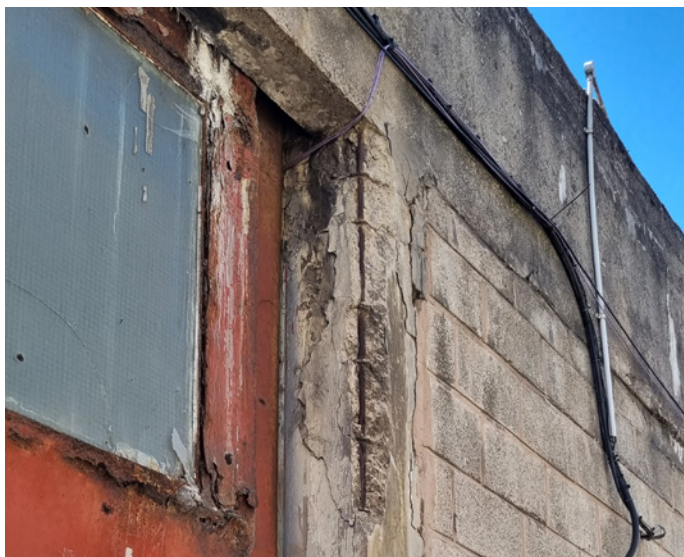
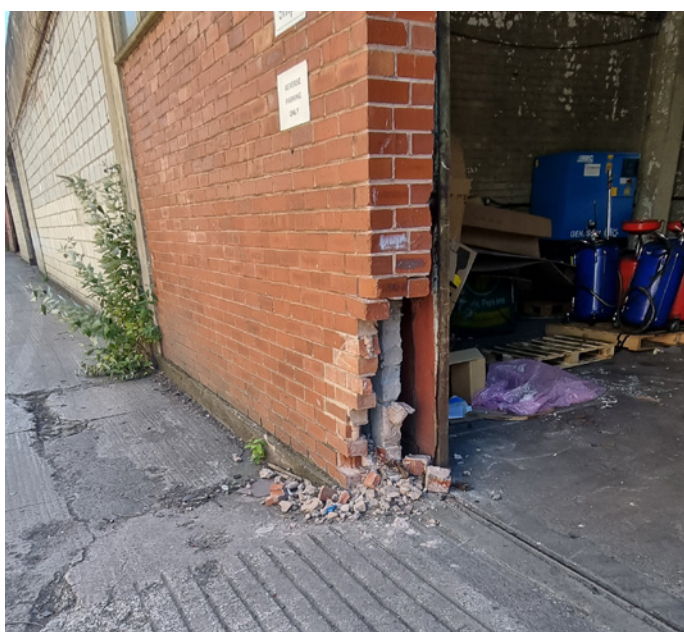
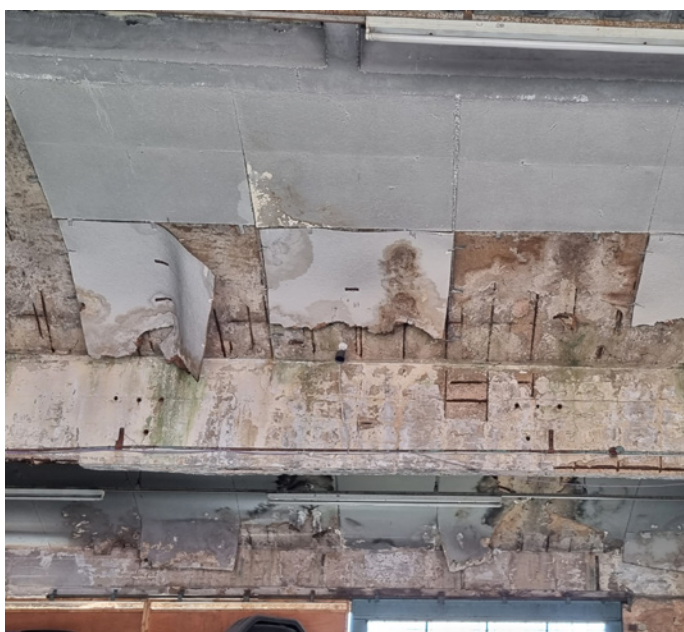
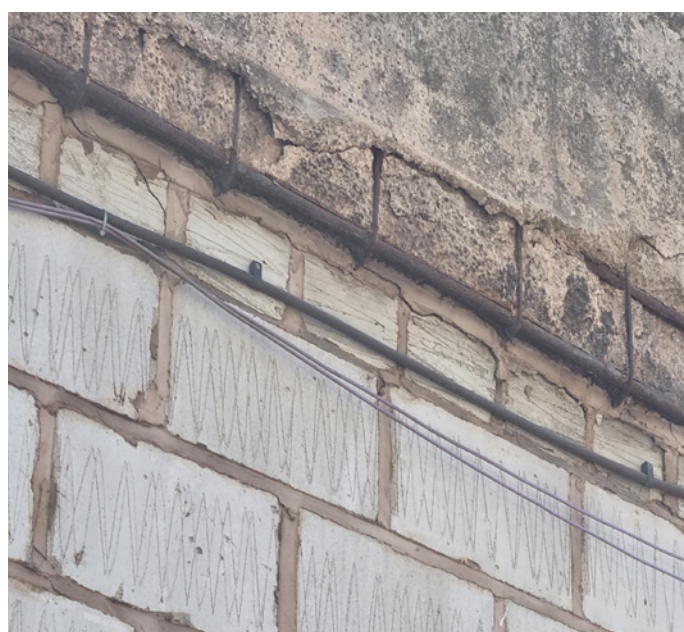
The workshops and office buildings, both have major structural issues and are in a state of disrepair.

One of the more common problems which can be seen in these spaces is deteriorating concrete. Over years of exposure to the elements it's clear that insufficient coverage was given to the concrete re-enforcement causing internal corrosion followed by blowing of the concrete cover. The re-enforcement steels are now exposed in many areas across all buildings causing falling debris and potential structural instability.

Other damage around the building includes damaged brickwork in the workshop space and collapsed ceilings in the office spaces. Although access was not available, we are advised that elements of the structural floors and roof slabs have collapsed causing extensive internal damage.
