## Internal Repairs – First Floor

November 2021

**CURTINS, PURCELL &  
AL UPDATE 08.03.22**

## London Road Fire Station, Manchester – Schedule of Enabling Works for Internal Repairs – First Floor

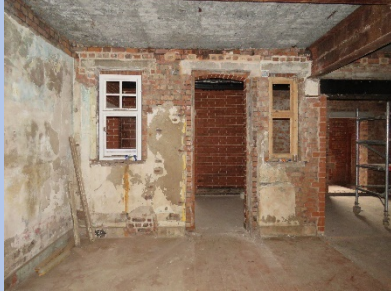
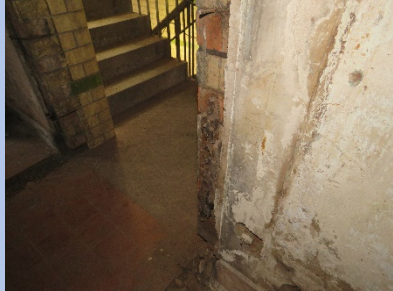
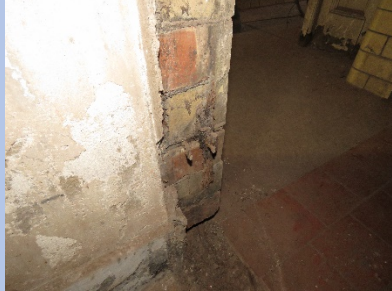
| Room Ref. | Element | Description / Item | Condition | Action | Photographs | | | |
|---|---|---|---|---|---|---|---|---|
| 101 | Walls | Plaster on brickwork with paint and paint finish.<br>Holes to fireplaces. | Fair | <div>Enabling works</div> <ul style="list-style-type: none"> <li>Hammer test remaining plaster and remove any bossed plaster (except where walls to be stripped to bare masonry)</li> <li>Brush down areas of flaking paint.</li> <li>De-nail walls.</li> </ul> <div>Proposed works</div> <ul style="list-style-type: none"> <li>Existing north, south &amp; east walls stripped back to bare masonry</li> <li>Patch in new lime plaster to Minshull Street wall NBS:M20/210A ready for decoration.</li> </ul> | | | | 006 |

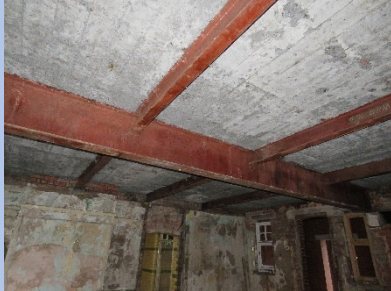
| Room Ref. | Element | Description / Item | Condition | Action | Photographs | | | |
|---|---|---|---|---|---|---|---|---|
| | Ceiling | Exposed concrete slab and steel beams. | Fair | <div>Enabling works</div> <ul style="list-style-type: none"> <li>De-rust steel beams ready for re-decoration.</li> </ul> <div>Proposed works</div> <ul style="list-style-type: none"> <li>Existing exposed concrete soffit retained, repaired to SE details, and decorated in intumescent paint NBS:Z12/211 applied to manufacturers recommendations.</li> <li>Steel beams to receive intumescent paint NBS:M61/120.</li> </ul> | | | | |

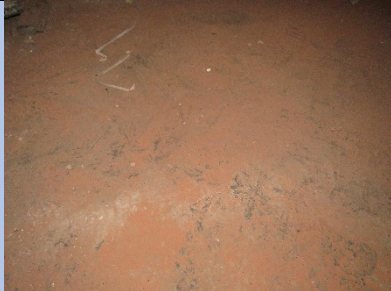
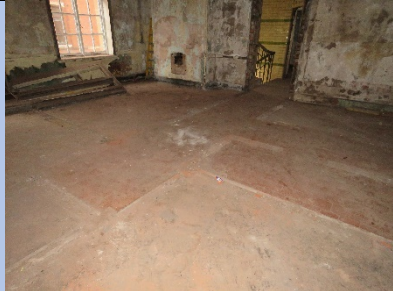
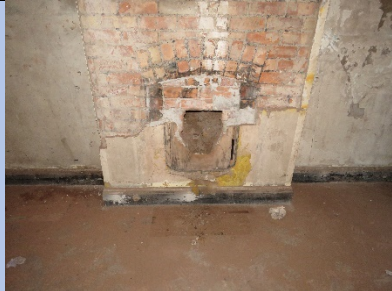
| Room Ref. | Element | Description / Item | Condition | Action | Photographs | | | |
|---|---|---|---|---|---|---|---|---|
| | Floor | Red quarry tile, wood block and glazed tile to hearth. Floor screed partially covering red quarry tile. | Fair | <div>Enabling works</div> <ul style="list-style-type: none"> <li>Remove screed from floor and all debris.</li> <li>Clean red quarry tile and protect.</li> <li>Record quantity of wood block, lift and store on pallet in room.</li> </ul> <div>Proposed works</div> <ul style="list-style-type: none"> <li>Provide new polished screed (NBS:E41/112) finish to whole space except area containing existing quarry tiles.</li> <li>Quarry tiles to be retained in-situ and cleaned.</li> </ul> | | | | |

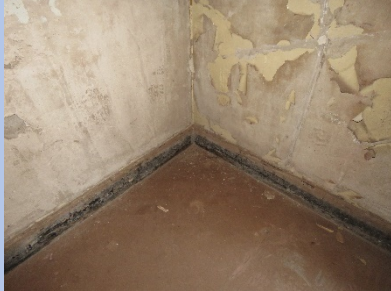
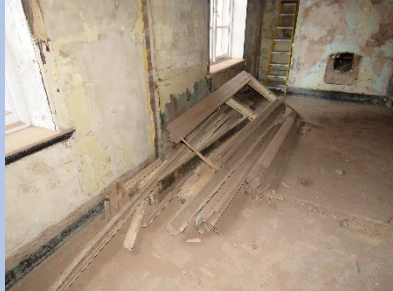
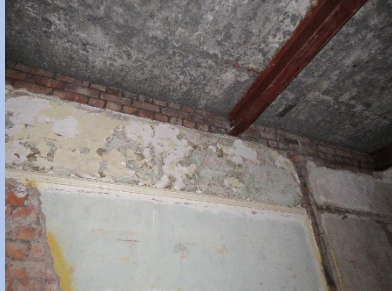
| Room Ref. | Element | Description / Item | Condition | Action | Photographs | | | |
|---|---|---|---|---|---|---|---|---|
| | Joinery | Skirtings:<br>Sections in render and in timber remain in-situ.<br>Picture rail<br>Pile of misc. joinery. | Poor | <div>Proposed works</div> <ul style="list-style-type: none"> <li>Repair/reinstate render skirtings to north, south, and east walls.</li> <li>Remove failed and rotten sections of timber skirting against MMS wall and repair/reinstate in full along repaired lime plaster.</li> <li>Reinstate picture rail to MMS wall only.</li> <li>Pile of timber to be reused where condition is acceptable, otherwise to be scrapped.</li> </ul> | | | | |

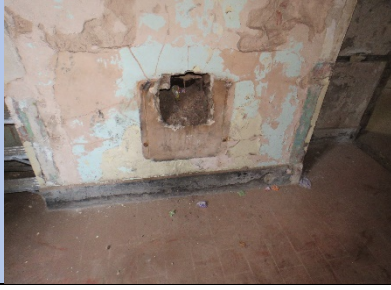
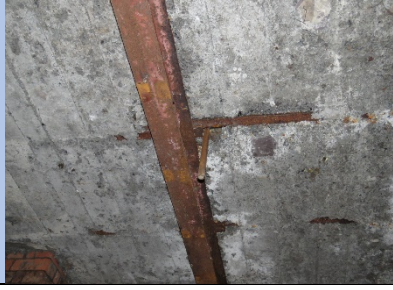
| Room Ref. | Element | Description / Item | Condition | Action | Photographs | | | |
|---|---|---|---|---|---|---|---|---|
| | Misc. | Redundant pipe coming through ceiling. | | <ul style="list-style-type: none"> <li>Remove pipe and undertake concrete repair to SE details.</li> </ul> | | | | |

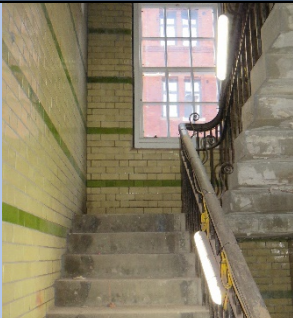
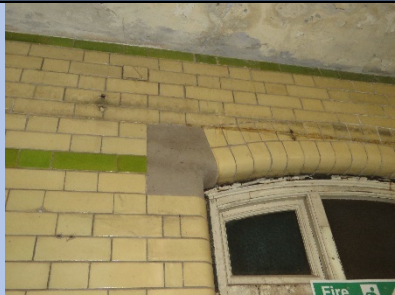
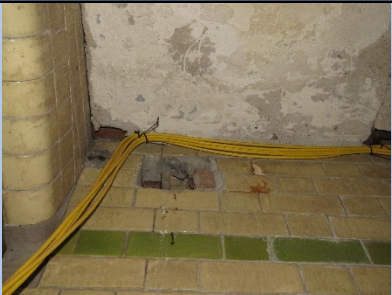
| Room Ref. | Element | Description / Item | Condition | Action | Photographs | | | |
|---|---|---|---|---|---|---|---|---|
| S01 and 111 | Walls | Glazed brick.<br>Holes to brickwork and protruding brick.<br>Misc. fixings.<br>Glazed timber screen. | Good / Fair | <div>Enabling works</div> <ul style="list-style-type: none"> <li>Remove all redundant fixings.</li> <li>Re-fix protruding brickwork and fix salvaged brick to any holes.</li> <li>Clean brickwork and install protection.</li> <li>Remove broken glass and redundant hinges.</li> </ul> <div>Proposed works</div> <ul style="list-style-type: none"> <li>Existing glazed brick cleaned and protected.</li> </ul> | | | | 007 |

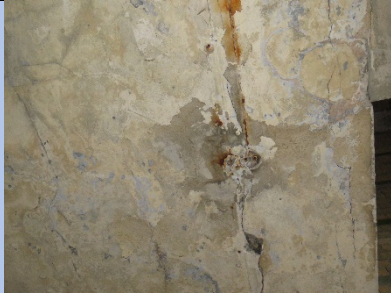
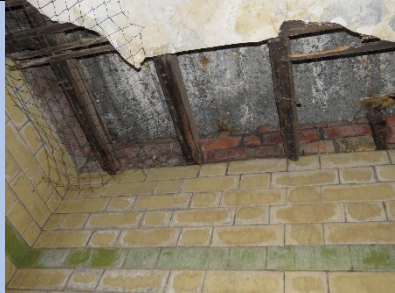
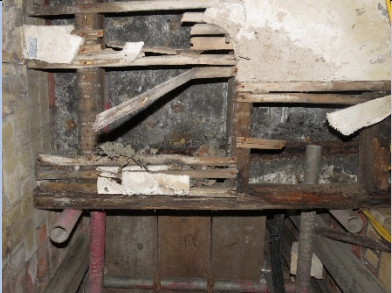
| Room Ref. | Element | Description / Item | Condition | Action | Photographs | | | |
|---|---|---|---|---|---|---|---|---|
| | Ceiling | Painted plaster on concrete.<br><br>Painted lath and plaster or exposed concrete. | Fair | <div>Enabling works</div> <ul style="list-style-type: none"> <li>Hammer test remaining plaster and remove any bossed plaster.</li> <li>Brush down areas of flaking paint.</li> </ul> <div>Proposed works</div> <ul style="list-style-type: none"> <li>Undertake repairs to lath and plaster ceiling (NBS:M20/340). and timber frame substrate where present</li> <li>Elsewhere, existing exposed concrete soffit to be retained, repaired to SE details and painted in intumescent paint to NBS:Z12/211.</li> </ul> | | | | |

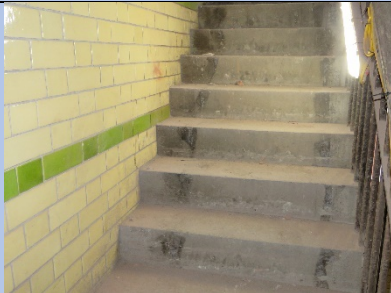
| Room Ref. | Element | Description / Item | Condition | Action | Photographs | | | |
|---|---|---|---|---|---|---|---|---|
| | Floor | Exposed concrete floor with minor holes. | Fair | <div>Enabling works</div> <ul style="list-style-type: none"> <li>Remove all debris and undertake concrete repair to any holes.</li> </ul> <div>Proposed works</div> <ul style="list-style-type: none"> <li>Clean and polish existing concrete floor following repairs.</li> </ul> | | | | |

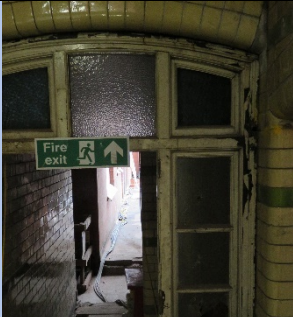
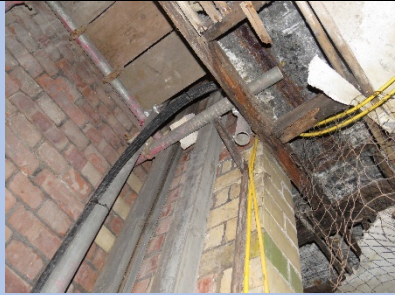
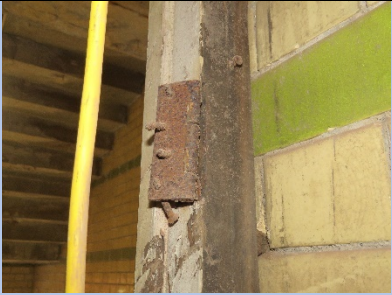
| Room Ref. | Element | Description / Item | Condition | Action | Photographs | | | |
|---|---|---|---|---|---|---|---|---|
| | Joinery | Timber to riser.<br>Door frame to 103a. | Fair | <div>Enabling works</div> <ul style="list-style-type: none"> <li>Remove timber to riser.</li> <li>Remove door frame and block up opening with salvaged glazed brick.</li> </ul> <div>Proposed works</div> <ul style="list-style-type: none"> <li>N/A</li> </ul> | | | | |

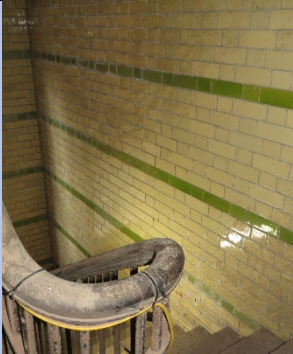
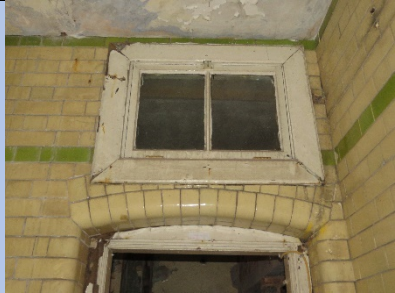
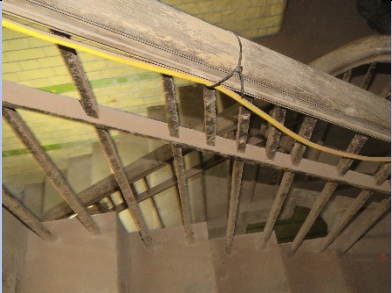
| Room Ref. | Element | Description / Item | Condition | Action | Photographs | | | |
|---|---|---|---|---|---|---|---|---|
| | Misc. | Stair handrail.<br>Glazed timber laylight. | Fair | <div>Enabling works</div> <ul style="list-style-type: none"> <li>Clean timber handrail and record all defects.</li> <li>Remove flaking paint from balusters.</li> <li>Protect handrail.</li> <li>Remove laylight and block opening with salvaged glazed brick.</li> </ul> <div>Proposed works</div> <ul style="list-style-type: none"> <li>Piece in missing section of timber handrail to match existing.</li> <li>Allied London Comment: Sand and treat timber to balustrade to refurbish.</li> <li>Allied London comment: Paint metalwork to balustrade (specification TBC by architect)</li> </ul> | | | | |

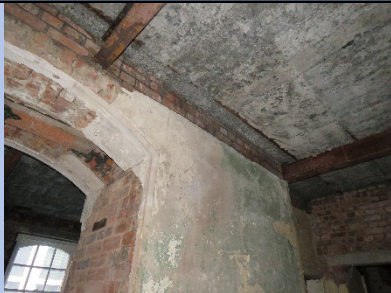
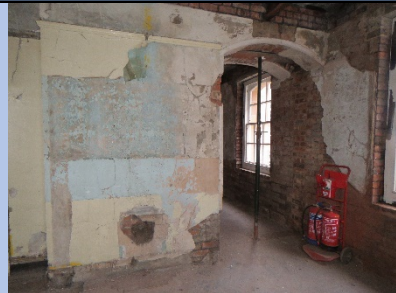
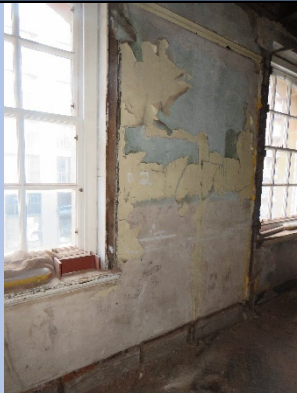
| Room Ref. | Element | Description / Item | Condition | Action | Photographs | | | |
|---|---|---|---|---|---|---|---|---|
| 103a | Walls | Painted plaster on brick. | Fair | <p>Enabling works</p> <ul style="list-style-type: none"> <li>• Hammer test remaining plaster and remove any bossed plaster (except where walls to be stripped to bare masonry).</li> <li>• Brush down areas of flaking paint.</li> <li>• Remove embedded timber and de-nail walls.</li> <li>• Remove soil pipe and fill all holes in wall with salvaged red brick.</li> <li>• Build up top section of stub wall.</li> </ul> <p>Proposed works</p> <ul style="list-style-type: none"> <li>• Patch in new lime plaster to north (WWS) and east (MSS) walls NBS:M20/210A ready for decoration.</li> <li>• All other walls to be stripped back to masonry.</li> </ul> | | | | 004 |

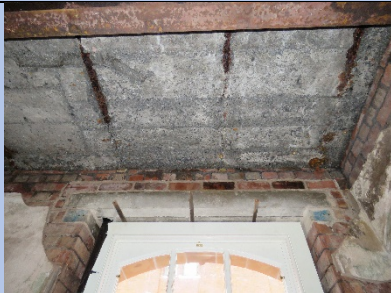
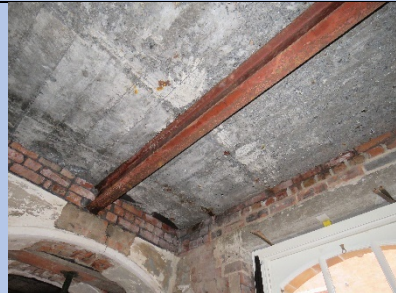
| Room Ref. | Element | Description / Item | Condition | Action | Photographs | | | |
|---|---|---|---|---|---|---|---|---|
| | Ceiling | Exposed concrete slab and steel beams. | Fair | <p>Enabling works</p> <ul style="list-style-type: none"> <li>• De-rust steel beam ready for decoration.</li> </ul> <p>Proposed works</p> <ul style="list-style-type: none"> <li>• Existing exposed concrete soffit retained, repaired to SE details and decorated in intumescent paint NBS:Z12/211 applied to manufacturers recommendations.</li> <li>• Steel beams to receive intumescent paint NBS:M61/120.</li> </ul> | | | | |

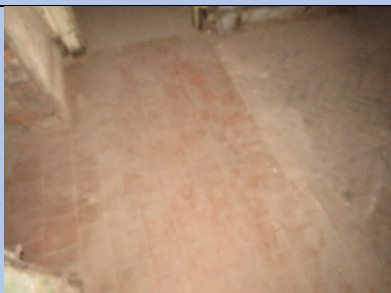
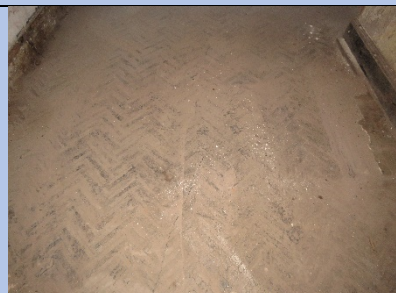
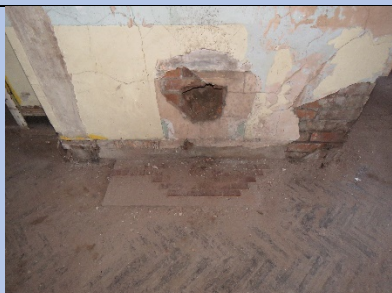
| Room Ref. | Element | Description / Item | Condition | Action | Photographs | | | |
|---|---|---|---|---|---|---|---|---|
| | Floor | Red quarry tile, wood block (already lifted) and glazed tile to hearth. | Good / Fair | <p>Enabling works</p> <ul style="list-style-type: none"> <li>• Quantify woodblock and store on pallet.</li> <li>• Remove underlay and adhesive from red quarry tile, clean and protect.</li> <li>• Remove toilet base.</li> <li>• Remove all debris.</li> </ul> <p>Proposed works</p> <ul style="list-style-type: none"> <li>• Install reclaimed parquet floor on resilient layer NBS:M10/295A</li> <li>• Existing quarry floor tiles cleaned and retained NBS:M10/295A</li> <li>• Provide new resin Thresholds.</li> </ul> | | | | |

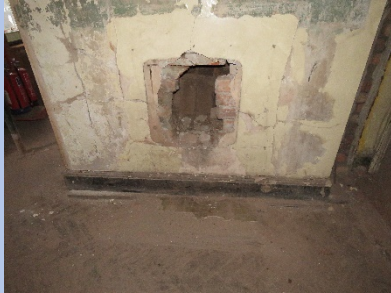
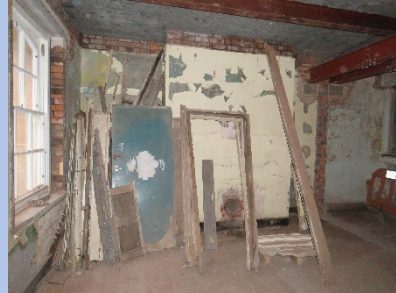
| Room Ref. | Element | Description / Item | Condition | Action | Photographs | | | |
|---|---|---|---|---|---|---|---|---|
| | Joinery | 2no. doors<br>Skirting<br>Picture Rail<br>Architrave<br>Pile of misc. joinery | | <p>Proposals</p> <ul style="list-style-type: none"> <li>• Reinstate render skirtings to bare masonry walls.</li> <li>• External walls (WWS &amp; MSS) to have skirting and picture rails repaired &amp; reinstated following completion of plaster repairs.</li> <li>• Architrave to FFD02 to be retained and repaired.</li> <li>• Misc. joinery to be used for repairs where possible, otherwise scrapped.</li> </ul> | | | | |

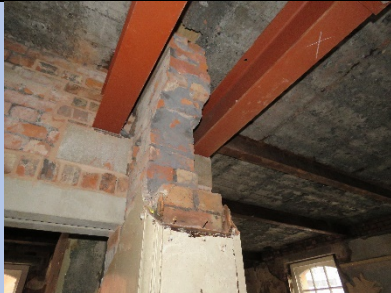
| Room Ref. | Element | Description / Item | Condition | Action | Photographs | | | |
|---|---|---|---|---|---|---|---|---|
| | Misc. | | | <p>Proposals</p> <ul style="list-style-type: none"> <li>• Infill masonry wall at high level with reclaimed bricks to SE approval.</li> </ul> | | | | |
