**HBL ASSOCIATES LTD**  
**VISUAL STRUCTURAL INSPECTION REPORT**

**BRIDGEWATER HOUSE**  
**CHESTER ROAD**  
**MANCHESTER**  
**M15 4AX**

**WATCH THIS SPACE (Jembrana) Ltd.**

**HBL Ref: 9757**

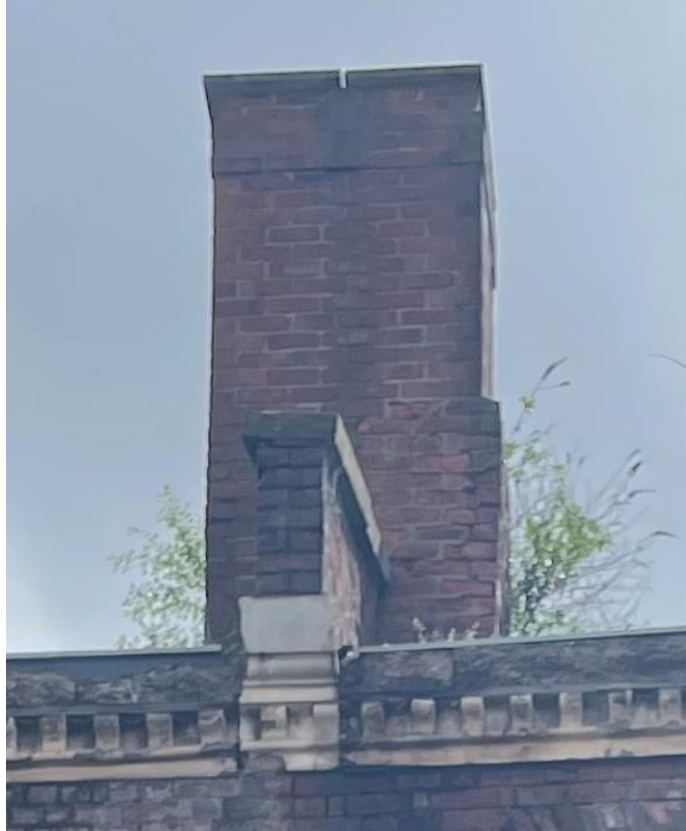
*Photo A1*

- 4.6. The chimney and projecting spine/parapet wall above roof level appeared to be showing signs of lateral movement and there were some perished mortar joints and cracks in the masonry. The spine/parapet coping was not level and vegetation was growing from the junction between the chimney and roof. See Photo A1.

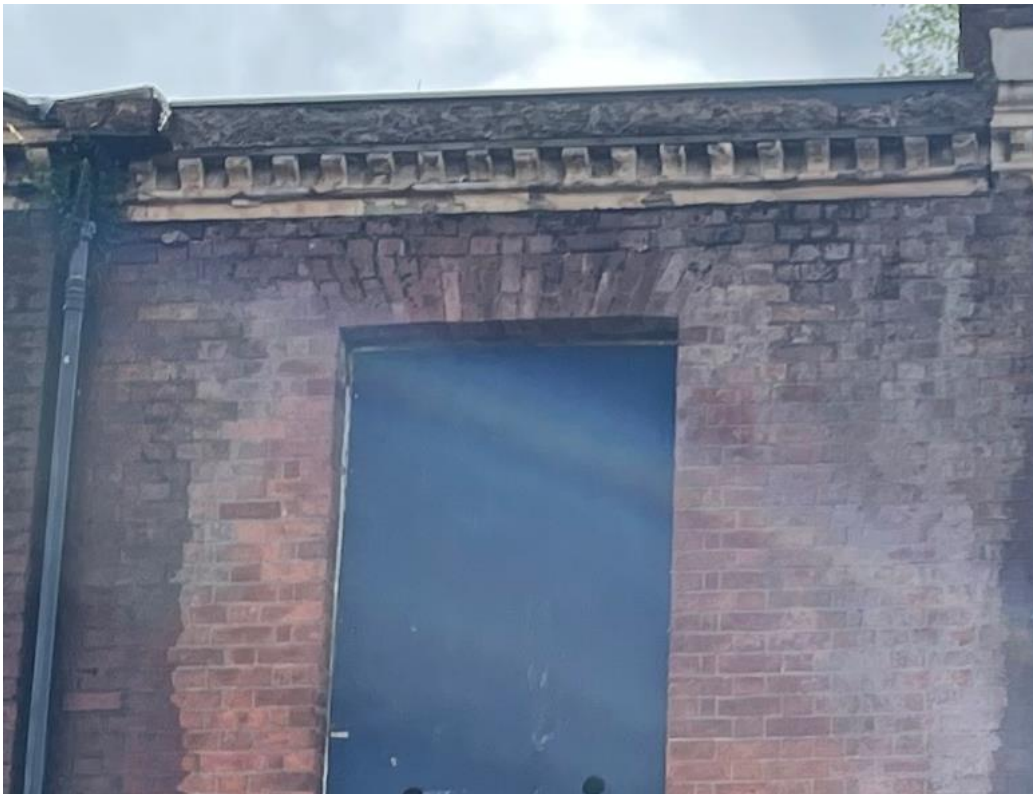
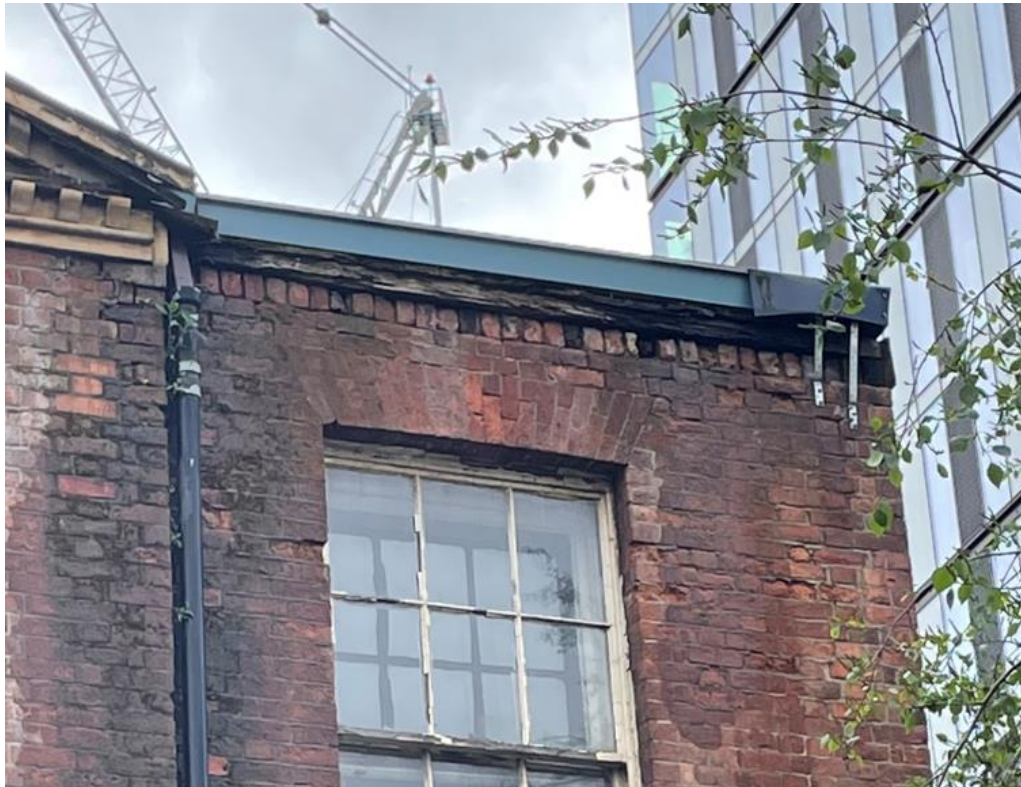
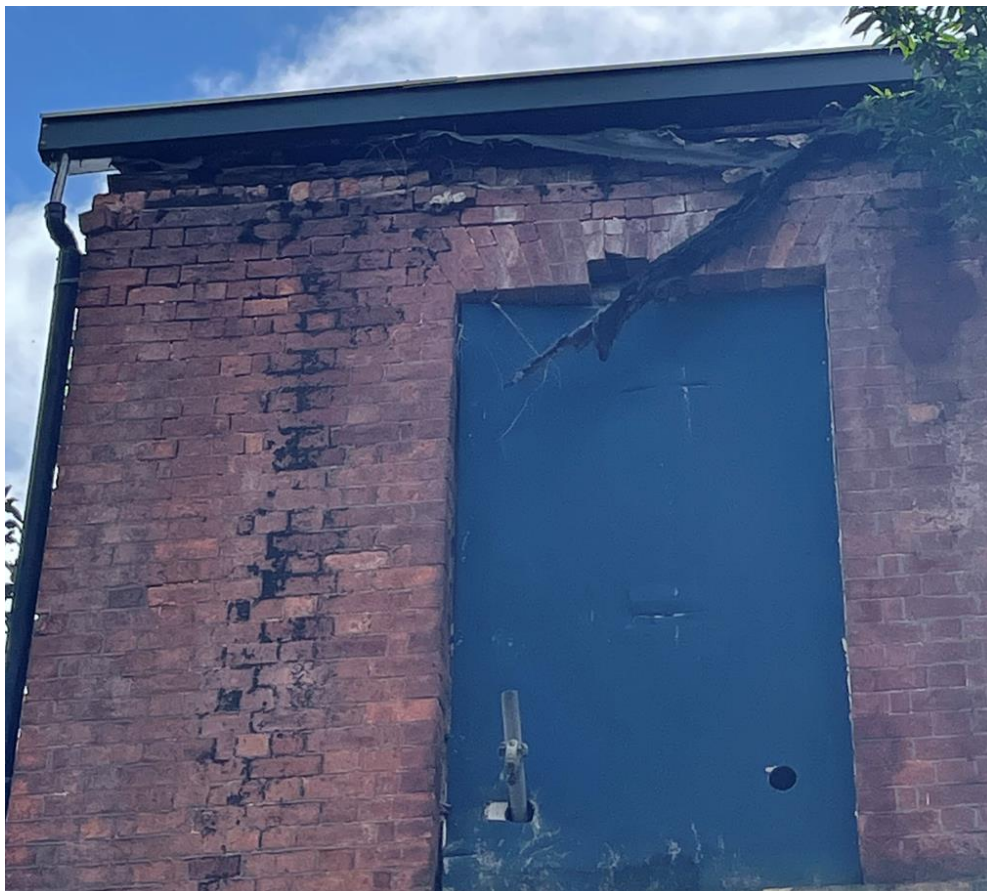
- 4.7. Brickwork and mortar joints were generally in good condition, but there were some localised areas of perished brickwork, missing brickwork, and degraded mortar joints - typically at eaves level. In these areas, water staining was typically evident, and fascias had typically been damaged or were missing. See Photos A2, A3 & A4.

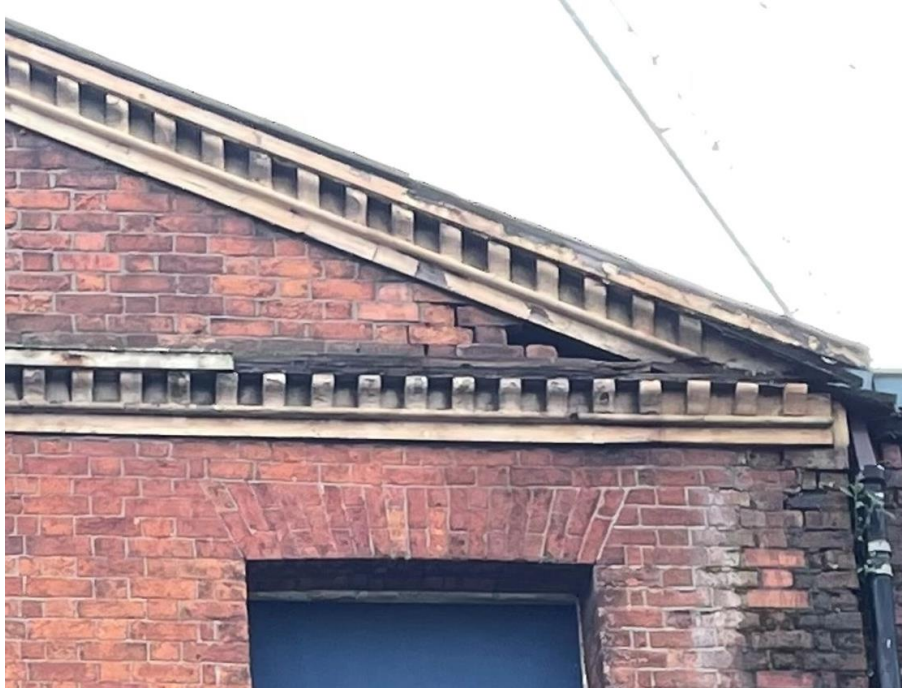
*Photo A5*

- 4.8. Some sections of architectural detailing were damaged or missing. See Photos A5 & A11.
- 4.9. A windowsill was cracked and displaced. See Photo A6

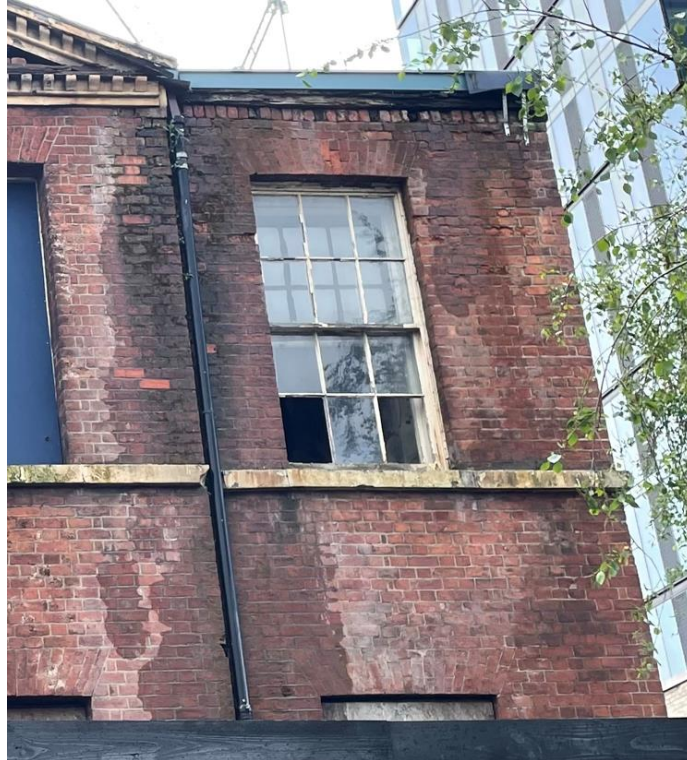
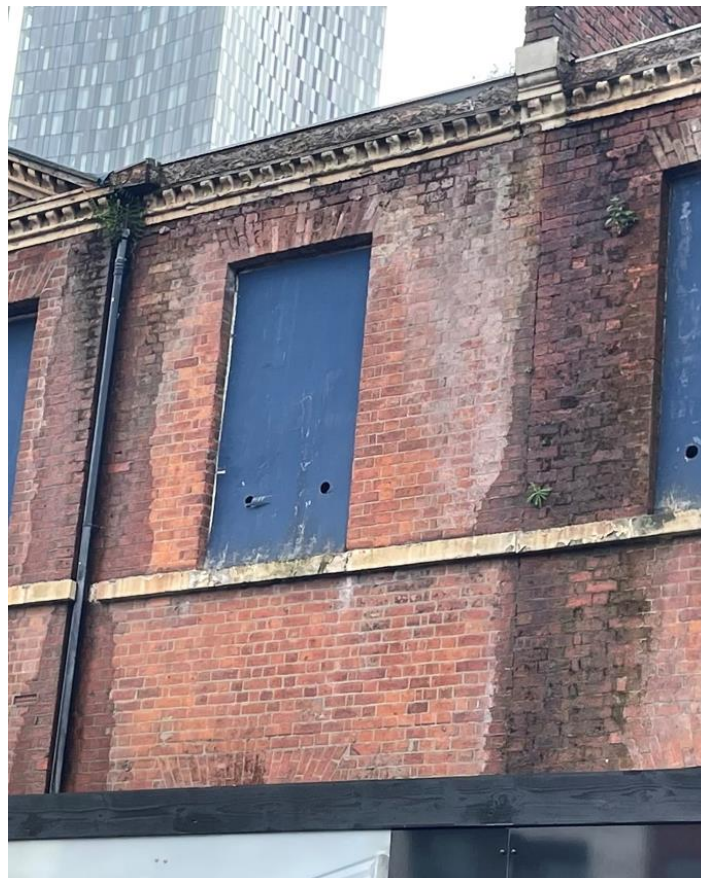
- 4.10. It was evident from severe water staining and water damaged brickwork/mortar joints that most of the rainwater goods (gutters and downpipes) were dysfunctional. See Photos A7 & A8

Repair/replace all defective rainwater goods.

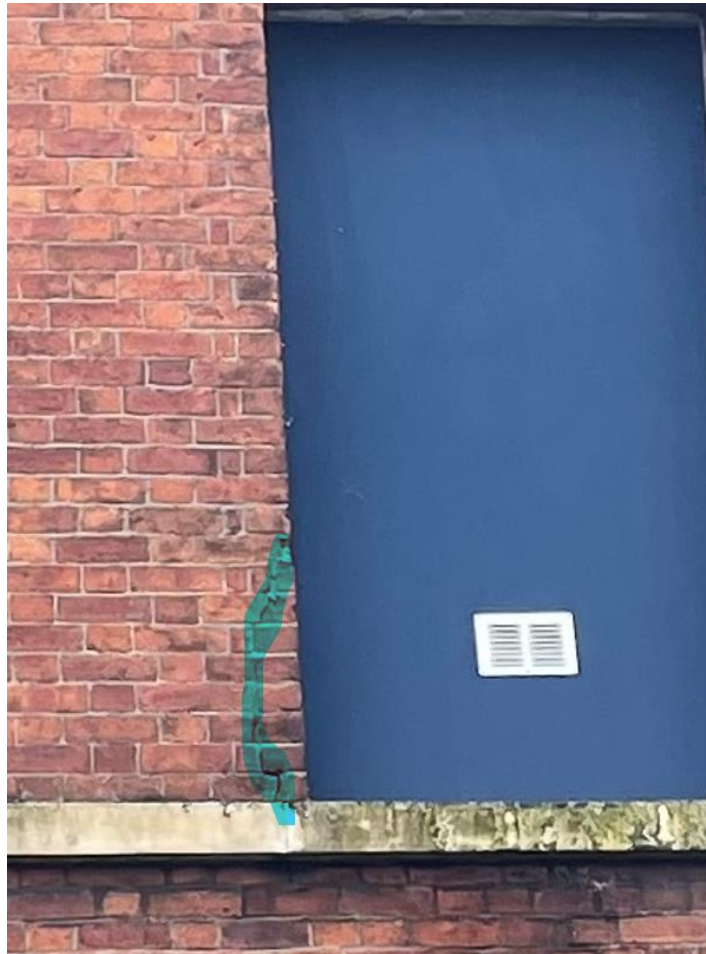
*Photo A9*

- 4.11. There was a vertical, slightly stepped crack in the brickwork adjacent to a second-floor windowsill. See Photo A9.
- 4.12. Brickwork was missing from the corners of both pediments. See Photos A10 & A11.

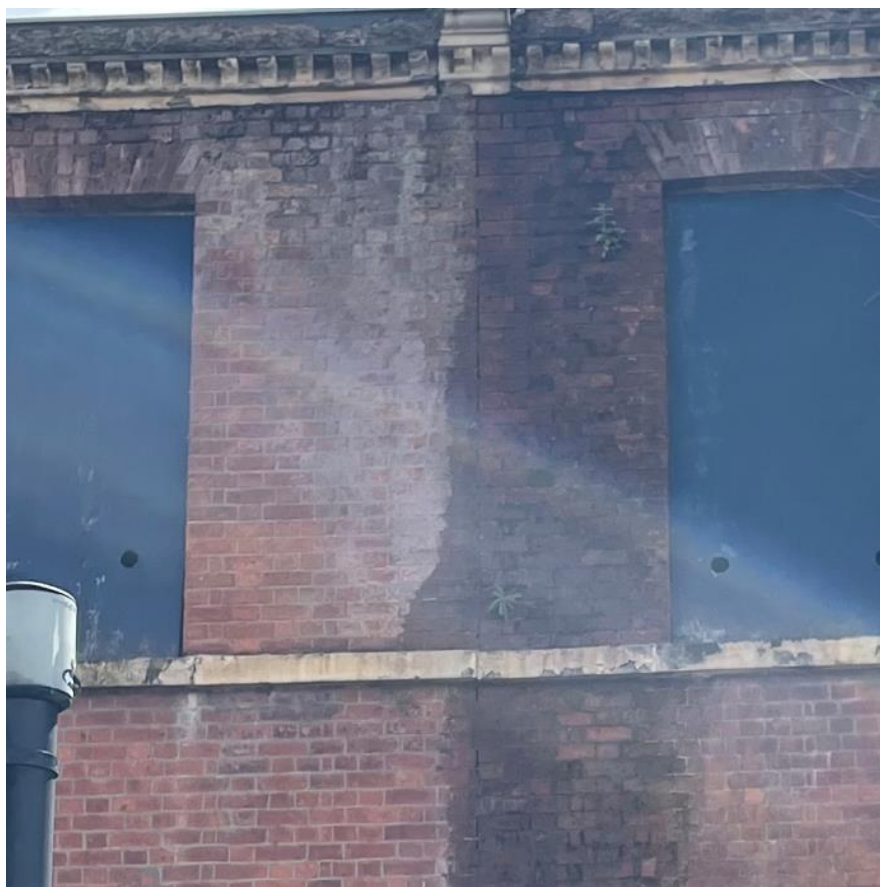
*Photo A12*

- 4.13. An apparent vertical brickwork movement joint was not sealed. See Photo A12.
- 4.14. Well established vegetation was growing from brickwork and downpipes. See Photos A13 & A14.

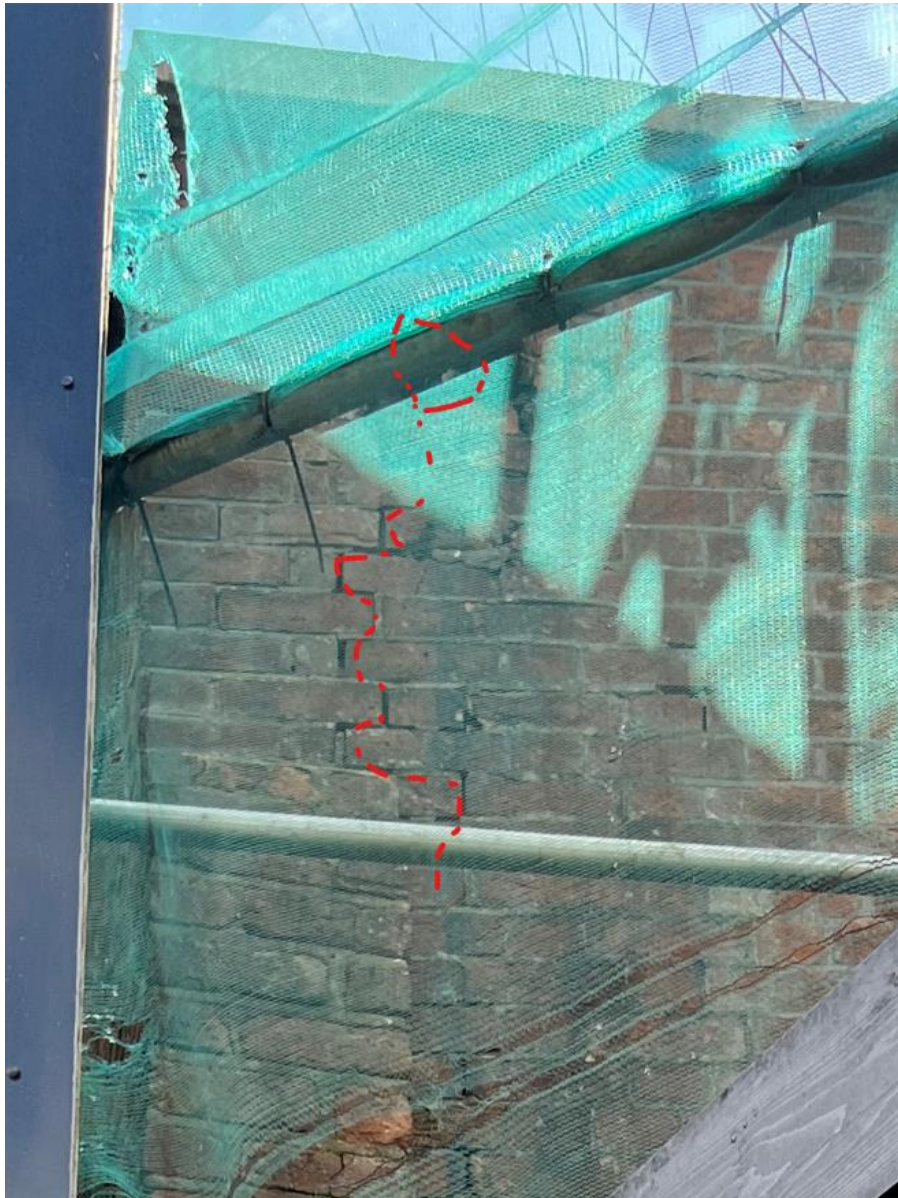
*Photo A15*

- 4.15. Towards the top of the single storey building, the masonry was cracked and there was a large hole. A See Photo A15.

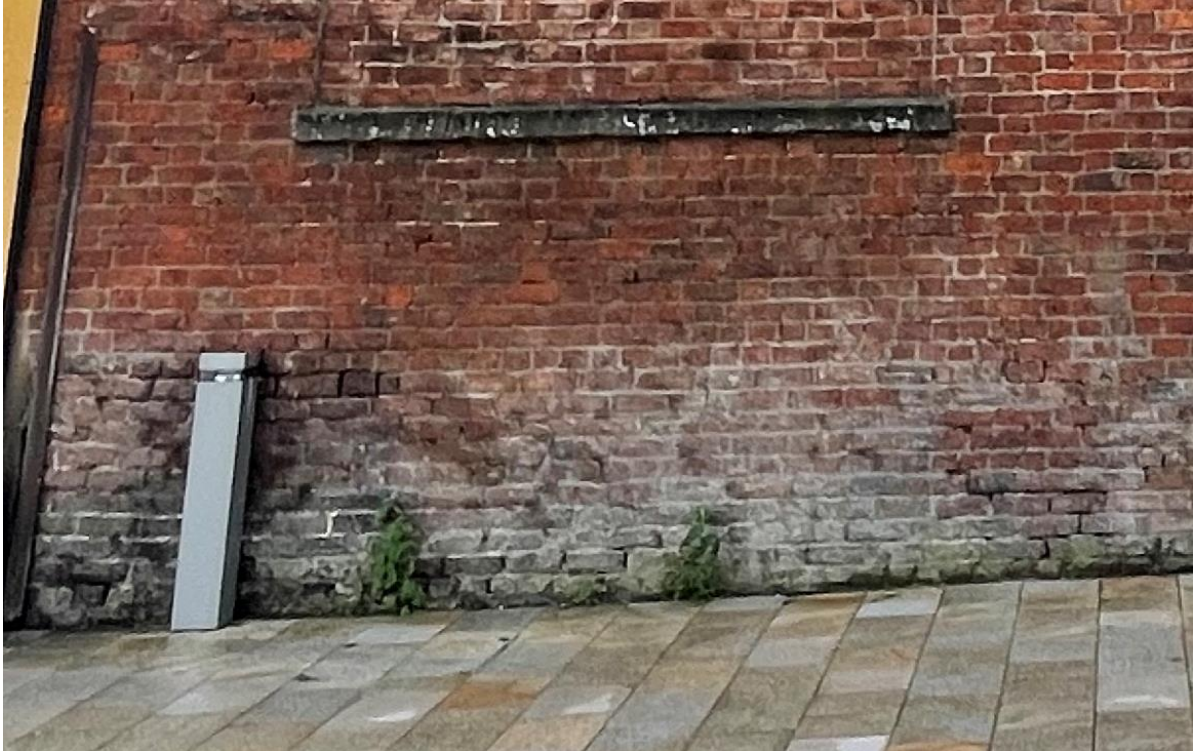
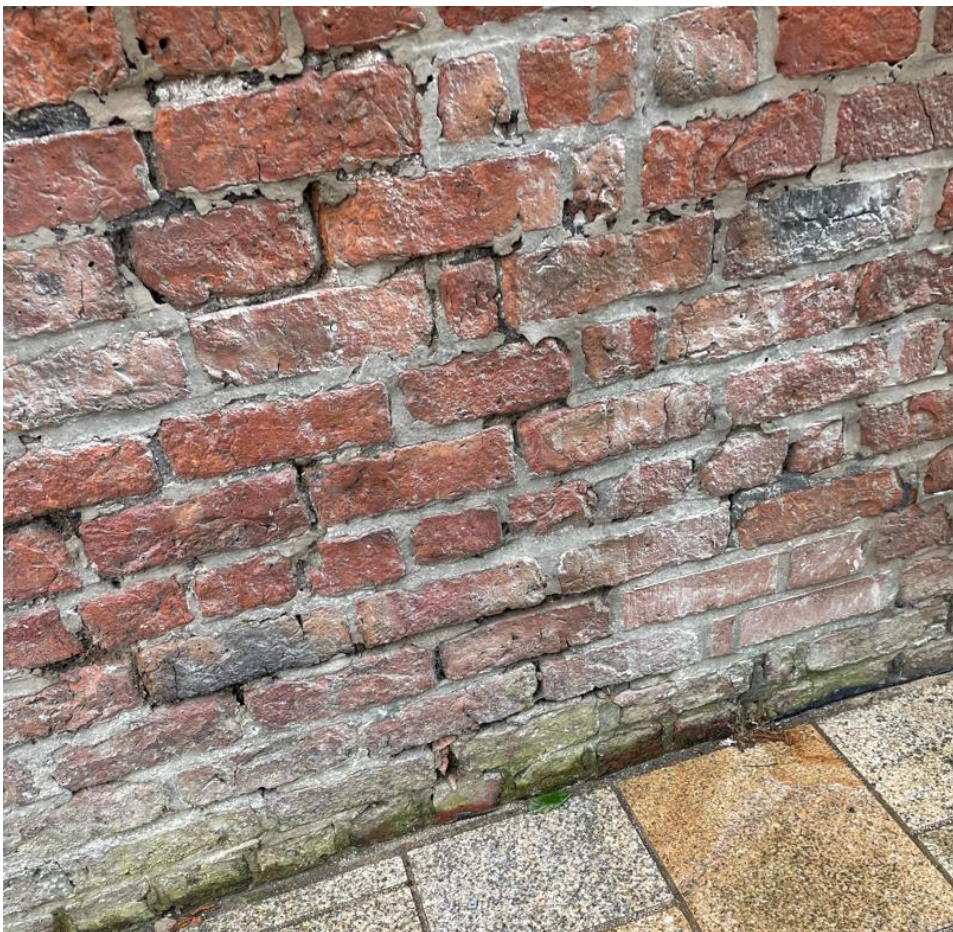
4.18. Brickwork up to a height of approx. 1.0m from road level showed signs of water damage, with prevalent water staining, brickwork efflorescence, degraded brickwork, and degraded mortar joints. See Photos B1 & B2.

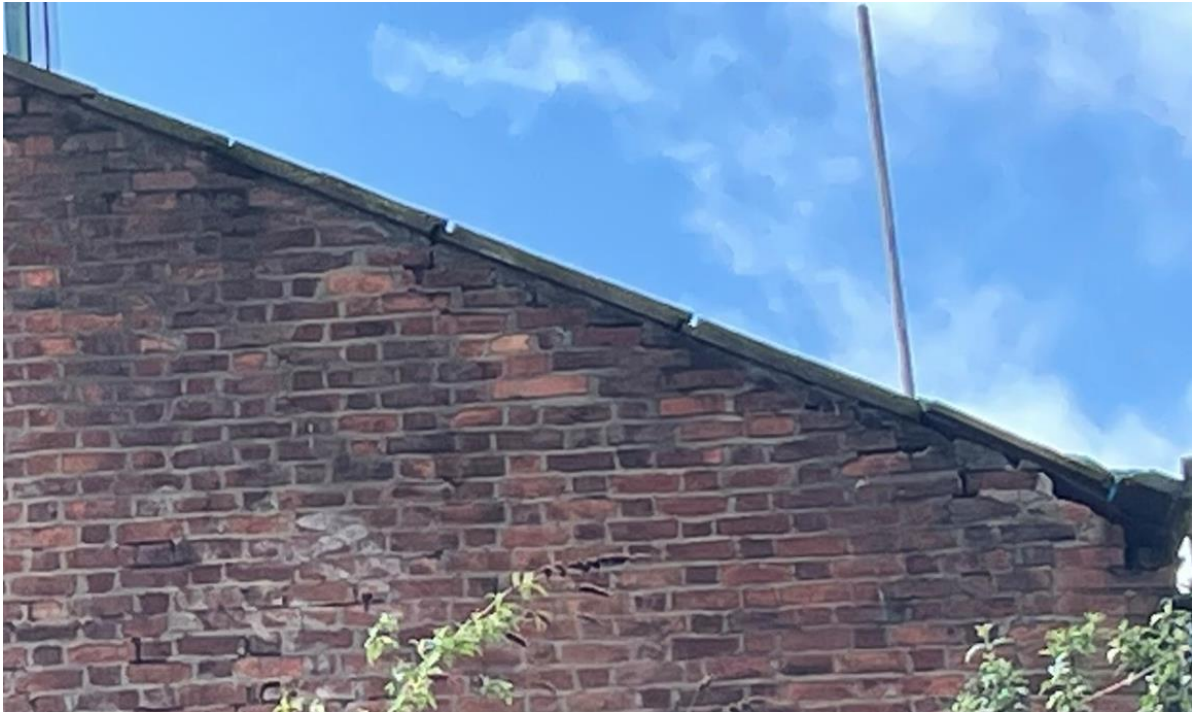
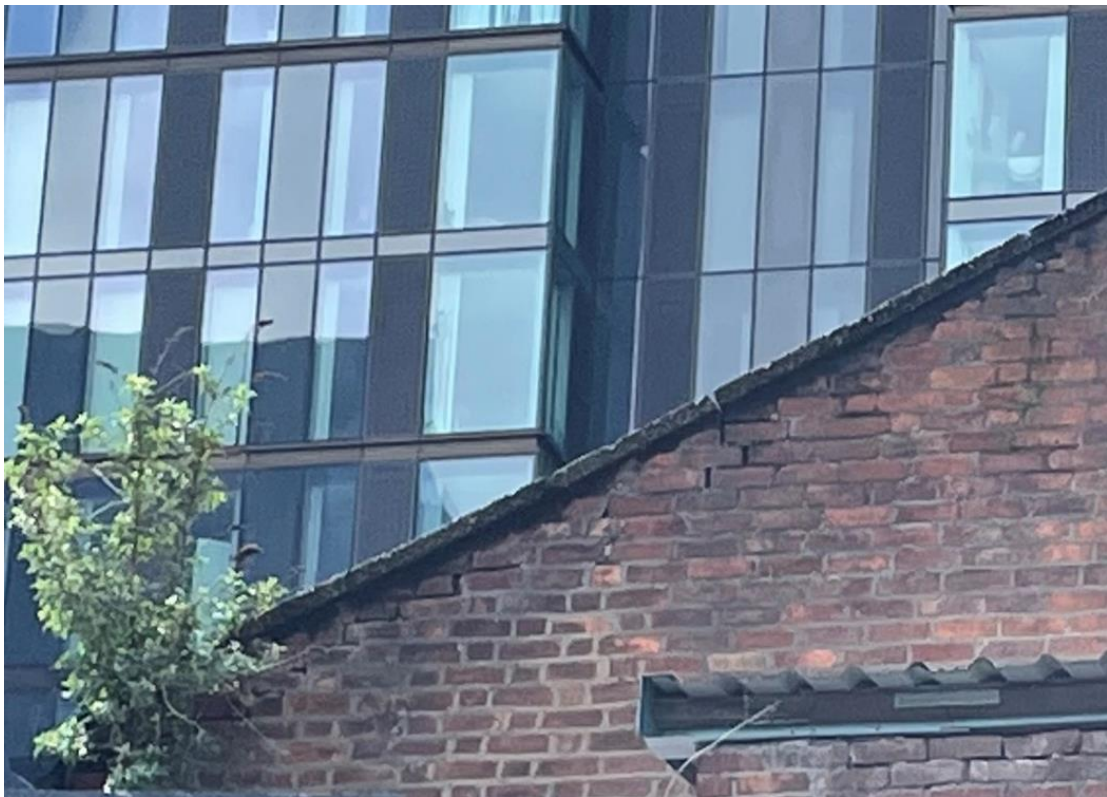
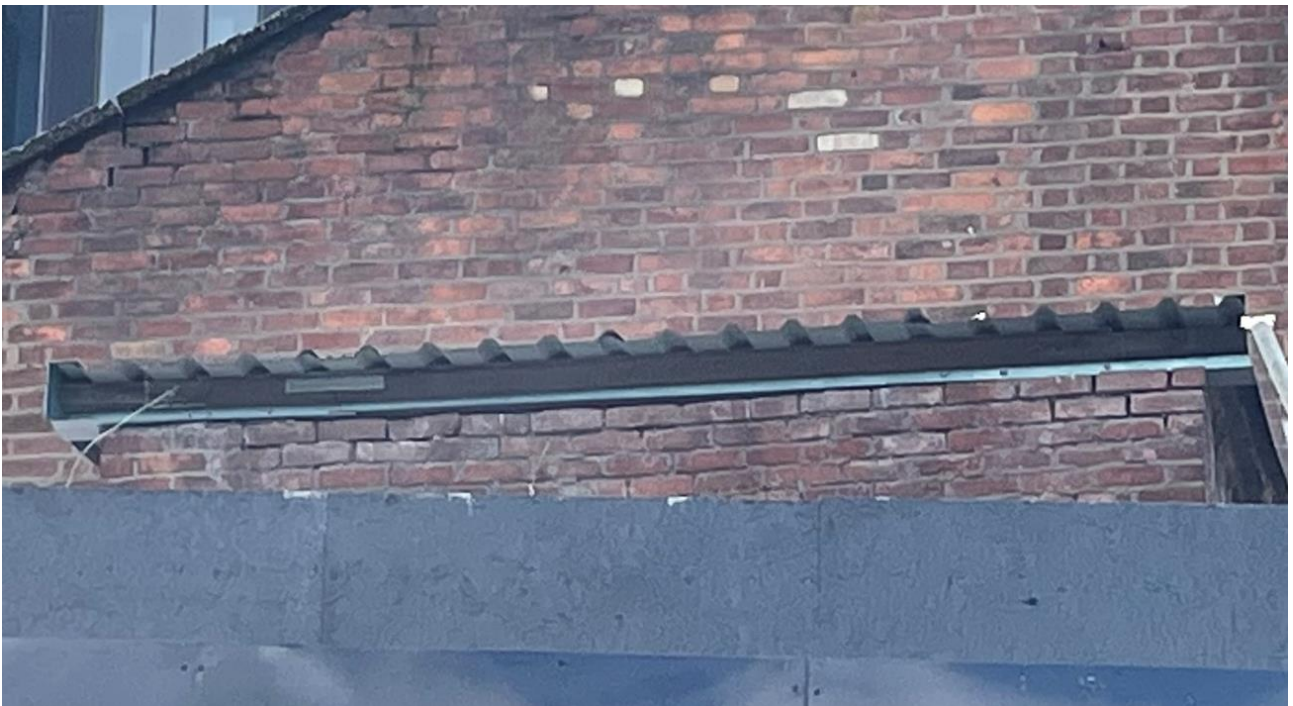
4.21. Some of the brickwork at verge level had perished and mortar joints were degraded. Vegetation was growing from the eaves. See Photos C1, C2 & C3.

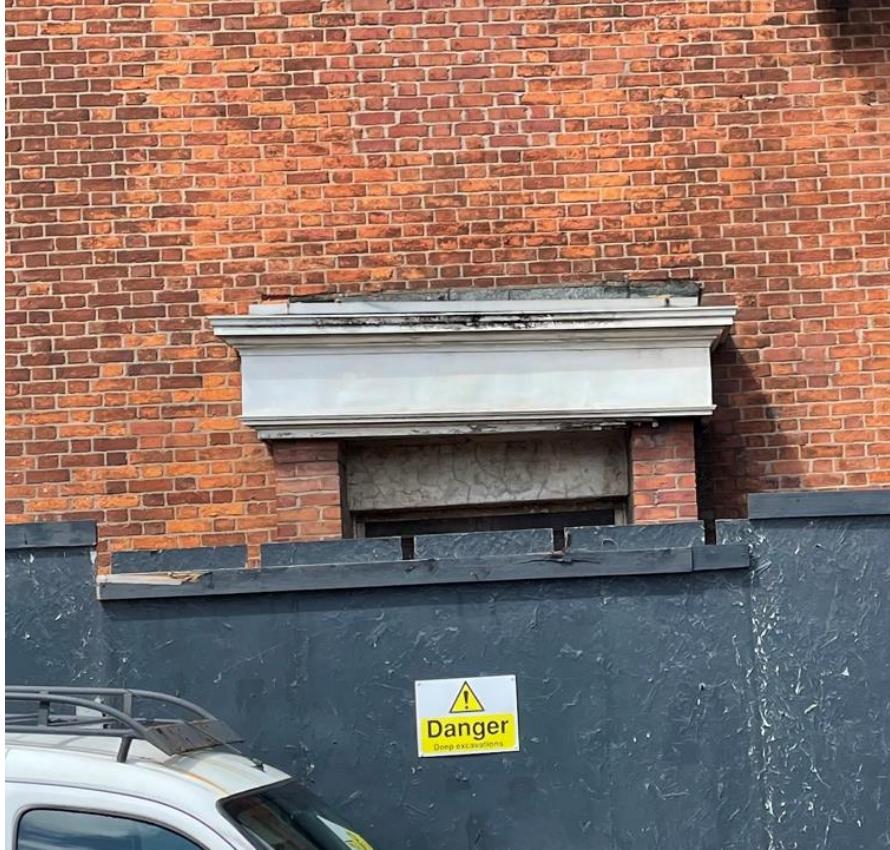
*Photo D1*

4.23. The roof of the side entrance porch was not level, it was noticeably sloping. See Photo D1.

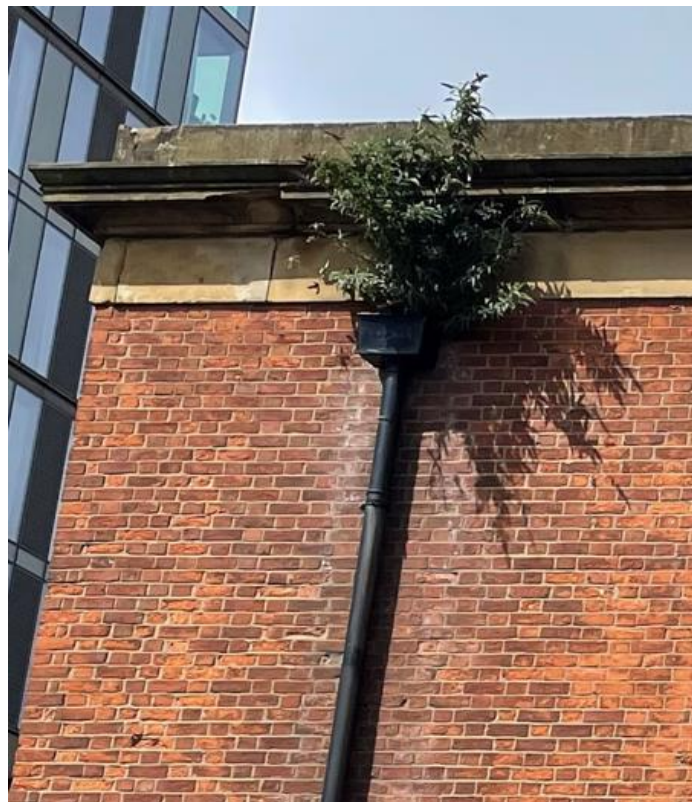
*Photo D2*

4.24. Well established vegetation was growing from a downpipe. See Photo D2.

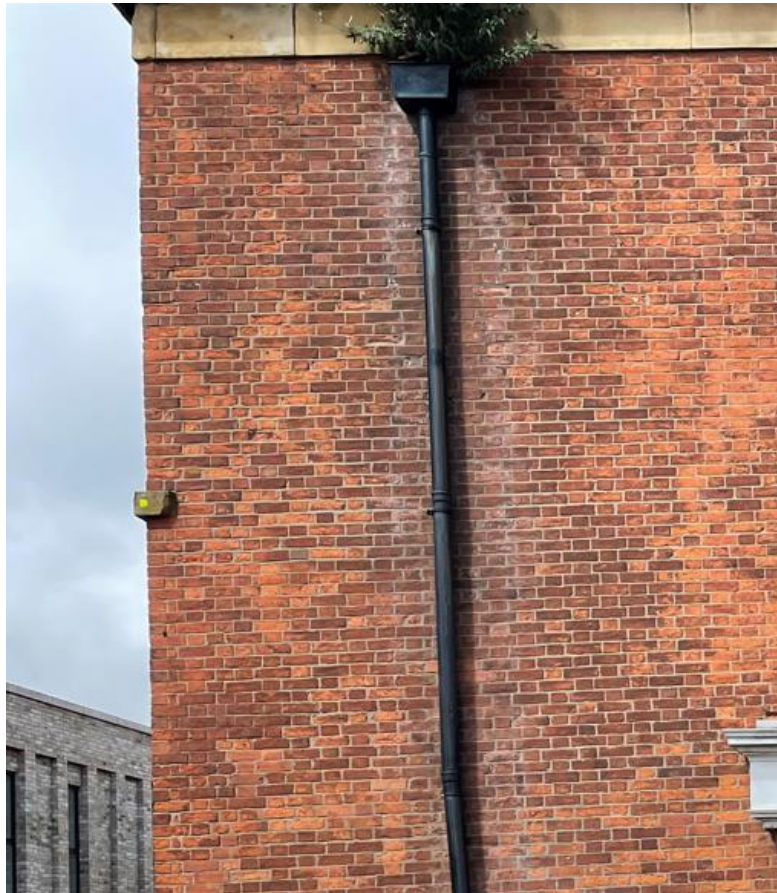
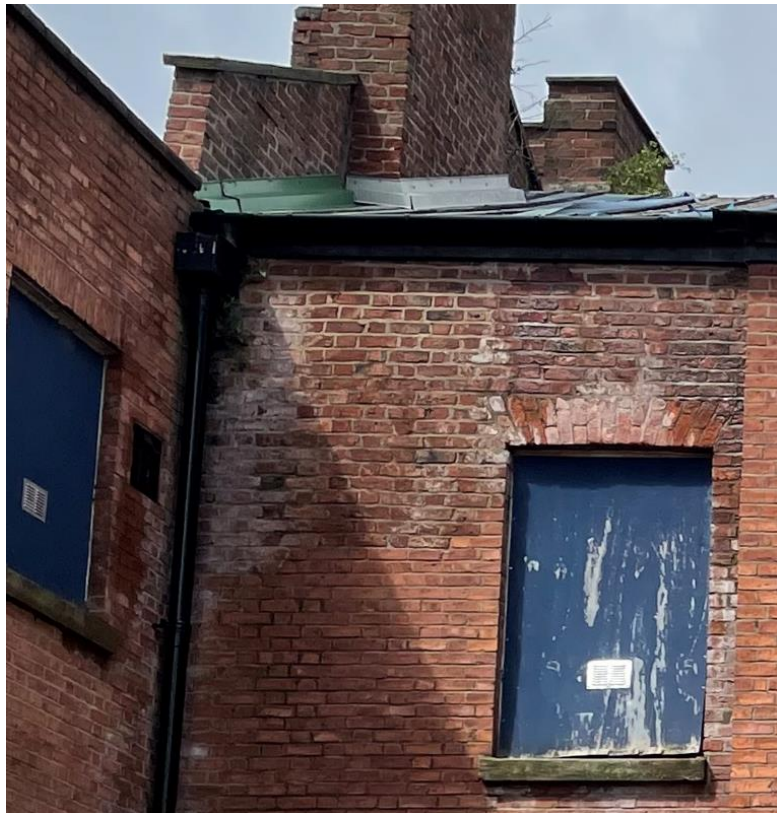
4.25. It was evident from water staining that most of the rainwater goods (gutters and downpipes) were dysfunctional. See Photo D3 & D7

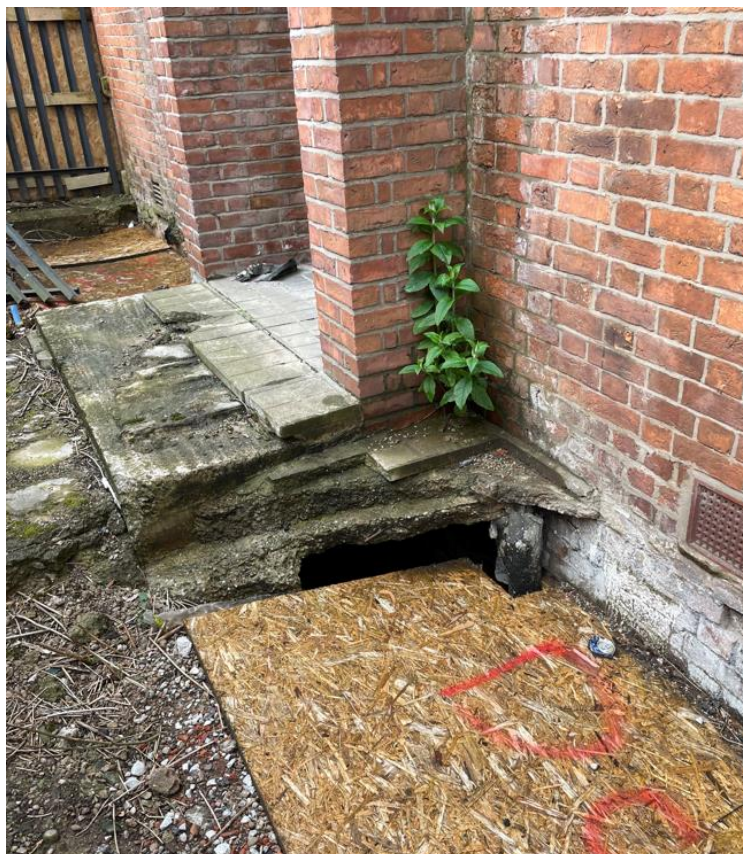
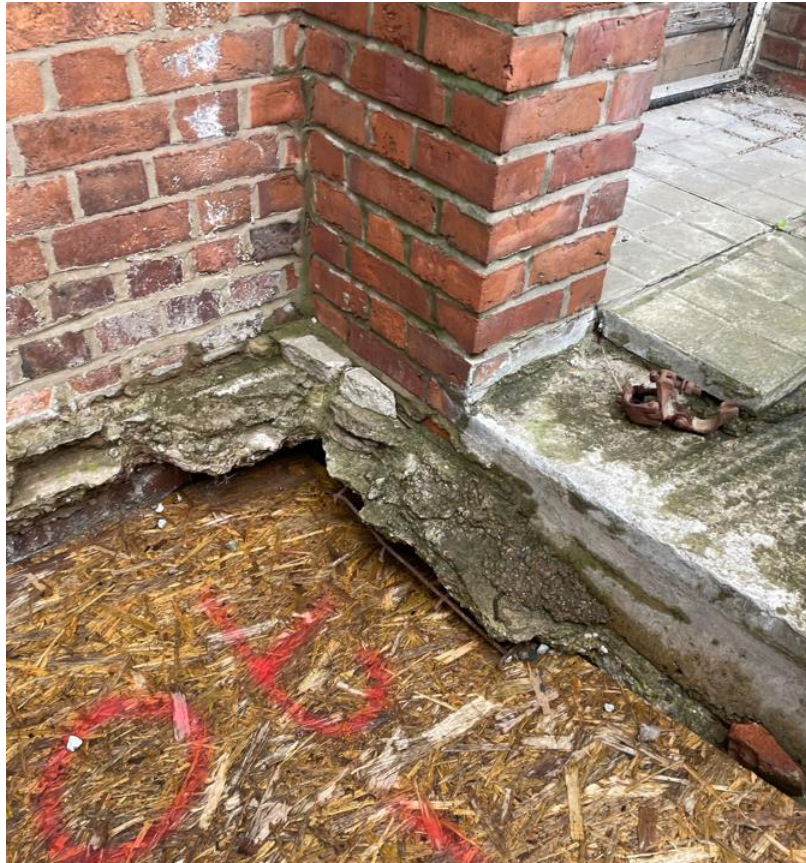
4.26. The suspended entrance slab/step for the side porch was in poor condition. The concrete had spalled, and reinforcement was exposed and corroding. See Photos D5 & D6.

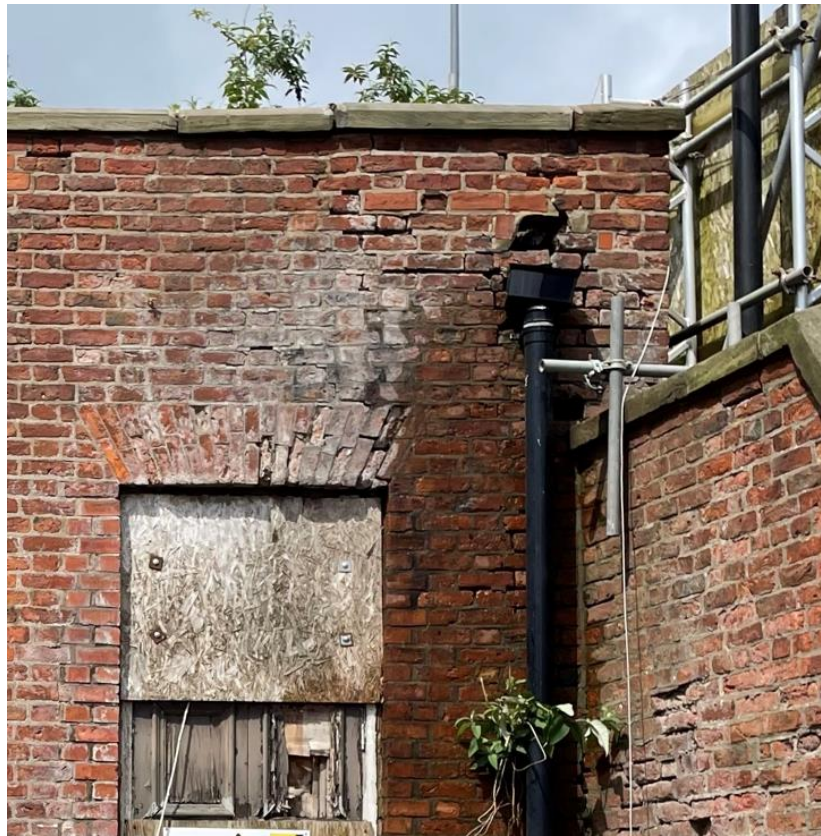
*Photo D8*

4.27. On the single storey building, some brickwork was missing adjacent to a dysfunctional rainwater pipe. There were significant vertical stepped cracks and cracks in a soldier course brick lintel. See Photo D8.

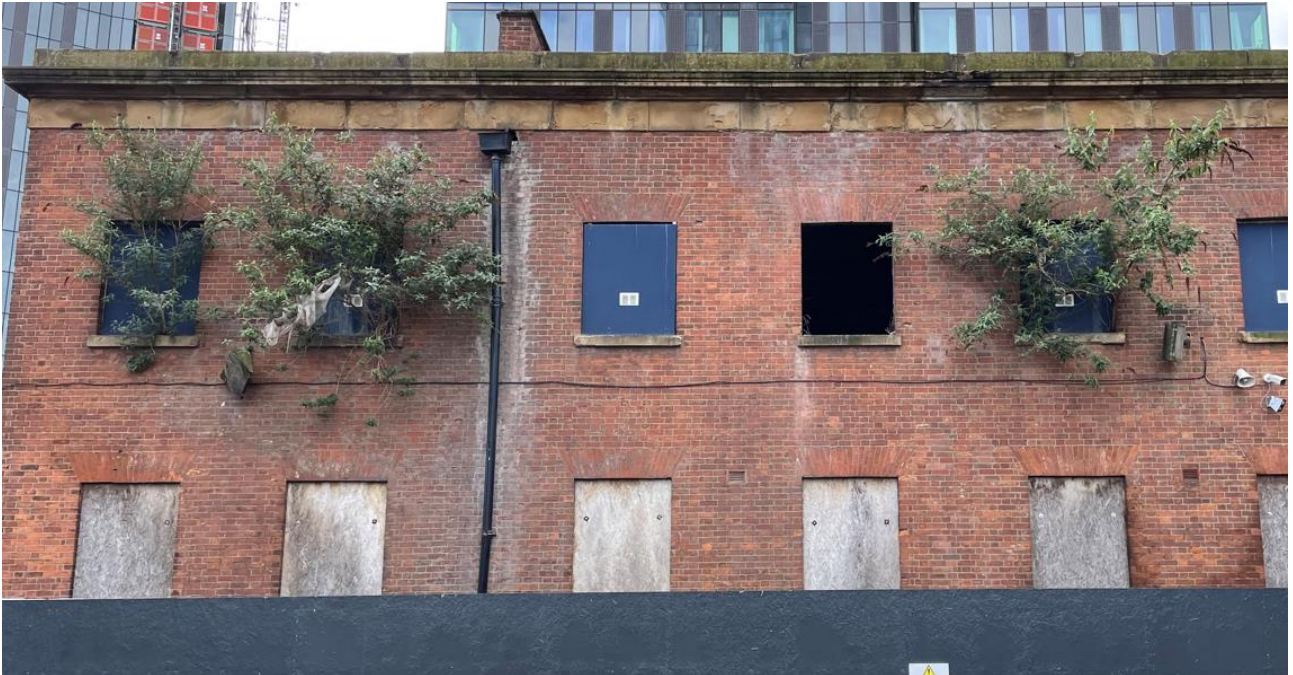
*Photo E1*

4.30. Well established vegetation was growing from the windows. See Photo E1.

4.35. It was evident from water staining that most of the rainwater goods (gutters and downpipes) were dysfunctional. See Photo E1.

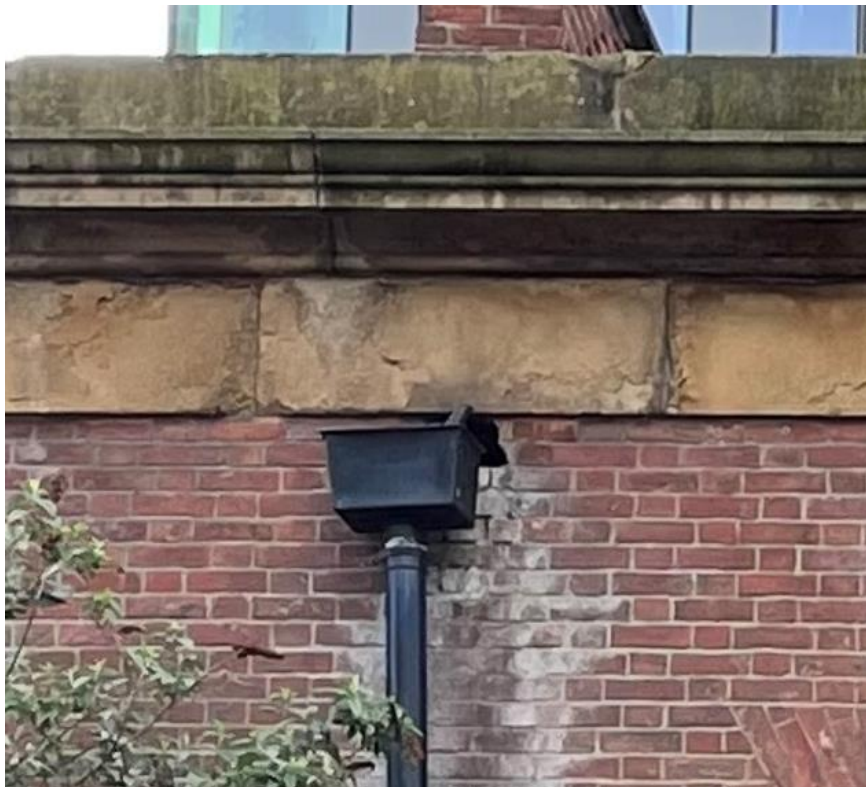
*Photo E2*

4.31. Brickwork was missing near to eaves level adjacent to a rainwater pipe. See Photo E2.

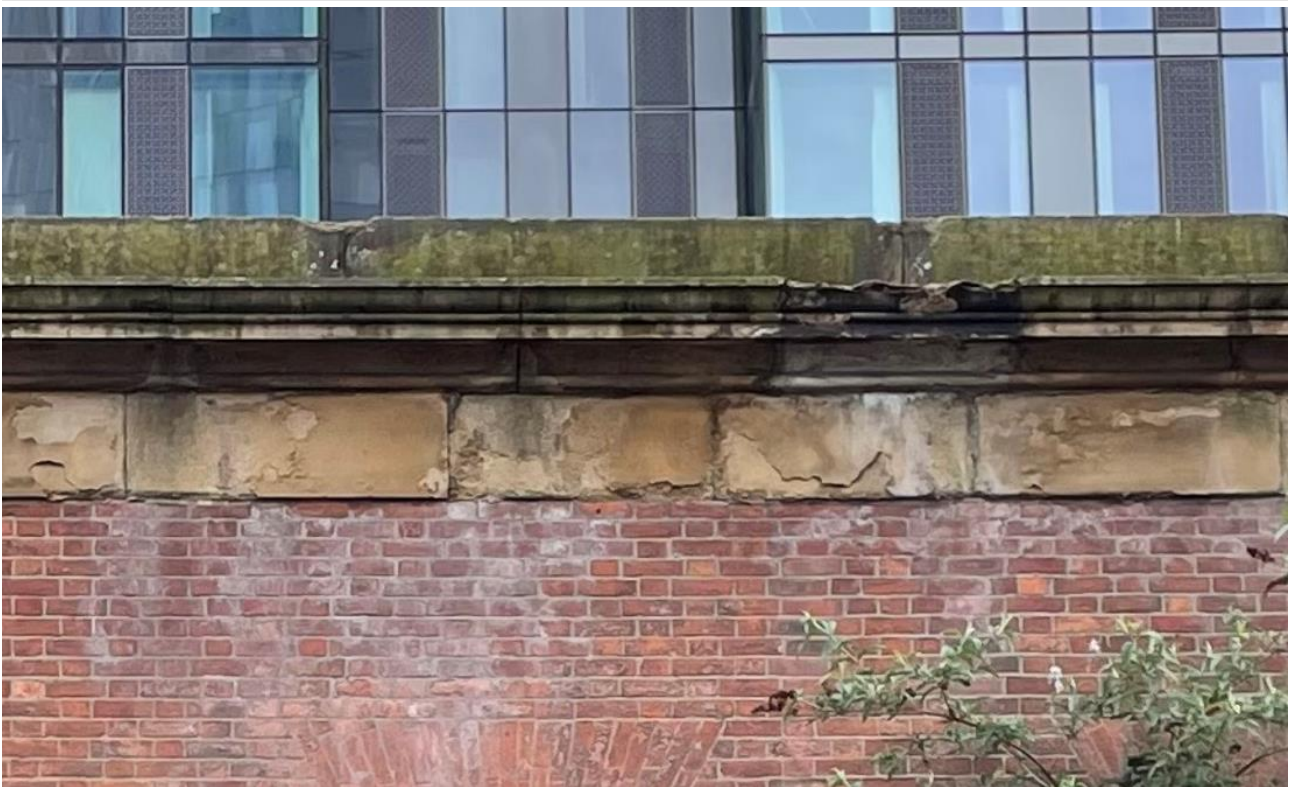
*Photo E3*

4.32. The architectural stone banding detail at eaves level was generally weathered and was spalling/perishing. See Photo E3.

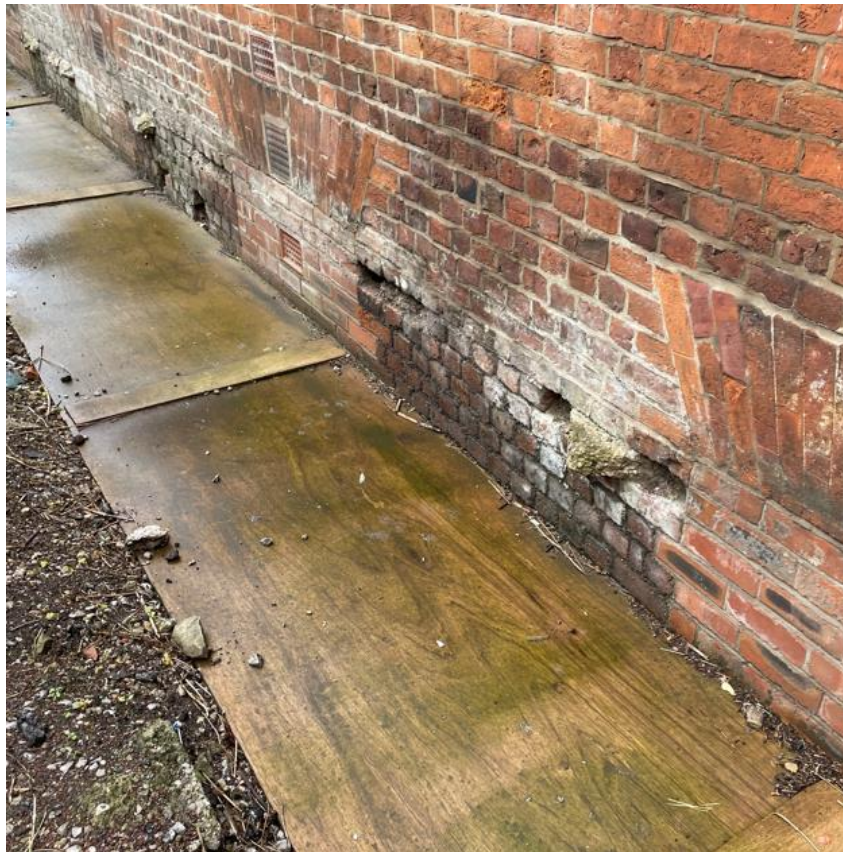
*Photo E4*

4.33. Brickwork up to a height of approx. 1.0m from ground level showed signs of water damage, with prevalent water staining, brickwork efflorescence, degraded brickwork, missing brickwork, and degraded mortar joints. See Photo E4.

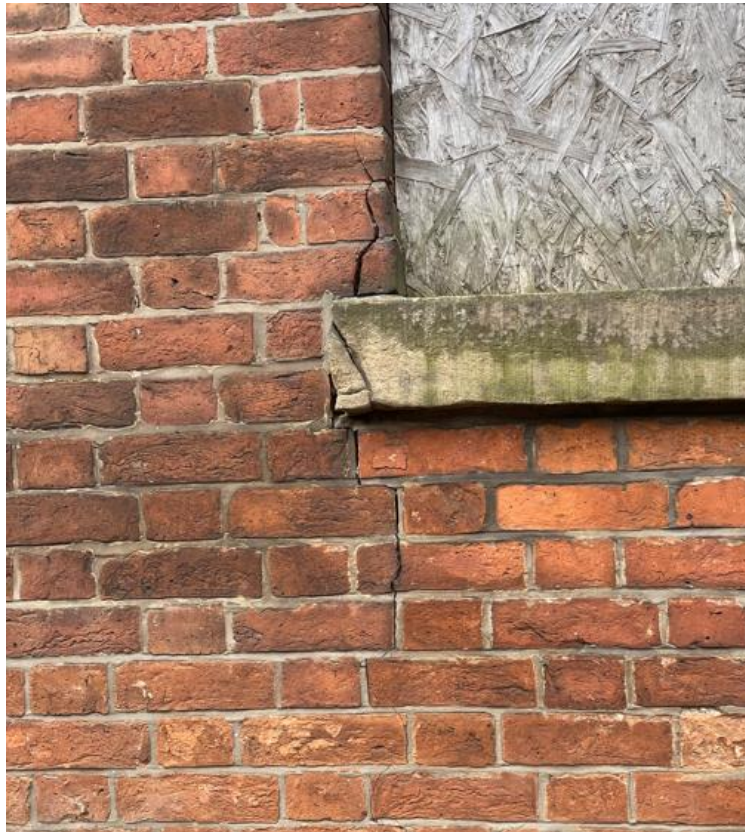
*Photo E5*

4.34. There was a vertical crack through brickwork and stone windowsill. See Photo E5.

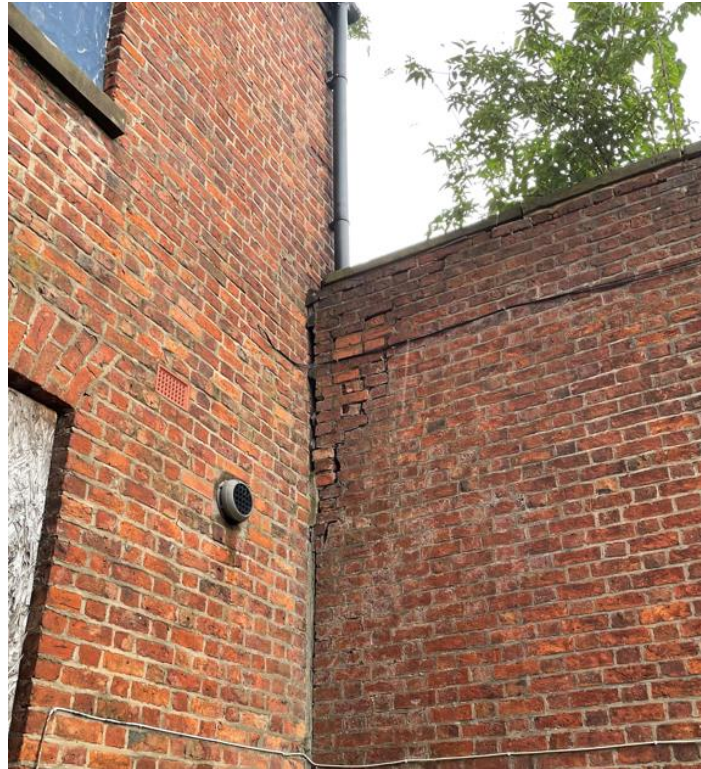
*Photo F1*

4.37. At the interface between the single storey building and main building, the brickwork was debonding and there was significant cracking and evidence of movement. See Photo F1.

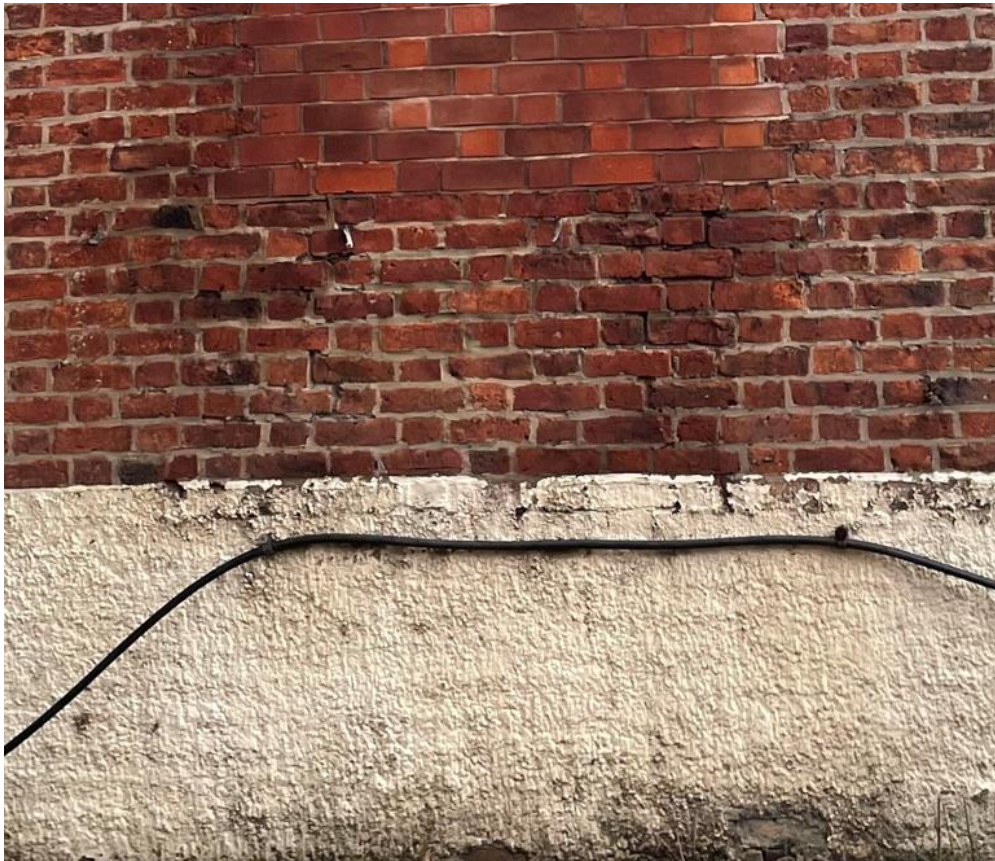
*Photo F2*

4.38. Some mortar joints on the elevation had perished. See Photo F2.
