**HBL ASSOCIATES LTD**  
**VISUAL STRUCTURAL INSPECTION REPORT**

**BRIDGEWATER HOUSE**  
**CHESTER ROAD**  
**MANCHESTER**  
**M15 4AX**

**WATCH THIS SPACE (Jembrana) Ltd.**

**HBL Ref: 9757**

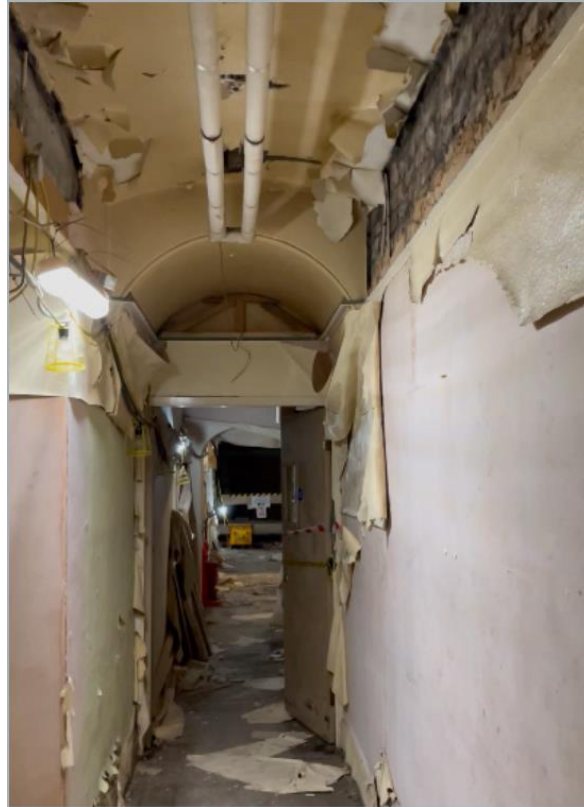
Photo 1A

- 4.46. Decorative finishes throughout Building 1 were badly deteriorated, wallpaper and paintwork were peeling from the walls and floors were strewn with debris. See Photo 1A.

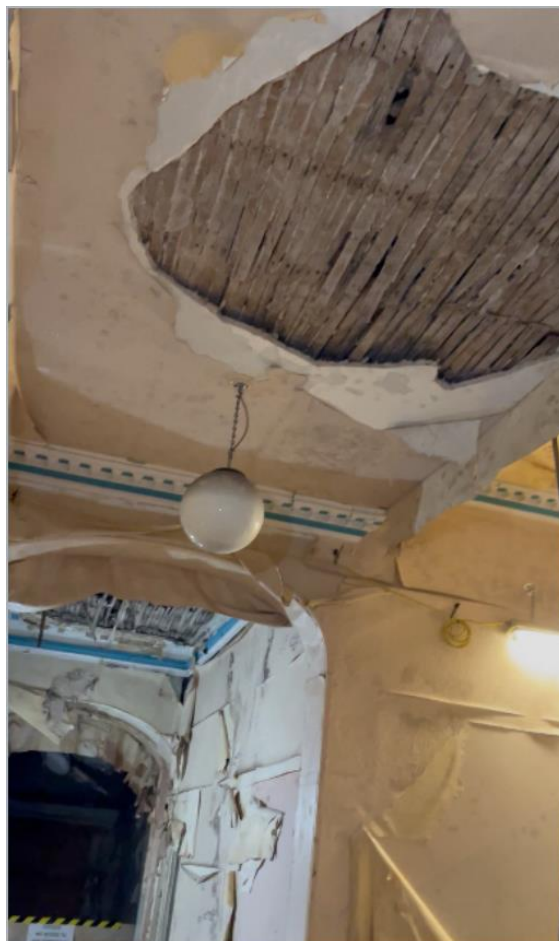
Photo 1B

- 4.47. Plastered ceilings in numerous locations had 'blown'. See Photo 1B.
- 4.48. The lath & plaster ceiling had partially collapsed in Room 0.23. See Photo 1C.

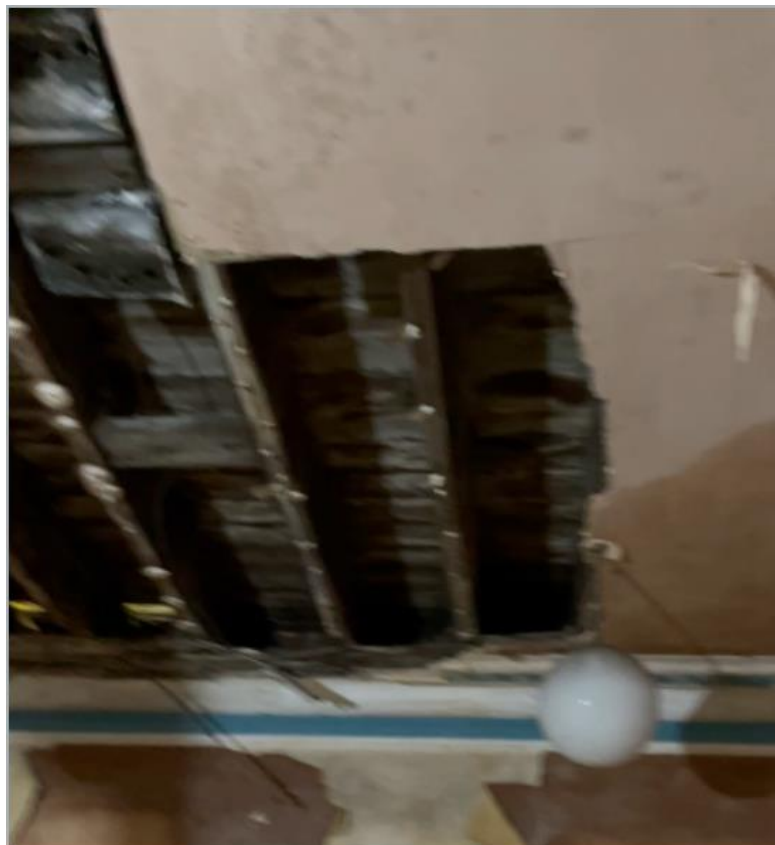
Photo 1D

- 4.49. The ceiling in Room 0.26 had been removed, it had most likely previously collapsed.
- 4.50. The plasterboard ceiling had partially collapsed in Room 0.03, and areas of the remaining ceiling appeared to be wet. See Photo 1D.

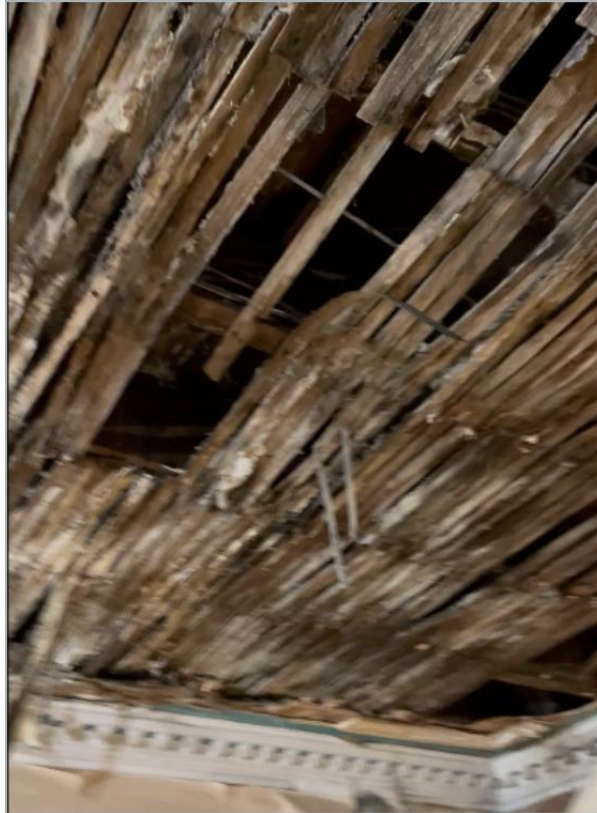
Photo 1E

- 4.52. Access into Room 1.26 was prohibited. Limited observations were made from the entrance doorway.
- 4.53. Much of the ceiling over the main staircase in Room 0.02 & Room 1.01 had collapsed. See Photo 1E.
- 4.54. There was a hole through the timber floor in Room 1.25 which appeared to have been caused by a small fire. See Photo 1F.
- 4.55. Some of the ceiling boards in Room 1.23 had collapsed. See Photo 1G.
- 4.56. The lath & plaster ceiling in Room 1.05 had partially collapsed. See Photo 1H.
- 4.57. The lath & plaster ceiling in Room 1.02 had partially collapsed. See Photo 1J.
- 4.58. Parts of the ceiling in Room 1.21 had collapsed. See Photo 1K.
- 4.59. Much of the ceiling in Room 1.20 had collapsed. See Photo 1L.

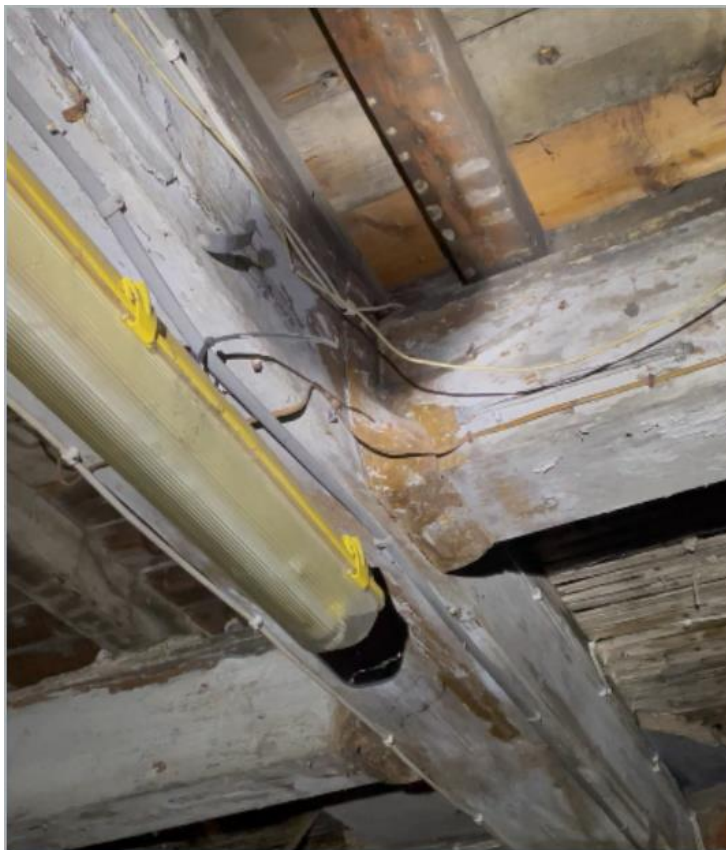
Photo 1Q

- 4.61. The basement was unlit at the time of our visit; therefore, observations were limited due to poor visibility.
- 4.62. The brickwork basement walls appeared to be in reasonable condition but showed some signs of decay and delamination.
- 4.63. The stone floor was generally level, however there were some areas where the floor undulated.
- 4.64. The bottom of what appeared to be a timber support post in Room b.05 was degraded/rotten. See Photo 1M with a loss of section.
- 4.65. Some of the casings of what appeared to be timber floor support beams were damaged/degraded. See Photo 1N taken in Room b.05, and there were signs of possible wet and dry rot on most timber elements.
- 4.66. Parts of the ceiling boards had collapsed in Room b.24. See Photo 1P.
- 4.67. Metal hangers connecting the floor support beams were in an advanced state of corrosion in Room b.26. See Photo 1Q.

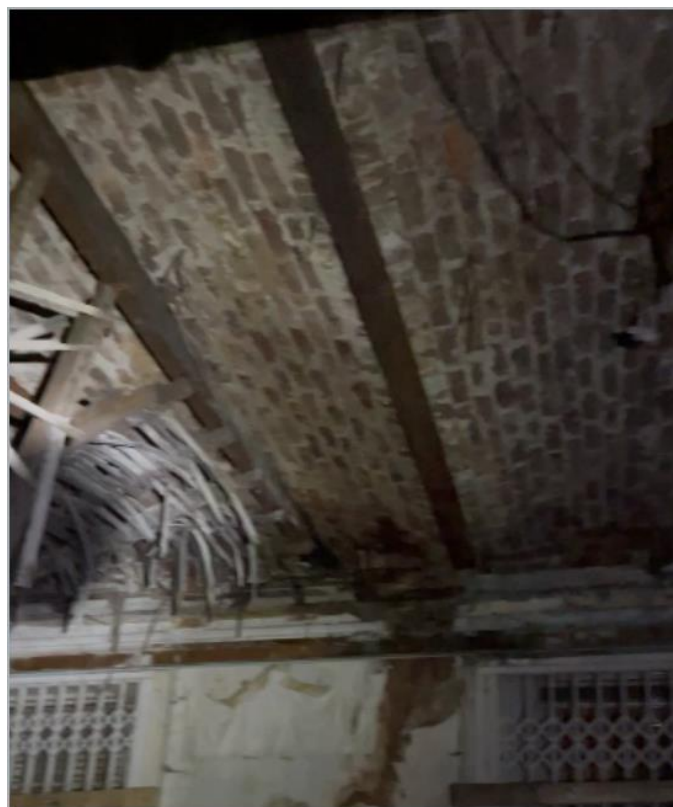
- 4.71. Access into all rooms was prohibited due to the collapse of the ceilings. Limited observations were made from the main corridor doorways. No observations could be made in Rooms 0.11, 0.12 & 0.13.
- 4.72. There was standing water on the floor for the length of the main corridor. See Photo 2A.
- 4.73. The floor joists over Room 0.17 had collapsed. See Photo 2B.
- 4.74. The steel filler joists supporting the barrel-vaulted masonry first-floor appeared to be in an advanced state of corrosion over Room 0.16. See Photo 2C
- 4.75. The ceiling had collapsed throughout Room 0.09. See Photo 2D.
- 4.76. The steel filler joists supporting the barrel-vaulted masonry first-floor appeared to be in an advanced state of corrosion over Room 0.15. See Photo 2E

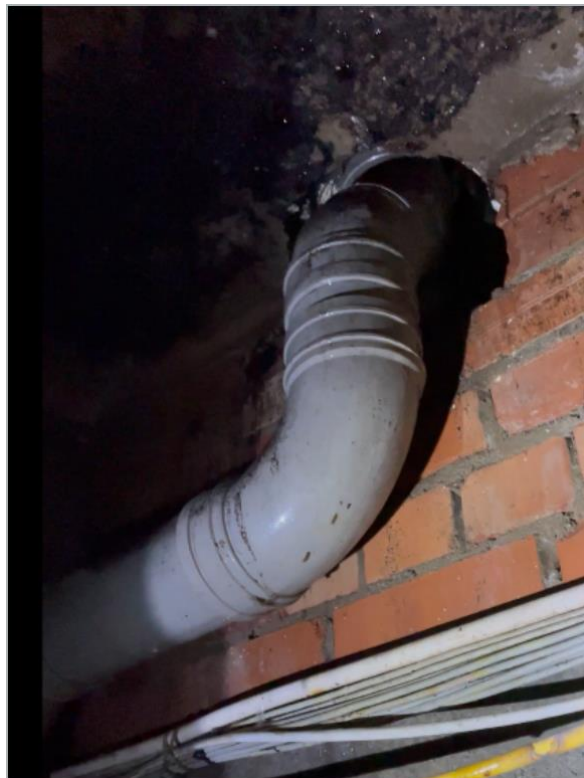
Photo 2G

- 4.78. The basement was unlit at the time of our visit; therefore, observations were limited due to poor visibility.
- 4.79. The Basement walls appeared to be in reasonable condition and the stone floor was generally level, however there were some areas where the floor undulated.
- 4.80. Generally, the steel filler joists supporting the barrel-vaulted masonry ground floor were corroding. Room 0.15. See Photo 2F.
- 4.81. There was water running down the walls and around a drainage pipe in corridor b.07. See Photo 2G.

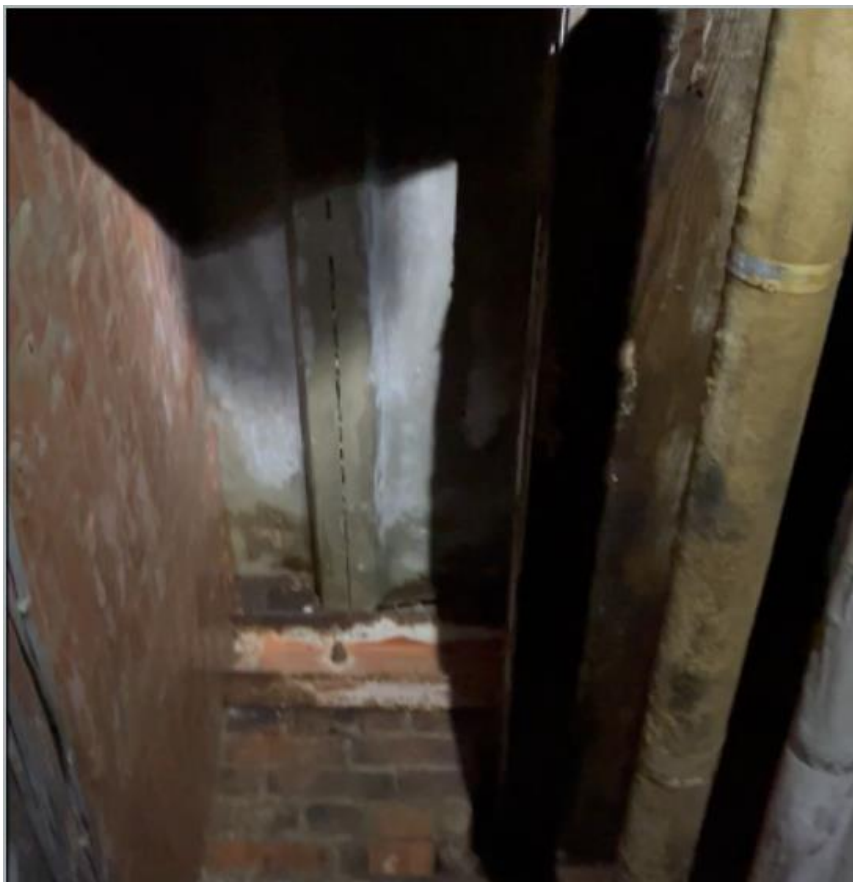
Photo 3B

4.90. A steel channel in the corridor (bolted to the brickwork wall) supporting the pre-cast first-floor was corroding. The bolts into the masonry were also corroding. See Photo 3B.

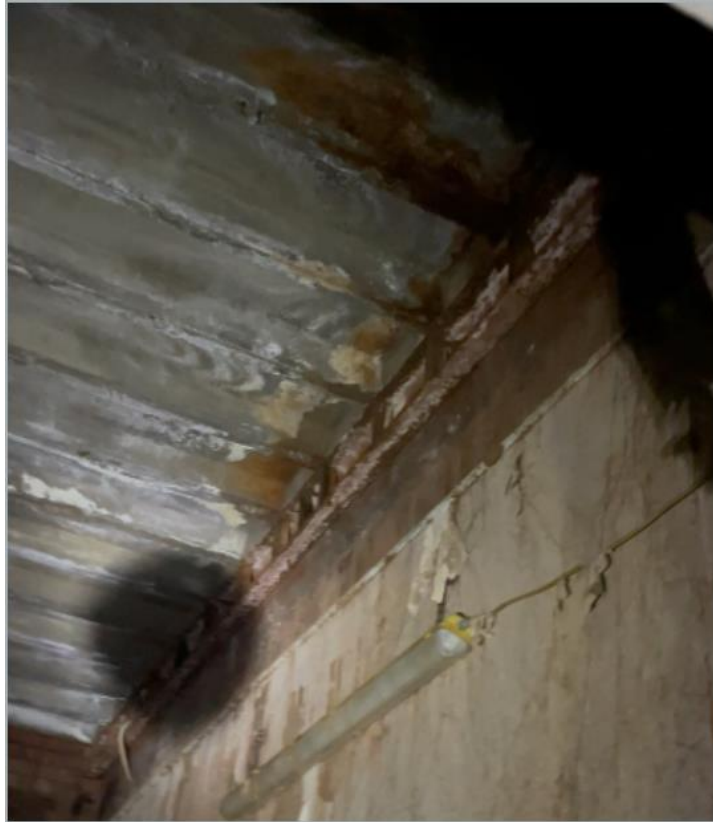
Photo 3C

4.91. A steel channel in room 0.08 and corridor (bolted to the brickwork wall) supporting the pre-cast first floor was corroding. The bolts into the masonry were also corroding. See Photo 3C.

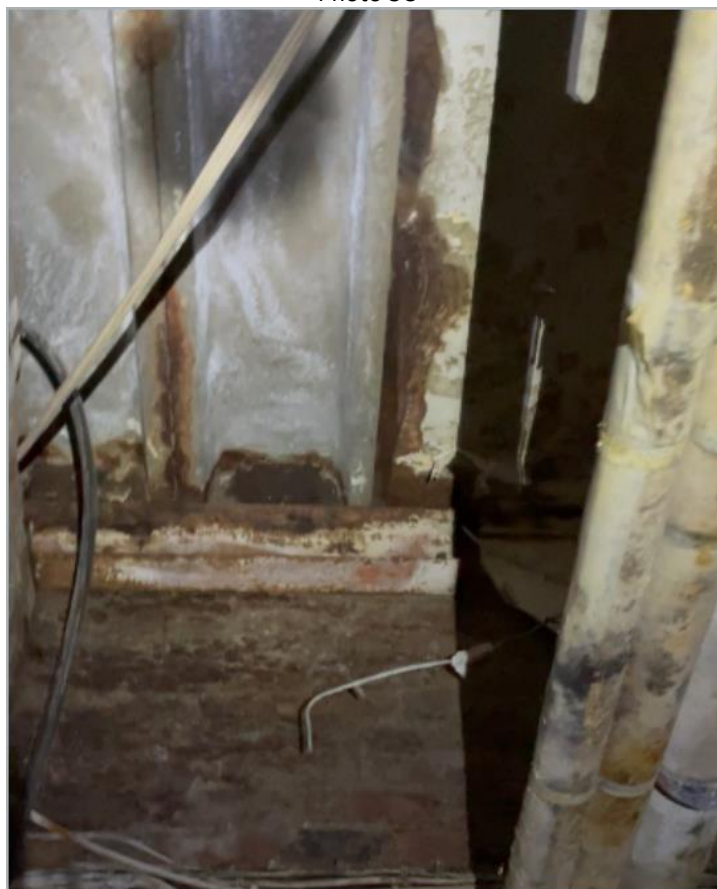
Photo 3D

4.92. There was rust staining on the precast floor over Room 0.08 & adjacent corridor. See Photo 3D.

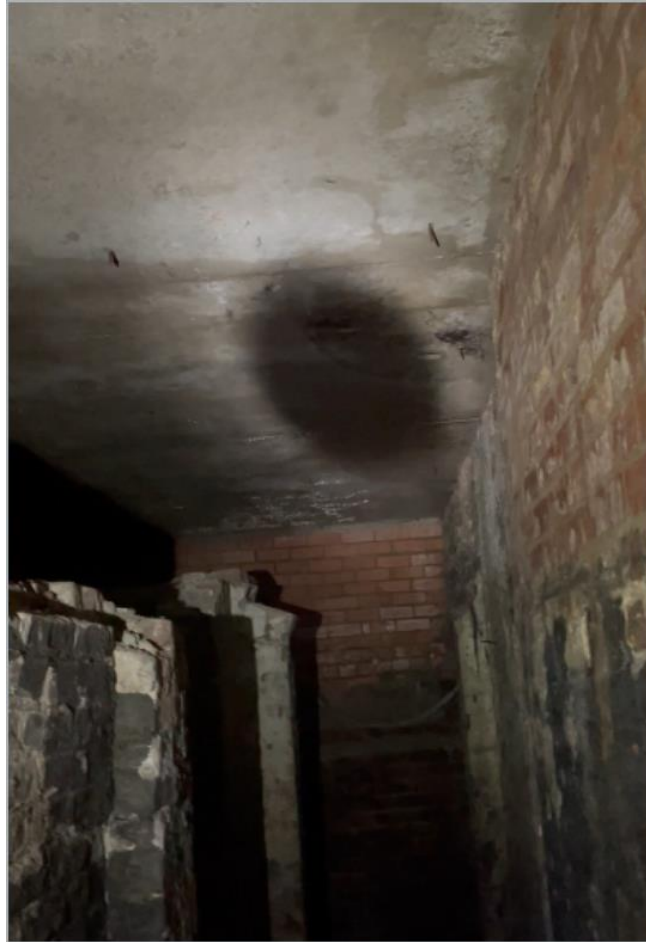
Photo 3E

4.95. There was significant water staining on the soffit of the concrete ground floor over Room b.07. See Photo 3E.
