# Drainage Report

Site  
**Tyson Site**  
**Barlow Moor Rd**  
**Chorlton**  
**Manchester**  
**M21 8ER**

**Tyson Stie Barlow Moor Road - CCTV Survey Report : 04/08/22**

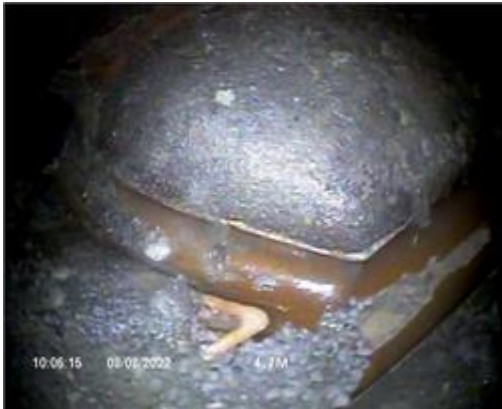
| Pos | Video Ref | Code | Description | Image |
|---|---|---|---|---|
| 04.70m | | MHF | Finish node type, manhole<br>ExMH2 - Buried | <div>Image Provided - Ref: 7_9999</div> |
