## THE OLD STATIONMASTER'S HOUSE LIVERPOOL ROAD RAILWAYS STATION, MANCHESTER

### GRADE I CONDITION INSPECTION REPORT

For the Landmark Trust  
Date of primary Inspection 21<sup>st</sup> Oct 2021  
Weather: Dry and warm. Heavy rain the previous day  
Inspection status: First by this Architect

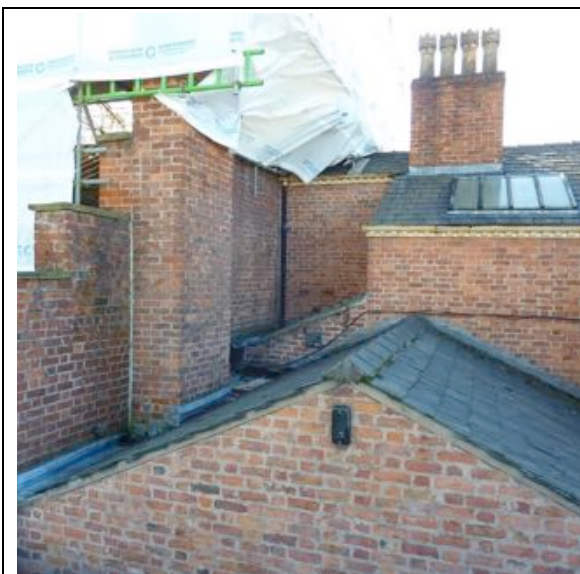
General view of the roofs from the north. The chimney stacks seem in reasonable condition. Some face loss of bricks on the north side on the upper roof.

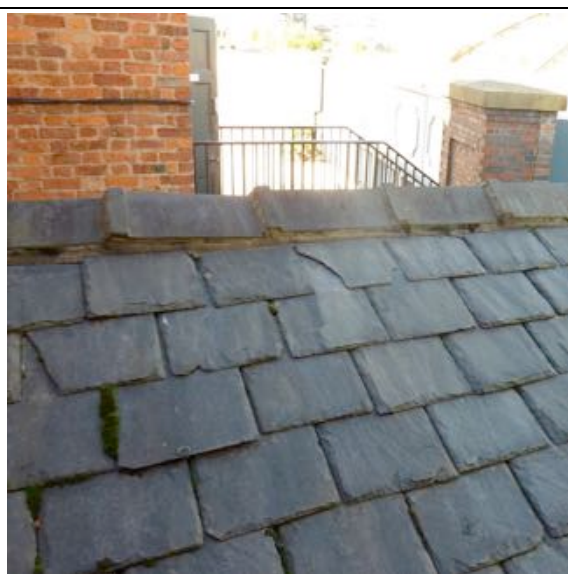
Slates to the East pitch with numerous cracks and chips. These are relatively small and thick slates for welsh.

| Cond'n | Action | Item | Cost |
|---|---|---|---|
| <b>F</b> | <b>2</b> | Reset slipped or cracked slates, replace thin slates used in patching with ones that match the originals. This comment would apply to all of the roof areas. | <b>(M)</b> |

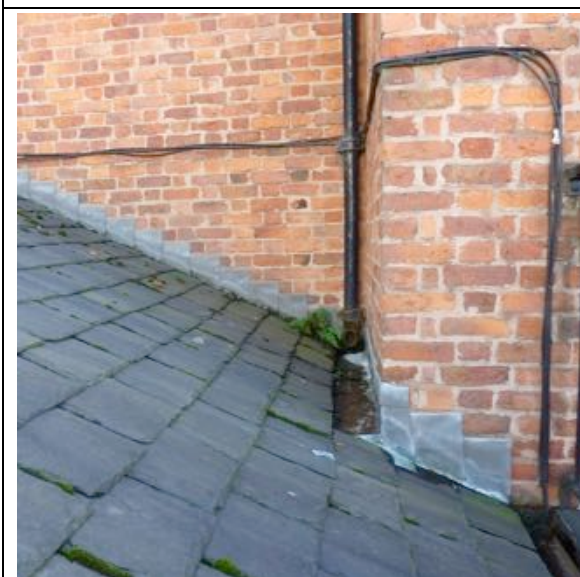
General view of the West pitch showing build up of plant debris in back gutter.

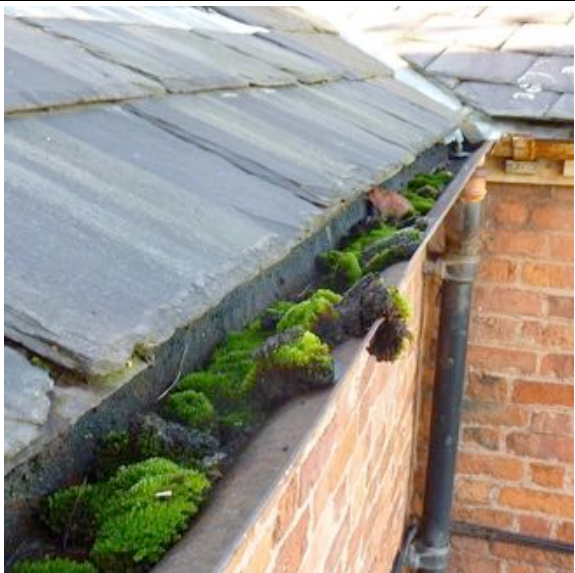
| Gutter full of debris | Evidence of log term overtopping or leaks to the gutter inner corner. |

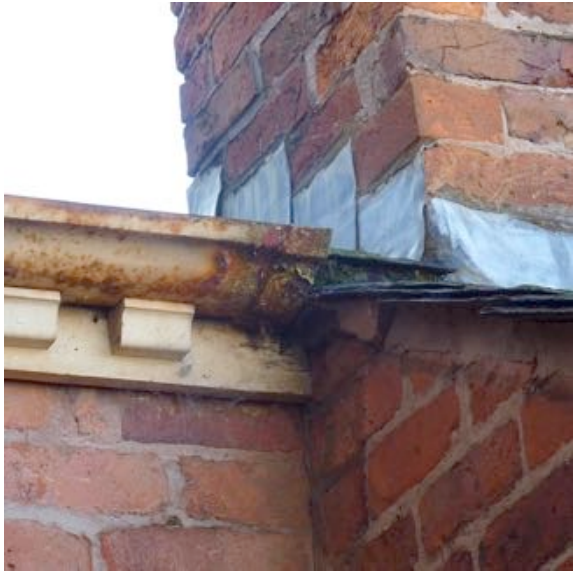
| Slop end of gutter above the toilet roof leaking | Long term leak from one of the gutter joints has rotted out the dentil on the fascia |

| Cond'n | Action | Item | Cost |
|---|---|---|---|
| <b>F</b> | <b>3</b> | Refurbish and paint the cast iron eaves gutter and fascia, seal the joints and replace any damaged timber corbel blocks. This comment would apply to all of the roof areas. | <b>(M)</b> |

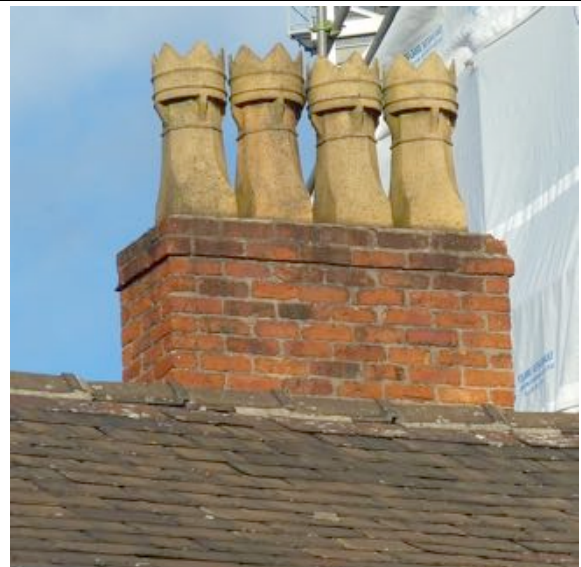
| <p>Crowning of the ridge line over the internal cross wall</p> | <p>Mortar loss to the ridge tiles. The chimney stacks seem in reasonable condition. Some face loss of bricks on the north side.</p> |

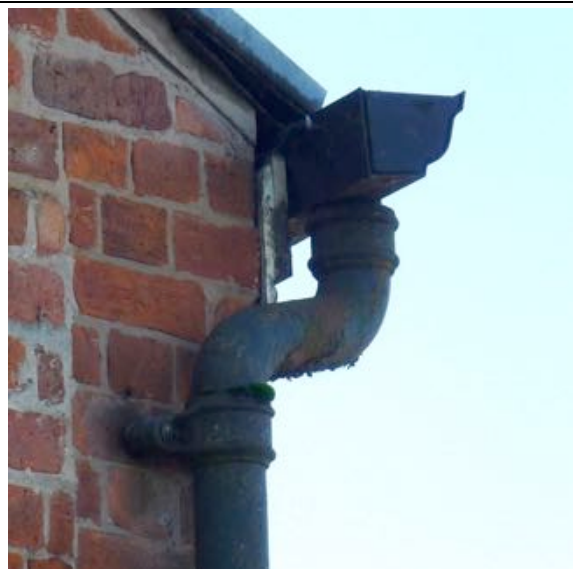
View of the downpipe which has to take all of the water from the south and west roof pitches. The rust would suggest this is often blocked and overflowing.

Ideally we would recommend that this gutter has a new pipe added towards the east end to share the load out but we think it is unlikely that negotiations to get a viable drain to suit this could be negotiated with the council. Adding a larger capacity gutter and downpipe is probably the most practical solution.

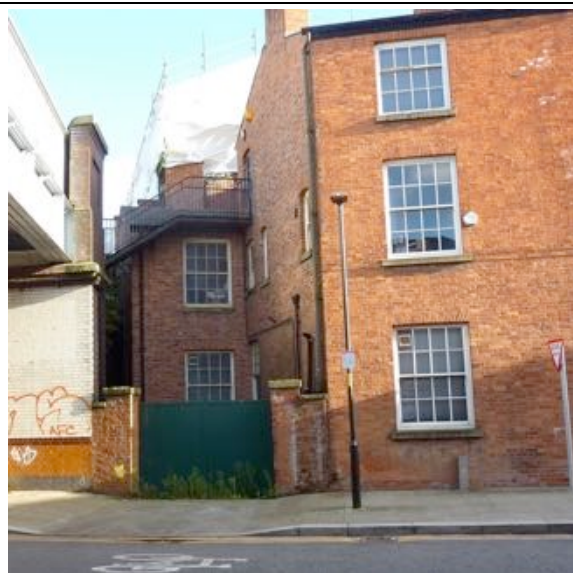
The damp staining to the boundary wall at low level may be where the over-topping rainwater pipe drops its water.

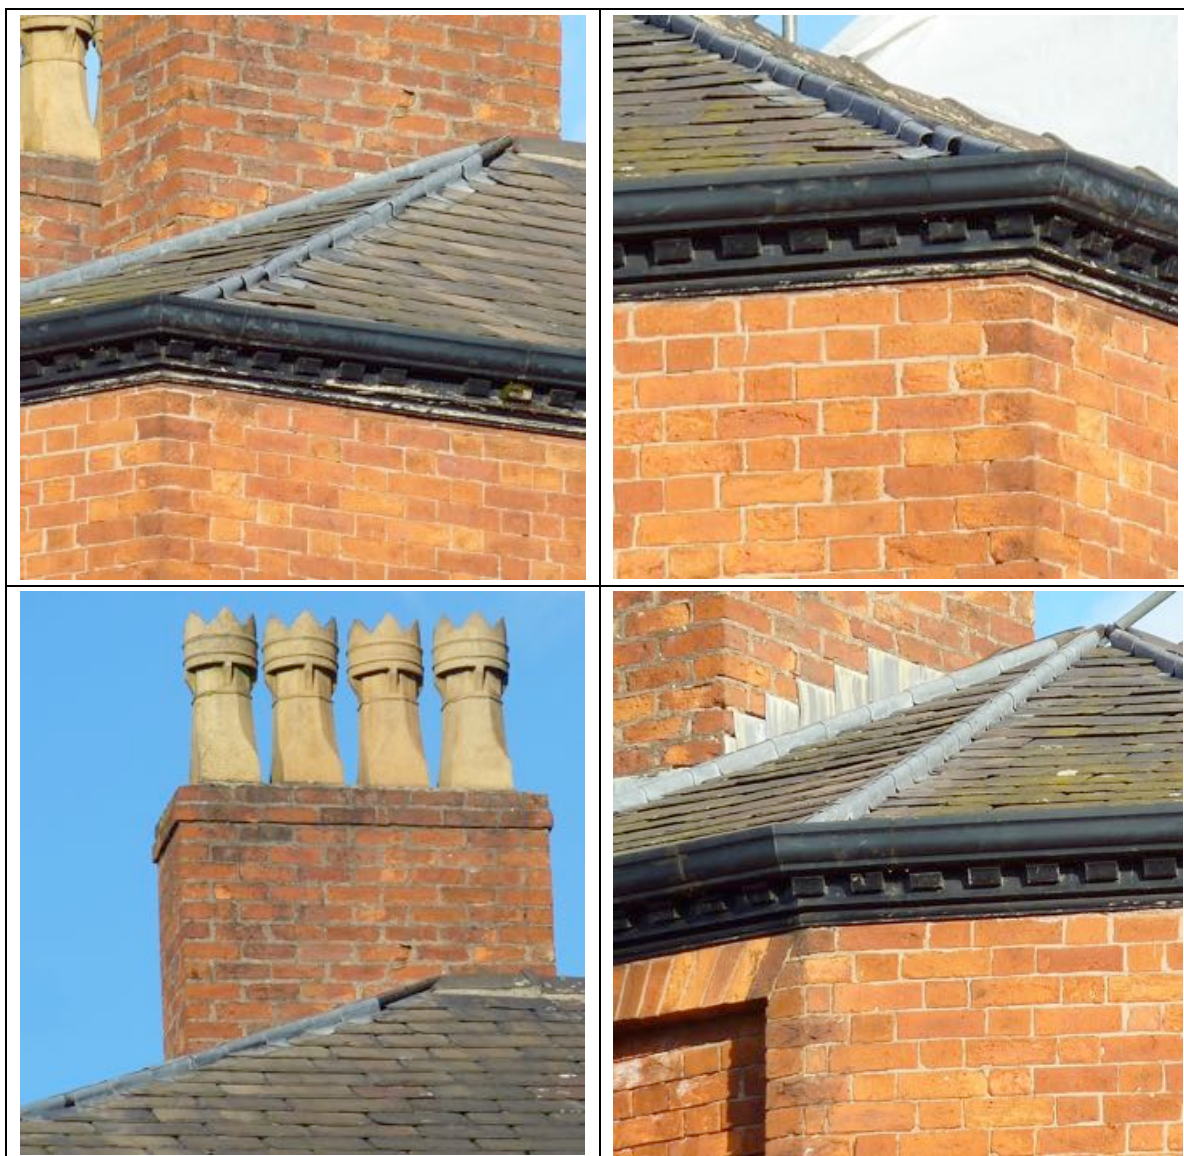
Photos showing the poor detailing and condition of the lead covered rolls at the faceted section of roof. It is quite an unusual detail and clearly not one that has proven effective.

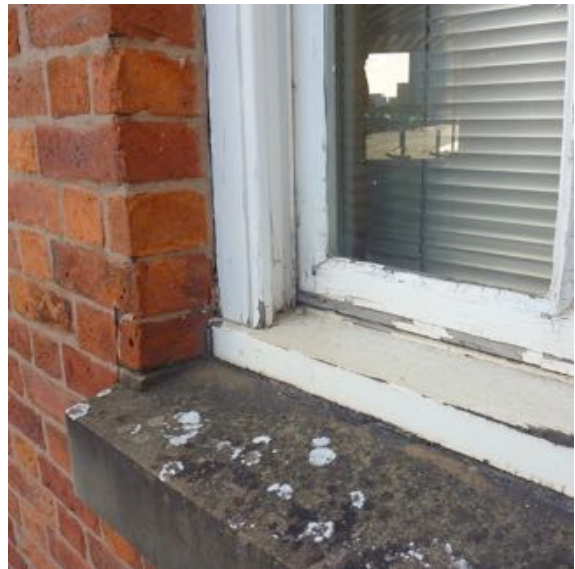
Typical condition of the ground floor windows. The rot damage is mainly limited to the softwood fascia board of the sash boxes. The cills are oak.

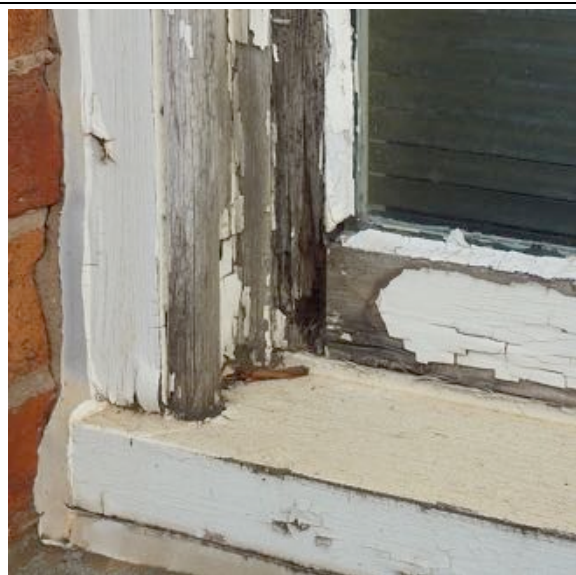
Rot in the frame and sash to the ground floor window in the facet area is more advanced than other areas.

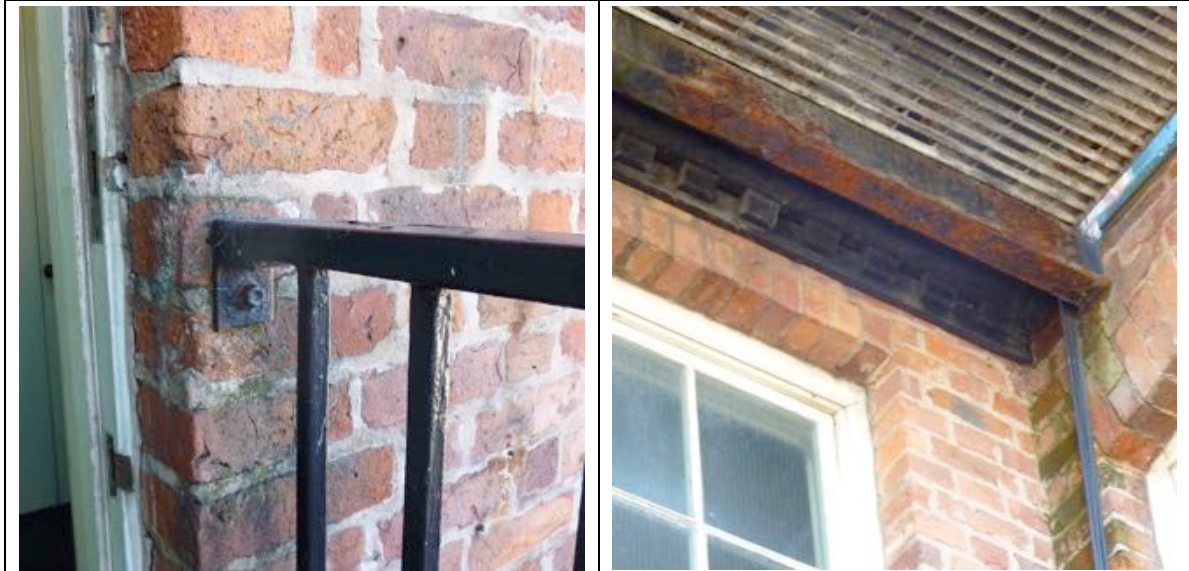
Ferrous fixings for the end of the access bridge to the gable wall. Bolts are into the joint not the brick.

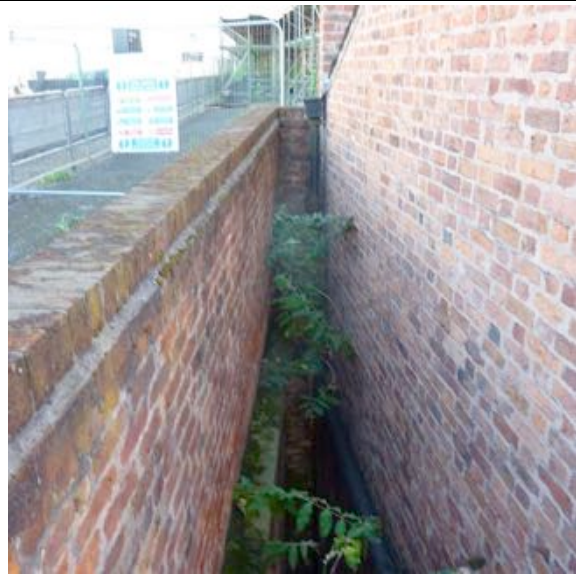
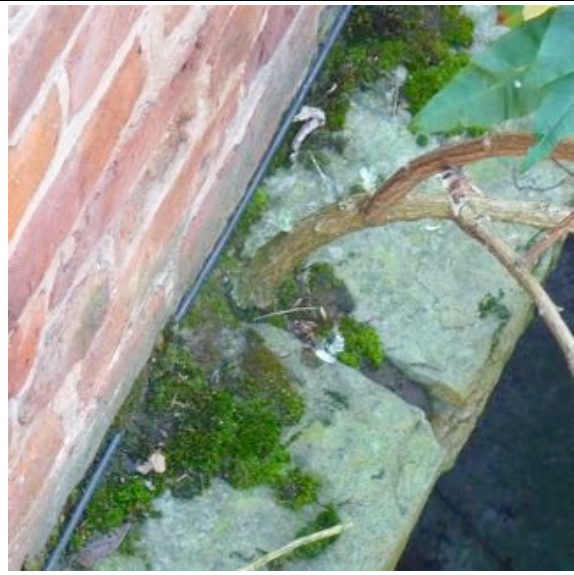
General views of the accessible area of the old train platform. Quite a few potential trip hazards.

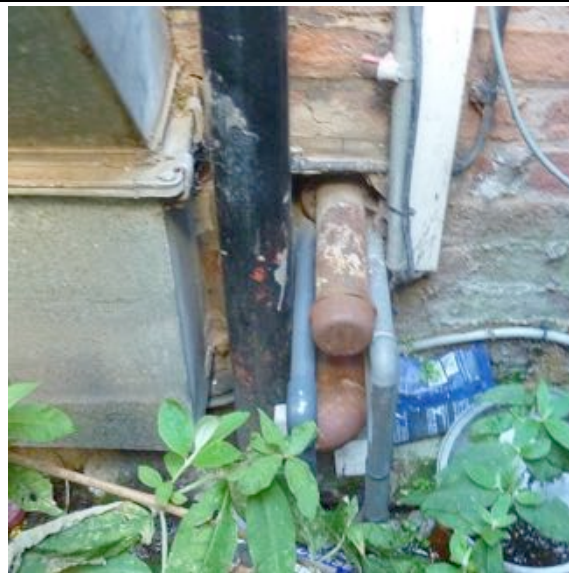
Jumble of pipework entering the basement boiler room through a broken section of cast iron grille. The gaps are big enough for vermin to enter the building.

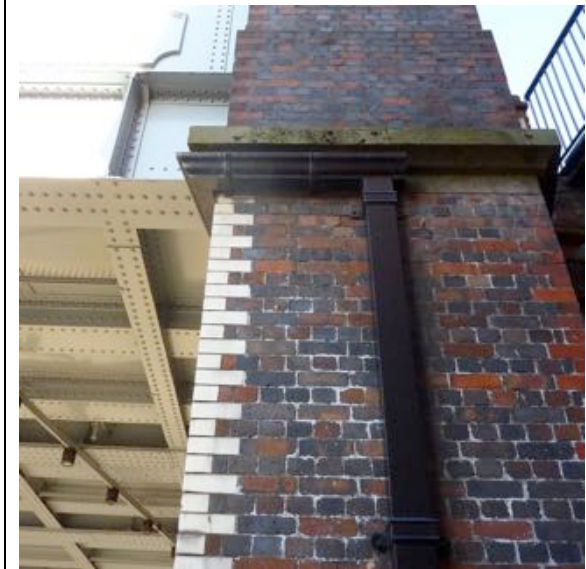
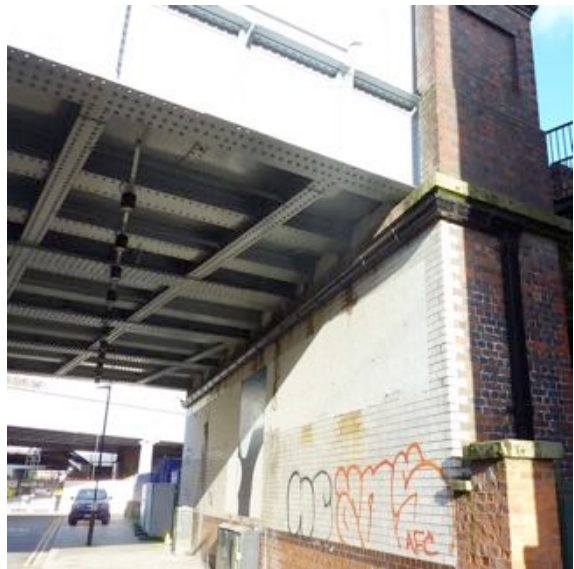
At the NW corner of the yard is a large pipe carrying rainwater from the upper level of the bridge. There is no actual drain gulley at this point and water must flood the yard and seep down past the drain cover.

Photos showing the pipe that discharges into the yard.

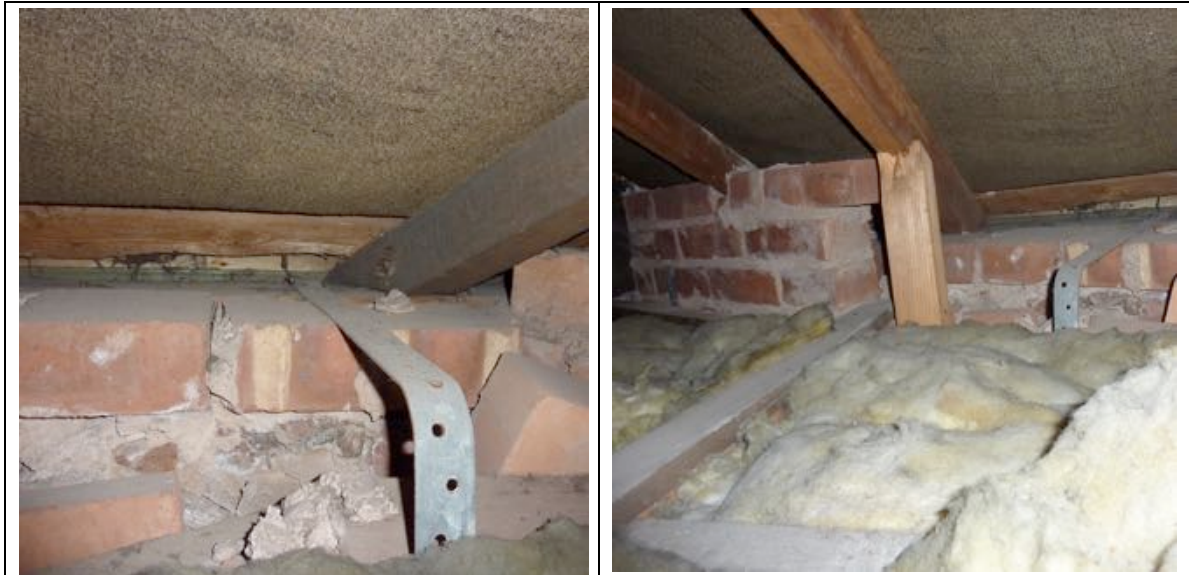
Shots into the eaves of the 'faceted roof' area. The brickwork is all a modern rebuild and looks bone dry.

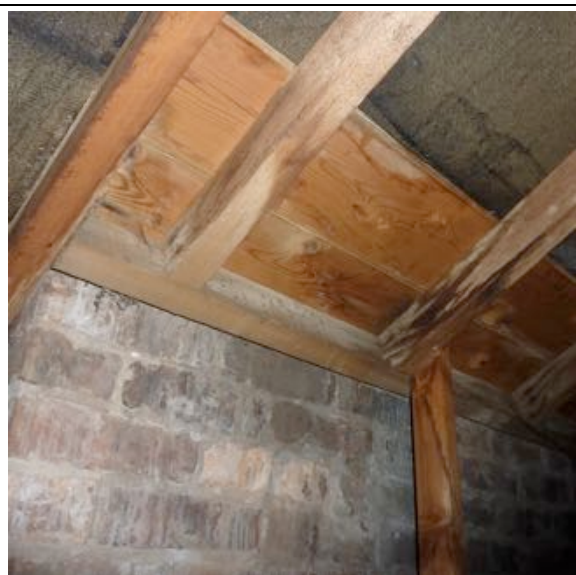
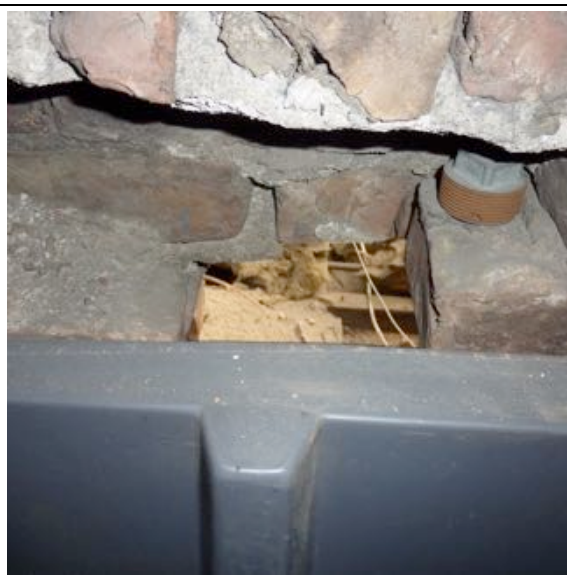
North wall evidence of past leaks around back gutter of chimney stack. Currently all dry.

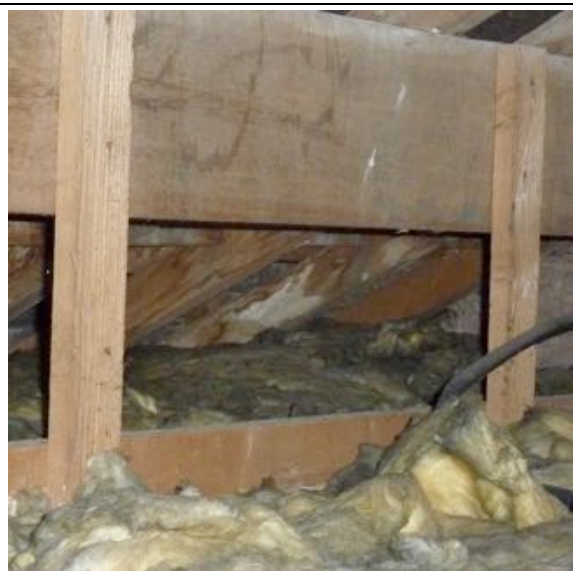
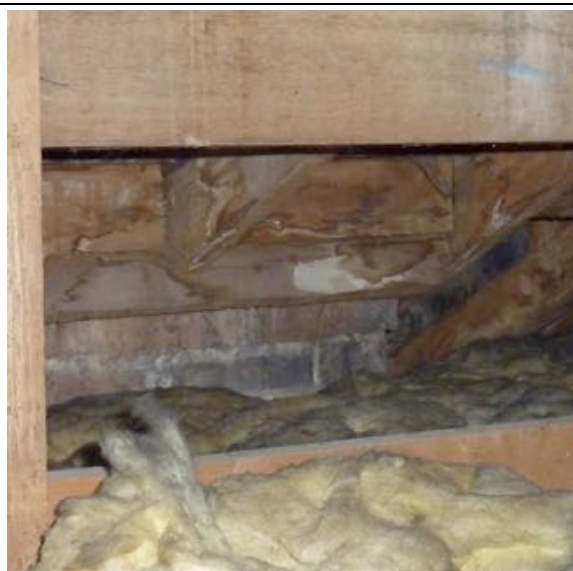
Views of the timbers to the east eaves showing evidence of past water penetration under the lead flat valley,. Currently this looks dry.

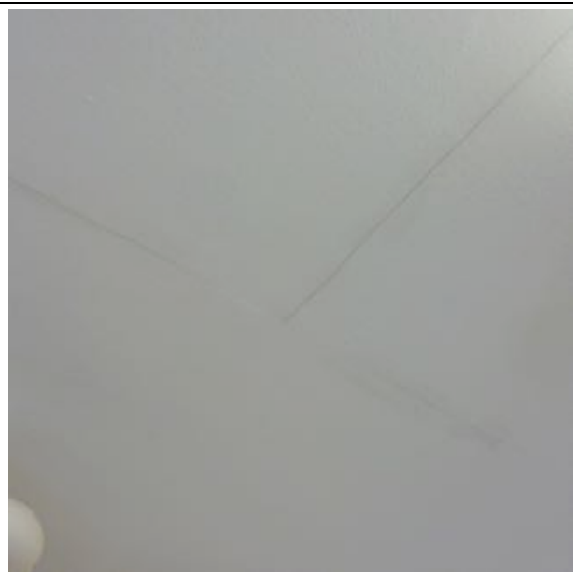
Cracks between individual sheets of plasterboard on the ceiling. They were probably butted rather than taper edge and scrimed and as this is a very hot room we are not surprised there are cracks. This is common in all rooms.

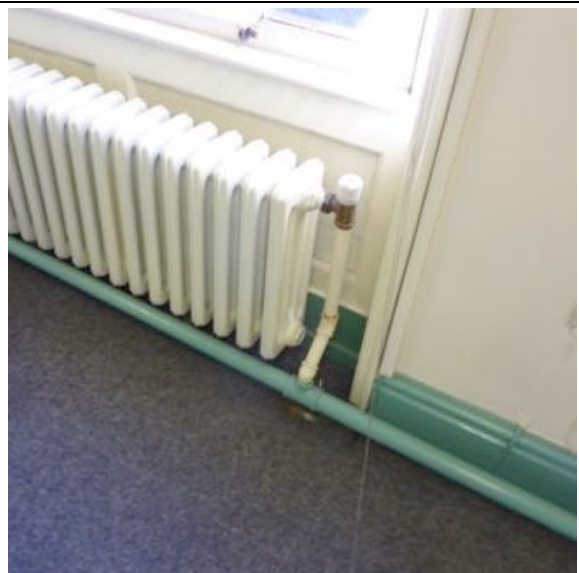
Rusting pipe connection to radiator. Very 'ordinary,' skirtings.

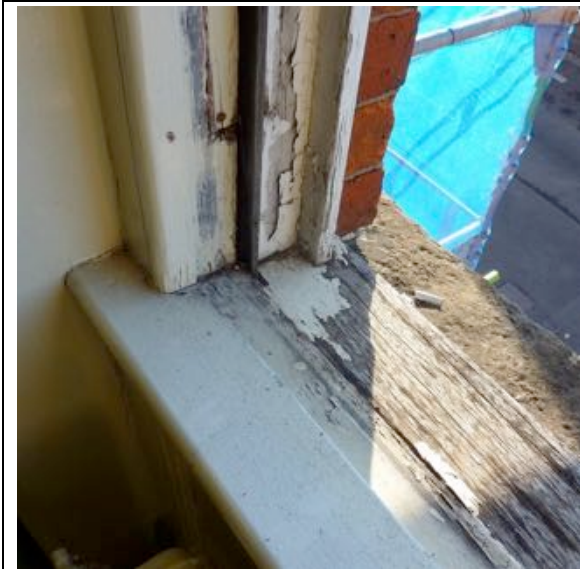
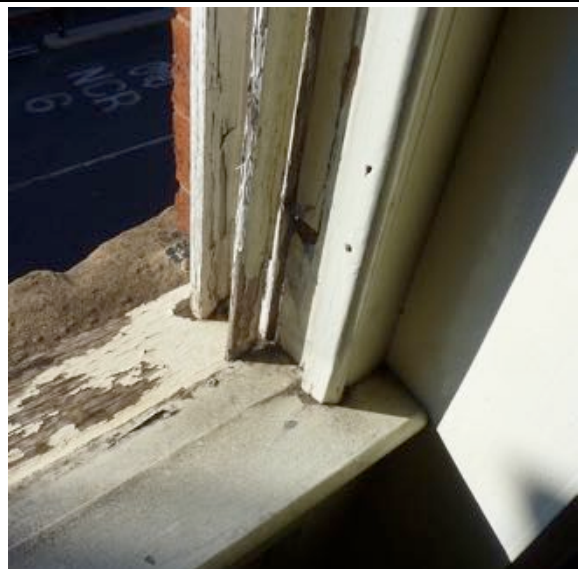
Condition of the window. The cill is oak and quite firm despite losing the paint. The parting bead is loose and needs replacement.

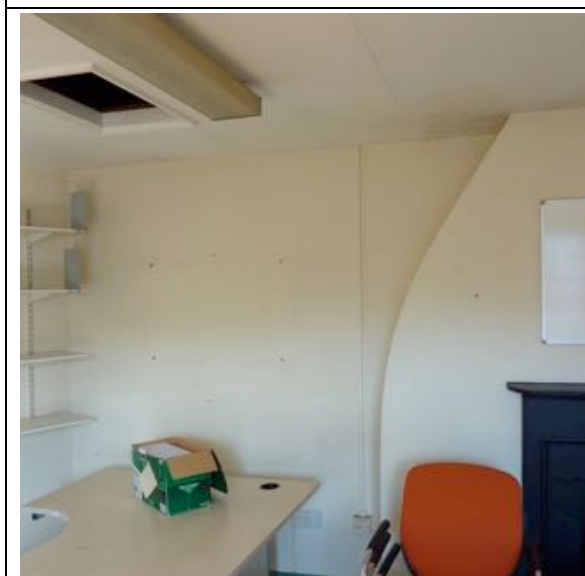
Stain to the ceiling the west of the chimney stack. This is currently dry though

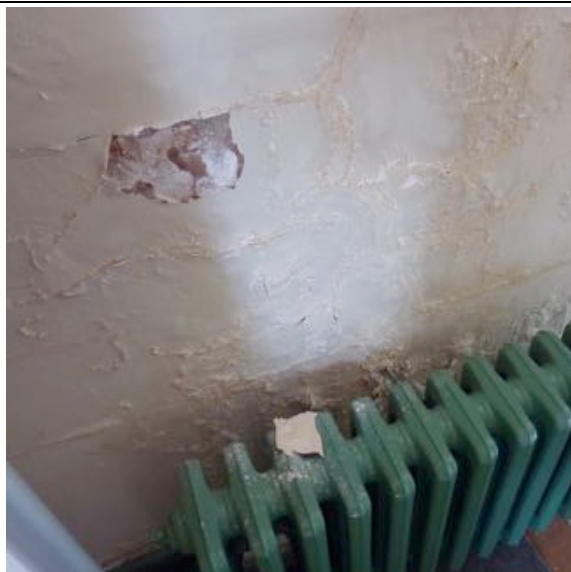
Salting particularly bad above the radiator as this will be force dried. This will also coincide with the height of the window cill to the blanked window on the outside.

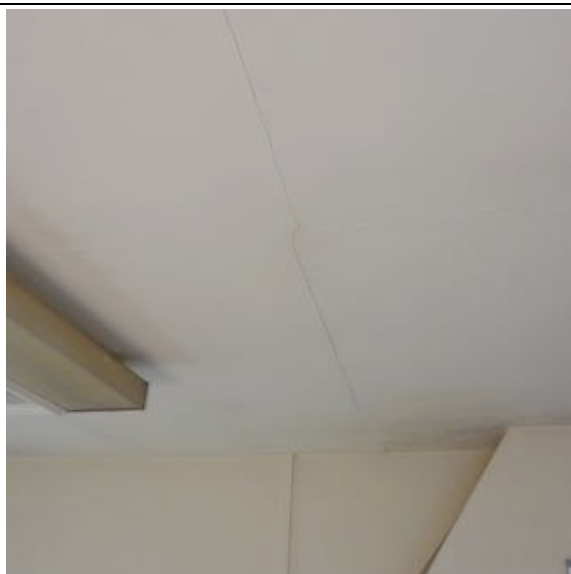
Cracking across the ceiling as is common in all of the rooms.

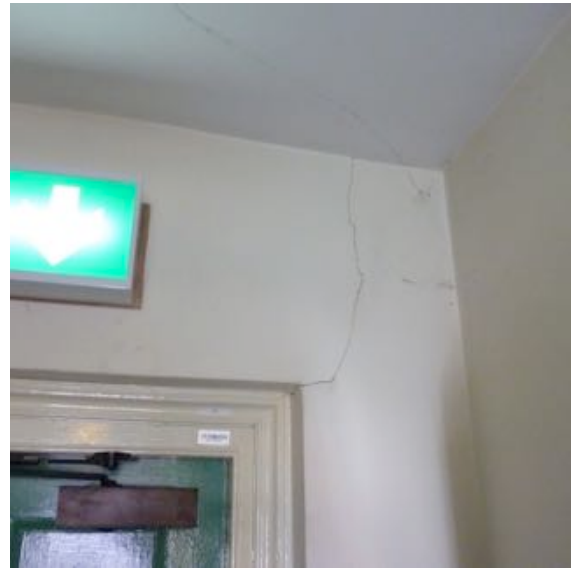
| <p>Fine cracking where the flat ceiling of the landing meets the north wall.</p> | <p>This cracking adjacent extends into the outer lobby area to the north where it is more prominent.</p> |

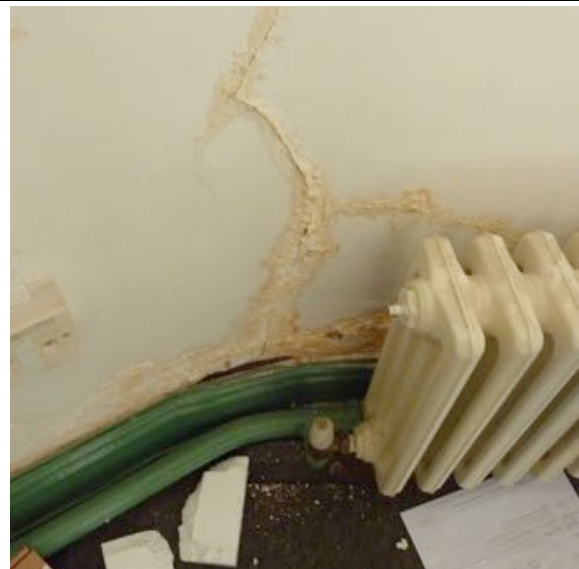
| <p>Old damp staining to the top of the wall and the edge of the ceiling on the West wall.</p> | <p>The wall did feel slightly damp behind the radiator. Is water sitting on the cill externally and tracking in?</p> |

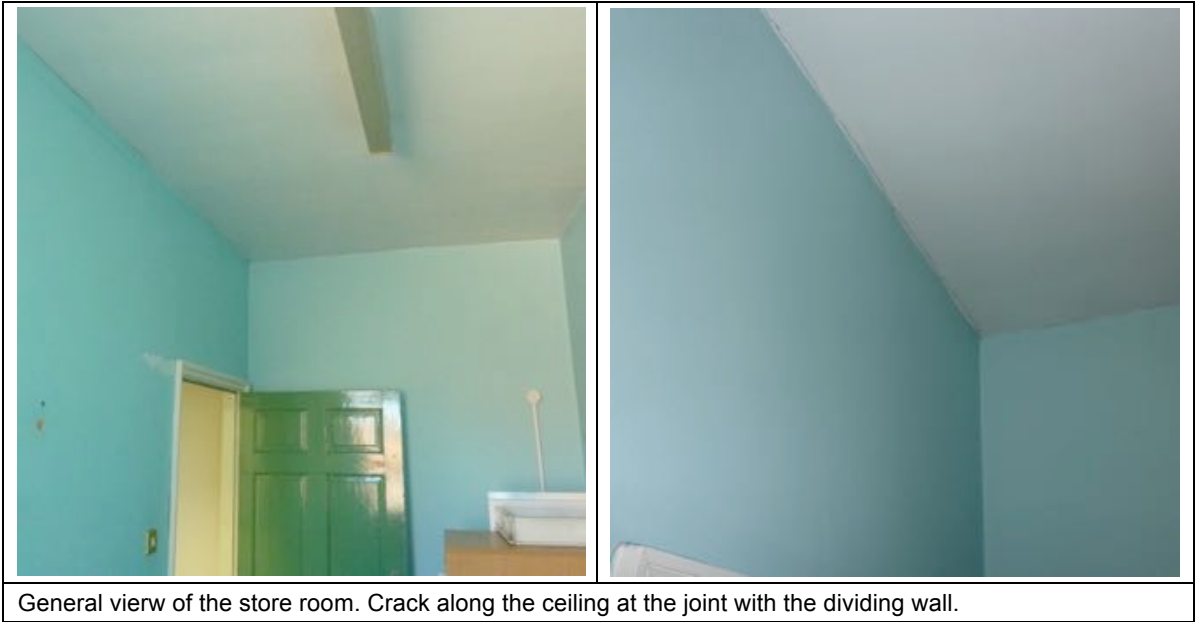
General view of the store room. Crack along the ceiling at the joint with the dividing wall.

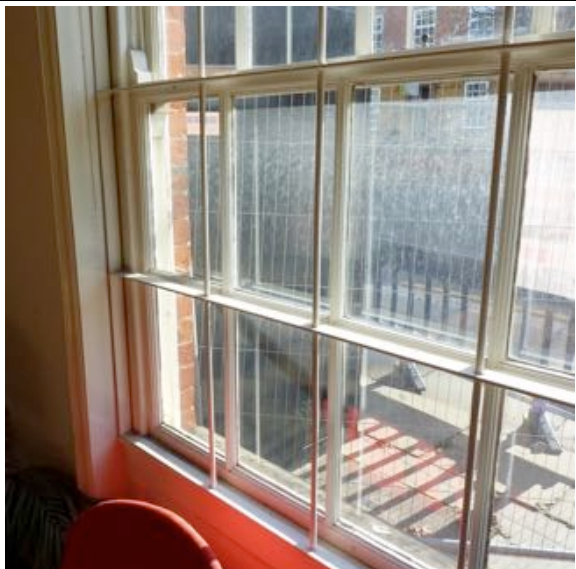
| <p>Fine cracking running up from the door to the lobby</p> | <p>Metal grilles to the windows are quite tasteful.</p> |

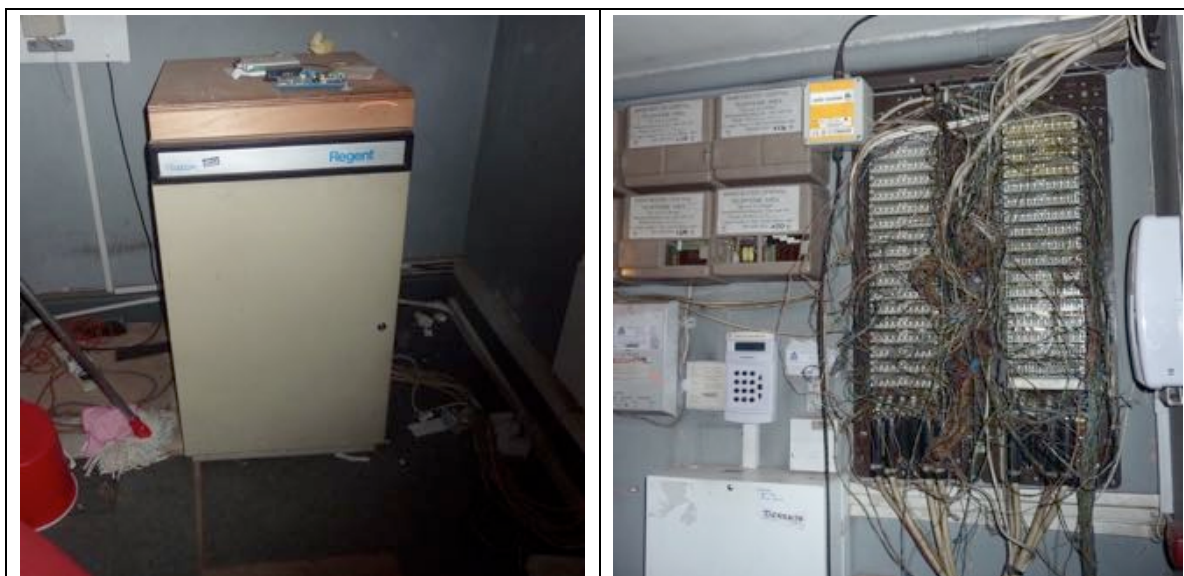
Quite a lot of telecom equipment in the room under the stair WC. Is this still live?

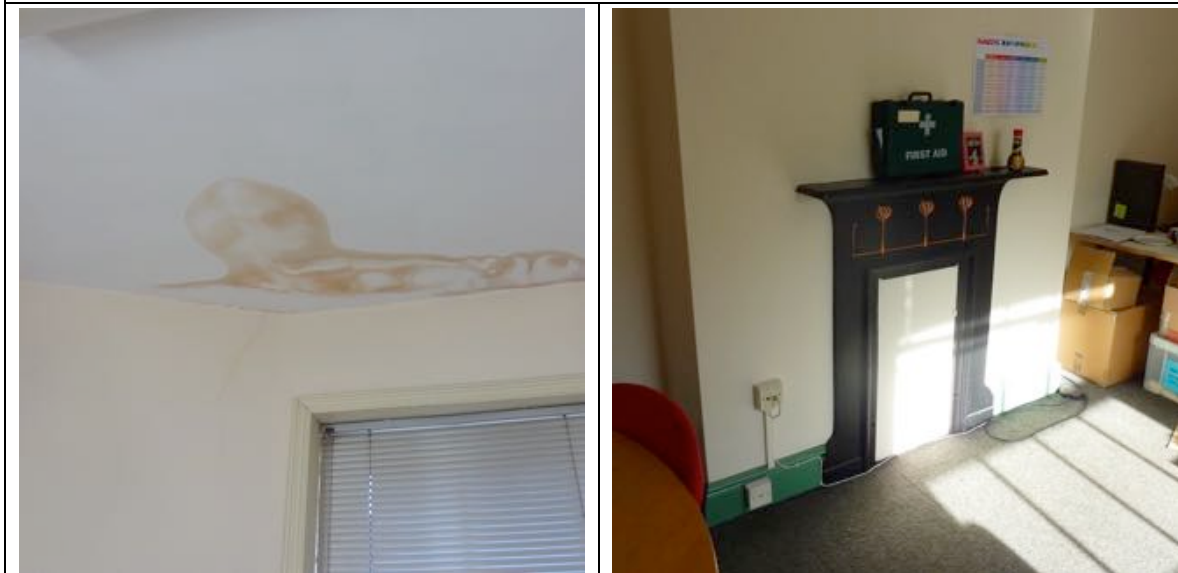
Damp staining to the edge of the ceiling at the west end but the wall otherwise free of the damp and salting on the floors above.

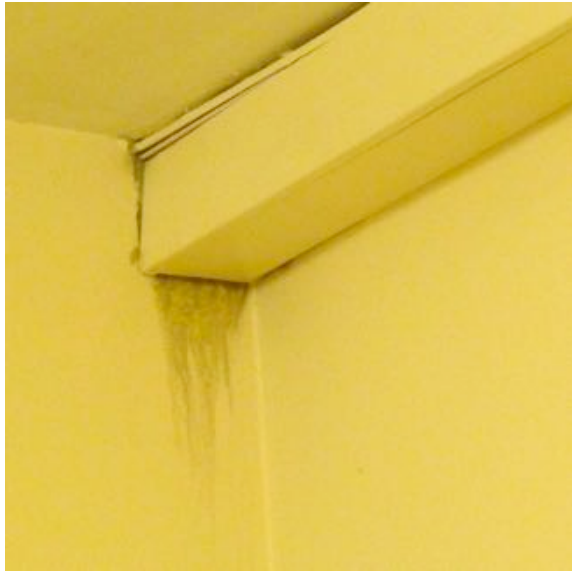
| General view | Data trunking against the ceiling at the NE corner looks like water has been getting through. |

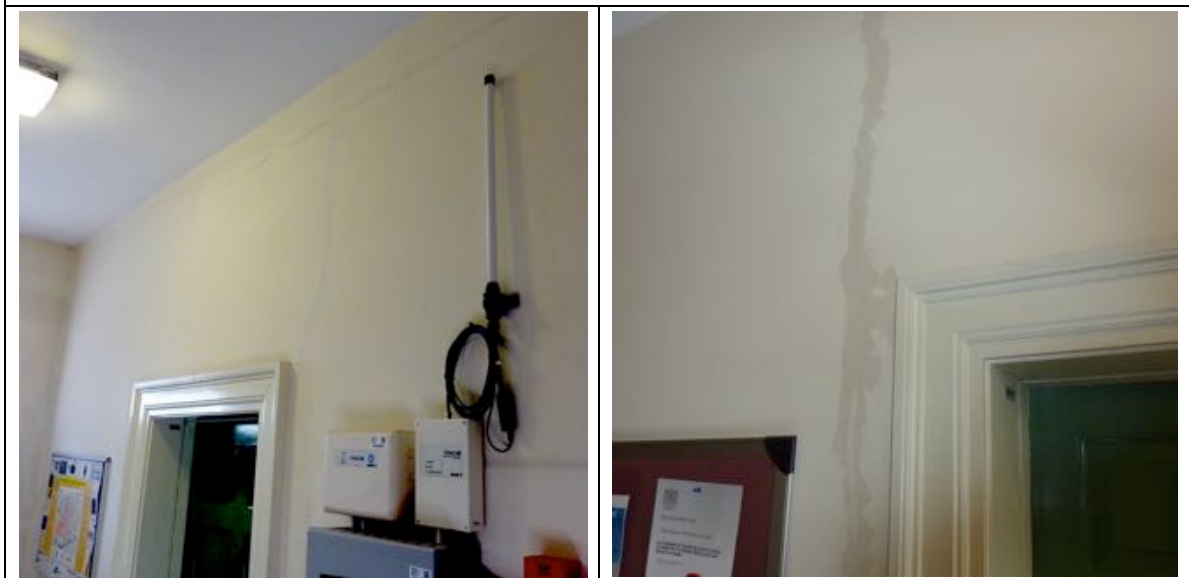
Quite a heavily trafficked area so lots of bumps and knocks to the wall plaster and skirtings.

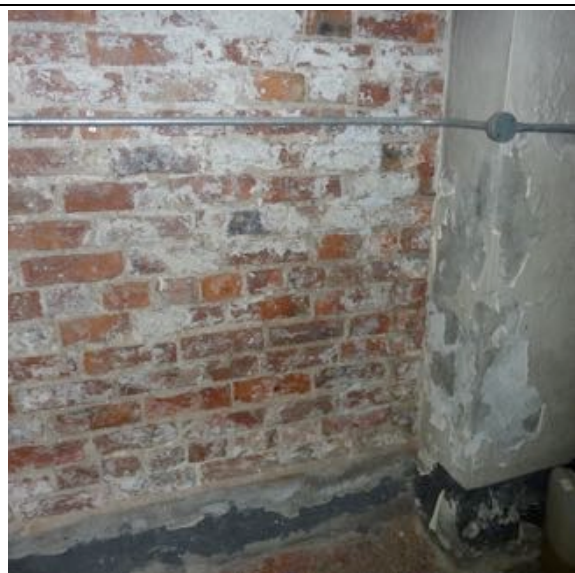
The bricks to the south spine wall are salted but do not have the extensive damage as other rooms.

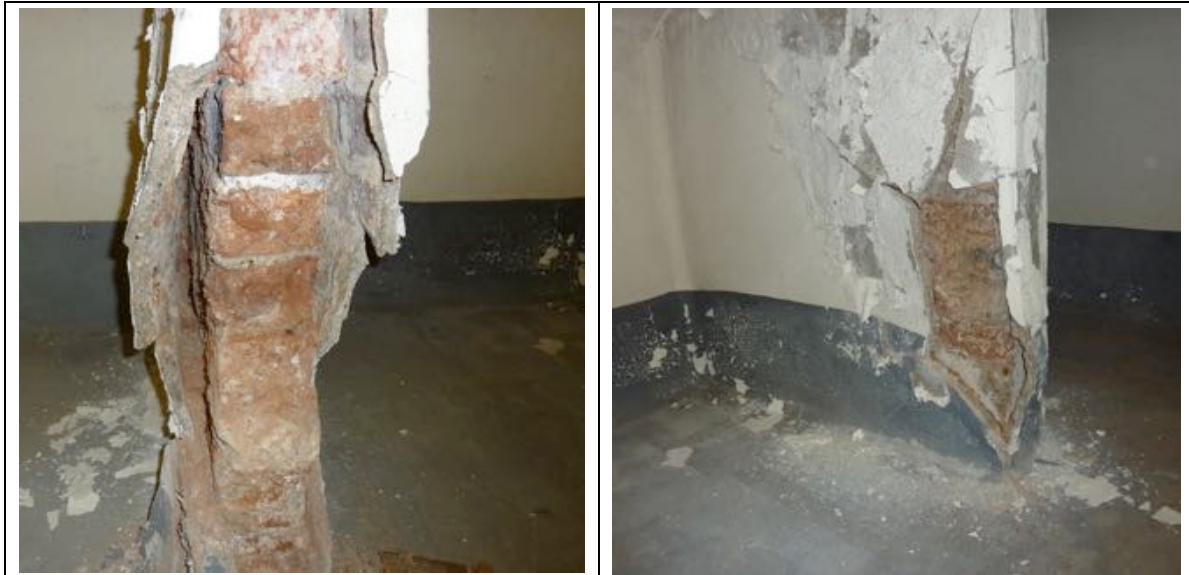
The render encasement to the thin brick nibs has failed in quite a spectacular fashion.

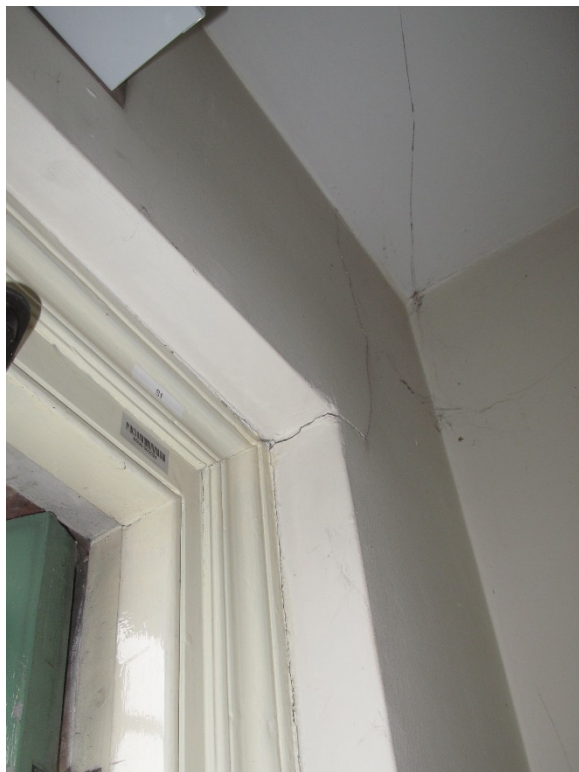
SECOND FLOOR REAR DOOR OPENING

The visible cracks are in the finishings, not the masonry, but there is evidence portions of the wall have been increased in thickness at some time. At high level the roof valley terminates in this area. It has a 5.5 metre span on plan and almost 6 metre on the slope. A photograph of the valley appears on page 14 of the Wiles & Maguire Report. There are load-bearing walls at third points along the valley so it is reasonable to assume they would have been used to break the span in the substantially modern re-roofing exercise that included the rafters. main sewer and not to ground will minimise the risk of further foundation disturbance if this was involved. As can be seen in the photograph above, the north wing has been constructed at a different time, seeming to pre-date the rest of the building with a more industrial appearance founded on a barrel vaulted foundation. This may account for the disturbance, with the two portions reacting differently to variations in ground conditions or the foundation depths not being the same.
