10000612 – 77 Whitworth Street West, Manchester – Photo Appendix

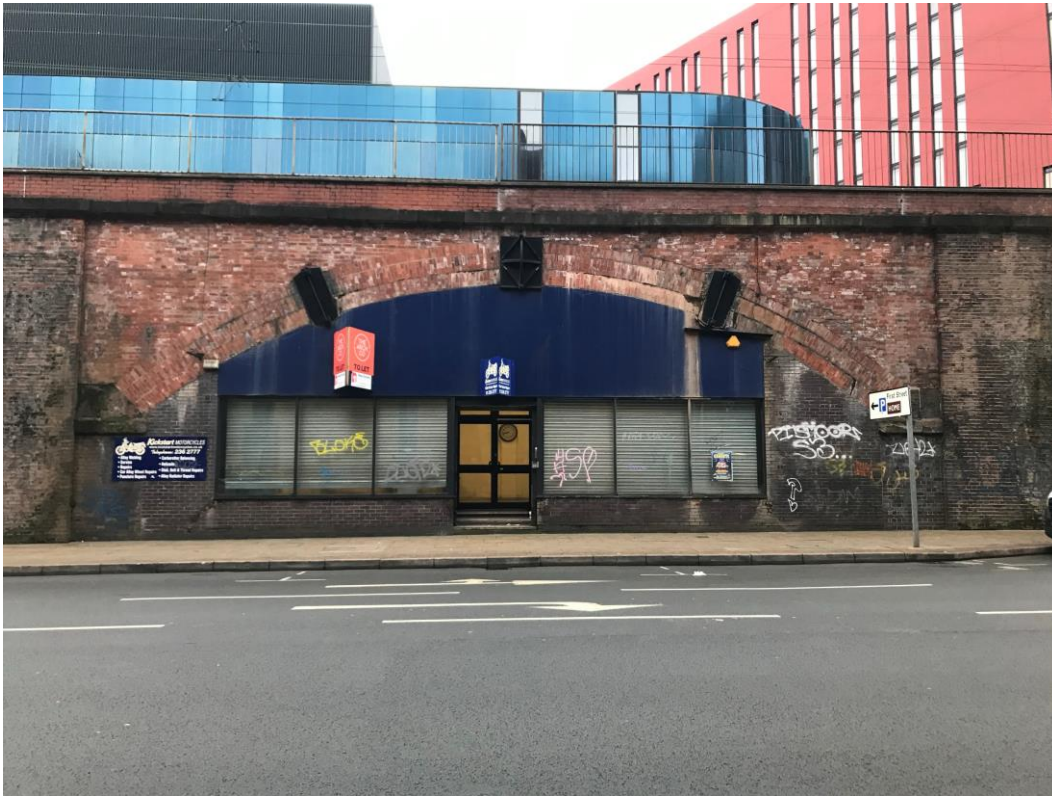
1) Front Elevation of the unit at 77 Whitworth Street West.

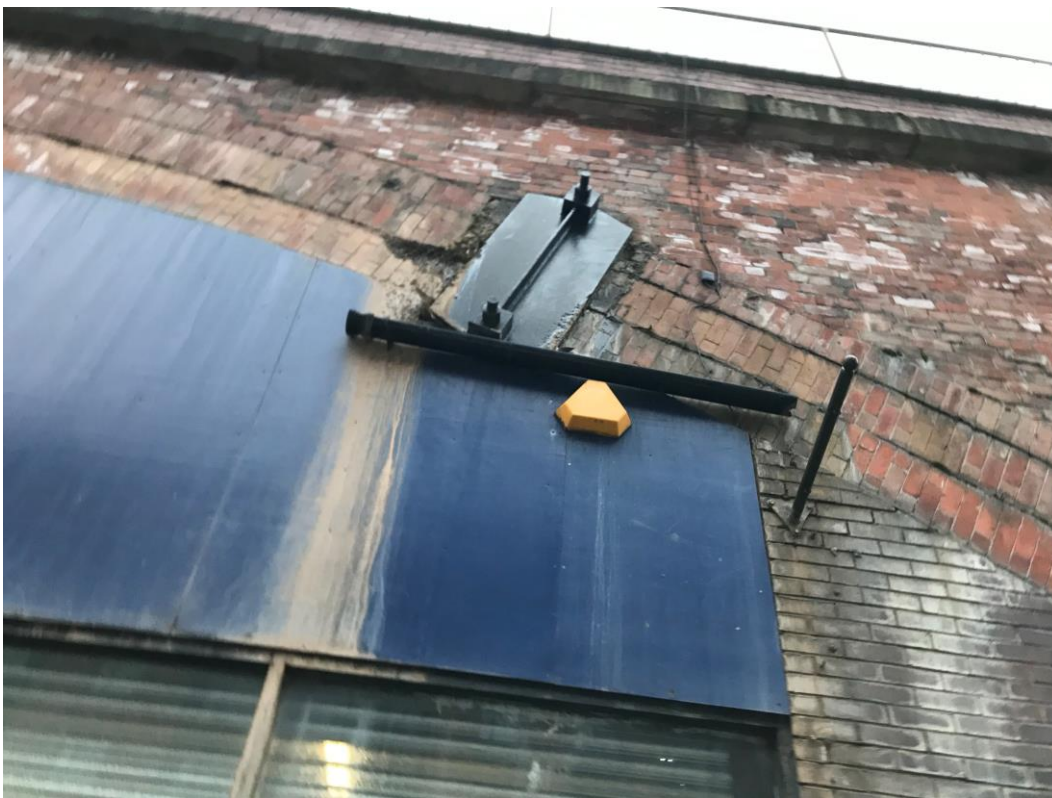
2) Failed guttering detail with the water bypassing the gutter and rinsing down the fascia.

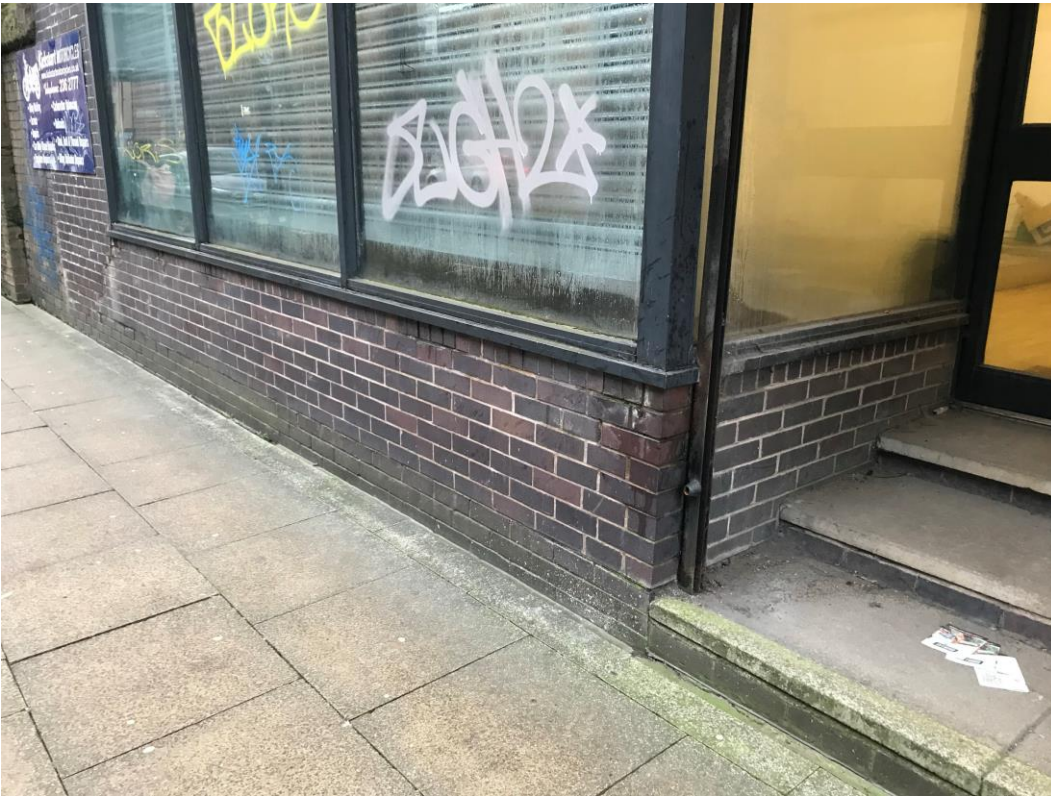
3) Left hand side soiled stall riser constructed using engineering brick.

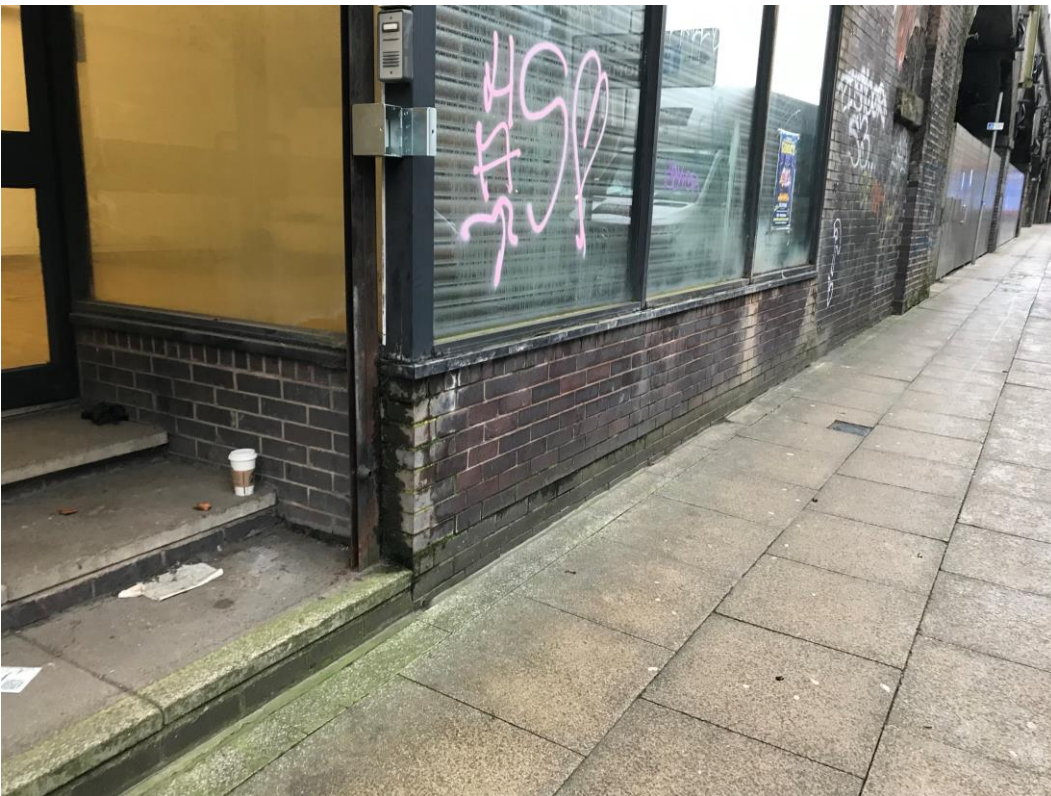
4) Right hand side soiled stall riser constructed using engineering brick. Adjacent to the shop front is the proposed location of the emergency exit.

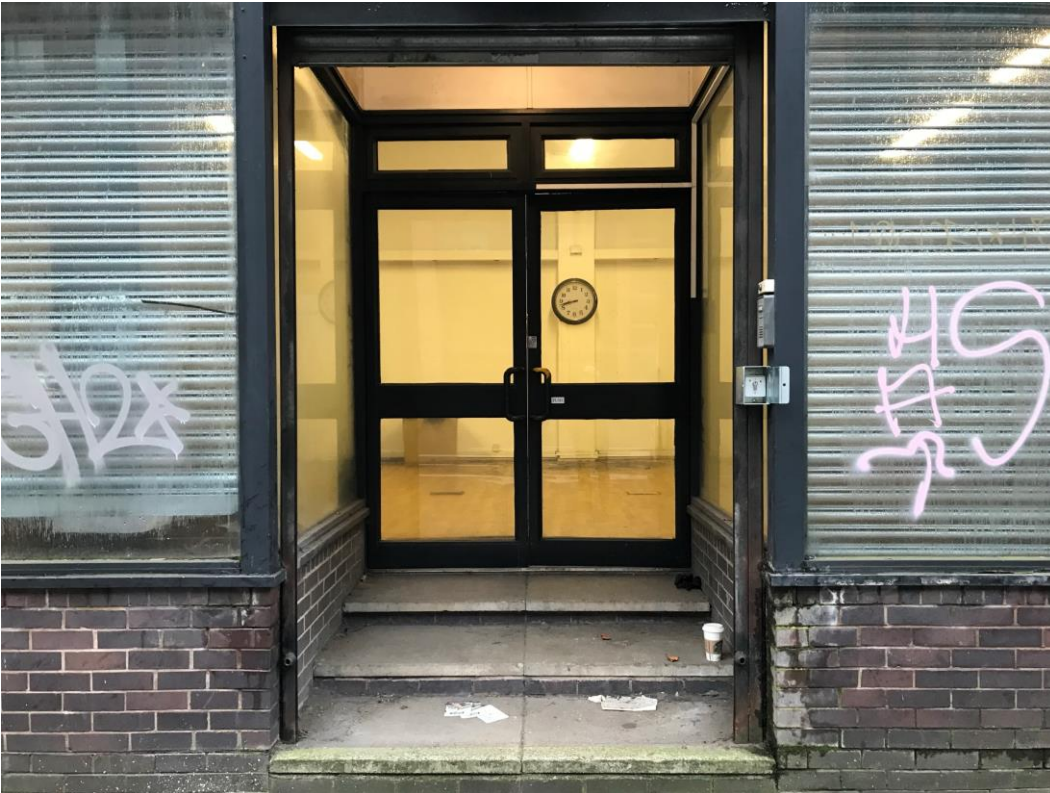
5) The paved stepped entrance and double entrance doors which would be altered to create a fully accessible entrance into the unit.

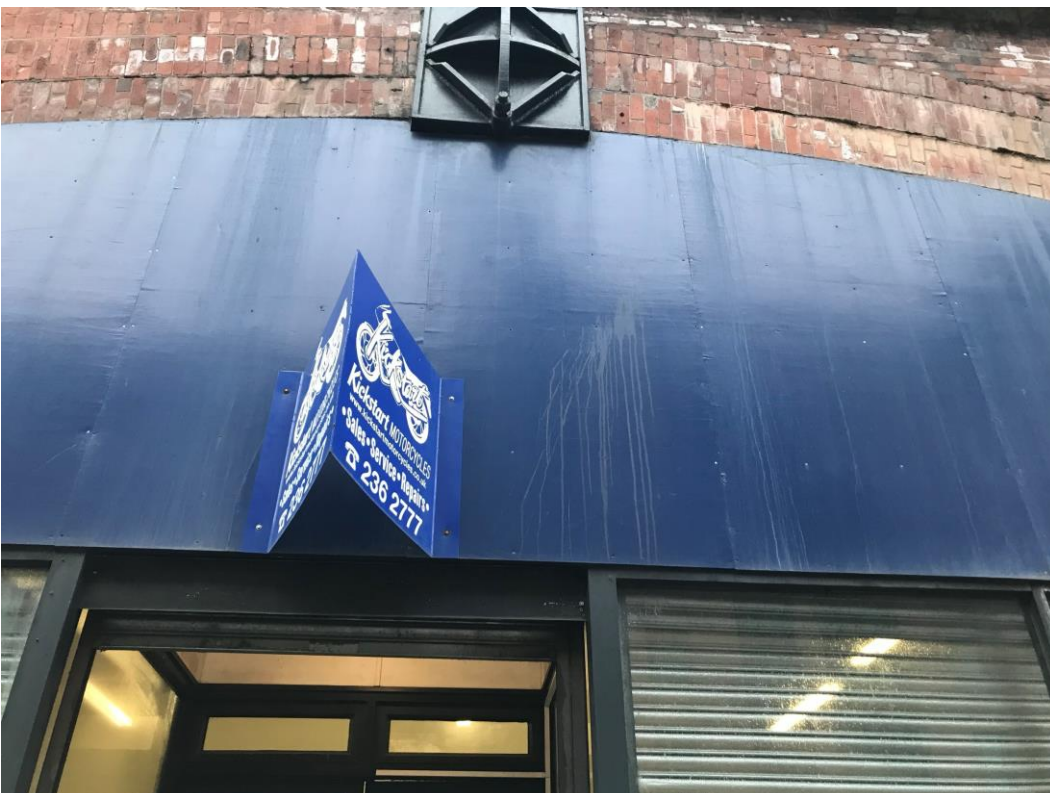
6) Painted signage fascia which would receive redecoration works as part of the project. The colour of paint would match the existing.

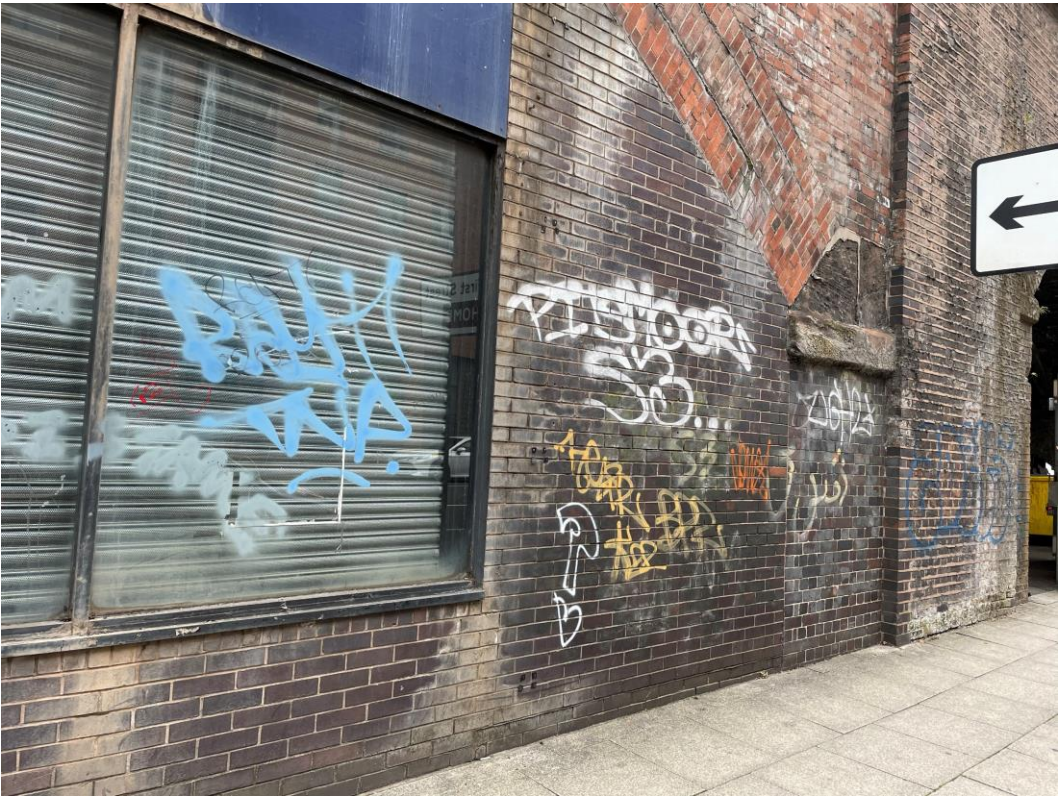
7) Right hand side of the brickwork infill where the proposed emergency exit would be situated.

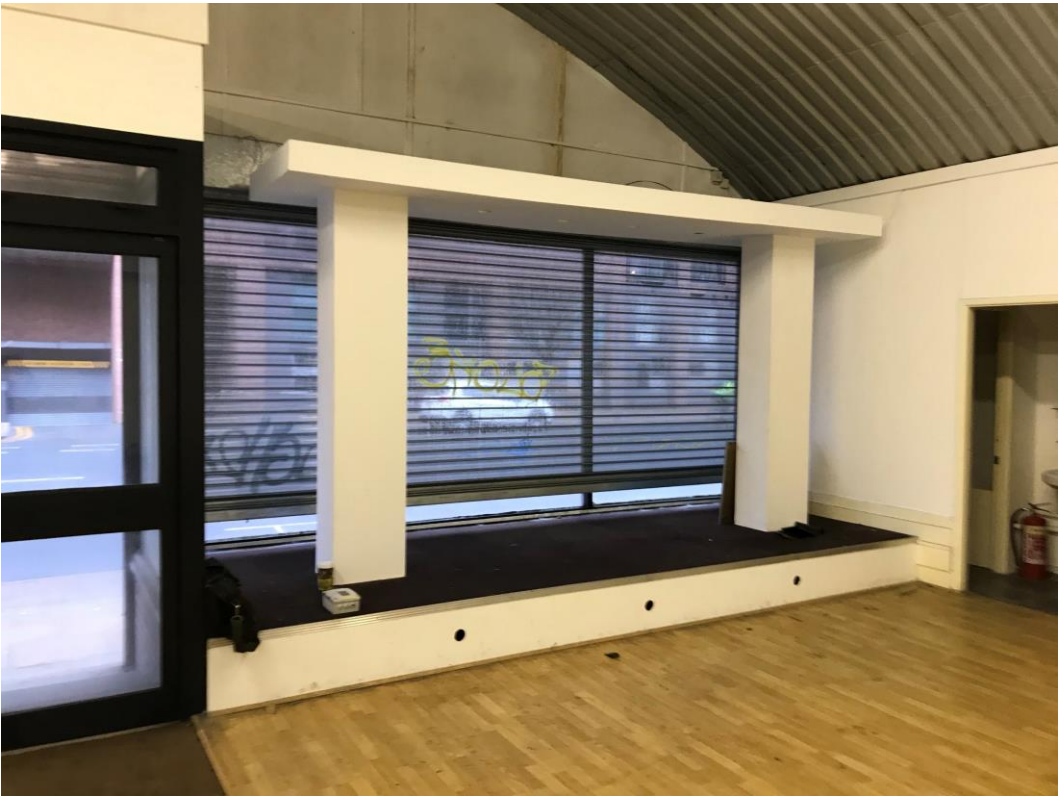
8) Internal view of the shopfront.

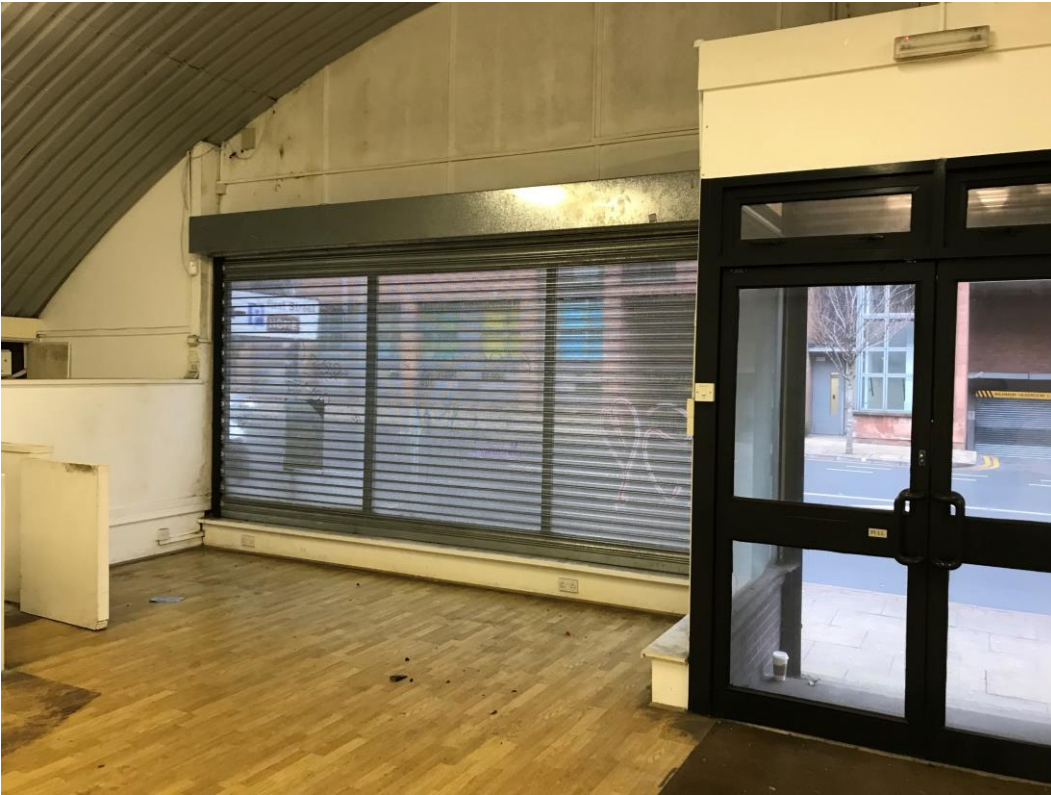
9) Internal view of the shopfront.

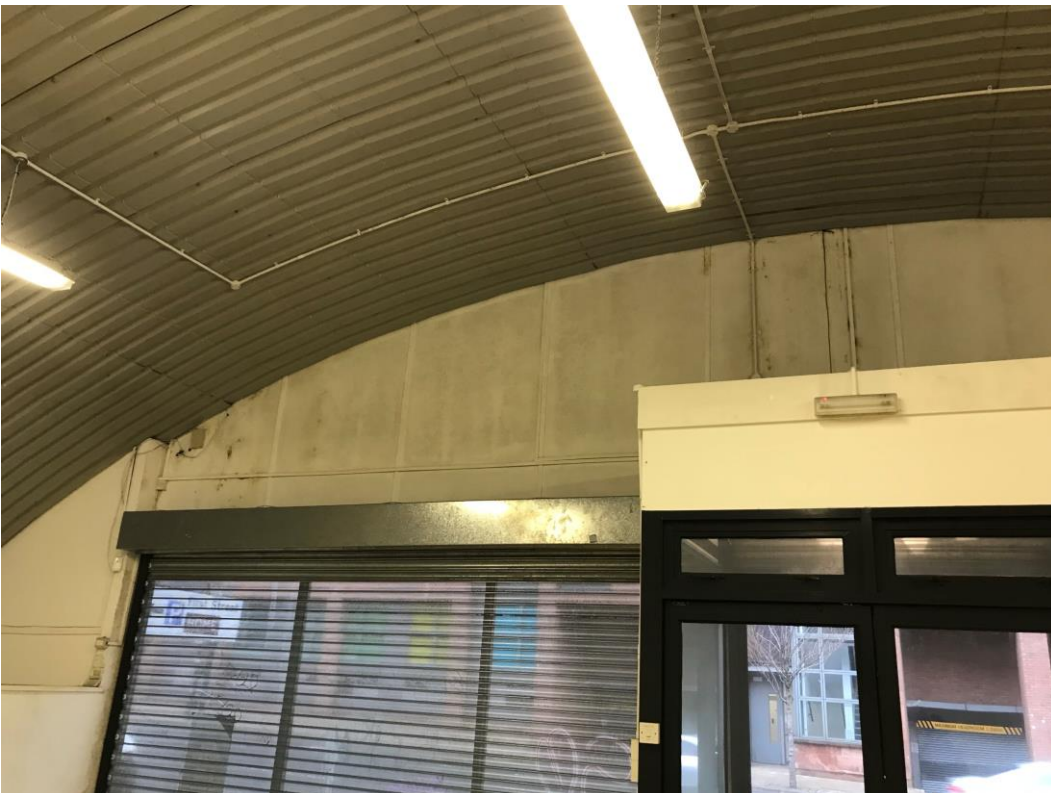
10) Stained wall lining.

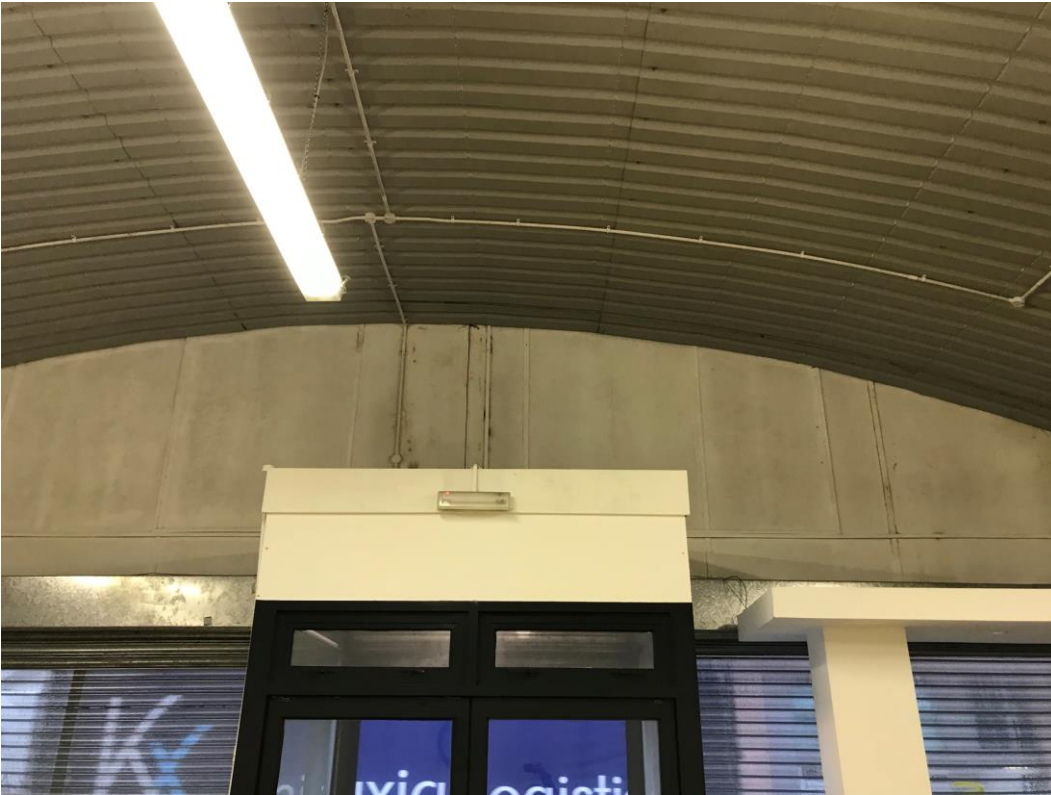
11) Stained wall lining.

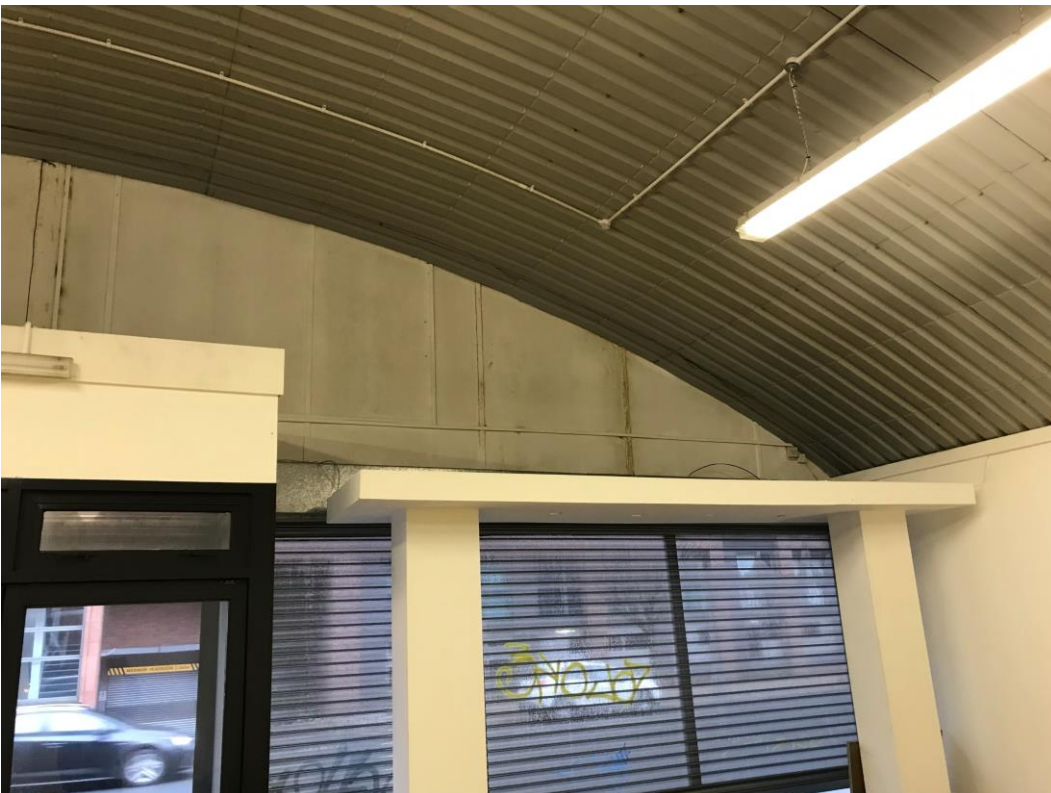
12) Stained wall lining.

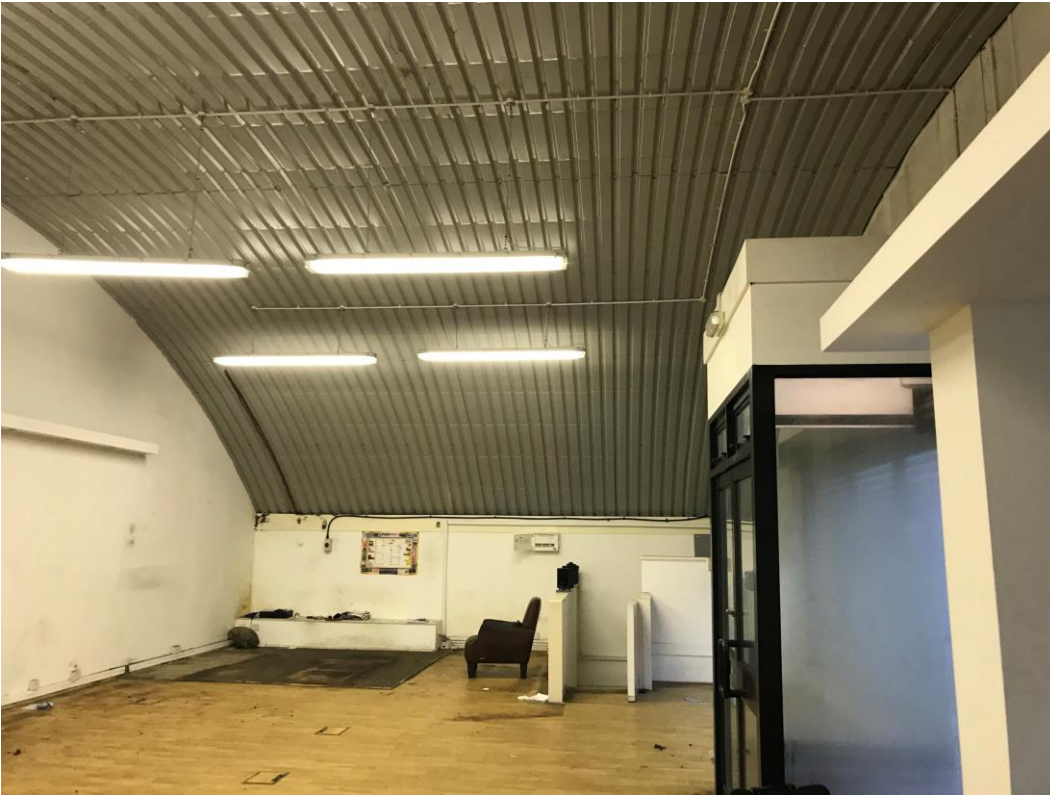
13) Overview of shop floor which has been formed from the existing mezzanine structure.

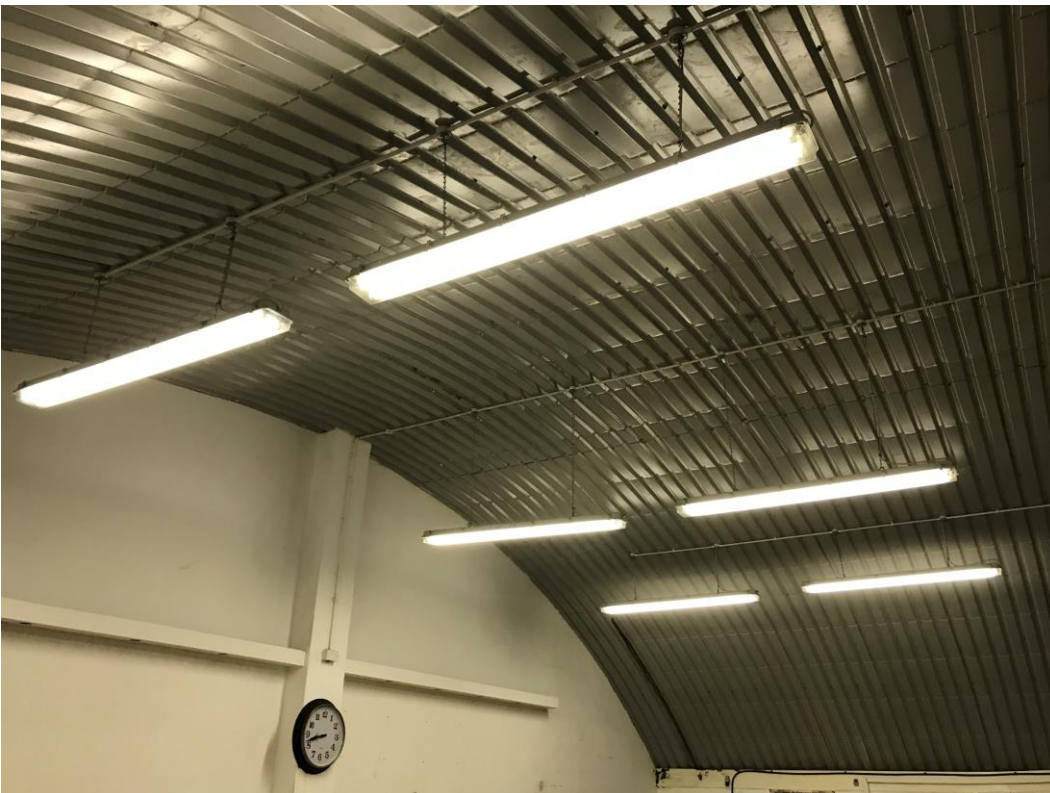
14) Overview of ceiling lining and lighting system.

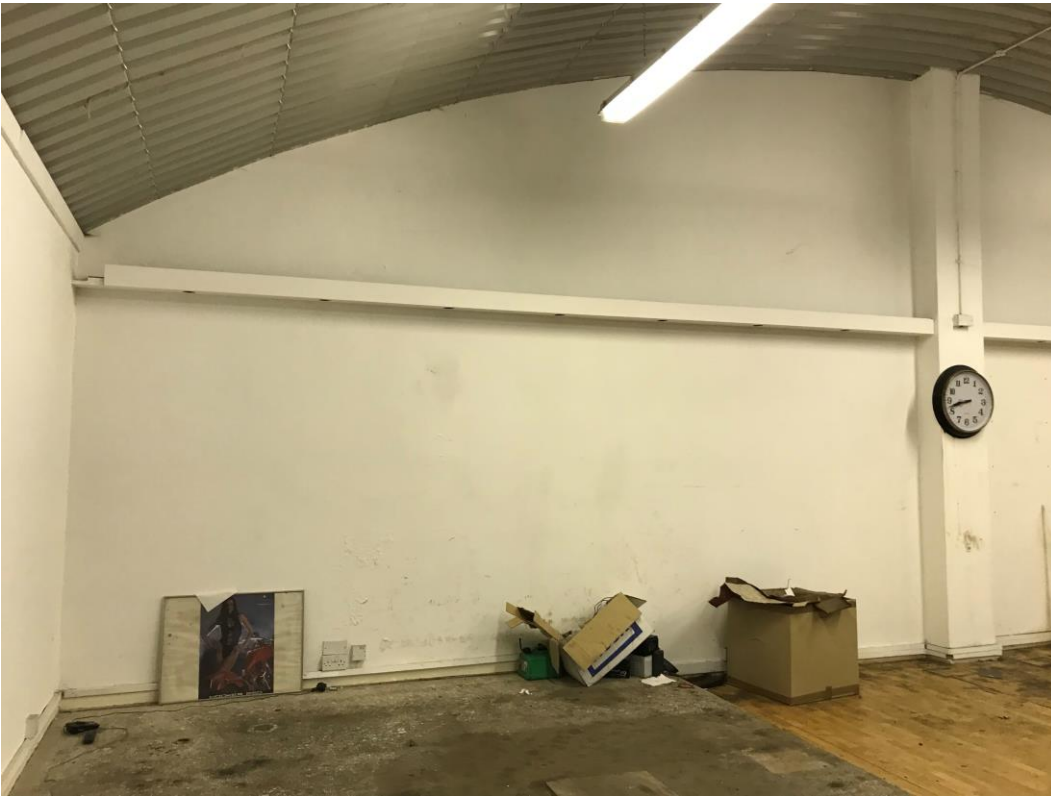
15) Overview of shop floor which has been formed from the existing mezzanine structure.

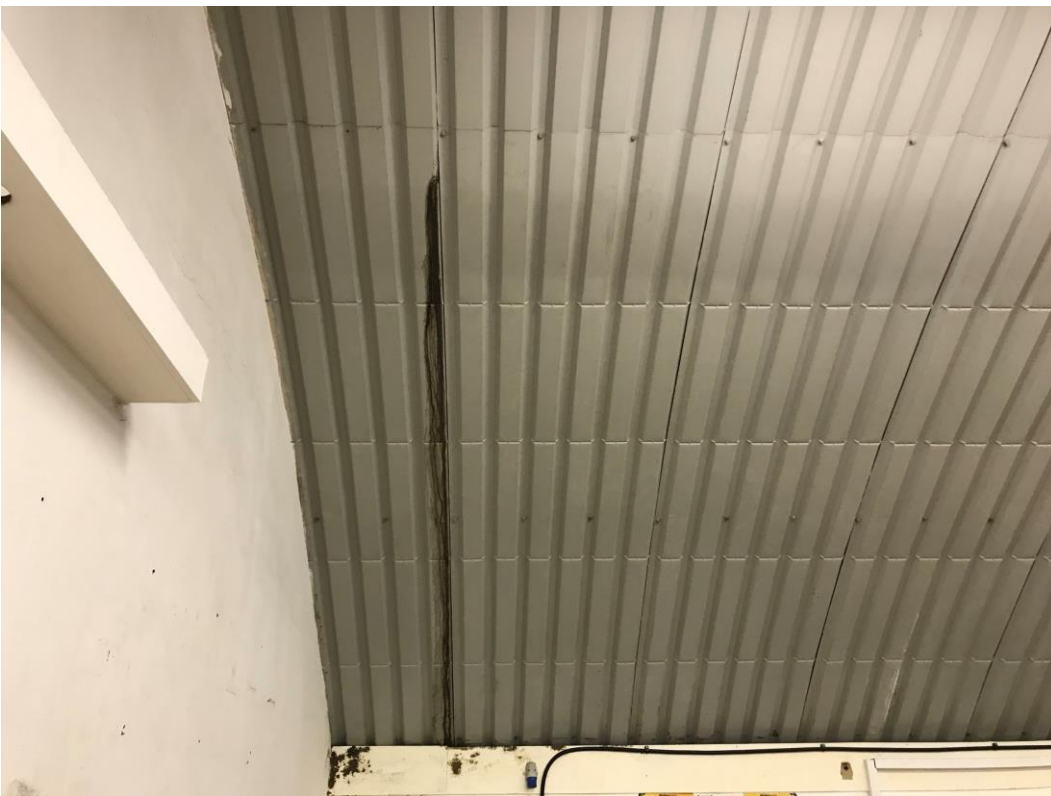
16) Isolated location of leak coming through the lining system.

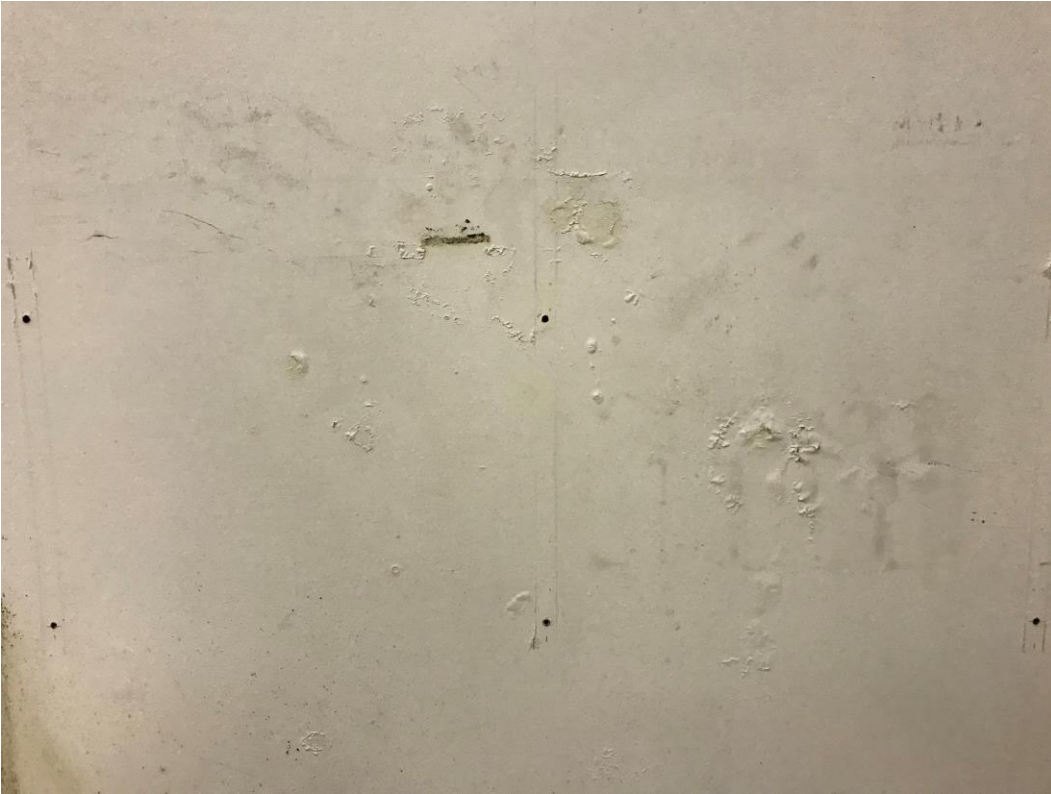
17) Damp affected paint finish.

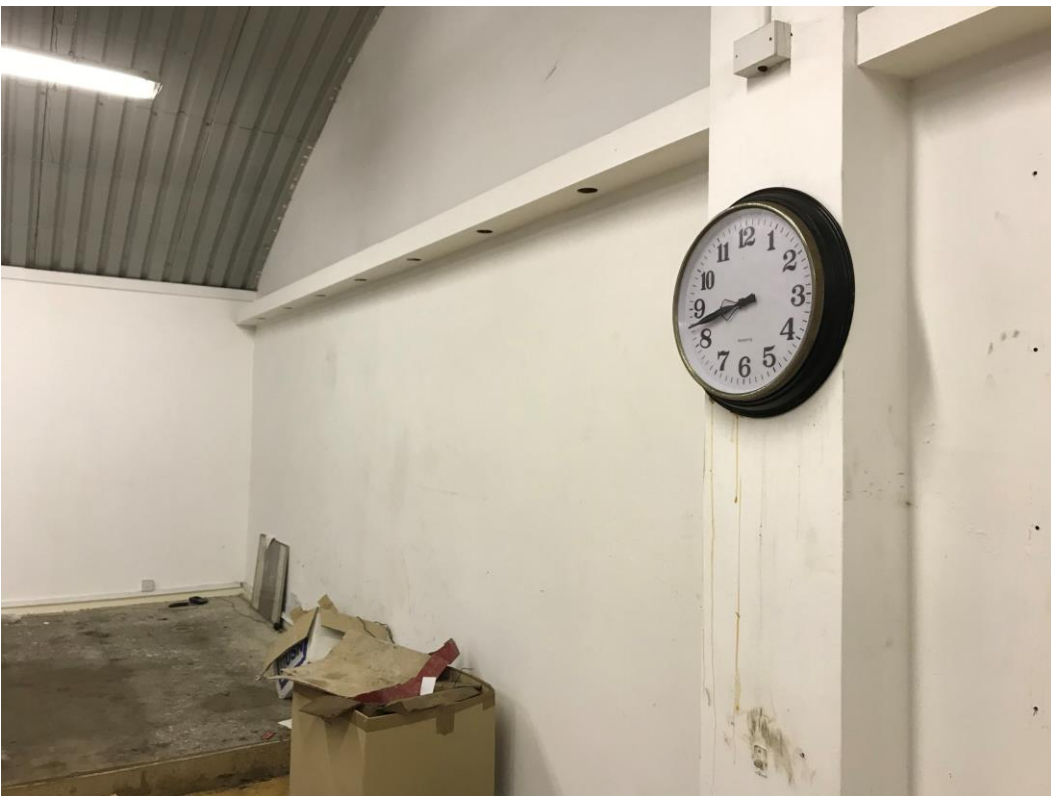
18) Overview of shop floor.

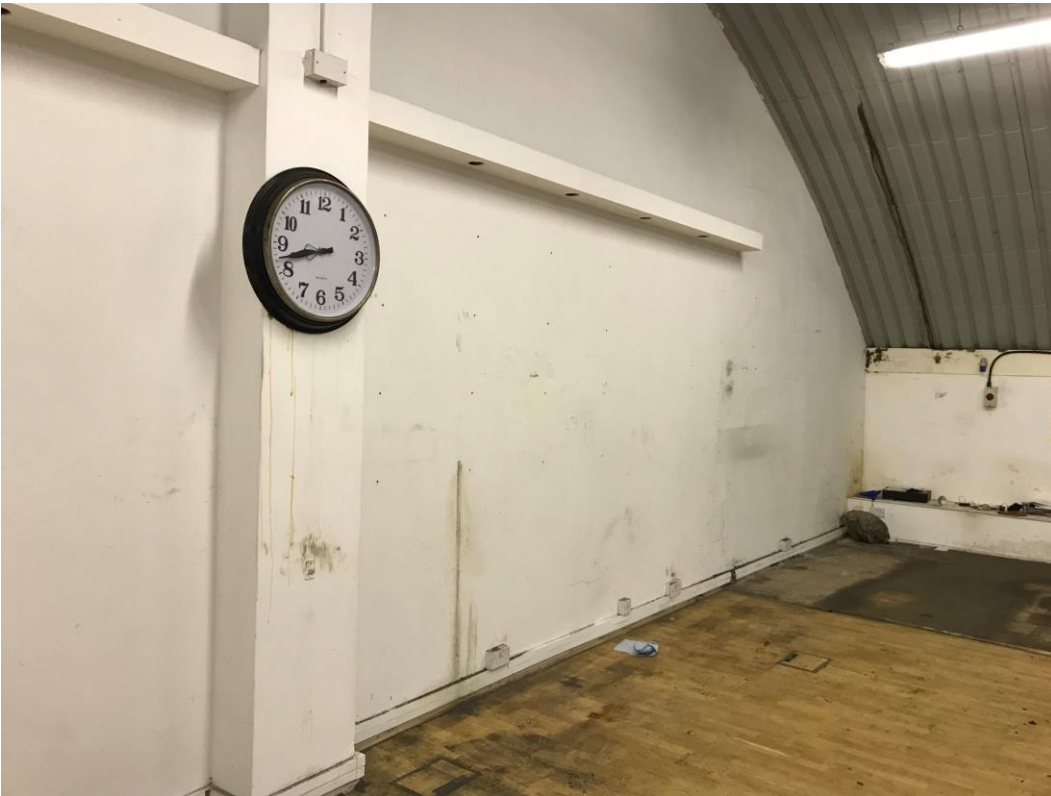
19) Overview of shop floor which has been formed from the existing mezzanine structure.

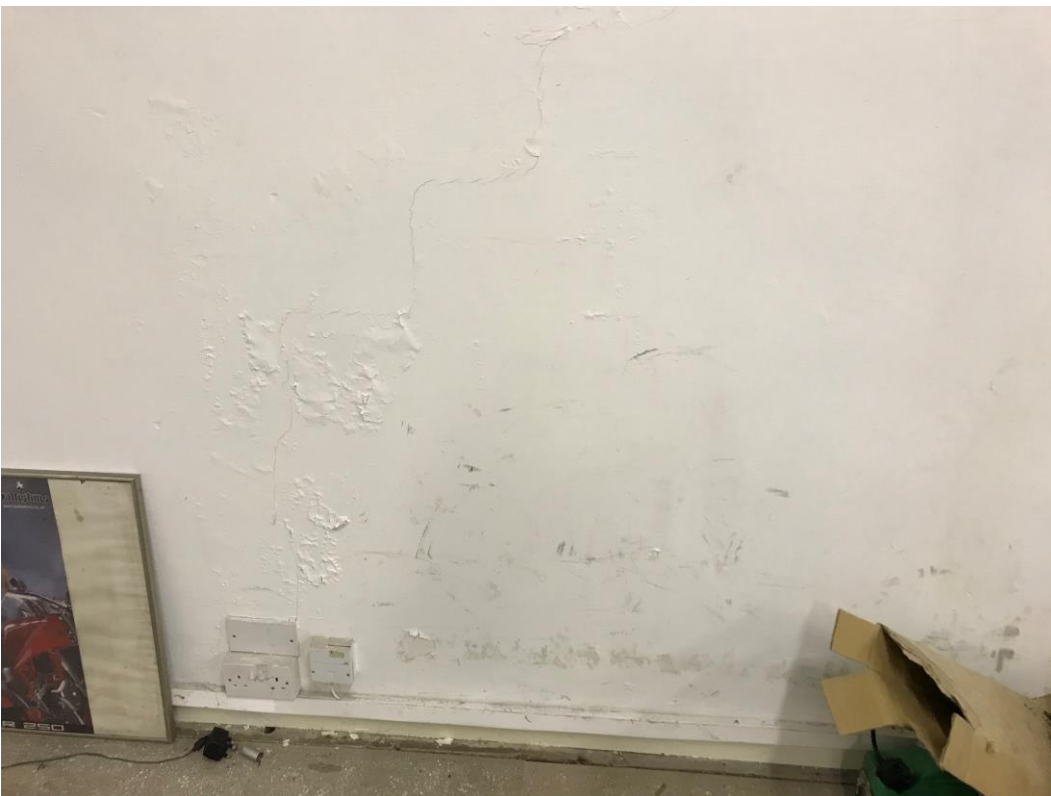
20) Damp affected paint finish.

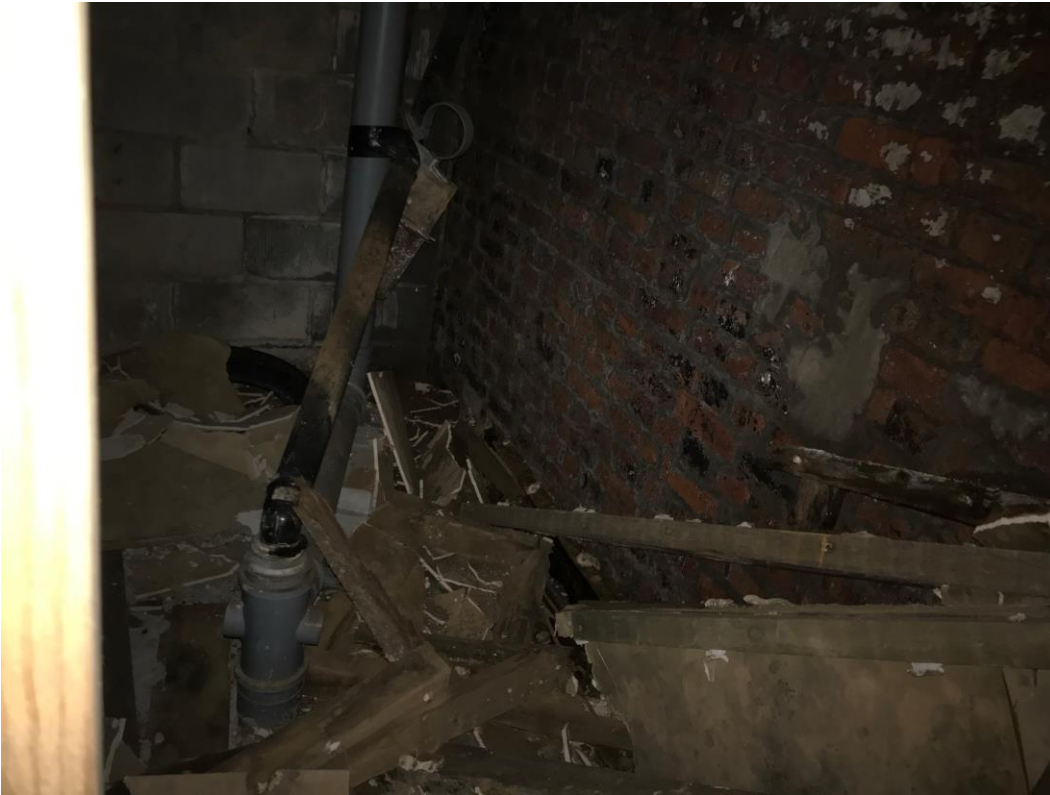
21) Debris to basement level. Location of existing foul waste which will be connected into as part of the WC construction works.

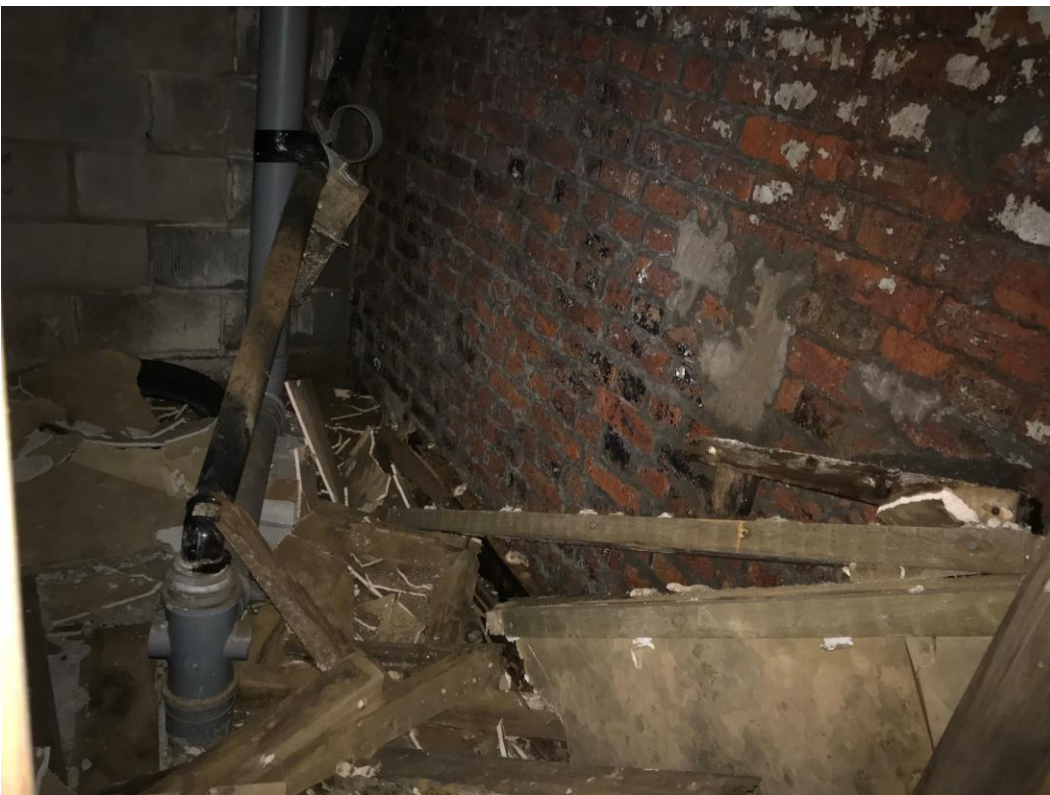
22) Debris to basement level. Location of existing foul waste which will be connected into as part of the WC construction works.

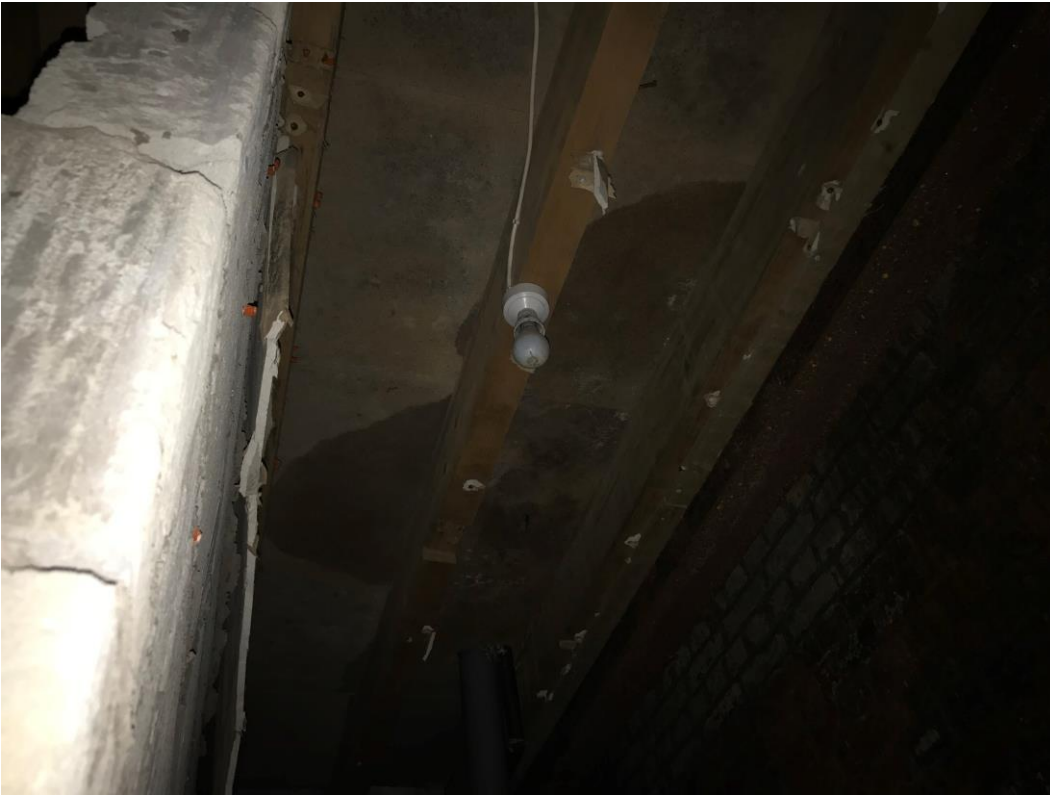
23) Underside of the mezzanine structure, which is damp affected and not fit for purpose.

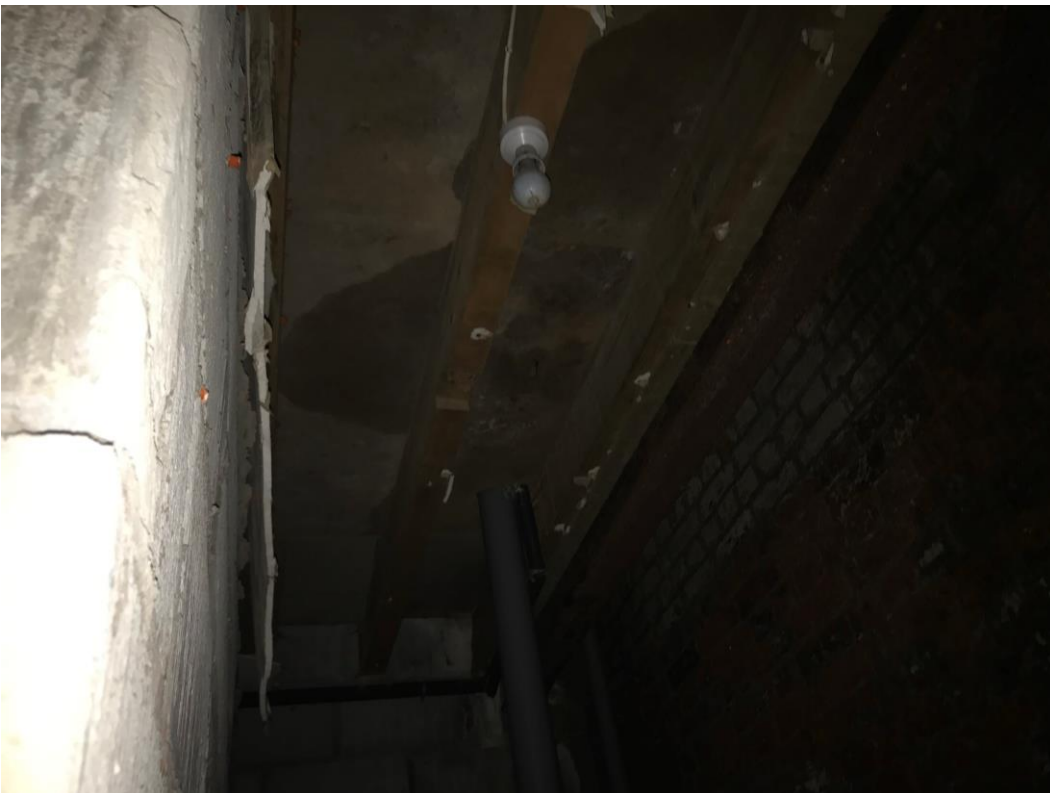
24) Underside of the mezzanine structure, which is damp affected and not fit for purpose.

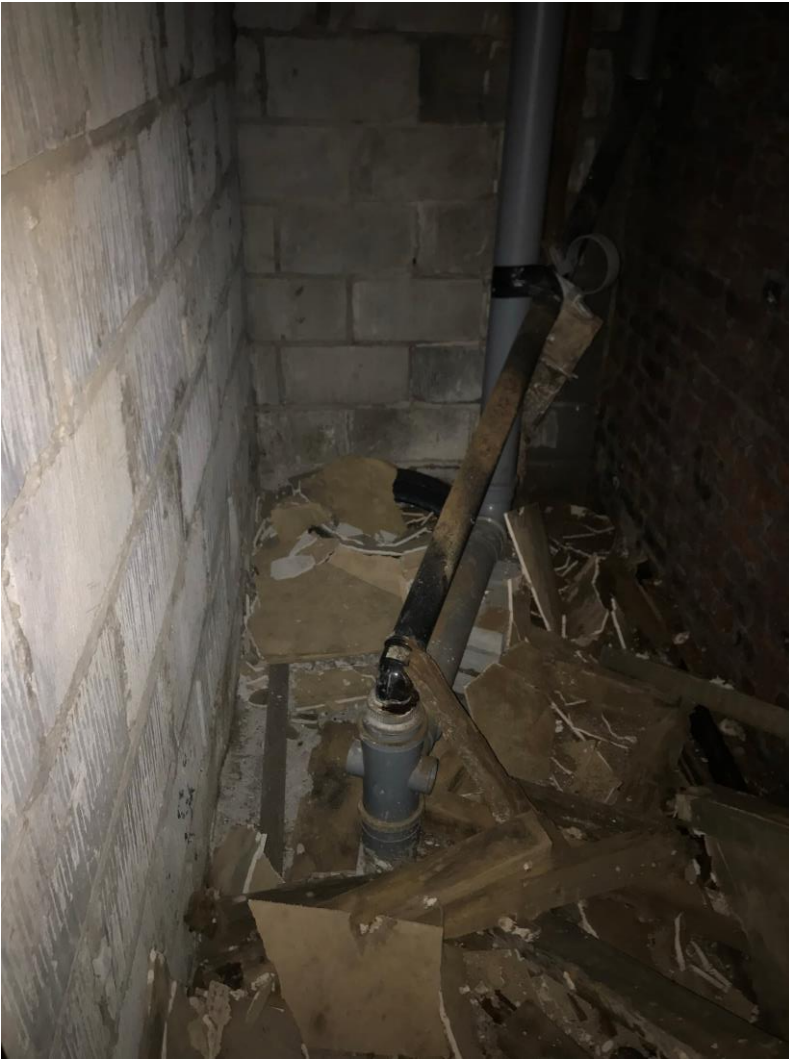
25) Debris to basement level. Location of existing foul waste which will be connected into as part of the WC construction works.

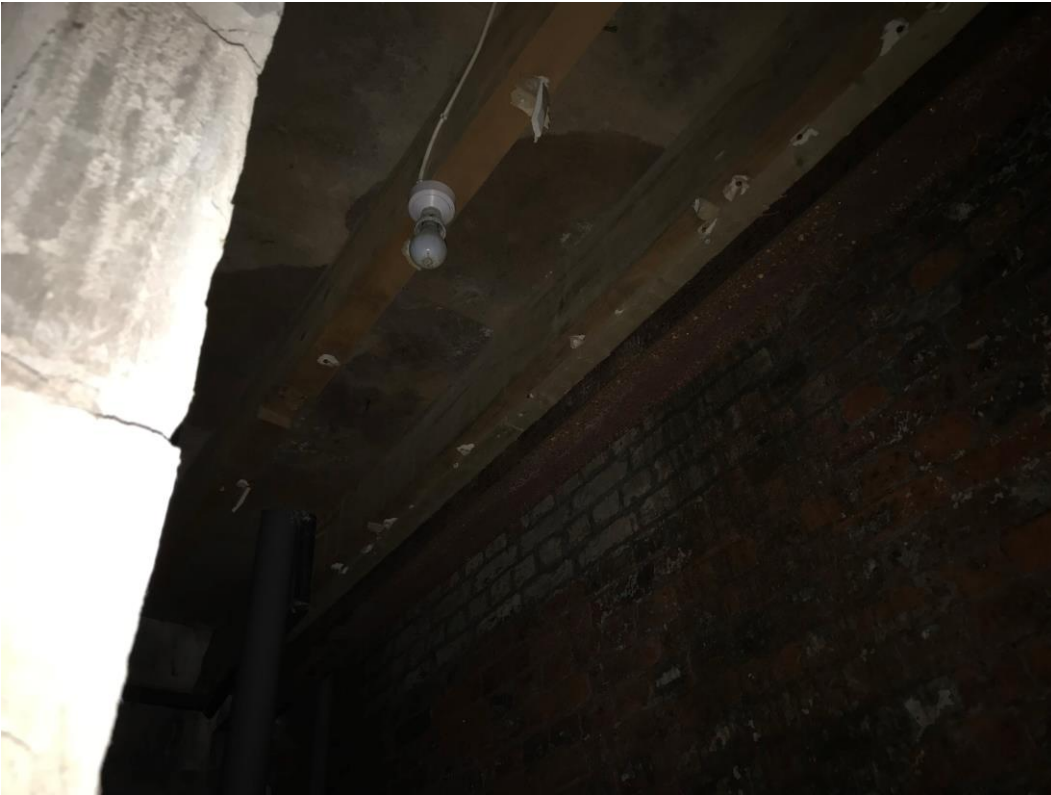
26) Underside of the mezzanine structure, which is damp affected and not fit for purpose.

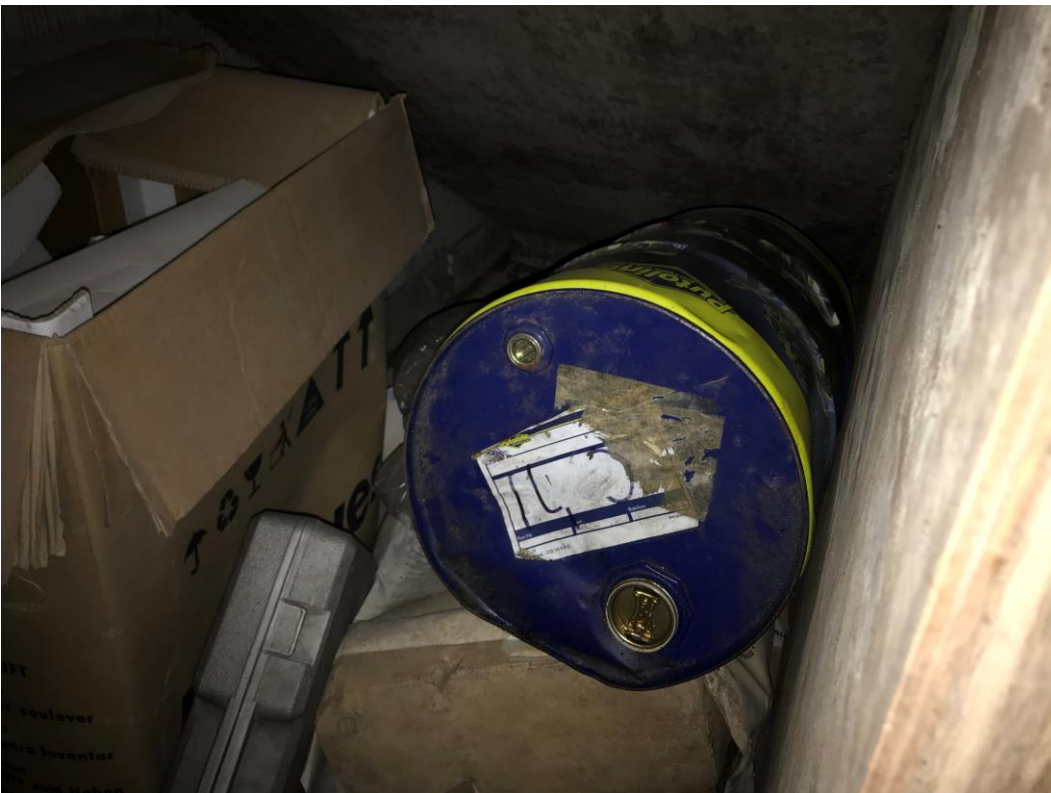
27) Debris to basement level.
