10000612 – 77 Whitworth Street West, Manchester – Photo Appendix

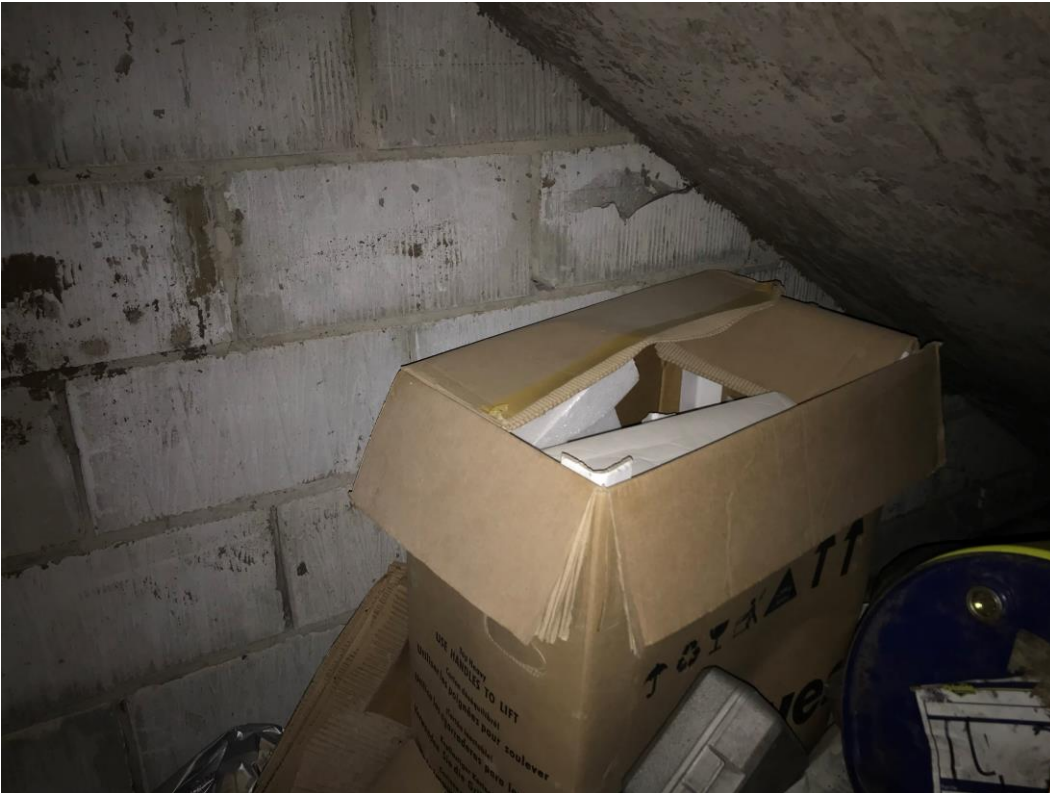
28) Debris to basement level.

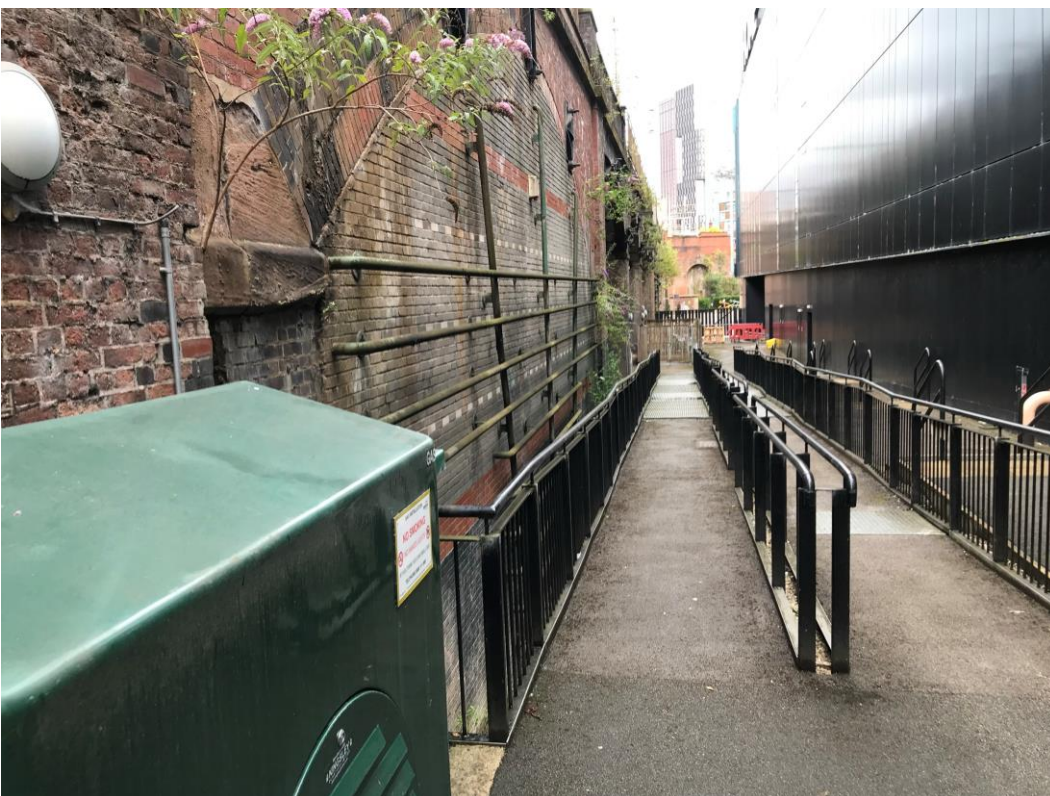
29) Overview of the rear infill with the neighbouring retaining structure in close proximity.

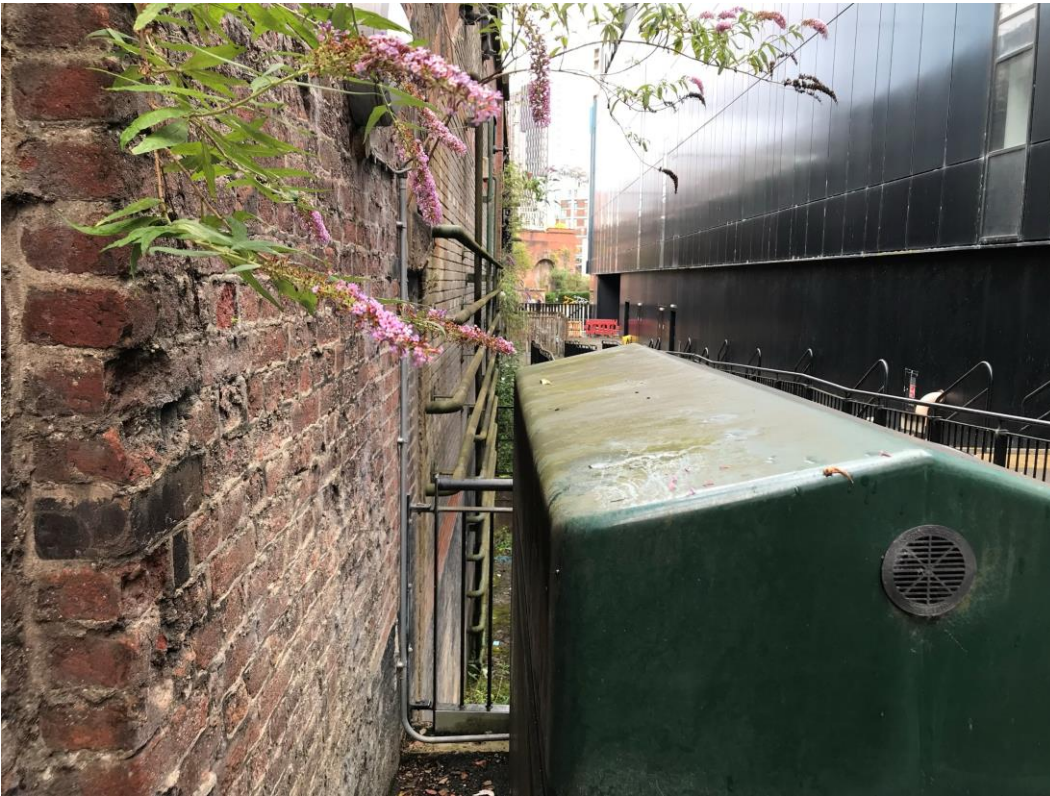
30) Overview of the rear infill with the neighbouring retaining structure in close proximity.

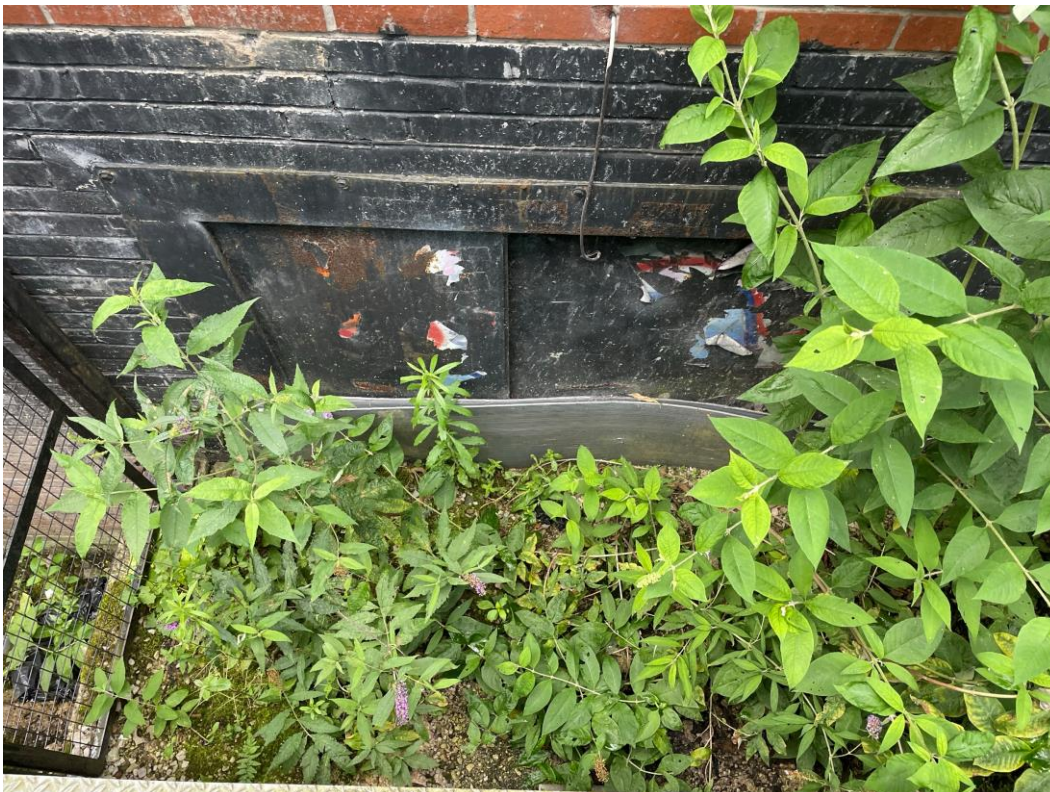
31) The rear emergency exit to 77 Whitworth Street West with the neighbouring retaining structure being built in close proximity, meaning that it is unsafe and impractical to use this exit.

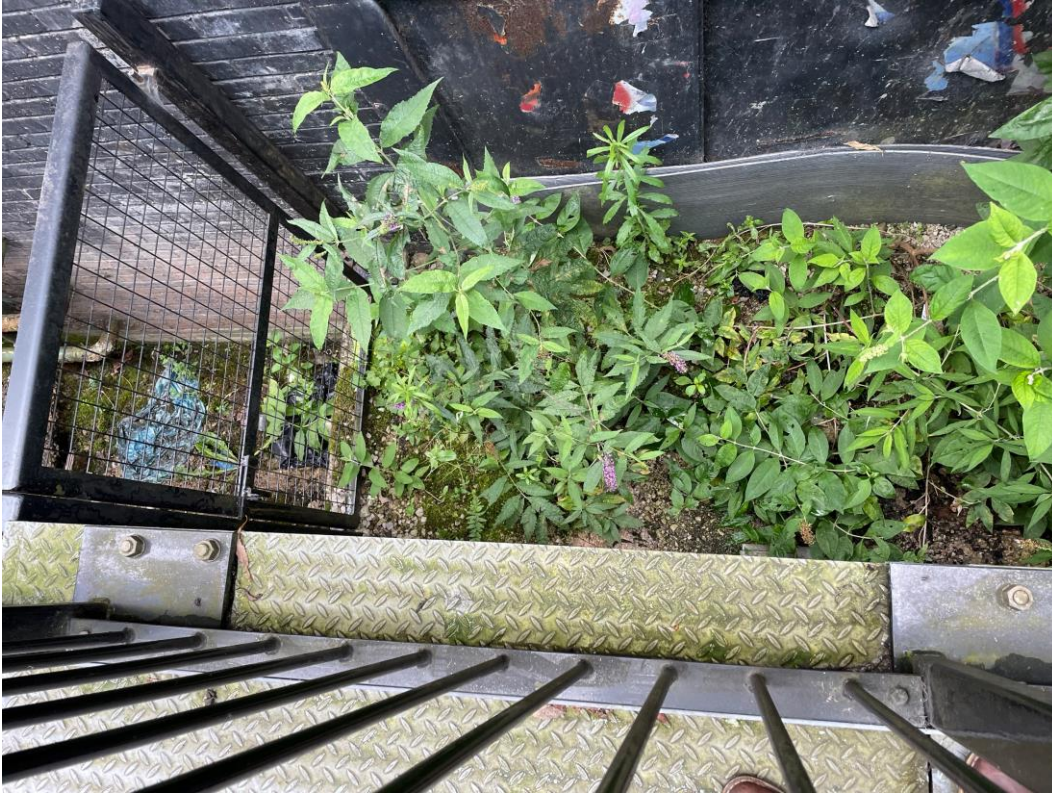
32) The rear emergency exit to 77 Whitworth Street West with the neighbouring retaining structure being built in close proximity, meaning that it is unsafe and impractical to use this exit.

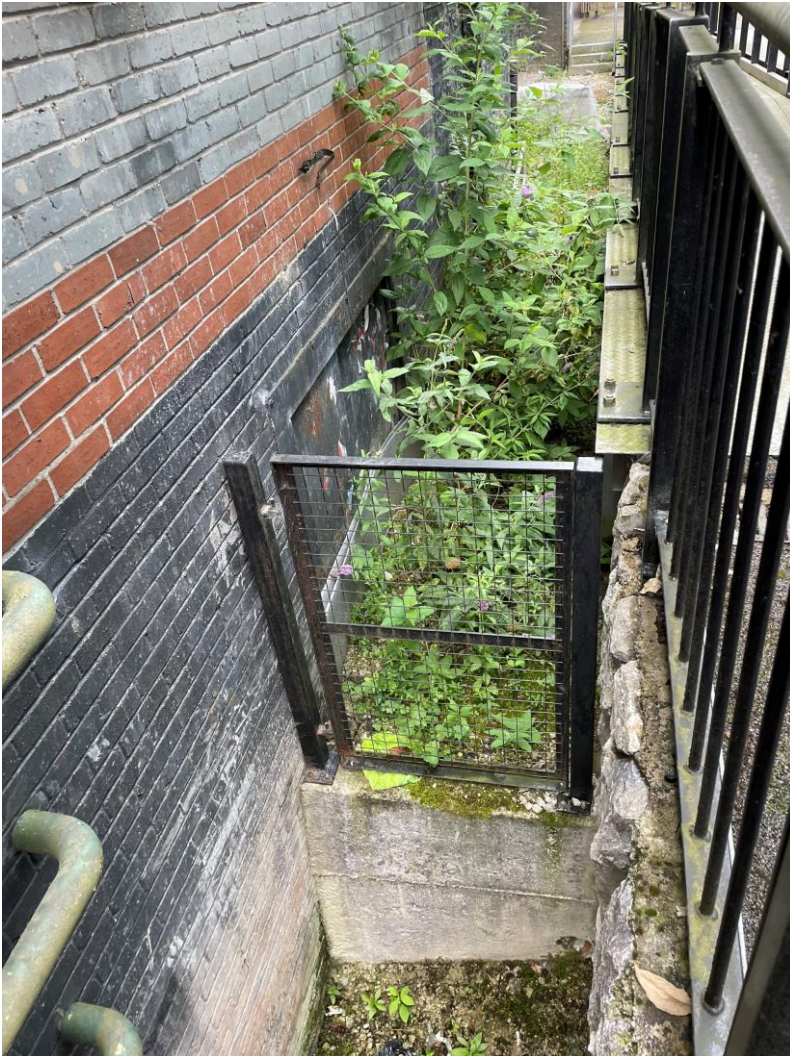
33) The rear emergency exit to 77 Whitworth Street West with the neighbouring retaining structure being built in close proximity, meaning that it is unsafe and impractical to use this exit.

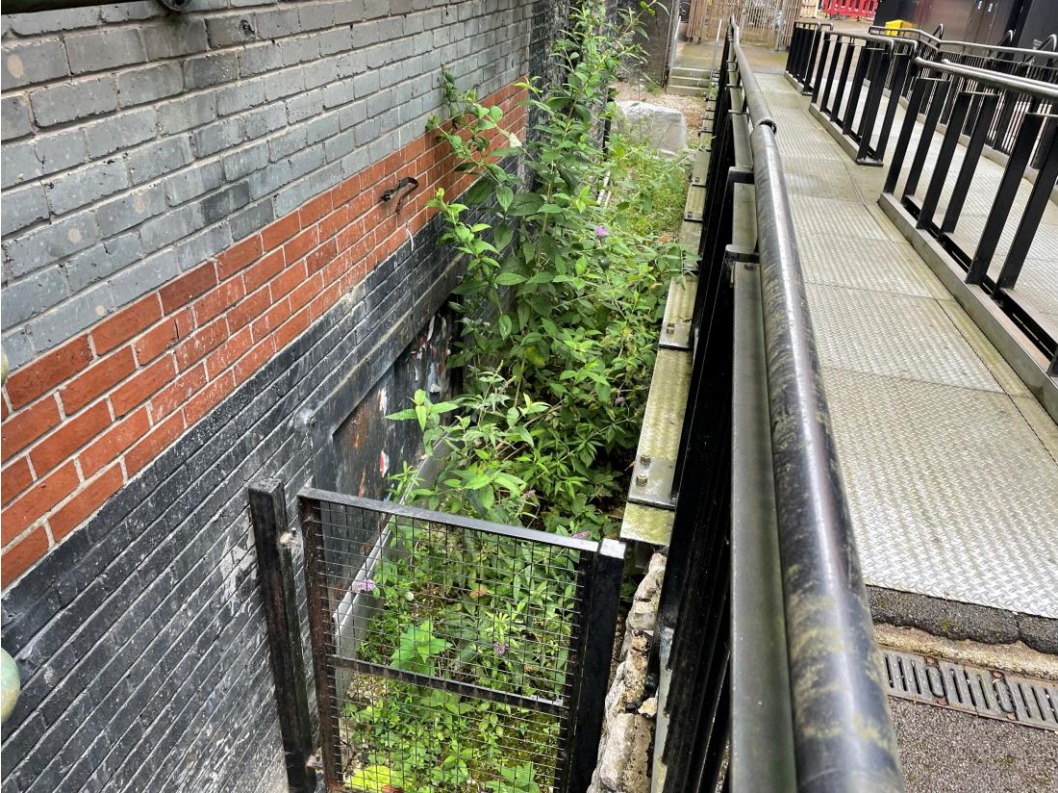
34) The rear emergency exit to 77 Whitworth Street West with the neighbouring retaining structure being built in close proximity, meaning that it is unsafe and impractical to use this exit.

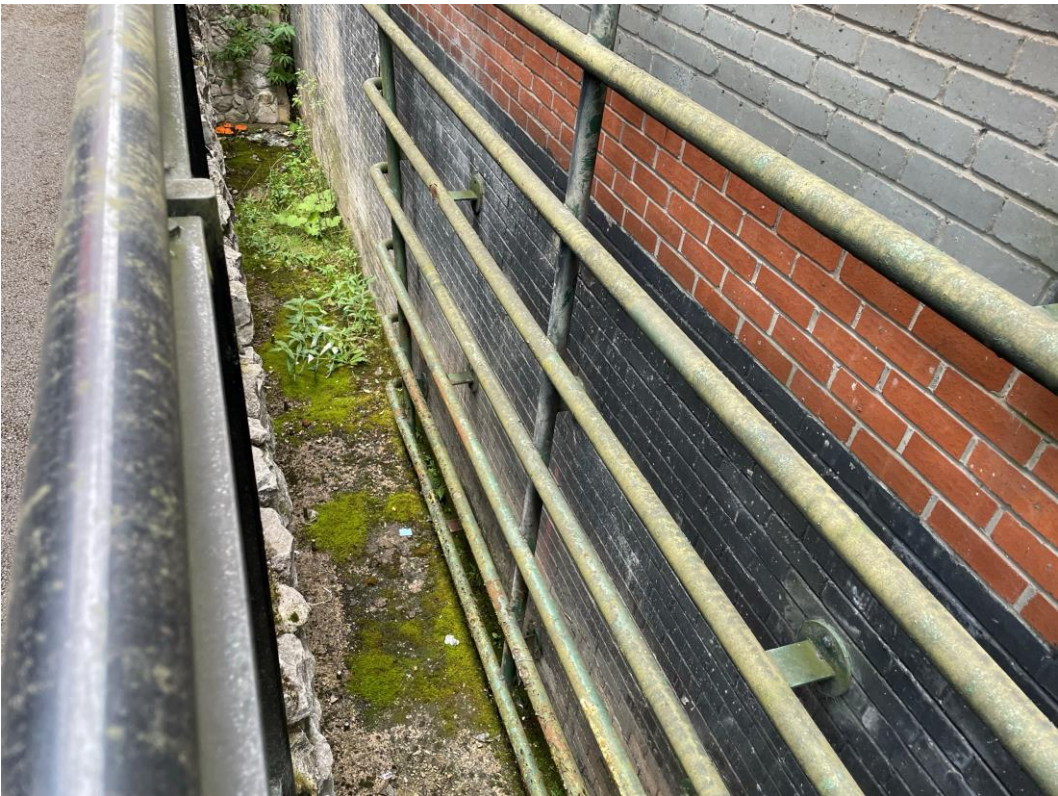
35) The rear emergency exit to 77 Whitworth Street West with the neighbouring retaining structure being built in close proximity, meaning that it is unsafe and impractical to use this exit.
