**PASSENGER LIFT CONDITION SURVEY**  
**3 York Street**  
**Manchester**  
**M2 2AW**

**On behalf of:**

**Design Coalition**  
**C/o Mitchells & Butler**  
**1 Navigation Court**  
**Calder Park**  
**Wakefield**  
**WF2 7BJ**

**ARDENT Lift Consultancy**  
**Ground Floor Office**  
**4 High Road West**  
**Felixstowe, Suffolk IP11 9JB**  
[\*\*info@ardentlc.co.uk\*\*](mailto:info@ardentlc.co.uk)

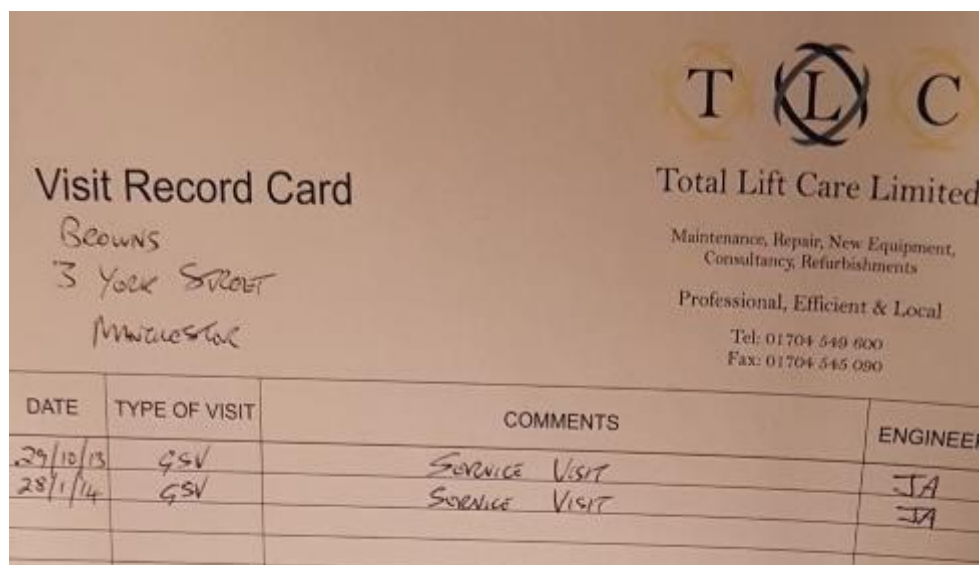
The last recorded maintenance visit shown on site was made by Total Lift Care Ltd 28<sup>th</sup> January 2014, it is assumed the lift has been out of normal service since then. No further records were available on site.

If the lift is to be reinstated as it currently exists, a full maintenance regime should be undertaken, in addition, LOLER inspections and BS5655–Part 10 test, must be undertaken to ensure the lift remains safe for use.

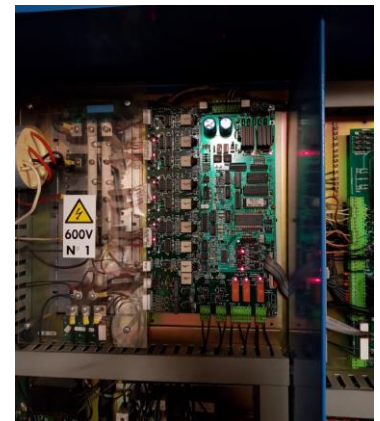
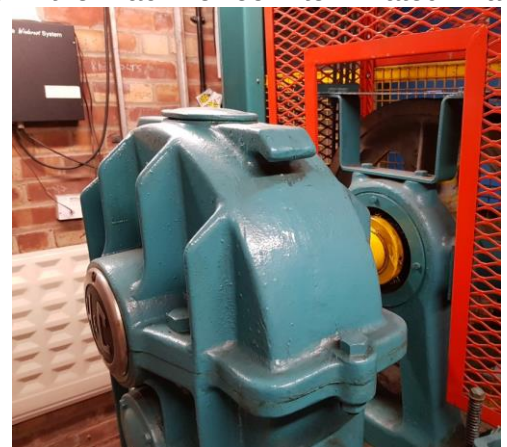
- 2.1.10 The main hoisting unit is the original Hammond & Champness No3 worn reduction gearbox as originally installed in the mid 1960's. This machine is obsolete being considered to be far beyond its original design life. We recommend this machine is replaced by a modern gearless alternative.

- 2.1.11 It was noted that both the car and balance weight buffer points are sited on the pit reinforced concrete slab. Consideration should be given for the transfer of buffer loads down through the machine room and machine room slab.

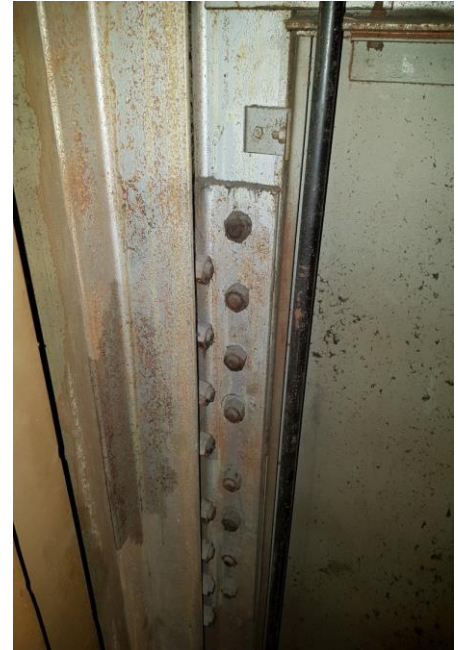
- 2.2.11 The reeving pulleys are currently housed above the shaft in the roof space supported directly by the lift shaft structural tower. This area is exposed, resulting in a potentially dangerous situation, whereby those accessing the roof space can access the unguarded pulleys and open lift shaft. Previously, the head of the shaft had a board cladding which is partially

removed, this was not load bearing. This situation is potentially dangerous and life threatening to those working on the lift or in the roof space and needs to be addressed urgently.

2.2.12 The revving pulleys must be fully inspected and or renewed. Thereafter guarded and “anti-rope jump” devices added.

2.2.13 The shaft structure should be extended up through the roof space to provide a safe working space for both lift engineers and other trades persons. If access is provided into this area emergency lift stop switches and decking to provide safe access. Should the shaft be extended to the existing roof structure, this area above the shaft should be protected against propagation of fire throughout the roof structure.

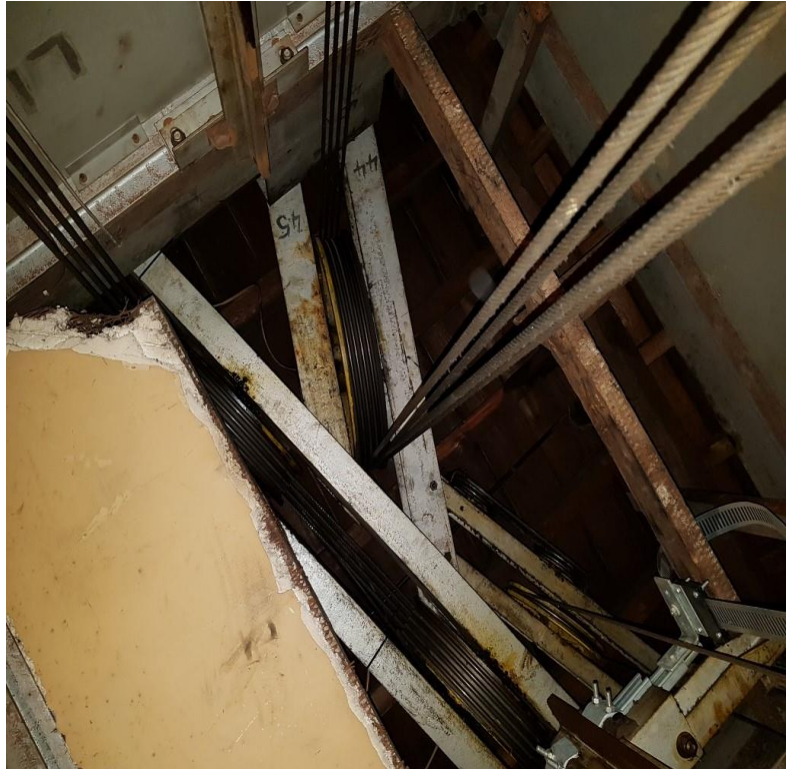
2.2.14 The balance weight rope hitch is of a “single pin” rope tension equalisation type. This must be replaced for a conventional multipoint hitch using compression springs for rope tension equalisation as part of any future planned works.

2.2.15 The balance weight assembly should be assessed and checked for adequate size and mass for the lift car as existing and or any intended works to achieve balance at 50% of the duty load.

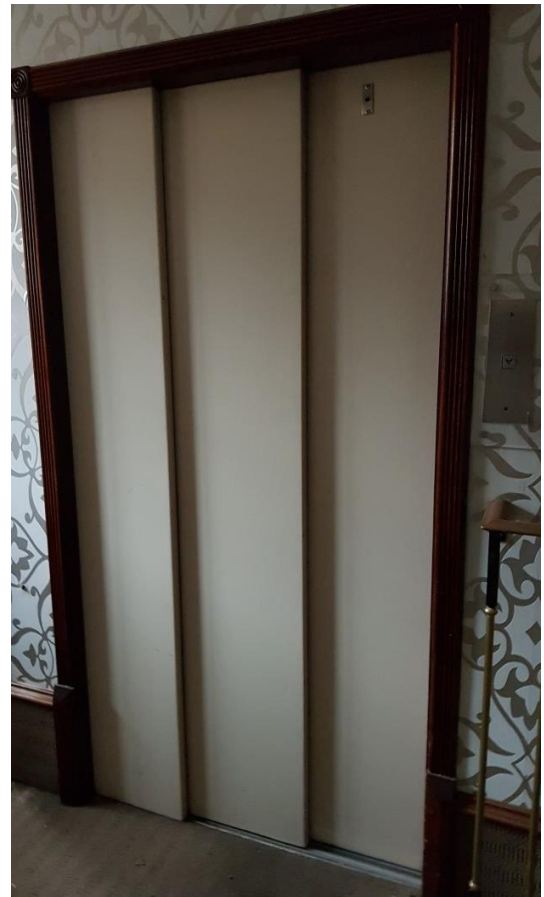
- 2.4.6 The landing buttons are electro-mechanical type, and formed part of the control system replacement works carried out in 1996 approx. These are not compliant with the Equality Act 2010 both in operation and location.

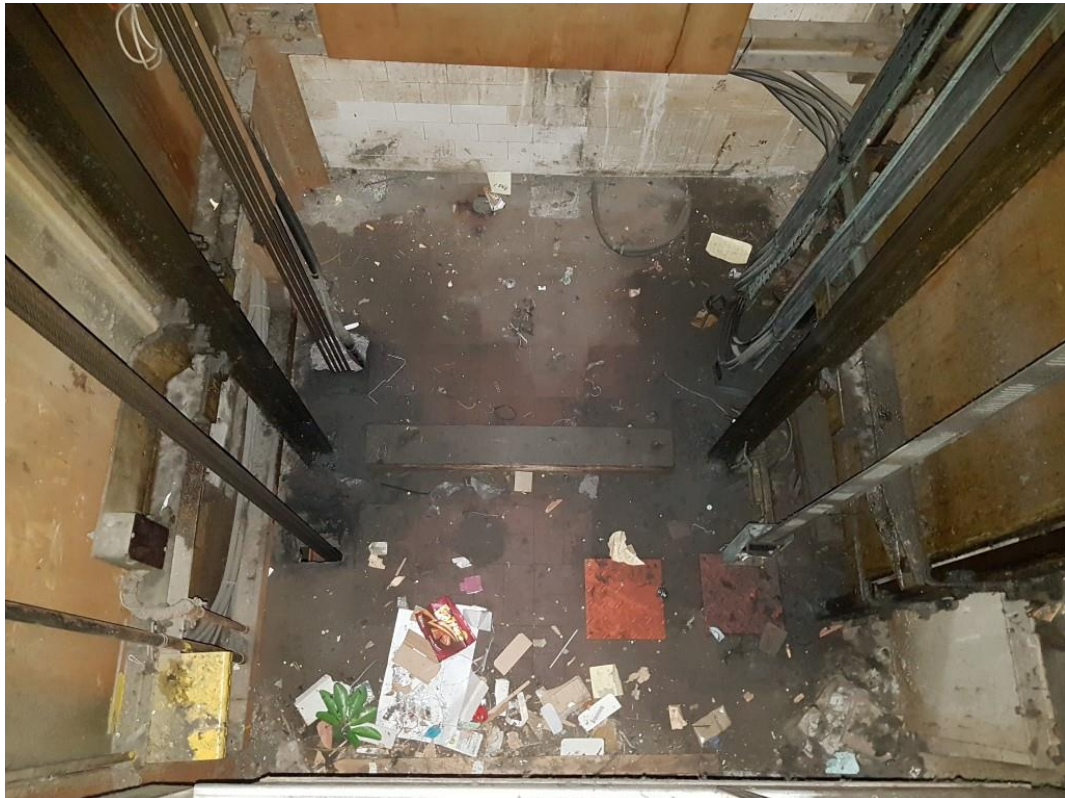
- 2.5.8 Protection to be provided around pit slab rope apertures.
- 2.5.9 An imperforate balance weight guard will be required, of sufficient height to comply with EN81, also including a vision panel to enable the lift rope lengths to be readily observed and checked during maintenance and inspection. The current guard is of insufficient height at 2200mm
