# London Road Fire Station

Manchester

Internal Repairs – Third Floor

## London Road Fire Station, Manchester – Schedule of Enabling Works for Internal Repairs – Third Floor

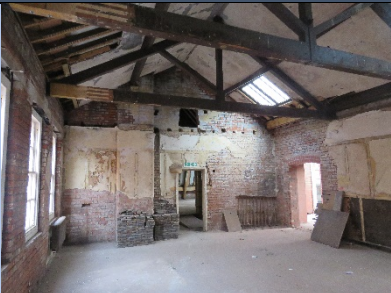
| Room Ref. | Element | Description / Item | Condition | Action | Photographs | | | | |
|---|---|---|---|---|---|---|--|--|---|
| 302 | Walls | Plaster on brickwork with paint and wallpaper finish. | Fair | <ul style="list-style-type: none"> <li>Hammer test remaining plaster and remove any bossed plaster (except where walls to be stripped to bare masonry).</li> <li>Brush down areas of flaking paint (except where walls to be stripped to bare masonry).</li> <li>Remove all peeling wallpaper (except where walls to be stripped to bare masonry).</li> </ul> <hr/> <ul style="list-style-type: none"> <li>Existing north, south &amp; east walls stripped back to bare masonry.</li> <li>Patch in new lime plaster to Minshull Street wall NBS:M20/210A ready for decoration.</li> </ul> <p><i>NOTE: Access not available at time of survey, details provisional for pricing purposes only</i></p> | | | | | 006 |

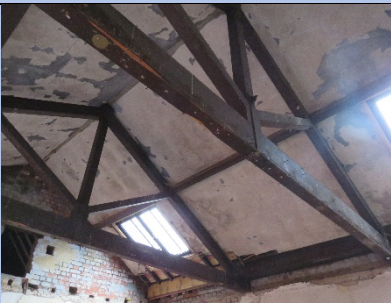
| Room Ref. | Element | Description / Item | Condition | Action | Photographs | | | | |
|---|---|---|---|---|---|---|--|--|---|
| | Ceiling | Exposed roof truss and rafters, not painted. Plaster to underside of rafters | Good / fair | <ul style="list-style-type: none"> <li>Remove nails and screws from timberwork.</li> <li>Clean roof truss.</li> <li>All existing ceilings to be removed</li> <li>Provide new insulated plasterboard ceiling below rafters (to be read in conjunction with roof type drawing 3501)</li> </ul> <p><i>NOTE: Access not available at time of survey, details provisional for pricing purposes only</i></p> | | | | | |

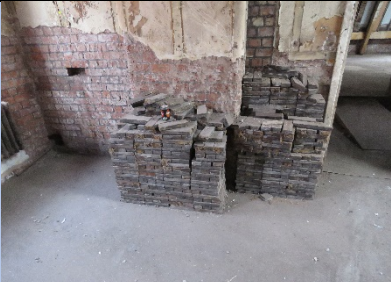
| Room Ref. | Element | Description / Item | Condition | Action | Photographs | | | | |
|---|---|---|---|---|---|---|--|--|---|
| | Floor | Exposed concrete floor (previously wood block with glazed tile hearth, now removed and stacked in room). | Good | <ul style="list-style-type: none"> <li>Remove all debris.</li> <li>Quantify wood block and put on pallet in room.</li> </ul> <hr/> <p>Proposed works</p> <ul style="list-style-type: none"> <li>Provide new polished screed (NBS:E41/112) finish.</li> <li>Provide resin thresholds.</li> </ul> <p><i>NOTE: Access not available at time of survey, details provisional for pricing purposes only</i></p> | | | | | |

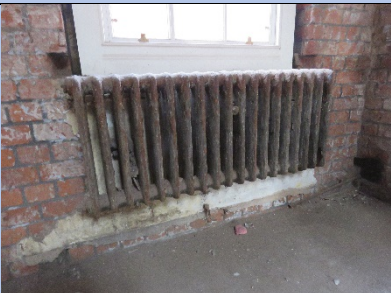
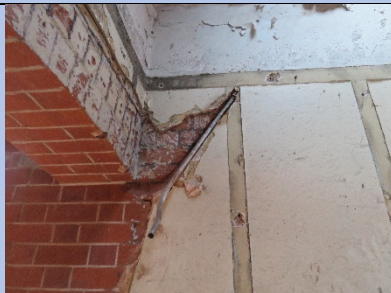
| Room Ref. | Element | Description / Item | Condition | Action | Photographs | | | | |
|---|---|---|---|---|---|---|--|--|---|
| | Misc. | 2no. radiators hung on wall with support brackets / fixings. Electrical conduit to wall. | Fair / poor | <ul style="list-style-type: none"> <li>Remove radiator from wall and store in room (fill holes in wall).</li> <li>Remove fixings and wall bracket and dispose (fill holes in wall).</li> <li>Remove electrical conduit (fill holes in wall).</li> </ul> <p><i>NOTE: Access not available at time of survey, details provisional for pricing purposes only</i></p> | | | | | |

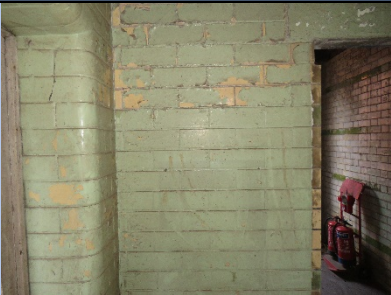
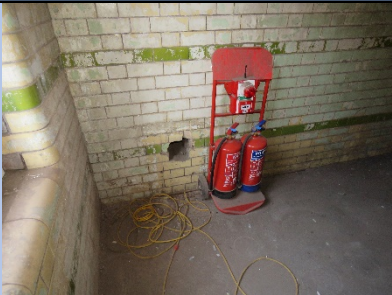
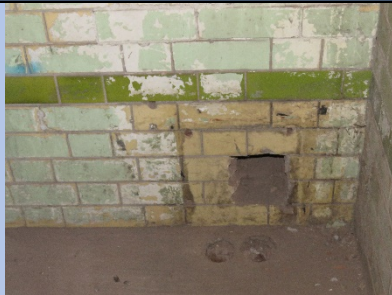
| Room Ref. | Element | Description / Item | Condition | Action | Photographs | | | |
|---|---|---|---|---|---|---|---|---|
| S01 | Walls | Glazed brick partially painted.<br>Holes to brickwork. | Good / poor | <ul style="list-style-type: none"> <li>Remove flaking paint with hand tools.</li> <li>Remove remaining paint using peelaway.</li> <li>Repair holes with salvaged glazed brick.</li> <li>Existing glazed brick cleaned and protected.</li> </ul> <p><i>NOTE: Access not available at time of survey, details provisional for pricing purposes only</i></p> | | | | 007 |

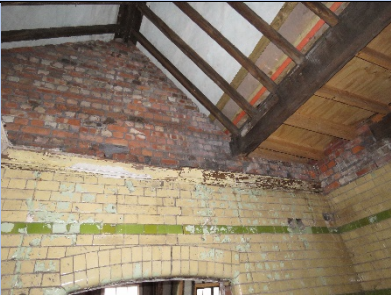
| Room Ref. | Element | Description / Item | Condition | Action | Photographs | | | |
|---|---|---|---|---|---|---|---|---|
| | Ceiling | No ceiling, exposed roof structure. | N/A | <ul style="list-style-type: none"> <li>Clean down roof timbers and de-nail.</li> </ul> <p>Proposed works</p> <ul style="list-style-type: none"> <li>All existing ceilings to be removed</li> <li>Provide new insulated plasterboard ceiling below rafters (to be read in conjunction with roof type drawing 3501)</li> </ul> <p><i>NOTE: Access not available at time of survey, details provisional for pricing purposes only</i></p> | | | | |

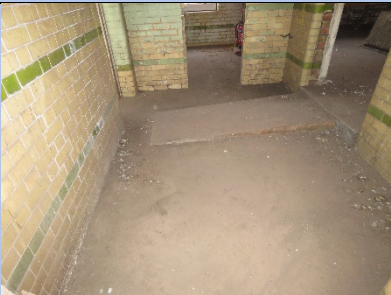
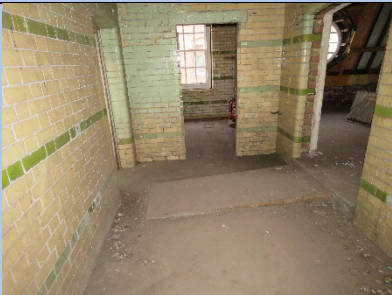
| Room Ref. | Element | Description / Item | Condition | Action | Photographs | | | |
|---|---|---|---|---|---|---|---|---|
| | Floor | Exposed concrete floor with minor holes. | N/A | <ul style="list-style-type: none"> <li>Remove all debris and undertake concrete repair to holes.</li> </ul> <p>Proposed works</p> <ul style="list-style-type: none"> <li>Carry out repairs to cracks and holes in concrete floors (NBS:M10/121)</li> <li>Clean and polish existing concrete floor following repairs.</li> </ul> <p><i>NOTE: Access not available at time of survey, details provisional for pricing purposes only</i></p> | | | | |

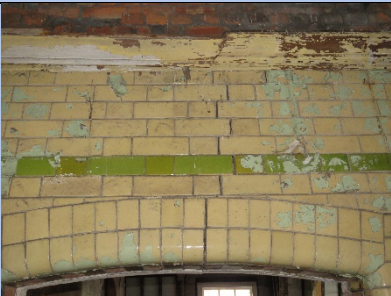
| Room Ref. | Element | Description / Item | Condition | Action | Photographs | | | |
|---|---|---|---|---|---|---|---|---|
| | Misc. | Curtins to inspect and specify repair to cracked brickwork. | | <ul style="list-style-type: none"> <li>CURTINS COMMENT: Helifix crack stitching to standard detail CS05. Repoint.</li> </ul> | | | | |

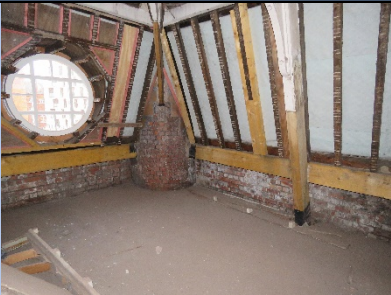
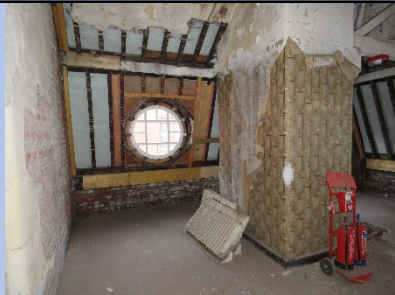
| Room Ref. | Element | Description / Item | Condition | Action | Photographs | | | |
|---|---|---|---|---|---|---|---|---|
| 303 | Walls | Plaster on brickwork with paint and wallpaper finish.<br>Holes to red brick walls. | Fair | <ul style="list-style-type: none"> <li>• Hammer test remaining plaster and remove any bossed plaster (except where walls to be stripped to bare masonry).</li> <li>• Brush down areas of flaking paint (except where walls to be stripped to bare masonry).</li> <li>• Remove all peeling wallpaper (except where walls to be stripped to bare masonry).</li> <li>• Fix salvaged red brick to holes.</li> </ul> <hr/> Proposed works <ul style="list-style-type: none"> <li>• Patch in new lime plaster to north (MMS &amp; WWS) walls NBS:M20/210A ready for decoration.</li> <li>• All other walls to be stripped back to masonry.</li> </ul> <i>NOTE: Access not available at time of survey, details provisional for pricing purposes only</i> | | | | 003 |

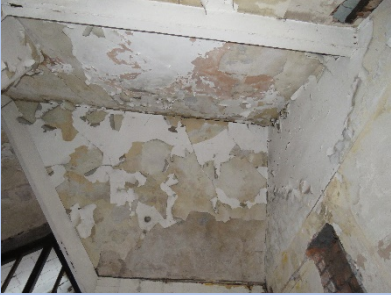
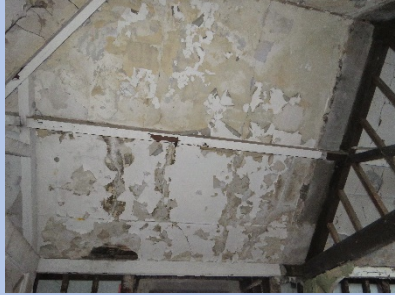
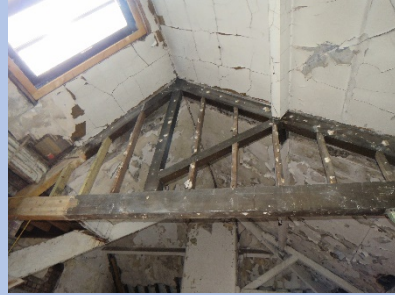
| Room Ref. | Element | Description / Item | Condition | Action | Photographs | | | |
|---|---|---|---|---|---|---|---|---|
| | Ceiling | Exposed roof truss and rafters, partially painted.<br>Plaster to underside of rafters, paint finish. | Good / fair | <ul style="list-style-type: none"> <li>• Remove flaking paint, nails and screws from timberwork.</li> <li>• Clean roof truss.</li> </ul> Proposed works <ul style="list-style-type: none"> <li>• All existing ceilings to be removed</li> <li>• Provide new insulated plasterboard ceiling below rafters (to be read in conjunction with roof type drawing 3501)</li> </ul> <i>NOTE: Access not available at time of survey, details provisional for pricing purposes only</i> | | | | |

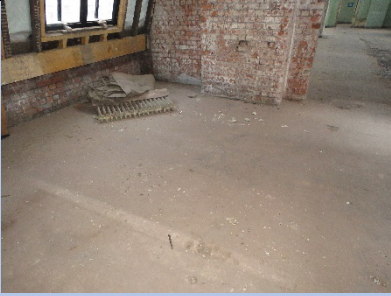
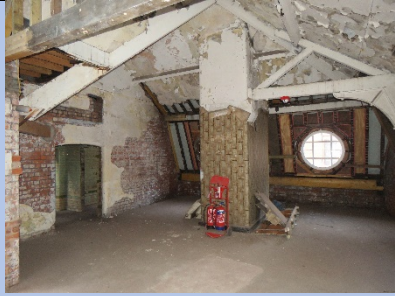
| Room Ref. | Element | Description / Item | Condition | Action | Photographs | | | |
|---|---|---|---|---|---|---|---|---|
| | Floor | Exposed concrete floor. | Good | <ul style="list-style-type: none"> <li>• Remove all debris.</li> </ul> <hr/> Proposed works <ul style="list-style-type: none"> <li>• Install reclaimed parquet floor on resilient layer NBS:M10/295A</li> <li>• Existing quarry floor tiles cleaned and retained.</li> <li>• Provide new resin Thresholds.</li> </ul> | | | | |

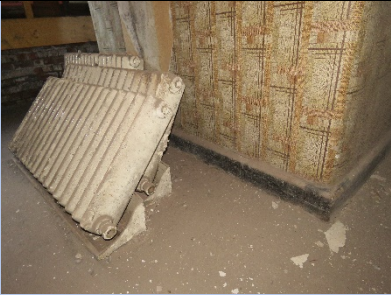
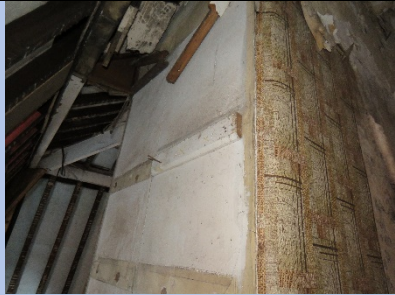
| Room Ref. | Element | Description / Item | Condition | Action | Photographs | | | |
|---|---|---|---|---|---|---|---|---|
| | Joinery | Skirting board and fixtures rail in-situ.<br>Timber conduit.<br>Timber bead to wall and ceiling junction | | Proposed works <ul style="list-style-type: none"> <li>• Repair/reinstate timber picture rail, skirting, conduit and beading to repaired lime plaster on north &amp; west walls (MSS/WWS).</li> <li>• Repair/reinstate render skirtings to bare masonry walls.</li> </ul> <i>NOTE: Access not available at time of survey, details provisional for pricing purposes only</i> | | | | |

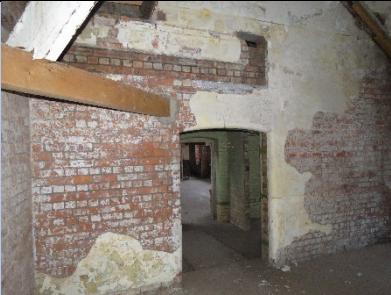
| Room Ref. | Element | Description / Item | Condition | Action | Photographs | | | |
|---|---|---|---|---|---|---|---|---|
| | Misc. | Curtins to inspect and specify repair to cracked brickwork above door to S01.<br>4no. radiators in room.<br>Miscellaneous debris / waste. | | <ul style="list-style-type: none"> <li>• CURTINS COMMENT: Helifix crack stitching to standard detail CS05. Repoint. Note doorway proposed to be infilled so could be cheaper to infill in masonry so lintel repair no longer required.</li> <li>• Record and store radiators in heritage store room.</li> <li>• Remove all other waste.</li> </ul> | | | | |

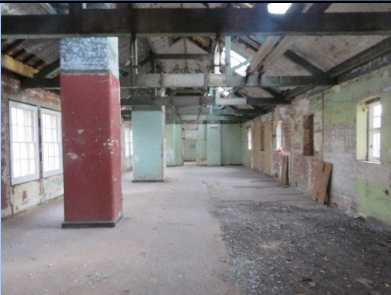
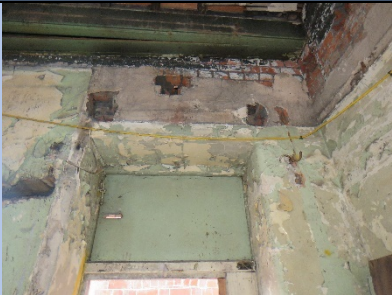
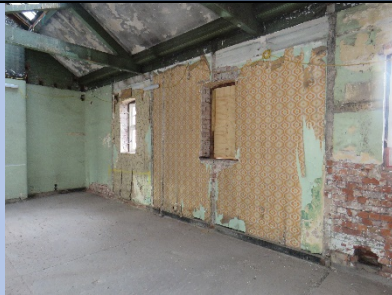
| Room Ref. | Element | Description / Item | Condition | Action | Photographs | | | |
|---|---|---|---|---|---|---|---|---|
| 304a + 306a | Walls | Plaster on brickwork with paint and wallpaper finish.<br>Holes to red brick walls.<br>Misc. screws and M&E fixings. | Fair | <ul style="list-style-type: none"> <li>Hammer test remaining plaster and remove any bossed plaster (except where walls to be stripped to bare masonry).</li> <li>Brush down areas of flaking paint (except where walls to be stripped to bare masonry).</li> <li>Remove all peeling wallpaper (except where walls to be stripped to bare masonry).</li> <li>Fix salvaged red brick to holes.</li> <li>Remove all screws and fixings from walls.</li> </ul> <hr/> Proposed works <ul style="list-style-type: none"> <li>Patch in new lime plaster to north (WWS) wall and courtyard wall NBS:M20/210A ready for decoration.</li> <li>All other walls to be stripped back to masonry.</li> </ul> <i>NOTE: Access not available at time of survey, details provisional for pricing purposes only</i> | | | | 004 |

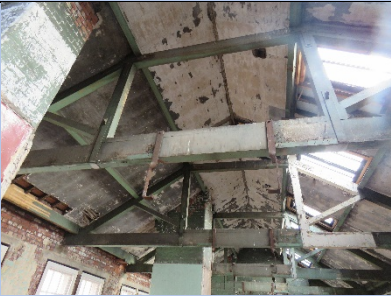
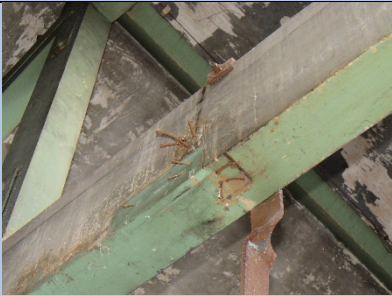
| Room Ref. | Element | Description / Item | Condition | Action | Photographs | | | |
|---|---|---|---|---|---|---|---|---|
| | Ceiling | Exposed roof truss and rafters, partially painted.<br>Plaster to underside of rafters, paint finish. | Good / fair | <ul style="list-style-type: none"> <li>Remove flaking paint, nails and screws from timberwork.</li> <li>Clean roof truss.</li> <li>Retain iron hangers to trusses (check fixings are sufficient &amp; replace with new if required).</li> </ul> <hr/> Proposed works <ul style="list-style-type: none"> <li>All existing ceilings to be removed</li> <li>Provide new insulated plasterboard ceiling below rafters (to be read in conjunction with roof type drawing 3501)</li> </ul> <i>NOTE: Access not available at time of survey, details provisional for pricing purposes only</i> | | | | |

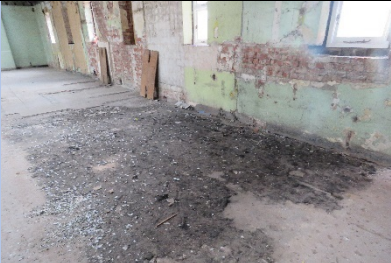
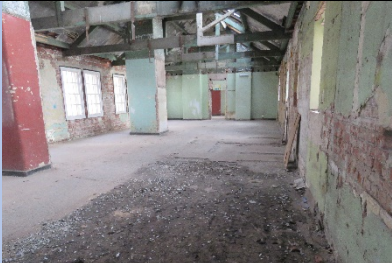
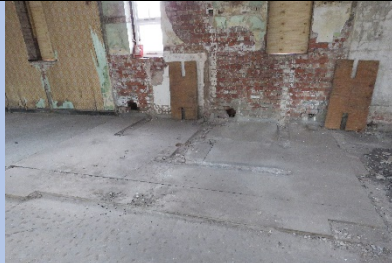
| Room Ref. | Element | Description / Item | Condition | Action | Photographs | | | |
|---|---|---|---|---|---|---|---|---|
| | Floor | Exposed concrete floor with remnants of carpet underlay.<br>Area of terrazzo tiles. | Good | <ul style="list-style-type: none"> <li>Remove underlay and adhesive back to exposed concrete.</li> <li>Remove all debris.</li> </ul> <hr/> Proposed works <ul style="list-style-type: none"> <li>Install reclaimed parquet floor on resilient layer NBS:M10/295A</li> <li>Existing quarry floor tiles cleaned and retained.</li> <li>Provide new resin Thresholds.</li> </ul> | | | | |

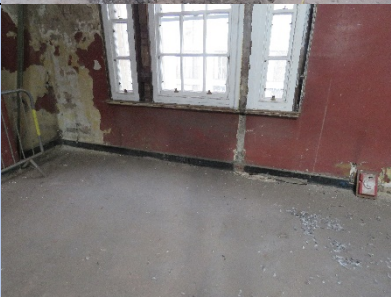
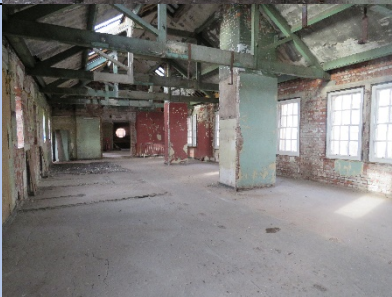
| Room Ref. | Element | Description / Item | Condition | Action | Photographs | | | |
|---|---|---|---|---|---|---|---|---|
| | Joinery | Skirting board in-situ.<br>Timber bead to wall and ceiling junction | | Proposed works <ul style="list-style-type: none"> <li>Repair/reinstate timber picture rail, skirting, conduit and beading to repaired lime plaster on north &amp; south walls (WWS).</li> <li>Repair/reinstate render skirtings to bare masonry walls.</li> </ul> <i>NOTE: Access not available at time of survey, details provisional for pricing purposes only</i> | | | | |

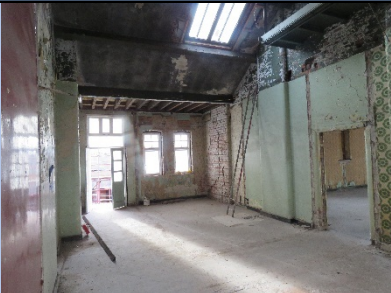
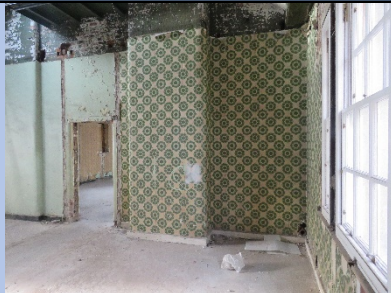
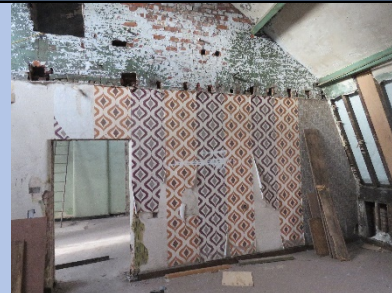
| Room Ref. | Element | Description / Item | Condition | Action | Photographs | | | |
|---|---|---|---|---|---|---|---|---|
| 310a + 310b | Walls | Plaster on brickwork with paint and wallpaper finish.<br>Holes to red brick walls.<br>Misc. screws and M&E fixings. | Fair | <ul style="list-style-type: none"> <li>• Hammer test remaining plaster and remove any bossed plaster (except where walls to be stripped to bare masonry).</li> <li>• Brush down areas of flaking paint (except where walls to be stripped to bare masonry).</li> <li>• Remove all peeling wallpaper (except where walls to be stripped to bare masonry).</li> <li>• Fix salvaged red brick to holes.</li> <li>• Remove all screws and fixings from walls.</li> </ul> <hr/> Proposed works <ul style="list-style-type: none"> <li>• Patch in new lime plaster to north (WWS) wall and courtyard wall NBS:M20/210A ready for decoration.</li> <li>• All other walls to be stripped back to masonry.</li> </ul> <i>NOTE: Access not available at time of survey, details provisional for pricing purposes only</i> | | | | 004 |

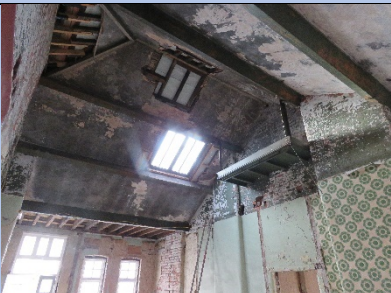
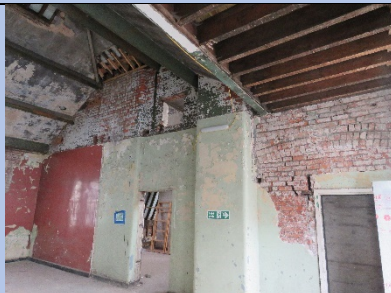
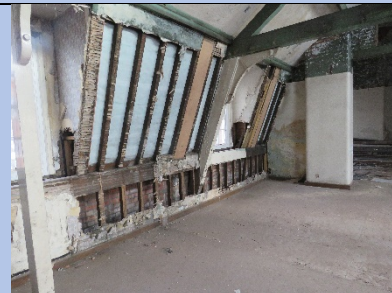
| Room Ref. | Element | Description / Item | Condition | Action | Photographs | | | |
|---|---|---|---|---|---|---|---|---|
| | Ceiling | Exposed roof truss and rafters, partially painted.<br>Plaster to underside of rafters, paint finish.<br>Misc. M&E fixings and nails. | Good / fair | <ul style="list-style-type: none"> <li>• Remove flaking paint, nails and screws from timberwork.</li> <li>• Clean roof truss.</li> <li>• Remove any redundant fixings.</li> </ul> <hr/> Proposed works <ul style="list-style-type: none"> <li>• All existing ceilings to be removed</li> <li>• Provide new insulated plasterboard ceiling below rafters (to be read in conjunction with roof type drawing 3501)</li> </ul> <i>NOTE: Access not available at time of survey, details provisional for pricing purposes only</i> | | | | |

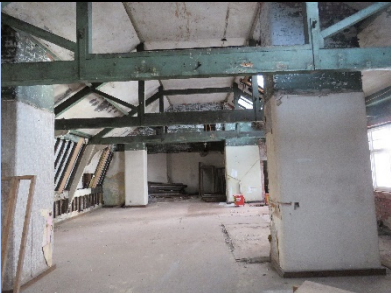
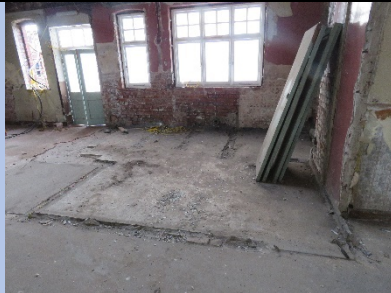
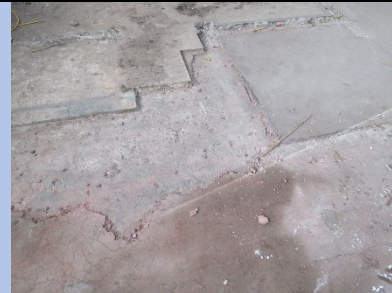
| Room Ref. | Element | Description / Item | Condition | Action | Photographs | | | |
|---|---|---|---|---|---|---|---|---|
| | Floor | Exposed concrete floor with remnants of carpet underlay and floor screed.<br>Area of terrazzo tiles. | Good | <ul style="list-style-type: none"> <li>• Remove screed, underlay and adhesive back to exposed concrete.</li> <li>• Remove all debris.</li> <li>• Remove terrazzo tiles.</li> </ul> <hr/> Proposed works <ul style="list-style-type: none"> <li>• Install reclaimed parquet floor on resilient layer NBS:M10/295A</li> <li>• Existing quarry floor tiles cleaned and retained.</li> <li>• Provide new resin Thresholds.</li> </ul> | | | | |

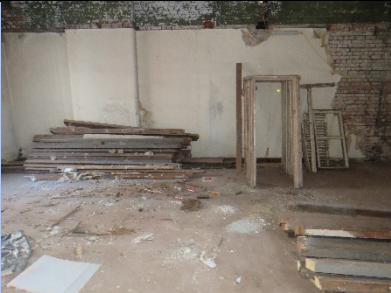
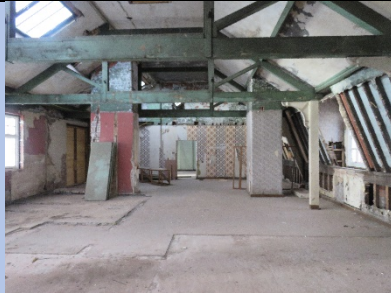
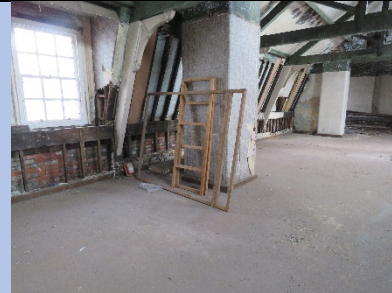
| Room Ref. | Element | Description / Item | Condition | Action | Photographs | | | |
|---|---|---|---|---|---|---|---|---|
| | Joinery | Skirting board in-situ.<br>Timber bead to wall and ceiling junction.<br>4no. cubicle doors and frames.<br>Piles of misc. timber. | | Proposed works <ul style="list-style-type: none"> <li>• Repair/reinstate timber picture rail, skirting, conduit and beading to repaired lime plaster on north (WWS) &amp; south (courtyard) walls.</li> <li>• Repair/reinstate render skirtings to bare masonry walls.</li> <li>• Cubicle doors and frames to be removed.</li> </ul> <i>NOTE: Access not available at time of survey, details provisional for pricing purposes only</i> | | | | |

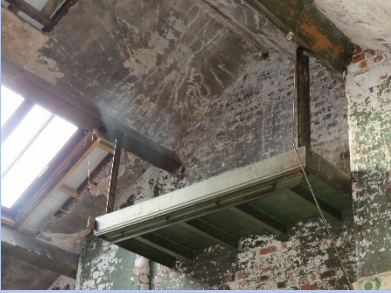
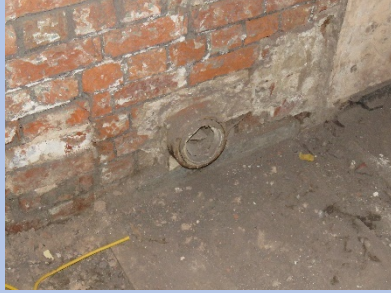
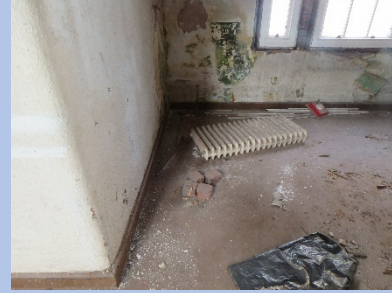
| Room Ref. | Element | Description / Item | Condition | Action | Photographs | | | |
|---|---|---|---|---|---|---|---|---|
| | Misc. | Timber and steel shelf.<br>Soil pipe to wall.<br>4no. radiators. | N/A | <ul style="list-style-type: none"> <li>• Clean down timber shelf and remove flaking paint (review fixings with Structural Engineer and replace fixings if necessary).</li> <li>• Remove soil pipe to wall.</li> <li>• Record and store radiators on pallet in heritage store room.</li> </ul> | | | | |

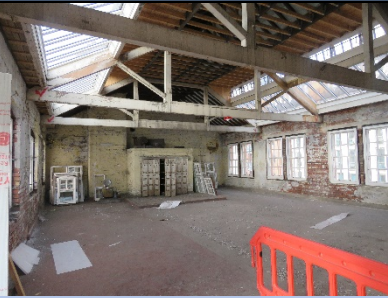
| Room Ref. | Element | Description / Item | Condition | Action | Photographs | | | |
|---|---|---|---|---|---|---|---|---|
| 312 | Walls | Paint to brickwork.<br>Holes to red brick walls.<br>Misc. screws and M&E fixings. | Fair | <ul style="list-style-type: none"> <li>Fix salvaged red brick to holes.</li> <li>Remove all screws and fixings from walls.</li> </ul> Proposed works <ul style="list-style-type: none"> <li>All walls stripped back to masonry and all loose material removed (brush down all walls)</li> </ul> <p><i>NOTE: Access not available at time of survey, details provisional for pricing purposes only</i></p> | | | | 014 |

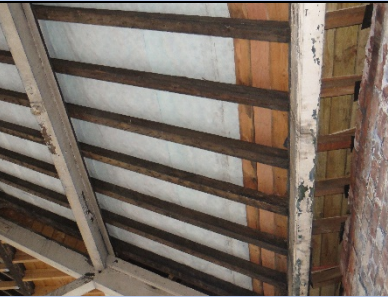
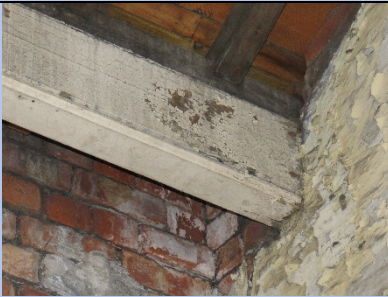
| Room Ref. | Element | Description / Item | Condition | Action | Photographs | | | |
|---|---|---|---|---|---|---|---|---|
| | Ceiling | Exposed roof truss and rafters, partially painted.<br>Misc. nails. | Good / fair | <ul style="list-style-type: none"> <li>Remove flaking paint, nails and screws from timberwork.</li> <li>Clean roof truss.</li> </ul> Proposed works <ul style="list-style-type: none"> <li>Prepare and decorate existing trusses (colour TBC by architect)</li> <li>Provide new insulated plasterboard ceiling below rafters where roof windows are not present (to be read in conjunction with roof type drawing 3501)</li> </ul> <p><i>NOTE: Access not available at time of survey, details provisional for pricing purposes only</i></p> | | | | |

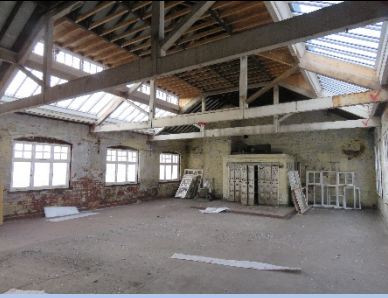
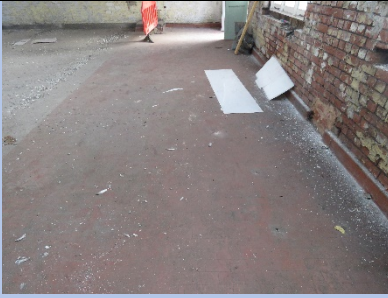
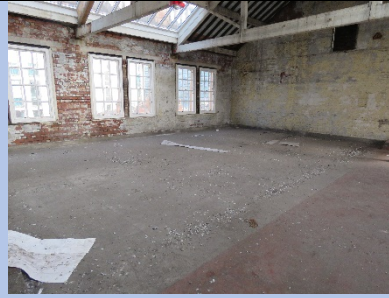
| Room Ref. | Element | Description / Item | Condition | Action | Photographs | | | |
|---|---|---|---|---|---|---|---|---|
| | Floor | Red quarry tile or exposed concrete. | Good | <ul style="list-style-type: none"> <li>Clean floor to remove all debris.</li> <li>Install protection to area of red quarry tile.</li> </ul> Proposed works <ul style="list-style-type: none"> <li>Existing concrete and tiled floor cleaned and protected</li> </ul> <p><i>NOTE: Access not available at time of survey, details provisional for pricing purposes only</i></p> | | | | |

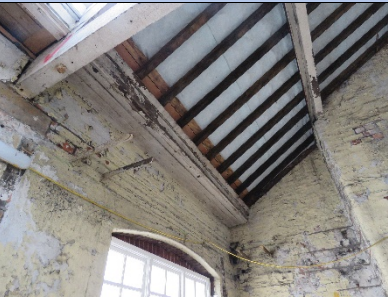
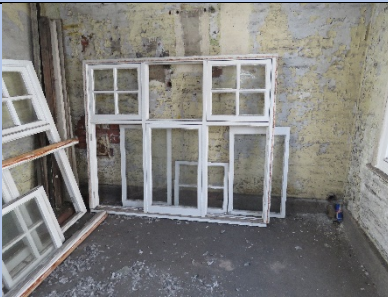
| Room Ref. | Element | Description / Item | Condition | Action | Photographs | | | |
|---|---|---|---|---|---|---|---|---|
| | Joinery | Timber bead to wall and ceiling junction.<br>Pile of misc. timber windows. | | Proposed works <ul style="list-style-type: none"> <li>Timber picture rail, skirting and beads to be removed</li> <li>Misc. joinery to be used for repairs where possible, otherwise scrapped.</li> </ul> <p><i>NOTE: Access not available at time of survey, details provisional for pricing purposes only</i></p> | | | | |

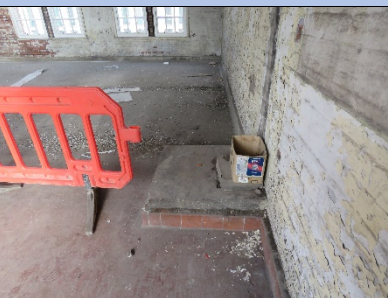
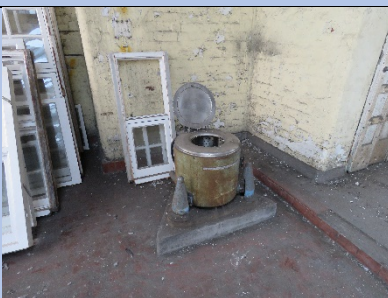
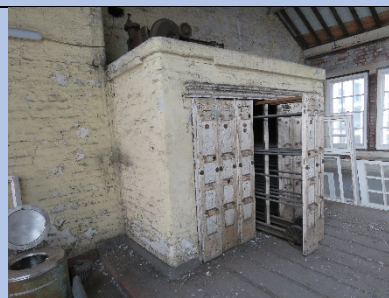
| Room Ref. | Element | Description / Item | Condition | Action | Photographs | | | |
|---|---|---|---|---|---|---|---|---|
| | Misc. | Concrete plinth. for redundant cleaning equipment.<br>Original cloths washer and drying racks.<br>Redundant steel angles to wall.<br>Redundant conduit / pipe to ceiling. | | <ul style="list-style-type: none"> <li>Remove concrete plinth (except where adjacent/ interfacing with the heritage drying rack).</li> <li>Clean heritage drying rack equipment before installing protection. Remove any flaking paint.</li> <li>Remove redundant angles and conduit / pipe (and fill holes following removal).</li> </ul> | | | | |
