FLOYDCONSULT

Assessment of timber at

32-34 LAYSTALL STREET, M1 2JZ

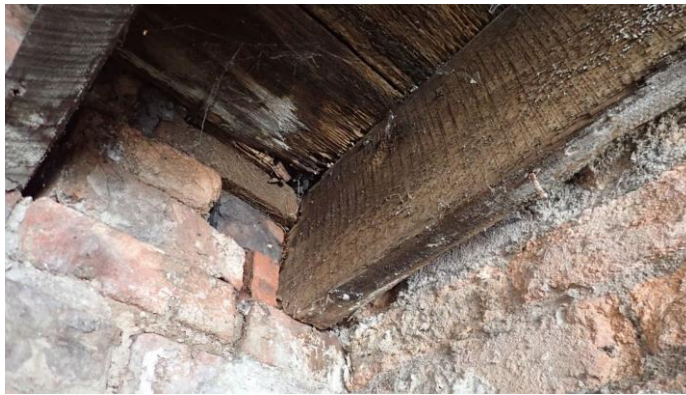
1  
The decking board and top and side of the embedded section of the joist in the corner have been wet up historically. The joist end has lost approximately 50% of its section in the bearing and would **benefit from some additional support such as a partner section.**

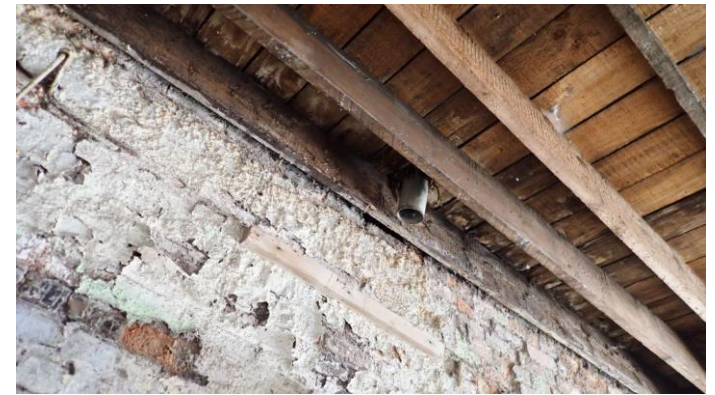
2  
The joist closest to the W wall has suffered from decay along its top edge where the sarking has also deteriorated. There is some movement in this joist, probably due more to the fact it has lost its connection and therefore stiffening effect with the sarking. **The entire joist would benefit from replacement when the sarking is replaced where it has decayed in contact with the W wall.**

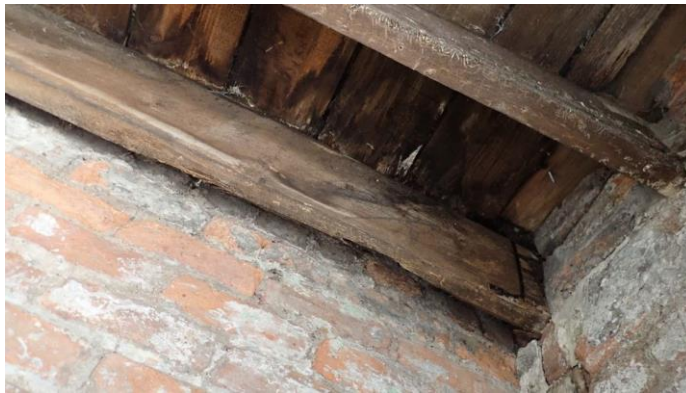
3  
The joist has decayed in its N bearing. Again the sarking is decayed over the top of the joist **and it would probably benefit from complete replacement.**

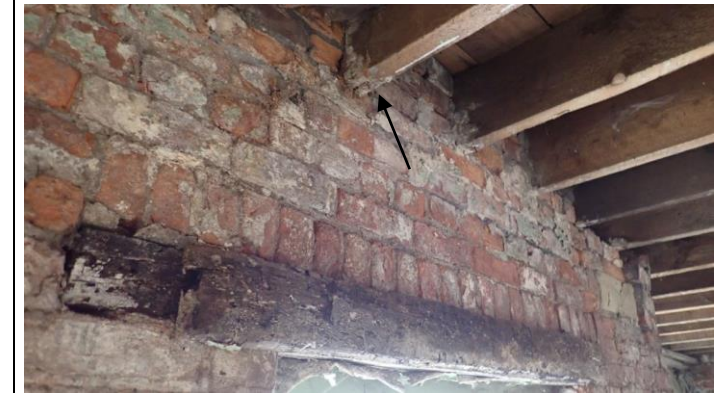
4  
The joist arrowed is decayed in its bearing as is the lintel of the window below.

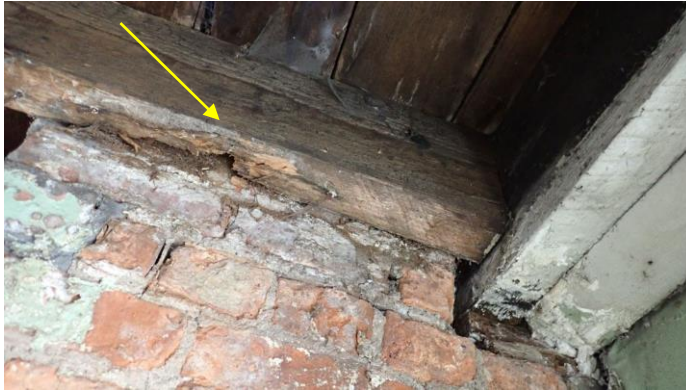
5

The joist against the reveal has been wet up historically and has lost approximately a third of its section against the masonry (arrowed), although its connection with the trimmer is sound. As such it can remain. The trimmer is packed up off the masonry and runs across the central window-the bearing of which is sound.

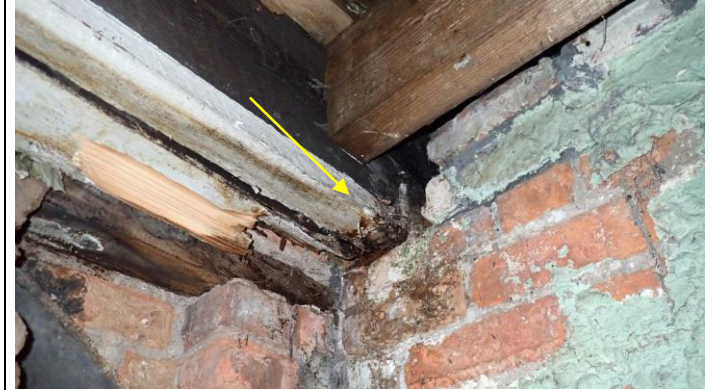
6

The end of the window frame is decayed in the corner as is the end of the trimmer beam which has lost approximately 50% of its section where it runs into the masonry (arrowed) **and would benefit from some additional support.**

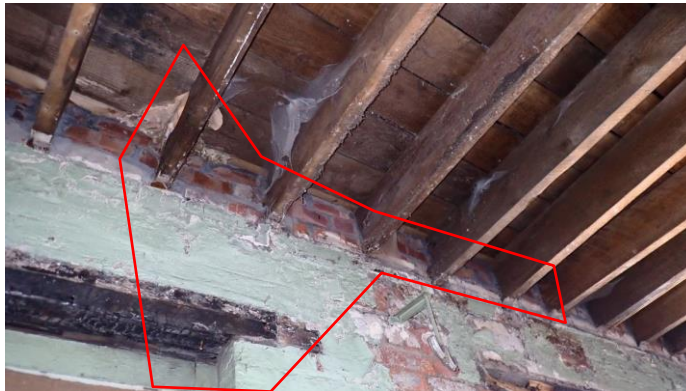
7

5 joists are decayed in their bearings together with the window lintel (window right-hand side).

**The joists would benefit from additional support and the lintel requires replacement.**

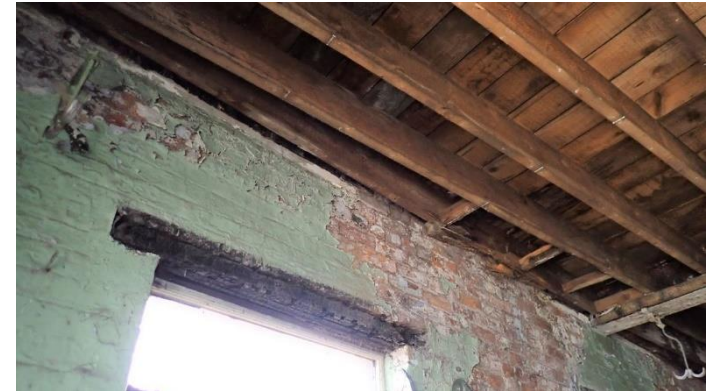
8

The edge joist has been damaged on its upper face and outer face against the masonry. As such it may be **necessary to replace this timber completely when the sarking board is repaired or cut out from over the top.** The 2 piece lintel below requires replacement also.

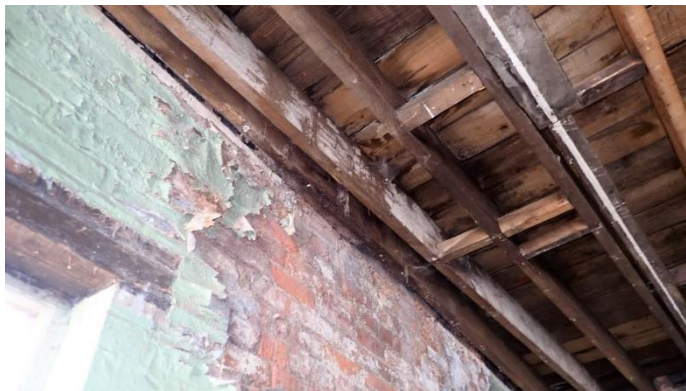
9

This joist has also deteriorated and would **benefit from replacement at the same time as the sarking.**

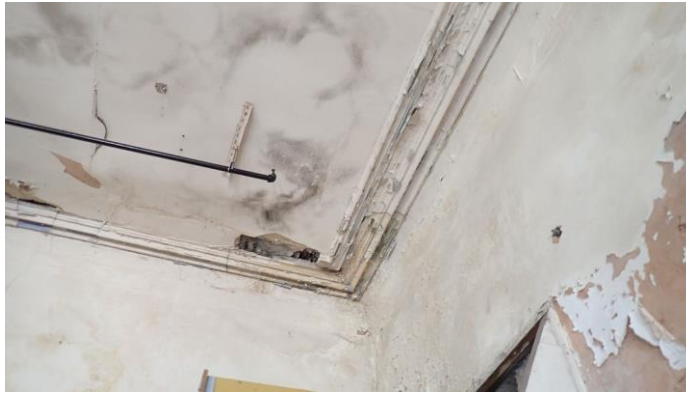
10  
Showing the underside of the second floor. **There is a possibility of some decay to 1 or 2 joist bearings in the W wall at this point and possibly to the floorboards also** (which were concealed from above).

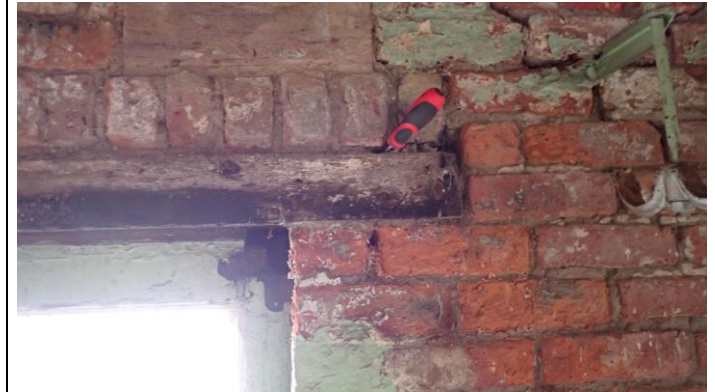
11  
The lintel (which is probably 300 mm wide) is **decayed in its E bearing and will require replacement**.

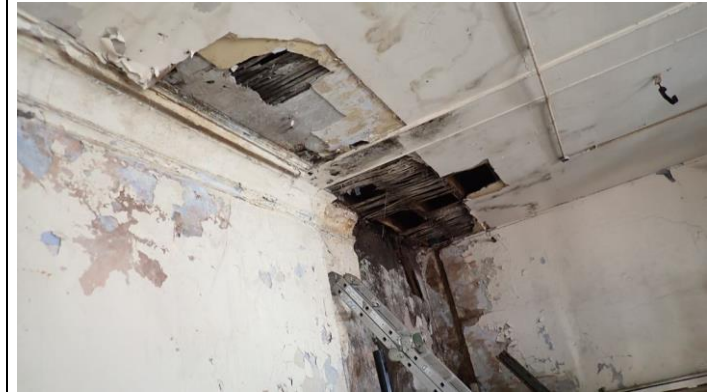
12  
Water ingress (presumably from the opening at this point) has caused decay to the floor structure to the approximately extent shown on plan. **The solid line represents decay to the floor joist and floor boarding (extent of damage the floor boarding is represented by the shaded area). The dashed line represents possible damage to the joist adjacent to the wall which should be checked from below when the ceiling is repaired.**

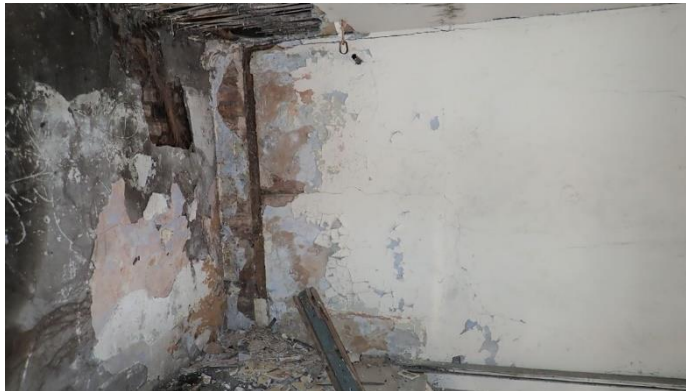
13  
There is a stud and masonry partition laid on steel at mezzanine level. **Some exposure was made showing all the timber stud work to be decayed at least 1 m from the S wall.**

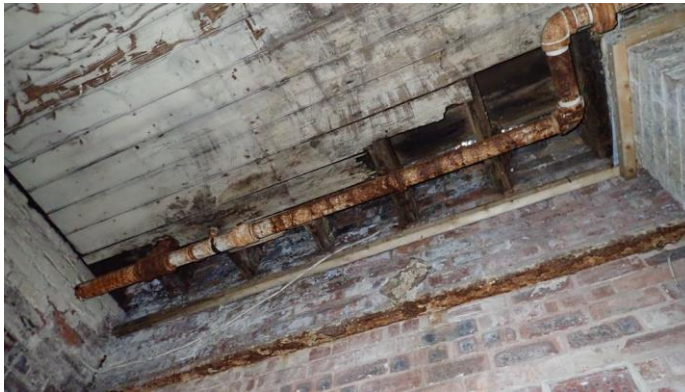
14

Close access was not possible from below. There is a continuation of the damage caused by the water ingress down through the building. Further exposure is required from below where the timber under boarding has decayed. **There is a possibility of 10 to 12 joists decayed in their bearings together with the floor boarding directly above. Exposure is required either from above or below to confirm.**

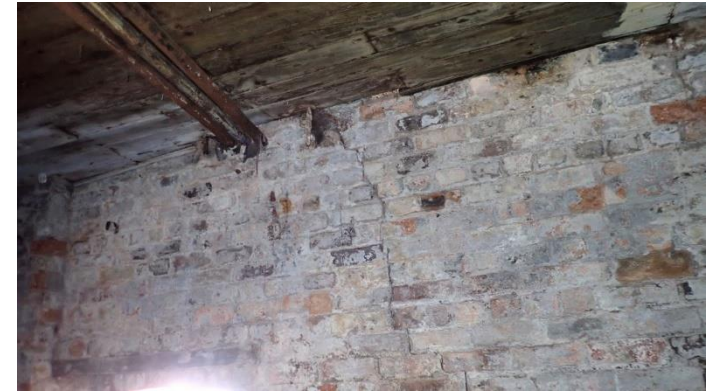
15

There are signs of an historic outbreak of dry rot to the underside of the first floor structure. The fungus is now dying back. However it would seem the joists bear into the S wall at this point and as such it is **possible that at least seven or eight joist ends might well be decayed in the bearings together with the floor boarding above. Exposure is needed at this point.**

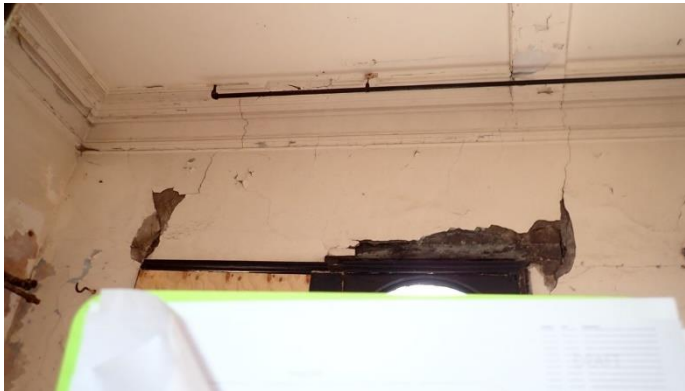
16

An area of fractured plaster was removed from above a window revealing a narrow section lintel spanning over the window opening, just supporting the inner skin of masonry and plaster. The timber is sound.

The fractures in the plaster seems to have been caused by deflection of the timber owing to the length of span. The timber is approximately 4 in<sup>2</sup>, although it doesn't span the full width of both windows but bears onto some brickwork at the central column.

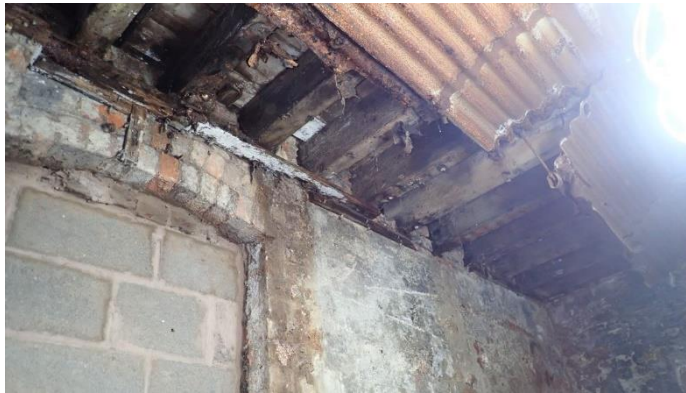
17

The underside of the suspended timber structure has been covered with corrugated iron. **Some of this was removed revealing joists decayed in their S bearings for all of the extent shown on plan.**

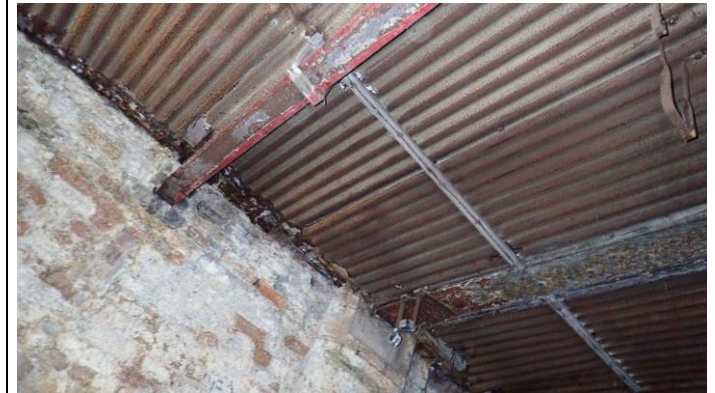
18

The joist adjacent to the W wall is decayed for pretty much the full extent of the elevation.

General. The fitting of the corrugated iron has not been beneficial to the condition of the joists given the water ingress from above. Away from the W and S masonry walls, as a minimum the surfaces of the joists are likely to have been affected by wood boring weevil and furniture beetle which will make fixing to it difficult. Worse case scenario is more significant structural decay which will require joist replacement. **Given the extent of damage to the existing joist bearings, it might be prudent to allow for full joist replacement in this area.**

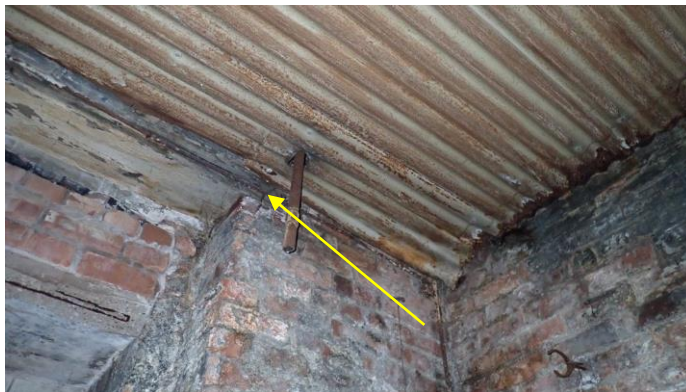
19

There are signs of rusting and the possibility of one or two joist bearings being decayed in this corner. **The corrugated iron needs to be stripped from the underside of the floor for a full inspection. The lintel arrowed is also decayed and requires replacement.**

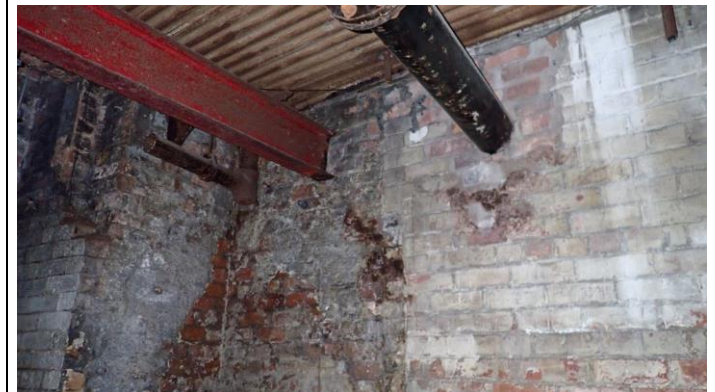
20

There are signs of dried up dry rot fruiting bodies on the wall and therefore almost certainly decayed timber directly above. The corrugated iron needs to be removed from the underside of the ceiling (inaccessible from above).

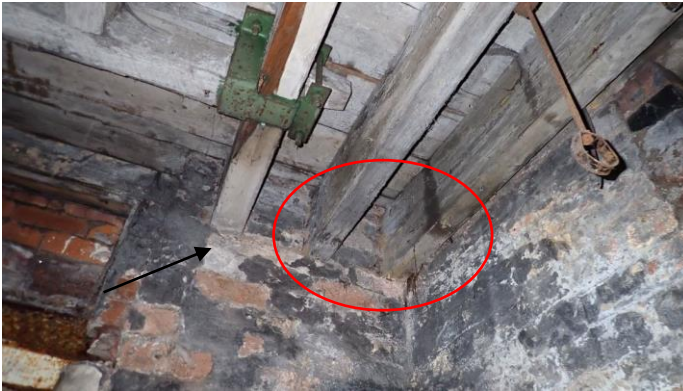
21

Two of the joists (circled) have lost section in the wall and **will require some additional support with partnered sections or similar**. The damage appears to be very slow and historic, caused by a combination of furniture beetle and wet rot. The arrowed joist was microdrilled (measurement no.11) and found to be sound.

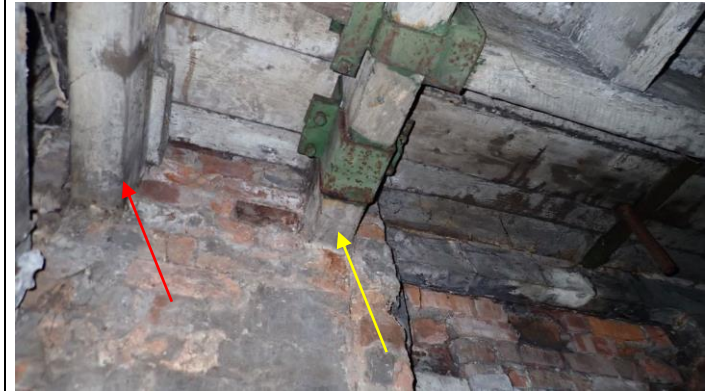
22

The beam travelling into the wall-(red arrow) is decayed in its bearing.

The beam right-hand side (yellow arrow) was microdrilled (measurement nos 12 – 14), which showed some loss of section within the wall. **As such additional support is recommended for both beams in shot.**

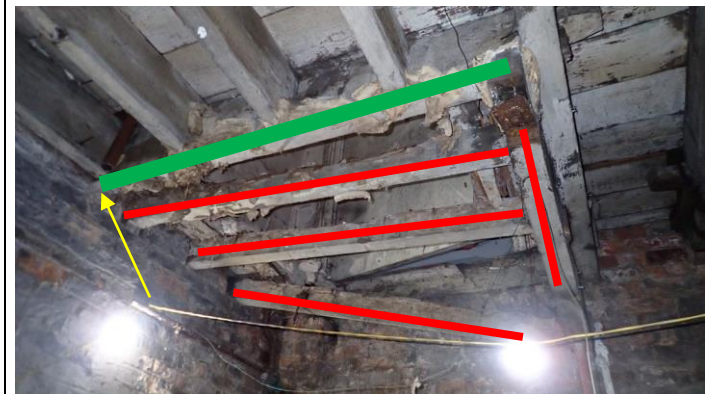
23

Access was limited as there were a couple of joists which were loose. There has been a relatively recent outbreak of dry rot and mycelium is growing on the timber (most of the energy would have been derived from decay to the floorboards) – although it is now dying back. This is not reason in itself to dispose of the timber. The main trimmer beam (green line) was microdrilled in the wall (yellow arrow, measurement no 15) and found to be sound in the wall and along its length.

**It is likely the three common joists which are in a state of partial collapse below the door entrance will not be suitable for reuse.**
