32-34 Laystall Street, Manchester

## Method Statement for Removal of Cladding and Render to West Elevation.

June 2022.

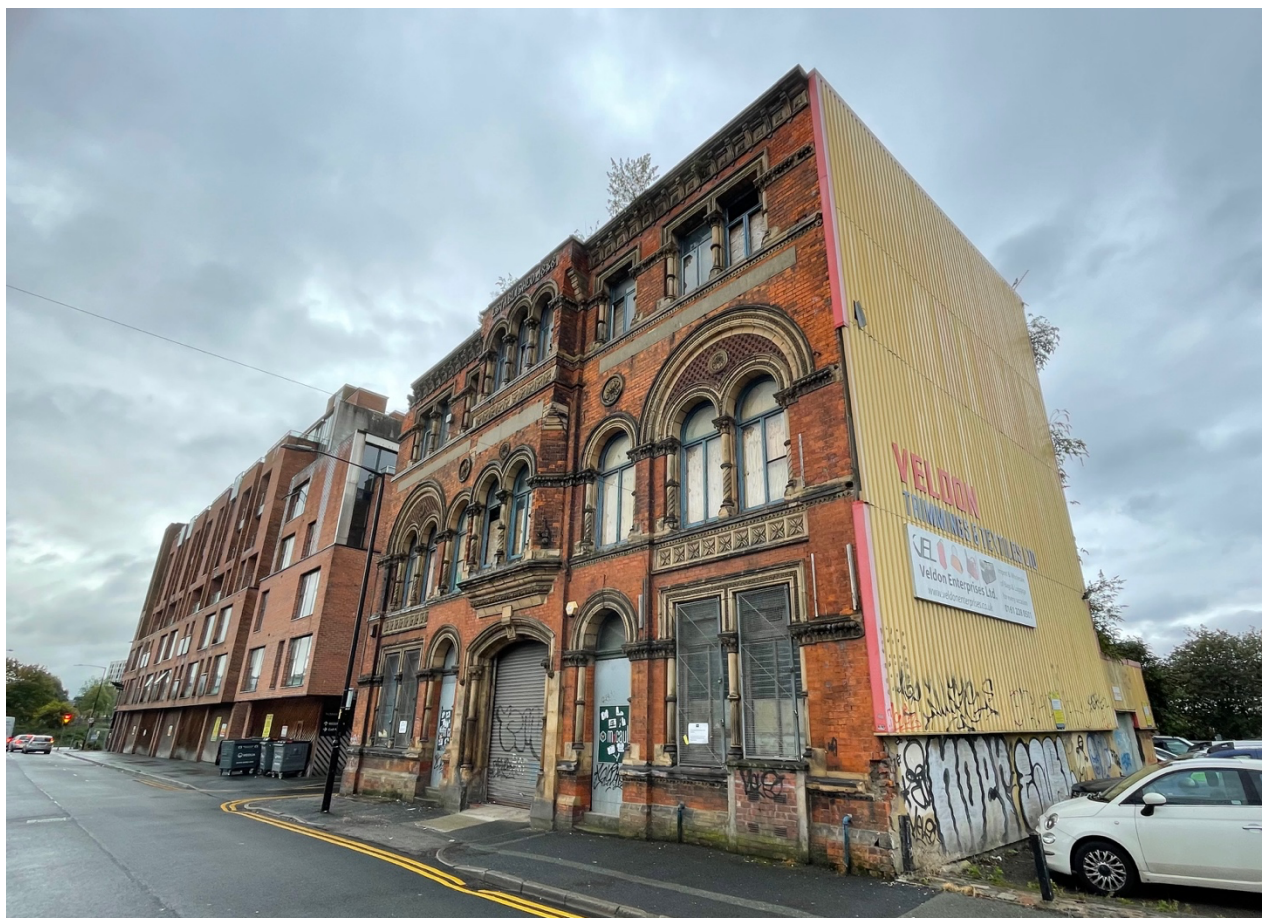
As part of the survey and inspection works, some concern has been raised both by the conservation architect and engineer about the condition and saturation of the gable to the west of the building, which is clad in metal sheet with cement render below, and the approach to its consequent conservation and repair. There is therefore an urgent need to remove the modern metal sheet cladding and the (assumed) cementitious render below which is trapping moisture in the wall and preventing both drying and full inspection. Consequently a method statement for the removal has been prepared by Chambers Conservation, specialist conservation architects.

View from the North-west, (2021), showing the metal cladding to the west elevation with cement render visible at low level.

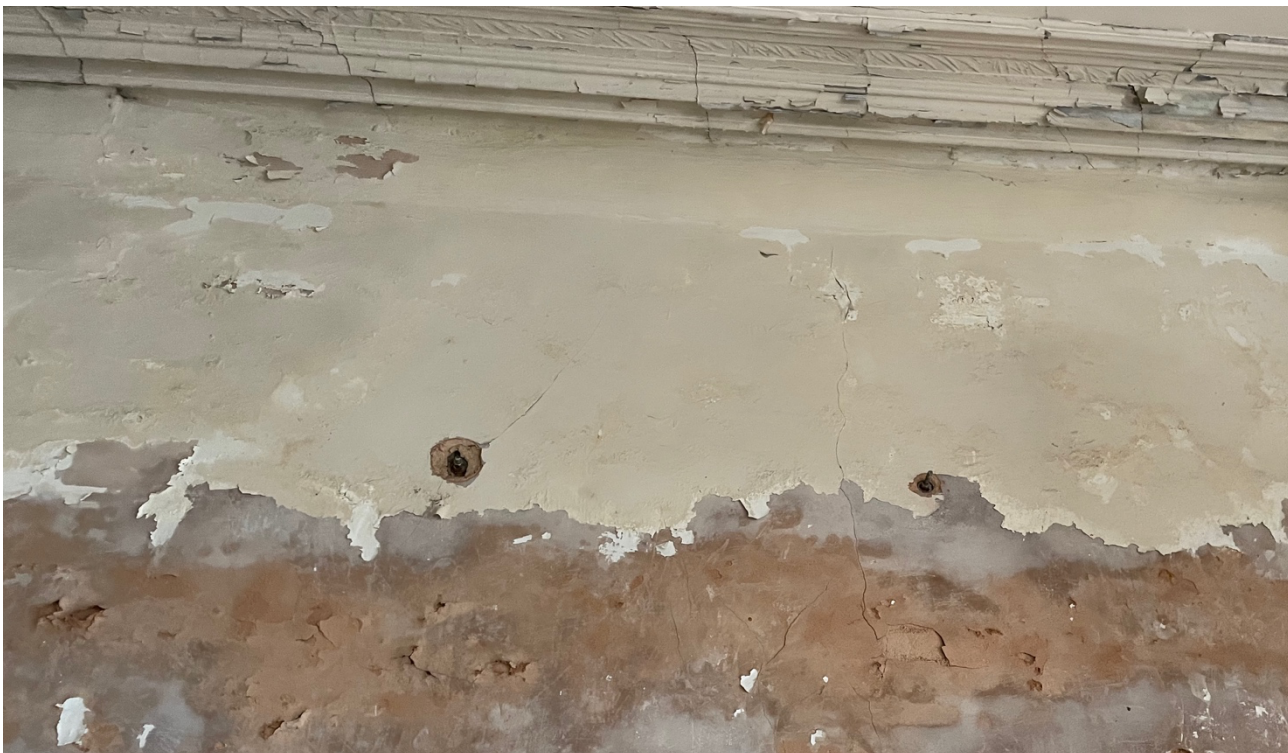
The cladding is understood to be bolted through the wall as bolt fixings are visible internally. Cement render is assumed as it is exposed at ground floor level.

Internal fixings associated with metal sheet cladding (2022).

- 2.2 Prior to commencement the contractor is to identify all fixings for the metal cladding visible internally and identify on internal elevations (provided by OMI architects).

- 2.6 Support cladding panels externally and provide adjacent scaffold or similar to enable removal. Initially loosen fixings internally to enable removal. If fixings are corroded beyond use, carefully cut cladding externally around each fixing (this is less likely to damage the fabric than cutting internally). Ensuring support at all times both for safe removal and to ensure minimum risk of damage to brickwork.
