10 Minshull Street and 11 Bloom Street

**ADDITIONAL FEATURES**

PLANNING CONDITIONS RELEASE 11(a), (h), (r), (s)

Planning Permission 119374/FO/2018 – BOTH BUILDINGS

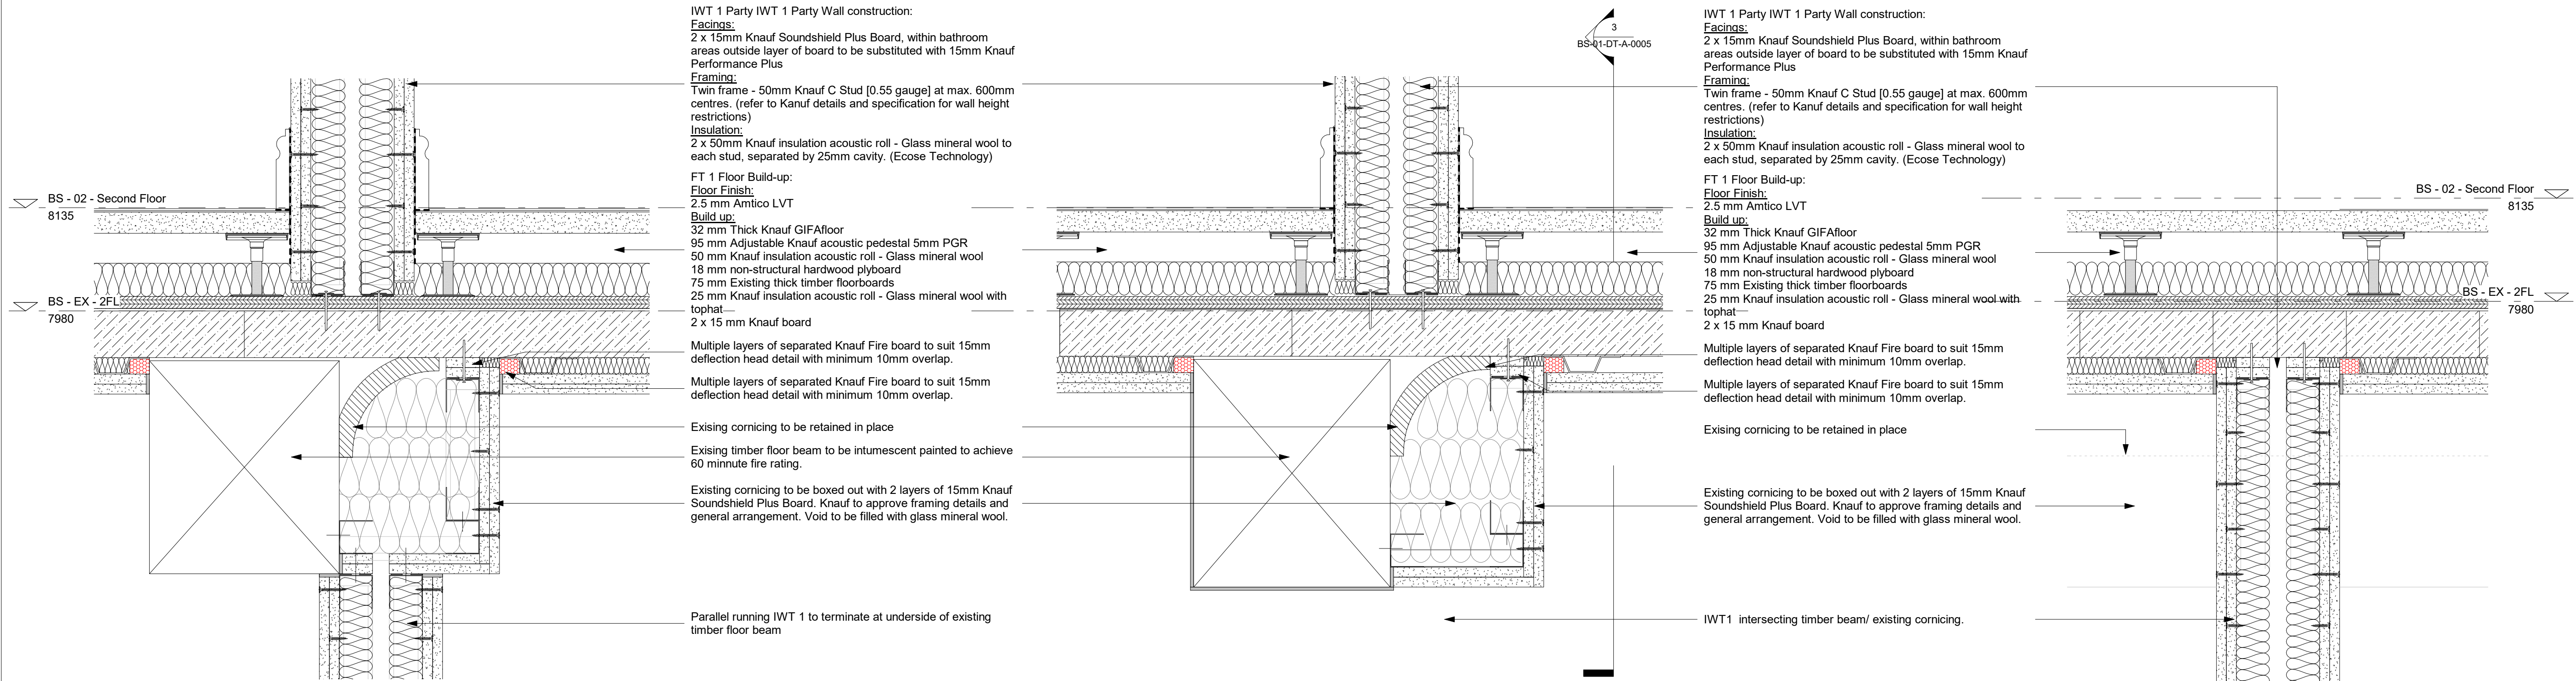
1 | EXISTING CORNICE & PARALLEL PARTY WALL JUNCTION DETAIL

Historic cornicing has been found in limited locations, their existence and retention have both been highlighted in the drawing package (**Appendix K**). Though not of high quality in appearance or condition, the elements speak to the former office use, meaning retention of the elements would be valued. The issue arising from this is that the locations of the cornicing do not coincide with the approved layouts in a way that would retain their exposure. The condition of the cornicing is highlighted in the plaster conditions report (**Appendix C**).

As can be seen from the (**Appendix K**) proposed drawing package, the proposal seeks to retain the cornicing in place whilst protecting them for fire rating purposes. Approved party walls currently clash with existing cornicing, whilst exposure would be preferable it would require intrusive and irreversible works to the existing elements to retain necessary fire separation between apartments or communal areas. To negate removal and potential disruption to their condition the scheme seeks to protect and encase these features in place (**Appendix C**) for future use.

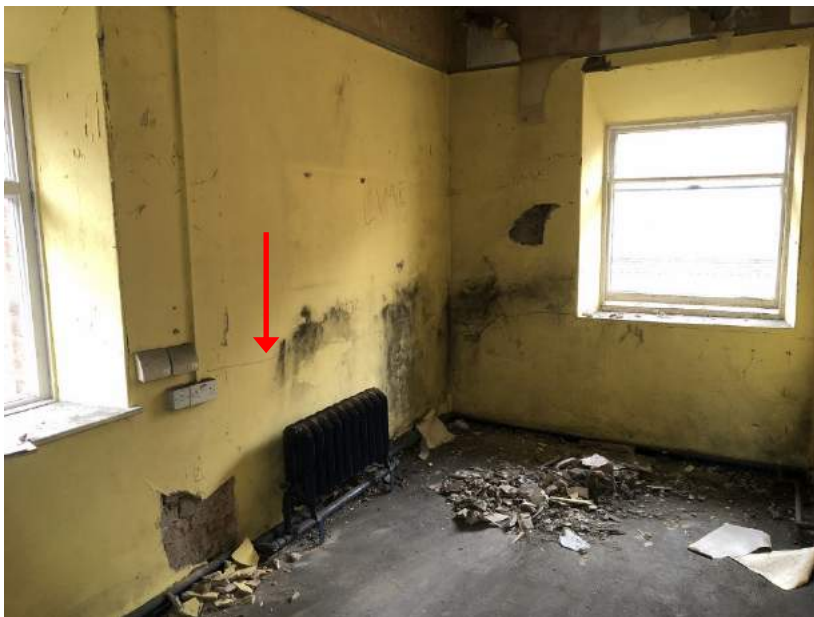
**Fig 14:**

Fourth Floor, MS-406-MS-411;  
showing extensive deterioration of the  
plaster finished in the area of ongoing  
water penetration

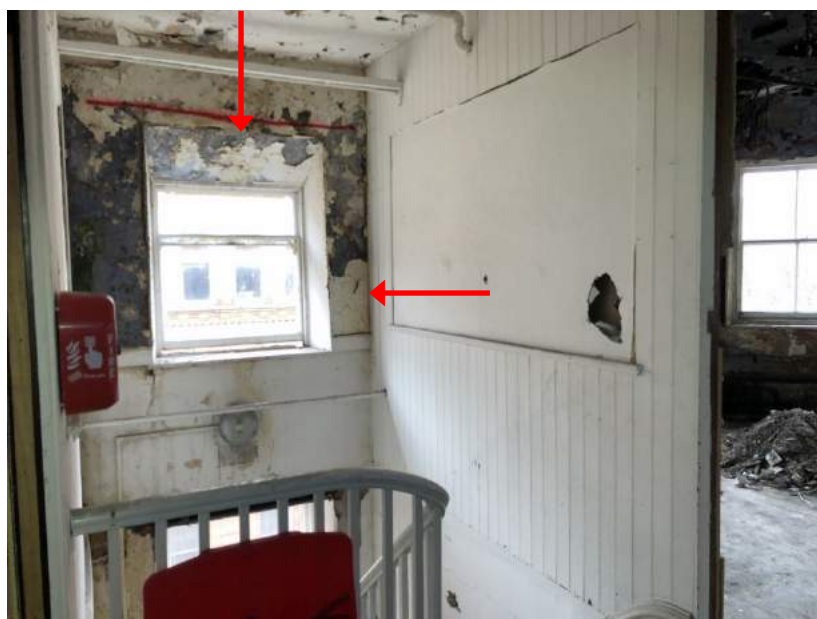
**Fig 22:**

Fourth Floor, MS-414; showing an area of water penetration. All wall finishes were damp and decayed. The timber panelling to the stud partitions were also damp and partially decayed where abutting the external wall

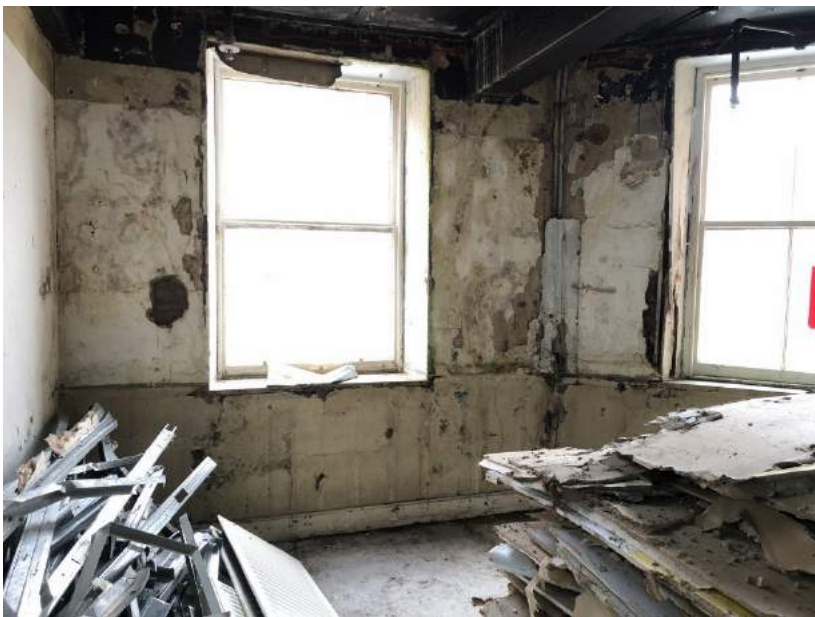
**Fig 24:**

Fourth Floor, Goods lift; showing largely non-original plasterboard linings around the central goods and passenger lift shafts. The lime plaster behind was largely damp and had debonded from the substrate

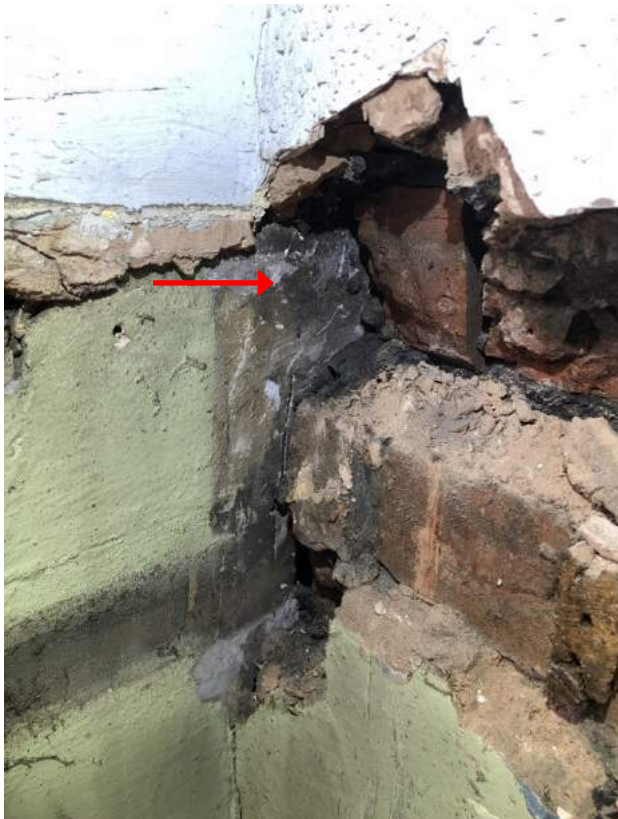
**Fig 28:**

Third Floor, MS-309; showing an area of significant debonding of the plaster caused by historical water penetration

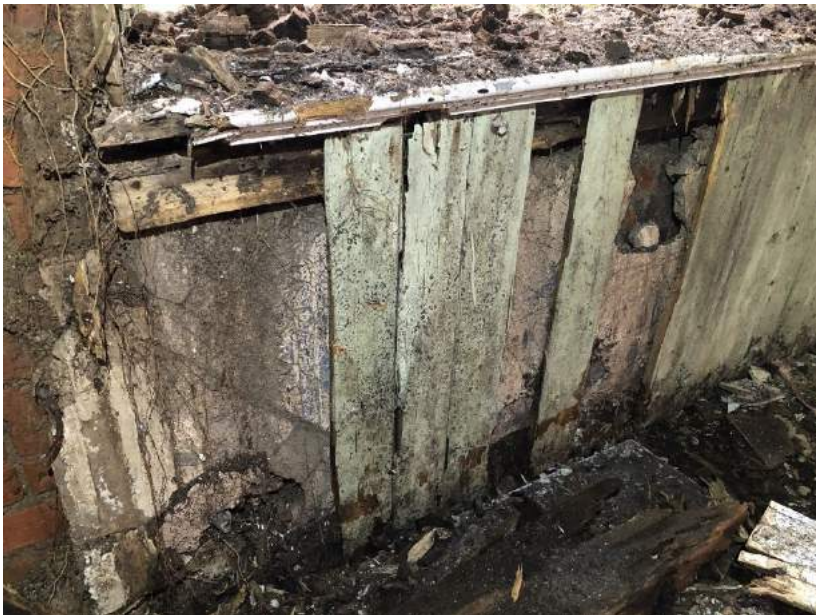
**Fig 30:**

Third Floor, MS-312-MS-320; showing deterioration of the wall finishes in the area of water penetration

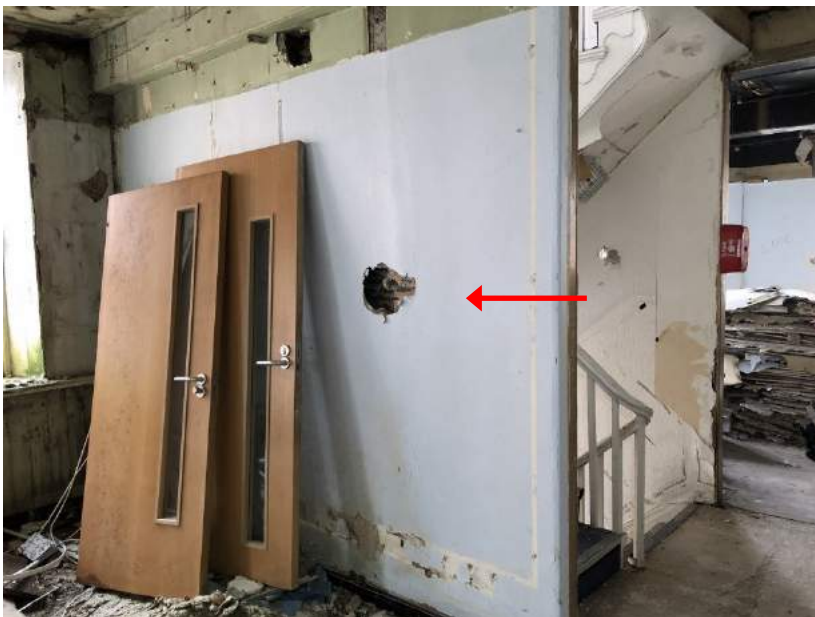
**Fig 34:**

Third Floor, MS-320; showing an area of water penetration and deterioration of the wall finishes

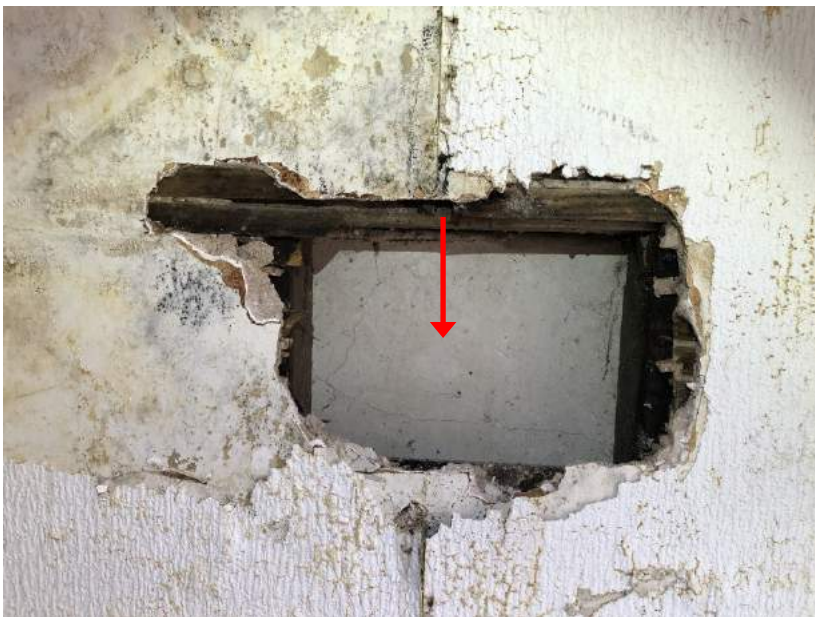
**Fig 38:**

Third Floor, MS-302; showing deterioration of the external and internal wall finishes in the area of water penetration

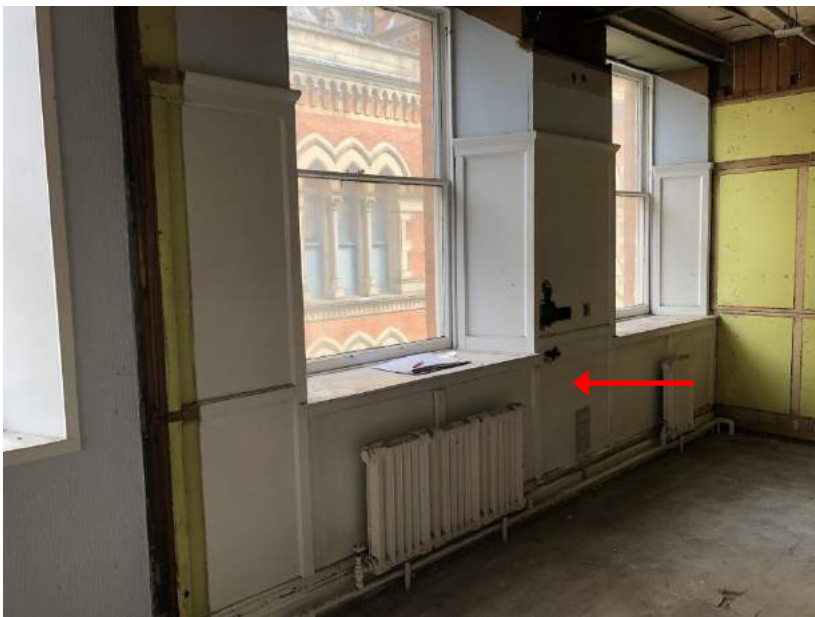
**Fig 42:**

Second Floor, MS-201; showing deterioration of the lime plaster in the area of ongoing water penetration. The softwood square-edge skirting board was also damp and partially decayed in this area

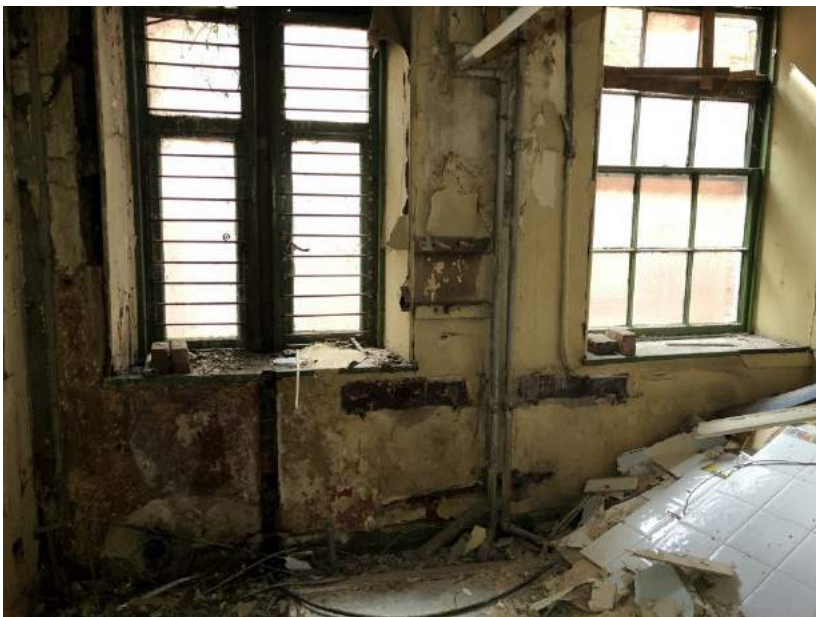
**Fig 48:**

Second Floor, MS-213; showing deterioration of the lime plaster in an area of ongoing water penetration

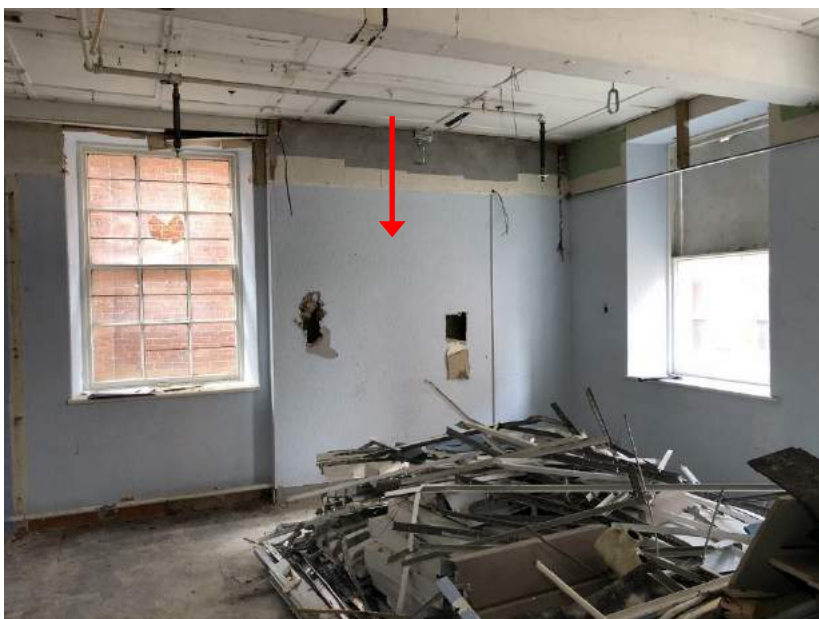
**Fig 50:**

Second Floor, MS-216; showing an area of lath and lime plaster used behind the cupboard of MS-218. The lath and plaster was damp and partially decayed where abutting the external wall

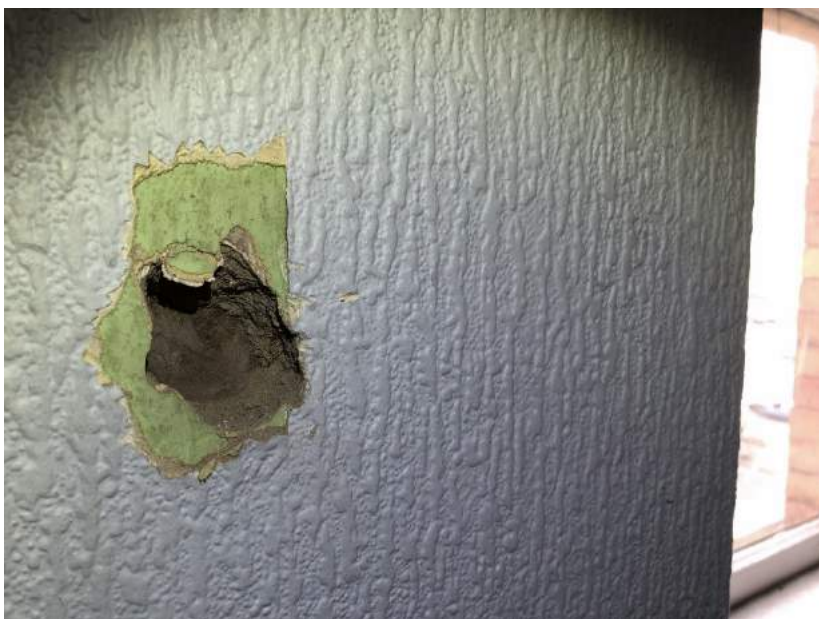
**Fig 52:**

Second Floor, MS-218; showing lime plaster with an earlier paint scheme behind the plasterboard. Note cracking of the plaster associated with salt

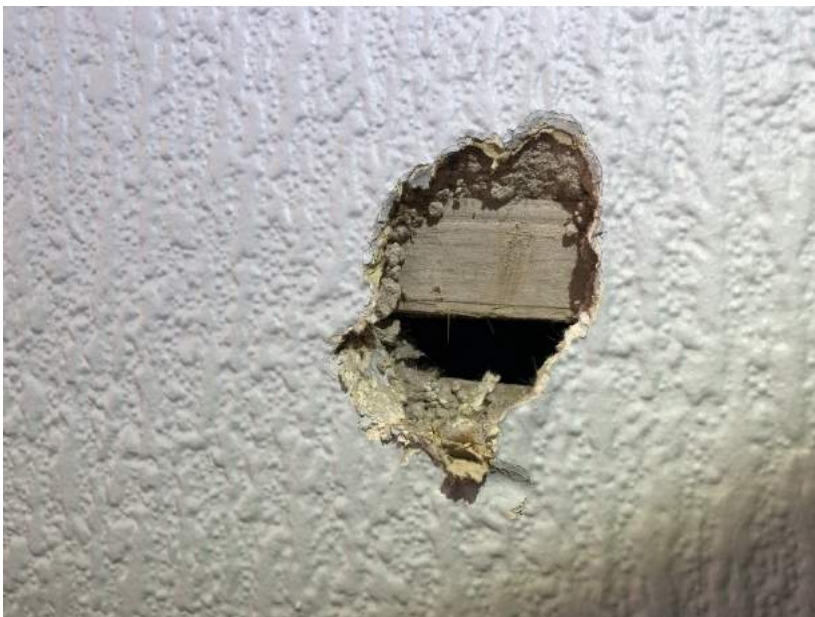
**Fig 54:**

Second Floor, MS-218; showing an area of ongoing water penetration that had caused deterioration of the lime plaster

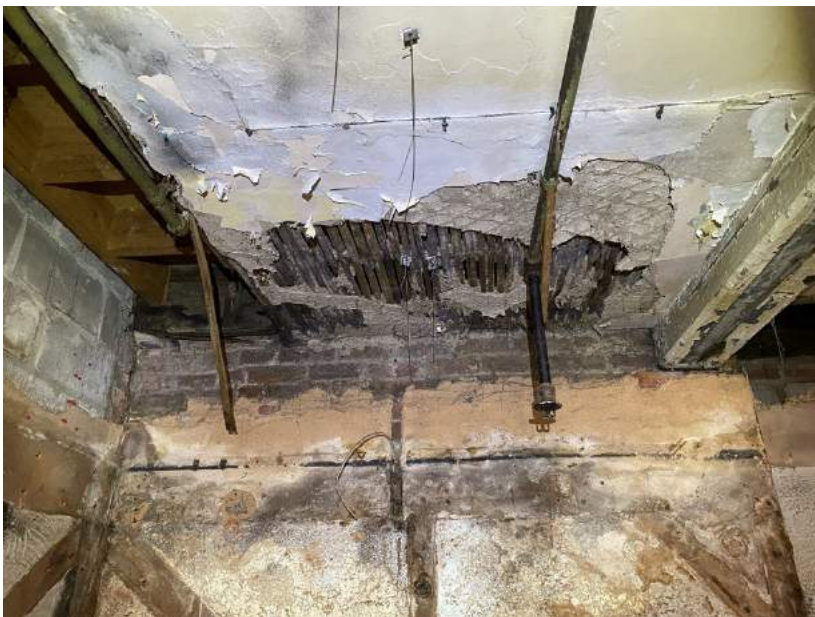
**Fig 94:**

Lower Ground Floor; showing lath and plaster applied to the underside of the floor joists to the north-east bay. The addition of services had caused widespread mechanical damage to the lime plaster resulting in widespread cracking

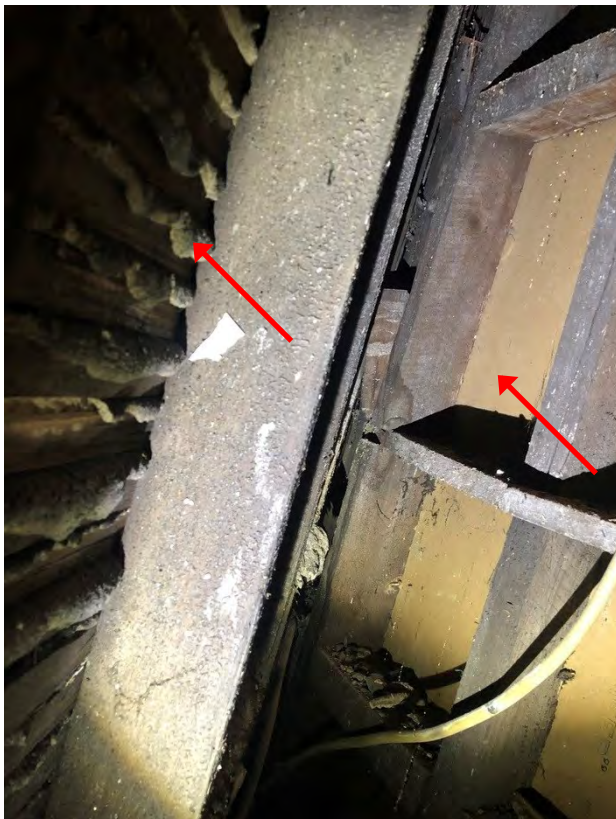
**Fig 14:**

Third floor, West staircase; showing the north west stud partition that was lined with softwood lath and lime plaster. Although there was localised mechanical damage and cracking of the lime plaster, the plaster 'keys' were intact where visible and the lath and plaster was largely repairable

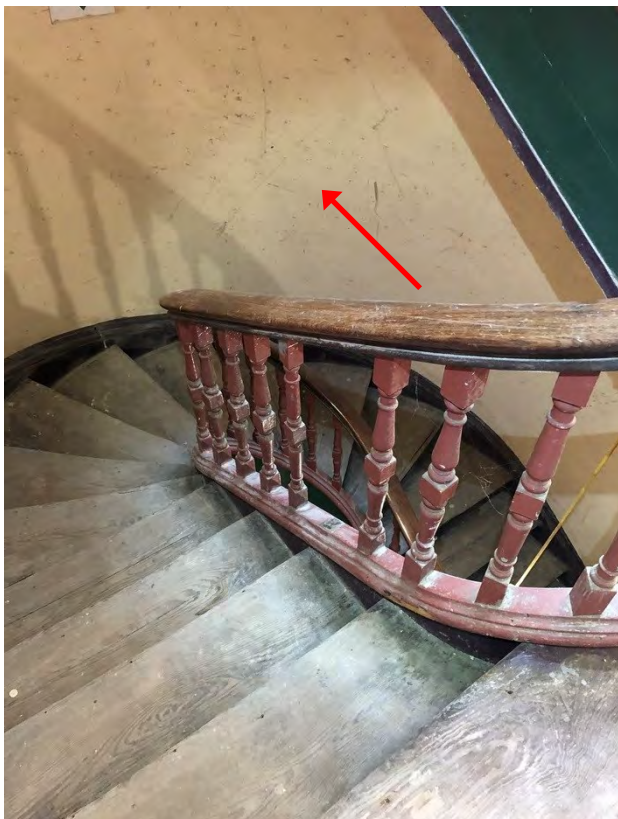
**Fig 24:**

Second floor, West staircase; showing a small area of lath and plaster and vertical softwood timber dado panelling. There was localised mechanical damage but the lath and plaster was repairable. There was no significant defect in the timber panelling

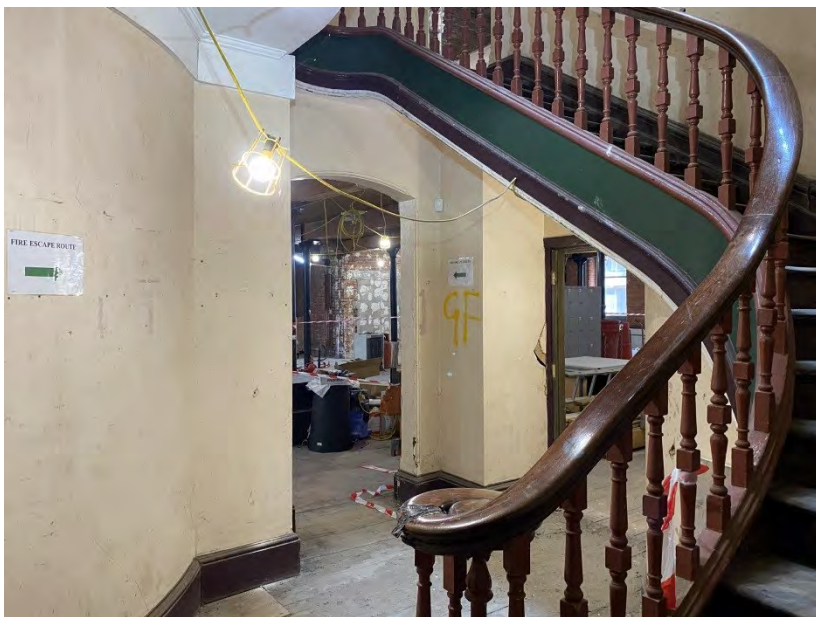
**Fig 54:**

Upper ground floor, West staircase; showing the backside of the lath and plaster as well as later timber fibreboard to the staircase. The plaster 'keys' in this partition were inconsistent on original application

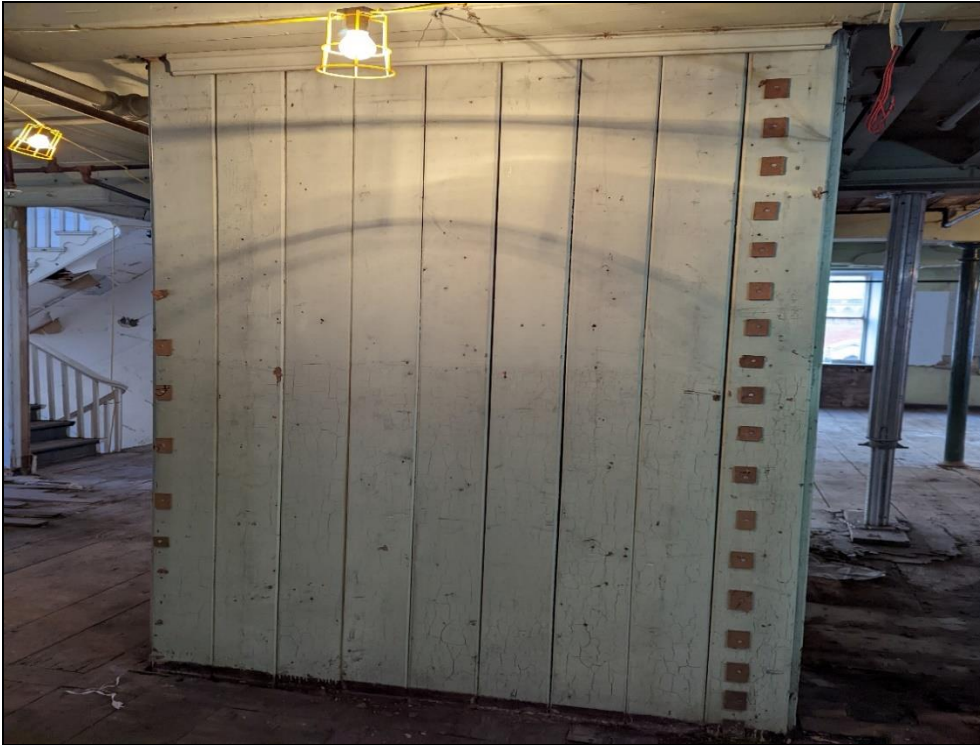
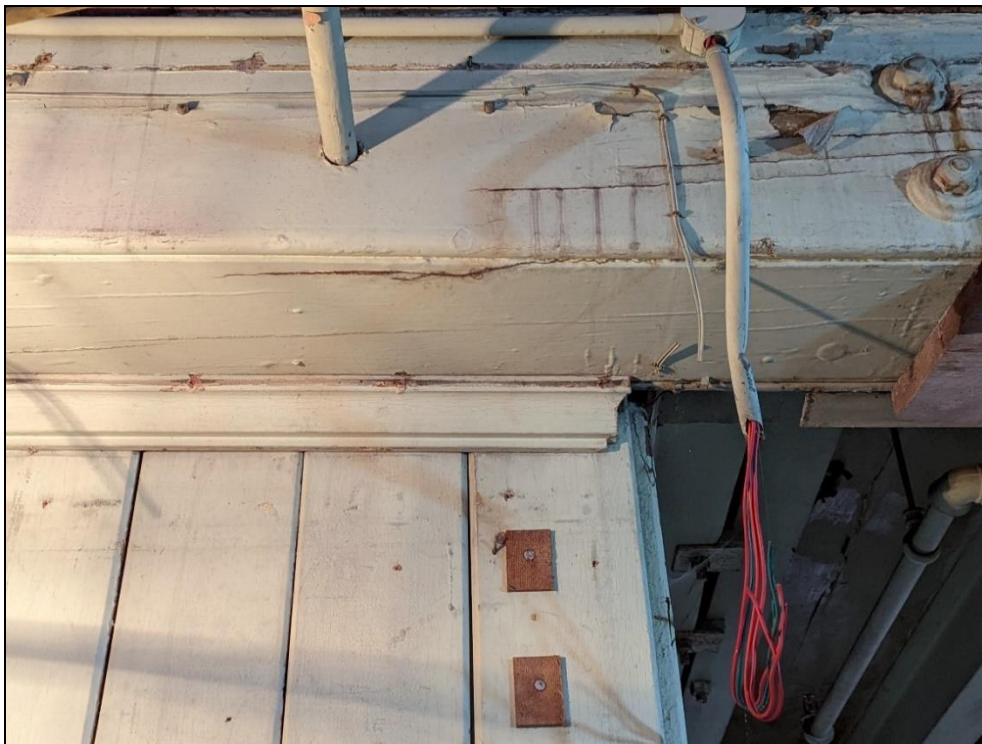
The timber panelling around the modern lift appears to be modern and is wider than the rest of the panelling found throughout, suggesting it was added during a different period.

Rough finish of panelling around lift

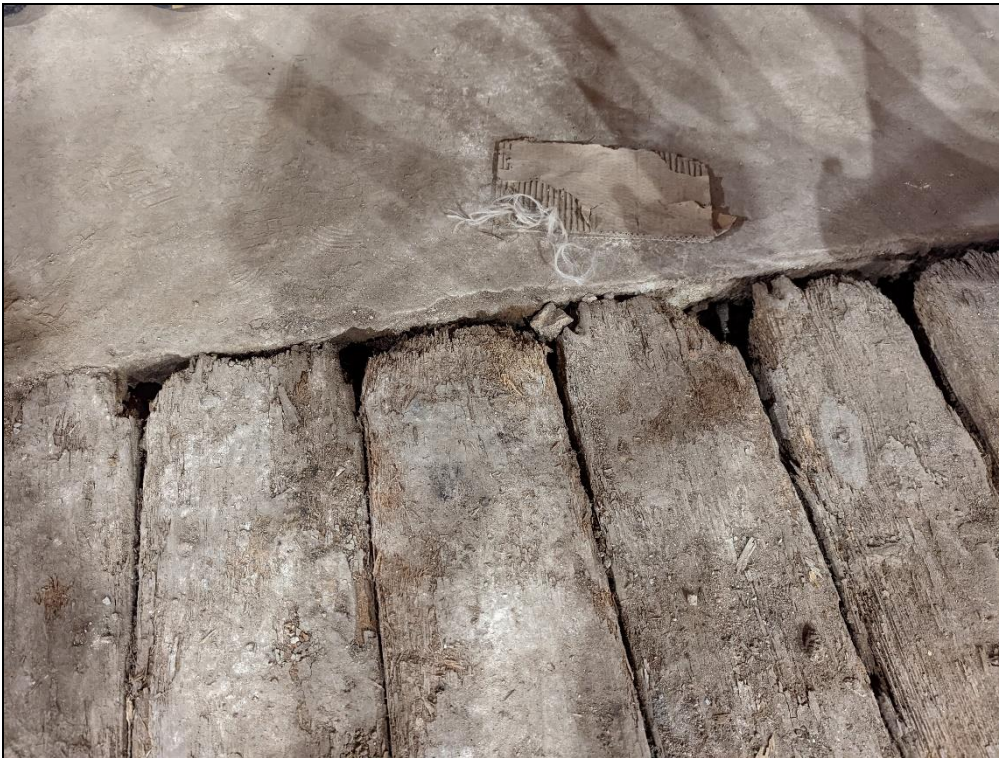
The timber boards appear to be original, although in a very poor condition. This timber area appears to have only been in the centre of the room, rather than across the whole basement. The line of the concrete which butts up against the edge of the boards is straight, with the occasional offset. This is reminiscent of stone flags having been in place prior to the concrete, suggesting that the basement had flags around the outside with timber boards to the centre.

Decayed timber boards butted by concrete

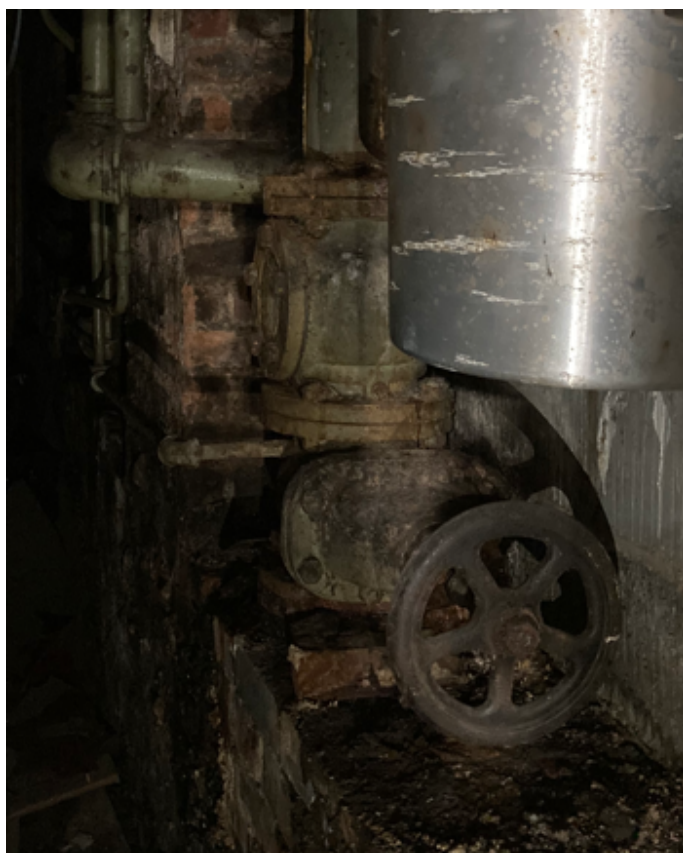
Photo 6: Extensively corroded alarm valve

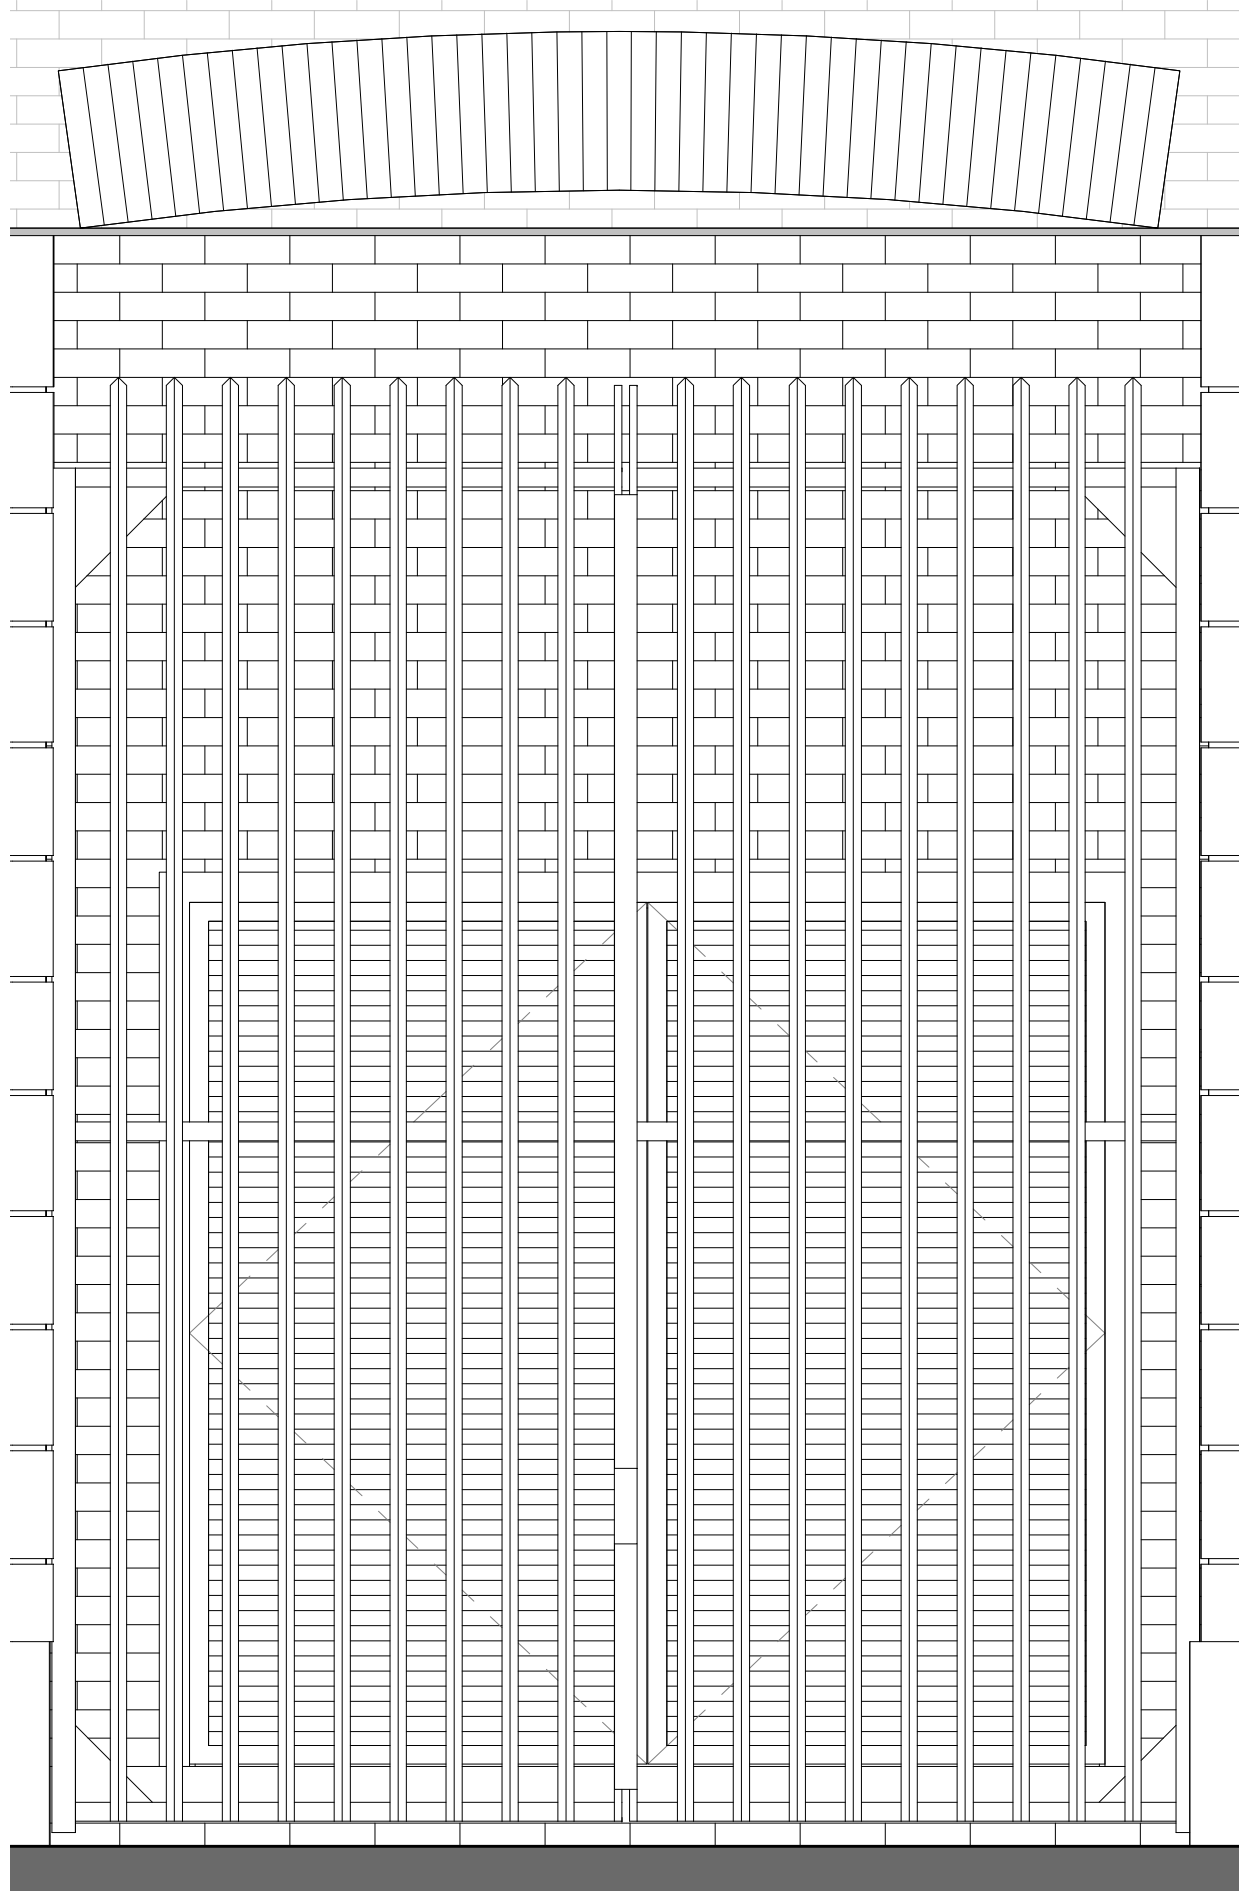
1 Existing Refurbished Hovel Gate - Richmond St.

**Richmond St. Hovel Gate:** This is a painted, metal, palisade style double door gate fixed on to the internal face of the external masonry wall. It is evident that the gate has been previously amended as there are multiple pickets that have been vandalised at low level and then subsequently re-welded with new pickets. Generally the gate is in a state of disrepair with rusting, poor re-welding, flaked paint and deflections due to attempted vandalism. The value aesthetically is low with the historic value being its highest quality. The function of the gate is compromised by its current state also.

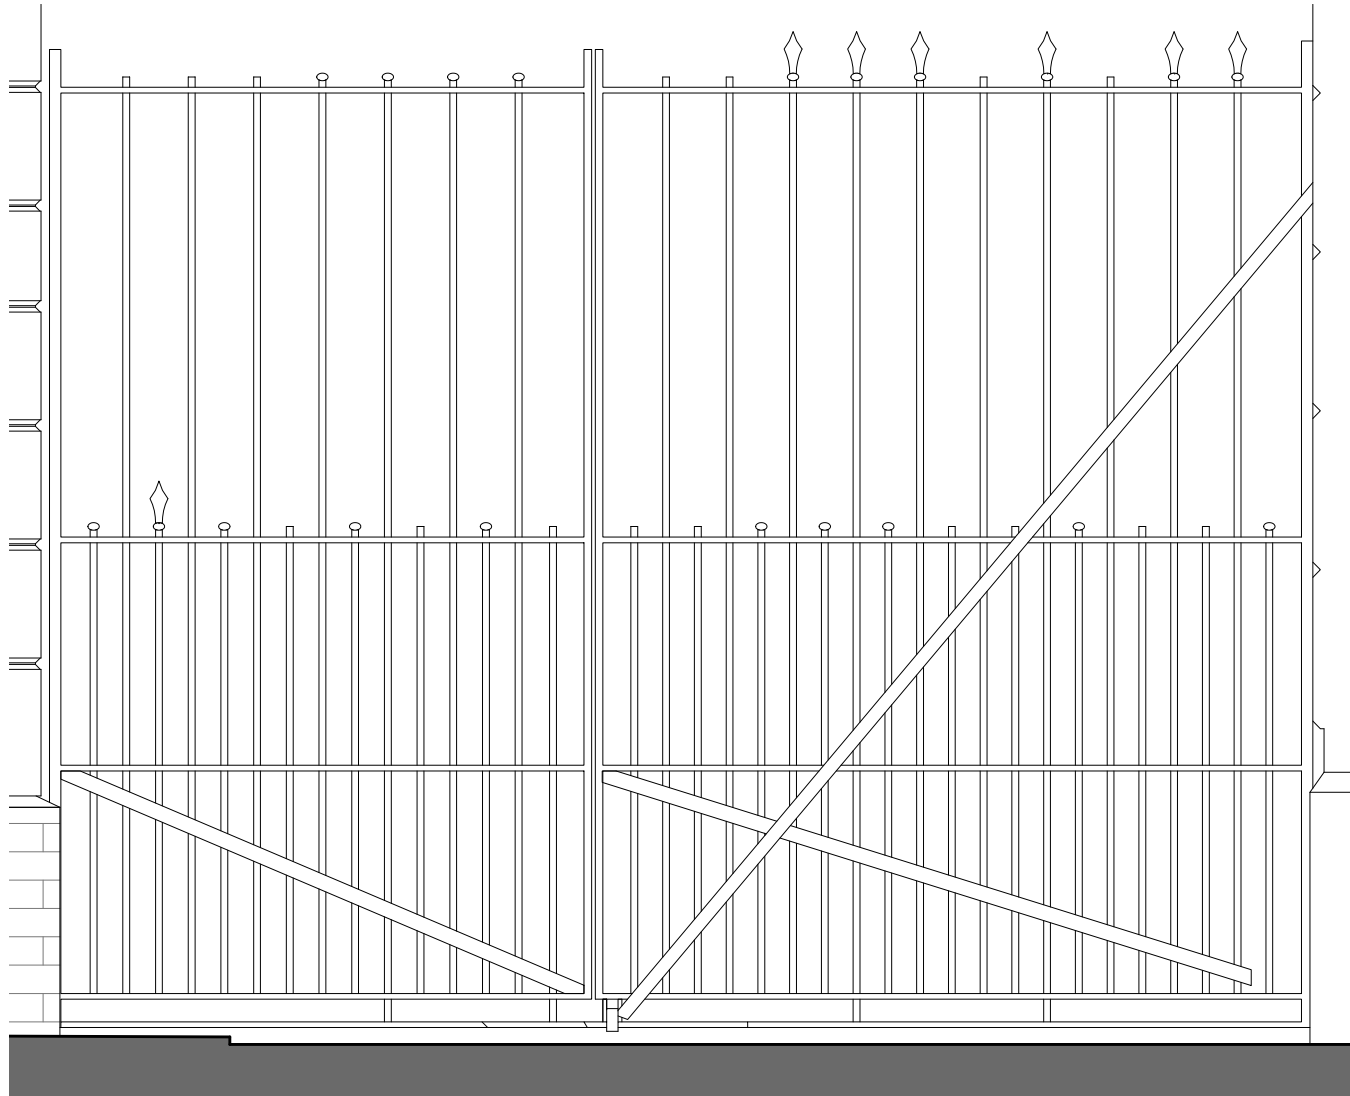
4 Existing Refurbished Gate - Bloom St.

**Bloom St. Alleyway Gate:** This is a wrought iron Corfe style bi-fold gate with arrow top railheads at high and low level with an additional series of rails at low level. A roller wheel enables the gate to swing open with the track still present. The gate is able to fully open however the whole unit is in serious disrepair and hazard to operate in its present format. The gate is painted black, rusted in areas causing flaking of this paint, the majority of the rail heads are missing and the central post is deflected likely due to vandalism. The gate is not currently serving its security function for the site.

**Bloom St. Alleyway Gate:** It is proposed for this gate to be retained and refurbished but the position modified to be fixed open against the Blooms Street Alleyway wall. Along with this, the specifications of the refurbishment specialist will be followed (**appendix**) in order that the gate will be refurbished to prevent further aging and disrepair. Unfortunately repurposing this element as a security element to a main access point of the building is hazardous because of its mechanism due to potential for risk of hand trapping and force required in line with building regulations. An imitation style gate (**Appendix G**) will be located in place of the existing to act as vehicular, pedestrian and cycle access to both buildings.
