## Record of Site Visit

Job Number: 14356  
Project Title: O2 Apollo, Manchester

Date of Visit: 04.08.2022  
Time of Visit: 13:00

Site Visited: O2 Apollo, Manchester  
Purpose of Visit: Inspection opening up works at partition wall at Whiteroom Lounge Bar

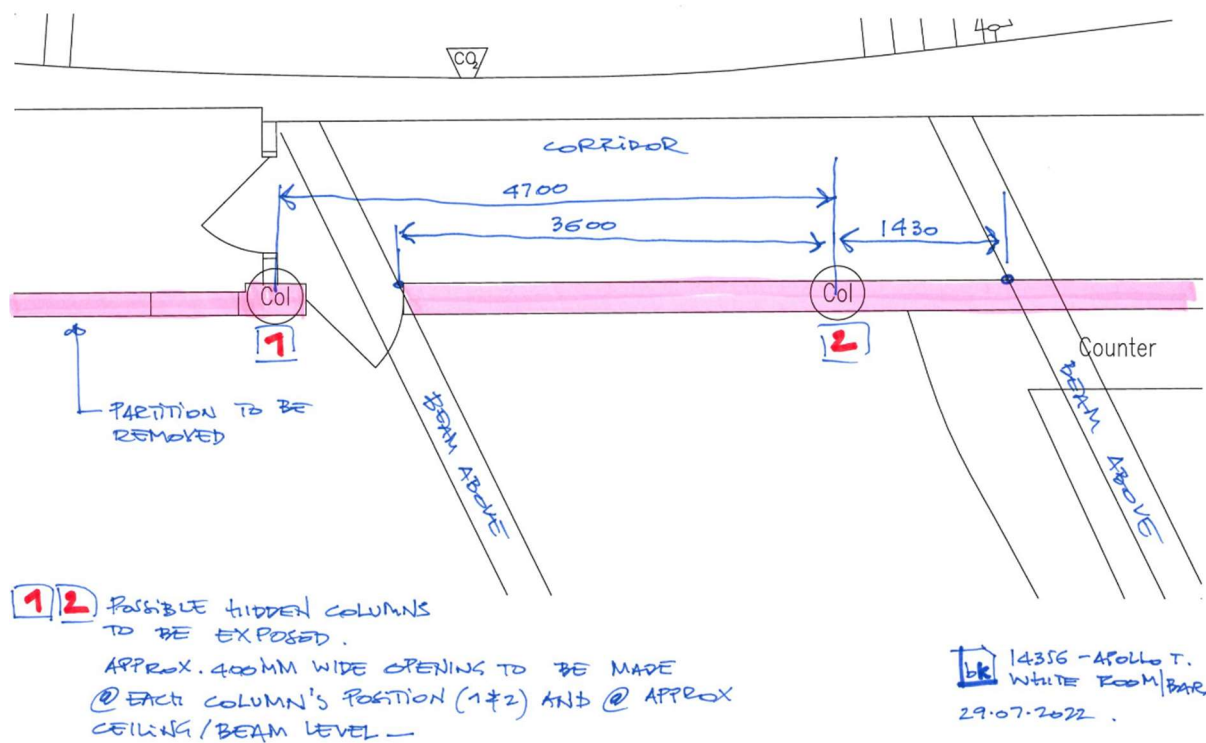
As shown in the sketch below, two areas were requested to be exposed to investigate structural build-up of the partition wall and presence of potential structural columns in line with position [1] and [2] as sketched below.

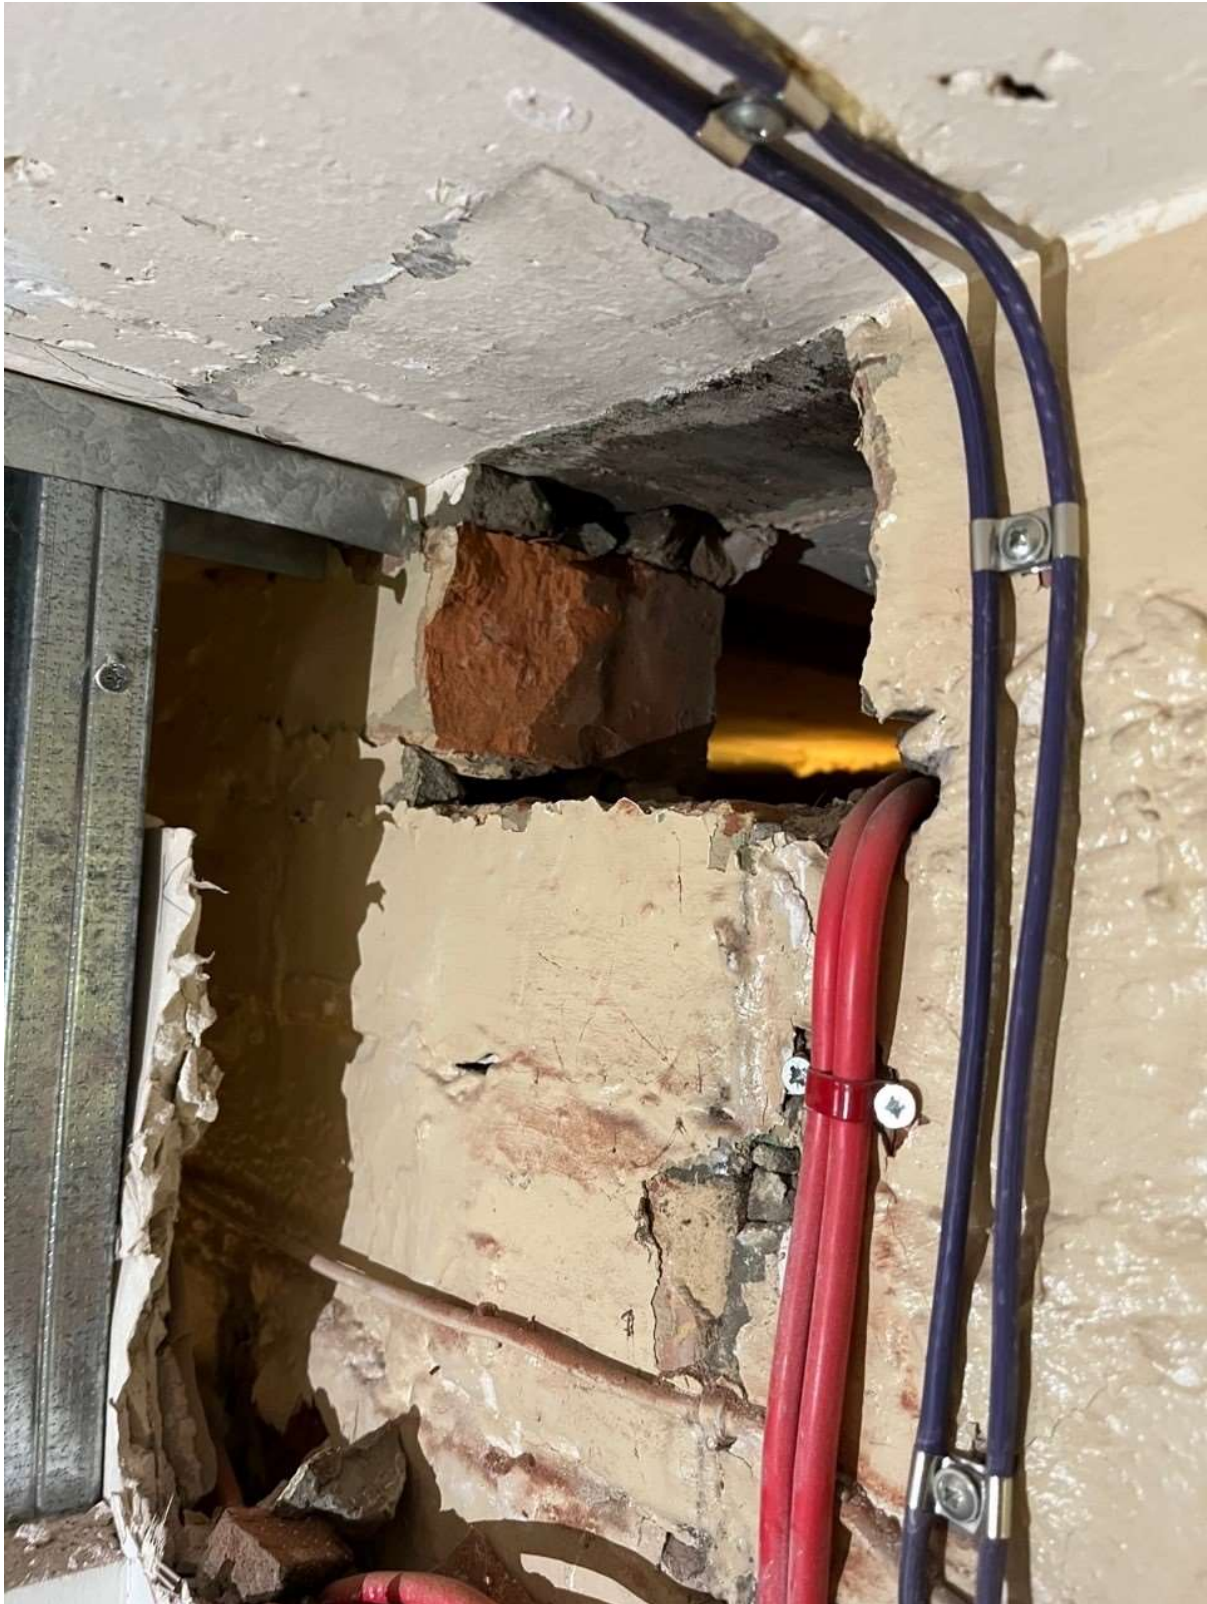
The wall in position [1] was broken through to confirm its overall thickness but also to expose the soffit of the slab above, showing a continuity of the concrete cast slab over the partition. No evidence of a structural elements in line with the column below was visible.

*Photo 1 – Position [1] - View of the partition wall's opening works.*

It is finally recommended that during the demolition of the wall, the principal contractor to take all relevant precautions in order to remove the wall safely. It is moreover required that an engineer is called to witness the demolition works as they progress.

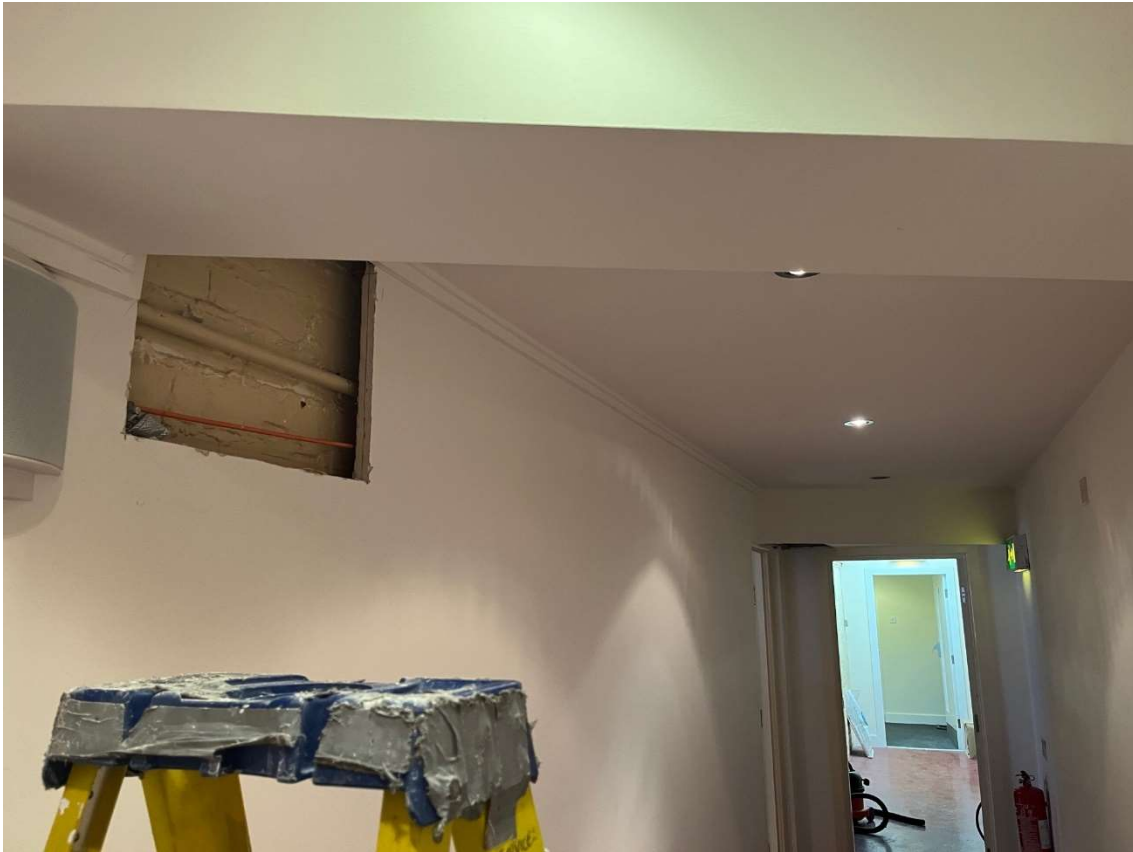
*Photo 2 - Corridor for the far end to show both of the opening up works completed to expose downstand beams and wall.*

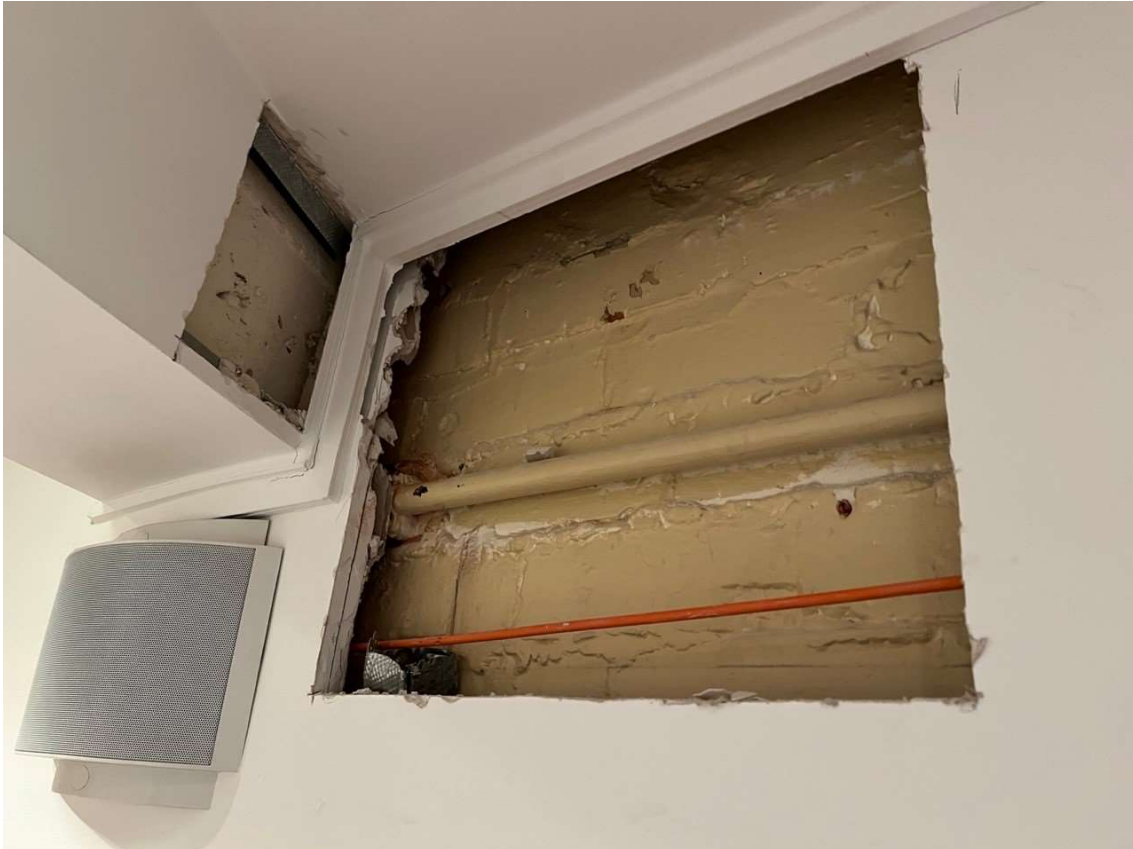
The wall in position [2] was also exposed from its finishes to show similar brickwork wall structure as in position [1]. The opened patch extended from the end of the downstand beam above for approx. 500-600mm. No evidence of a structural elements in line with the column below was visible, although due to some discrepancies between the electronic AutoCAD files and real dimensions on site (as shown in the attached), the exposure of the brickwork wall behind the finishes was undertaken closer to the downstand encased steel beam.

*Photo 3 – Position [2] – Exposure of partition brickwork wall and downstand beam.*

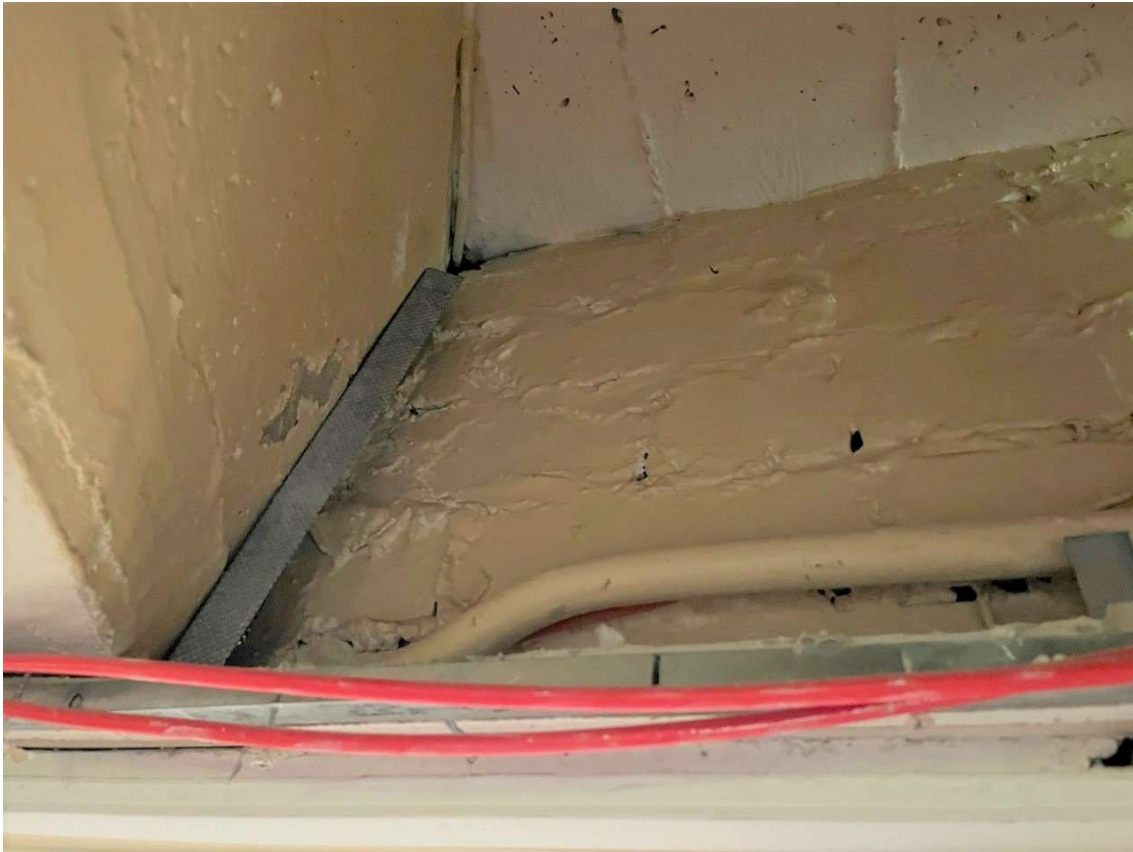
*Photo 4 – Position [2] – link between RC downstand beam and brickwork wall.*
