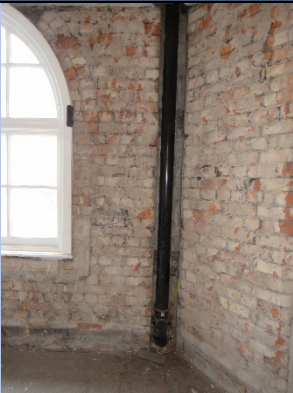
| Room Ref. | Element | Description / Item | Condition | Action | Photographs | | | |
|---|---|---|---|---|---|---|---|---|
| 217a | Walls | Plaster on brickwork with wallpaper finish. Remnant of partition from removed wall. | Fair | <ul style="list-style-type: none"> <li>Remove remainder of partition.</li> <li>De-nail walls.</li> </ul> <hr/> Proposed works <ul style="list-style-type: none"> <li>Strip all walls back to masonry</li> <li>Provide insulated plasterboard (refer to wall type drawing) and secondary glazing (NBS:L10/580A) to east wall (LR).</li> <li>Provide stud partitions to form internal bathroom pods as per drawing 2417.</li> <li>Provide acoustic plaster board to south party wall alcoves and to north party wall as per drawing 2417.</li> <li>South (party) wall to remain as bare masonry at chimney breast locations, refer to drawing 2417.</li> </ul> | | | | 001 |

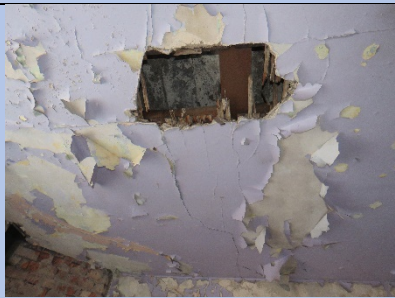
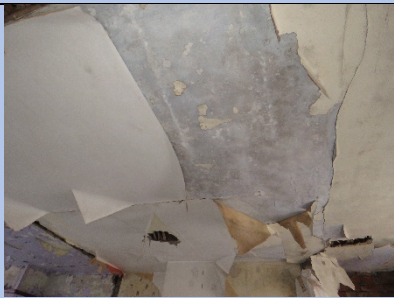
| Room Ref. | Element | Description / Item | Condition | Action | Photographs | | | |
|---|---|---|---|---|---|---|---|---|
| | Ceiling | Plaster on lath with ceiling paper finish. | Fair | Proposed works <ul style="list-style-type: none"> <li>Remove existing lath and plaster ceiling.</li> <li>Steel beams to be de-rusted and treated with intumescent paint per NBS:M61/120 (allowance if steel beams exist).</li> <li>Provide new plasterboard ceiling within the structural steel zone. Refer to drawing 2253.</li> </ul> | | | | |

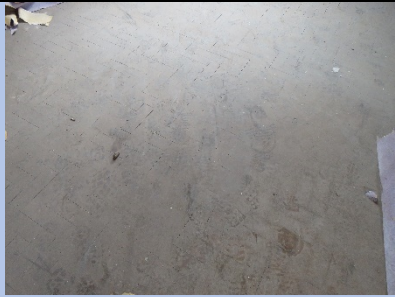
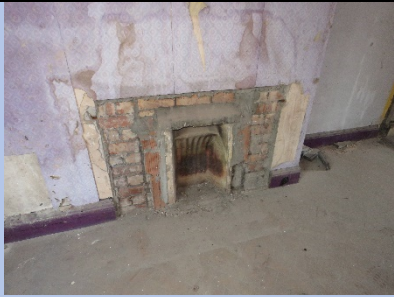
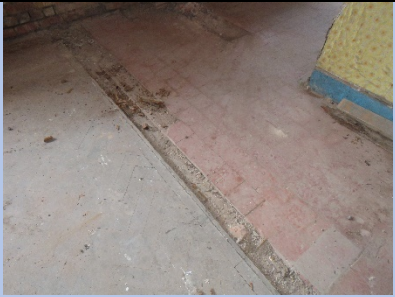
| Room Ref. | Element | Description / Item | Condition | Action | Photographs | | | |
|---|---|---|---|---|---|---|---|---|
| | Floor | Red quarry tile, wood block and glazed tile to hearth. | Good / fair | <ul style="list-style-type: none"> <li>Remove all debris.</li> <li>Clean red quarry tile and protect.</li> <li>Record quantity of wood block, lift and store on pallet in room.</li> </ul> Proposed works <ul style="list-style-type: none"> <li>Floor to be levelled and prepared throughout with latex levelling screed or similar NBS:M10/120.</li> </ul> | | | | |

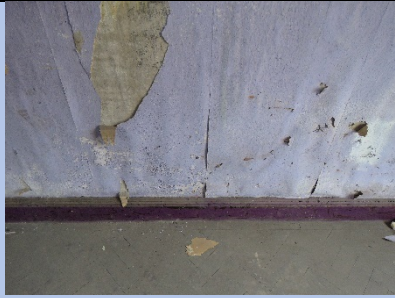
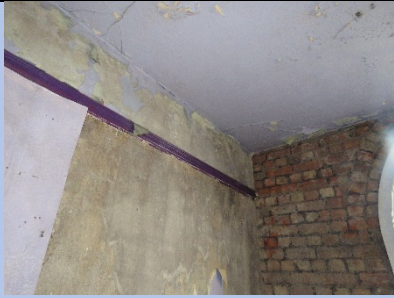
| Room Ref. | Element | Description / Item | Condition | Action | Photographs | | | |
|---|---|---|---|---|---|---|---|---|
| | Joinery | Skirting in situ. Picture rail. | | Proposed works <ul style="list-style-type: none"> <li>Timber skirting and picture rail to be removed.</li> </ul> | | | | |

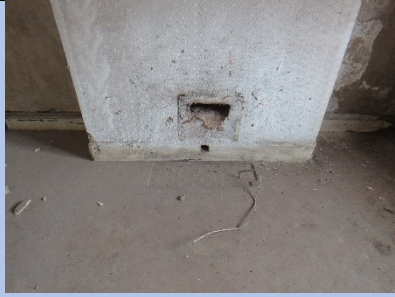
| Room Ref. | Element | Description / Item | Condition | Action | Photographs | | | |
|---|---|---|---|---|---|---|---|---|
| | Misc. | Redundant cables to fire. Partially blocked up fire place. | | <ul style="list-style-type: none"> <li>Remove cables &amp; fill holes.</li> </ul> Proposed works <ul style="list-style-type: none"> <li>Repair, clean fireplace insert.</li> </ul> | | | | |

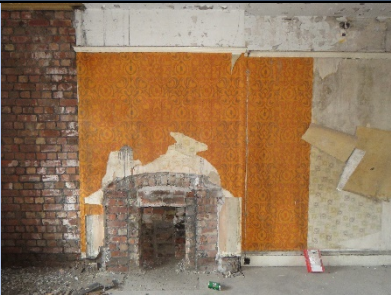
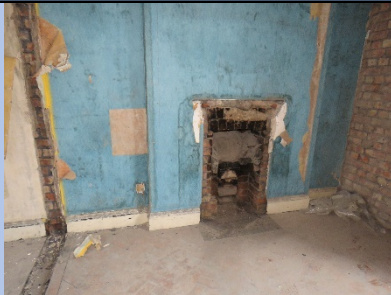
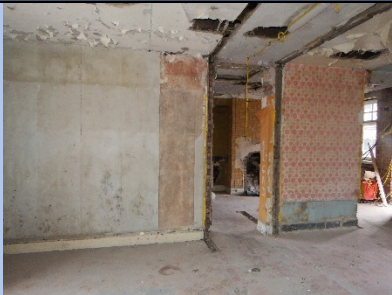
| Room Ref. | Element | Description / Item | Condition | Action | Photographs | | | |
|---|---|---|---|---|---|---|---|---|
| 219a | Walls | Plaster on brickwork with wallpaper finish. Hole to wall. | Fair | <ul style="list-style-type: none"> <li>De-nail walls.</li> <li>Fill hole with salvaged brickwork.</li> </ul> <hr/> Proposed works <ul style="list-style-type: none"> <li>Strip all walls back to masonry</li> <li>Provide insulated plasterboard (refer to wall type drawing) and secondary glazing (NBS:L10/580A) to east wall (LR).</li> <li>Provide stud partitions to form internal bathroom pods as per drawing 2415.</li> <li>Provide acoustic plaster board to south party wall and to west corridor party wall as per drawing 2415.</li> <li>North (party) wall to remain as bare masonry, refer to drawing 2415.</li> </ul> | | | | 001 |

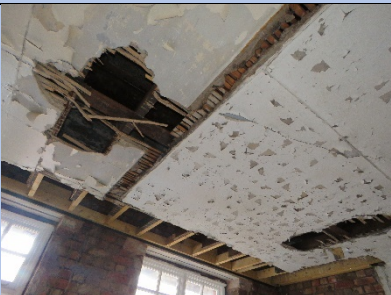
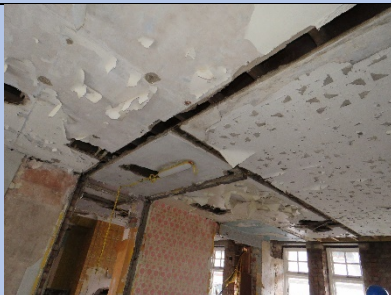
| Room Ref. | Element | Description / Item | Condition | Action | Photographs | | | |
|---|---|---|---|---|---|---|---|---|
| | Ceiling | Plaster on lath with paint finish. Remnant of partition from removed wall. | Poor | <ul style="list-style-type: none"> <li>Remove remainder of partition.</li> </ul> <hr/> Proposed works <ul style="list-style-type: none"> <li>Existing lath and plaster ceiling to be removed along with timber substrate</li> <li>Steel beams to be de-rusted and treated with intumescent paint per NBS:M61/120.</li> <li>Provide new plasterboard ceiling within the structural steel zone. Refer to drawing 2253.</li> </ul> | | | | |

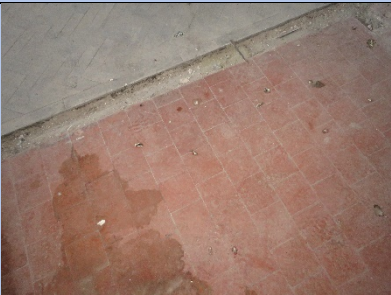
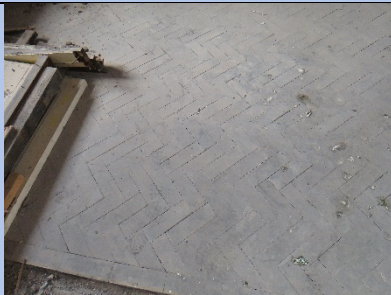
| Room Ref. | Element | Description / Item | Condition | Action | Photographs | | | |
|---|---|---|---|---|---|---|---|---|
| | Floor | Red quarry tile, wood block and glazed tile to hearth. | Good / fair | <ul style="list-style-type: none"> <li>Remove all debris.</li> <li>Clean red quarry tile and protect.</li> <li>Record quantity of wood block, lift and store on pallet in room.</li> </ul> <hr/> Proposed works <ul style="list-style-type: none"> <li>Floor to be levelled and prepared throughout with latex levelling screed or similar NBS:M10/120.</li> </ul> | | | | |

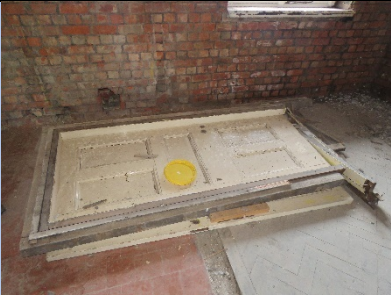
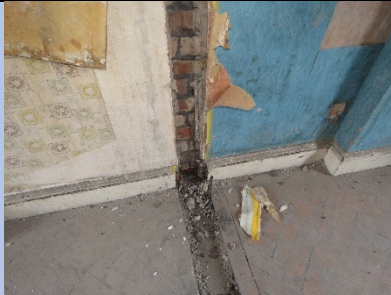
| Room Ref. | Element | Description / Item | Condition | Action | Photographs | | | |
|---|---|---|---|---|---|---|---|---|
| | Joinery | Skirting in situ. Picture rail. Pile of joinery including door and frame. | | <hr/> Proposed works <ul style="list-style-type: none"> <li>Timber skirting and picture rail to be removed.</li> <li>Door and frames to be set aside for reuse elsewhere.</li> <li>Loose timber to be reused where possible otherwise scrapped.</li> </ul> | | | | |

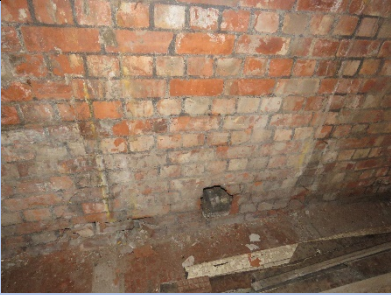
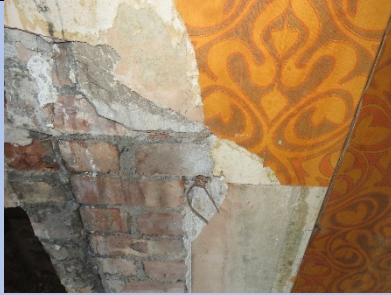
| Room Ref. | Element | Description / Item | Condition | Action | Photographs | | | |
|---|---|---|---|---|---|---|---|---|
| | Misc. | Misc. pipework to floor | | <ul style="list-style-type: none"> <li>Remove redundant pipe.</li> </ul> <hr/> Proposed works <ul style="list-style-type: none"> <li>Repair, clean fireplace insert.</li> </ul> | | | | |

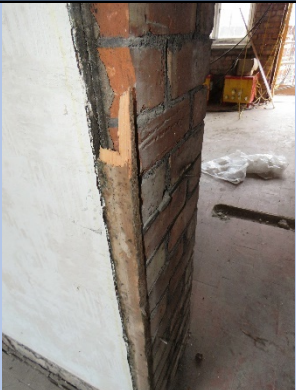
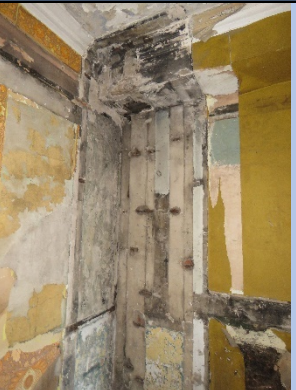
| Room Ref. | Element | Description / Item | Condition | Action | Photographs | | | |
|---|---|---|---|---|---|---|---|---|
| 222a-c | Walls | Plaster on brickwork with wallpaper finish. Hole to wall. | Fair | <ul style="list-style-type: none"> <li>De-nail walls.</li> <li>Infill area of wall to door opening with salvaged brickwork.</li> </ul> <hr/> Proposed works <ul style="list-style-type: none"> <li>Strip all walls back to masonry</li> <li>Provide insulated plasterboard (refer to wall type drawing) and secondary glazing (NBS:L10/580A) to east wall (LR).</li> <li>Provide stud partitions to form internal bathroom and lobby (222b&amp;c) as per drawing 2415.</li> <li>Provide acoustic plaster board to south party wall and to west corridor party wall as per drawing 2415.</li> <li>North (party) wall to remain as bare masonry, refer to drawing 2415.</li> </ul> | | | | 00<br>1 |

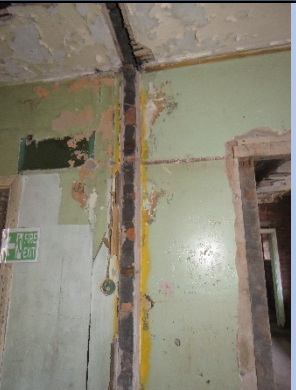
| Room Ref. | Element | Description / Item | Condition | Action | Photographs | | | |
|---|---|---|---|---|---|---|---|---|
| 224a-b | Walls | Plaster on brickwork with wallpaper finish. Hole to wall from old vent. Remnant of removed wall. | Fair | <ul style="list-style-type: none"> <li>De-nail walls.</li> <li>Remove remainder of now removed partition.</li> </ul> <hr/> Proposed works <ul style="list-style-type: none"> <li>Strip all walls back to masonry</li> <li>Provide insulated plasterboard (refer to wall type drawing 2415) and secondary glazing (NBS:L10/580A) to east wall 224a (LR).</li> <li>Provide stud partitions to form internal bathroom (224b) as per drawing 2415.</li> <li>Provide acoustic plaster board to opening in south party wall &amp; to west corridor party wall &amp; north party wall to 224a as per drawing 2415.</li> <li>South (party) wall to otherwise remain as bare masonry, refer to drawing 2415.</li> </ul> | | | | 00<br>1 |

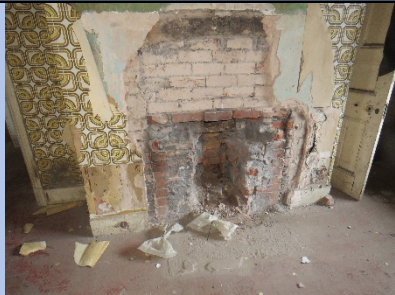
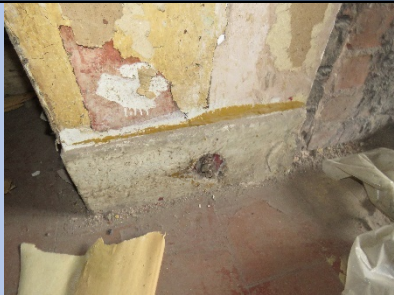
| Room Ref. | Element | Description / Item | Condition | Action | Photographs | | | |
|---|---|---|---|---|---|---|---|---|
| 226a-c | Walls | Plaster on brickwork with wallpaper finish. | Fair | <ul style="list-style-type: none"> <li>De-nail walls.</li> </ul> Proposed works <ul style="list-style-type: none"> <li>Strip all walls back to masonry</li> <li>Provide insulated plasterboard (refer to wall type drawing 2415) and secondary glazing (NBS:L10/580A) to east wall 226a (LR).</li> <li>Provide stud partitions to form internal bathroom (226b) and lobby (226c) as per drawing 2415.</li> <li>Provide acoustic plaster board to north party wall as per drawing 2415.</li> <li>South (party) wall to remain as bare masonry, refer to drawing 2415.</li> </ul> | | | | 001 |

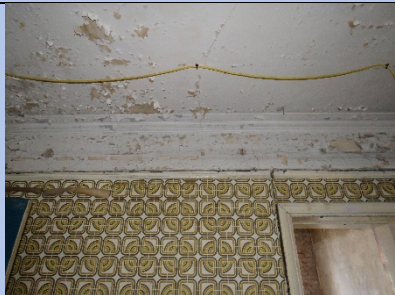
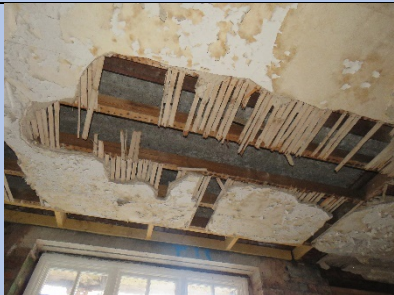
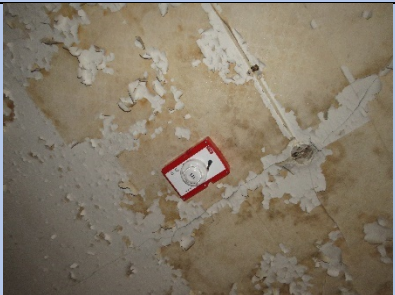
| Room Ref. | Element | Description / Item | Condition | Action | Photographs | | | |
|---|---|---|---|---|---|---|---|---|
| | Ceiling | Plaster on lath with paint finish. Areas of lost ceiling. Plaster cornice. | Poor | <ul style="list-style-type: none"> <li>Retain plaster cornice.</li> </ul> Proposed works <ul style="list-style-type: none"> <li>Existing lath and plaster ceiling to be removed along with timber substrate</li> <li>Steel beams to be de-rusted and treated with intumescent paint per NBS:M61/120.</li> <li>Provide new plasterboard ceiling within the structural steel zone. Refer to drawing 2253.</li> </ul> | | | | |

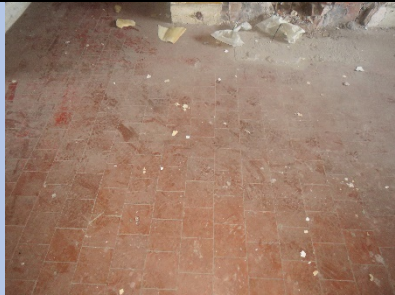
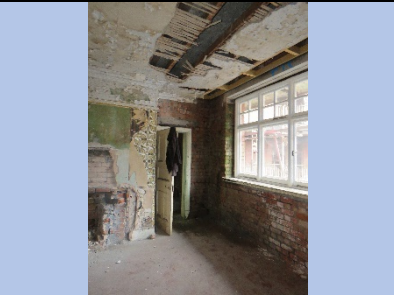
| Room Ref. | Element | Description / Item | Condition | Action | Photographs | | | |
|---|---|---|---|---|---|---|---|---|
| | Floor | Red quarry tile and wood block. | Good / fair | <ul style="list-style-type: none"> <li>Remove all debris.</li> <li>Clean red quarry tile and protect.</li> <li>Record quantity of wood block, lift and store on pallet in room.</li> </ul> Proposed works <ul style="list-style-type: none"> <li>Floor to be levelled and prepared throughout with latex levelling screed or similar NBS:M10/120.</li> </ul> | | | | |

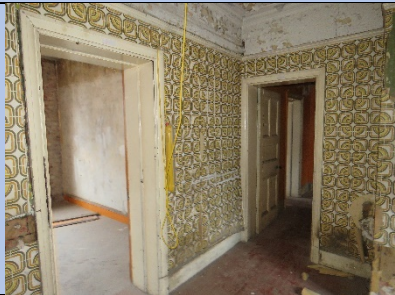
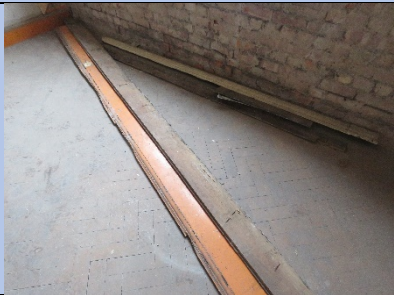
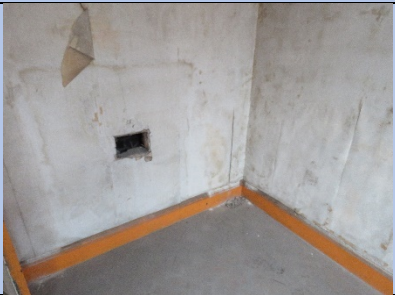
| Room Ref. | Element | Description / Item | Condition | Action | Photographs | | | |
|---|---|---|---|---|---|---|---|---|
| | Joinery | Skirting in situ. Picture rail. Pile of joinery. 4no doors and architraves. | | Proposed works <ul style="list-style-type: none"> <li>Timber skirting and picture rail to be removed.</li> <li>Doors, frames, architraves to be set aside for reuse elsewhere.</li> </ul> | | | | |

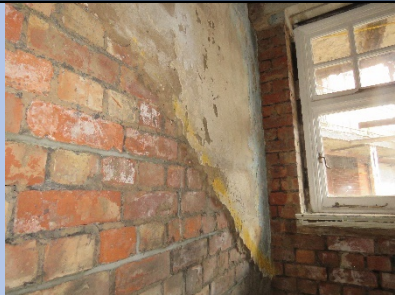
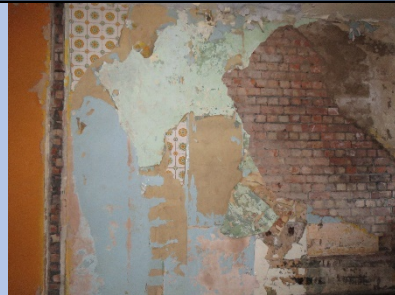
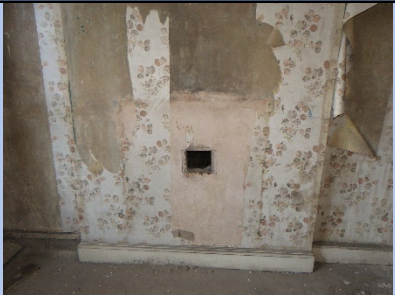
| Room Ref. | Element | Description / Item | Condition | Action | Photographs | | | |
|---|---|---|---|---|---|---|---|---|
| 228a-b | Walls | Plaster on brickwork with wallpaper and paint finish.<br>Later infill to fireplace. | Fair | <ul style="list-style-type: none"> <li>De-nail walls.</li> </ul> <hr/> Proposed works <ul style="list-style-type: none"> <li>Strip all walls back to masonry</li> <li>Provide insulated plasterboard (refer to wall type drawing 2415) and secondary glazing (NBS:L10/580A) to east wall 228a (LR).</li> <li>Provide stud partitions to form internal bathroom (228b) as per drawing 2415.</li> <li>Provide acoustic plaster board to north party wall of 228a as per drawing 2415.</li> <li>South (party) wall to remain as bare masonry, refer to drawing 2415.</li> </ul> | | | | 001 |

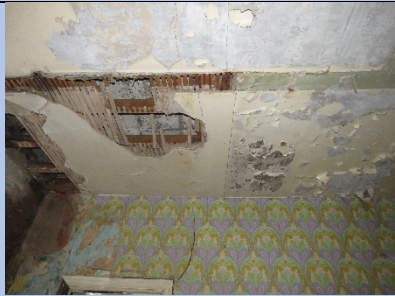
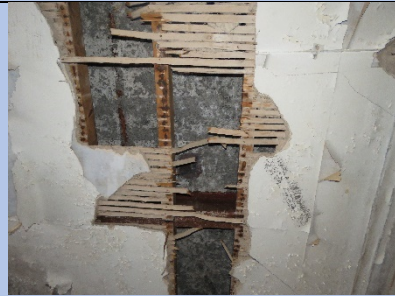
| Room Ref. | Element | Description / Item | Condition | Action | Photographs | | | |
|---|---|---|---|---|---|---|---|---|
| | Ceiling | Plaster on lath with paint finish.<br>Areas of lost ceiling.<br>Plaster cornice. | Poor | Proposed works <ul style="list-style-type: none"> <li>Existing lath and plaster ceiling to be removed along with timber substrate</li> <li>Steel beams to be de-rusted and treated with intumescent paint per NBS:M61/120.</li> <li>Provide new plasterboard ceiling within the structural steel zone. Refer to drawing 2253.</li> </ul> | | | | |

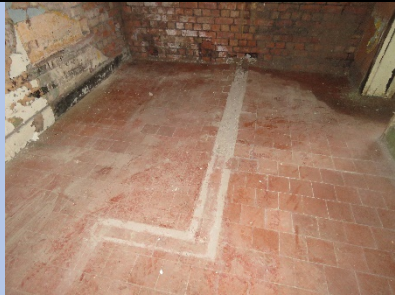
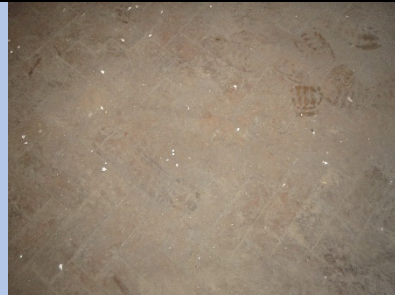
| Room Ref. | Element | Description / Item | Condition | Action | Photographs | | | |
|---|---|---|---|---|---|---|---|---|
| | Floor | Red quarry tile and wood block. | Good / fair | <ul style="list-style-type: none"> <li>Remove all debris.</li> <li>Clean red quarry tile and protect.</li> <li>Record quantity of wood block, lift and store on pallet in room.</li> </ul> <hr/> Proposed works <ul style="list-style-type: none"> <li>Floor to be levelled and prepared throughout with latex levelling screed or similar NBS:M10/120.</li> </ul> | | | | |

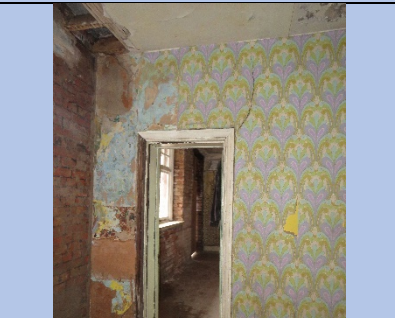
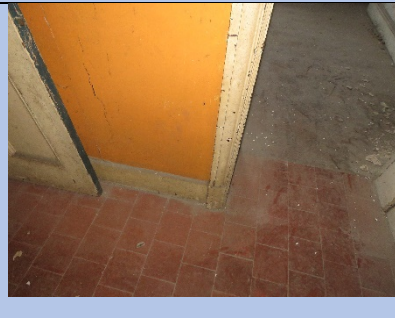
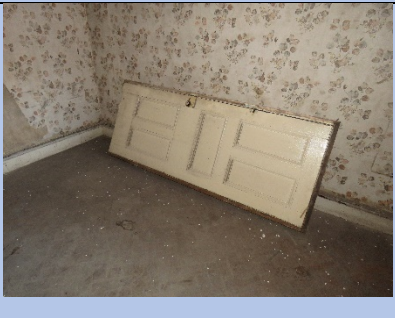
| Room Ref. | Element | Description / Item | Condition | Action | Photographs | | | |
|---|---|---|---|---|---|---|---|---|
| | Joinery | Purcell to survey and update schedule.<br>Skirting in situ.<br>2no doors and architraves. | | Proposed works <ul style="list-style-type: none"> <li>Timber skirting and picture rail to be removed.</li> <li>Doors, frames, architraves to be set aside for reuse elsewhere.</li> </ul> | | | | |

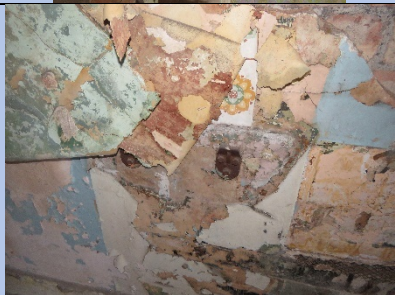
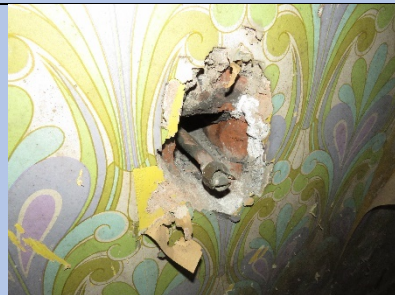
| Room Ref. | Element | Description / Item | Condition | Action | Photographs | | | |
|---|---|---|---|---|---|---|---|---|
| | Misc. | 2no sink brackets.<br>Redundant water pipe. | | <ul style="list-style-type: none"> <li>Remove brackets and put in site store.</li> <li>Remove pipe to wall.</li> <li>Fill all holes in walls following removal.</li> </ul> | | | | |

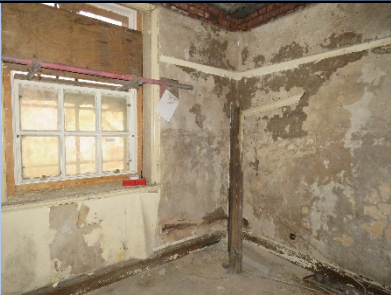
| Room Ref. | Element | Description / Item | Condition | Action | Photographs | | | |
|---|---|---|---|---|---|---|---|---|
| 229 – Lobby and Bed-room | Walls | Plaster on brickwork with wallpaper and paint finish. | Fair | <ul style="list-style-type: none"> <li>De-nail walls.</li> </ul> Proposed works <ul style="list-style-type: none"> <li>Strip all walls back to masonry</li> <li>Provide insulated plasterboard (refer to wall type drawing 2403) and secondary glazing (NBS:L10/580A) to east wall 229a (LR).</li> <li>Provide stud partitions to form internal bathroom (229b) and lobby (229) as per drawing 2403.</li> <li>Provide acoustic plaster board to south party wall of 229a and west party (corridor) wall as per drawing 2403.</li> <li>North (party) wall of 229a to remain as bare masonry, refer to drawing 2403.</li> </ul> | | | | 001 |

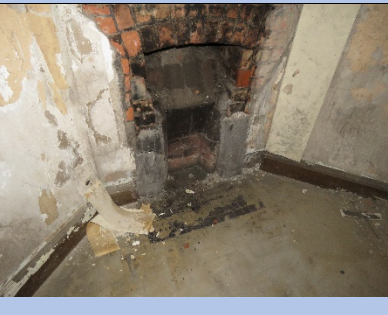
| Room Ref. | Element | Description / Item | Condition | Action | Photographs | | | |
|---|---|---|---|---|---|---|---|---|
| | Misc. | Redundant M&E conduit. | | <ul style="list-style-type: none"> <li>Remove conduit &amp; fill remaining hole in wall.</li> <li>Clean &amp; make good around existing fireplace opening.</li> </ul> | | | | |

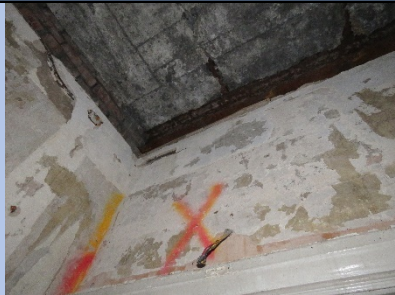
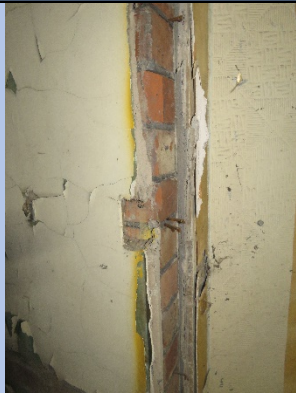
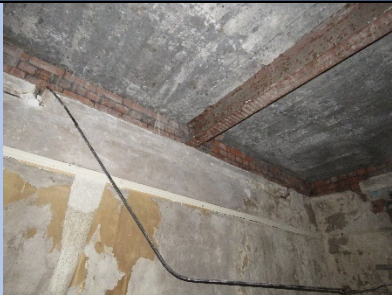
| Room Ref. | Element | Description / Item | Condition | Action | Photographs | | | |
|---|---|---|---|---|---|---|---|---|
| 230a, 230f | Walls | Plaster on brickwork with wallpaper and paint finish.<br>Hole to chimney. | Fair | <ul style="list-style-type: none"> <li>De-nail walls.</li> <li>Fill hole to chimney with salvaged red brick.</li> </ul> <hr/> Proposed works <ul style="list-style-type: none"> <li>Strip all walls back to masonry</li> <li>Provide insulated plasterboard (refer to wall type drawing 2403) and secondary glazing (NBS:L10/580A) to east walls (LR).</li> <li>Provide stud partitions to separate rooms from lobby 229 as per drawing 2403.</li> <li>North and south (party) walls of 229a to remain as bare masonry, refer to drawing 2403.</li> </ul> | | | | 001 |

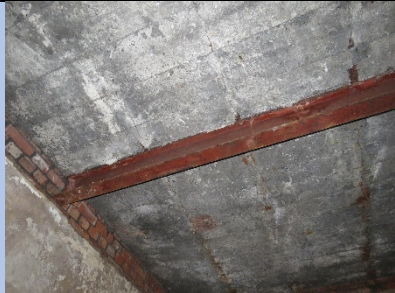
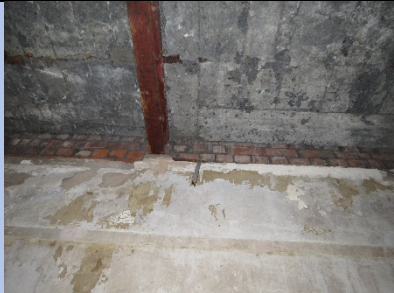
| Room Ref. | Element | Description / Item | Condition | Action | Photographs | | | |
|---|---|---|---|---|---|---|---|---|
| | Ceiling | Exposed concrete. | | Proposed works <ul style="list-style-type: none"> <li>Steel beams to be de-rusted and treated with intumescent paint per NBS:M61/120.</li> <li>Provide new plasterboard ceiling within the structural steel zone. Refer to drawing 2253.</li> </ul> | | | | |

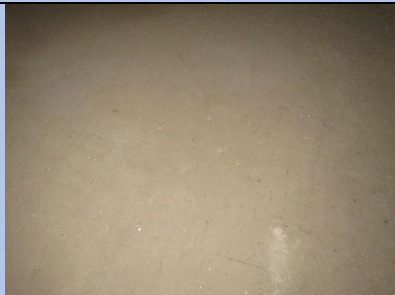
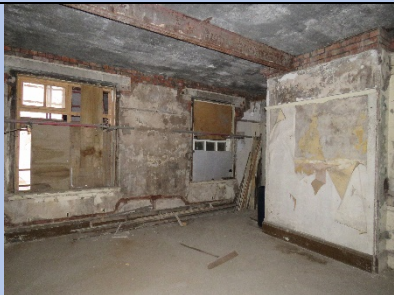
| Room Ref. | Element | Description / Item | Condition | Action | Photographs | | | |
|---|---|---|---|---|---|---|---|---|
| | Floor | Wood block. | Good / fair | <ul style="list-style-type: none"> <li>Remove all debris.</li> <li>Record quantity of wood block, lift and store on pallet in room.</li> </ul> <hr/> Proposed works <ul style="list-style-type: none"> <li>Floor to be levelled and prepared throughout with latex levelling screed or similar NBS:M10/120.</li> </ul> | | | | |

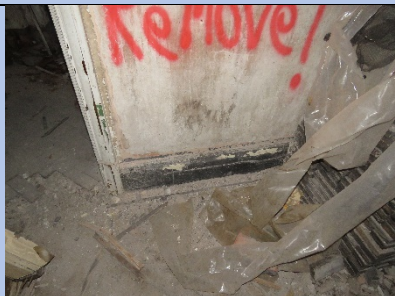
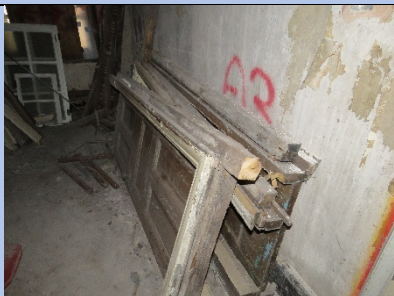
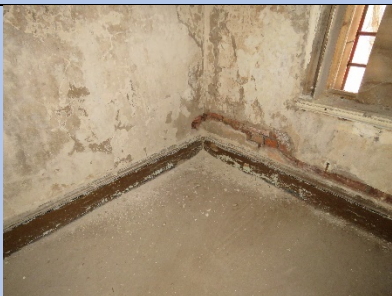
| Room Ref. | Element | Description / Item | Condition | Action | Photographs | | | |
|---|---|---|---|---|---|---|---|---|
| | Joinery | Skirting in situ.<br>Door architrave.<br>Picture rail.<br>Doors, frames and architraves. | | Proposed works <ul style="list-style-type: none"> <li>Timber skirting and picture rail to be removed</li> <li>Doors, frames, architraves to be set aside for reuse elsewhere.</li> </ul> | | | | |

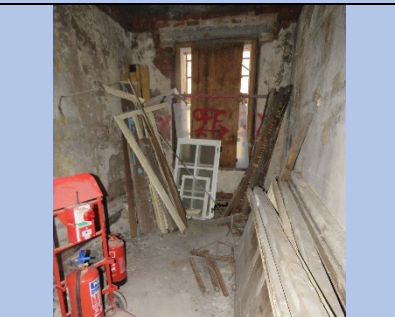
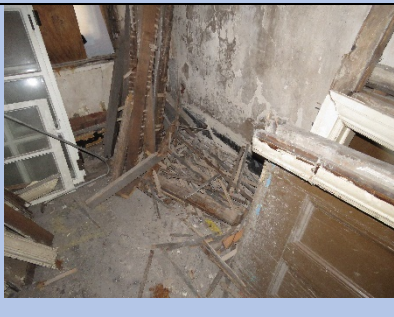
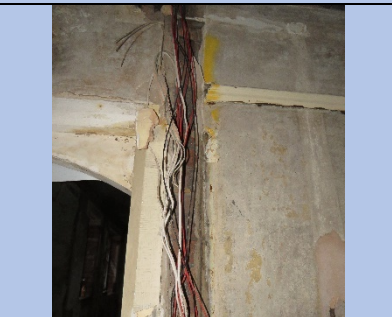
| Room Ref. | Element | Description / Item | Condition | Action | Photographs | | | |
|---|---|---|---|---|---|---|---|---|
| | Misc. | Redundant M&E cables, conduit and pipe. | | <ul style="list-style-type: none"> <li>Remove all redundant M&amp;E.</li> <li>Fill holes following removal of wires and conduit.</li> </ul> | | | | |

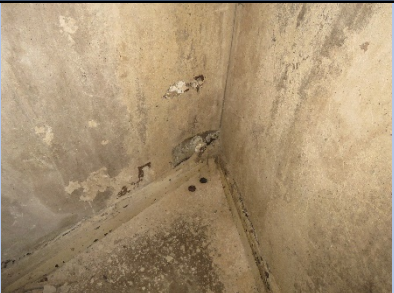
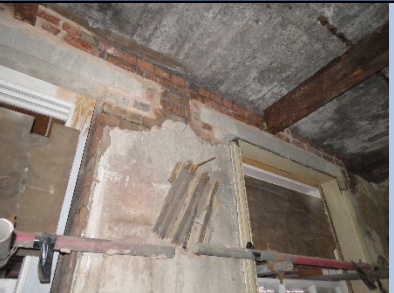
| Room Ref. | Element | Description / Item | Condition | Action | Photographs | | | |
|---|---|---|---|---|---|---|---|---|
| 230c, 230d (inc. stair-case) | Walls | Plaster on brickwork with wallpaper finish. | Fair | <ul style="list-style-type: none"> <li>Remove partition remnant and de-nail walls.</li> </ul> Proposed works <ul style="list-style-type: none"> <li>Strip all walls back to masonry</li> <li>Provide insulated plasterboard (refer to wall type drawing 2403) and secondary glazing (NBS:L10/580A) to south walls (FFS).</li> <li>Provide stud partitions to bathroom as per drawing 2403.</li> <li>Provide acoustic plasterboard wall to north and west wall of 230d as per drawing 2403.</li> <li>East walls to remain as bare masonry, refer to drawing 2403.</li> </ul> | | | | 001 |

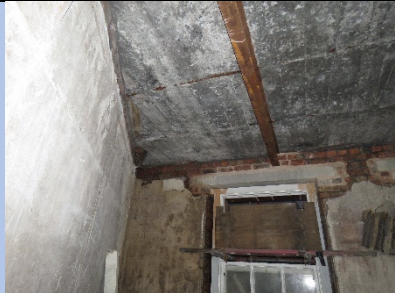
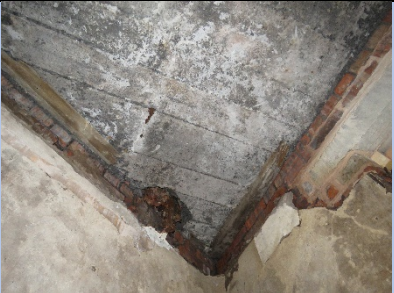
| Room Ref. | Element | Description / Item | Condition | Action | Photographs | | | |
|---|---|---|---|---|---|---|---|---|
| | Ceiling | Exposed concrete and plaster to staircase. | | <ul style="list-style-type: none"> <li>Remove plaster and lath to staircase.</li> </ul> Proposed works <ul style="list-style-type: none"> <li>Steel beams to be de-rusted and treated with intumescent paint per NBS:M61/120.</li> <li>Provide new plasterboard ceiling within the structural steel zone. Refer to drawing 2253.</li> </ul> | | | | |

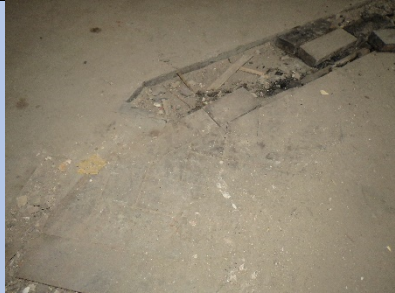
| Room Ref. | Element | Description / Item | Condition | Action | Photographs | | | |
|---|---|---|---|---|---|---|---|---|
| | Floor | Wood block and Glazed tile hearth. | Fair | <ul style="list-style-type: none"> <li>Remove all debris.</li> <li>Record quantity of wood block, lift and store on pallet in room.</li> </ul> Proposed works <ul style="list-style-type: none"> <li>Floor to be levelled and prepared throughout with latex levelling screed or similar NBS:M10/120.</li> </ul> | | | | |

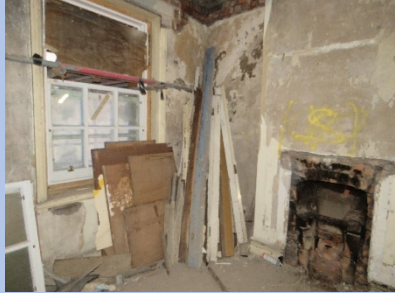
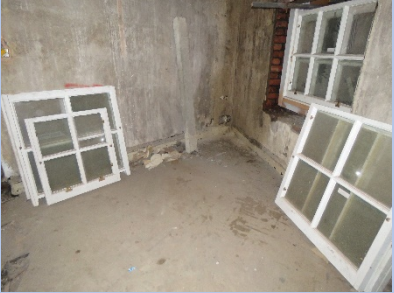
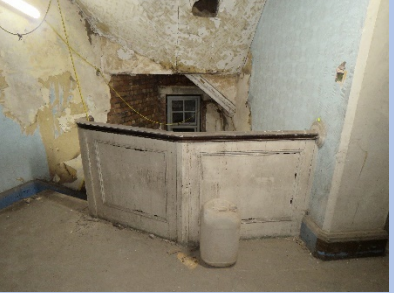
| Room Ref. | Element | Description / Item | Condition | Action | Photographs | | | |
|---|---|---|---|---|---|---|---|---|
| | Joinery | Skirting in situ. Misc. pile of joinery. Windows. | | Proposed works <ul style="list-style-type: none"> <li>Timber skirting and picture rail to be removed</li> <li>Misc. pile of joinery to be used where possible, otherwise scrapped</li> </ul> | | | | |
