### STRUCTURAL REPORT

#### CLAYTON HALL MANCHESTER

**Date:** February 2022

**Reference:** RGR/BBR/16076~srep rev 2

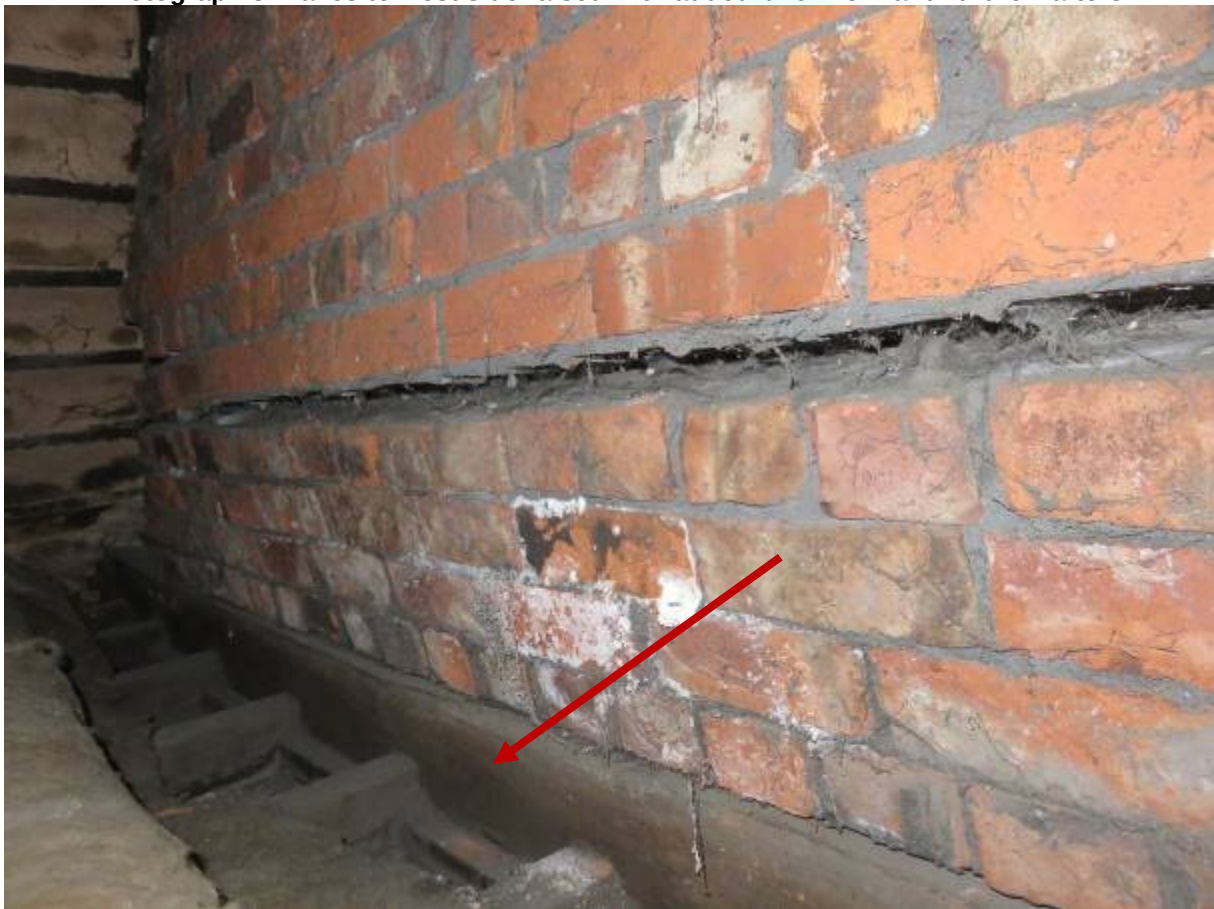
**Photograph 8: Eaves to west side raised with added brickwork and further rafters**

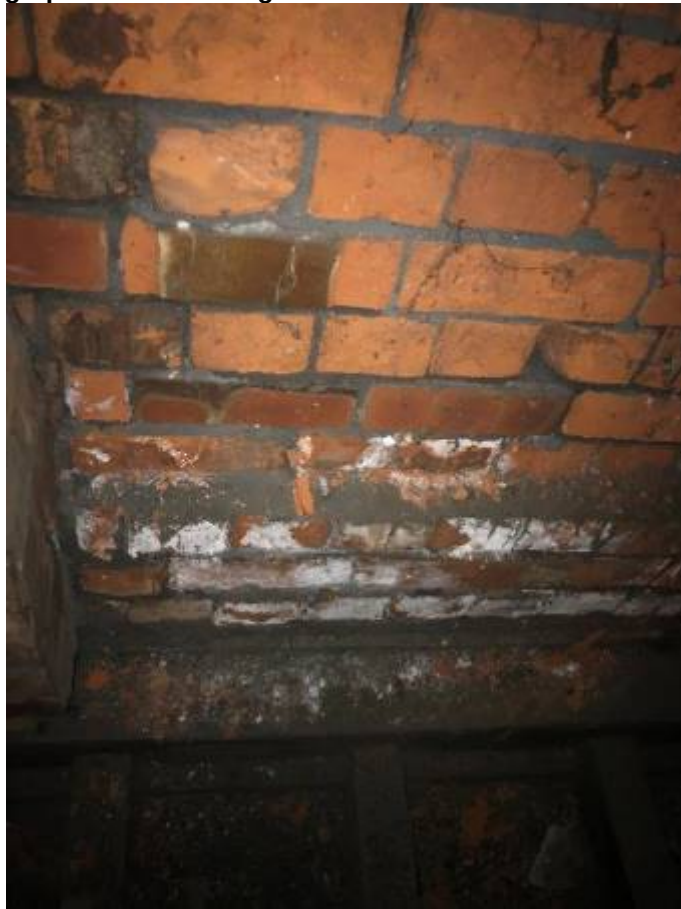
| 3.1.7 | To the south gable end there is a timber plate built into the brickwork to support the ceiling joists. The brickwork above this has rotated laterally inwards and there are areas of salt, perhaps suggesting moisture ingress. Three to four courses above the timber plate there is a horizontal crack which has opened up by 45mm approximately due to this action (see photograph 9). It has clearly been in this state for a considerable time, but warrants some attention. There is some racking of the roof including the trusses, but which appears historic. It is buttressed to the north direction by the northern range. | <p>This appears to have progressed as it has opened up to a further 5mm. It can be noted that this brickwork likely has never been properly supported by this timber plate as there is no contact between these materials even with the dropped masonry above and fits the conclusion of the ceiling being formed at a later date. It was likely envisioned that the headers of the brickwork would be able to stretch back and cantilever to pick up the brickwork above the timber, however with a limited wall thickness of 9" there is insufficient back span and the wall panel thins to 4" where the timber plate is present (see photographs 9A &amp; 9B).</p> <p>Externally this rotational movement is apparent, with more recent cracking patterns to the side of</p> |

| | <p>the stack, as well as toward the eaves.</p> <p>It can be noted that this rotational movement is allowing for water ingress to affect the ceiling finishes to the first-floor room below and propagate cracking patterns at this point. This is an area that requires attention.</p> |

Photograph 9A: Worsening of rotational movement to south gable

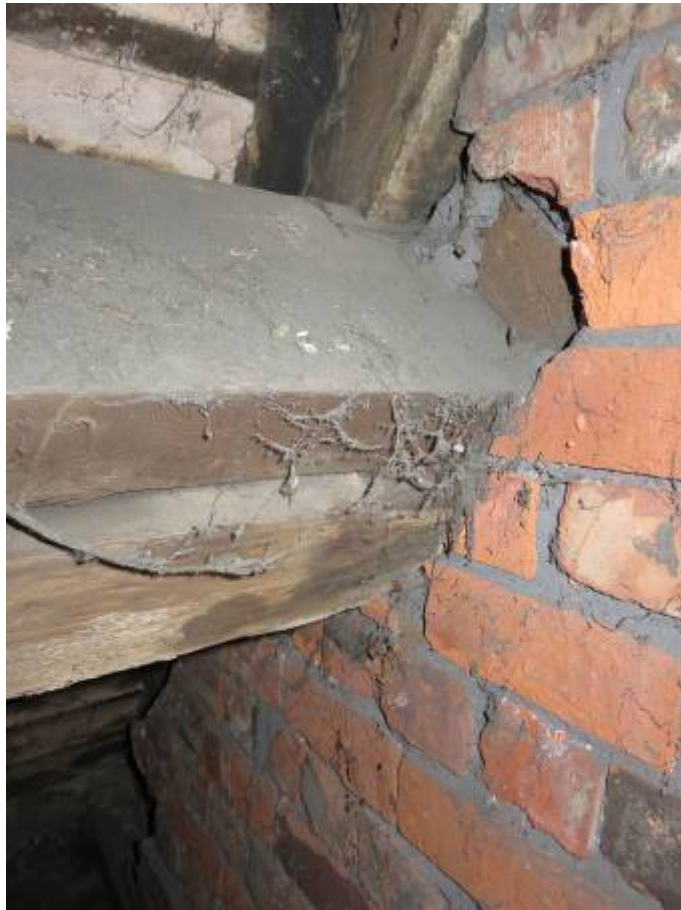
Photograph 9B: Salt staining and debris collection

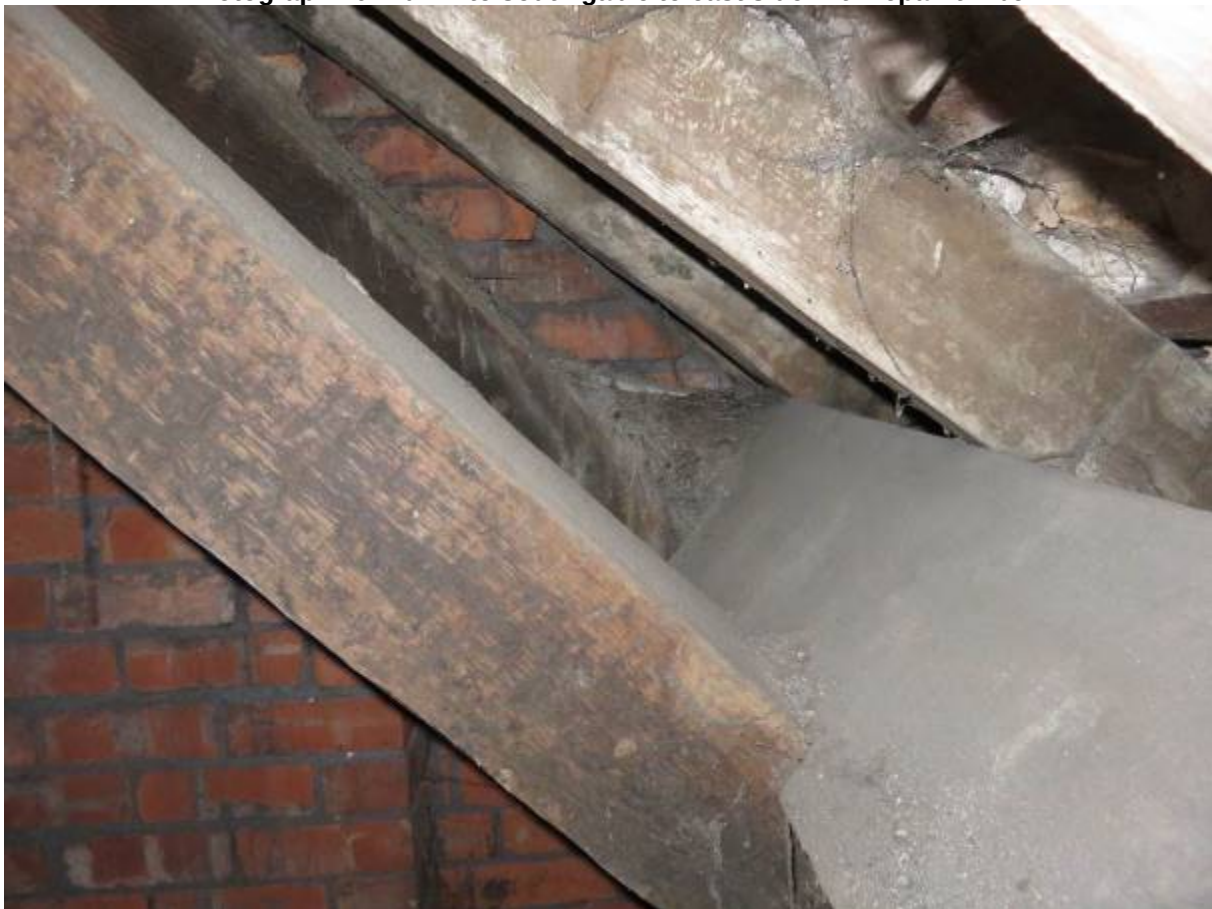
| 3.1.8 The purlin to the south end to the east side is built into the gable, but there is some decay to the end and a strengthening timber has been added, we presume as part of the 1970's work (see photograph 10). Micro-drilling has shown the original timber is decayed, whilst the repair timber is sound. | From testing with a screwdriver the repair timber remains sound. |

Photograph 10: Purlin to south gable to east side with repair timber

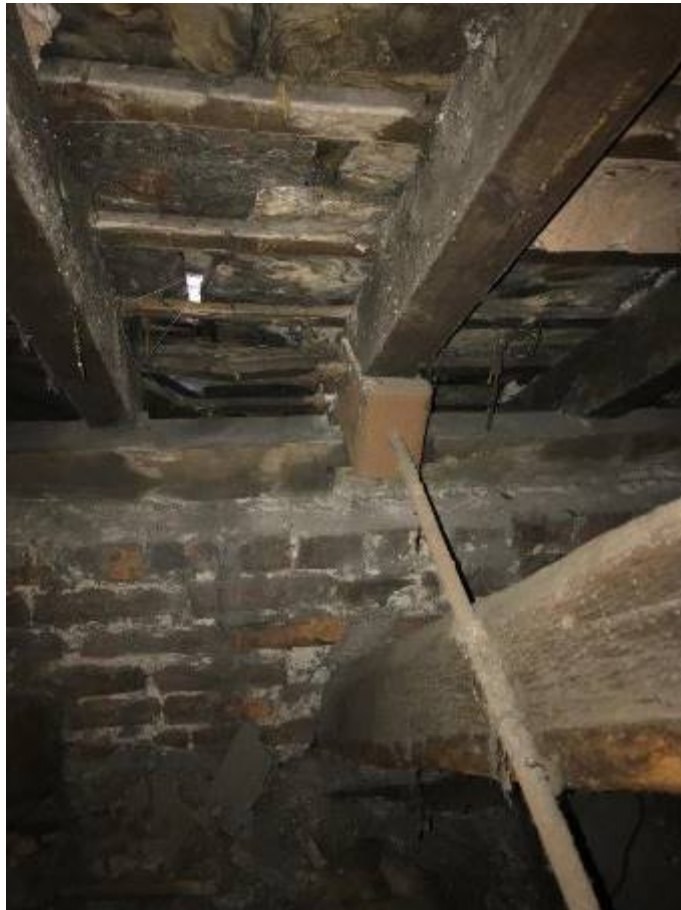
| 3.1.10 At high level to the west side there is a plate introduced over the original rafters at high level which then support the head of the added rafters related to the corridor condition (see photograph 11). Overall, and other than the isolated areas particularly mentioned, the condition of the timbers are reasonable. | It can be noted that in two locations to the western purlin, water ingress is present through the roof finish or glazed tile and affecting the timber section. At present this is at an acceptable level of strength; however localised repair to the roof finishes are a matter of urgency. It can also be noted to the eaves plate at the eastern side that water ingress is taking place which has created staining and fracture of the battens (see photograph 11A). |

Photograph 11: Added plate supporting upper later rafter from western corridor

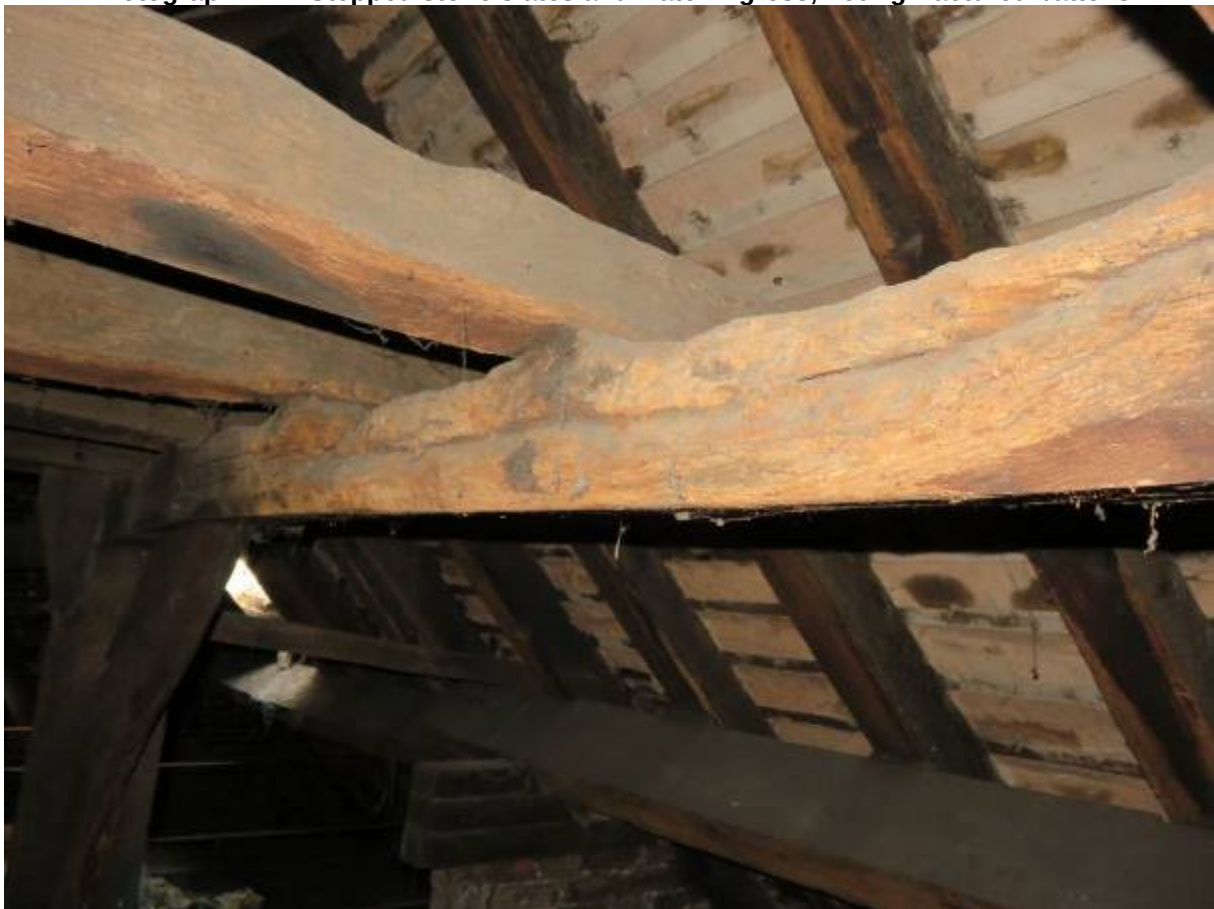
Photograph 11A: Stepped stone slates and water ingress, noting fractured battens

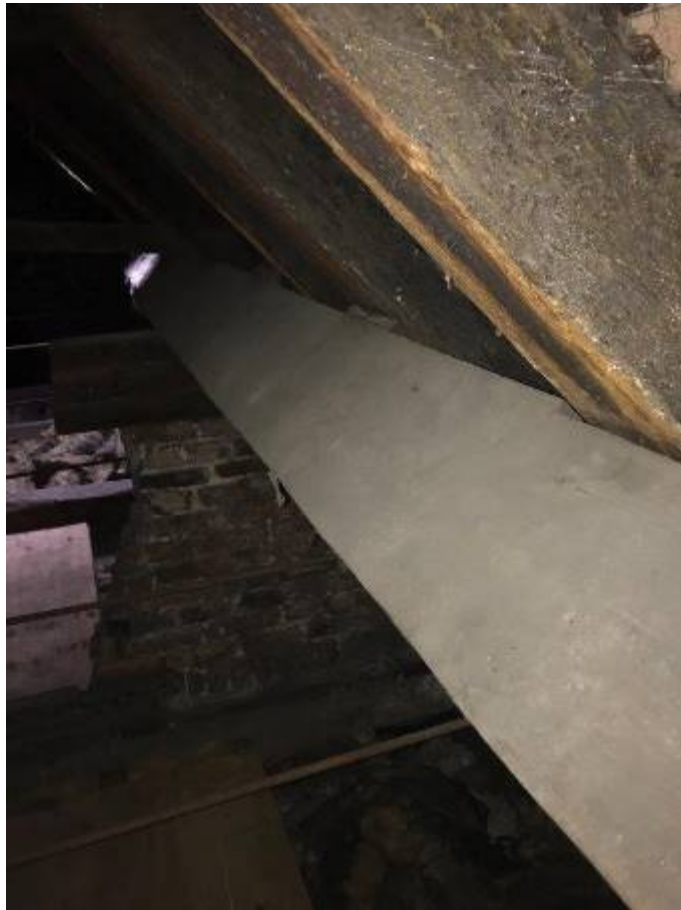
| 3.1.11 The collar purlin has been affected by some sapwood decay, but this is not structurally significant (see photograph 12). It is not possible to see the original eaves plate on which the rafters or ceiling beams sit, but there is a reasonably deep over-hanging eaves to the east side and a lean-to with the corridor to the west side and thus, it should be reasonably well protected. It was noted that there is a low level tie bar close to the south gable. | The sapwood decay is still apparent, but again there are no issues. |

Photograph 12: Collar purlin with sapwood decay

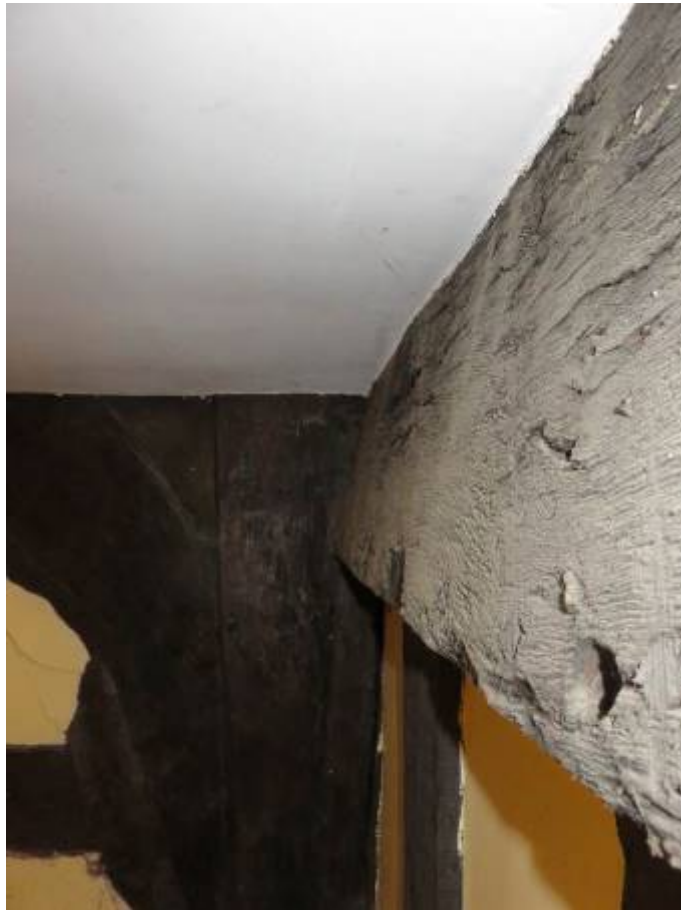
**Photograph 13A: Historic crack to end wall of south range**

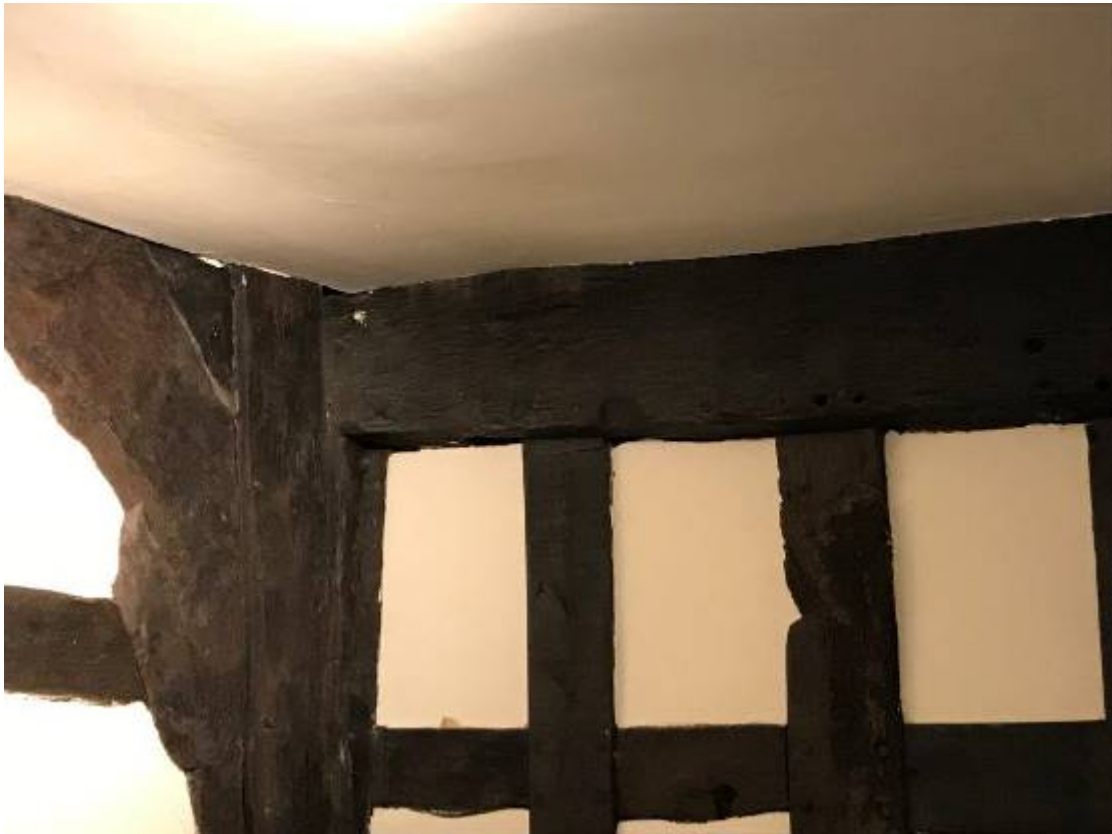
| 3.1.17 Some of the studs to the north panel (see photograph 15) are clearly later replacements, and there are wedges and repairs to heads of other studs. One stud has been introduced to the north side of the window which sits proud of the wall (see photograph 16) and helps support the apparent original cill member and thus, it is probably prudent to retain this. | No change in structural form or wedging, however it is noted that the condition of the adjacent finishes is improved (see photograph 15A). |

Photograph 15: North wall panel to north bay to east side with clear later introduced timbers

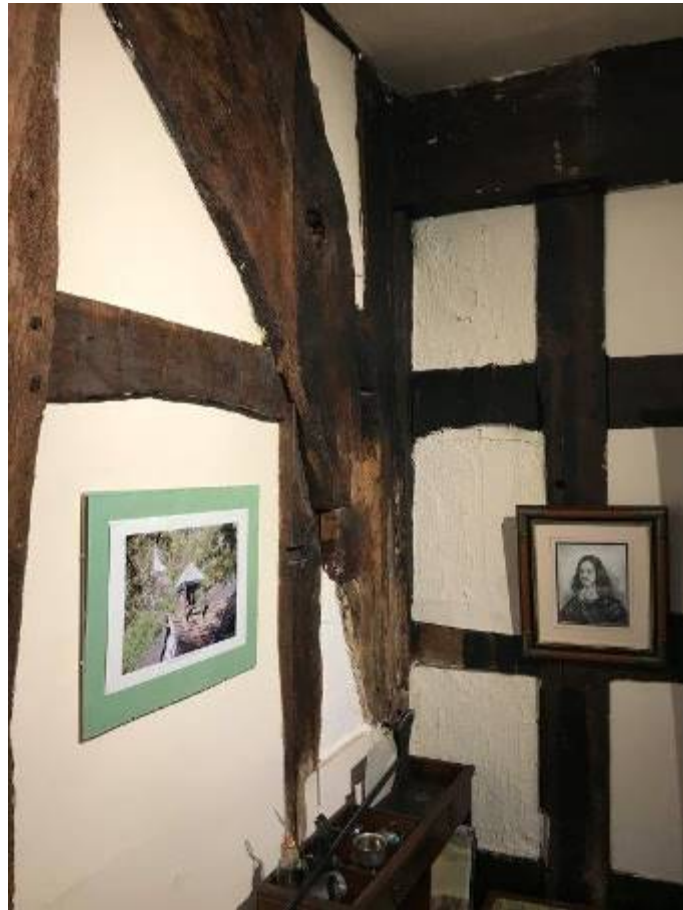
| 3.1.19 To the north 'party' wall, the condition generally appears reasonable, although there is some cracking to the plaster, particularly to the east side, but I suspect that this is simply where plasterboard | This movement through the finishes was no longer present, with suitable and successful repairs undertaken within this period (see photograph 18A). |

Photograph 18: Minor cracking to assumed infill plaster main frame

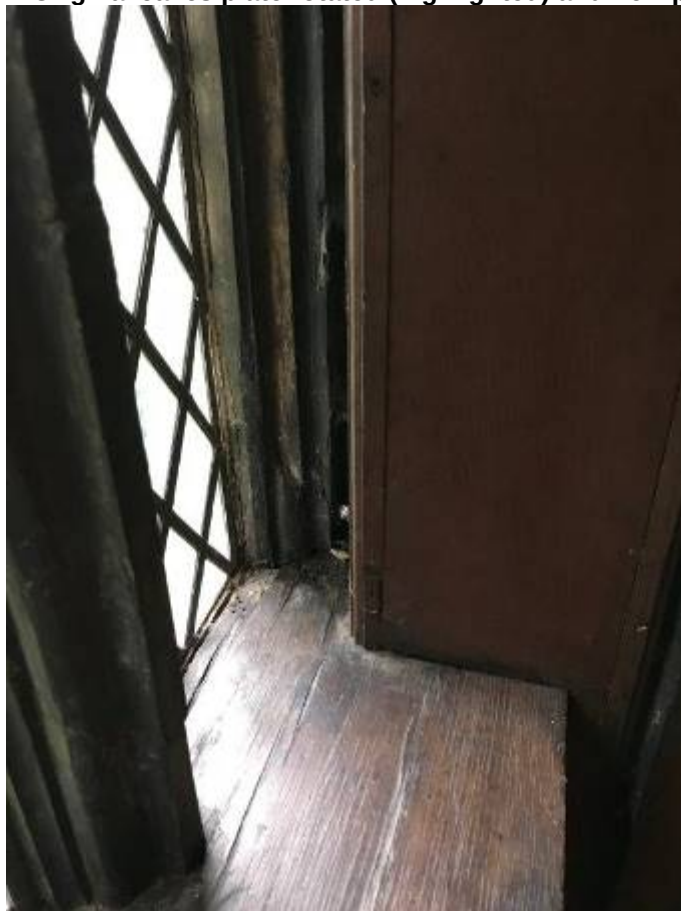
| 3.1.24 | The original eaves plate has rotated out (see photograph 22) here also, and thus the purpose of the plate may be to help restrain this and also support the added ceiling beams above, but this cannot be confirmed without opening up of the roof. However, assuming the conditions of the original timbers are sound, it should be perfectly possible to restrain the original eaves plate at the frame positions and also through the ceiling beams (if retained), perhaps with scarfed on sections if these end up slightly short, and which would allow removal of the secondary frame. | The same method of restraint would be possible, however due to localised water ingress around the mullion window the condition of the timber is at greater risk. Opening up then review is required (see photograph 22A). |

**Photograph 22: Original eaves plate rotated (highlighted) and new plate alongside**

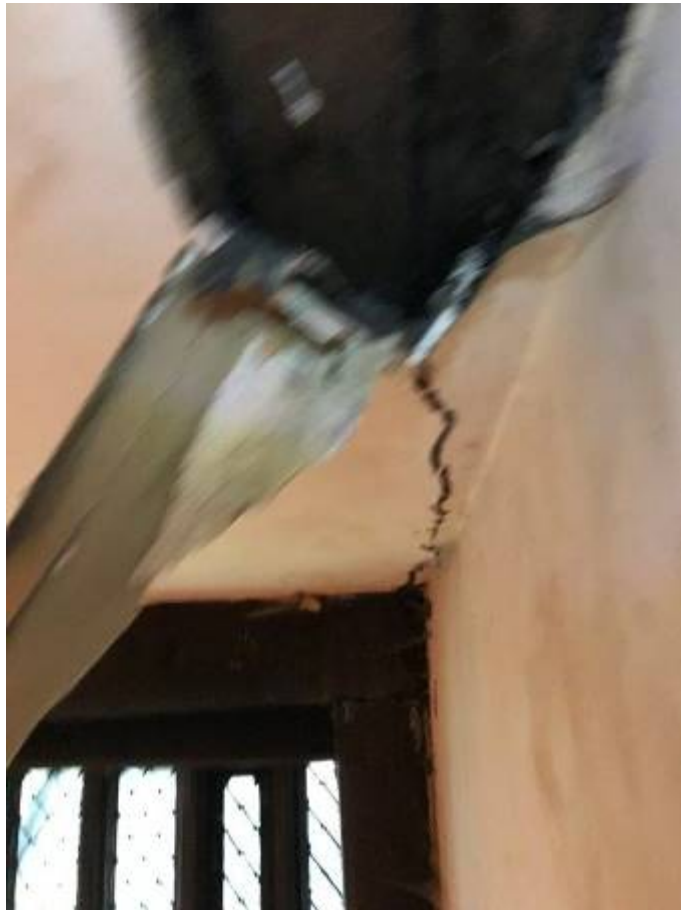
| 3.1.28 | The high-level plastered panel of masonry does appear to be slightly out of plumb (see photograph 25) in an inward direction marrying with movement seen above, although not too a significant degree. | It was noted that to the ceiling finishes in this location, cracking has taken place along a line between the wall and ceiling finish, highlighting progress of movement as seen above within the attic space (Photographs 25A & B), with water staining apparent on a large proportion of the finishes in this location, therefore highlighting water ingress is taking place. The cracking through the finishes is approximately 3-6mm. |

Photograph 25: Apparent minor movement to wall above fireplace

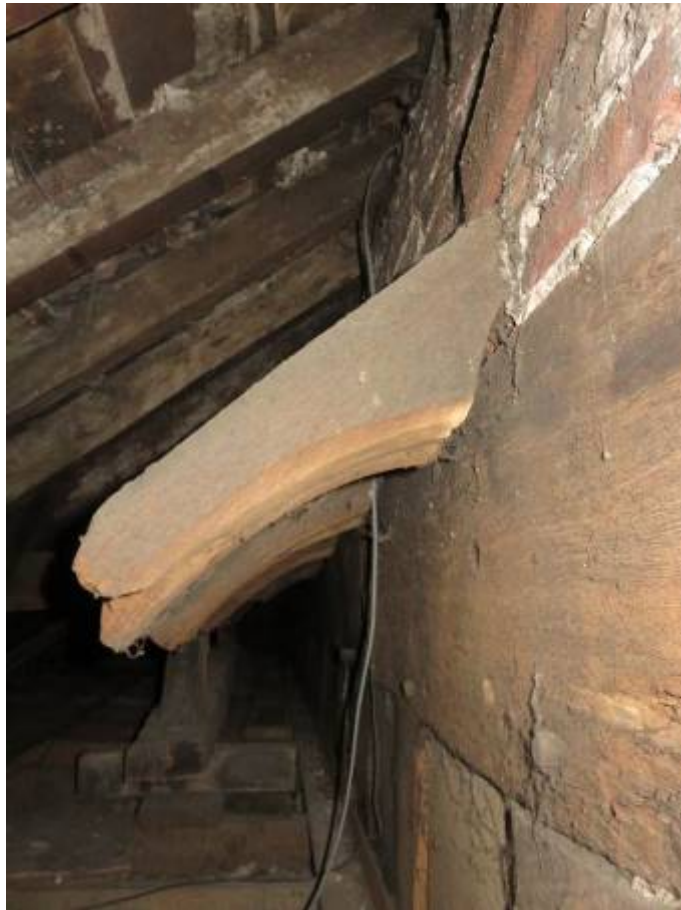
Photograph 25B: Cracking and loss of plaster at stack

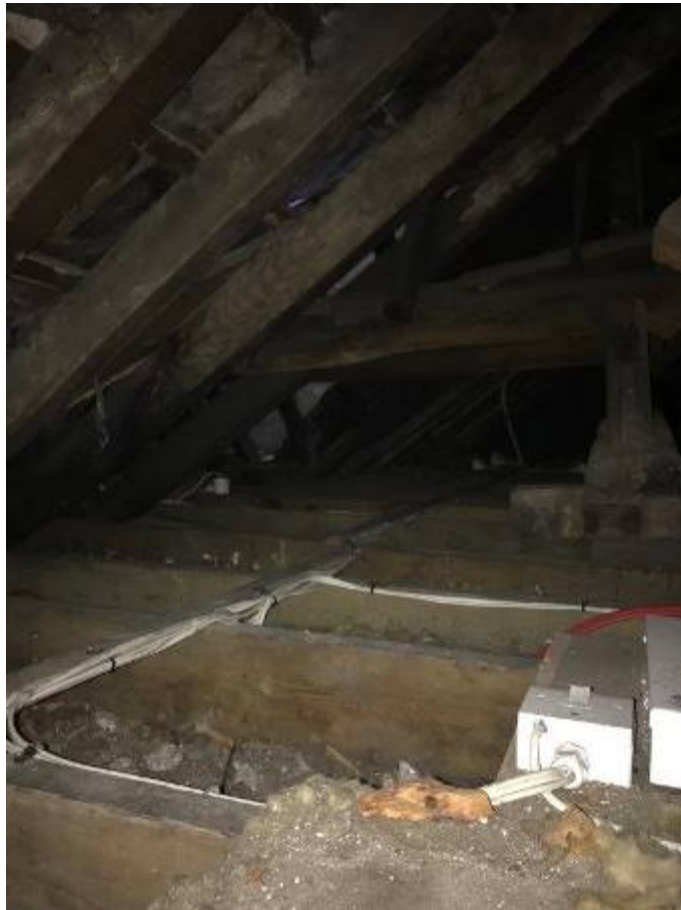
Photograph 28: View along western corridor roof looking north

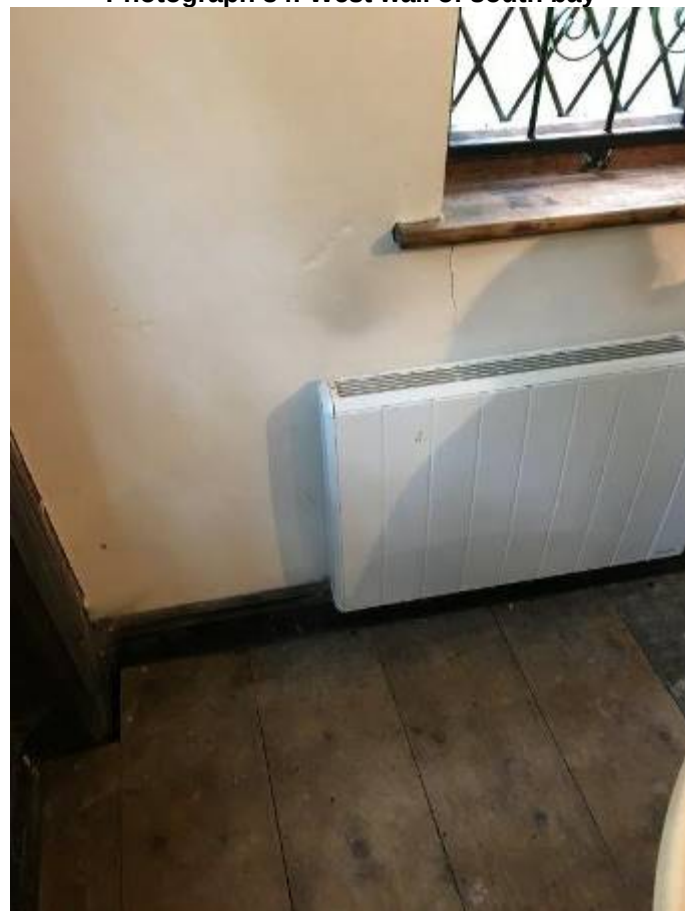
**Photograph 34: West wall of south bay**

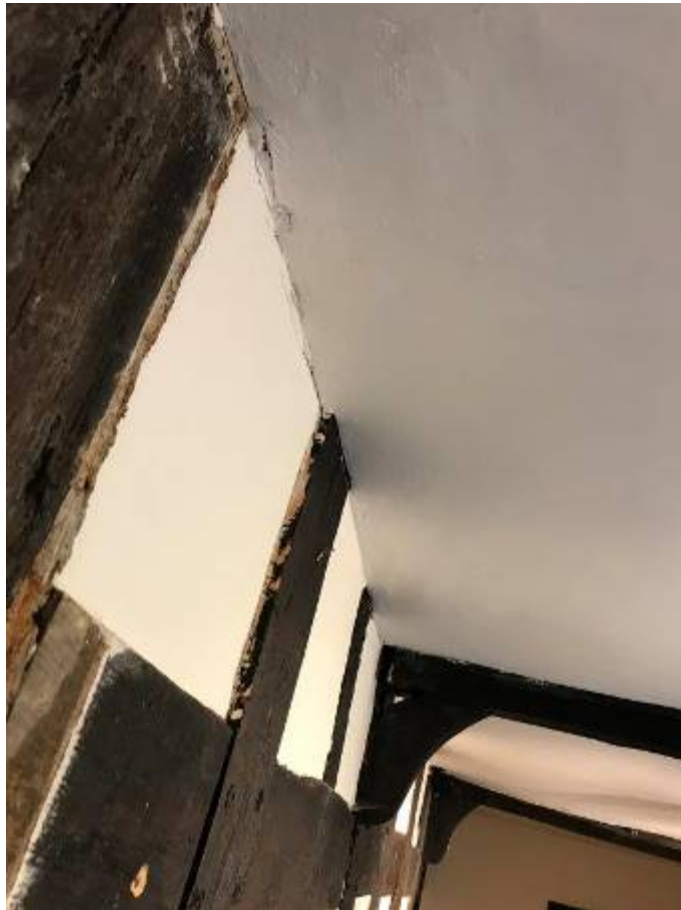
| <p>3.1.44 The south wall again has a wide inglenook full fireplace filled in and perhaps even narrowed slightly. This is all of masonry construction with the added wall plate at high level previously noted with significant evidence of structural distress. The floor is suspended timber as with the north and again was inspected by the Architect. The west wall appears in generally reasonably condition (see photograph 34).</p> | <p>The fireplace has been opened up and looks to have been restored as part of the 2016 works. There is however clear movement taking place with cracking patterns toward the bearings of the window with continuation of cracking from sill to floor level (see photograph 34A). Generally there is clear differential movement between the masonry and timber fabric to the south and east elevations respectively.</p> <p>Efflorescence and damp staining continues upon the façade of the fireplace (see photograph 34B). There is also some movement between the stone surround and the adjacent plasterwork to the west.</p> <p>At the junction between this elevation and the western wall, some opening up between the finishes and the western frame is present and there appears to be a fracture to the southern mid rail, so further tying in and strapping between the frame members at this point would be advised (see photograph 34C).</p> |

**Photograph 34C: South mid-rail to west frame connection indicating fracture to mid-rail and movement in adjacent finishes**

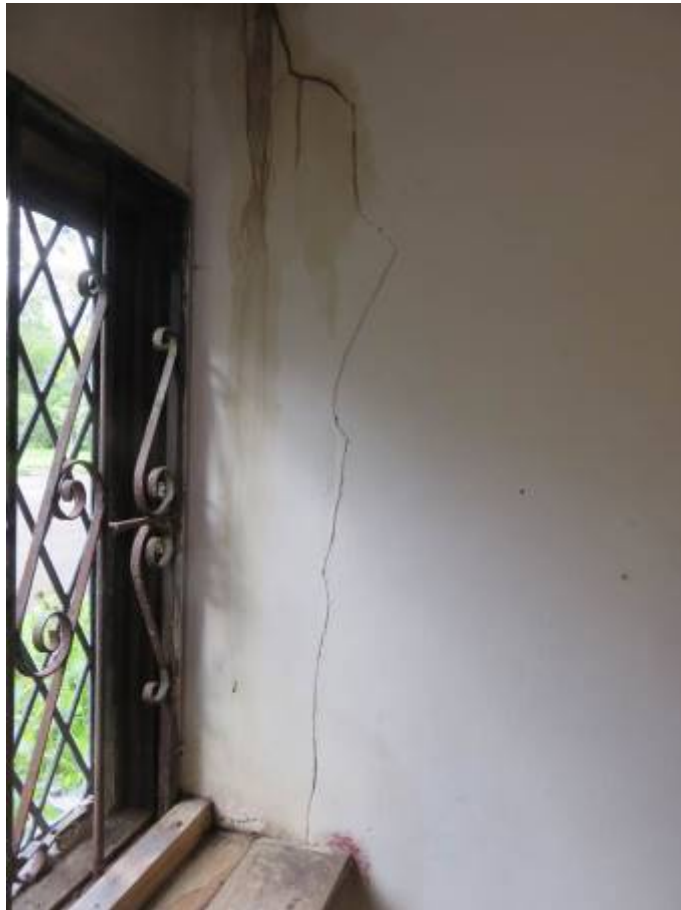
| <p>3.1.45 To the <b>west corridor</b> at ground floor level there is a small room at the north end with some plaster removed at high level to the north wall, and which exposes a much more recent brick repair. Cracks run around the edges, where this has not been bonded with the adjoining brickwork, and which would have been difficult as the brick units are different sizes. To the south side is an infill brick wall which is clearly a modern insert and not structurally significant. The floor above is supported on a series of short timber beams spanning east-west, and then with floor joists between.</p> | <p>This small room is no longer present, with the corridor now full length leading toward the north wing of the building. All finishes appeared in satisfactory condition, with hairline fracturing through the north wall perhaps in relation to the repairs previously undertaken. The floor structure above is supported through the same system; however the joists have been boarded over and some differential movement can be noted where wall meets ceiling (see photograph 34D).</p> <p>At low level minor levels of decay can be noted where the timber frame meets the solid ground construction (concrete) within the corridor (see photograph 34E).</p> |

**Photograph 34E: Decay to soleplate adjacent to entrance onto north bay**

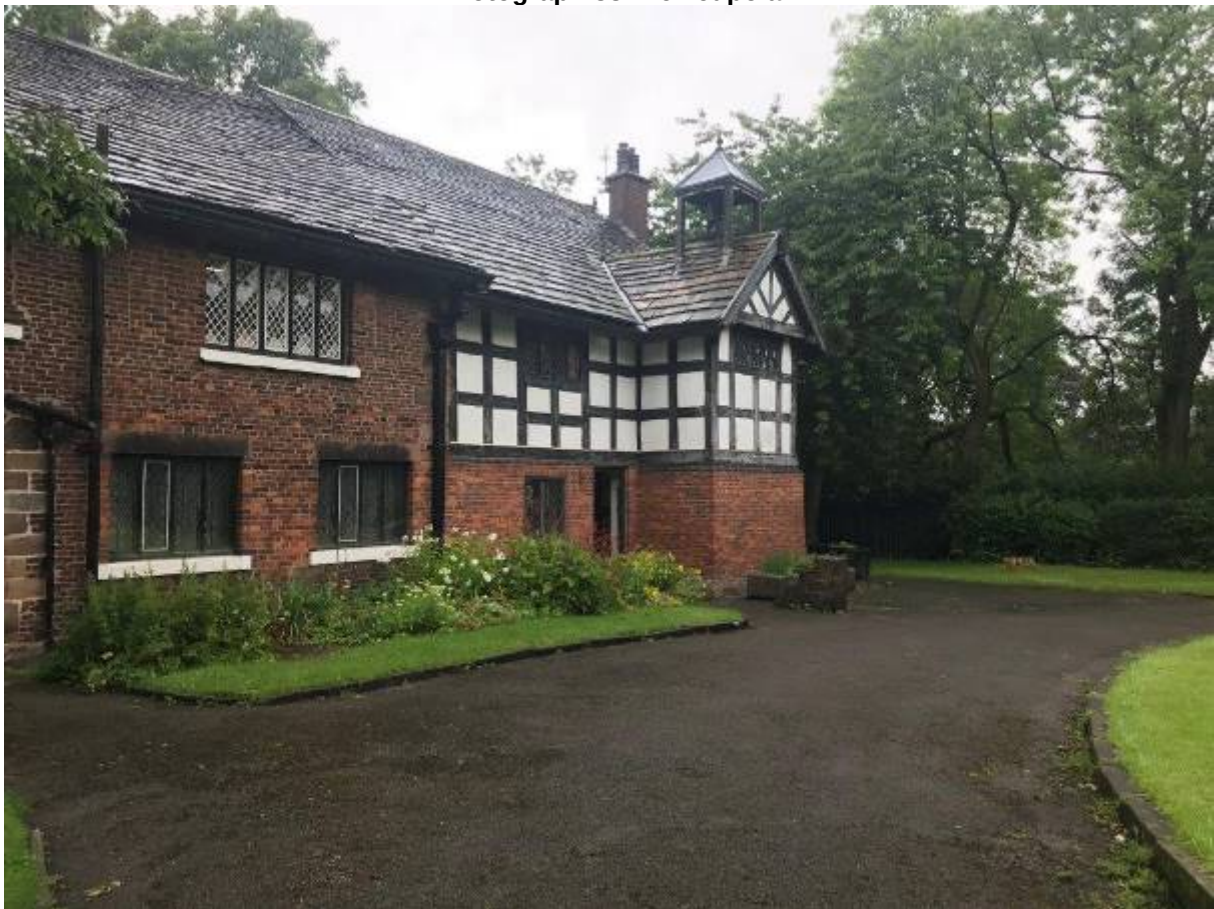
| <p>3.1.51 <b>Externally</b> to the <b>west</b> side, a large stone slated roof can be seen with obvious slipped slates. The small bell cupola to the front elevation will need to be checked with high level access and a reasonable provisional sum allowed for repairs particularly to the post feet (see photograph 38).</p> | <p>The extent of slipped stone slates to the roof has worsened from external and internal review. With greater areas of disturbance noted toward the southern chimney stack, as well as at the alteration in levels between north and south wings. It would still remain sensible to allow a provisional sum for repairs to the post feet of the cupola (see photograph 38A).</p> |

Photograph 38: Bell cupola

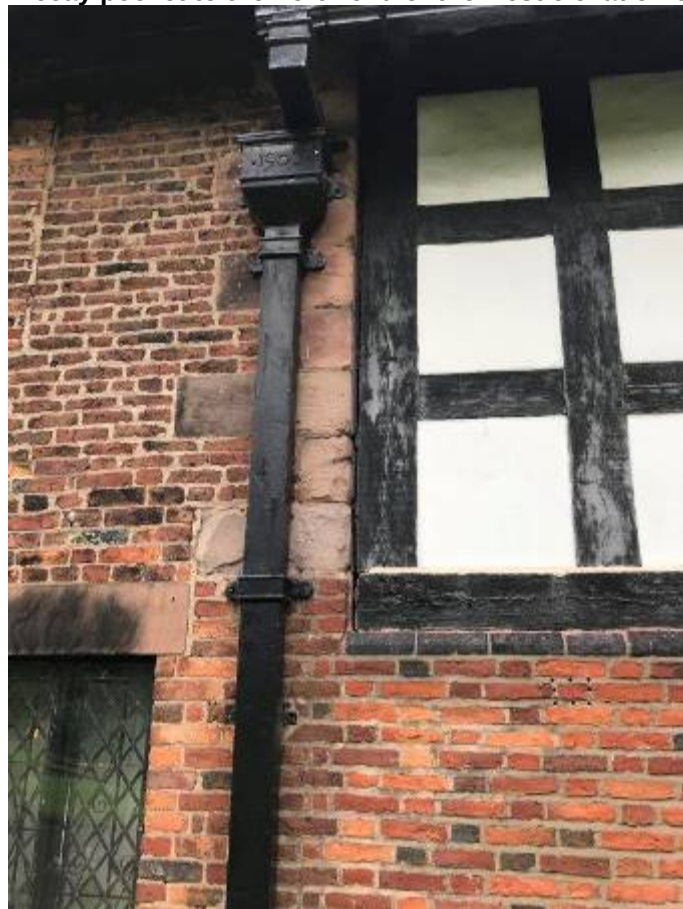
Photograph 39: Decay pocket to the north end of the west elevation of the stair turret

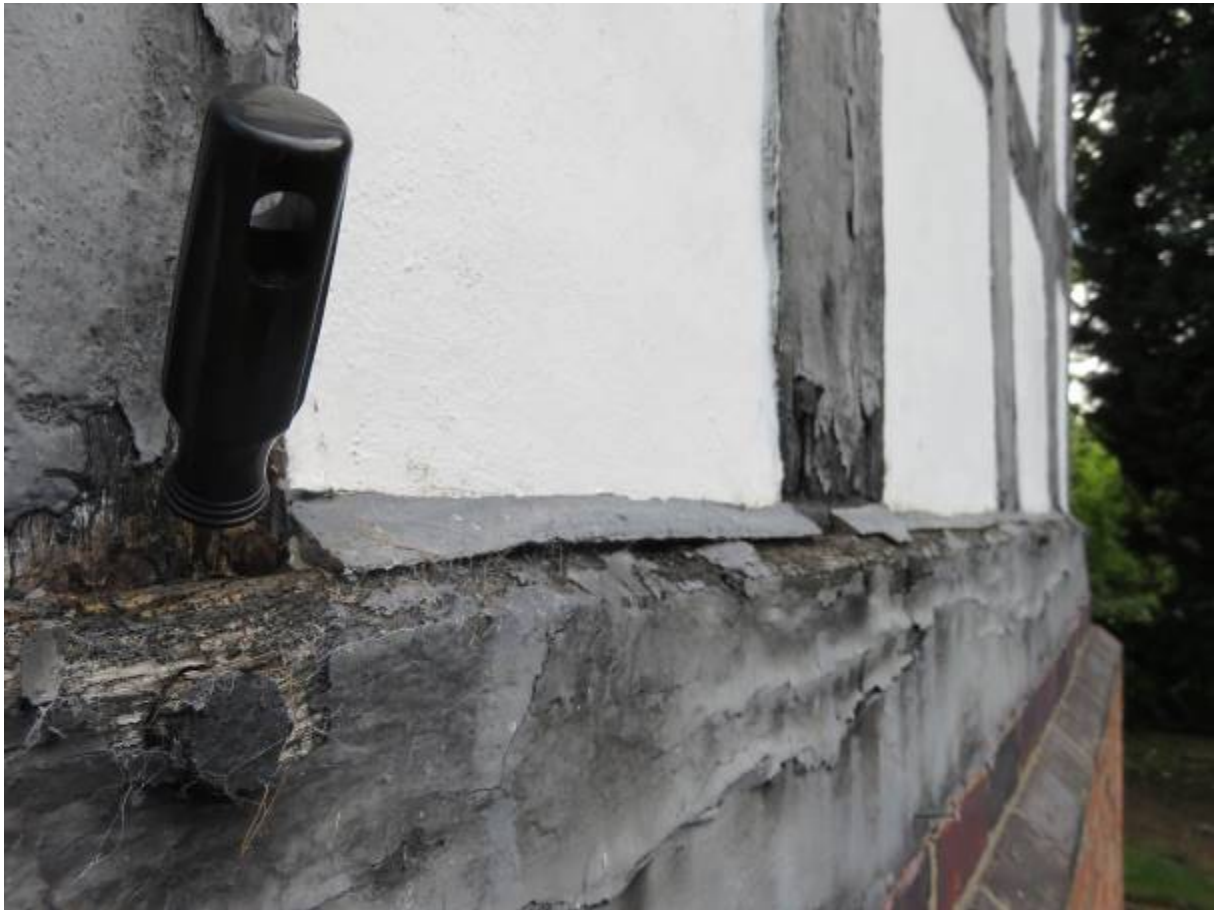
Photograph 39A: Opening up between timber frame panel and adjacent masonry wall structure

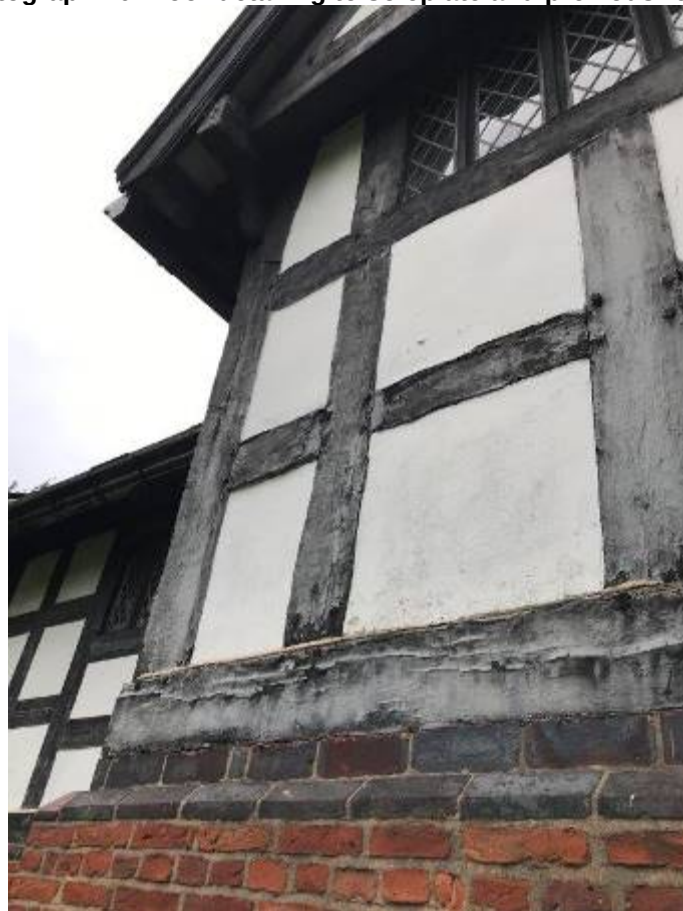
**Photograph 40: Poor detailing to soleplate and previous repairs**

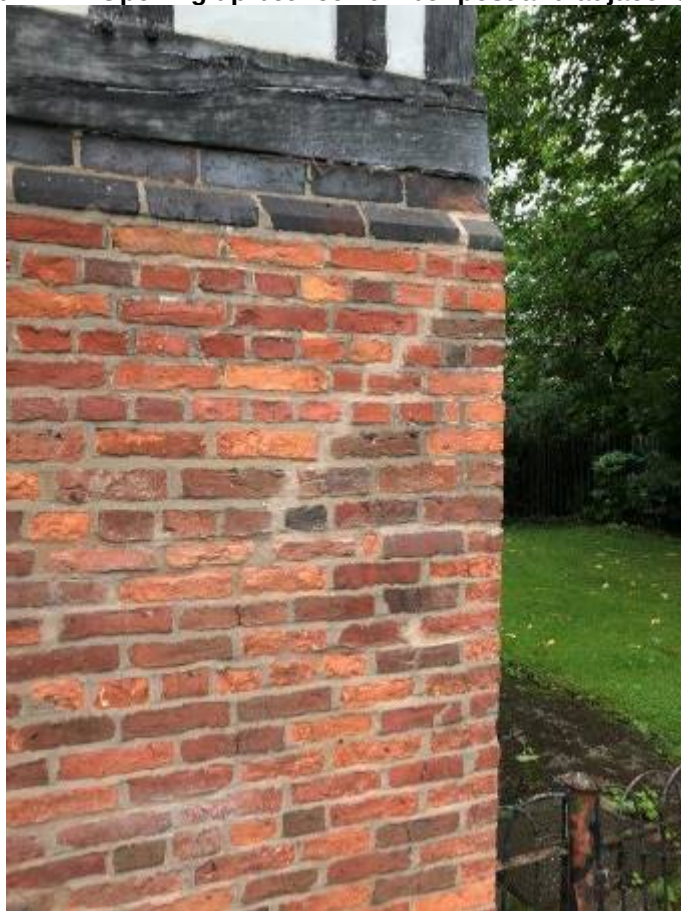
**Photograph 41A: Opening up between timber post and adjacent brickwork**

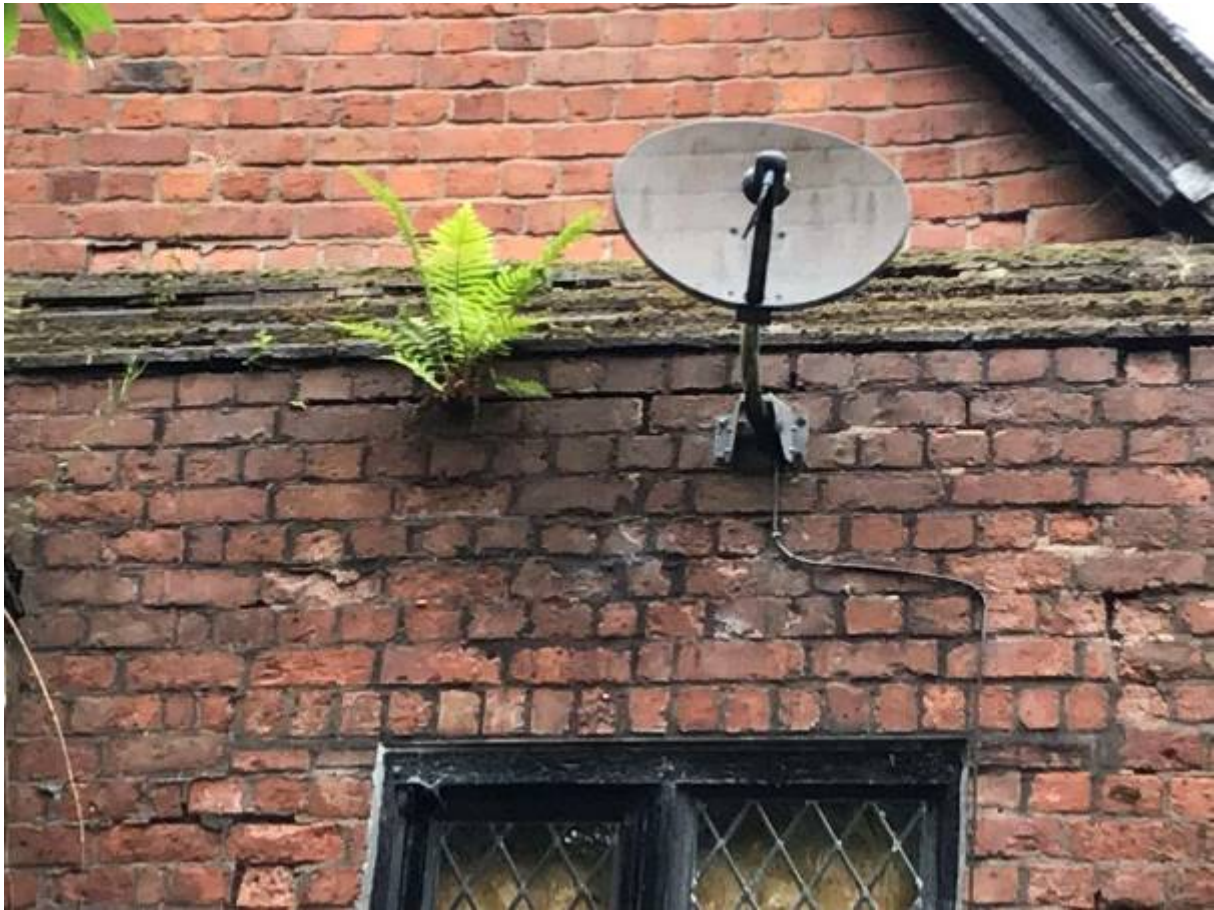
**Photograph 42D: Vegetation growth to stack as well as poor condition of weatherings**

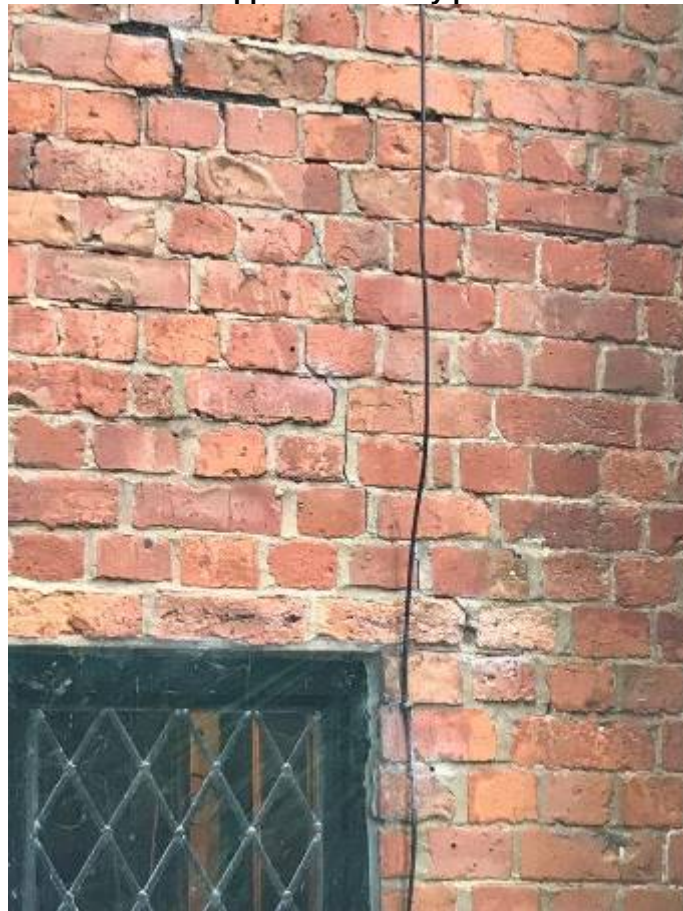
**Photograph 42E: Poor condition of upper 9" masonry panel and weatherings to south gable**

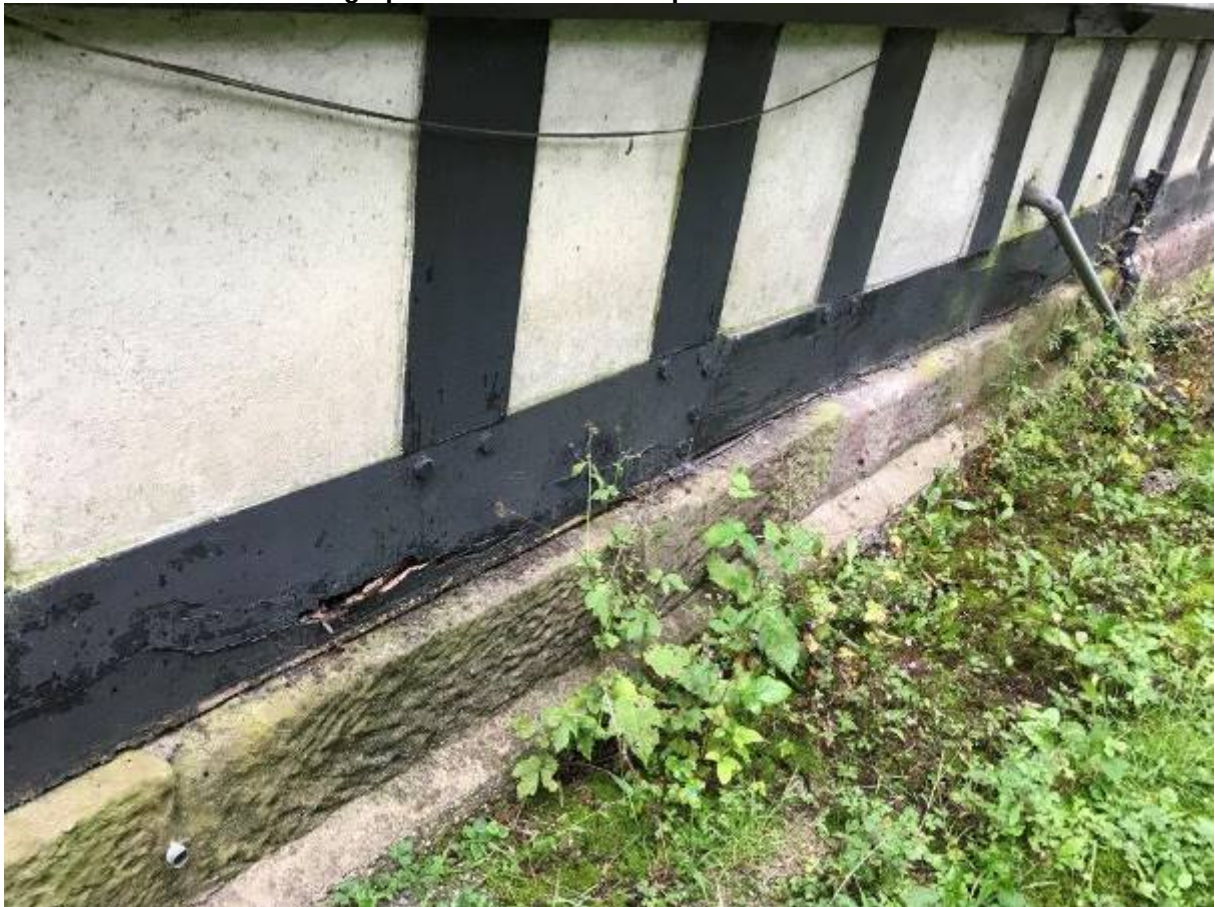
| 3.1.36 | The soleplate to the eastern elevation is partly exposed internally and externally and has been micro-drilled by Tim Floyd, and was found to be sound. | No micro-drilling took place as part of this survey. However from testing externally at the base of the soleplate a greater extent of decay is present. |

**Photograph 44: DPC below soleplate to east elevation**

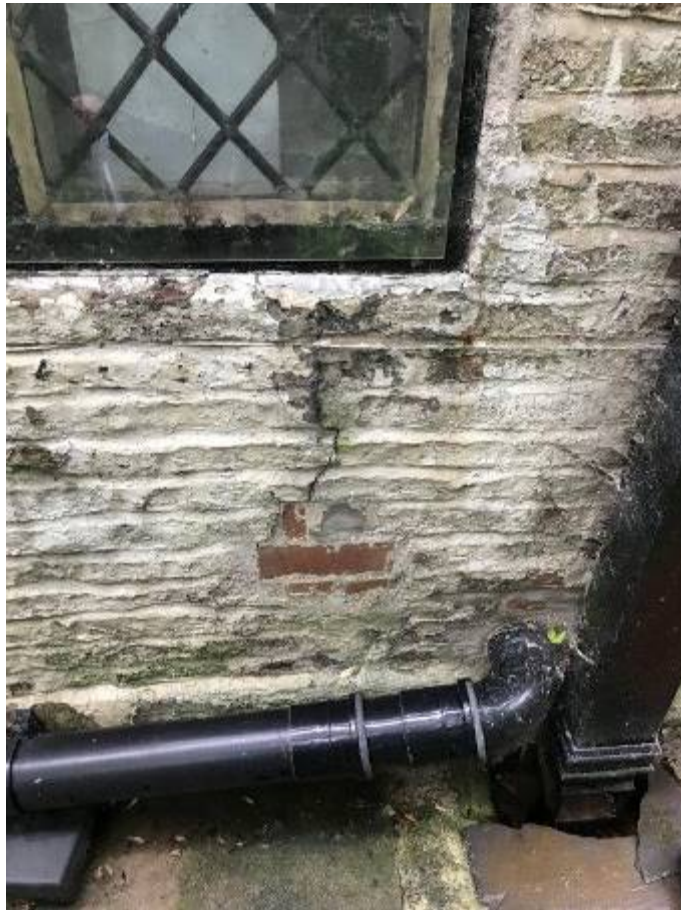
**Photograph 46: West elevation of northern range**
