### STRUCTURAL REPORT

#### CLAYTON HALL MANCHESTER

**Date:** February 2022

**Reference:** RGR/BBR/16076~srep rev 2

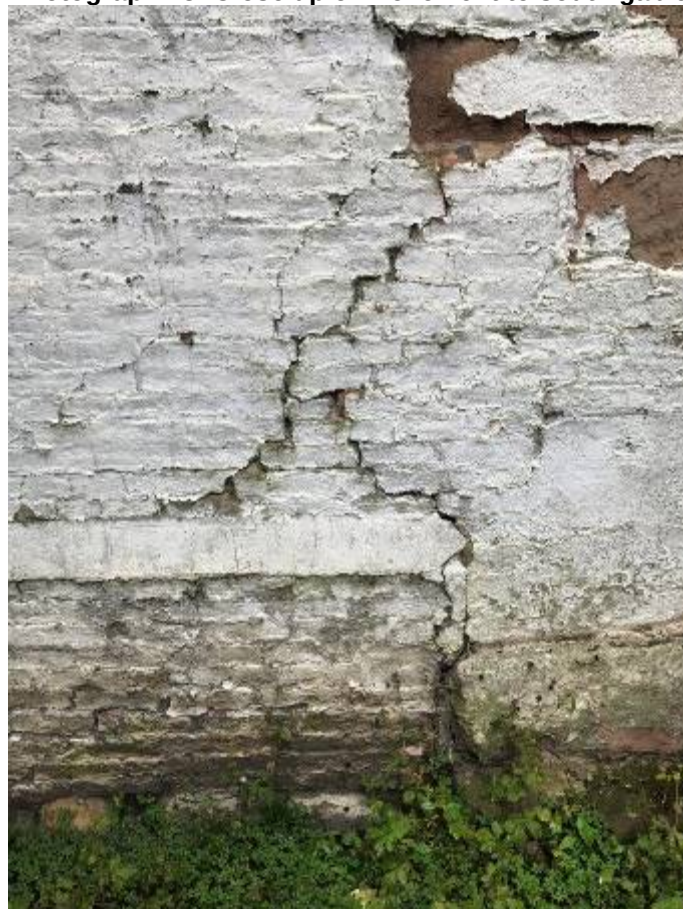
Photograph 48: Close up of movement to south gable

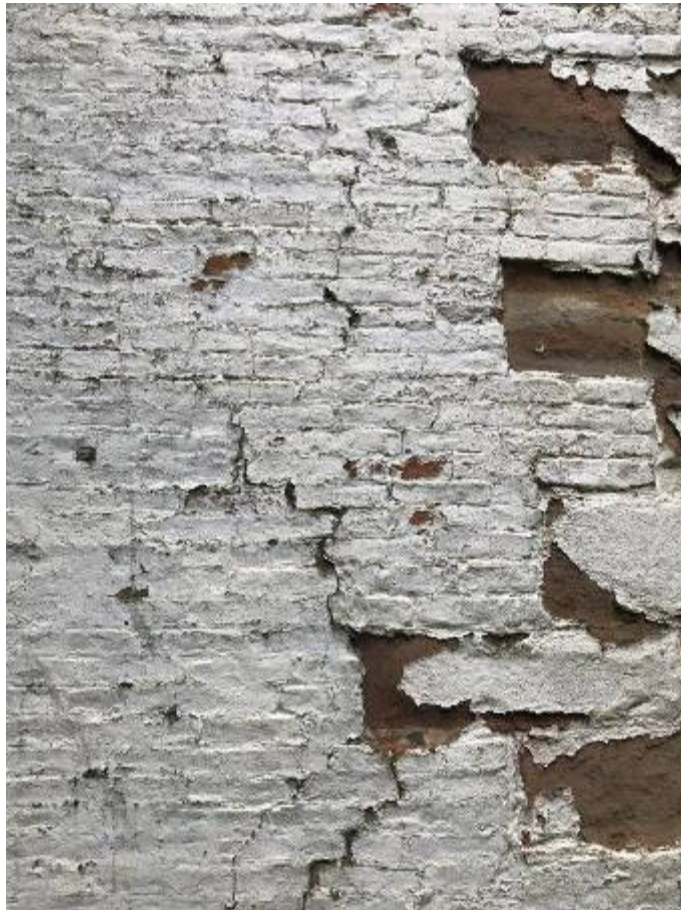
Photograph 48A: Cracking and deterioration to south wall of north range

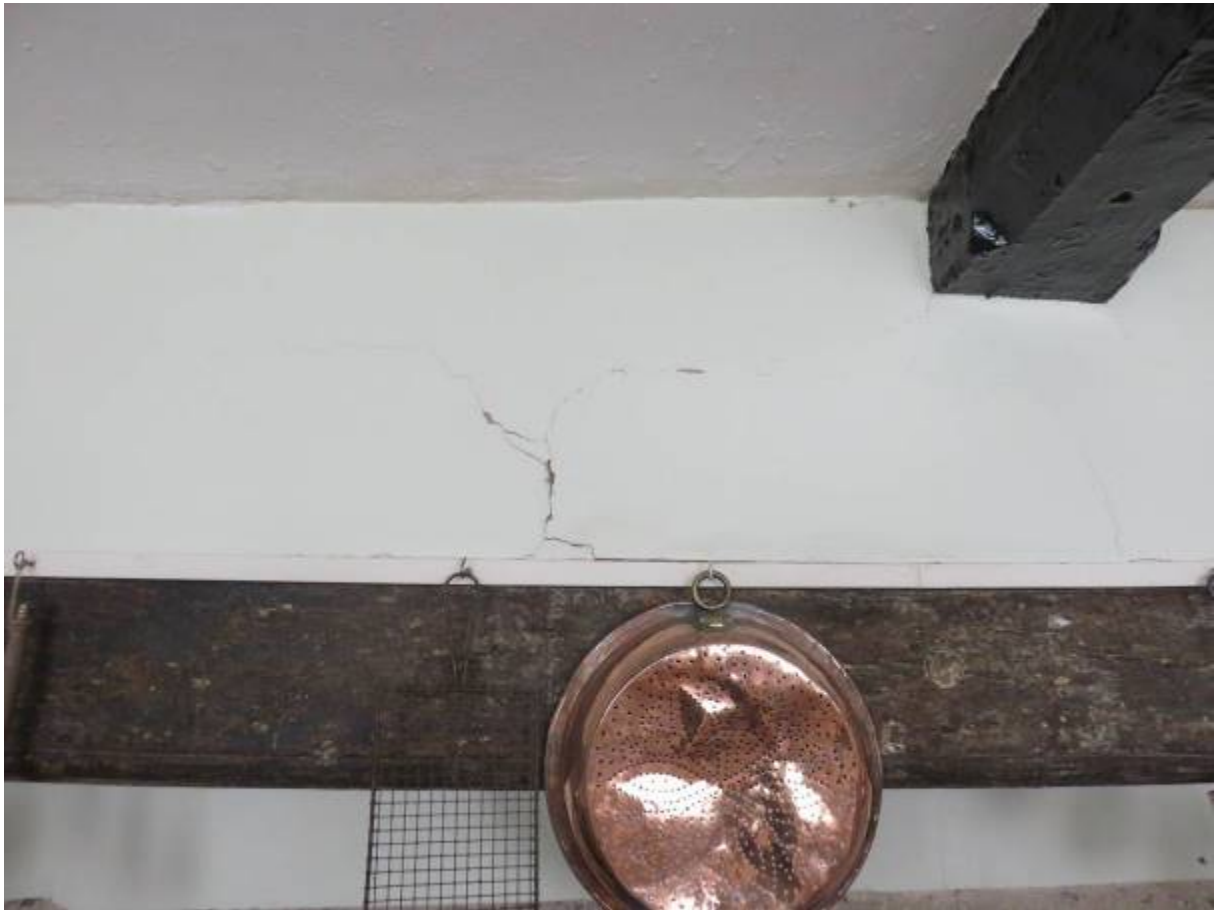
Photograph 61A: Minor differential movement between west wall and ceiling within pressed kitchen

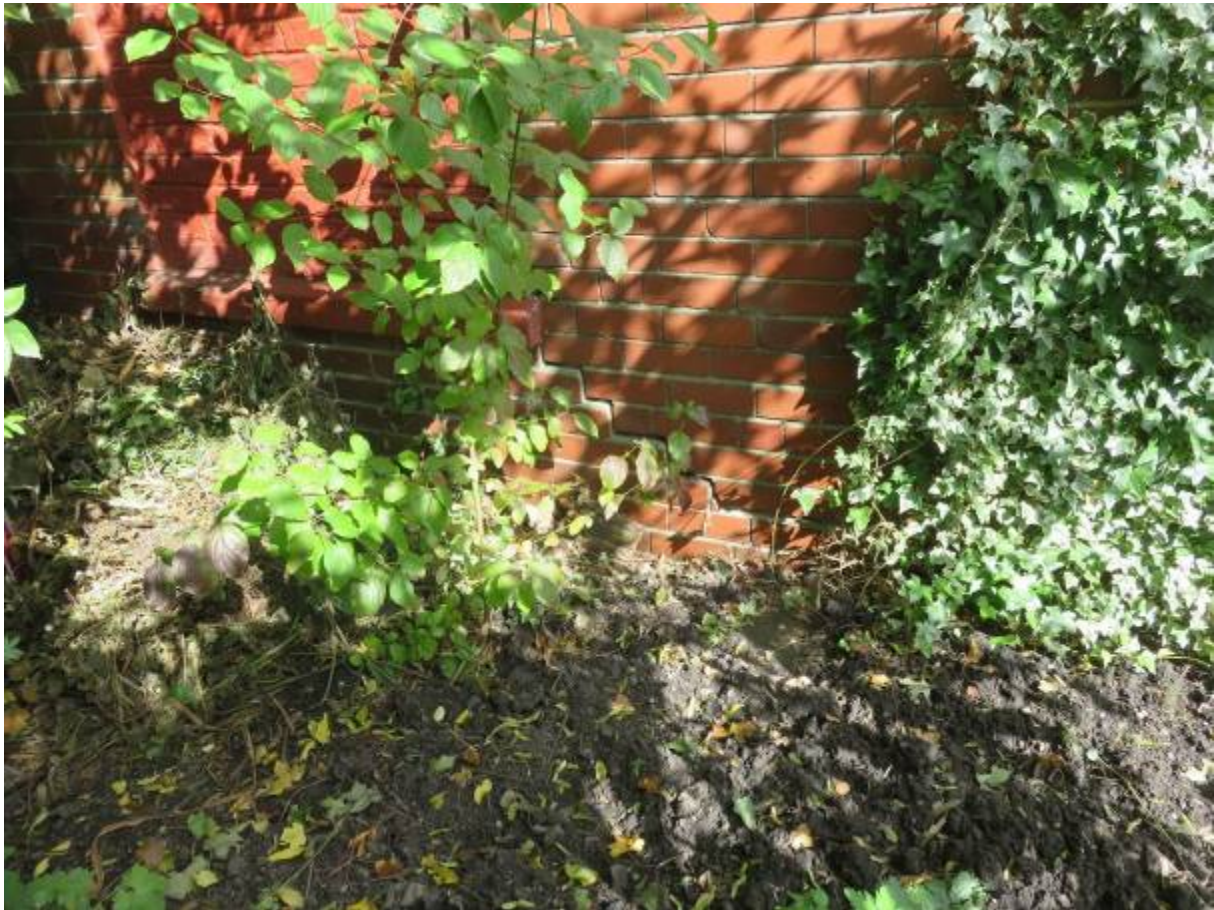
Photograph 67: Cracking to west elevation

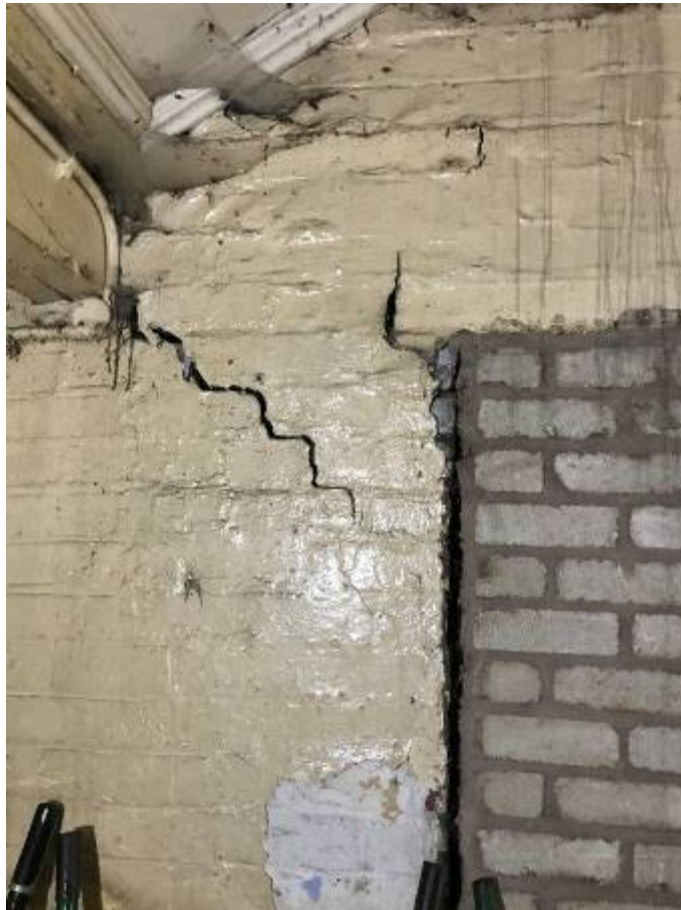
Photograph 68A: Horizontal cracking through the bricked in opening to west elevation

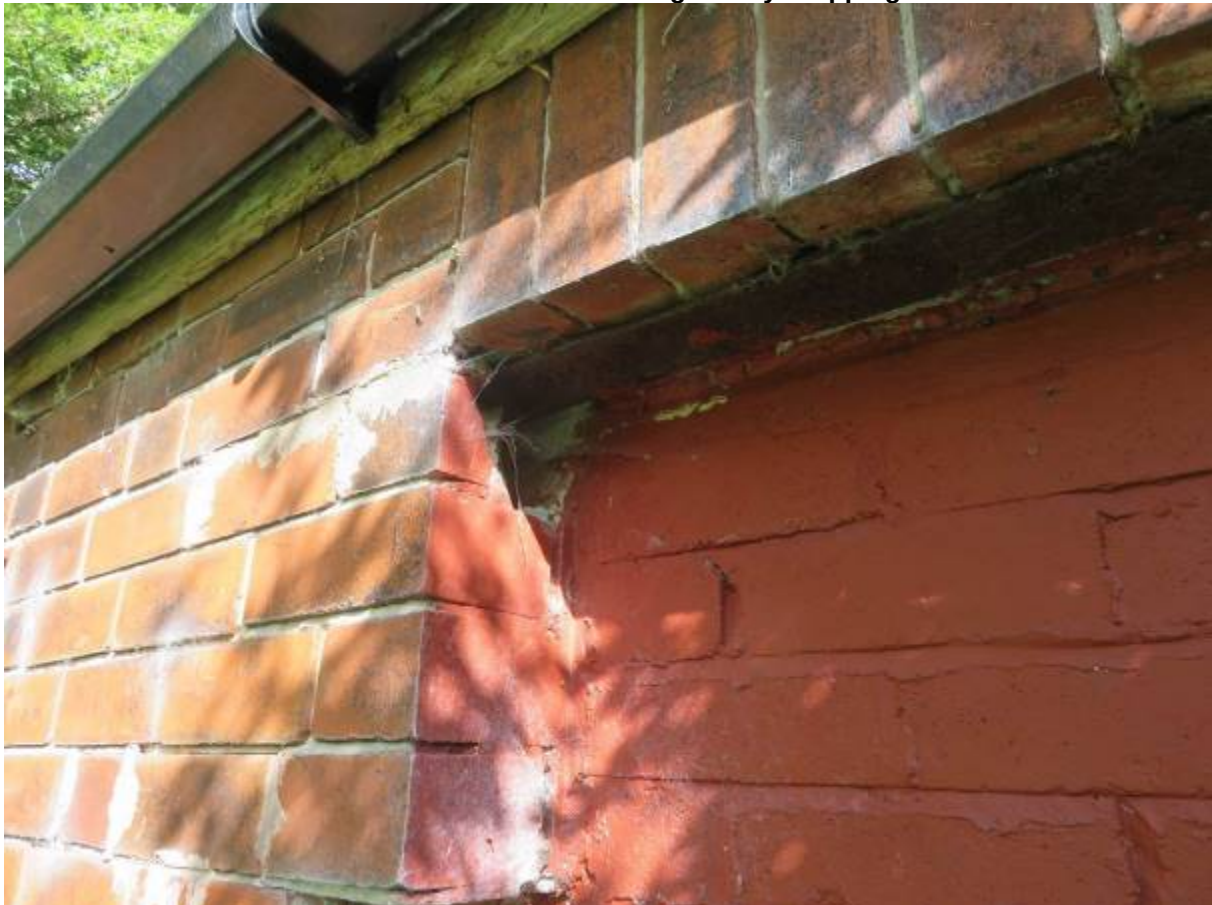
**Photograph 68B: Diagonal cracking from timber beam bearing toward adjacent opening, with north west corner of building clearly dropping**

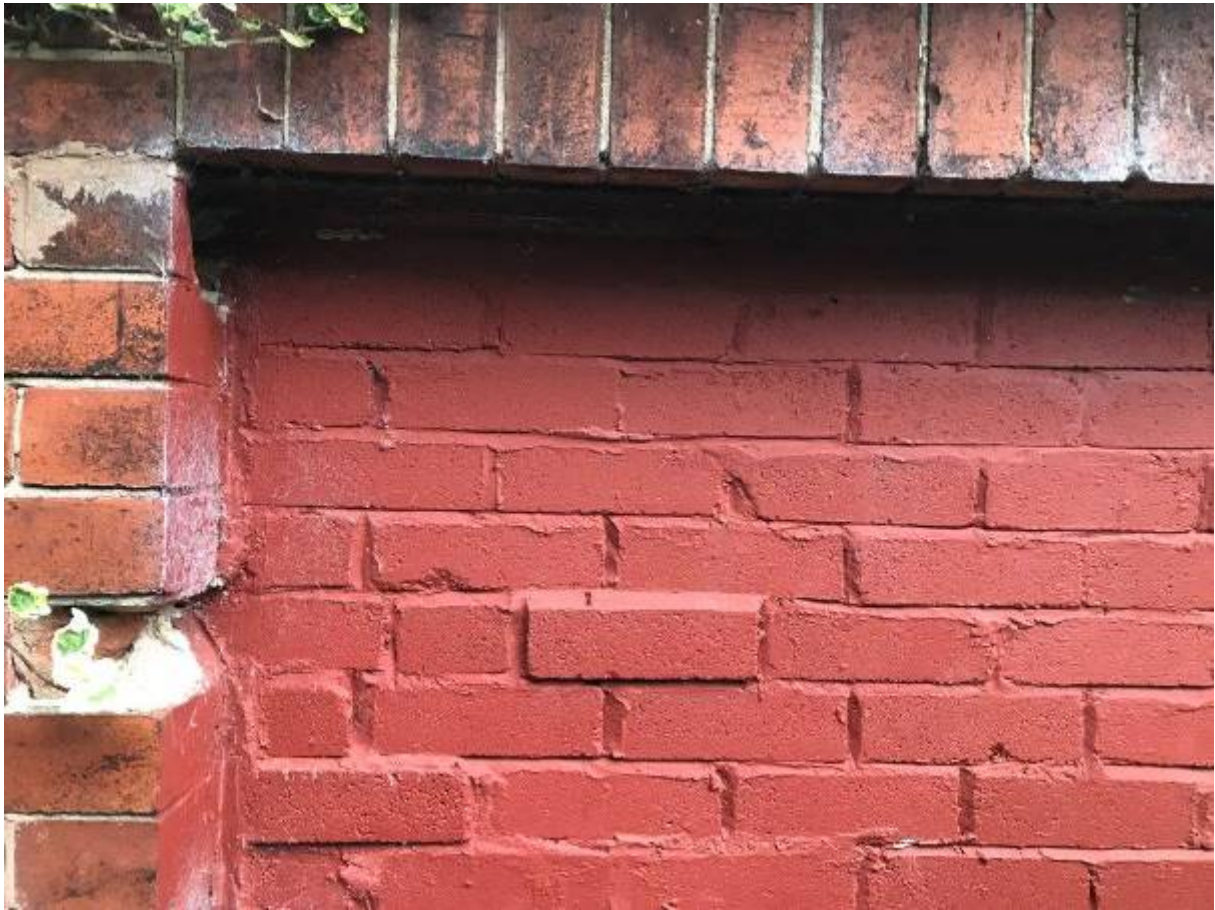
**Photograph 69: Window head with steel flat bar lintels and associated corrosion jacking**

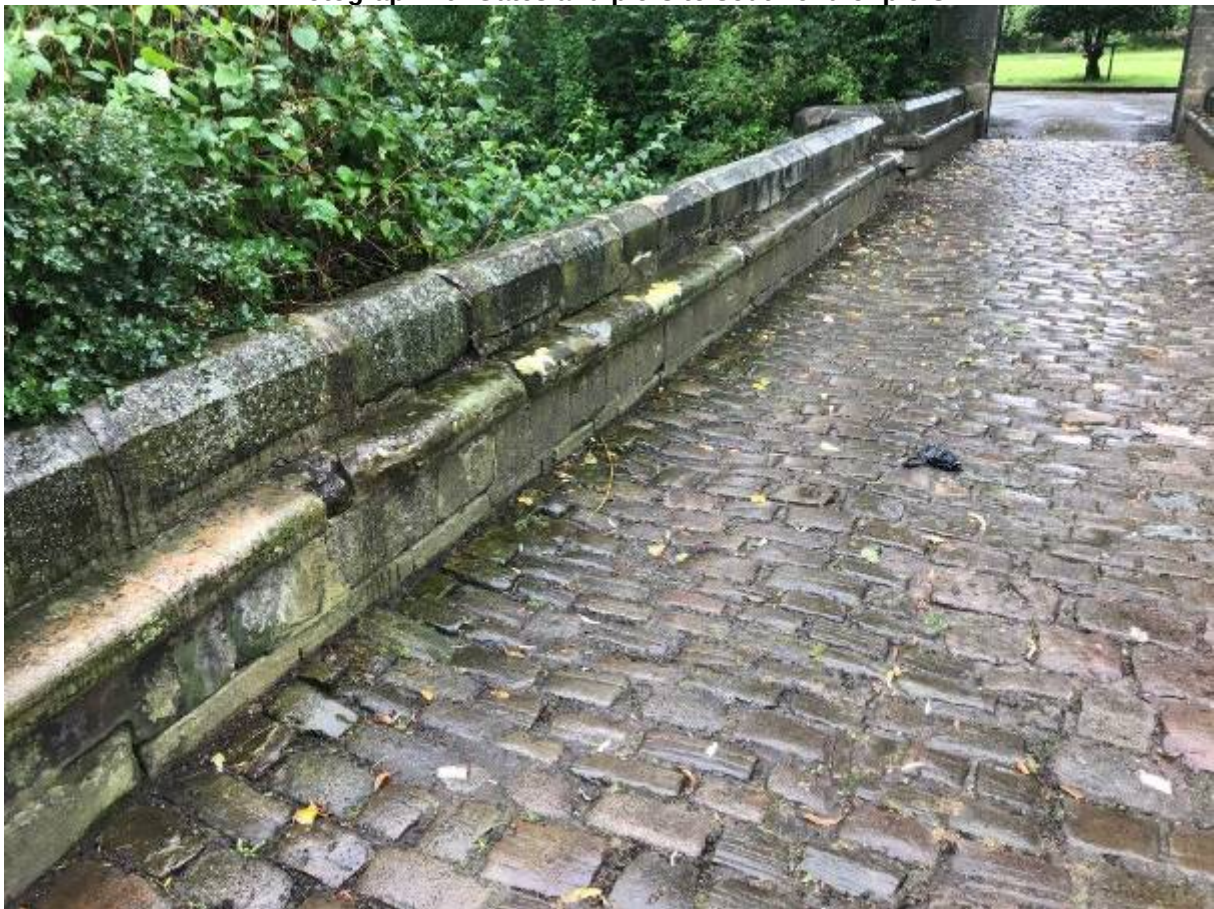
**Photograph 70: Gates and piers to south end of piers**

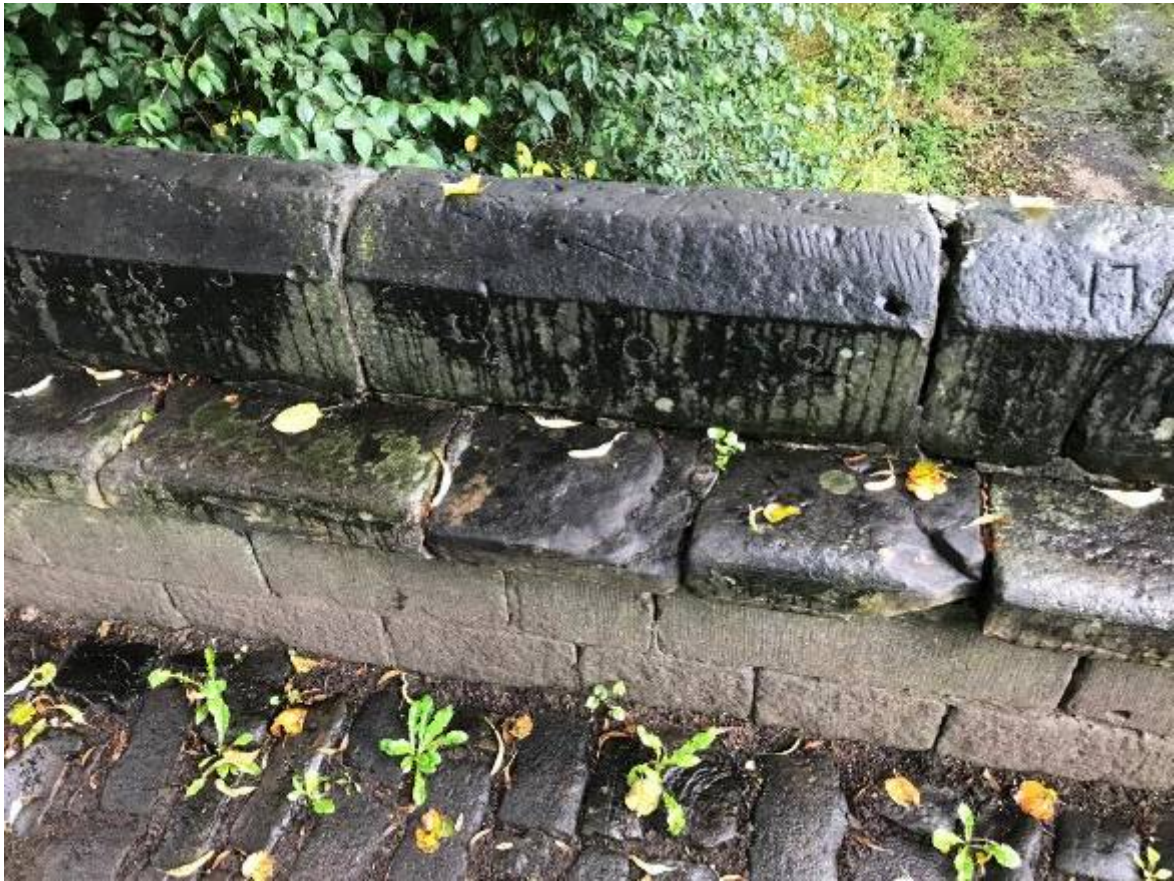
**Photograph 70A: Distorted nature of western copings and deterioration at base joint**

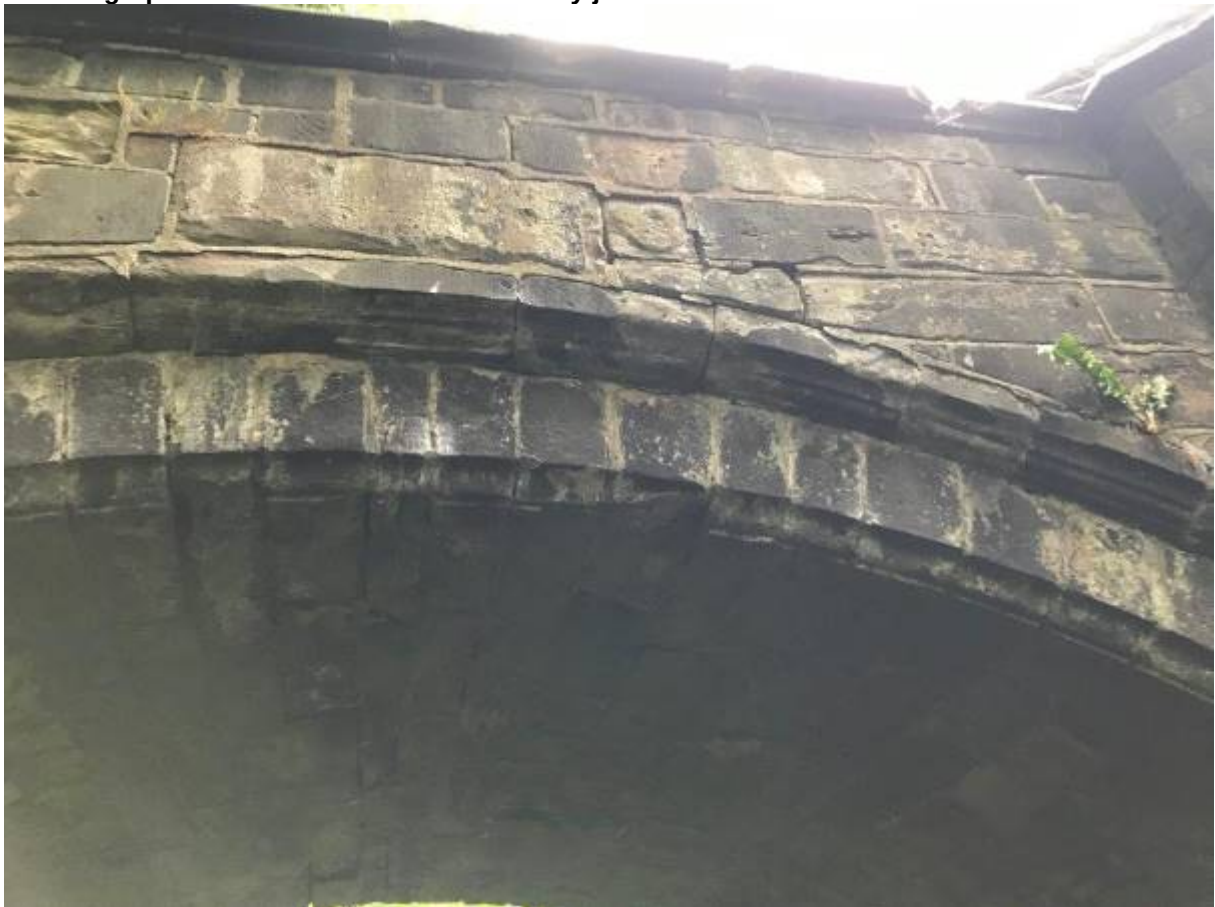
**Photograph 70J: Poor condition of masonry joints to the north can arch at its east elevation**

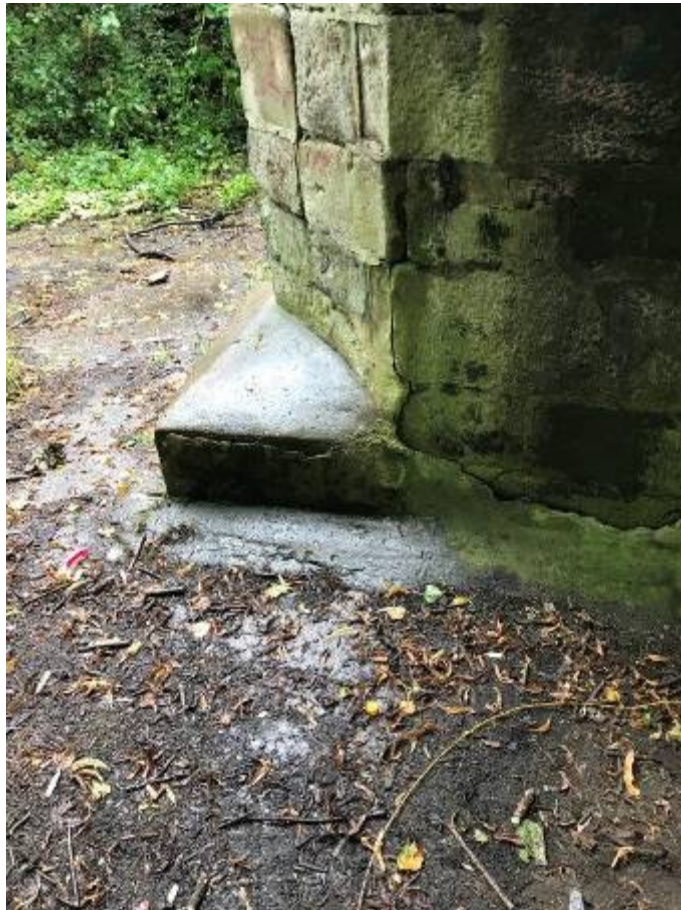
**Photograph 70K: Poor condition of masonry joints to the northern arch at its west elevation**

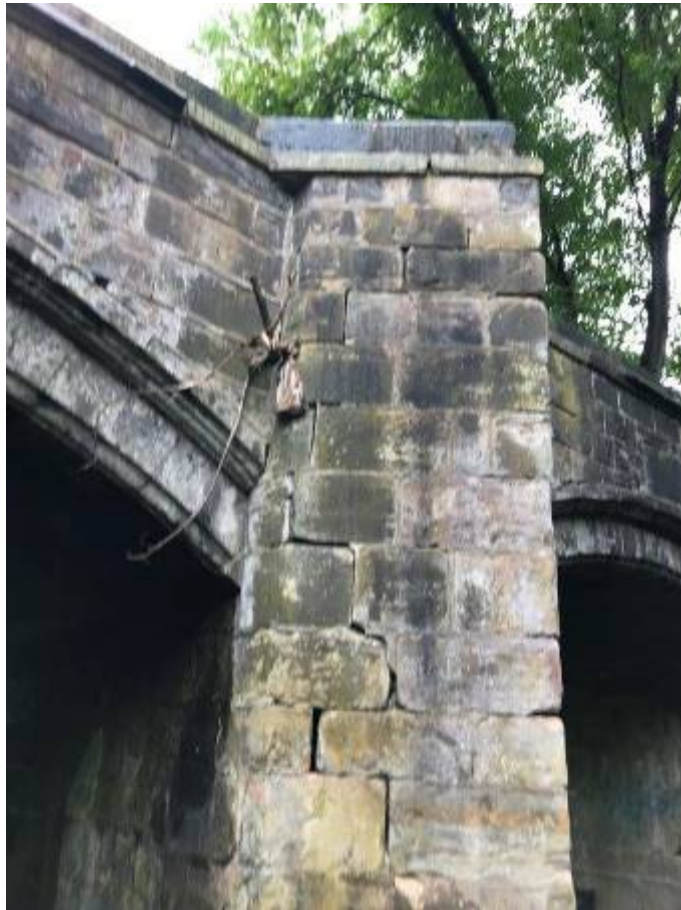
Photograph 71: Shrub growth to eastern side of bridge

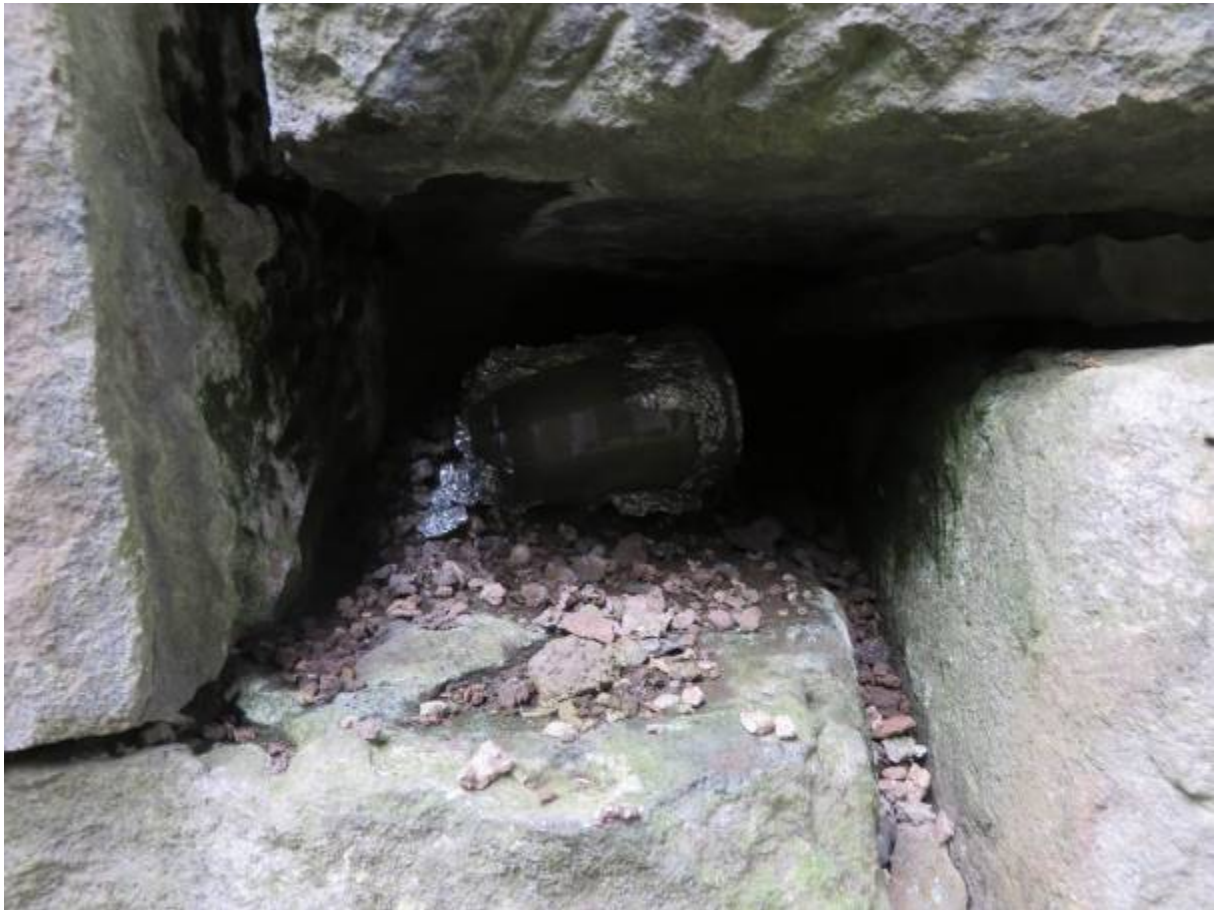
**Photograph 71B: Water staining to intrados of central pier, from southern side. Low level void**
