## Appendix III – Photosheets

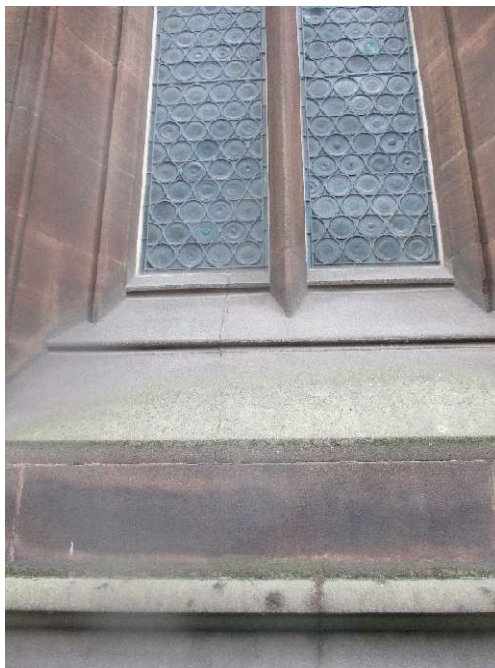
Example of moss and algae growth to window sill and string course on Deansgate (east) elevation

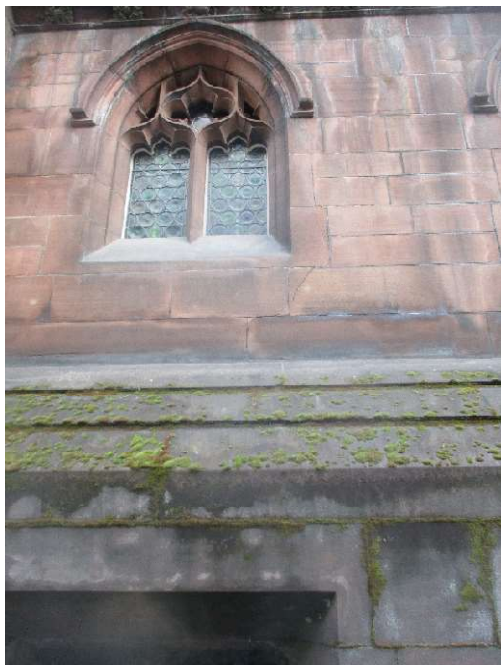
Example of moss and algae growth on Spinningfields (south) elevation

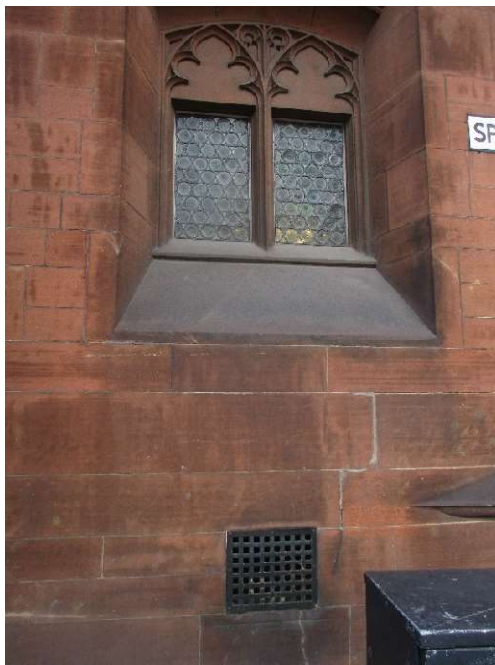
Example of unsympathetic previous mortar repair to cracking on Spinningfields (south) elevation

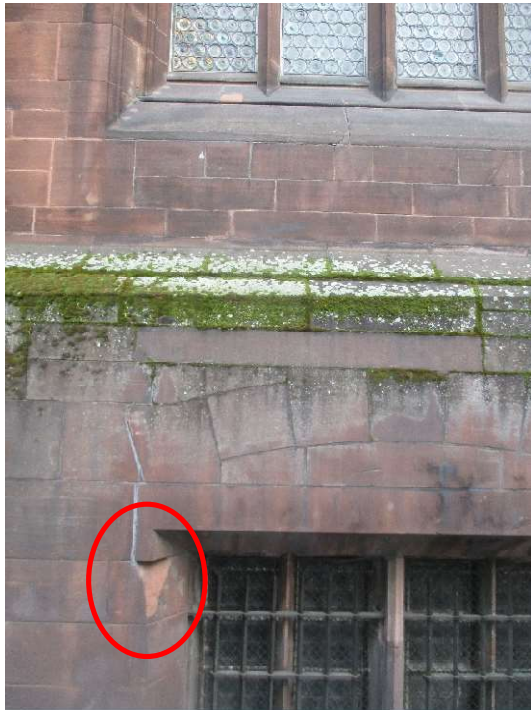
Stonework damage to window BW49(S) on Spinningfields (south) elevation

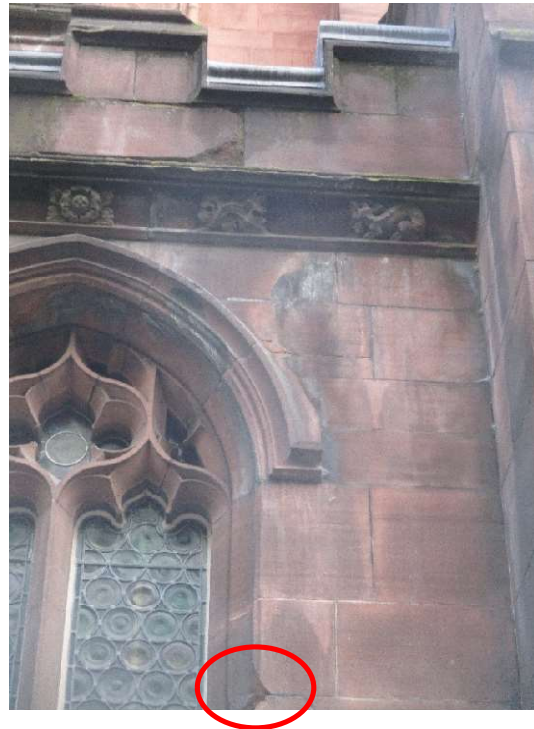
Stonework damage to window GW52(S) on Spinningfields (south) elevation

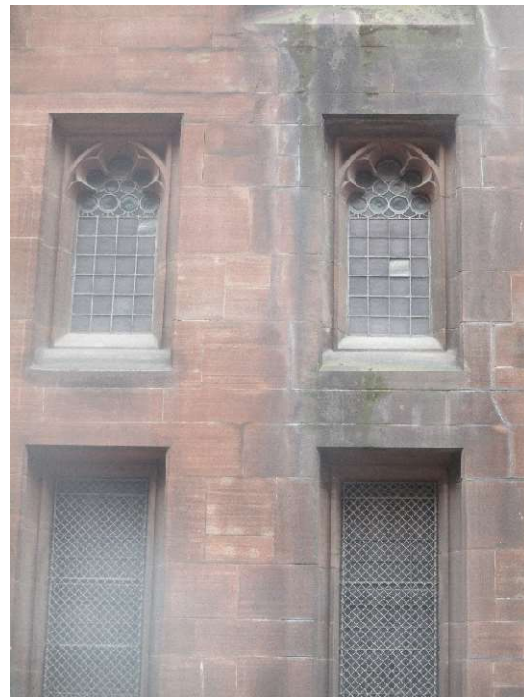
Example of moss and algae growth on Wood Street (north) elevation

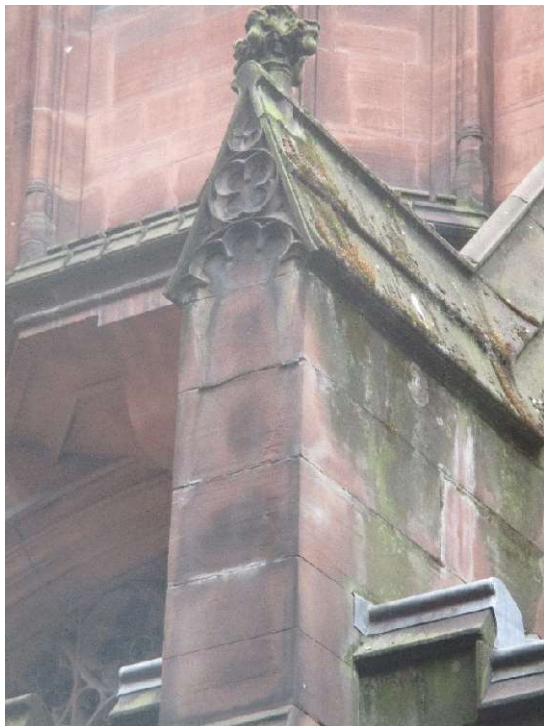
Example of moss and algae to buttress on Wood Street (north) elevation

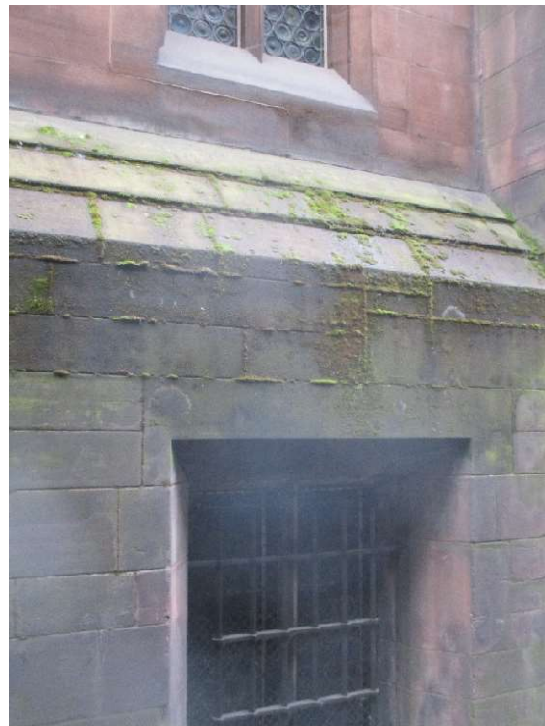
Example of moss and algae growth and open joints on Wood Street (north) elevation
