# Drainage Report

Site  
**Tyson Site**  
**Barlow Moor Rd**  
**Chorlton**  
**Manchester**  
**M21 8ER**

**Tyson Stie Barlow Moor Road - CCTV Survey Report : 04/08/22**

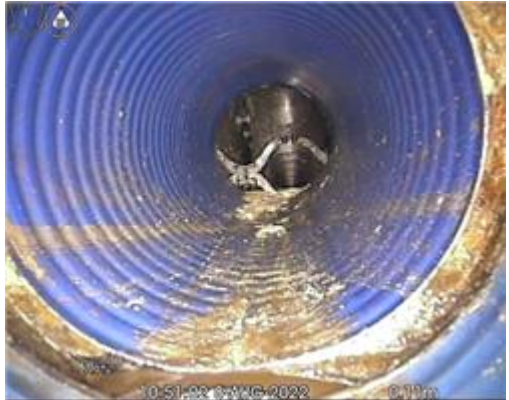
| Pos | Video Ref | Code | Description | Image |
|---|---|---|---|---|
| 00.15m | 0:00:09 | OJM | Open joint medium - Severity 3 | Image Provided - Ref: 16_2<br> |

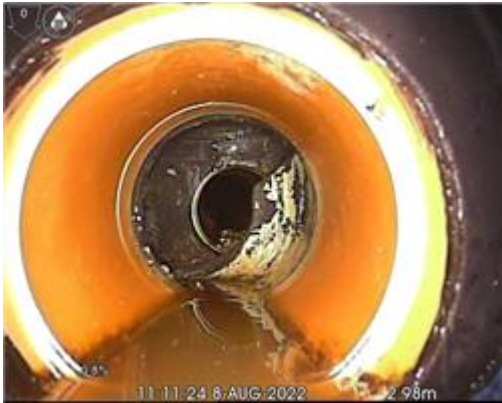
| Pos | Video Ref | Code | Description | Image |
|---|---|---|---|---|
| 03.12m | 0:00:40 | SC | Dimension of drain/sewer changes: 150mm Diameter | <p>Image Provided - Ref: 22_2</p> |

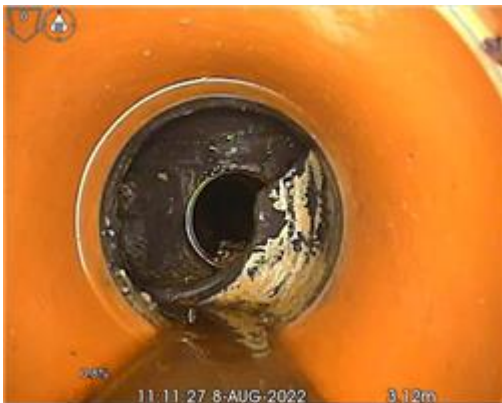
| Pos | Video Ref | Code | Description | Image |
|---|---|---|---|---|
| 03.12m | | SA | Survey abandoned<br>Cannot pass SC | <p>Image Provided - Ref: 22_9999</p> |

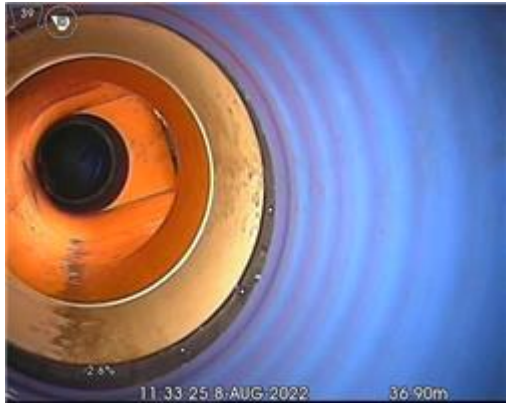
| Pos | Video Ref | Code | Description | Image |
|---|---|---|---|---|
| 36.90m | | SA | Survey abandoned<br>Cannot pass LLH | <p>Image Provided - Ref: 23_9999</p> |
