**P8486/21/11-1**

**STRUCTURAL INSPECTION**

**SYNERGY BUILDING, PARRS WOOD SCHOOL**

**PARRS WOOD SCHOOL.**

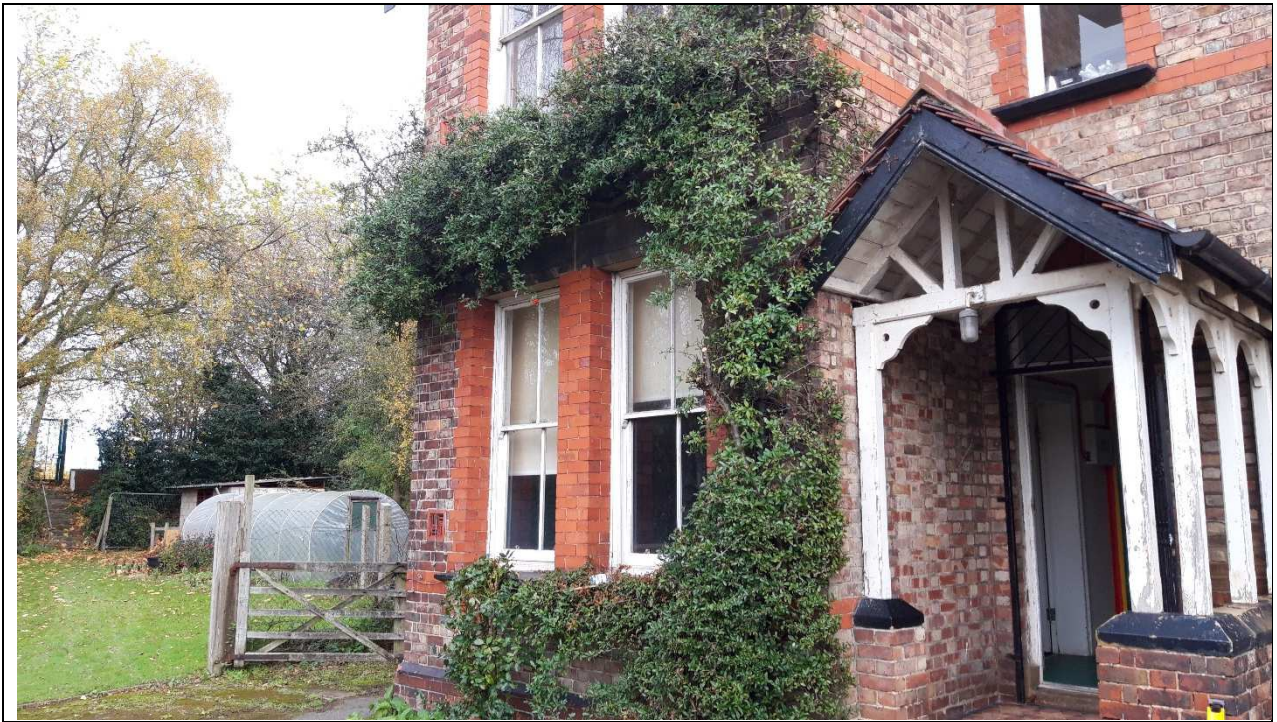
There is a tree to the front right of the property which should be removed. This tree will be causing damage to the brickwork locally and possibly could affect the foundations to the building.

Tree/Shrub to Front Wall

- 7.1.1 Remove tree/shrub from building frontage.
- 7.1.2 Repaint front access timber porch.
- 7.1.3 Take down and rebuild boundary garden wall to the right side of the property.

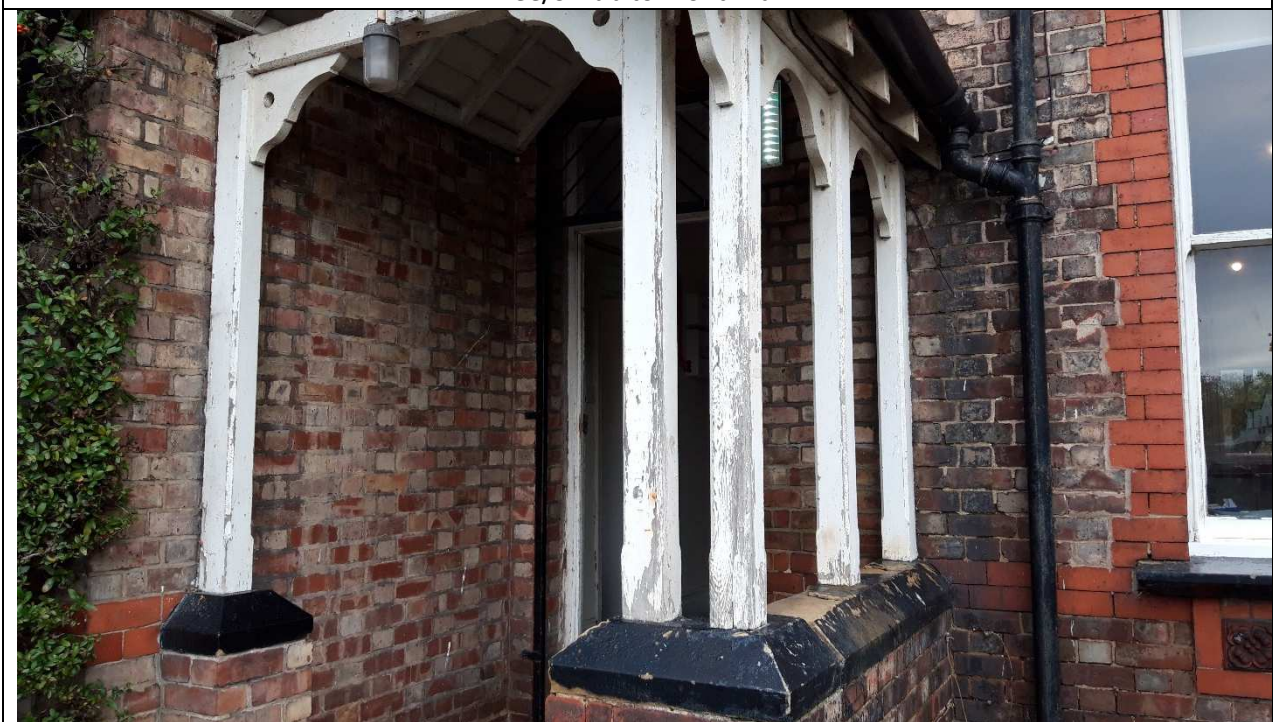
There is minor deterioration to the timber canopy to the front door area. The structure is stable, but the protective paintwork is breaking down. We would recommend that the paintwork is replaced.

Paint Breakdown to Front Porch

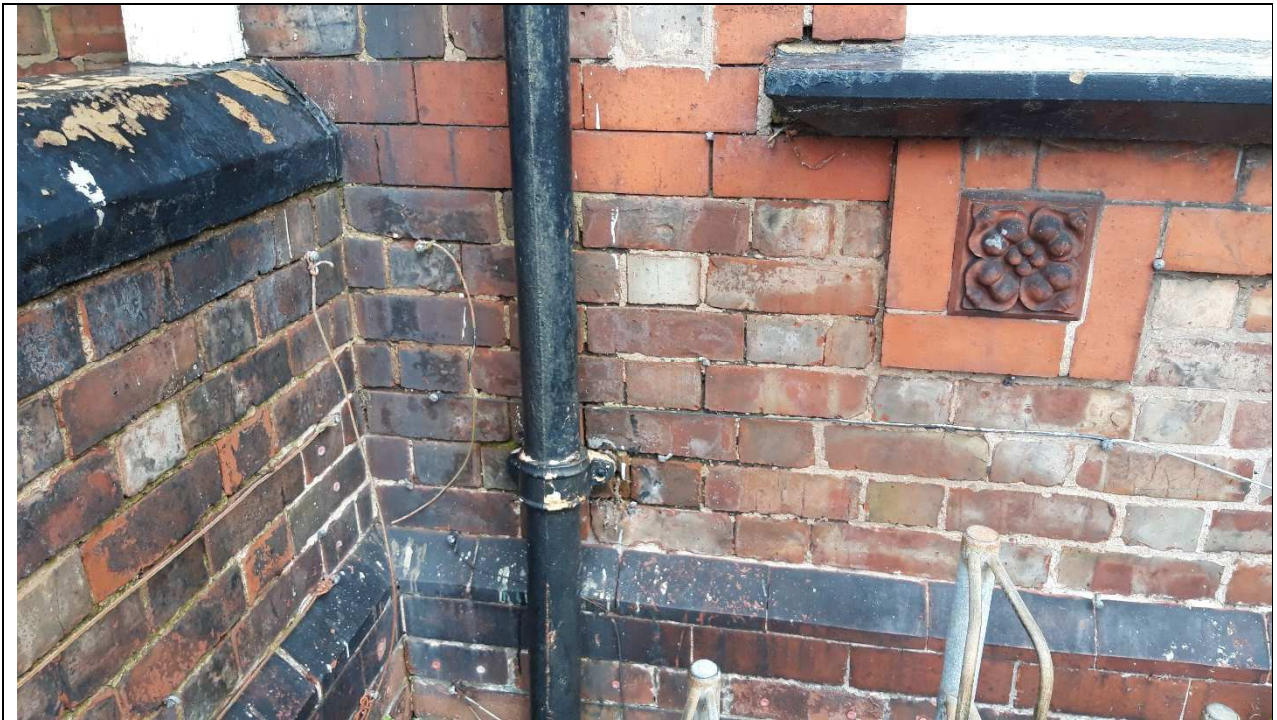
Staining & Perishing Joints to Front Wall Around Down-Pipe

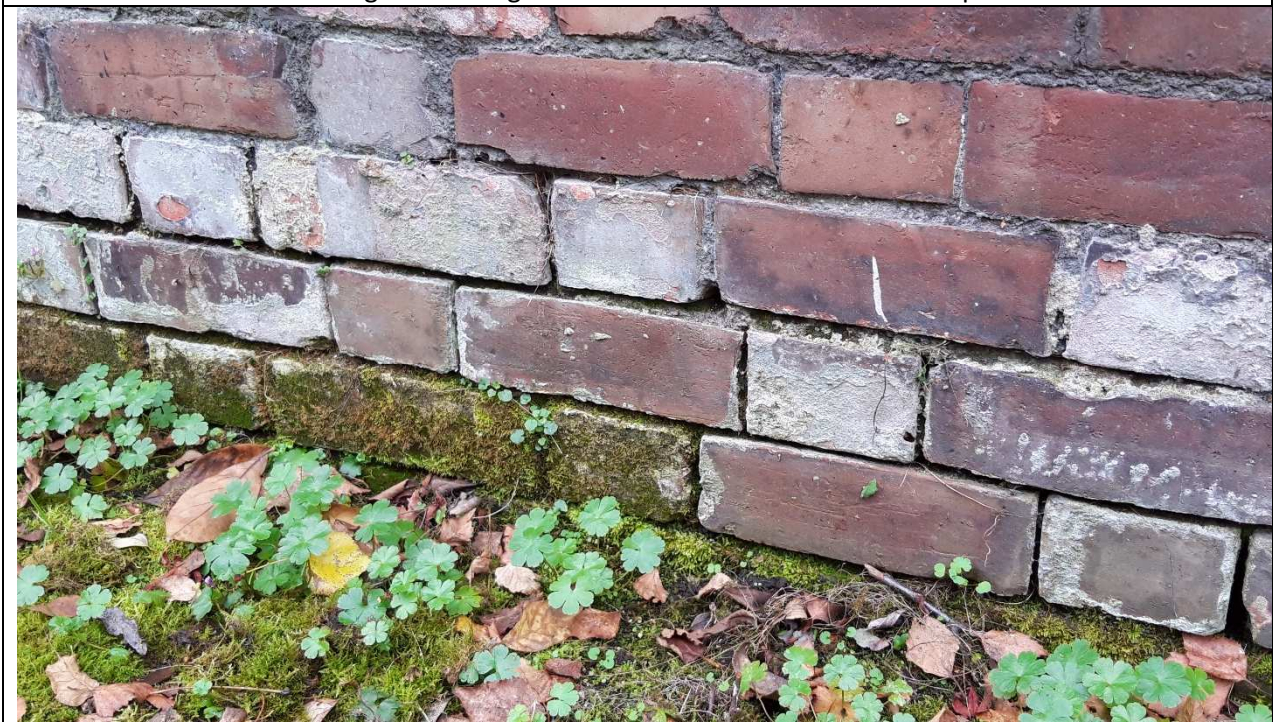
Eroded Mortar Joints to Left Gable Wall Base

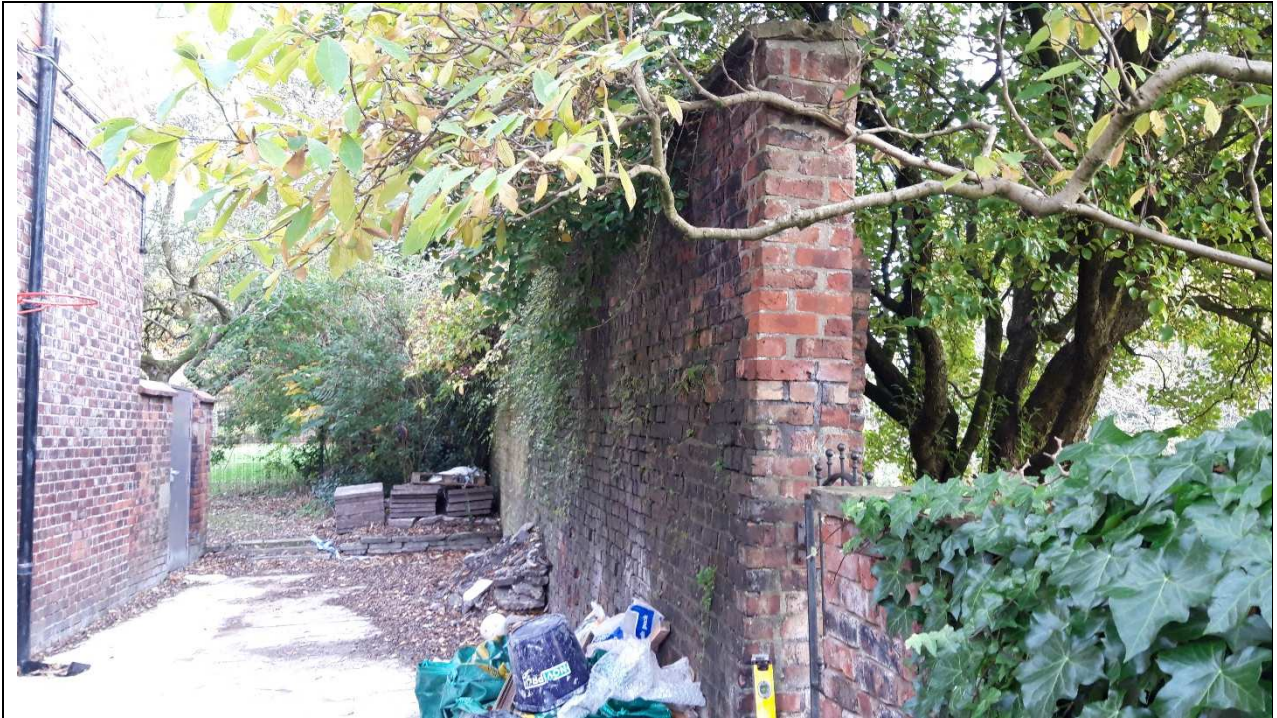
- Wall adjacent to right gable is 325mm thick and up to 2.5m high. Wall leans away from the building by up to 1 in 12.5.
- Wall has frost damaged stone to base at centre.
- Wall has brick piers to opposite side.

Our main concern relates to the existing condition of the boundary wall to the right side of the property. This wall has a significant lean and is in poor conditions. This wall should be taken down and rebuilt (should it be required) for safety purposes.

Leaning Garden Wall to Left of Property

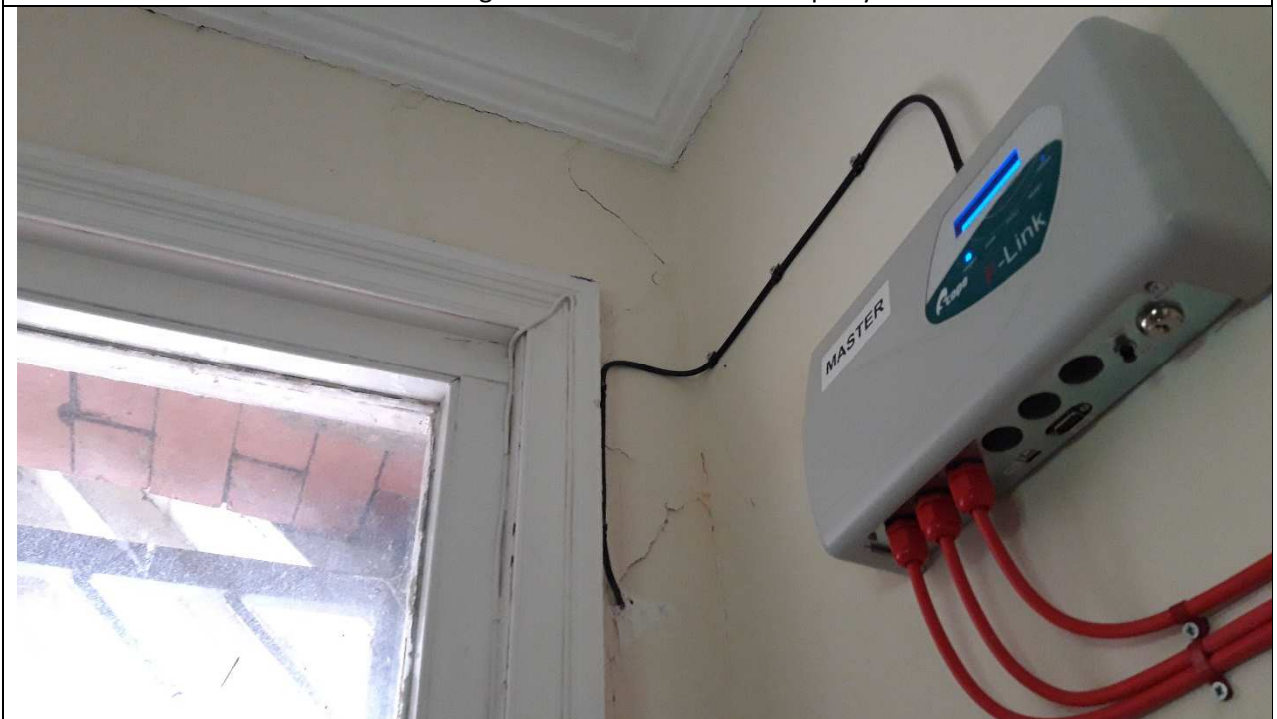
- Lino covered floor is level.
- Painted walls vertical with no significant cracks except to top right above door. Minor cracking likely to be due to vibration from door closing.
- Plastered ceiling has no significant visible cracks.
- No access to under stair store.

The main body of the house has only minor cracking, particularly over areas where doors are present. The cracking is therefore likely to have been affected where doors have been slammed shut. The cracking is not evidential of foundation movement occurring.

Minor Cracking in Lobby Over Front Access Door
