**Table 2: First Floor Gazetteer – 18<sup>th</sup> Century Dwellings** (N.B It should be noted that since 2007 the condition of the building has become significantly worse and full access to the building is now limited due to health and safety reasons).

### 5.1.3 Building description – 1842-3 Bridgewater Canal Company office – Exterior

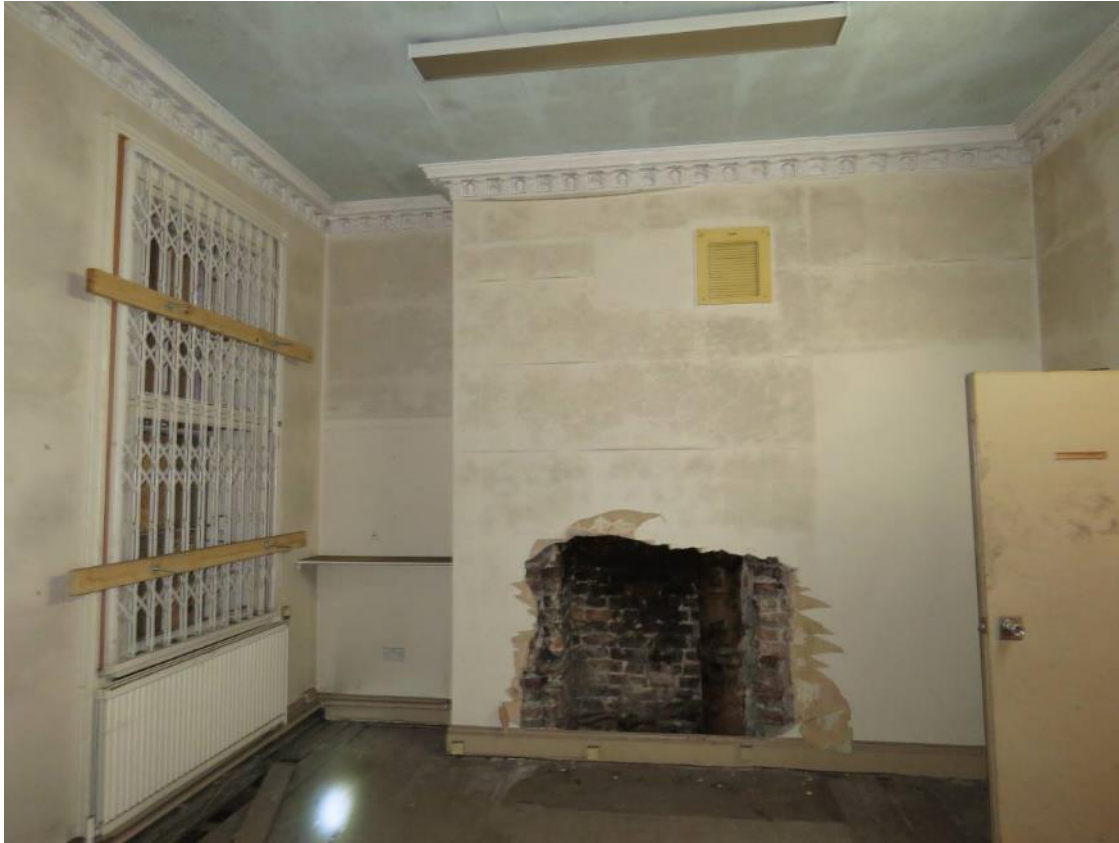
**Figure 51:** Room G10 (looking east) - This room formed the second reception room of the western dwelling and would have been originally entered from the former entrance hall corridor (now Room G11). This room retains all of its original 18<sup>th</sup> century plaster cornice featuring highly decorative cherub faces (See Figure 52). (Source: SLHA 2017 – Note the current condition of the building has since worsened)

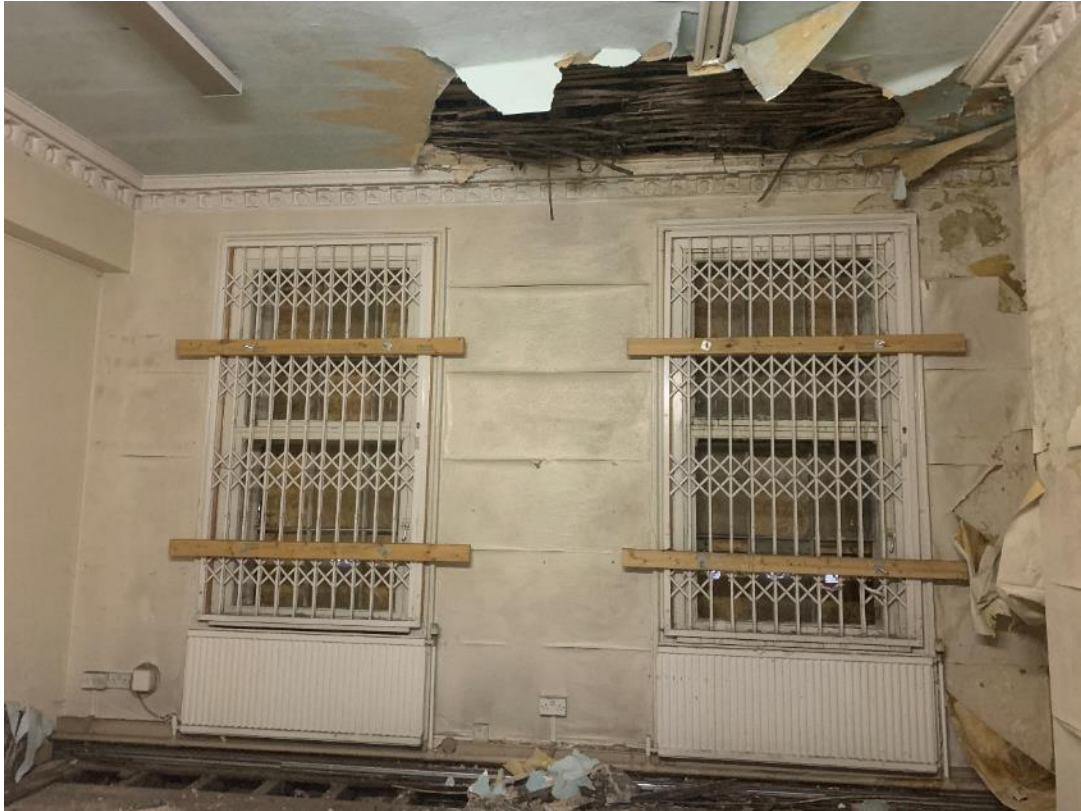
**Figure 52a:** The current condition of Room G10. (Source: Watch This Space (Jembrana) Ltd 2022)

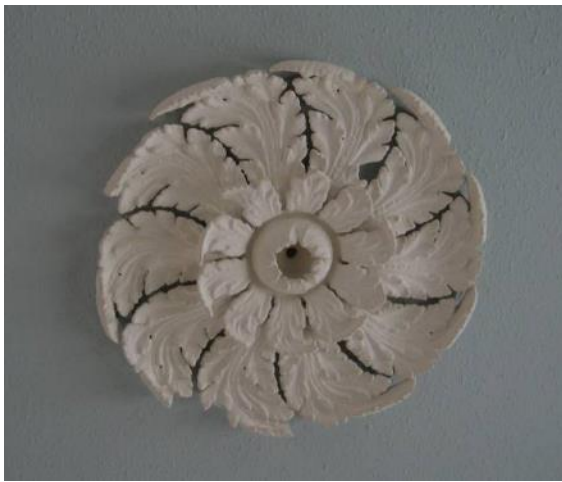
**Figure 56:** The heavily detailed original/early plaster ceiling rose as it appeared in Room G04 in 2007. (Source: SLHA 2007)

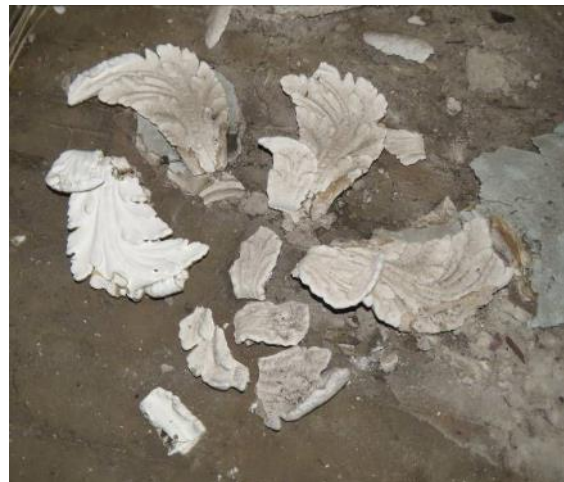
**Figure 57:** The current condition of the ceiling rose, which has fallen due to water ingress since 2007 and is now stored within the room. (Source: SLHA 2017)

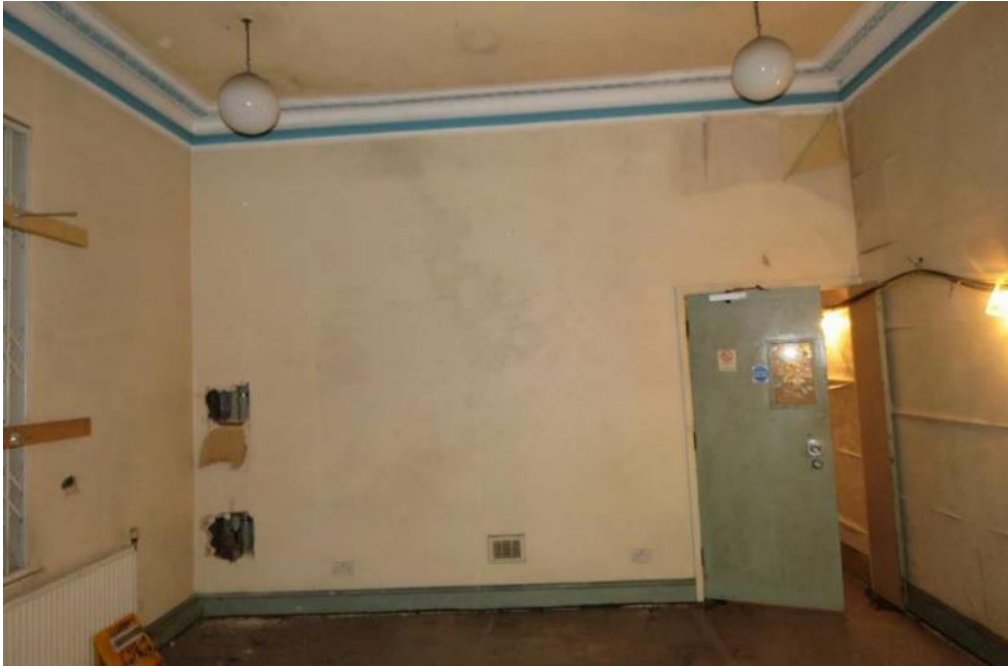
**Figure 58:** Room G03 (looking west) – This simpler room formed one of two original rear rooms, and was substantially altered to create a link corridor between the two former dwellings (right) in the late-19th century and is likely to have received the current plaster cornice in this period. The original open fireplace was blocked (note air vent cover) and the narrow alcove to the left covered in 1977 (Source: SLHA 2007 – please note the condition of the building has significantly worsened since 2007)

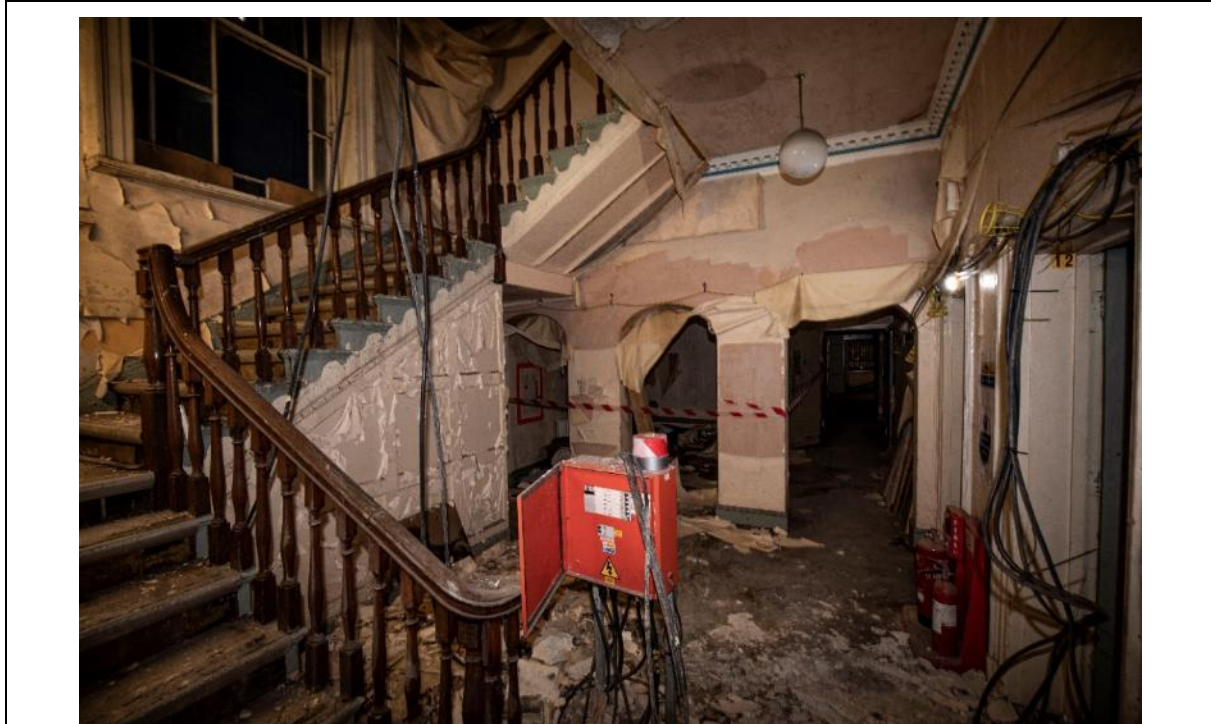
**Figure 61a:** The staircase and staircase hall as seen presently, showing its worsened general condition (Source: Watch This Space (Jembrana) Ltd 2022)

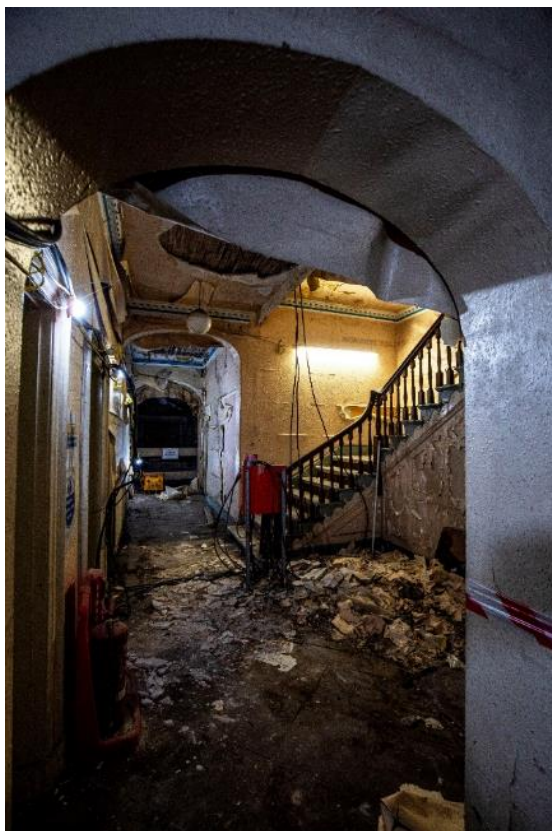
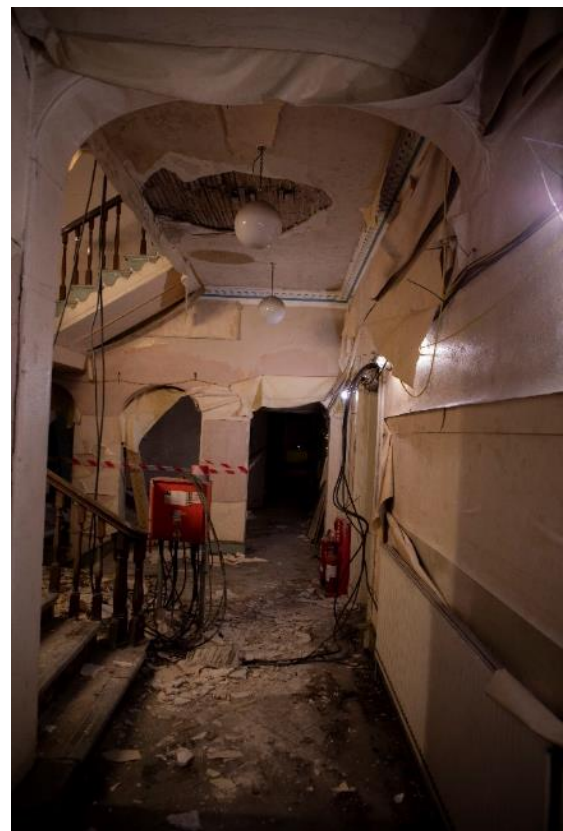
**Figure 63 & 63a:** Looking into the staircase hall from the east and west showing the current dilapidated condition of the space (Source: Watch This Space (Jembrana) Ltd 2022)

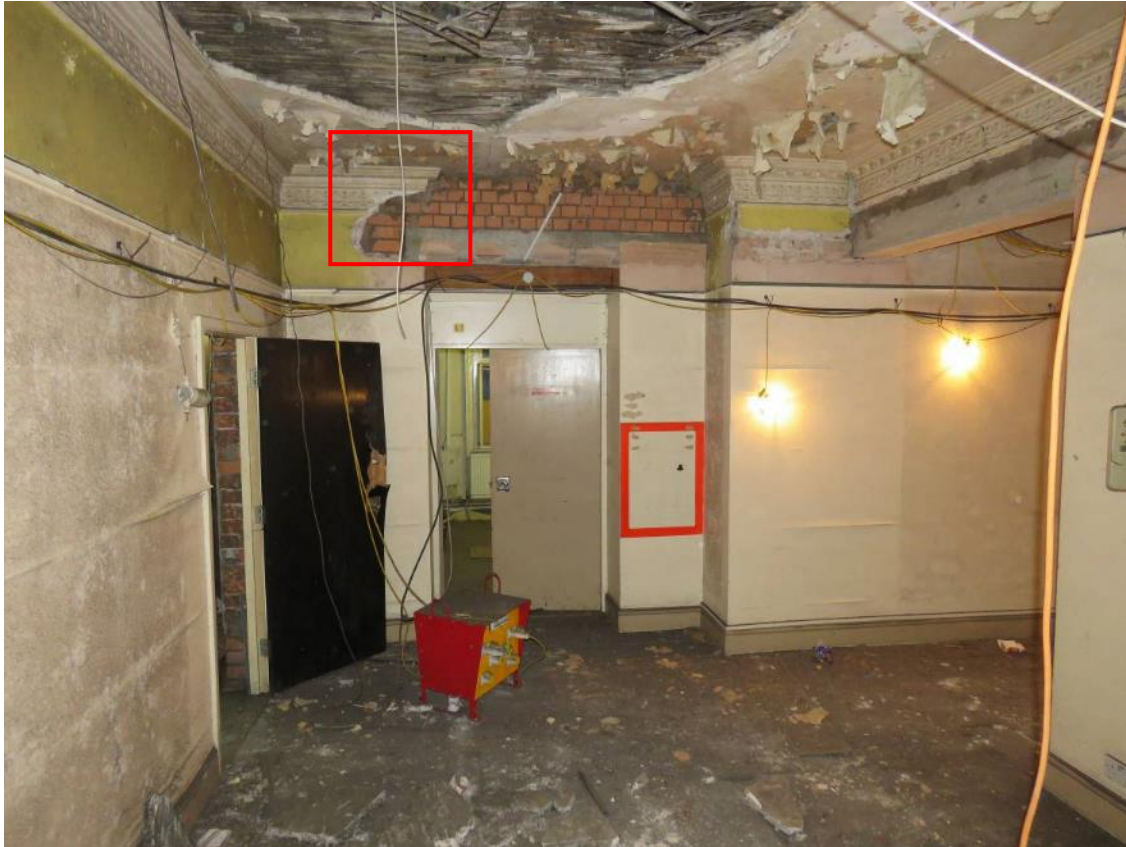
**Figure 67:** Room F16 (looking north) – This room was originally the landing of the western dwelling. The north wall shows evidence of the 1977 infilling of the original extension/alcove which gave access into the former dressing room (marked B in Figure 66 above). Note the return section of original plaster cornice denoting the corner of this now blocked alcove (outlined). (Source: SLHA 2017 - please note the condition of the building has significantly worsened since 2007)

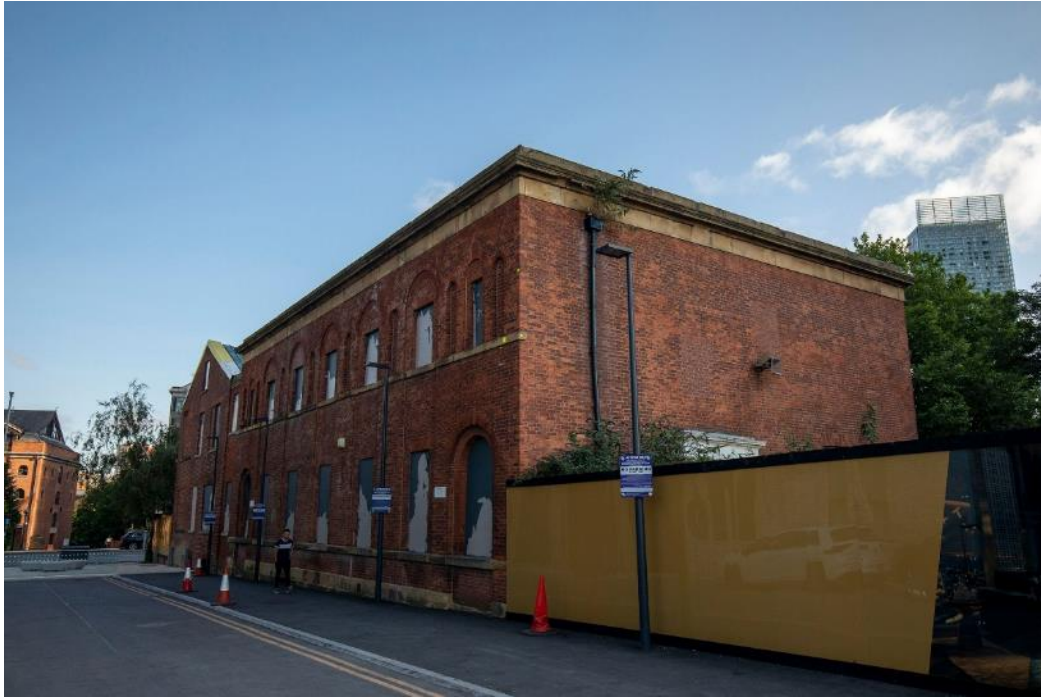
**Figure 99a:** The current appearance of the west elevation as seen in 2022. Note the original windows to the south elevation were in-filled in 1977 (compare with Figures 103 & 104 below) (Source: Watch This Space (Jembrana) Ltd 2022)

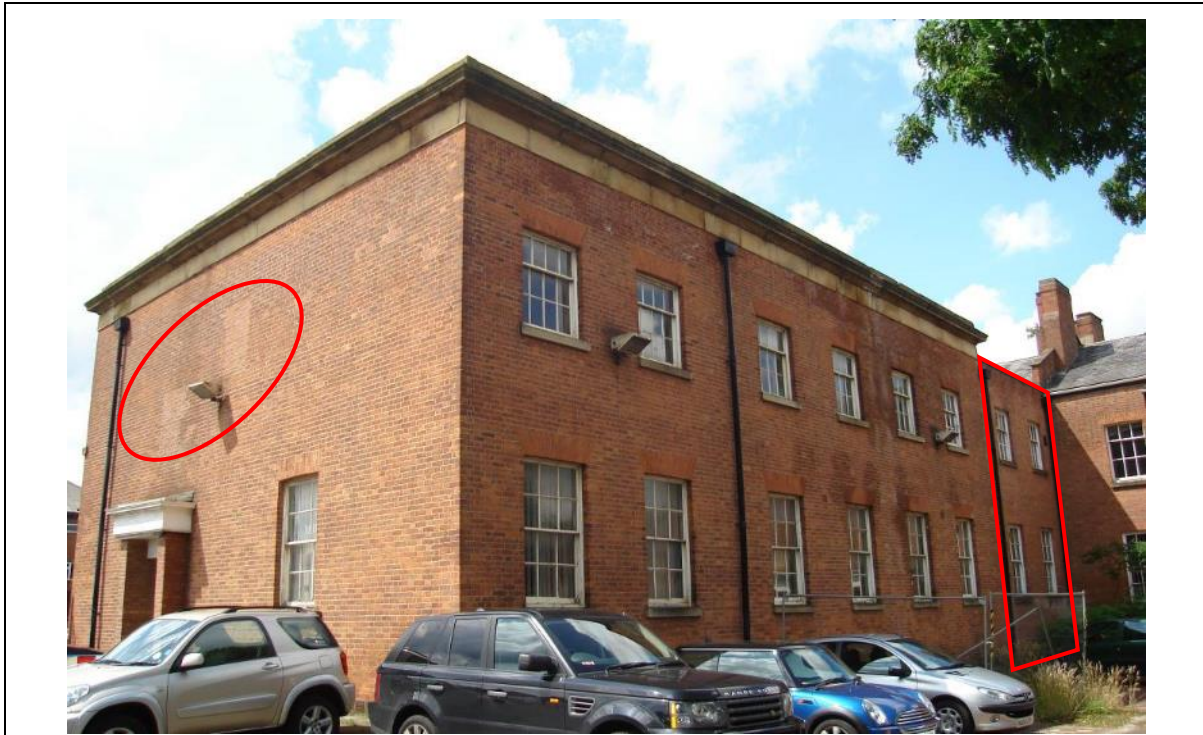
**Figure 102:** The east (right) and south (left) elevations of the 1842-3 office extension as seen in 2007, showing the 1977 alterations, including the infilling of the two original small windows (left) and addition of two-storey matching link in the location of the original office staircase and toilets (outlined right).

When originally built, the south and east elevations contained full-depth lightwells that extended around the perimeter of the building in order to allow light into the basement rooms. (Source: SLHA 2007)

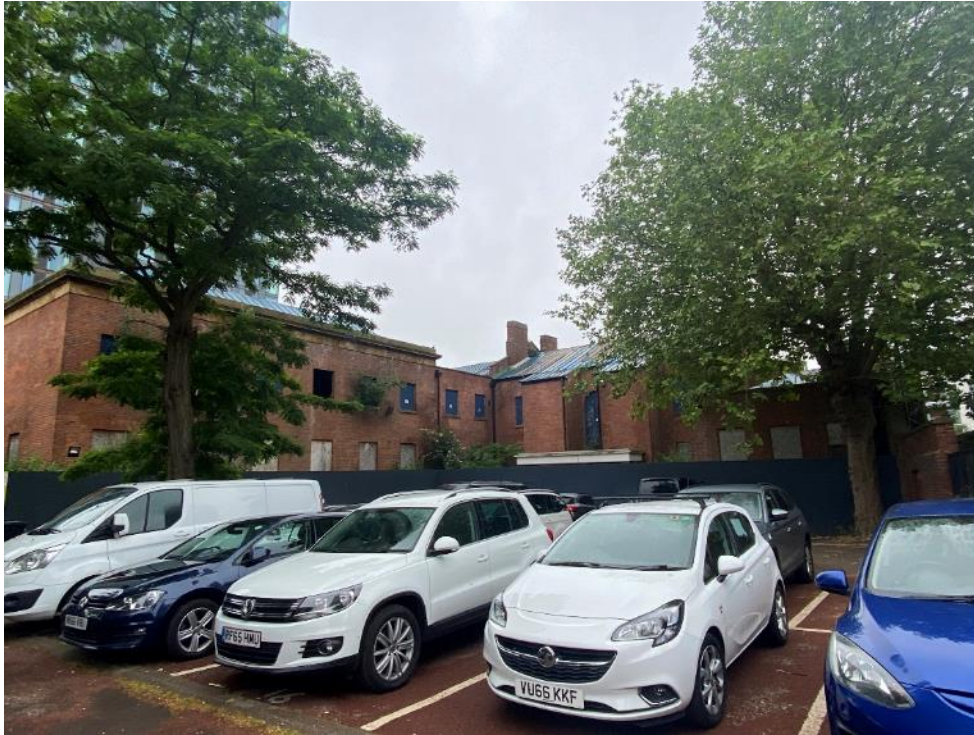
**Figure 104a:** The current appearance of the rear elevation of the building (Source: Watch This Space (Jembrana) Ltd 2022)
