Phase I Geoenvironmental Site Assessment  
Sulby Street, Manchester

Reference: 15-395-R1-1  
Date: February 2022

Land off Sulby Street  
Manchester  
M40 5HY

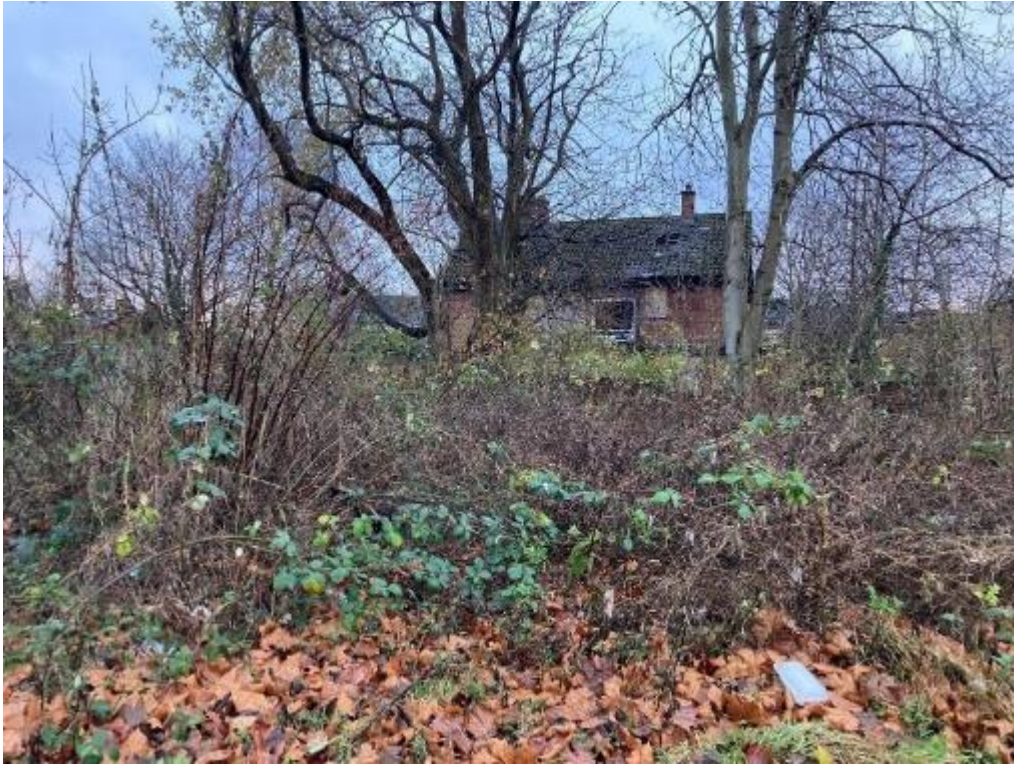
| <b>Vegetation/Ecology</b> | <p>Several mature trees were noted in the south east of the site.</p> <p>The south of the site contained a mixture of soft cover (grass) and scrub.</p> | |

PLATE 5      VEGETATION IN THE SOUTH EAST OF THE SITE

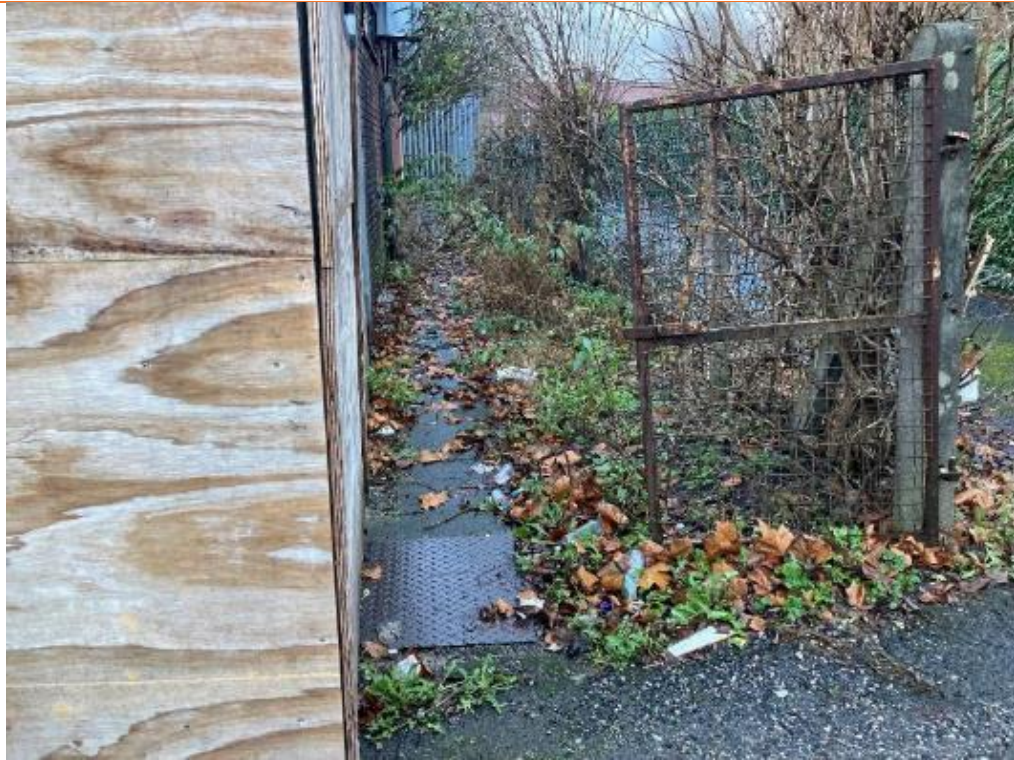
| <b>Utility Locations</b> | A formal drainage survey has not been completed; however, during the site walkover several manholes were noted around the perimeter of Luke's Social Club. An overhead cable is present transecting the site from the north east to the southwest. |

PLATE 6      MANHOLE COVER ALONG THE EASTERN SIDE OF ST LUKES SOCIAL CLUB
