**Arboricultural Advice in accordance with  
BS 5837:2012 Trees in relation to construction – Recommendations  
Tree survey and Impact Assessment  
8<sup>th</sup> July 2022**

Subject Property: 226-228 Errwood Road  
Manchester  
M19 1HX

Completed by: Hugh Wilson MSc BSc M.Arbor A.  
Forest & Tree Consulting Ltd  
40 Church Street  
Trawden  
Lancashire  
BB8 8RU

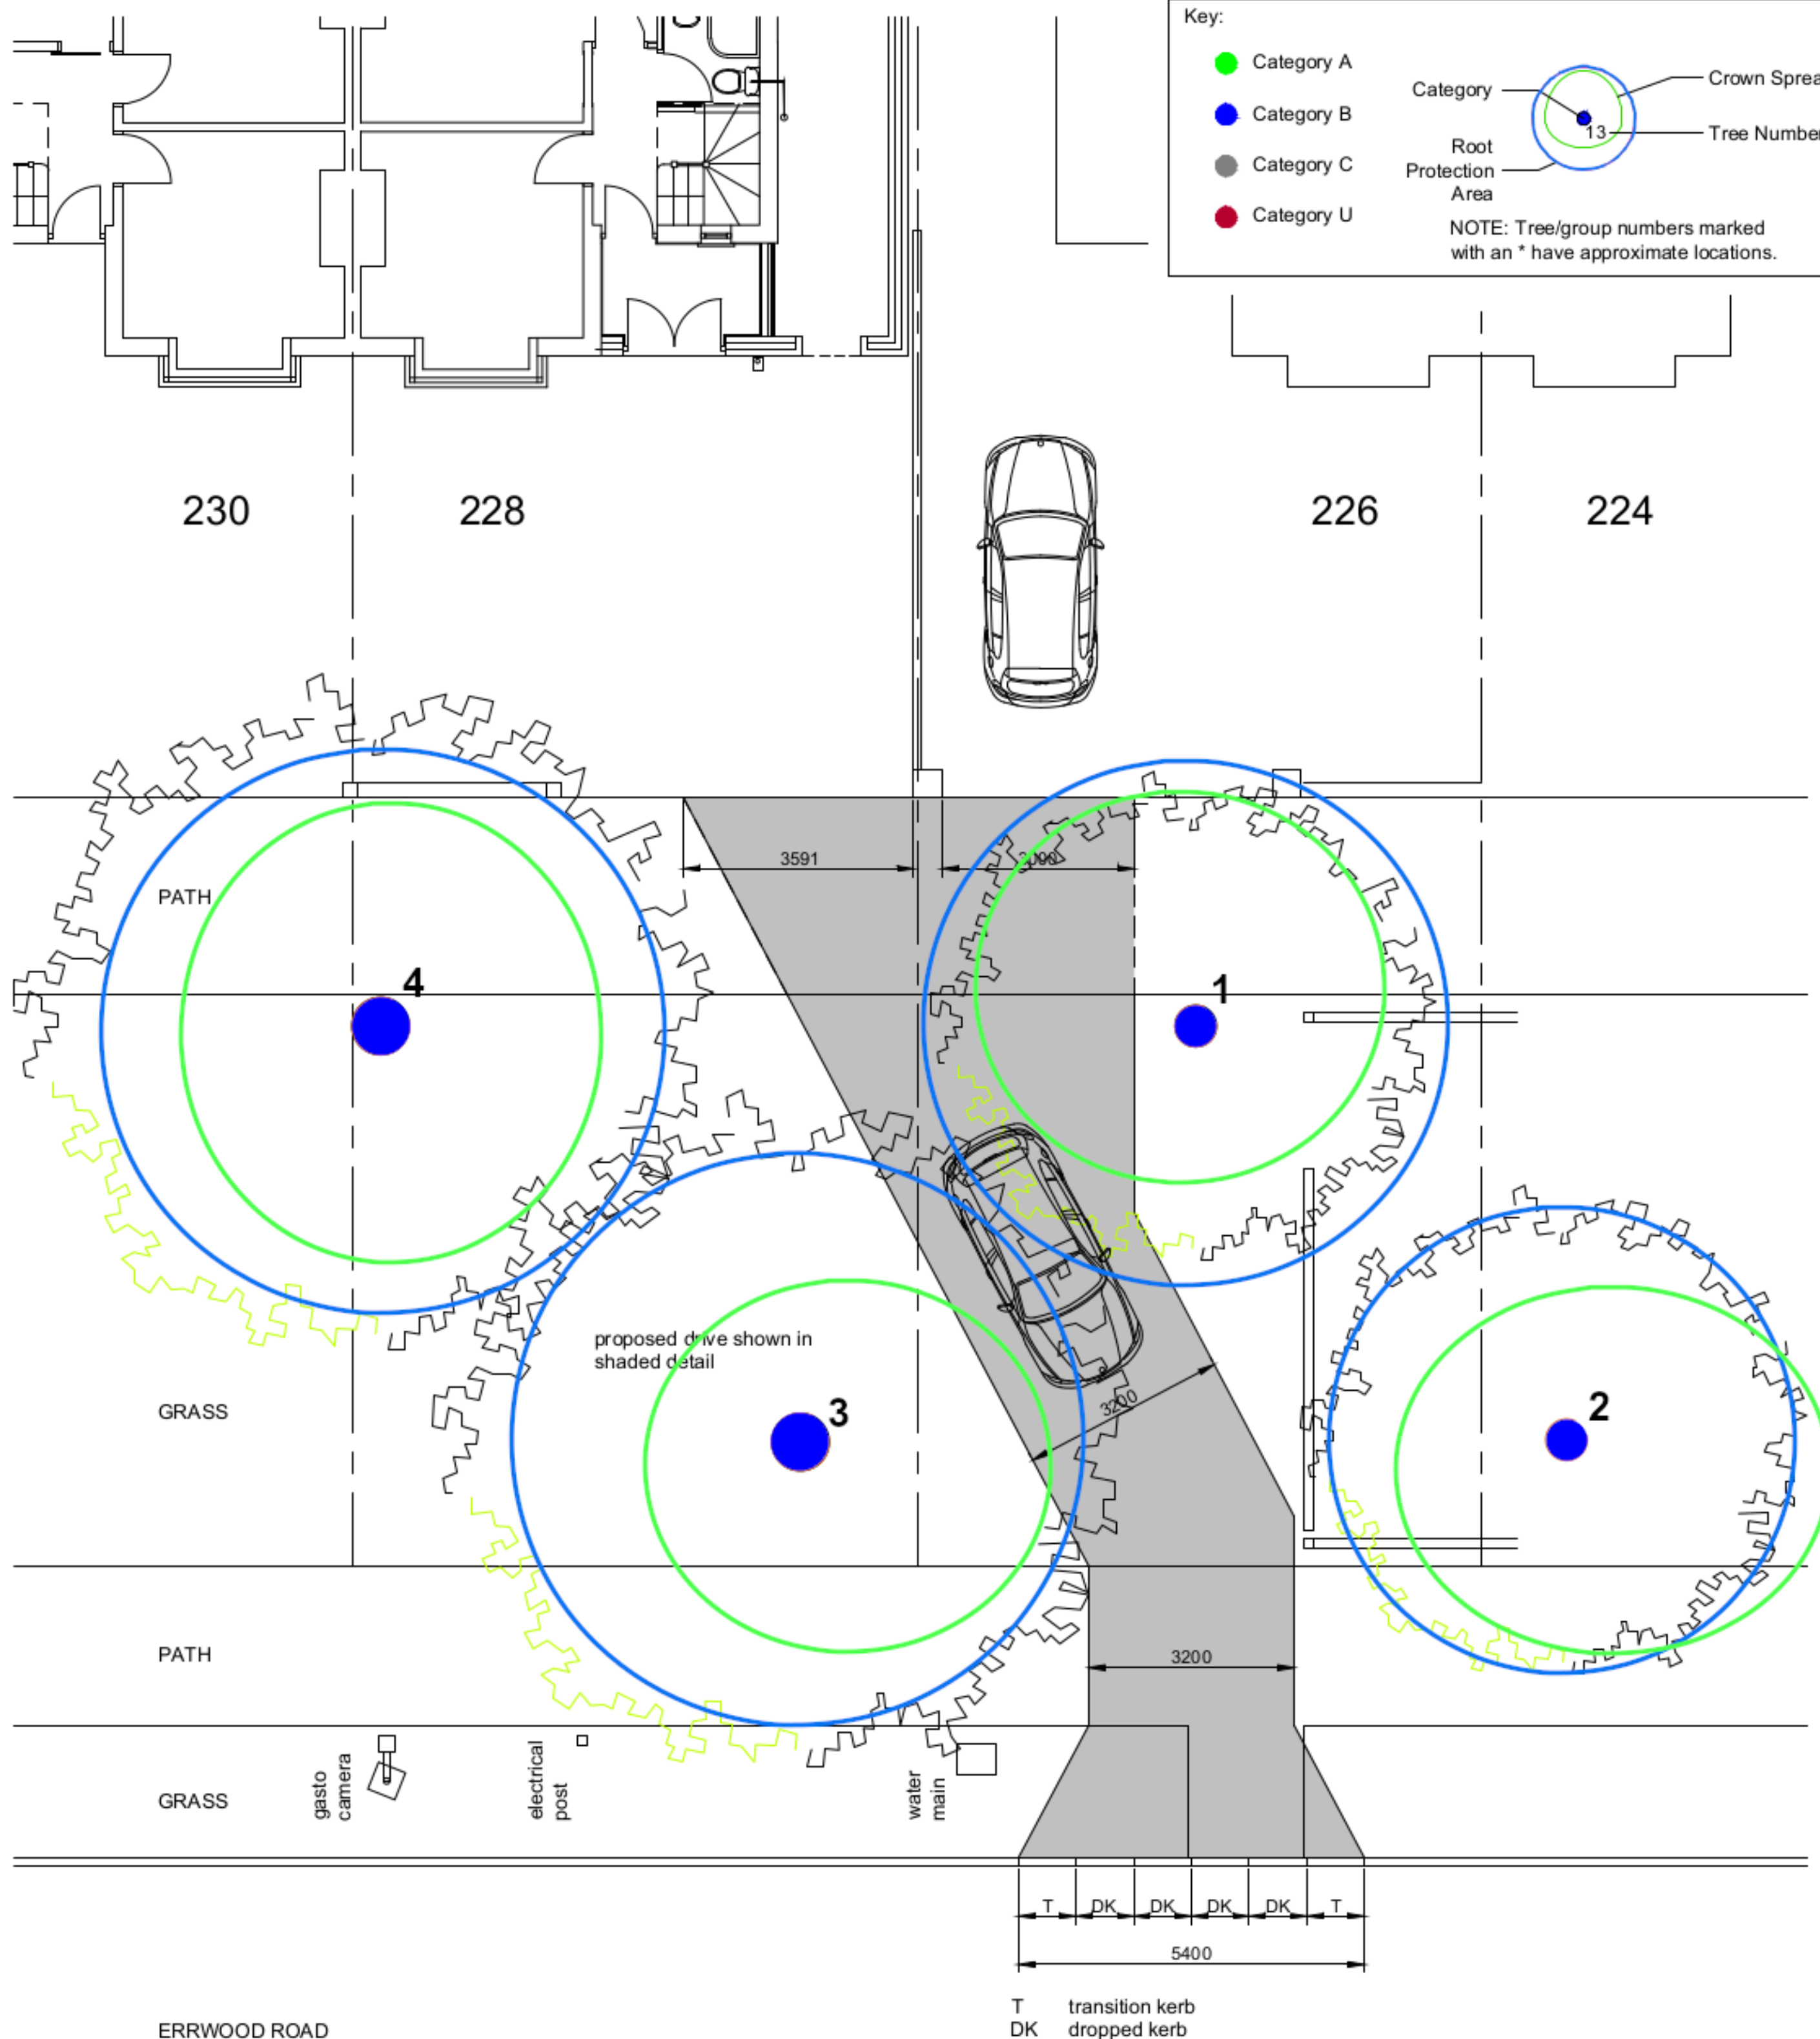
Drawing Number: 226-228 - AIA -1

4.1.1 The proposal is the creation of a formalised driveway from the road edge (Errwood Road) to the existing driveways of 226 and 228 Errwood Road. This route goes across grass verge that lies between two pavement areas running either side of it and parallel to the roadside and the fronts of the properties. Currently access to the property's driveway's is informally made over the same grass verge in the same location.

4.2.1 There are two area of construction proposed within RPAs both of which are the creation of the new driveway across the grass verge between pavements. This will take the form of the installation of a no-dig driveway system. A plastic cellular confinement system will be placed on the existing ground level and then filled with gravel with a layer of topsoil added over this. At the edges of this system the soil surface will be graded down from the top of the new driveway to the existing ground level using suitable aggregate/soil.

From the above information it is readily apparent that in all incidences of incursion into RPAs the extent is well below the acceptable maximum set by BS5837 in the case of T1, but greater

than the maximum in the case of T3. However the use of a no-dig cellular confinement system means that the surface layer will not be a hard impermeable surface. Therefore the change in surface cover is not a consideration in this instance.

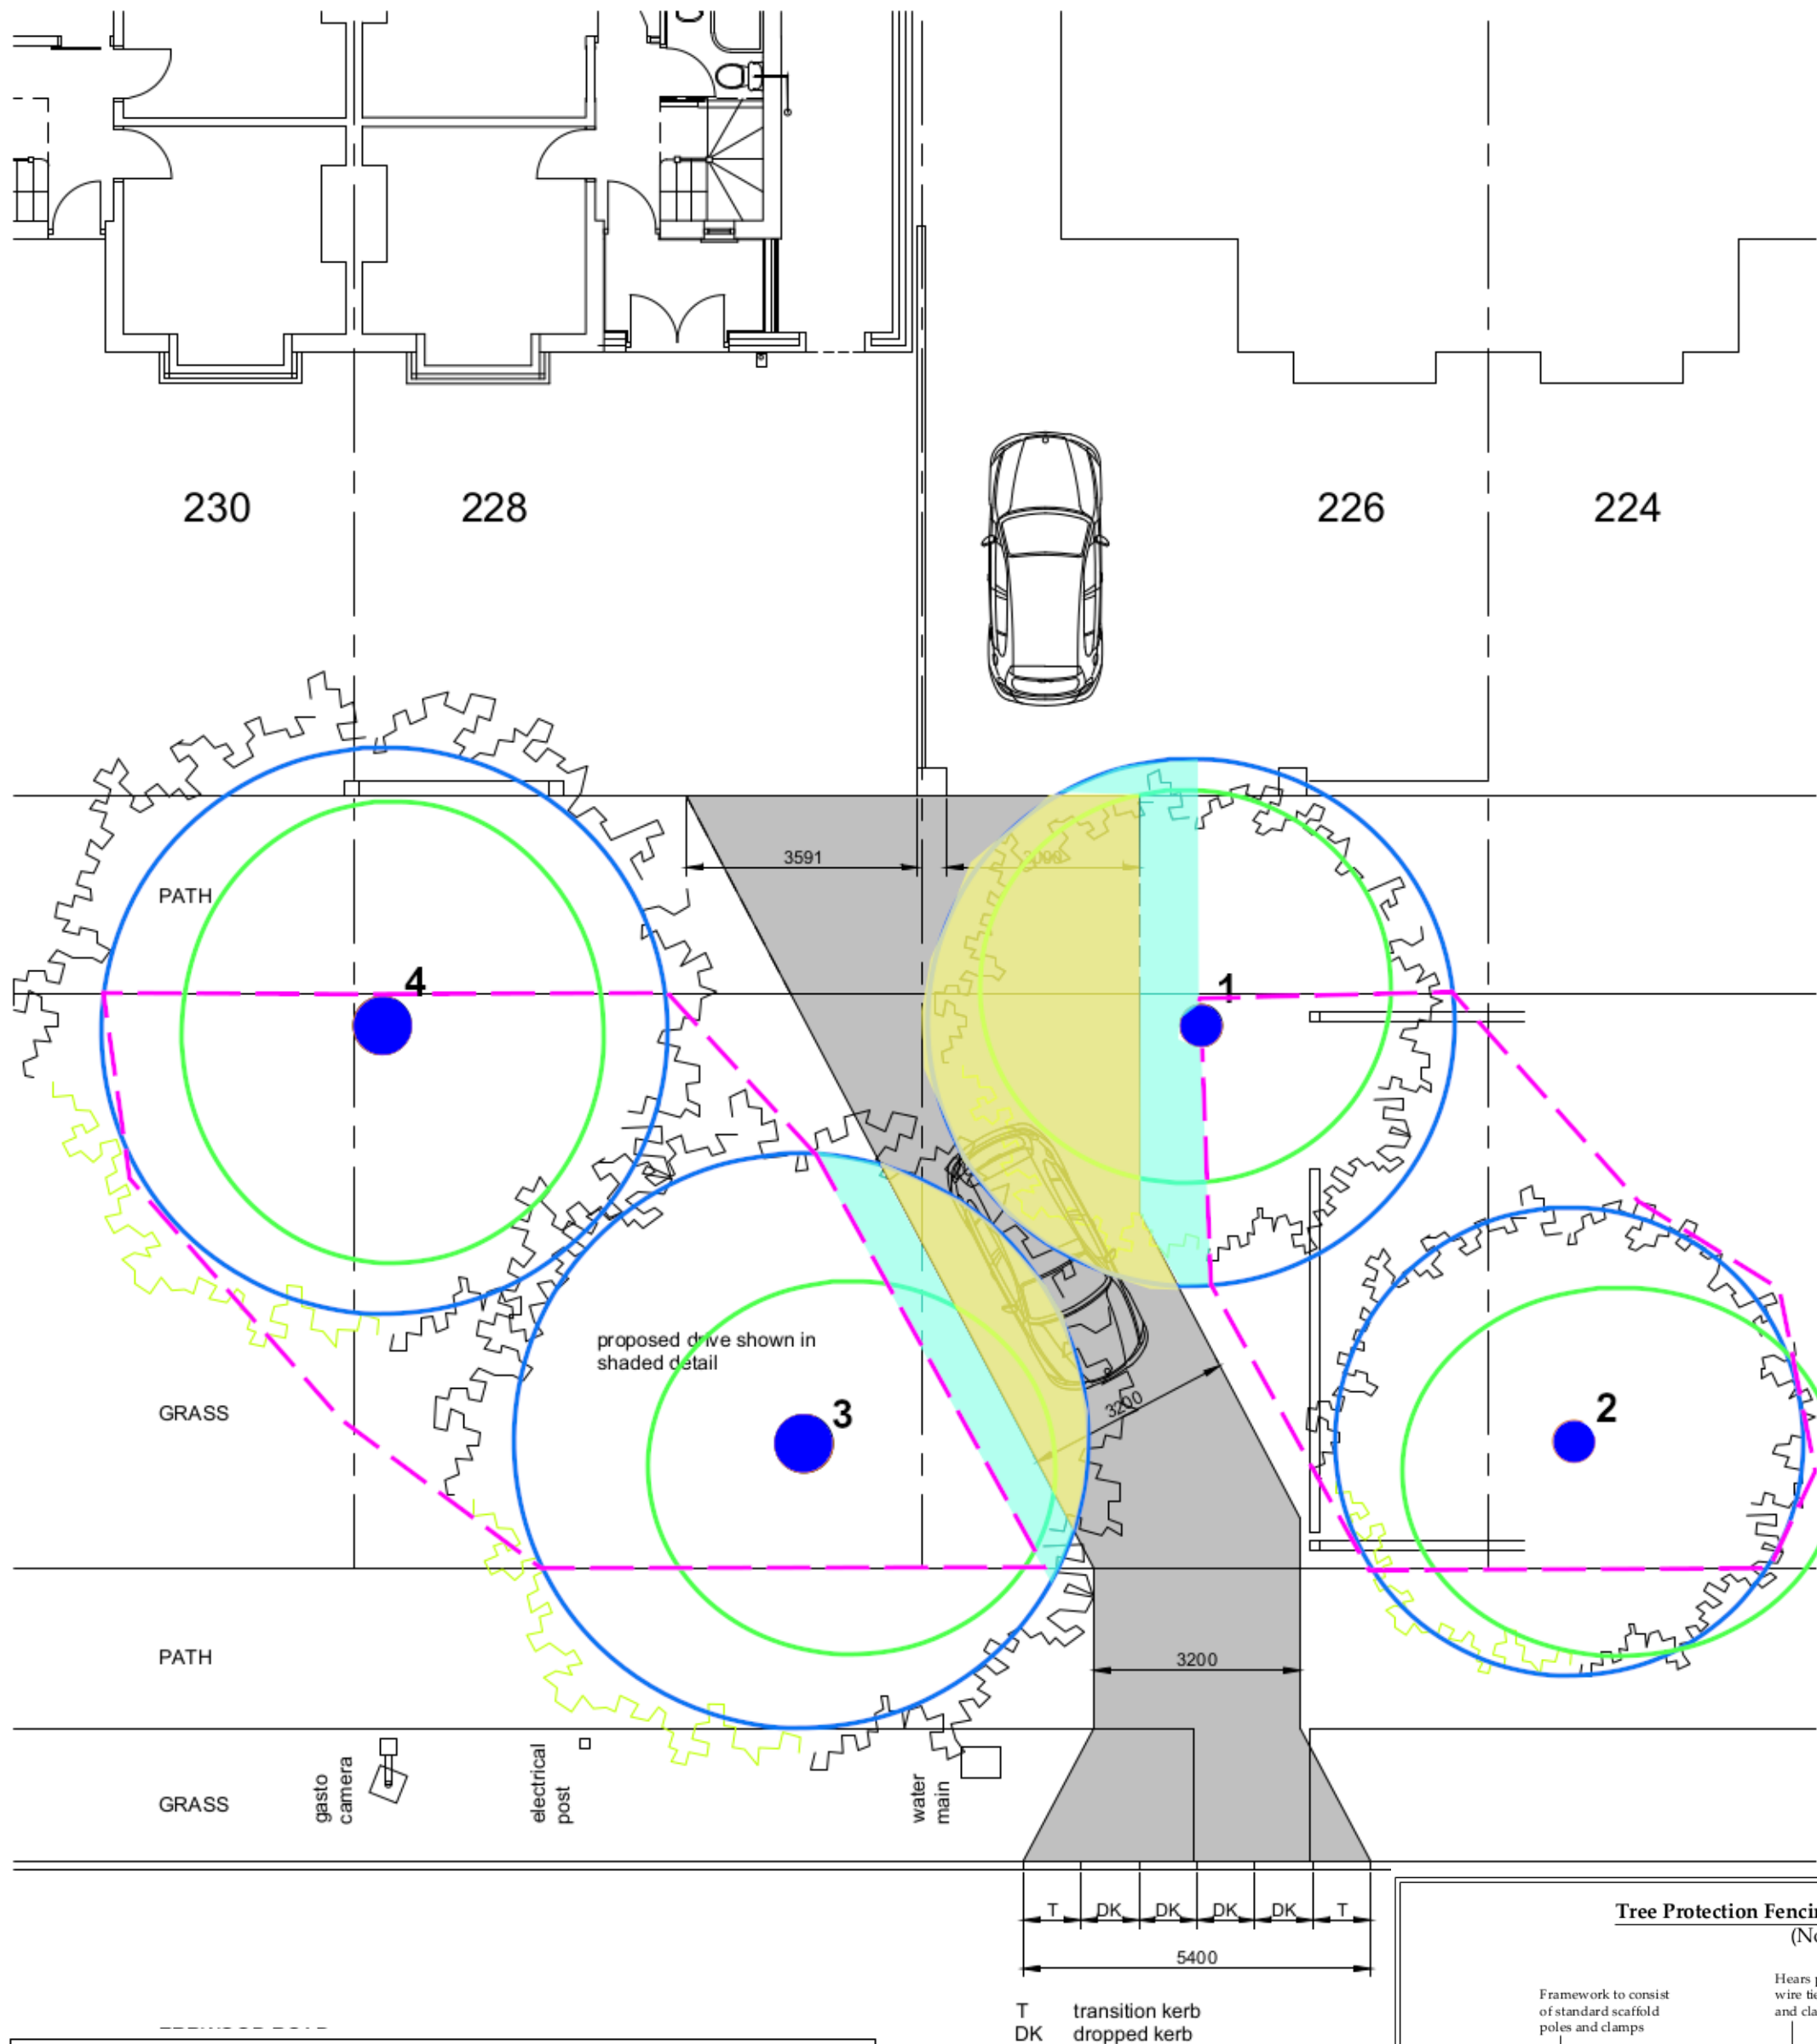
Tree Protection Plan

5. Within the CEZ, two areas of construction work within the RPA of T1 and 3 will be supervised by an arboricultural consultant, shown by the yellow shaded areas adjacent. Break out and replacement of existing hard surfaces and decommissioning of redundant services, including drainage structures, are also high-risk operations and shall be undertaken under site supervision by an arboricultural consultant. Redundant buried structures are preferably disconnected/backfilled and retained in situ; further advice should be sought from the arboricultural consultant before consideration is given to grubbing them out. Any existing hard surfaces within the CEZ are to be retained and not demolished/removed until completion of main building construction.

6. Additionally ground protection shall me implemented within the RPA of T1 and 3 also, this will be composed of two methods. Where a hard surface driveway is present within the blue shaded zone shown adjacent, it will be retained throughout the construction phase until completion. Where no hard surface is current present an area of constructed ground protection will be made as per the diagram adjacent. This will be maintained in place until the completion of the development. All other hard surfaces (pavements) within the CEZ will be retained intact.

7. Within the areas of construction required within the CEZ (see highlighted yellow area) no excavation will be undertaken. A no-dig driveway system will be installed over the grass verge area. This will take the form of a rigid plastic matrix backfilled with gravel and topsoil and then sow with grass. At the edges of the driveway a gradient of topsoil and sub-soil will be used to grade down from the new surface level of the no-dig system to the existing ground surface level.
