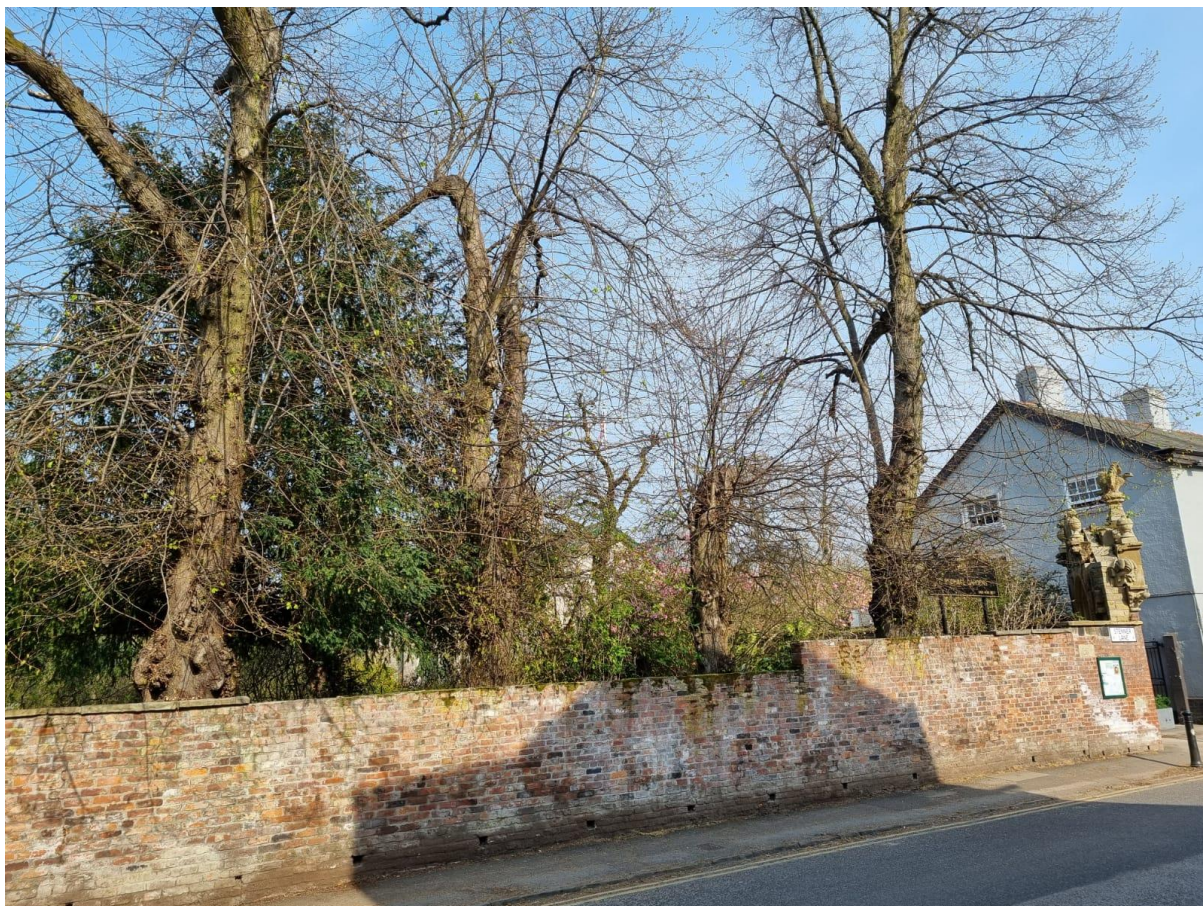
**Photo 1:** Photo taken on Stenner Lane facing the Eastern perimeter boundary retaining wall to Fletcher Moss Art Gallery.

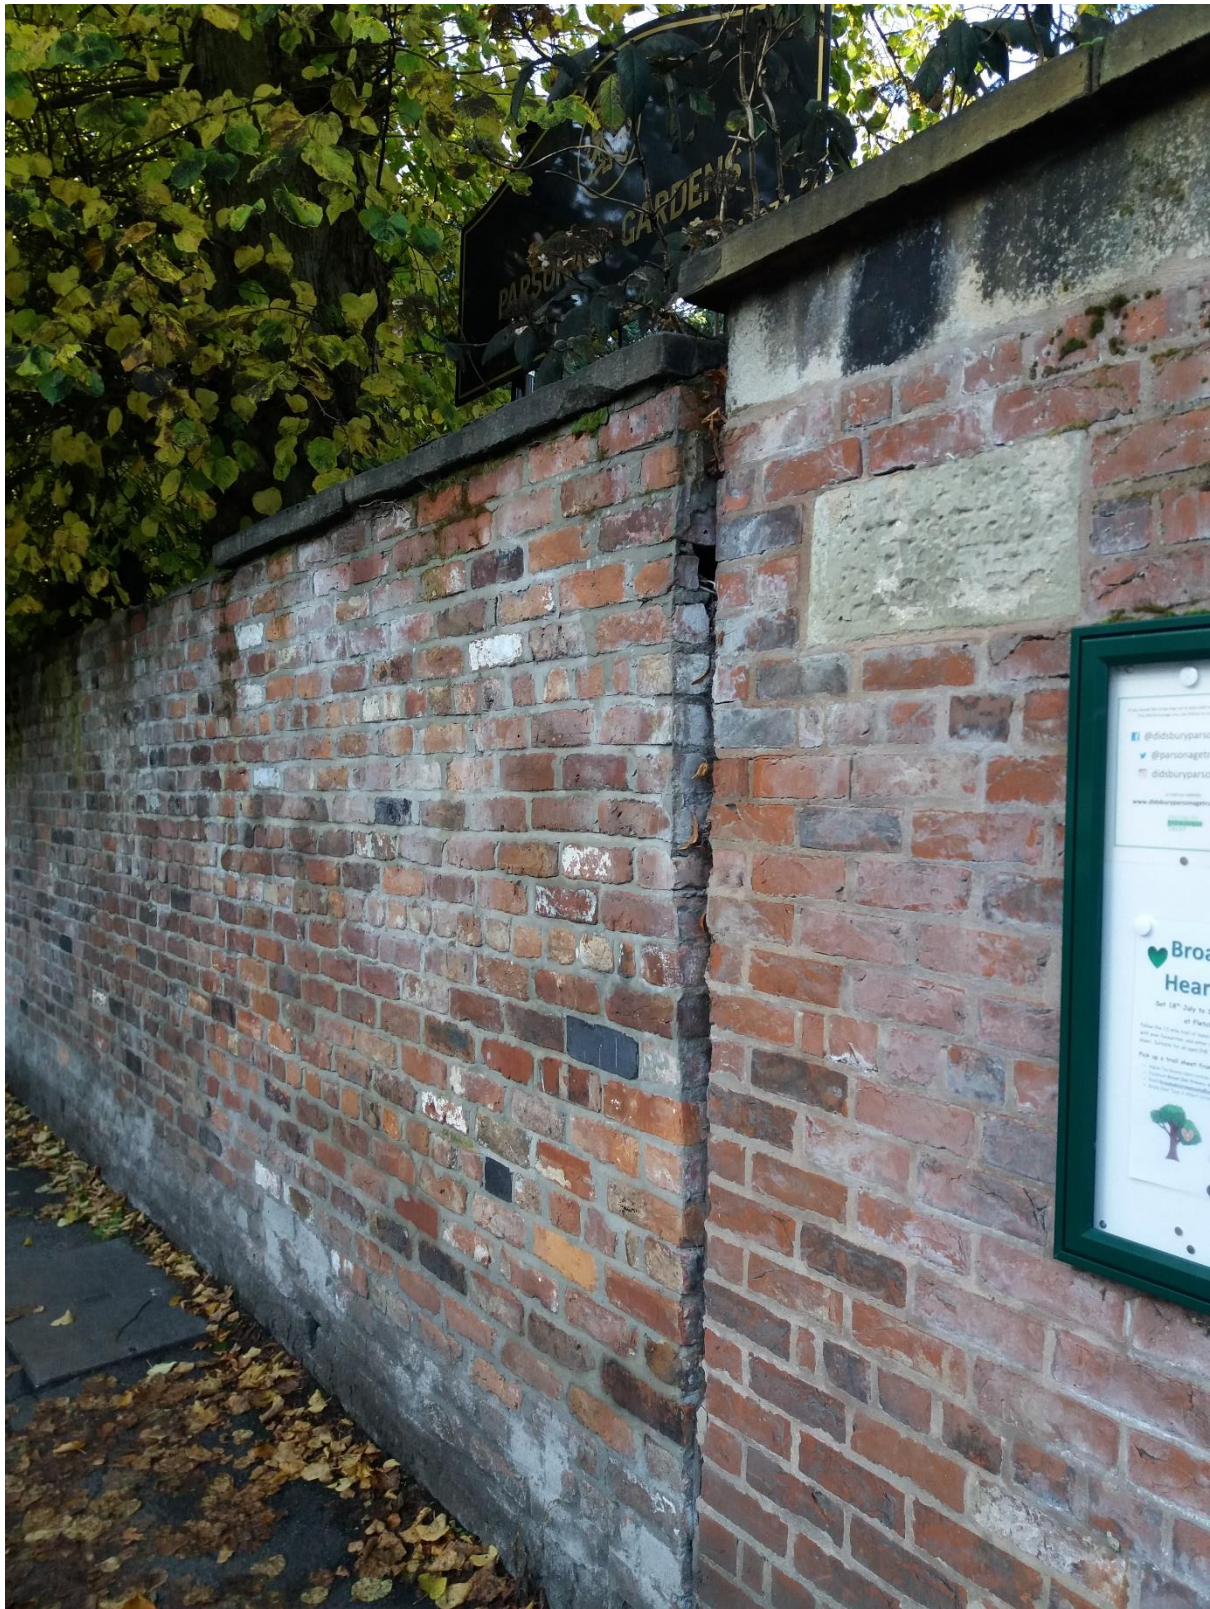
**Photo 2:** Leaning boundary wall close to stone arch entrance on Stenner Lane.

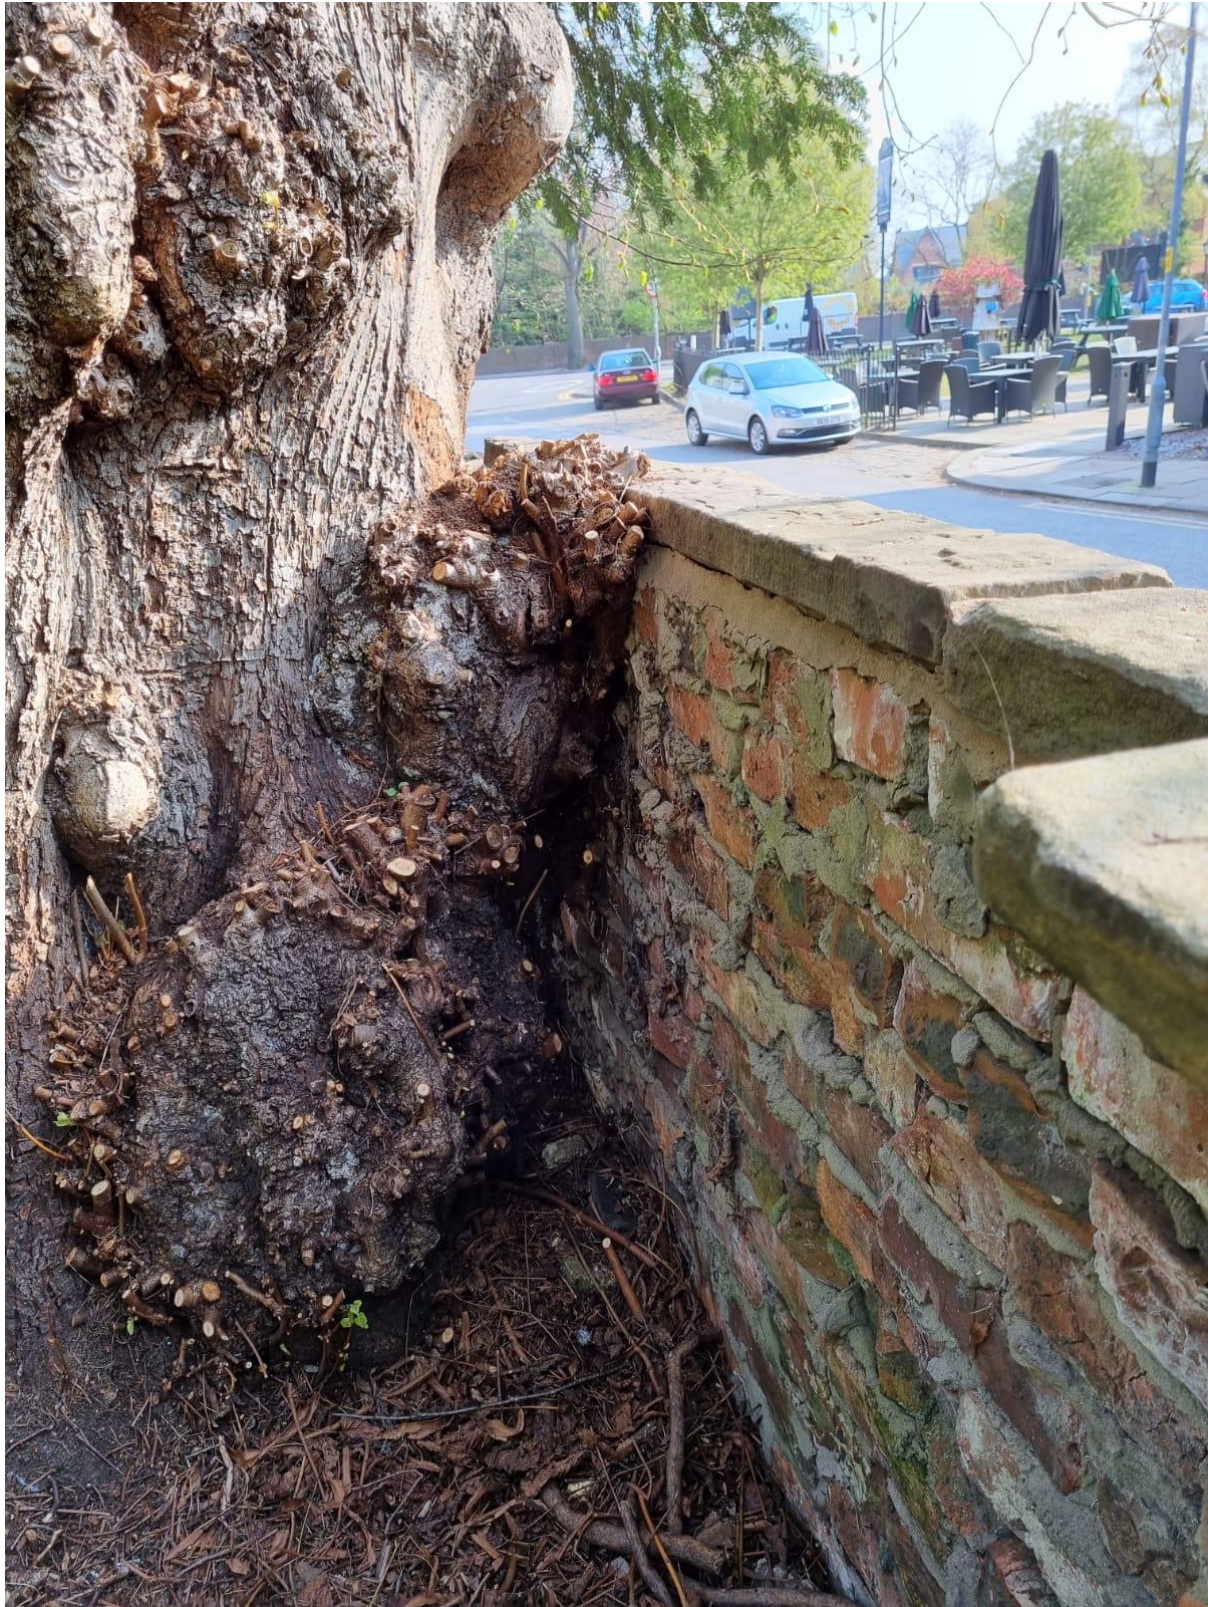
**Photo 3:** Lime tree adjacent to the boundary wall. This section of wall was removed as part of the emergency works.

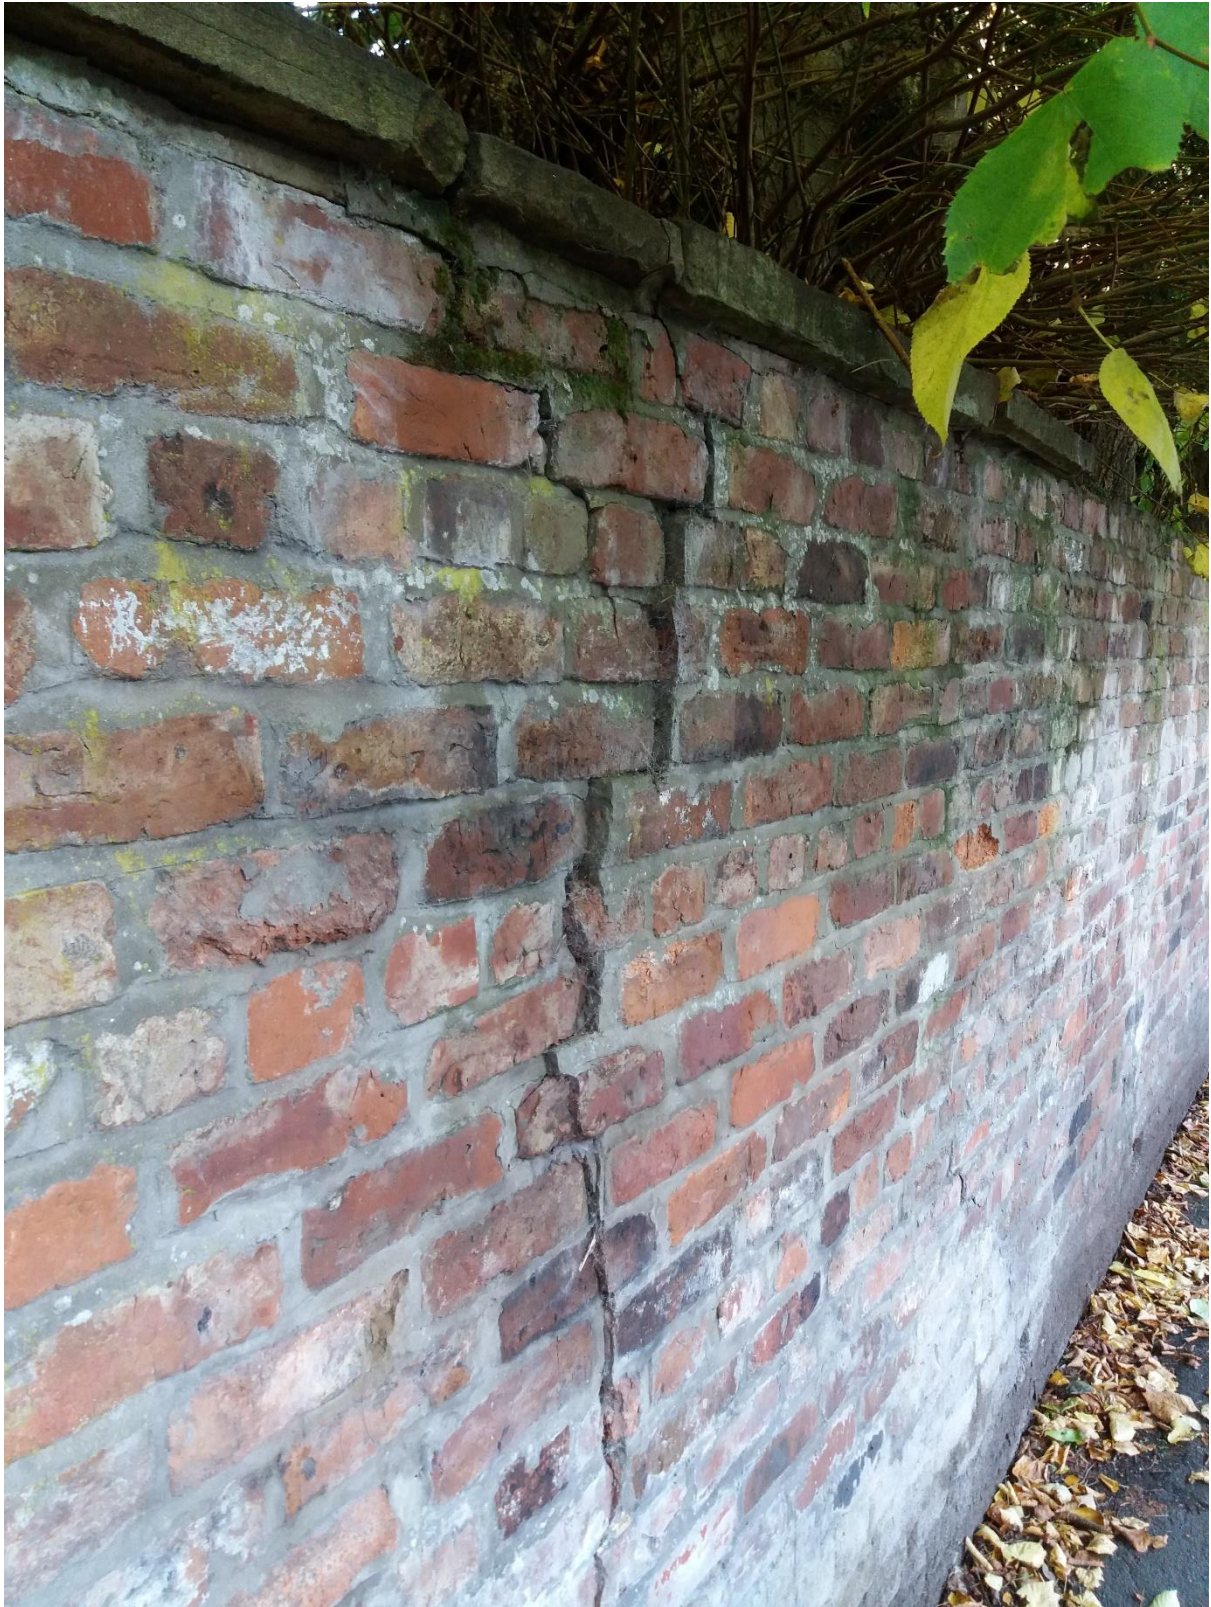
**Photo 4:** Photograph of cracking to boundary wall caused by tree growth and movement. Location of emergency works to reduce the wall height by 9 courses of brickwork, undertaken in June 2021. See Photo 5 for final finish.

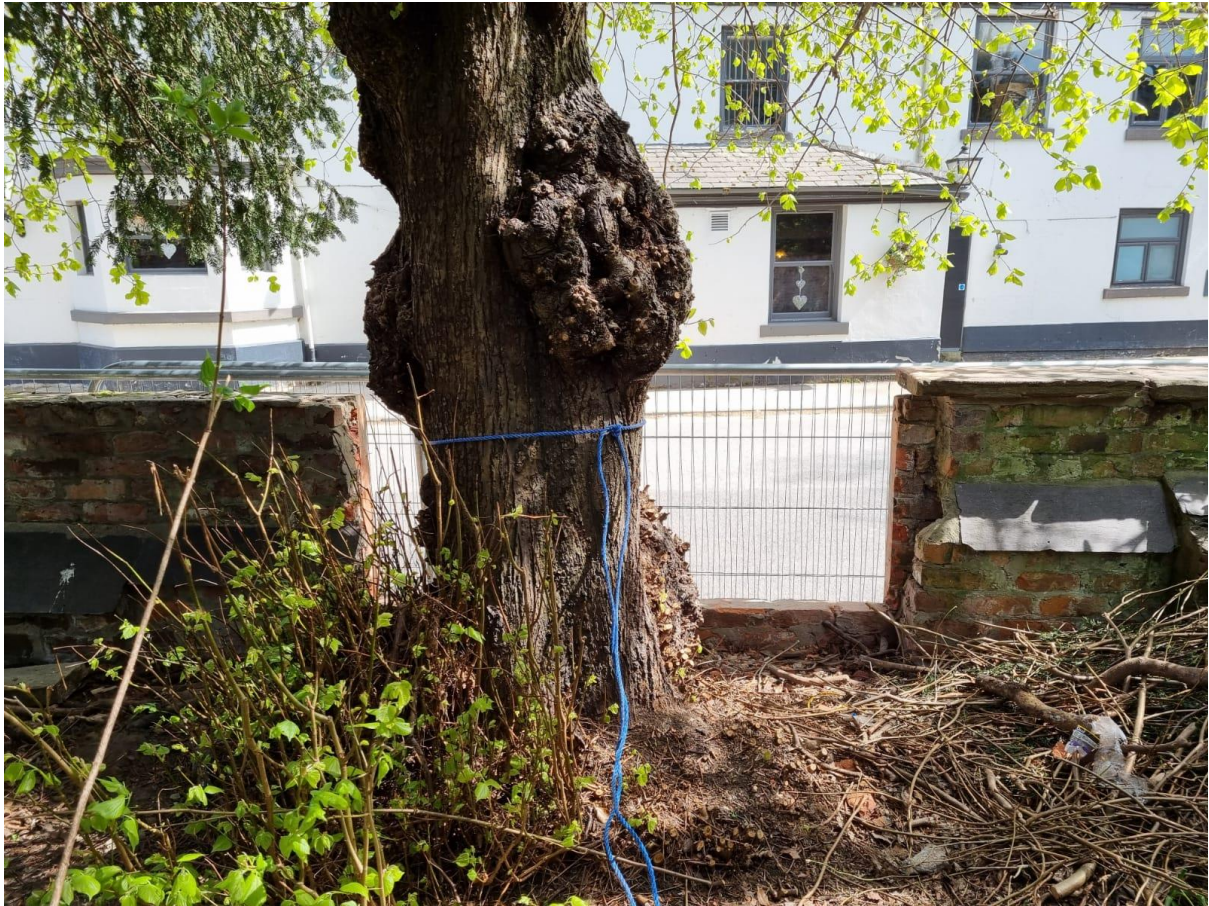
**Photo 5:** Section of boundary wall removed as part of the emergency works.

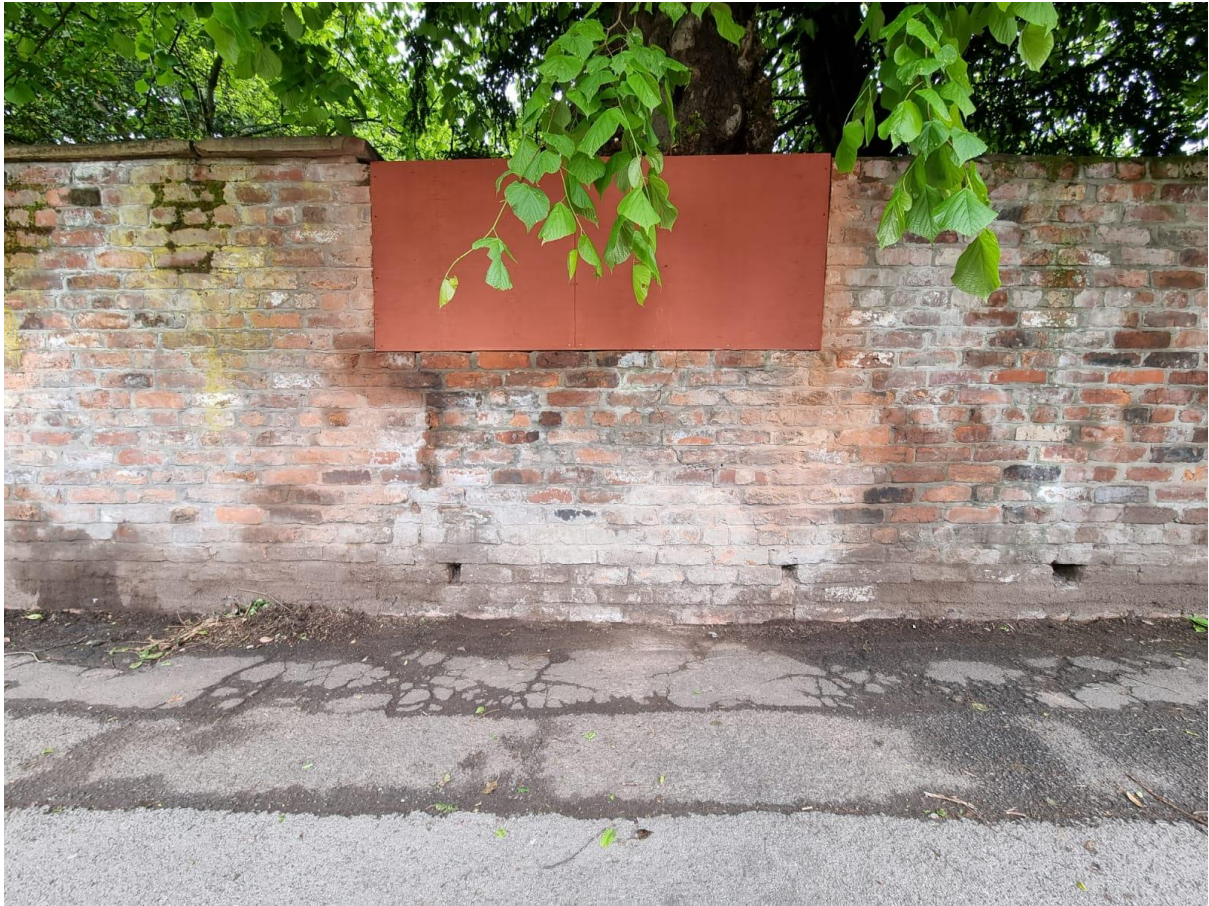
**Photo 6:** Boarded up section of wall put in place to temporarily secure the grounds.

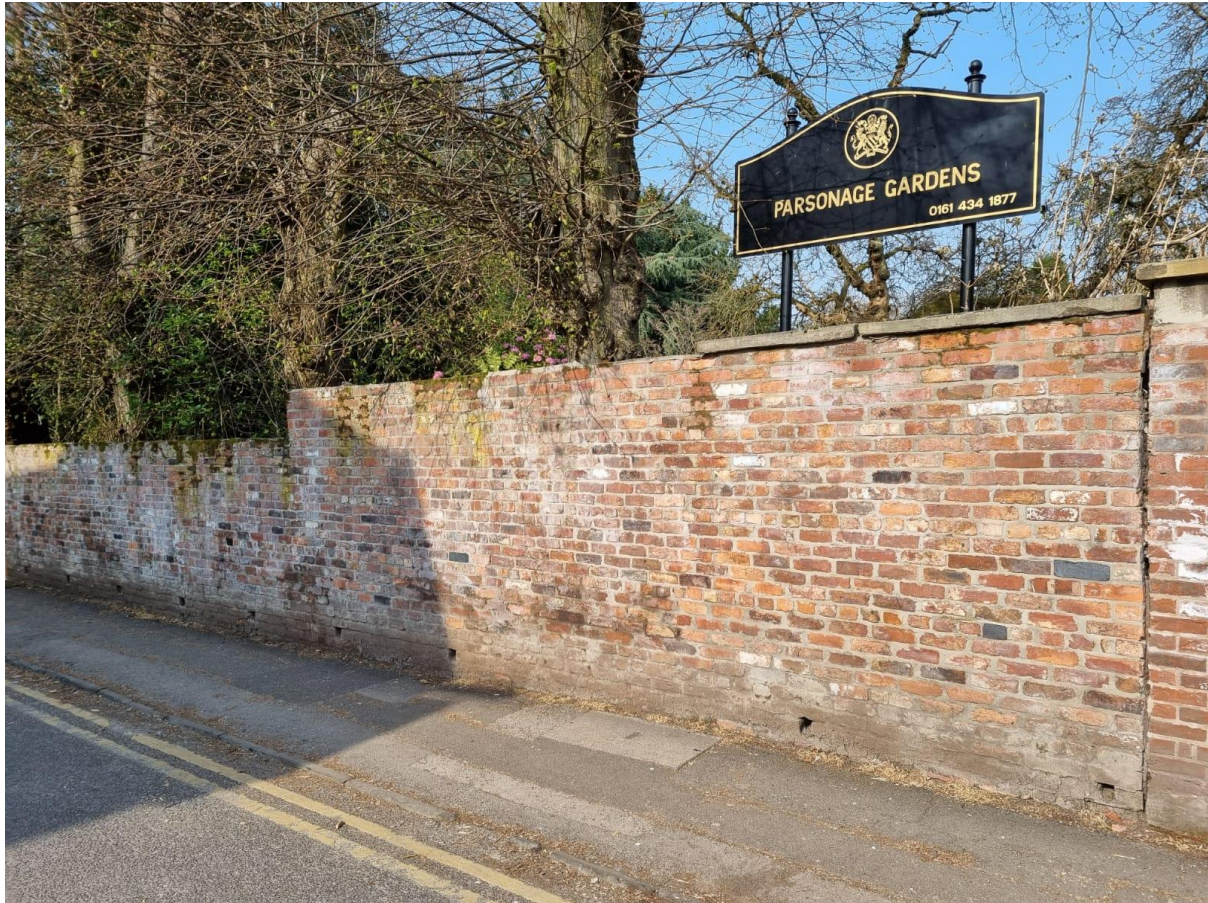
**Photo 7:** Existing section of wall to be dismantled and rebuilt to a reduced height to match attached lower section of boundary wall.

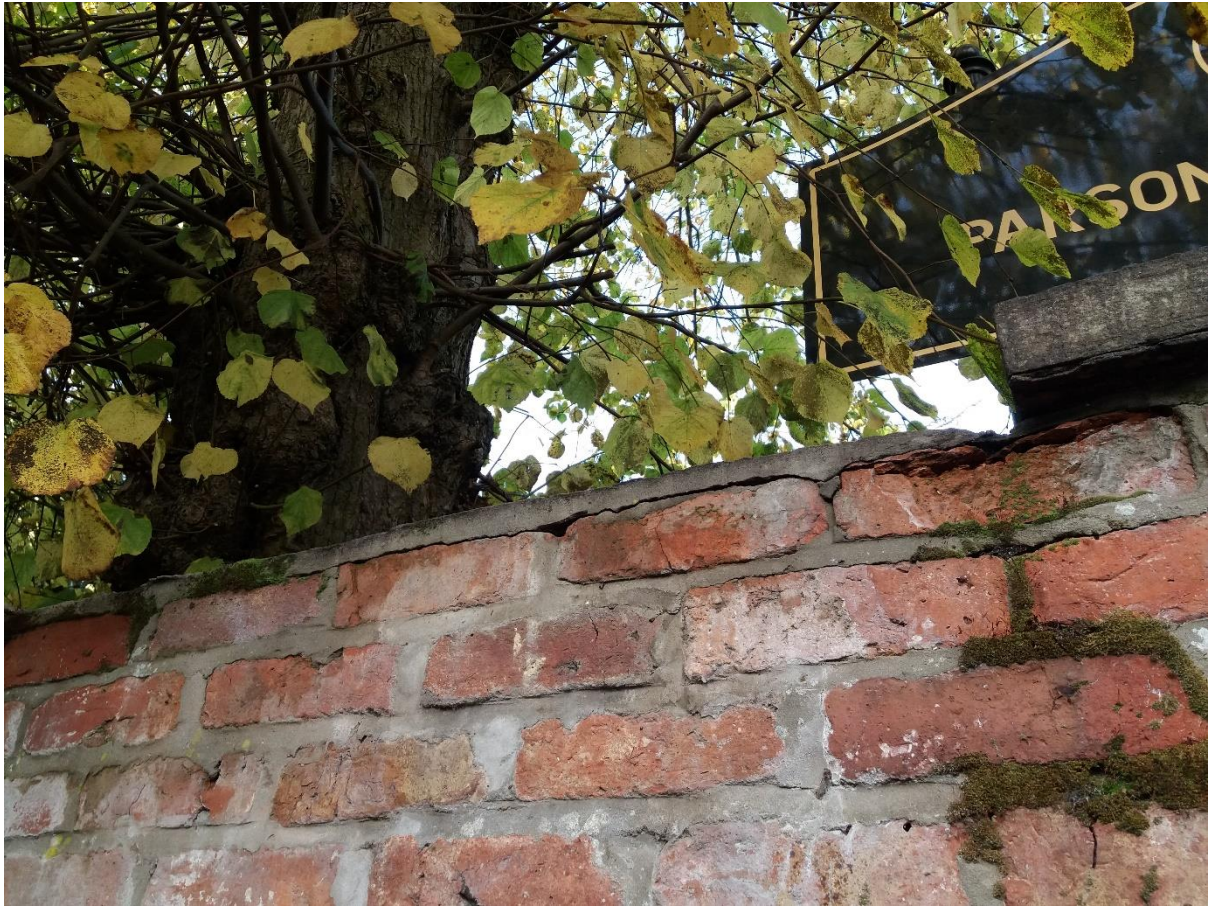
**Photo 8: Missing Coping stones;** the sandstone coping stones are missing to the majority of this section of wall on Stenner Lane

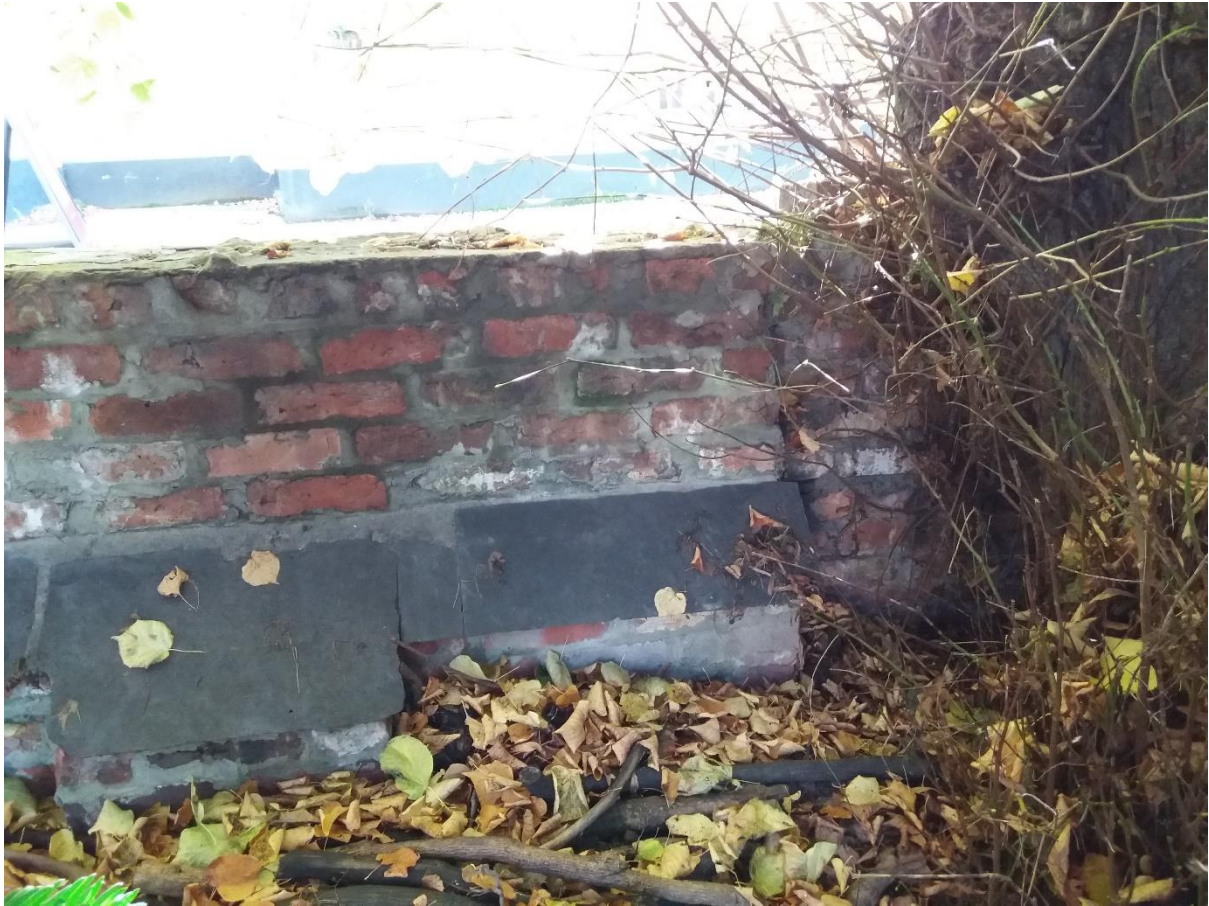
**Photo No.9:** See changes in wall thickness from top of boundary wall down to increased thickness at ground level.

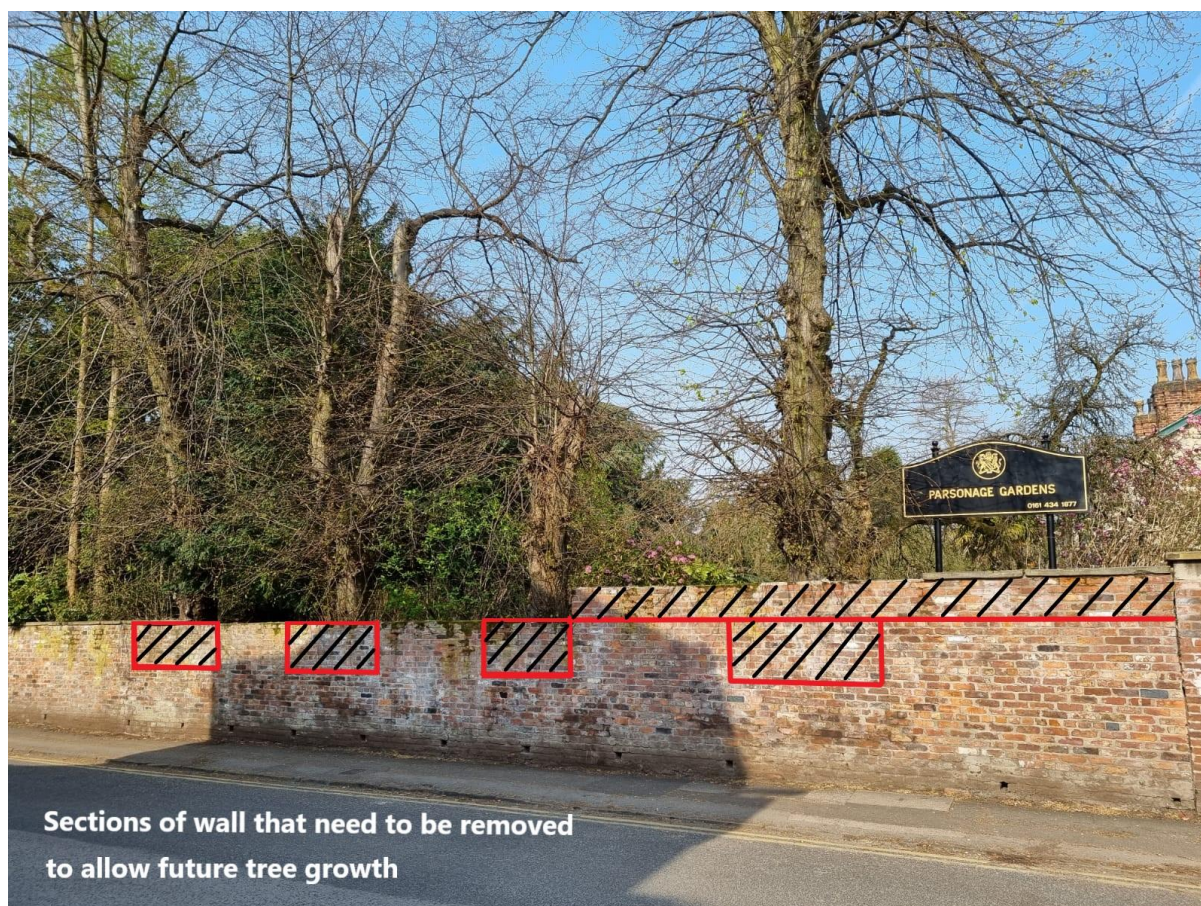
**Photo No.10:** Highlighted sections of wall that need to be permanently removed to allow the trees space for future growth.

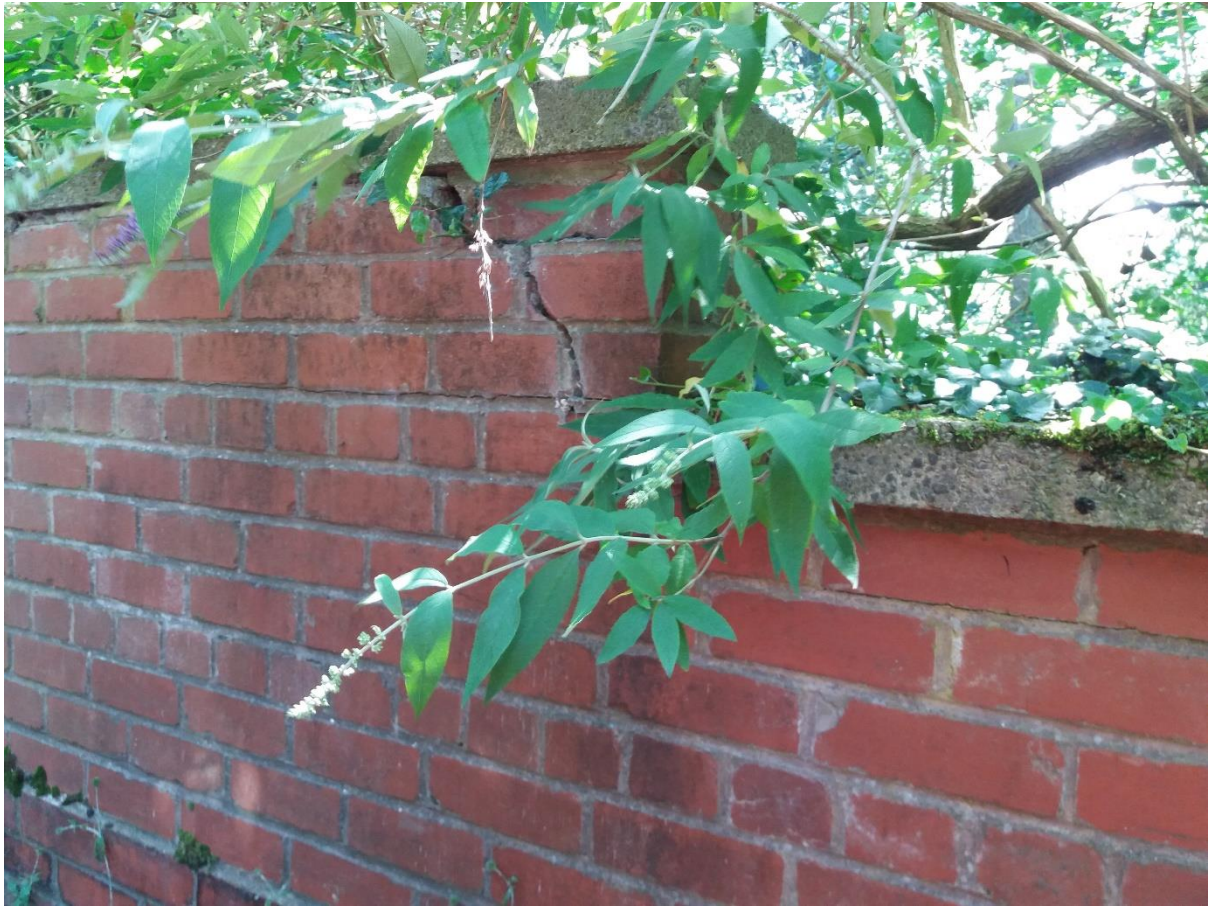
**Photo No.11:** Damage to section of boundary wall to Fletcher Moss Park to Western side of Stenner Lane.

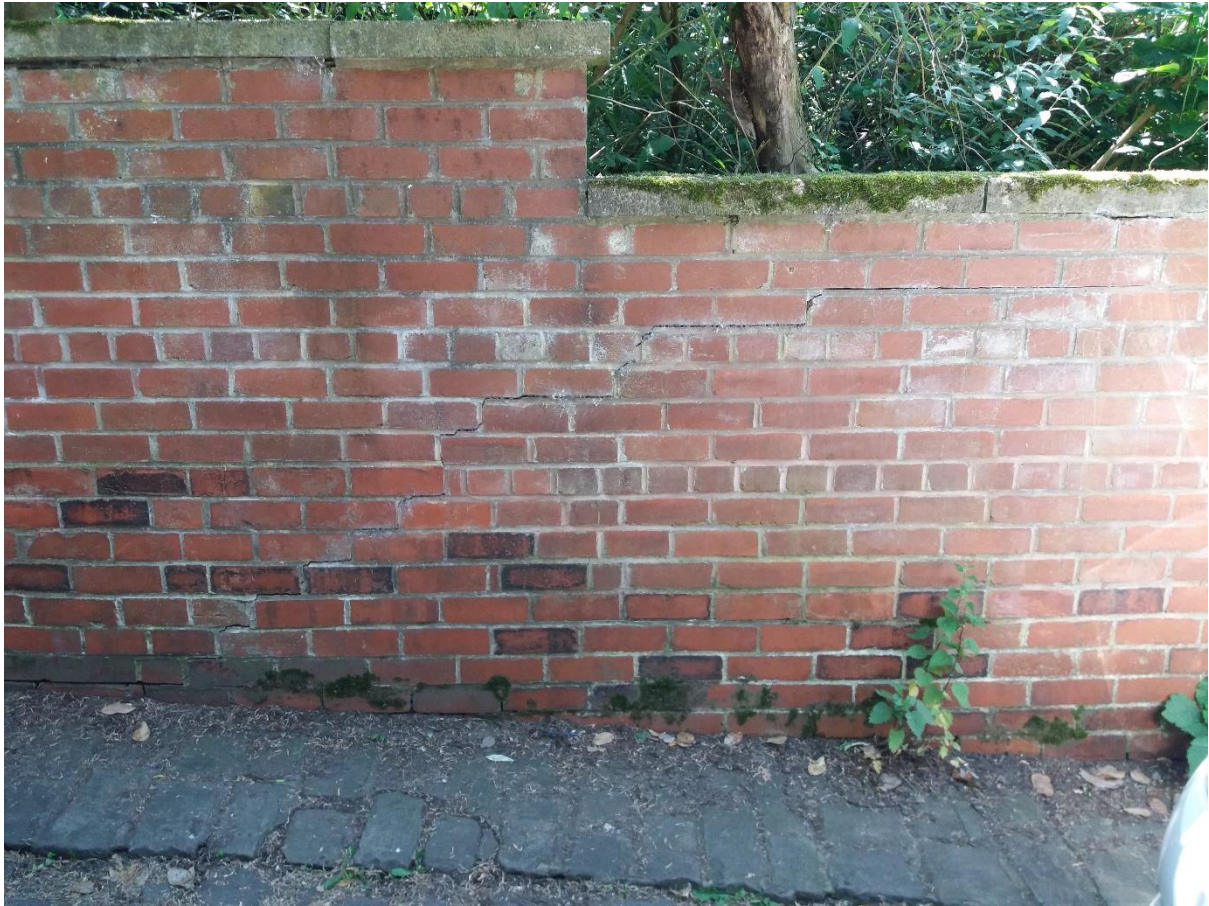
**Photo No.12:** Stepped cracking to boundary wall on western side of Stenner Lane adjacent Fletcher Moss Park.
